**NATIONAL TRANSPORTATION SAFETY BOARD
OFFICE OF AVIATION SAFETY
WASHINGTON, D.C. 20594**

POWERPLANTS GROUP CHAIRMAN'S FACTUAL REPORT

NTSB ID No.: ENG08IA038

Location: McCarran International Airport, Las Vegas, Nevada
Date: August 6, 2008
Time: 15:40 Pacific daylight time
Aircraft: Boeing 757-232, N666DN, Delta Air Lines, Flight 624

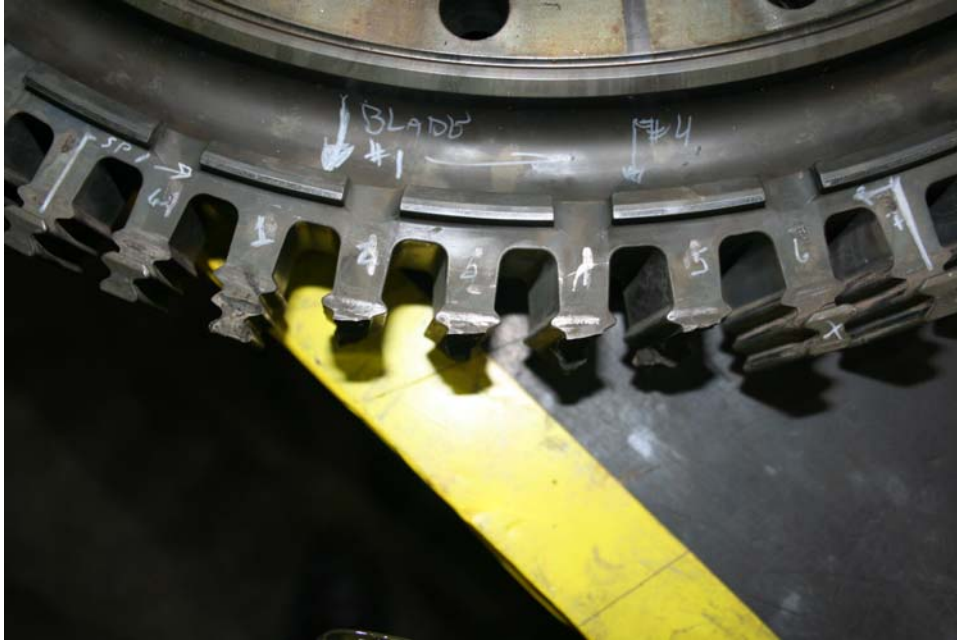
The 2nd stage turbine hub was intact except for five adjacent disk lugs, Nos. 2 through 5, that were fractured transversely through the fir trees.⁵ (Photo 1) Disk lug No. 1 had the forward blade retaining plate retention hook fractured. The fracture surface on disk lug No. 1 had a dark-colored, elliptical-shaped flat surface radiating from the inner diameter of the retaining plate snap fillet outward. (Photo 2) The fracture surfaces on disk lugs Nos. 2 through 5 had dark-colored, elliptical-shaped flat features radiating from the front acute corner. (Photo 3) The visual inspection of the 2nd stage turbine hub revealed 11 other lugs, Nos. 6, 9, 13, 14, 18, 28, 29, 40, 47, 58, and 59 were cracked. (Photo 4) The front and rear faces of the hub as well as the hub bore did not have any rub marks. The following markings were noted on the 2nd stage turbine hub: PN 1B6602J, SN DKLBA86546, heat code PHNLS 2007, 33459 S/N, 408.

Photo 1: Close up of 2nd stage turbine hub showing fractured lugs Nos. 2 through 5 (P&W)

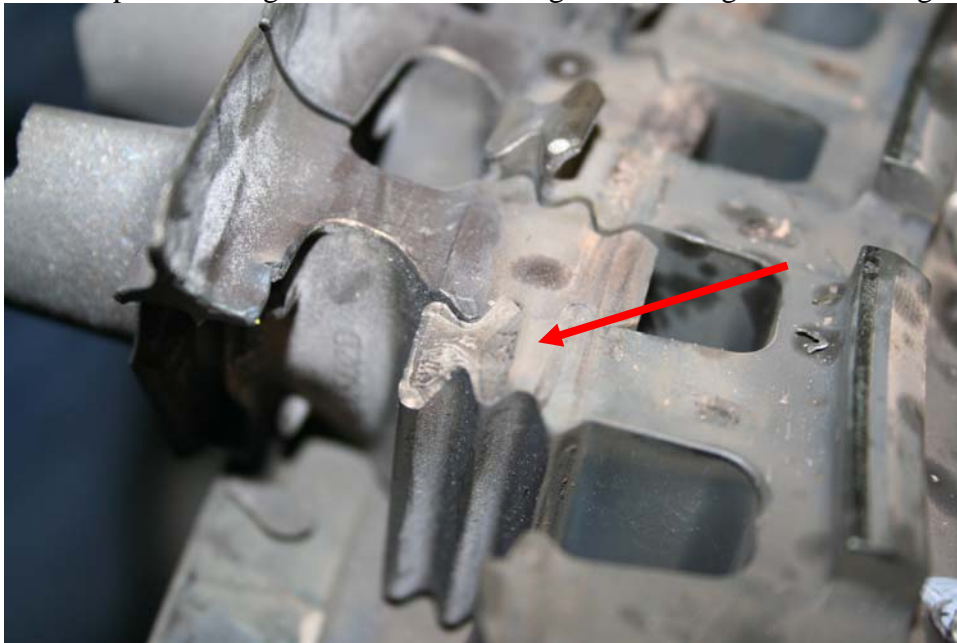
Photo 2: Close up of lug No. 1 with arrow pointing to the dark-colored, elliptical-shaped fracture surface feature (P&W)

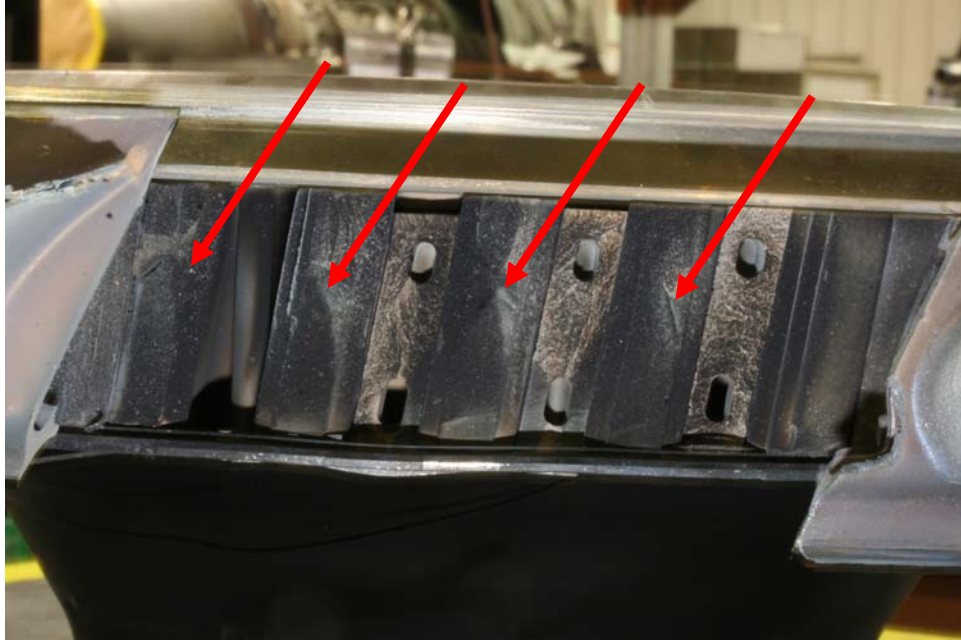
Photo 3: Close up of fracture lugs Nos. 2 through 5 with arrows pointing to the elliptical-shaped fracture surface features (P&W)

According to the Safety Board's Materials Laboratory report, the examination of lugs Nos. 2 through 5 revealed fracture surfaces that were smooth and flat, consistent with fatigue. The areas of fatigue on lugs Nos. 2 through 5 originated from multiple origins along the root radius between the middle and inner serration on the pressure side of the lug. The examination of the fracture surfaces on lugs Nos. 2 through 5 with the scanning electron microscope revealed the fractures were consistent with fatigue at elevated temperatures. Lug No. 5 had the largest area of fatigue. On both sides of the blade retaining lugs, but primarily on the pressure side, the inner tooth non-contacting area had a wavy surface pattern that was most prominent at the tip and extended back about 0.3 to 0.6 inches from the front face of the hub.

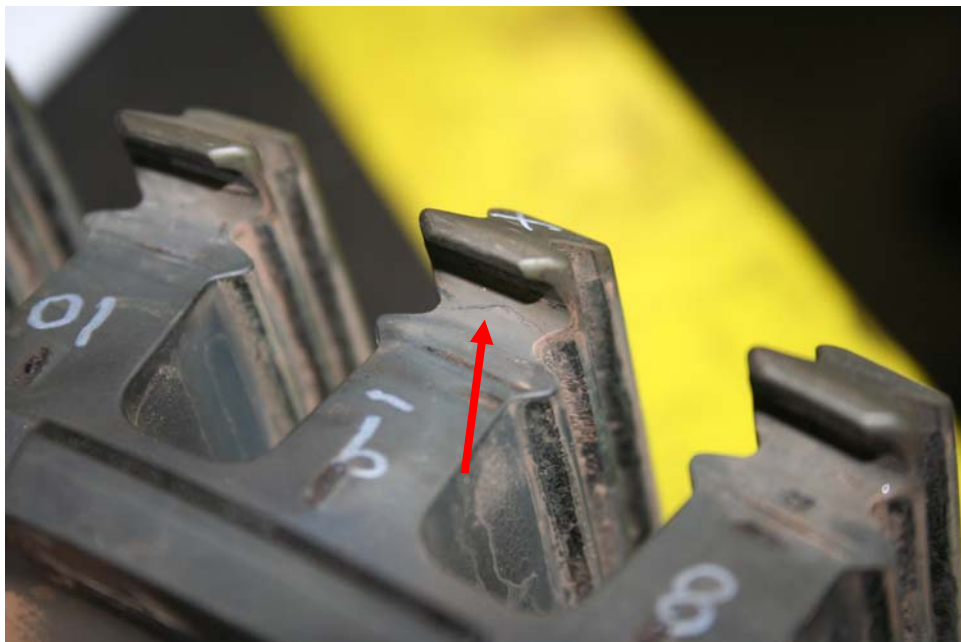
Photo 4: Close up of lug No. 9 with arrow showing crack (P&W)

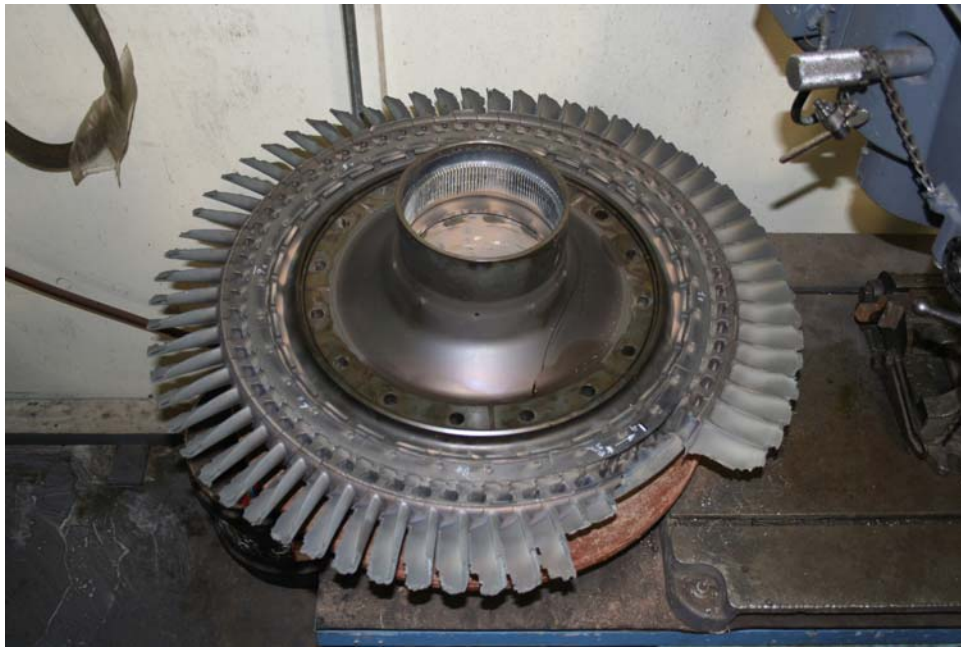
Of the 64 2nd stage turbine blades, 1 was missing completely, three were fractured transversely through the inner most blade root serrations, and the remaining blades were in the blade slots. The blades in slots Nos. 1, 2, and 3 were fractured transversely through the inner most blade root serrations. There was one 2nd stage turbine blade recovered that had an airfoil

Photo 5: 2nd stage hub with 2nd stage turbine blades showing missing blades, blades fractured near platform, and remaining blades damaged (P&W)

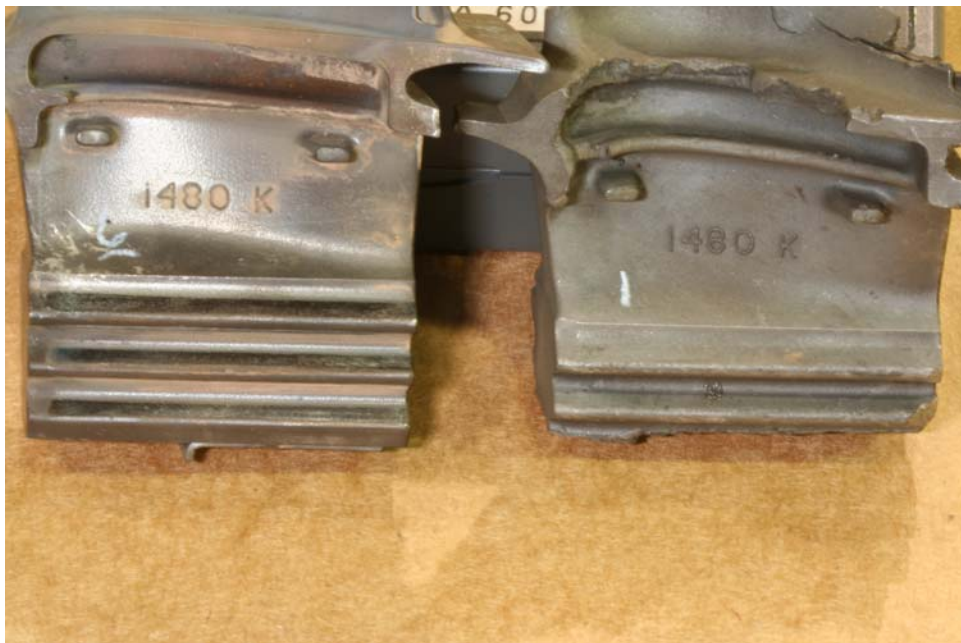
The contact patterns of the 2nd stage turbine blade root serrations were qualitatively evaluated. With the exception of blades Nos. 1 and 5, all exhibited six-tooth contact, but the degree/heaviness of the contact on the pressure side serrations varied from blade to blade. (Photo 7) Refer to Table 1.

Photo 7: 2nd stage turbine blades Nos. 1 and 6 showing different wear patterns on root fir trees (P&W)

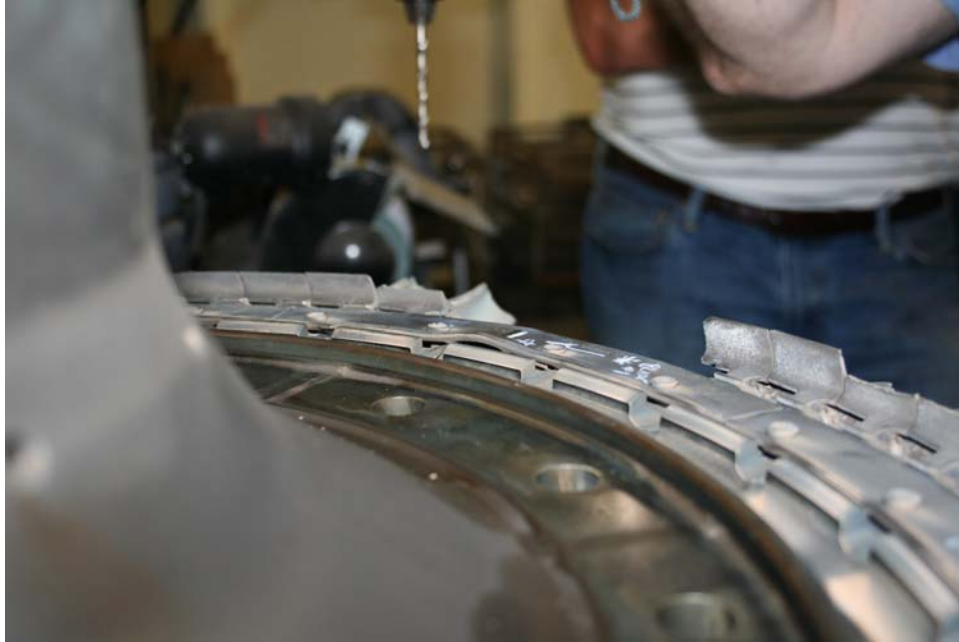
Photo 8: Front 2nd stage turbine blade retaining plate that was buckled (P&W)

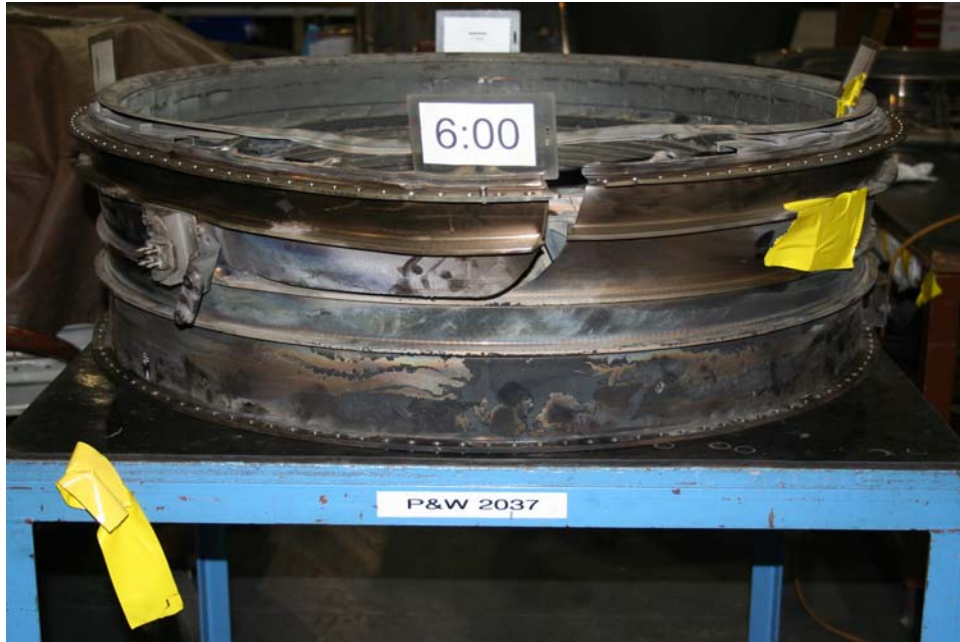
The HPT case had a 4 1/4-inch long axial crack at 6 o'clock between the rear flange and the rail that turned clockwise and progressed approximately 11 inches to the turbine cooling air (TCA) temperature probe boss at 8 o'clock. The flap of the fractured HPT case was displaced radially outward about 3 inches. (Photo 9) The fracture surface on the flap of the HPT case matched the fracture surface on the body of the HPT case. The HPT case, in the plane of the 2nd stage turbine vanes, had a purple discoloration 360 degrees around the case.

Photo 9: View of tab of displaced material on ruptured HPT case (P&W)

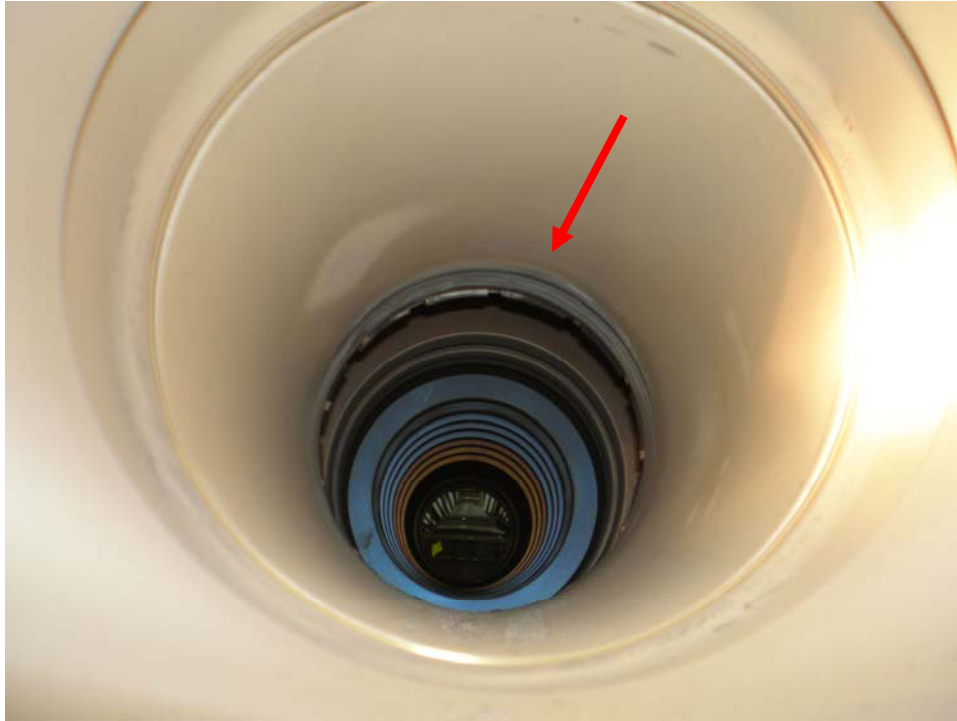
The HPT shaft was intact. The forward end of the HPT shaft heat shield on the inner diameter had an approximately 2-inch wide axial 180 degree rub mark that corresponded to the 2-inch wide rub mark on the outer diameter of the LPT shaft. (Photo 10) The center of the rub mark on the HPT shaft heat shield was located 180 degrees from the missing 2nd stage turbine blades.

Photo 10: Inside of HPT shaft with arrow showing rub mark

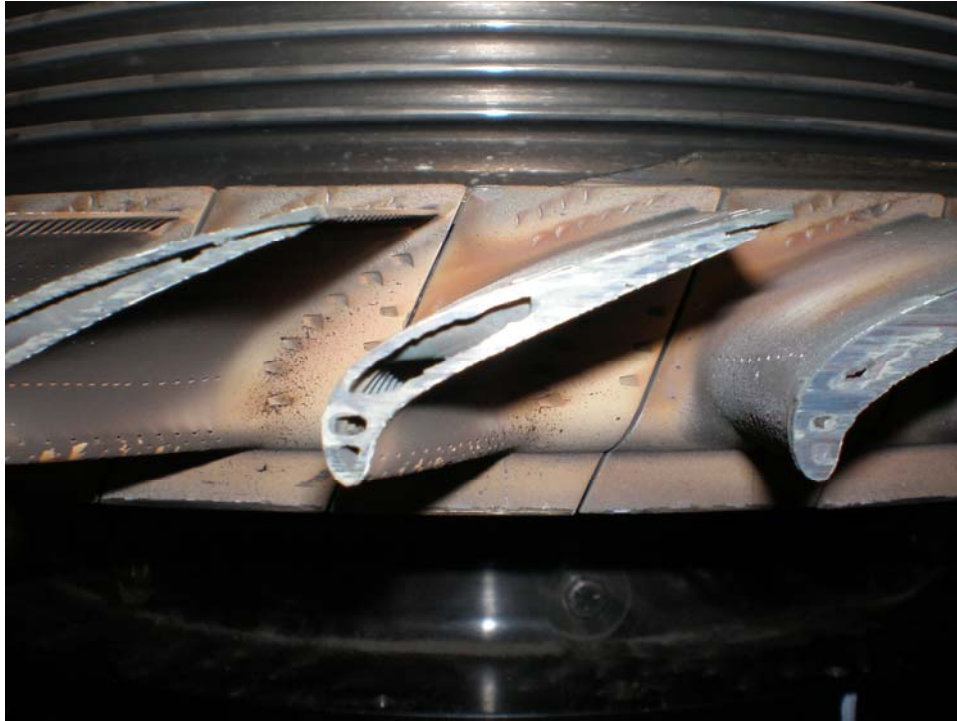
Photo 11: Close up of 1st stage turbine blade tips showing rub into internal cavity

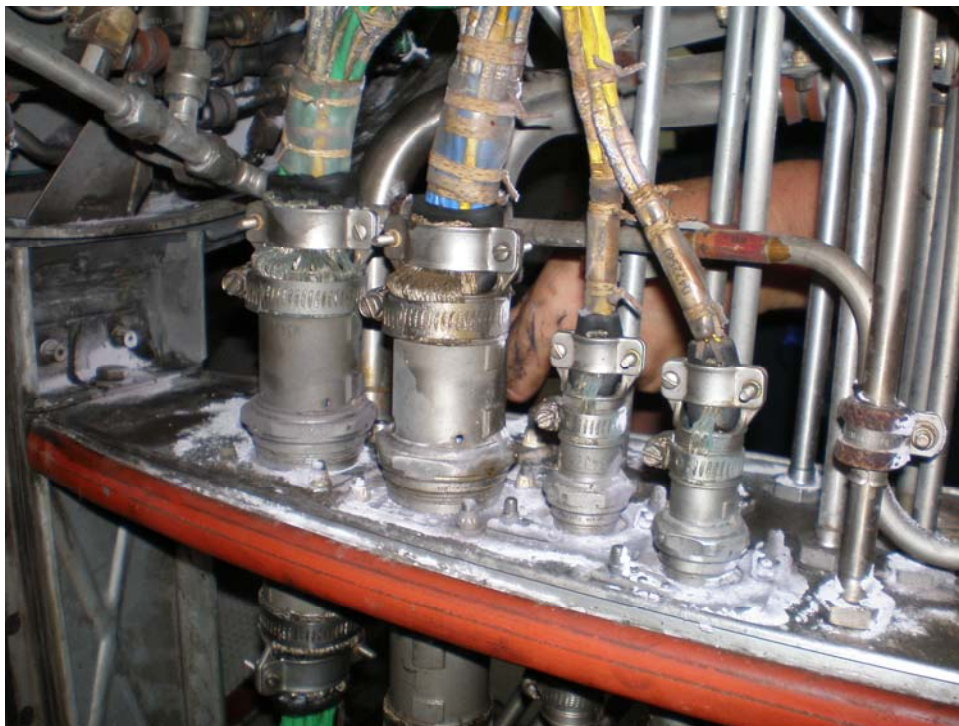
Photo 14: Close up of bifurcation panel showing dry chemical fire extinguishing agent

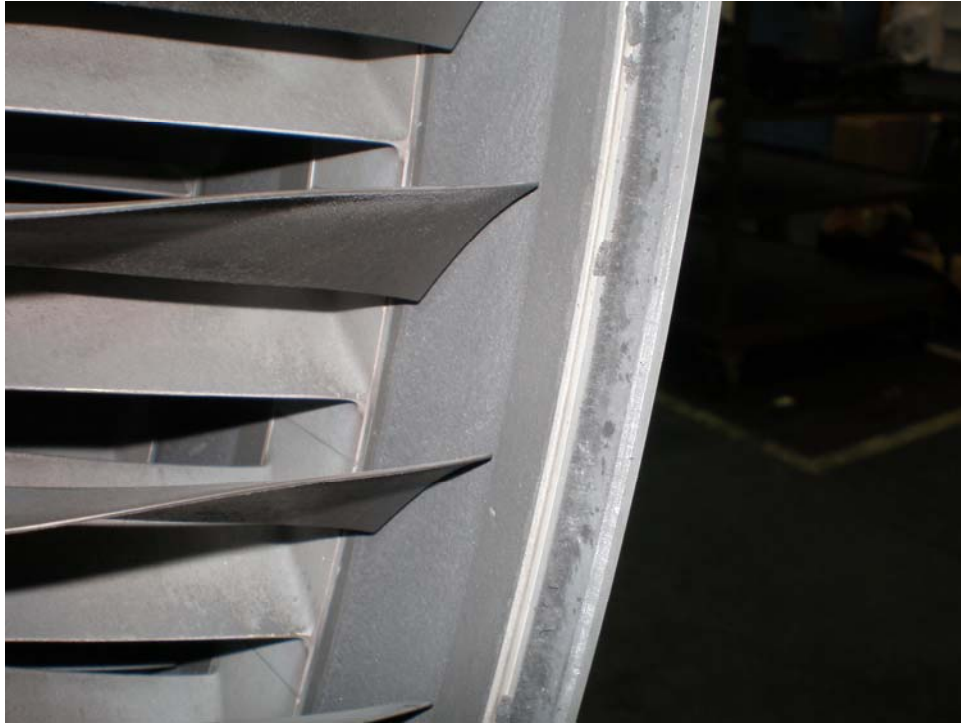
Photo 16: 5th stage compressor blades with groove worn in rub strip

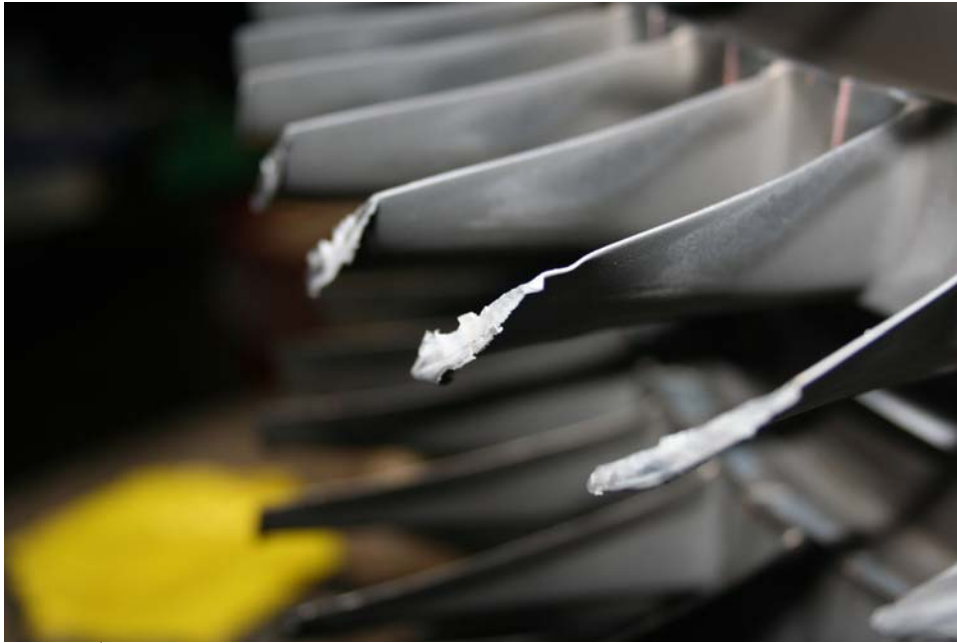
Photo 18: 8th stage compressor blades showing displaced material on the tips (P&W)

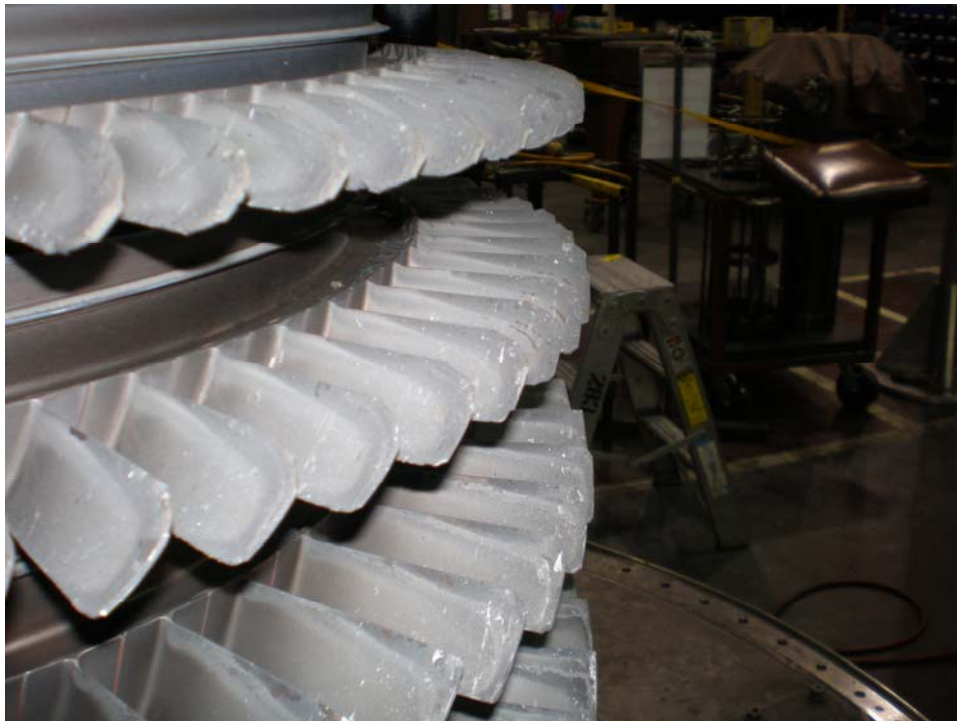
The tips of all of the 6th, 7th, 8th, and 9th stage compressor blades had circumferential rub marks. The 6th, 7th, 8th, and 9th stage compressor blades oriented towards the side of the rotor that had the missing 2nd stage turbine blades had the heaviest tip rubs with material displaced in both the direction of and away from rotation. (Photo 18) The 8th stage compressor blades were burned on the trailing edge tip corner between 7 and 1 o'clock. The 9th stage compressor blades were burned on the trailing edge tip corner between 8 and 2 o'clock. All of the 10th stage compressor blades were burned on the trailing edge tips corners. All of the 11th through 17th stage compressor blades were burned on the tips and leading and trailing edges that were progressively more severe towards the rear of the HPC. (Photo 19) There were several

Photo 19: Burned compressor blade tips at rear of compressor

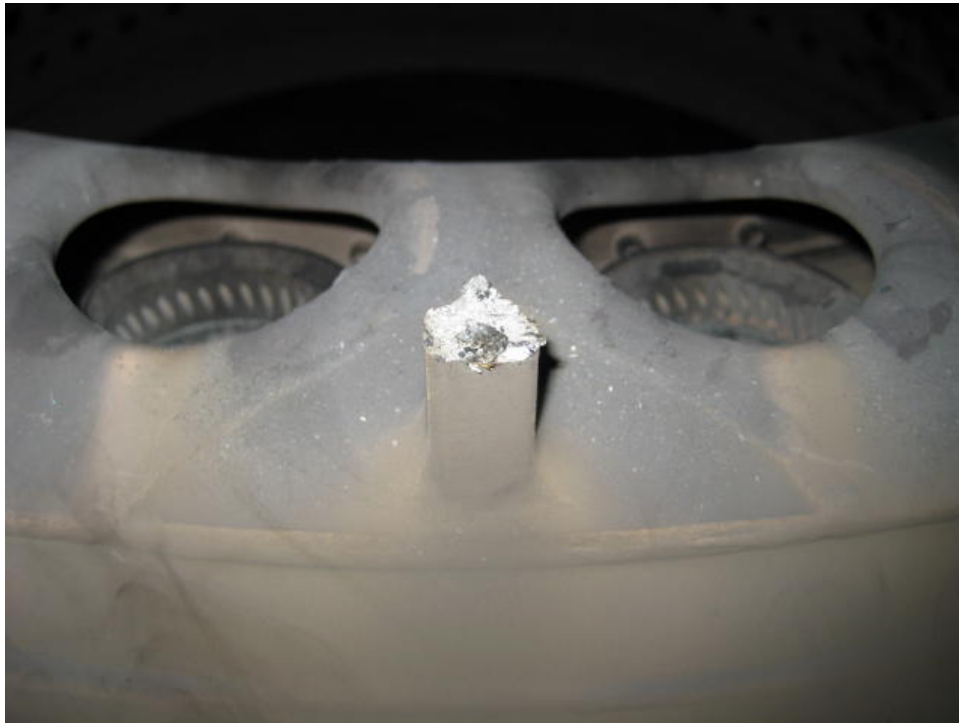
The combustor liner was in place in the diffuser case and the fuel nozzles were in place on the combustor liner. The combustor liner was intact except for the mount lugs at 3, 5, 7, and 11 o'clock that were broken off, although only three of the broken lugs were recovered from within the diffuser case. (Photo 20) The lugs at 1 and 9 o'clock were cracked. The combustor liner had an axial crack in the 4th louver at 2 and 5:30 o'clock and axial cracks in the 3rd, 4th, and 5th louvers at 8:30 o'clock.²⁴ The aft edge of the 5th louver was buckled slightly inward at 8:30 o'clock. There were four fuel nozzle guides adjacent to the igniter plug ports that had erosion around the edges. The interior and exterior of the combustor liner had numerous small pieces of black-colored, irregular-shaped material located randomly around the liner. There was a non-uniform deposit of black soot on the exterior of the combustor dome. The thermal barrier coating was intact and there were no indications of a burn through or hot gas erosion.

Photo 20: Broken lug on combustor dome (Delta)

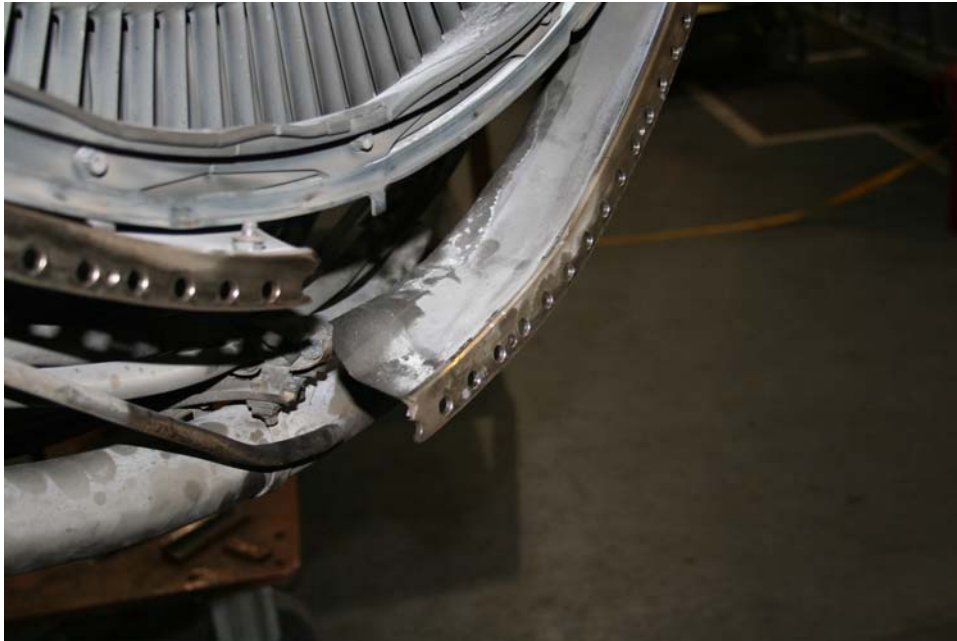
case was displaced radially outward about 3 inches. The fractured surfaces of the LPT case matched. The three most forward LPT ACC tubes were bent aft at the bottom of the engine. The most forward LPT ACC tube was fractured.

Photo 21: View of LPT case showing displacement of fractured front flange (P&W)

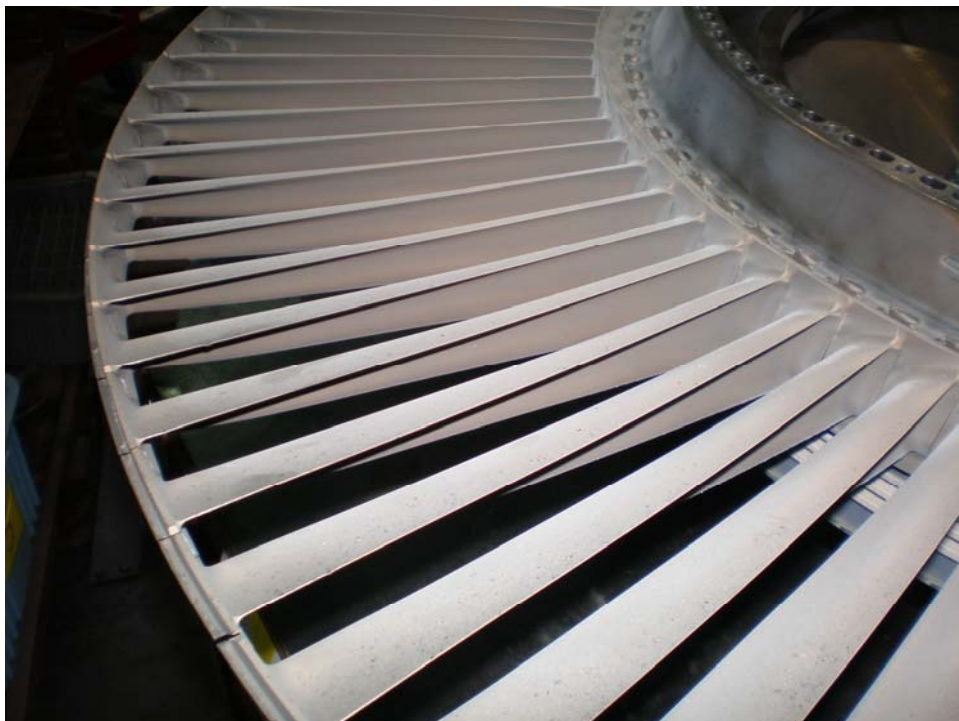
Photo 24: 4th stage turbine blades showing impact marks on airfoils

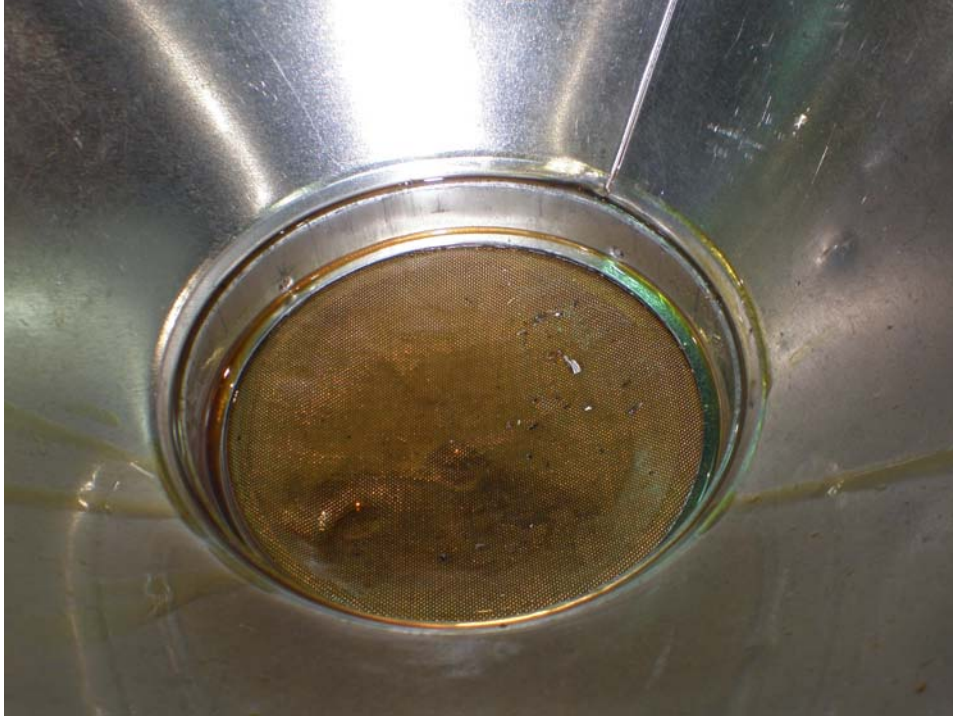
The oil in the oil tank was up to the bottom of the scupper. The oil was dark in color, but did not have an acrid odor. When the oil was drained from the tank through a screen, there were several small metallic shards collected in the screen. (Photo 26) When the oil was drained from the accessory gearbox, there was no debris collected in the screen. The oil filter had a few very small pieces of shiny metal and black-colored material in the filter element and there were several small pieces of shiny metal in the bottom of the filter bowl. (Photo 27)

Photo 26: Metal debris in screen from oil drained from engine oil tank

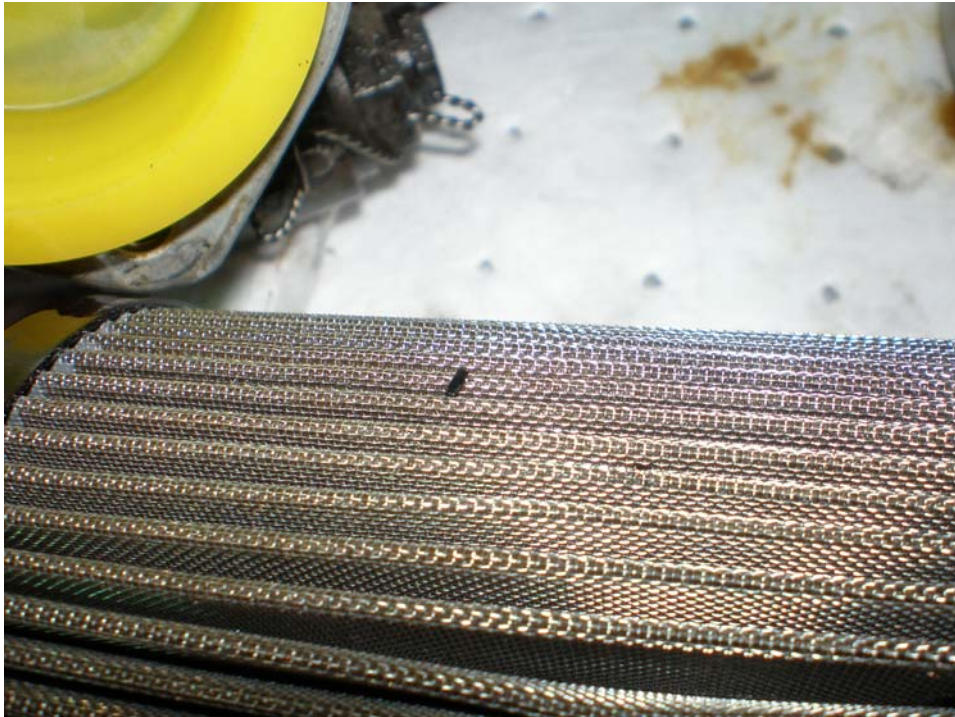
Photo 27: Debris in oil filter screen

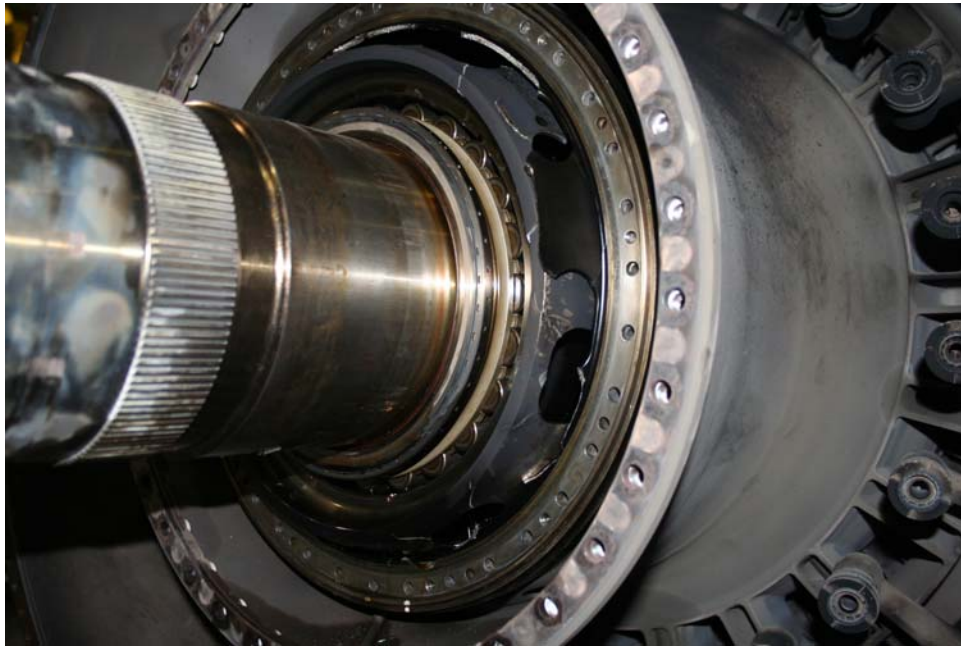
The No. 4 bearing housing cover was in place and intact. The interior surface of the No. 4 bearing housing cover had a black coating. The interior of the bearing housing also had an acrid smell. The No. 4 bearing support was broken through the race track slots 360 degrees around and the aft end was rotated and telescoped through the forward end. The No. 4 bearing was intact and wet with oil, but the ends of the rollers had rotational scoring. (Photo 30)

Photo 30: No. 4 bearing showing roller ends and broken housing (P&W)
