NATIONAL TRANSPORTATION SAFETY BOARD
OFFICE OF AVIATION SAFETY
WASHINGTON, D.C. 20594

POWERPLANTS GROUP CHAIRMAN'S FACTUAL REPORT

NTSB ID: ENG11IA021

Location: Pittsburgh, Pennsylvania
Date: March 17, 2011
Time: 1640 coordinated universal time (UTC)
Aircraft: Bombardier DeHavilland DHC-8, Reg. No. N339NG, Colgan Air flight 3212

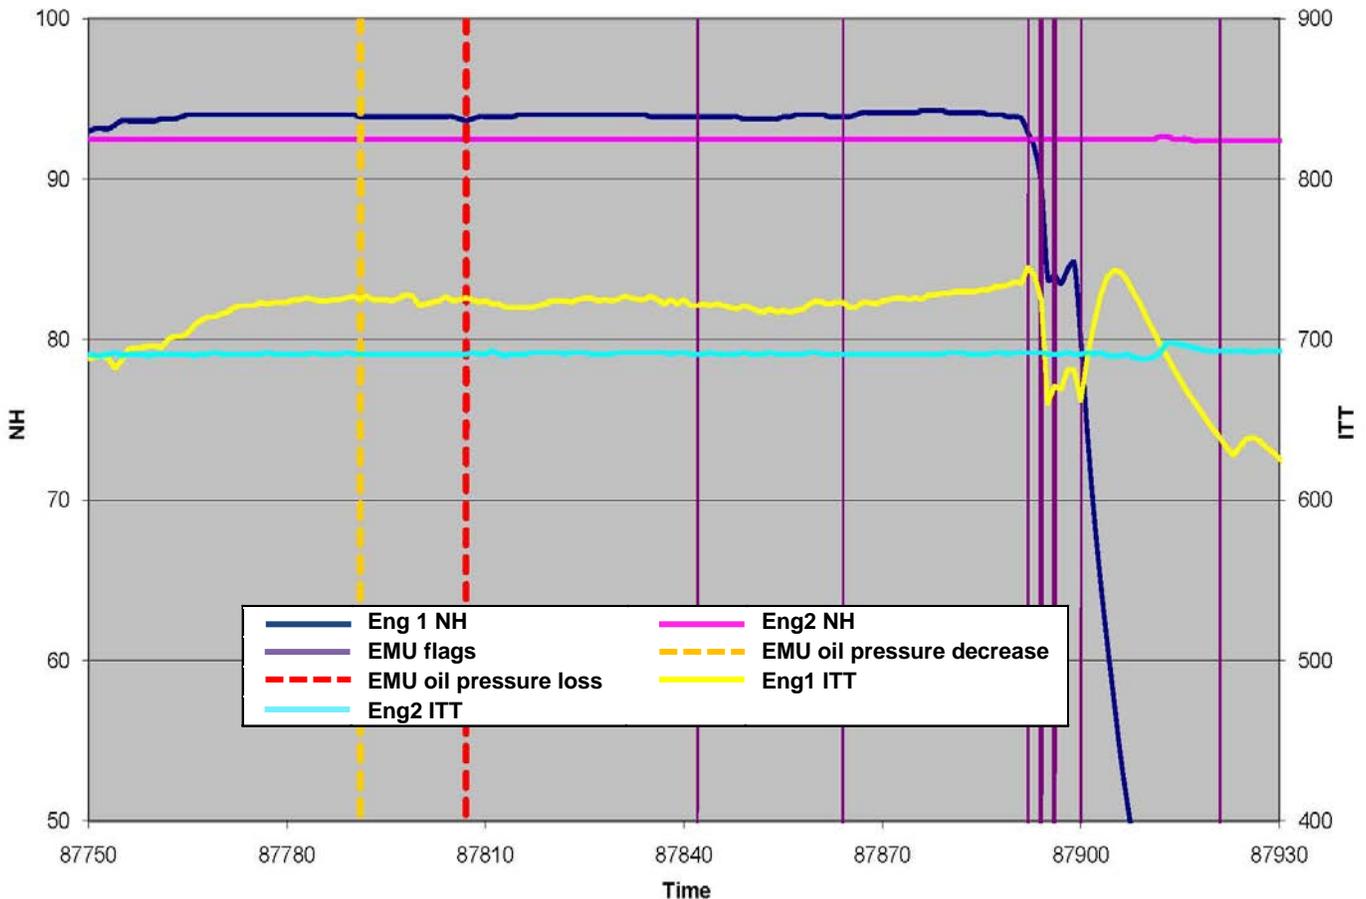
The PW150A is equipped with an engine monitoring unit (EMU) that observes FADEC and PEC operational data and records parameter exceedances, trend condition data, and fault codes. A review of the EMU data from October 2010 through March 14, 2011 found no unusual fault history. A RGB chip detector fault, which is a Class 2 maintenance² fault, was recorded on March 15, 2011. The next EMU fault download was scheduled for the evening of March 17, 2011.

Figure 1. N339NG March 17, 2011 EMU data with DFDR overlay

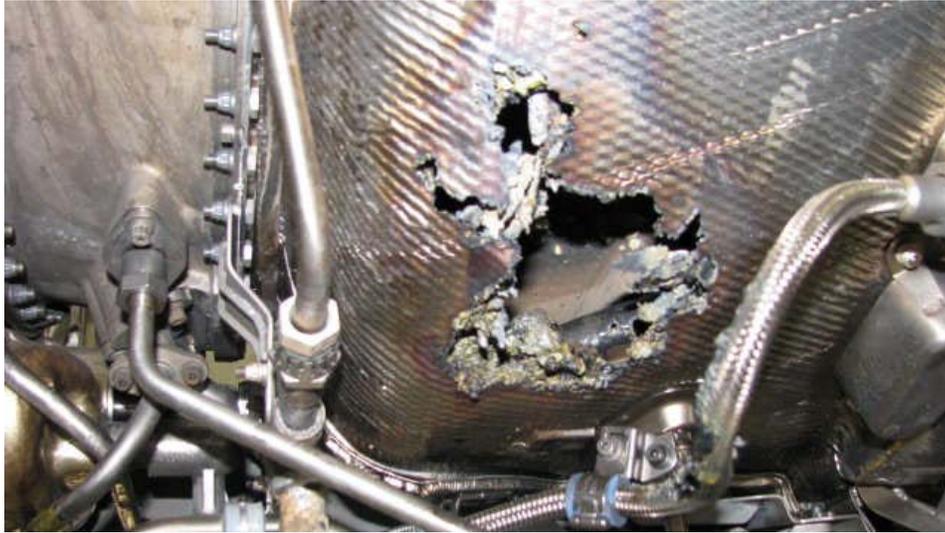
There was an approximately 4.5-inch circumferential by 3.5-inch axial hole through the gas generator case (GGC) and insulation blanket between 6 and 7 o'clock³ and roughly in line with the diffuser pipe exit ports. The edges of the hole were irregular and charred, with deposits of molten

metallic material characteristic of an internal engine fire burning through the side of the engine case from the inside out (burn-through). See Figure 6.

Figure 6. GGC viewed from bottom LH side

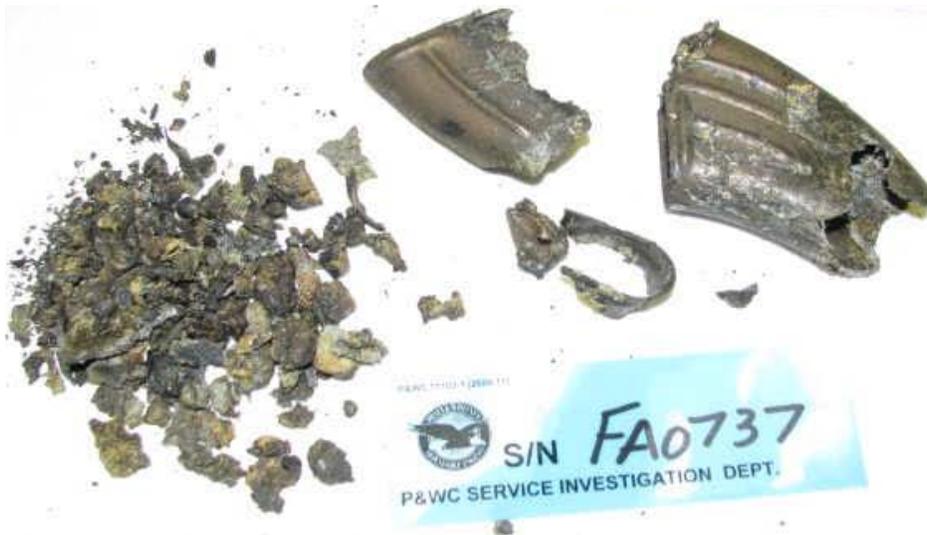
A borescope probe was inserted through the 4, 7, and 10 o'clock combustion positioning pin bores to inspect the fuel nozzles before their removal and to further document the damaged area. Partially consumed sections of combustion outer liner, diffuser duct, and HP impeller were observed through the hole. A bag of metallic debris received with the engine included fragments of burnt diffuser duct material. See Figure 7.

Figure 7. Burnt diffuser duct and other debris received with the engine

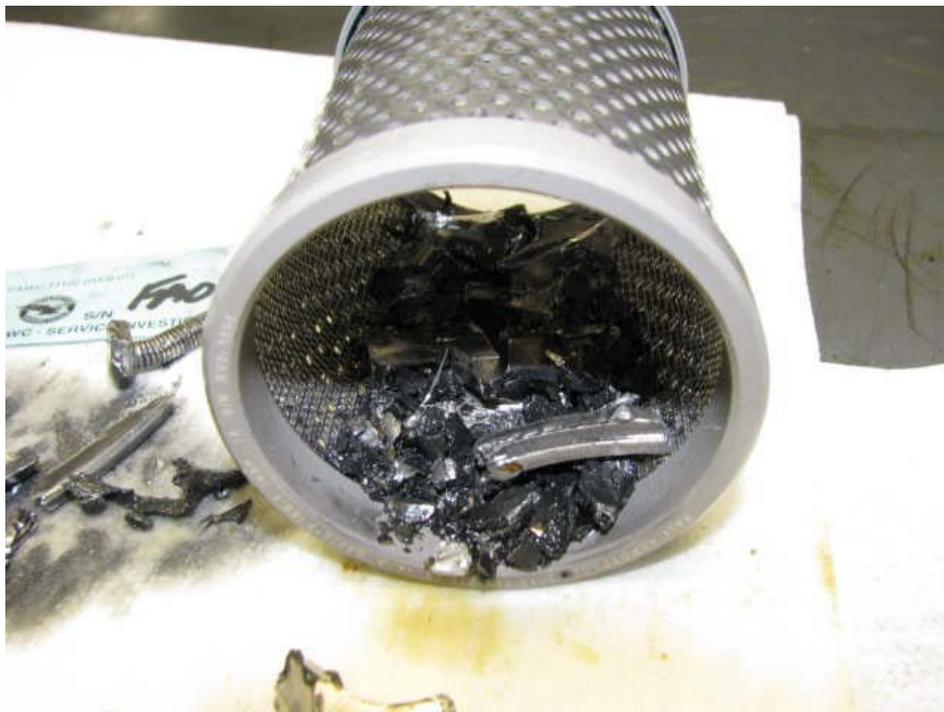
Both the RGB and turbomachinery (TM) magnetic chip detectors were covered with ferrous particles and chips. The main engine oil and RGB scavenge oil filters, which were removed and bagged in Pittsburgh, were contaminated with non-ferrous and ferrous particles. The RGB oil scavenge sump strainer contained a large amount of metal debris, including an O-ring segment, a key washer, one bolt (distorted and gouged), and material later identified as No.1 bearing cage and No. 1 bearing cavity lug fragments. The strainer also contained a large amount of small, dark, ferrous chips. See Figures 8 and 9.

Figure 8. RGB oil scavenge sump strainer

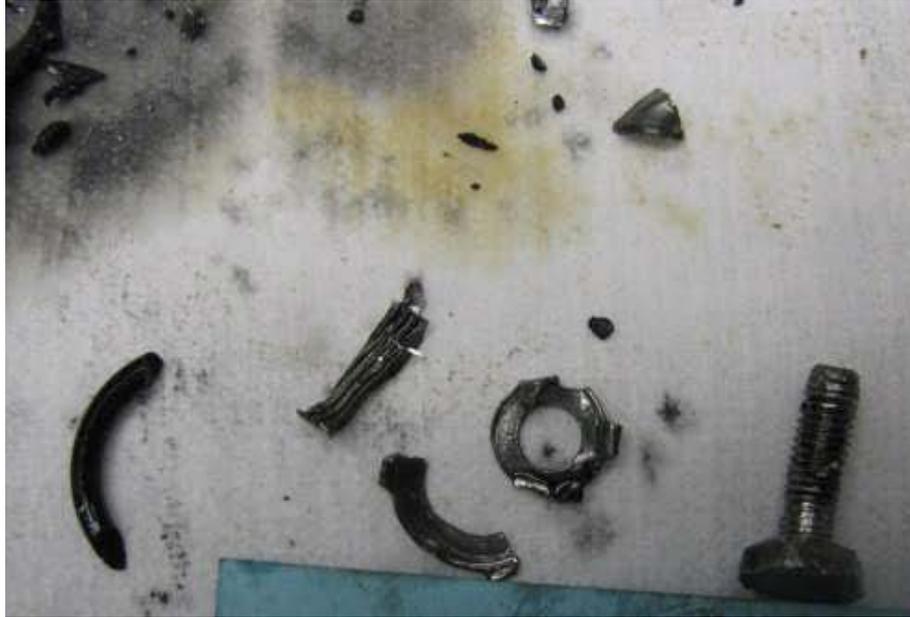
Figure 9. Some of the debris found in RGB oil scavenge sump strainer

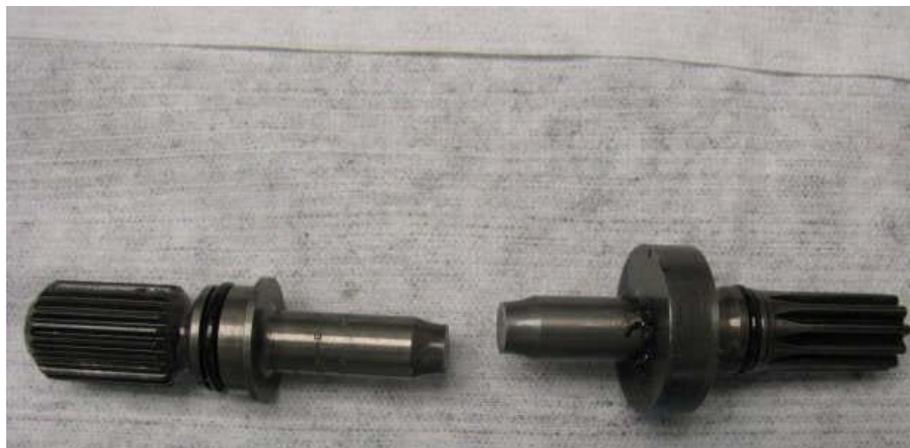
When the engine accessories were removed, the coupling shaft of the main engine oil pump was found fractured at its shear neck. See Figure 10. The oil pump was seized.

Figure 10. Oil pump coupling shaft separation

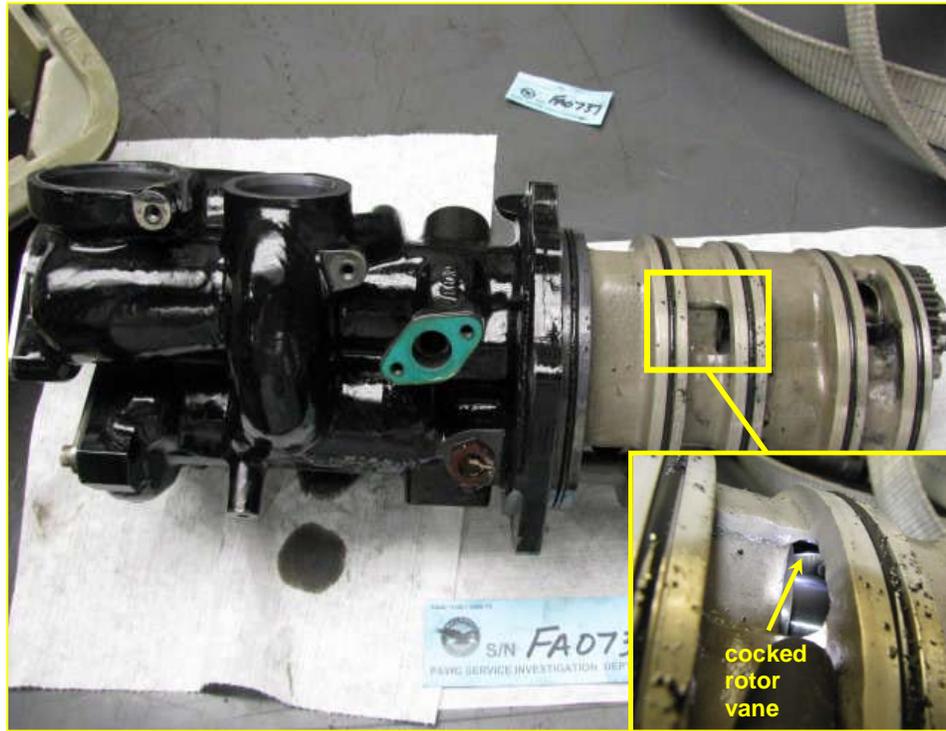
Metallic paste deposits were noted at the scavenge inlet ports, and a pump vane visible at the Nos. 2 and 2.5 (2/2.5) bearing scavenge oil entry port appeared damaged and out of alignment. See Figure 11.

Figure 11. Oil pump, with 2/2.5 bearing scavenge oil entry port noted

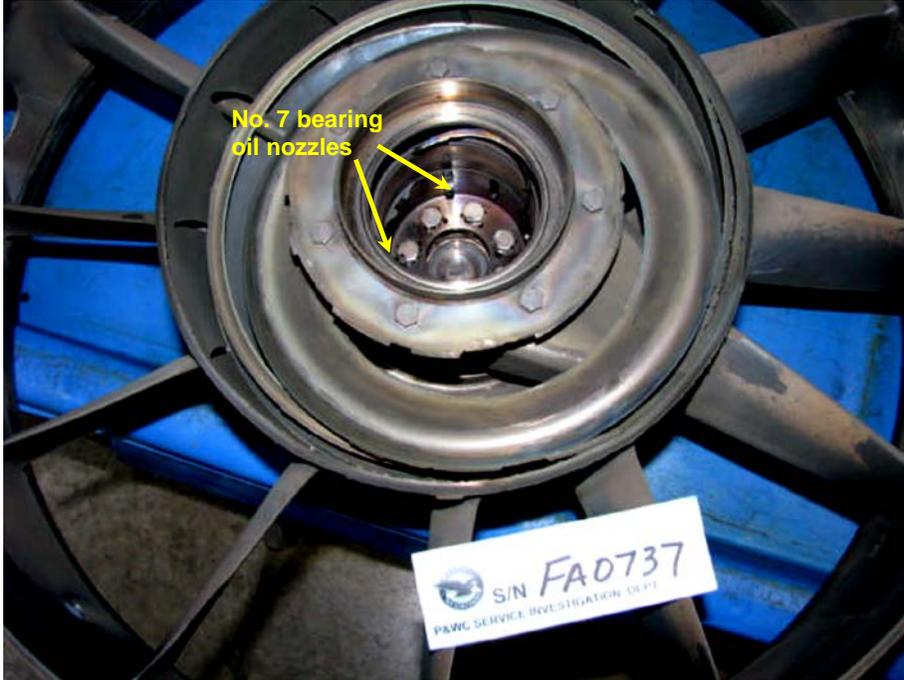
The forward face of the turbine exhaust duct (TED) assembly was rubbed 360° and its baffle section was detached. See Figure 12. The No. 7 oil delivery nozzles were damaged, with metal smearing at the orifices.

Figure 12. TED assembly, showing detached baffle

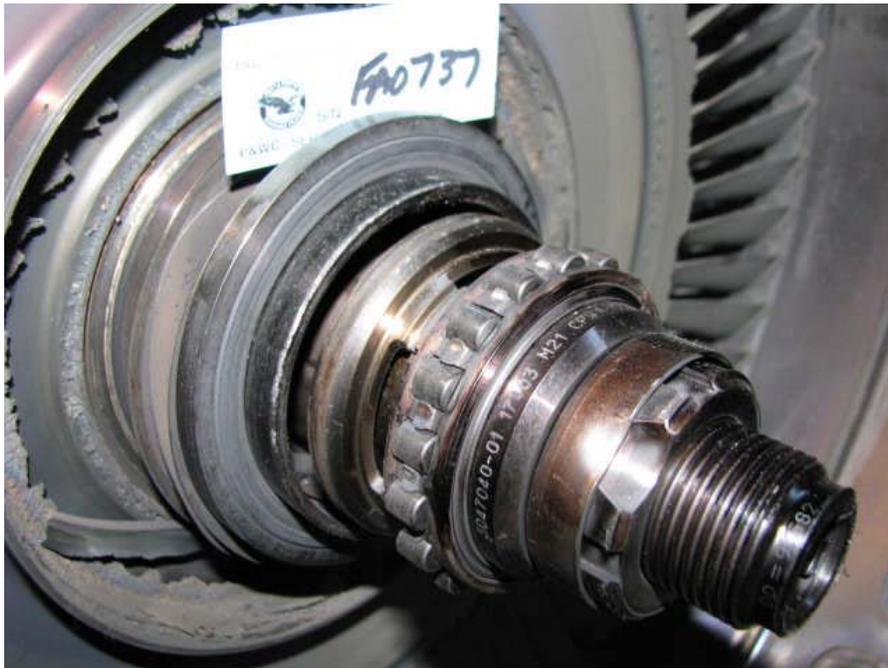
The second stage power turbine (PT2) disk assembly was intact. The No. 7 bearing was dry and heat discolored, but intact. The No. 7 bearing inner race, carbon seal and runner, and retention nut exhibited rotational damage. See Figure 13.

Figure 13. PT2 disk assembly, showing No. 7 bearing, seal, and retaining nut

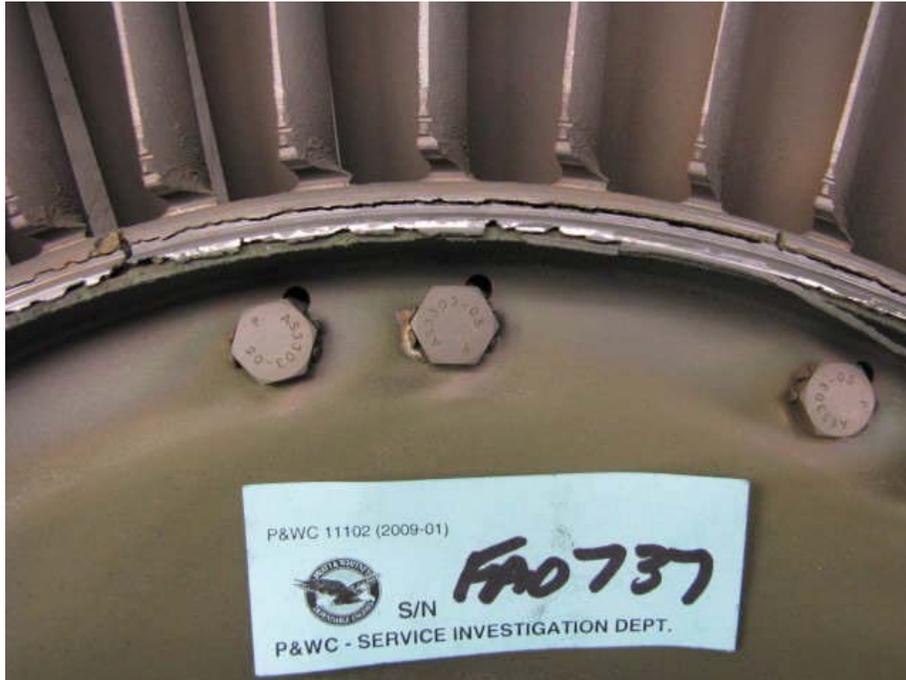
The PT2 vane ring assembly airfoil leading edges (LEs) were rubbed. See Figure 14.

Figure 14. PT2 vane ring assembly, showing contact damage

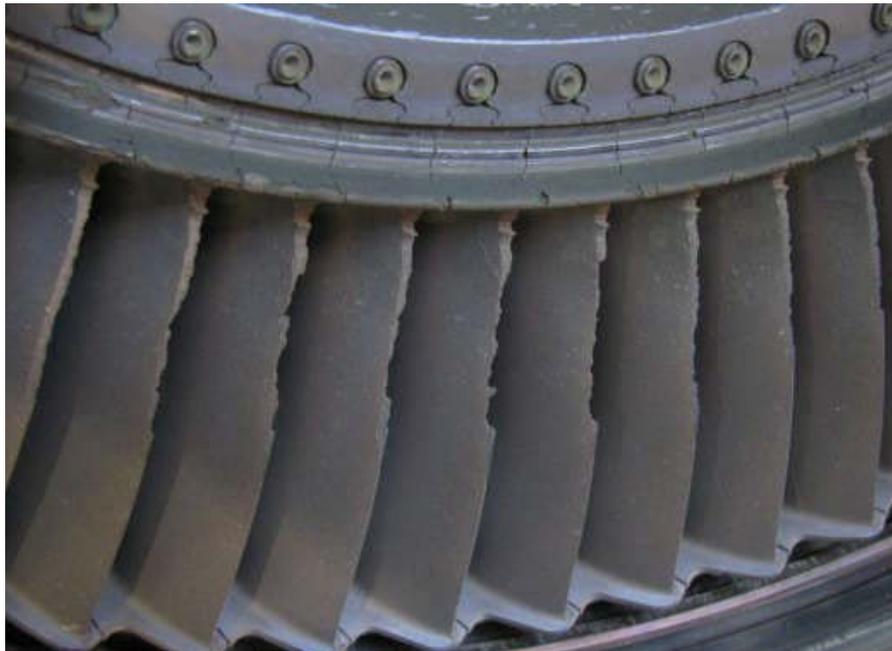
The first stage power turbine (PT1) disk assembly blade trailing edges (TEs) showed 360° scoring. See Figure 15.

Figure 15. PT1 disk assembly airfoil trailing edges

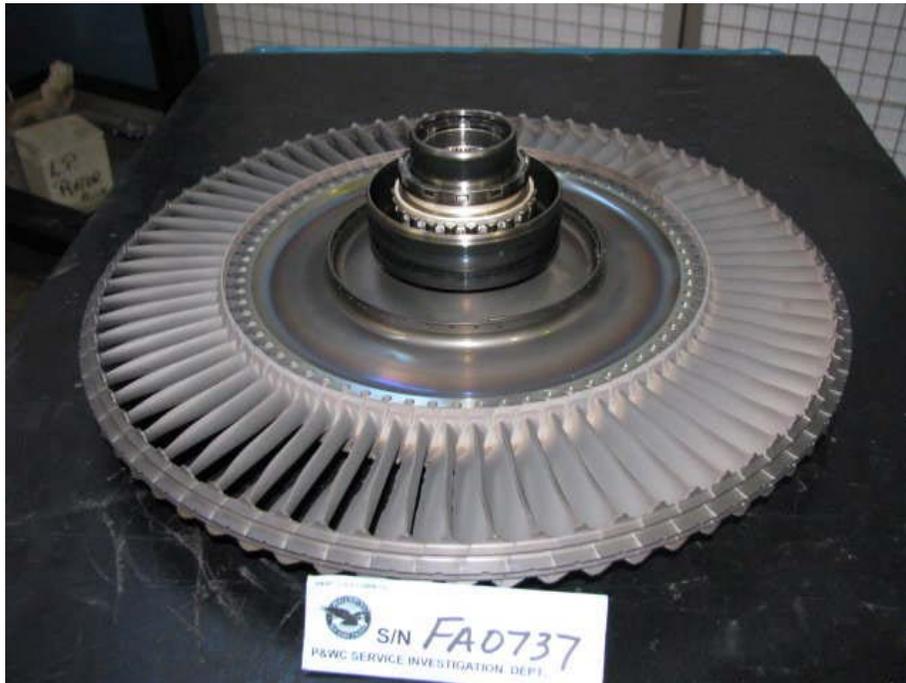
The 6.5 bearing and carbon seal runner were intact but dry. See Figure 16.

Figure 16. Forward side of PT1 disk assembly, showing 6.5 bearing and carbon seal runner

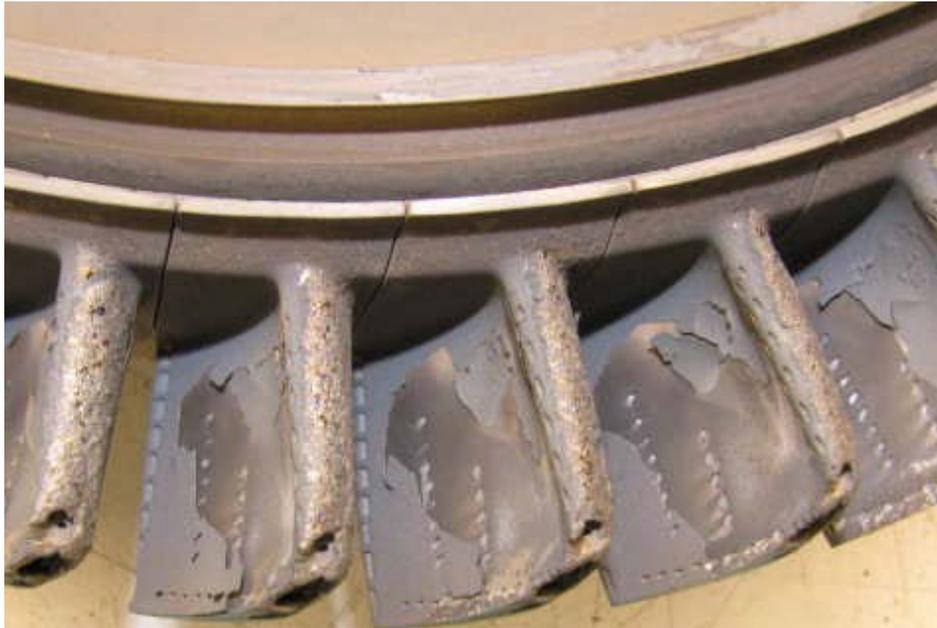
All of the HPT disk assembly blade tips were rubbed at the TEs and the LEs were heat discolored and thermally eroded, with exposure of the airfoil air passages. See Figure 18. There was a thin coating of metallic splatter over the airfoils and a heavy coating of metal deposits on the shrouds. The front stub splines were in normal condition. There were no indications of axial contact/rub. The bore was coated with metal splatter and oxidation material.

Figure 18. HPT blades

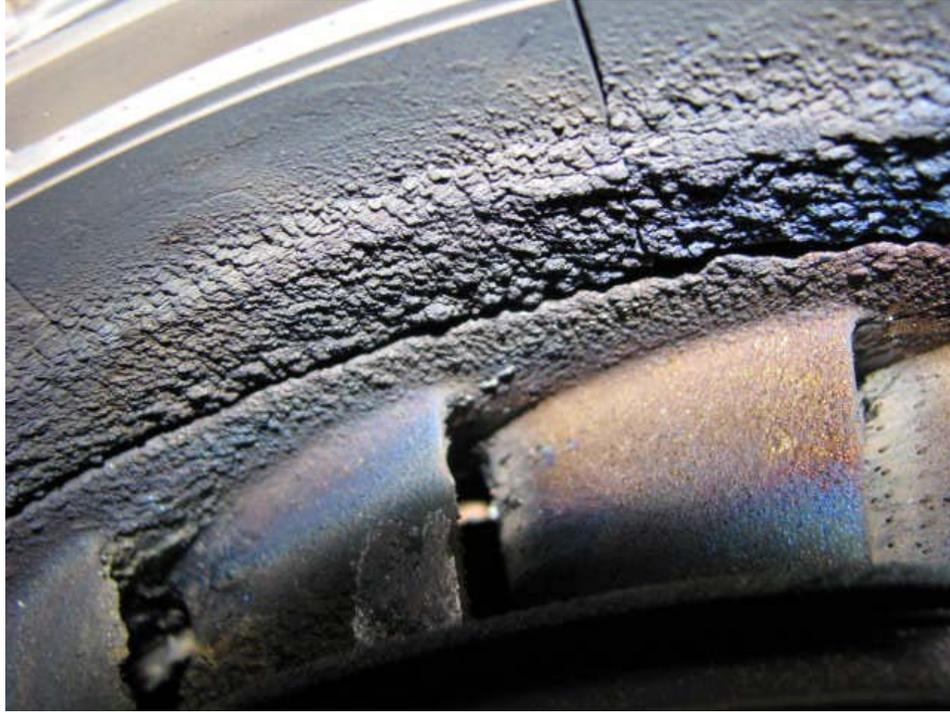
The HPT vane ring assembly showed no mechanical damage. There was a bluish discoloration on the vane trailing edges between 7 and 12 o'clock; the remaining TEs were metal splattered. See Figures 19 and 21. Chunks of re-solidified metallic debris adhered to the airfoil LE surfaces between 6 and 12 o'clock. See Figure 20. The HPT front cover was oxidized consistent with heat distress. The HPT rear cover showed deposits of reddish dust-like material.

Figure 19. HPT vanes showing metal deposits and thermal discoloration

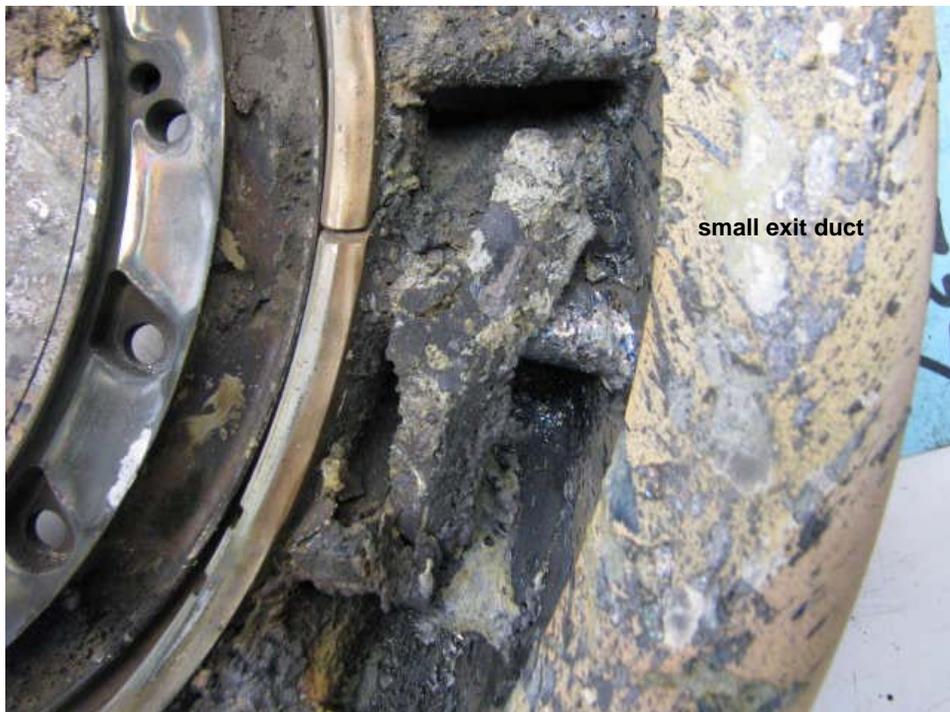
Figure 20. LE side of HPT vanes showing deposits of re-solidified metal; small exit duct showing metallic deposits

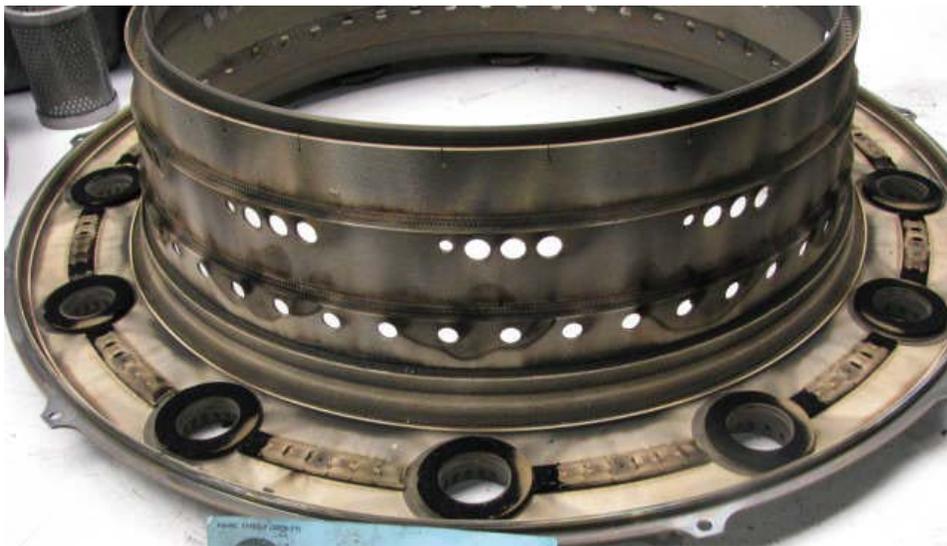
Several of the fuel nozzles had metal debris lodged in a few of the air atomization holes. The small exit duct (SED) exhibited metal splatter between 6 and 12 o'clock but was in otherwise good condition. See Figure 20. The combustor inner liner was intact, with some minor metallic splatter. See Figures 21 and 22.

Figure 22. Combustion inner liner

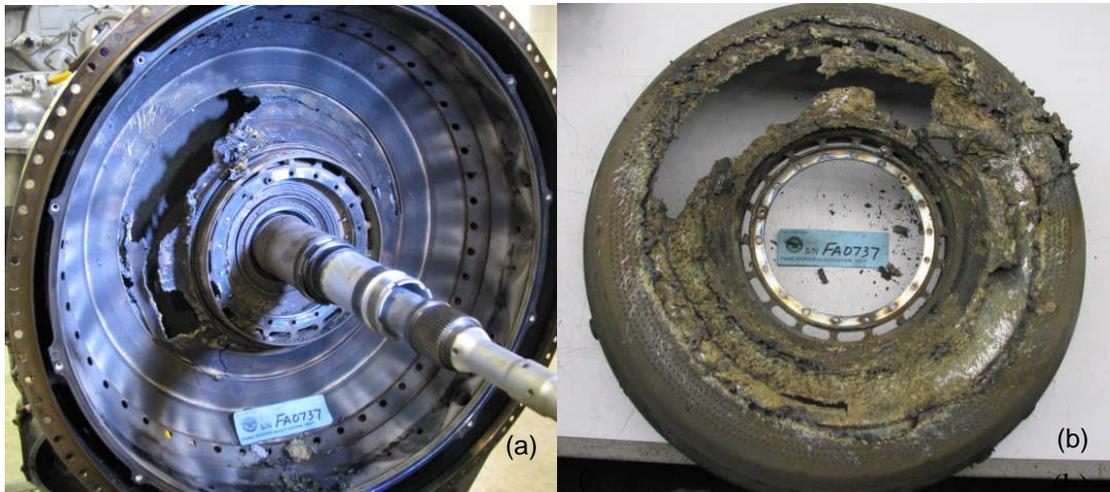
The large exit support duct (LESD) section of the combustion outer liner was in an advanced state of thermal deterioration with material missing between 7 and 12 o'clock and cracked and bulging inward between 12 and 3 o'clock. See Figure 23(a). Much of the LESD outer wall was thermally consumed and the remaining LESD outer wall was splattered with fused, re-solidified metal. See Figure 23(b).

Figure 23. Upstream (a) and downstream (b) views of the combustion outer liner

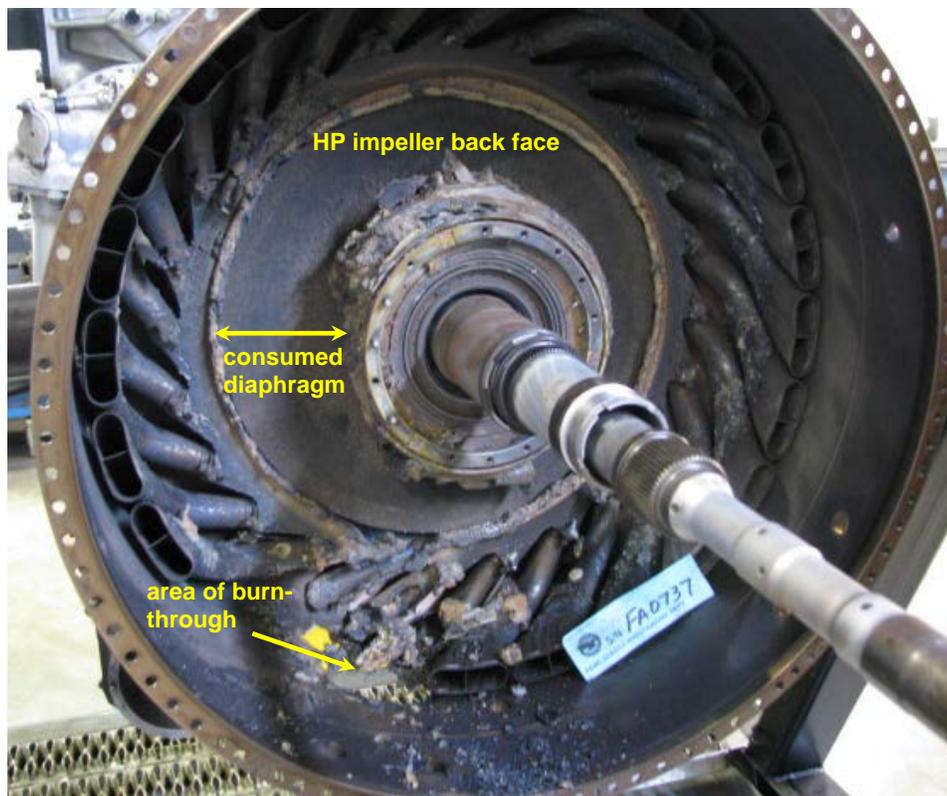
Much of the ring and diaphragm section of the diffuser, which is Ti-6-2-4-2, was missing/consumed, exposing the back face of the HP impeller. Three consecutive diffuser exit ducts located in the area of the GGC burn-through were partially or totally consumed. See Figure 24.

Figure 24. GGC with combustion outer liner removed

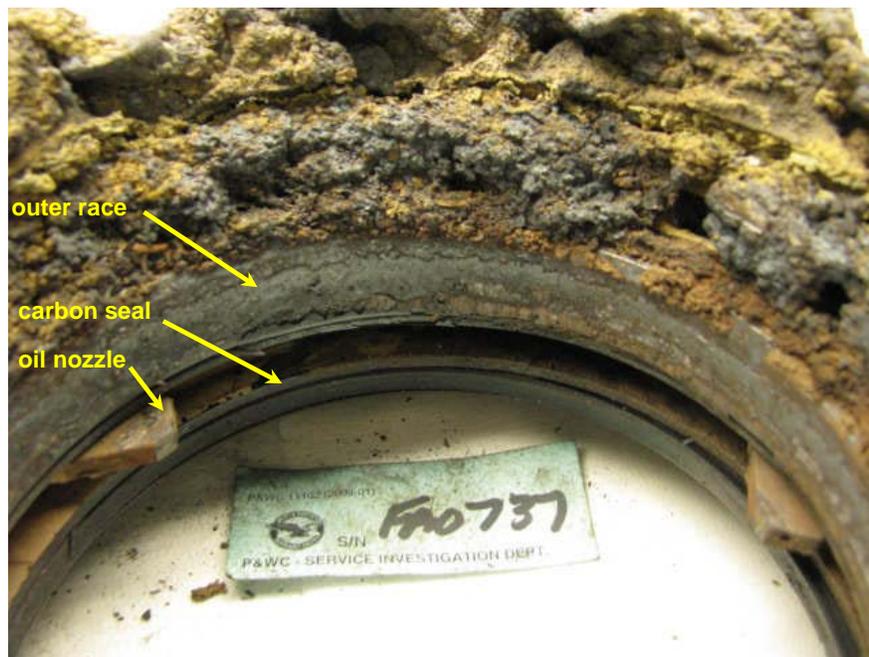
The remaining No. 5 bearing support housing was significantly heat-eroded, perforated and oxidized. The No. 5 bearing front cover, flexible support housing, which is Ti 6-2-4-2, and front carbon seal were melted or partially consumed and were not recognizable. The No. 5 bearing oil nozzle housing, rear carbon seal assembly, housing outer cover, and outer race were recognizable but showed severe thermal distress and were splattered with metal. The oil delivery nozzles were intact but showed rotational scoring. See Figure 25.

Figure 25. No. 5 bearing support housing

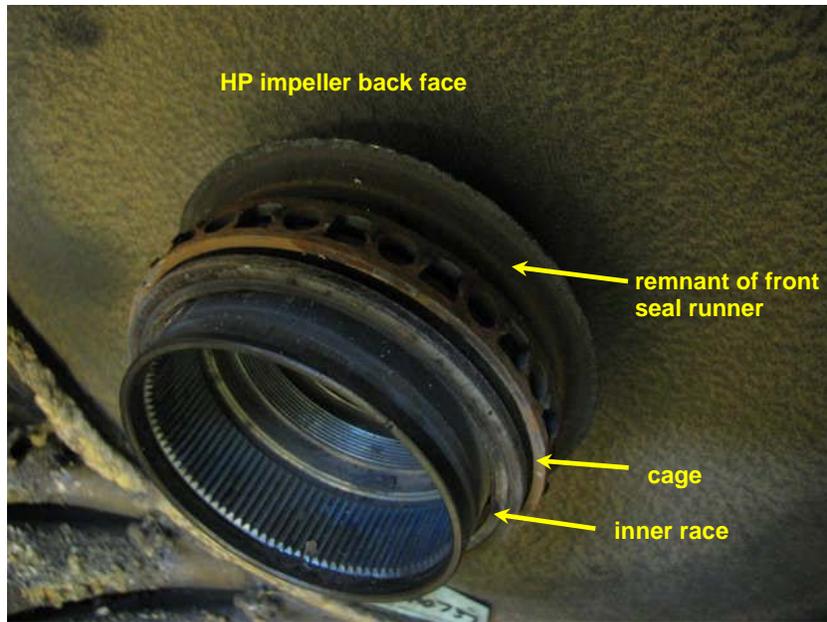
The No. 5 bearing was dry and oxidized. The cage and races were severely discolored, but intact. The raceways were smeared with metal. No races were fractured. The bearing rollers were disintegrated; two small spherical balls, approximately 1/8-inch in diameter, were recovered from the bearing cage. The inner race was found loose on the impeller rear shaft. The oil slinger was intact. The No. 5 bearing front air seal runner was scorched and partially missing. See Figure 26.

Figure 26. No. 5 bearing and seal components

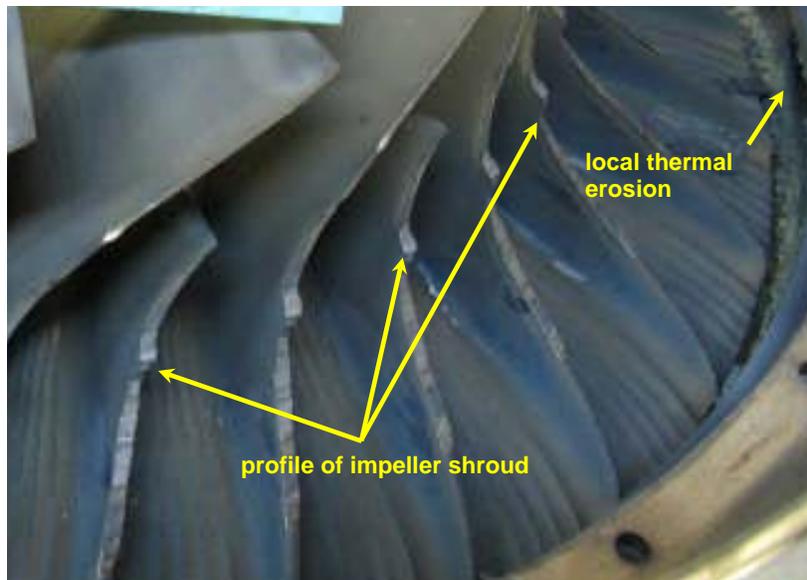
The back surface of the HP impeller was rough and eroded consistent with scorching. The impeller shroud housing profile, including the P_{2.8} plenum/cavity, was machined into the impeller vanes, and there was localized rub damage (thermal distress) on the exducer tips. See Figure 27.

Figure 27. HP impeller vane damage

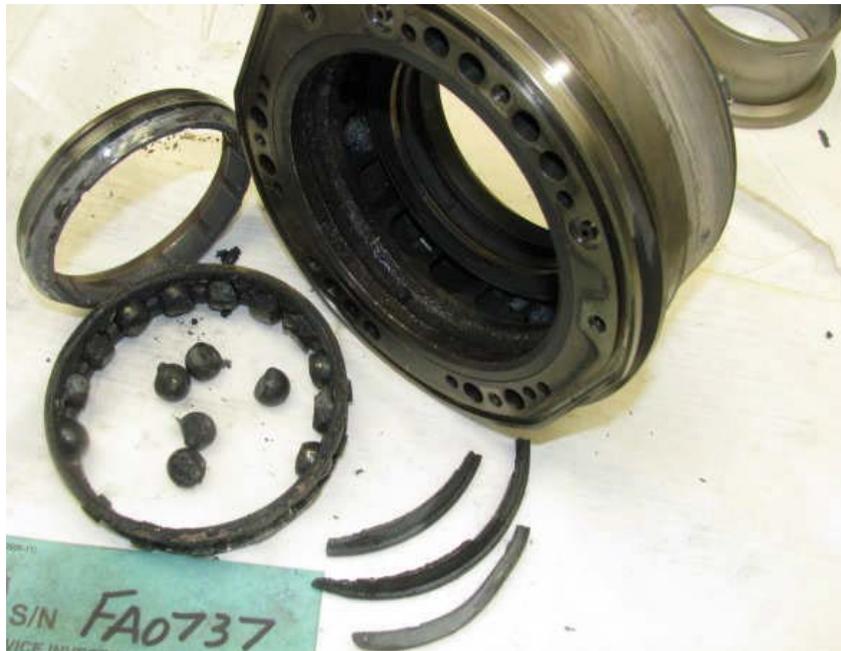
The No. 4 bearing was dry. All of the balls were worn and discolored. The non-thrust inner raceway was rubbed. The thrust-side inner race was broken into three segments that were partially disintegrated. The cage and outer race showed metal splatter and thermal discoloration. See Figure 28.

Figure 28. No. 4 bearing

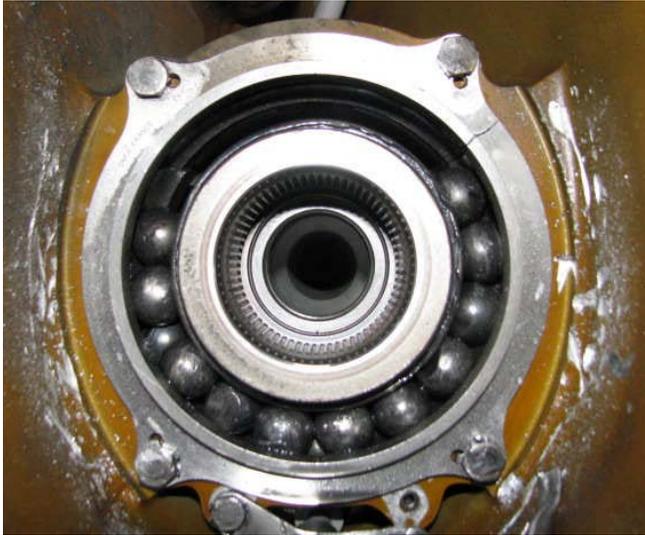
The No. 1 bearing was dry and severely distressed. The (flanged) outer race was fractured in place; the bolts retaining it were loose and the key washers were missing from under two of the bolts. The bearing balls were worn and stacked. See Figure 29. The missing key washers were recovered from the RGB oil scavenge sump strainer and were fretted and battered. Severely battered cage pieces were also recovered at the RGB oil scavenge sump strainer. In addition, a fragment identified as No. 1 bearing cage material and an approximately 2.5-inch piece of No. 1 bearing outer race were found lying at the bottom of the front inlet case oil compartment. The No. 1 bearing was submitted for metallurgical analysis. See Paragraph 3.1.

Figure 29. No. 1 bearing

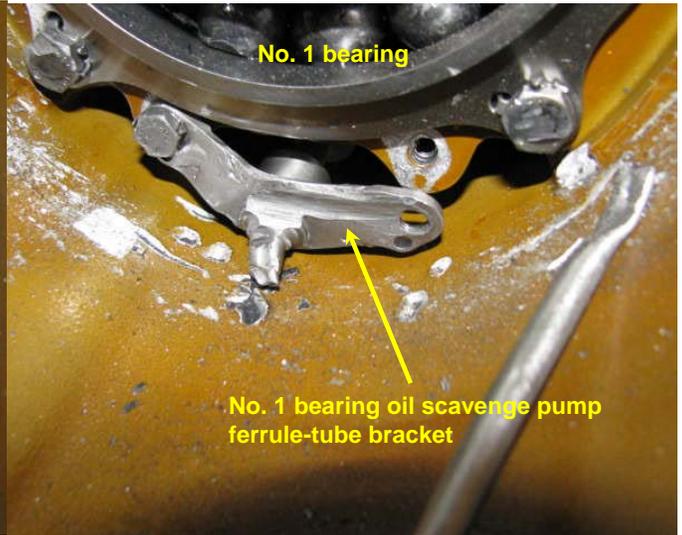
The No. 1 bearing jet pump scavenge line was severed. The left retention bolt of the No. 1 bearing jet pump ferrule tube assembly bracket was missing and the bracket was deeply scored and bent. See Figure 30. The missing retention bolt was recovered at the RGB oil scavenge sump screen. The

recovered bolt was scored and bent, and the bracket boltholes were elongated. The ferrule-bracket FIC mating face, the underside of the bolt heads, and the key washers all showed fretting damage.

Figure 30. Damaged and detached oil scavenge pump ferrule-tube bracket

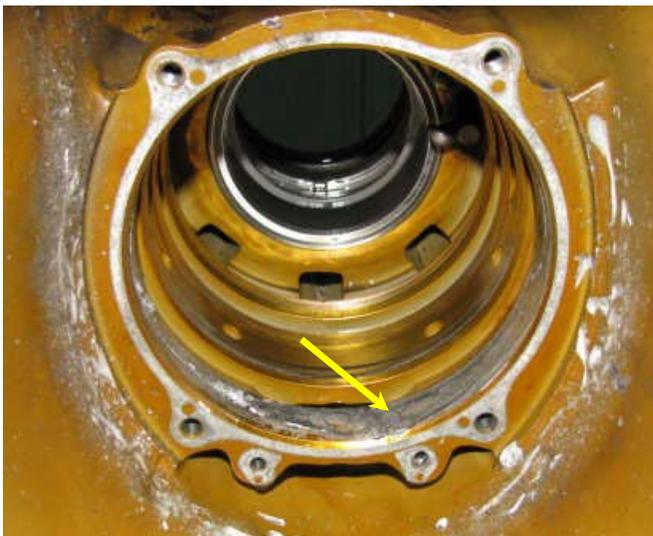
Underneath the No. 1 bearing outer race, the FIC surface was deeply fretted and gouged. See Figure 31. A 40° arc of the scavenge jet pump transfer tube O-ring was missing and the O-ring fragment recovered from the RGB oil scavenge sump screen matched the missing section. See Figure 32.

Figure 31. FIC, showing heavy fretting/gouging at No. 1 bearing fit area

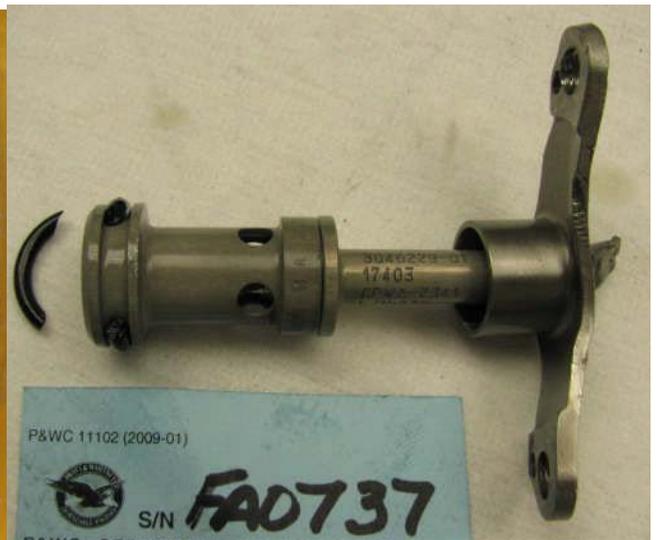
Figure 32. No. 1 bearing oil scavenge pump assembly, with severed O-ring and recovered segment

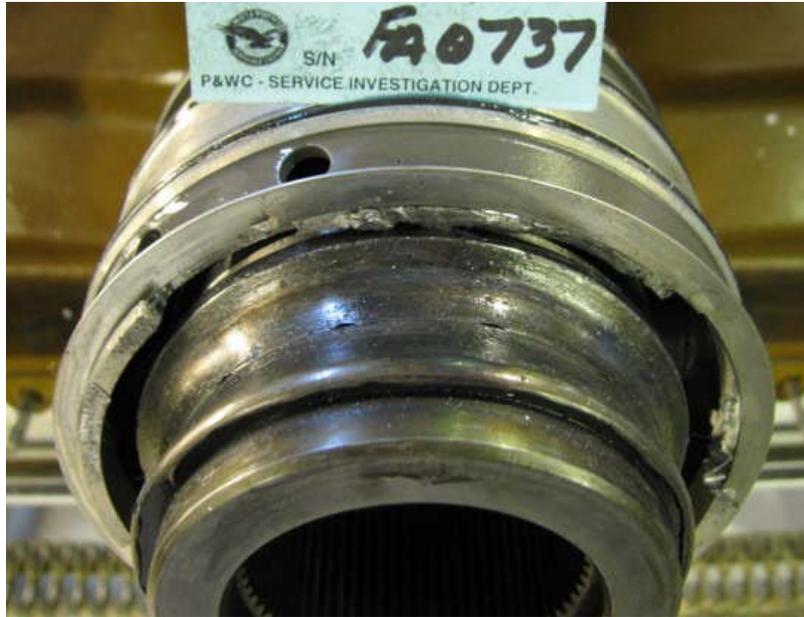
Figure 33. No. 1 bearing split inner race and oil nozzle housing retaining ring

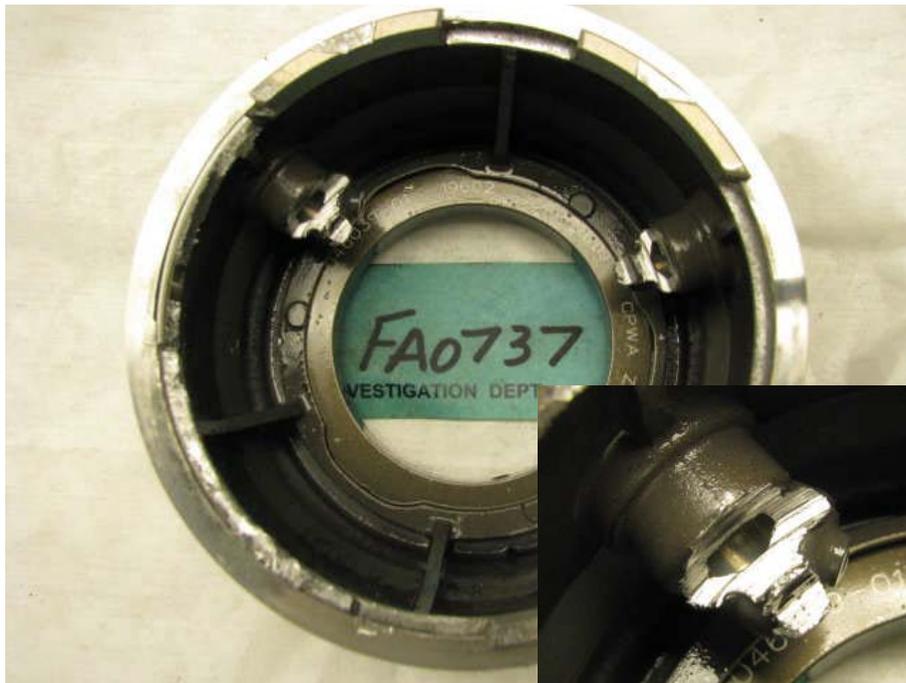
The ring that retains the No. 1 bearing oil nozzle housing to the bearing inner race was present but was fractured, and several retaining ring lugs and small pieces of the housing were fractured off. See Figure 33. Some of this material was recovered from the debris in the RGB oil scavenge sump strainer. The No. 1 bearing oil delivery nozzles were circumferentially scored. The scoring was approximately 3/8-inch deep and exposed the internal oil passages. See Figure 34. The No. 1 and No. 2 oil strainers were clean.

Figure 34. No. 1 bearing oil nozzle housing, showing circumferential scoring

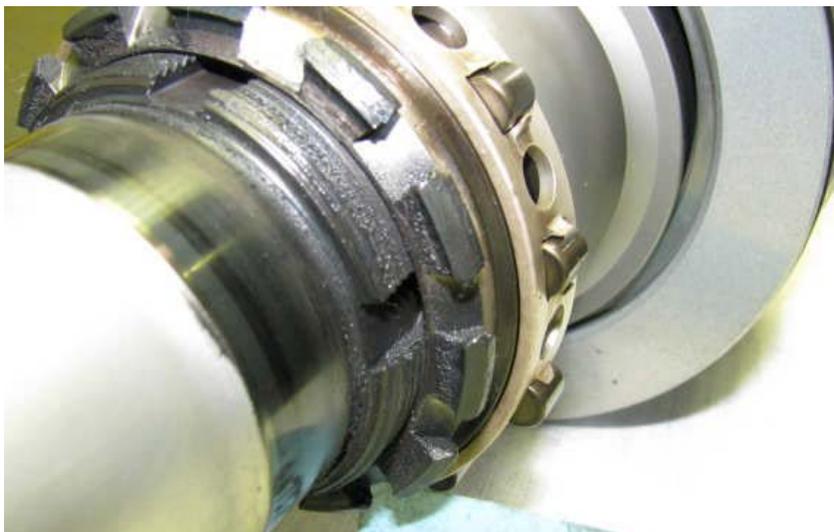
The No. 2 bearing was intact but dry. The bearing retaining nut, key washer, and retaining ring were torn and partially disintegrated. See Figure 35. The outer diameter of the PT shaft was not rubbed.

Figure 35. PT shaft and No. 2 bearing nut, key washer, and retaining ring, showing rotational damage

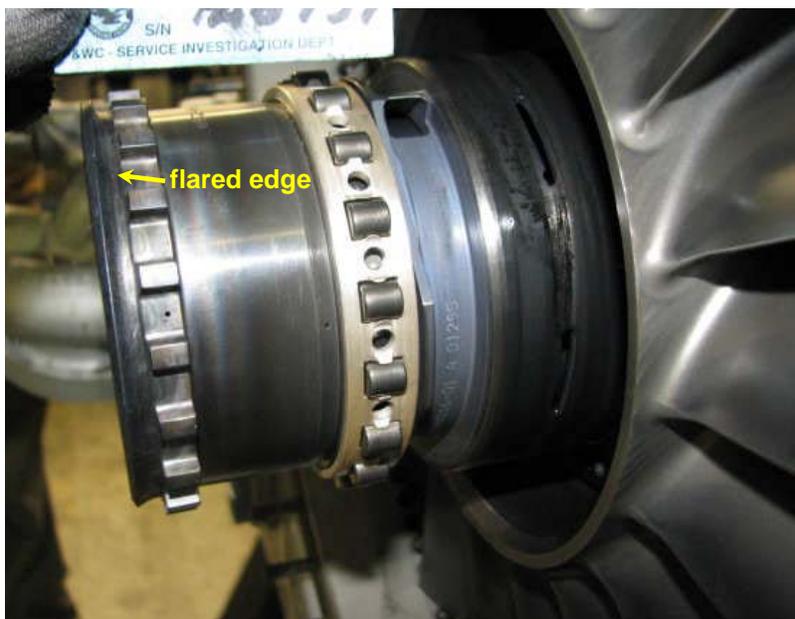
The No. 2.5 bearing was dry but intact. The front end of the phonic ring was flared. The LPC assembly was in otherwise good condition. See Figure 36.

Figure 36. LPC, showing phonic ring rub damage

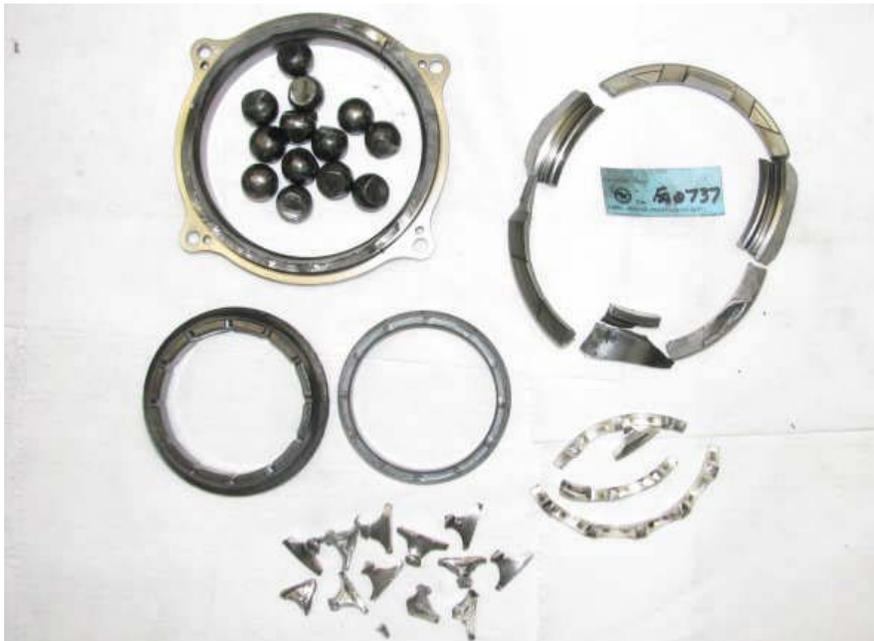
The No. 1 bearing cage was fractured circumferentially at the cross bars, and these sections were axially fractured into multiple fragments. See Figure 37. The split inner race was severely worn. The balls were heat discolored consistent with having rubbed against the split inner race. Five of the thirteen balls showed a circumferential band of spalling; the remaining balls were too damaged to confirm the presence of the band.

Figure 37. No. 1 bearing components

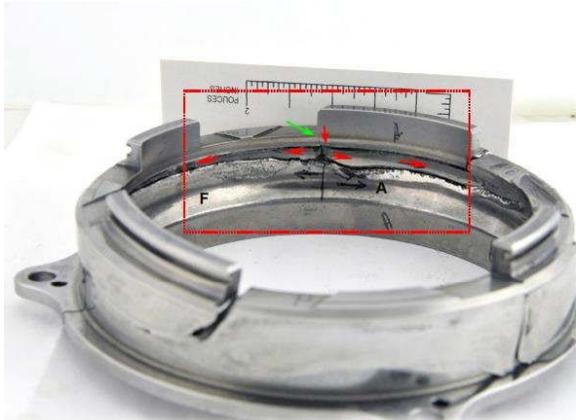
Several outer race fracture surfaces displayed fatigue features. A reconstruction of the outer race showed a fatigue crack initiating at the inner radius of a lug on the non-flanged side of the bearing and propagating axially to the middle of the rolling path, then circumferentially in both directions. See Figures 38 and 39.

Figure 38. Reconstruction of the bearing outer race. showing origin and direction of fatigue crack propagation (red arrows)

PWC determined that fatigue cracks initiated in the outer race at the inner radius of one of the large lugs due to a radial pressure on the loaded side of the outer race. The source of the radial pressure is unknown. However, the radial pressure may have been created by particle accumulation on the rolling surface of the outer race that was generated by the ball degradation.

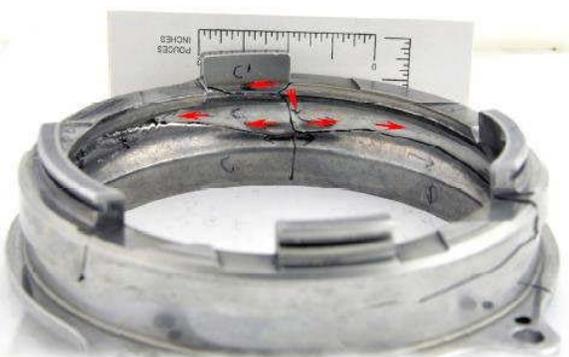
Figure 39. Bearing outer race rotated 180° clockwise

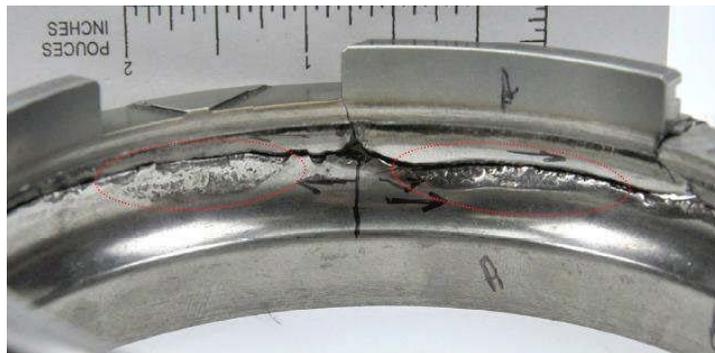
The fractured outer race showed spalled areas on either side of the main axial fracture. See Figure 40.

Figure 40. Regions of spalling on both sides of the axial crack

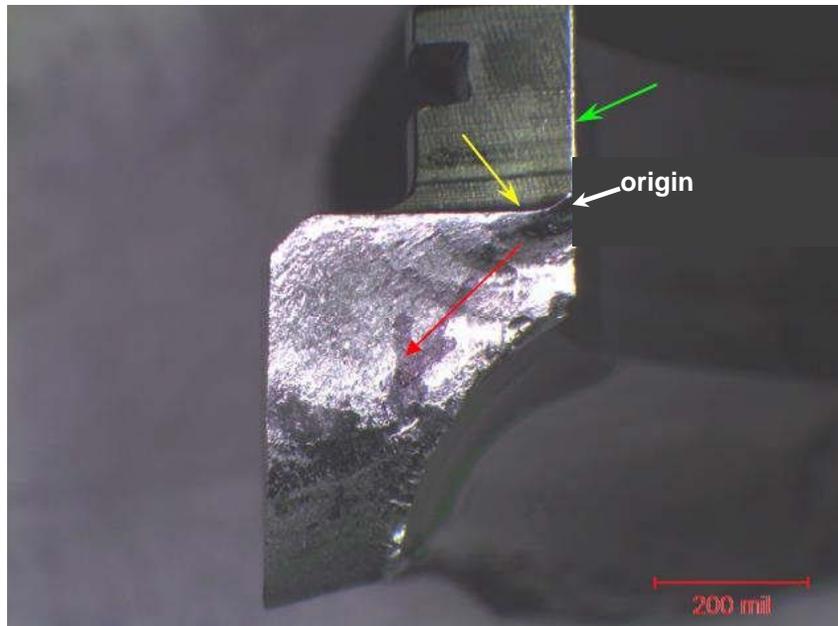
Microscopic examination of the origin area showed the fatigue crack propagating from the upper section of the radius at the intersection of the large lug and the end face of the outer race. See Figure 41.

A radius measurement performed at the origin of the fatigue crack between the edge of the large lug and the end face of the outer race was within drawing requirements. No metallurgical anomalies were observed in the base material of the outer race. The outer race microstructure and the hardness met drawing requirements.

Figure 41. Magnified view of origin area showing the fatigue crack propagating from the upper section of the radius at the intersection of the large lug (green arrow) and the end face of the outer race (yellow arrow). Red arrow denotes the direction of fatigue growth

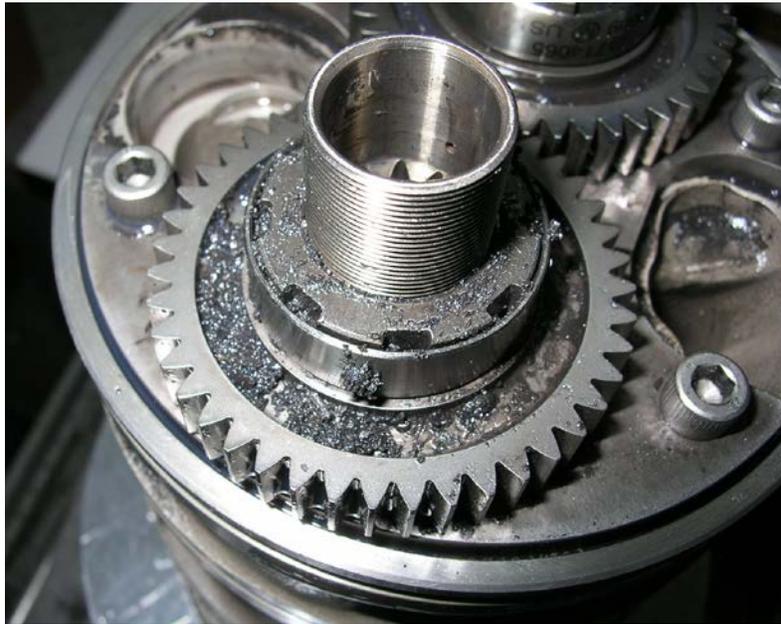
The pump external surfaces were heavily contaminated. See Figure 42.

Figure 42. Main oil pump external contamination - spur gears
