NATIONAL TRANSPORTATION SAFETY BOARD
OFFICE OF AVIATION SAFETY
WASHINGTON, D.C. 20594

POWERPLANTS GROUP CHAIRMAN'S FACTUAL REPORT

NTSB ID: ENG11IA021

Location: Pittsburgh, Pennsylvania
Date: March 17, 2011
Time: 1640 coordinated universal time (UTC)
Aircraft: Bombardier DeHavilland DHC-8, Reg. No. N339NG, Colgan Air flight 3212

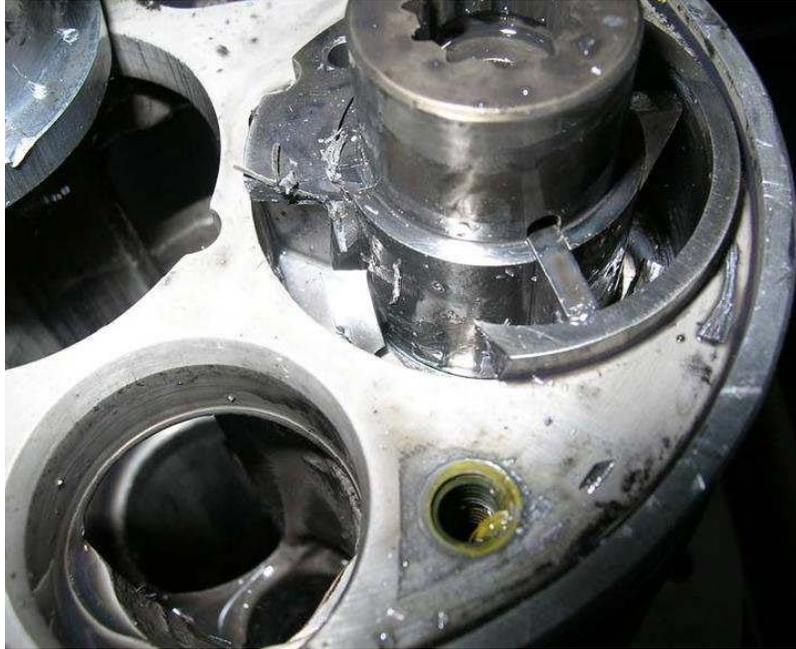
Contamination was also found between the element sleeves and the main housing bores and inside of the scavenge pump elements, making disassembly difficult. A fractured sleeve was found at the discharge window of the 2/2.5 element. See Figure 43.

Figure 43. 2/2.5 bearing element, showing fractured sleeve

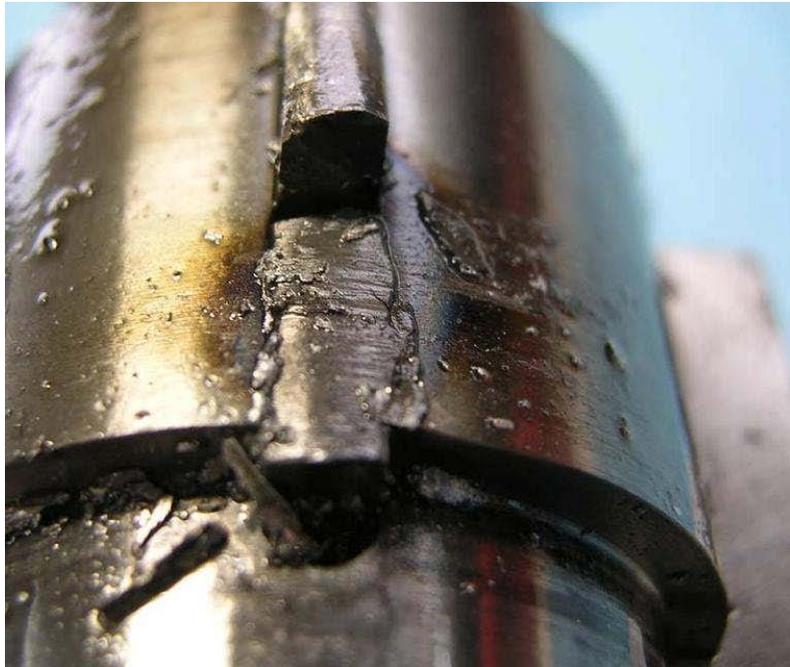
The vane 180° from the fractured sleeve damaged and was jammed inside its slot and the rotor exhibited localized metal smearing, adhesion and heat discoloration on either side of the slot. See Figure 44.

Figure 44. Vane seized in rotor, showing metal smearing and vane heat discoloration

Disassembly of the 2/2.5 element found that it was heavily contaminated and confirmed that the heat-discolored vane had seized inside its slot.
