NATIONAL TRANSPORTATION SAFETY BOARD
Office of Aviation Safety
Washington, D.C. 20594

POWERPLANT GROUP CHAIRMAN'S FACTUAL REPORT

NTSB No: ANC-10-MA-068

Location: Aleknagik, Alaska
Date: August 9, 2010
Time: 1442 Alaska daylight time (ADT)
Aircraft: DeHavilland Canada DHC-3 "Turbine Otter", N455A

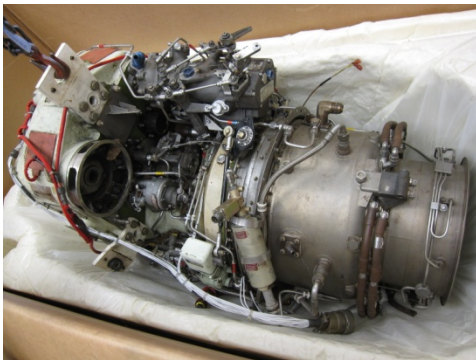
PHOTO 1: UNBOXED ENGINE

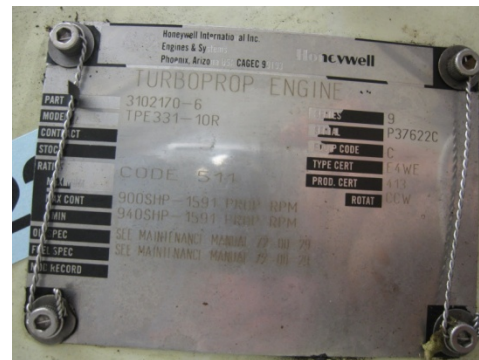
PHOTO 2: ENGINE DATA PLATE

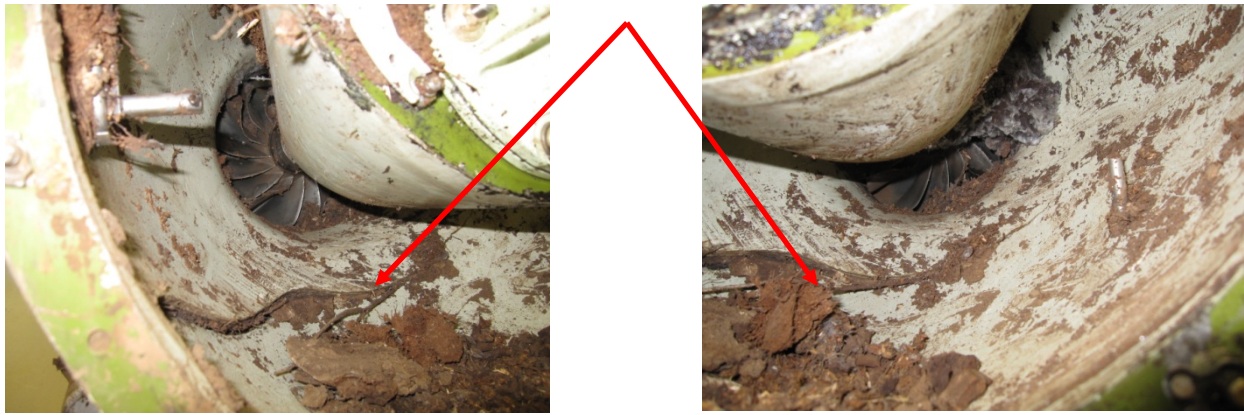
All the forward engine mounts, located on the accessory drive housing, were intact except for the left-hand mount that was fractured exposing the two of the four threaded inserts. The oil tank, located along the bottom of the engine was pushed inwards and fractured open. No oil remained within the tank. Dirt was found along the air inlet duct of the accessory drive housing up to the 1st-stage compressor impeller (**PHOTO 3**). Looking through the inlet, dirt was noted on the P₂T₂ inlet sensor and on the 1st-stage impeller with some of the blades bent in the direction opposite of rotation while others appeared to have been straightened (See section 2.3 *Compressor Section Disassembly* for more details). The air inlet duct exhibited about a 17-inch long crack but remained intact (**PHOTO 4**).

FRACTURE IN THE AIR INLET DUCT

**PHOTO 3: LOWER LEFT-HAND LOOKING THROUGH INLET****PHOTO 4: LOWER RIGHT-HAND LOOKING THROUGH INLET**

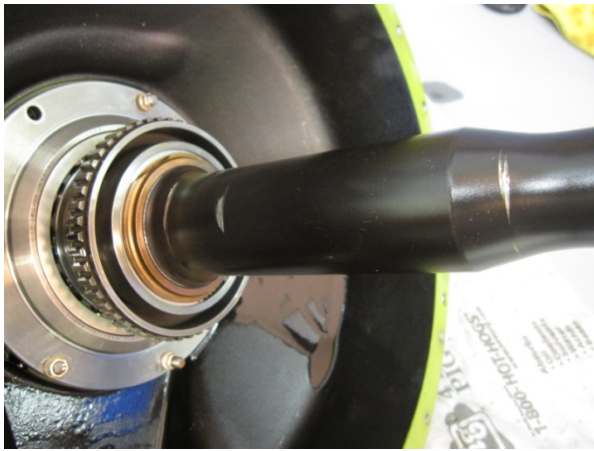
The nose-cone housing (also referred to the output housing) was removed from the diaphragm assembly (also referred to as the intermediate housing), exposing both the propeller shaft and the forward propeller shaft bearing that remained attached to the nose-cone housing, as well as the planetary gear assembly and the sun gear that were still installed in the diaphragm assembly. The nose-cone housing was intact, exhibited no impact damage or housing breaches, and was oil wetted. The propeller shaft was intact and exhibited 4 localized circumferential scoring marks along the shaft length – 1 mark immediately aft of the propeller shaft nut, 1 mark in the middle of the shaft, and 2 marks aft of the shaft taper. None of the scoring marks were 360° circumferentially around the shaft and the largest was about 180° around (**PHOTO 5**). The propeller shaft forward bearing was not disassembled but rotated freely, appeared undamaged, and was oil wetted. The propeller shaft forward bearing oil jet was intact and undamaged. Two adjacent forward propeller shaft bearing mount bolts were missing while two other adjacent bolts were loose with their respective nuts displaced aft but still engaged with the bolt threads. The propeller shaft coupler was intact and exhibited three axial cracks in the forward spline area (**PHOTO 6**). Neither internal splines of the propeller shaft coupler nor the mating external splines of the splined coupler exhibited heavy tooth damage which would have been consistent with the gears overriding each other.

PHOTO 5: PROPELLER SHAFT WITH MULTIPLE SCORING

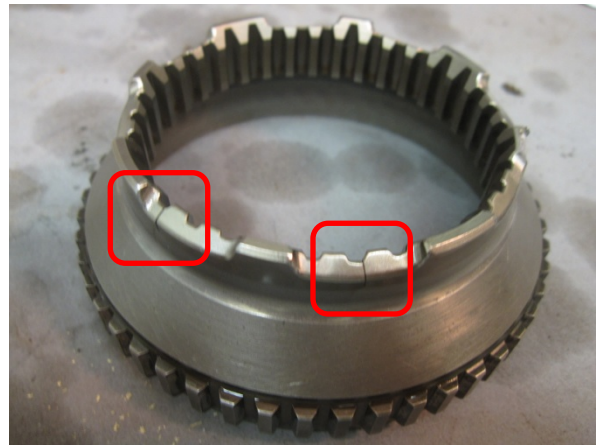
PHOTO 6: CRACKED PROPELLER SHAFT COUPLER

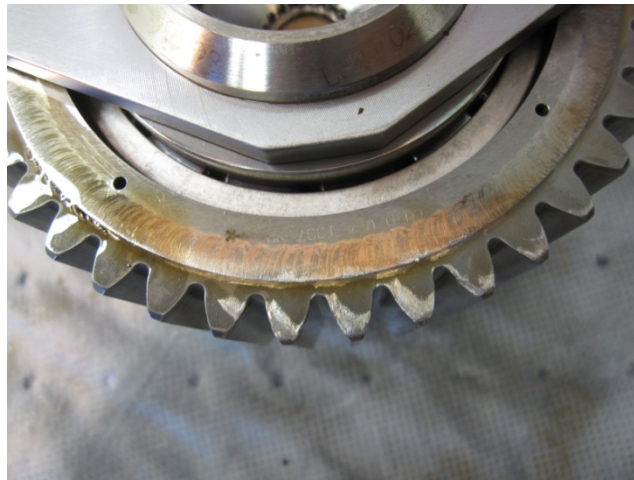
The planetary gear assembly was intact and removed from the ring gear with ease but was not disassembled further. All the planetary gears were oil wetted and turned freely. The contact patch was not around the entire circumference of the inner front face. Two adjacent planetary gears exhibited scoring on the aft face of 7 consecutive teeth consistent with contact with the ring gear support bumper plate (**PHOTO 7**).

PHOTO 7: PLANETARY GEAR TEETH WITH CONTACT SCORING

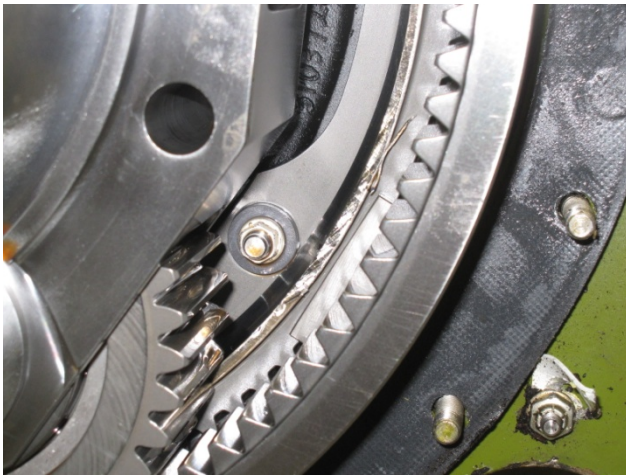
The ring gear, the ring gear support, and ring gear retainers were all in place, intact, and appeared to be undamaged. The ring gear support bumper exhibited two sets of distinctive circumferential scoring marks, one located from about the 8:00 – 9:00 o'clock position and the other centered at about the 11:00 o'clock position, consistent with contact from the planetary gear teeth (**PHOTO 8**). The sun gear was intact and appeared to undamaged but was not removed from the diaphragm assembly. Rotational scoring was noted on the sun gear inner bore near the aft end of the gear that corresponded to the rotational mark observed on the middle of the propeller shaft (**PHOTO 9**). The ring gear oil jets were all intact and appeared undamaged.

PHOTO 8: RING GEAR BUMPER LOCALIZED SCORING

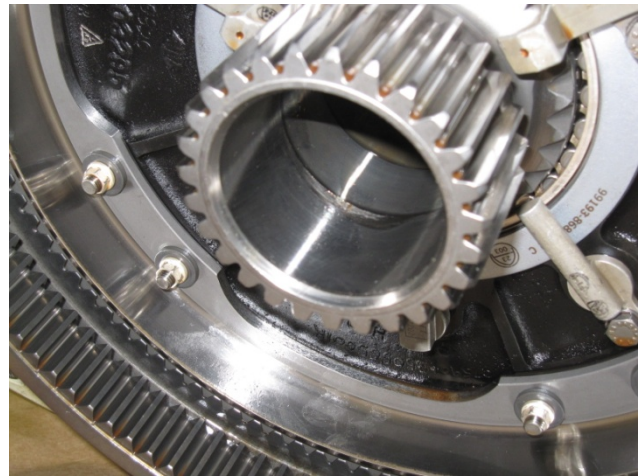
PHOTO 9: SUN GEAR INNER LOCALIZED SCORING

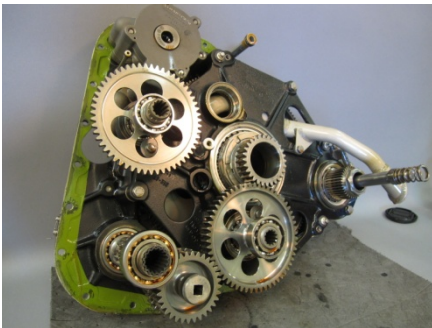
The diaphragm housing assembly was removed, exposing all the accessory drive gears installed on the aft side of the diaphragm housing and the gears in the accessory drive housing. The diaphragm assembly was not disassembled for detailed inspection, but the diaphragm housing, all the accessory drive gears,² and the bearings were intact, oil wetted, appeared to be undamaged, and all gears rotated freely by hand and in unison (**PHOTO 10**). The bull gear was not removed from the diaphragm housing assembly; however, by rotating the gear set, all the bull gear teeth were visible and they all appeared to be in good condition. The high speed pinion (HSP) gear appeared to be undamaged and was not removed from the diaphragm assembly. The HSP gear rotated freely along with bull gear and accessory gear set with no resistance. The HSP-to-torsion shaft coupling shaft was fractured/sheared consistent with overload, near the aft spline and was not removed from the HSP gear (**Photos 11 and 12**). The accessory drive housing was oil wetted and clean.

PHOTO 10: ACCESSORY GEARS INTACT

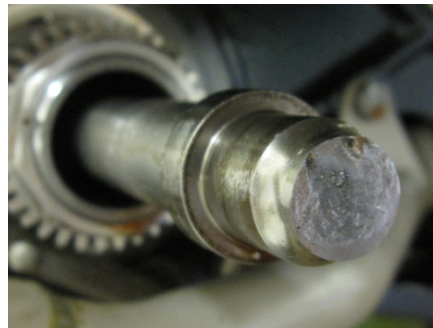
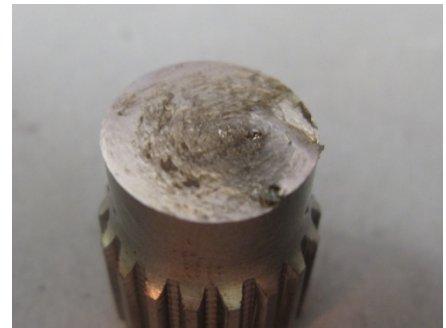
PHOTO 11: SHEARED COUPLING SHAFT

PHOTO 12: SHEARED COUPLING SHAFT

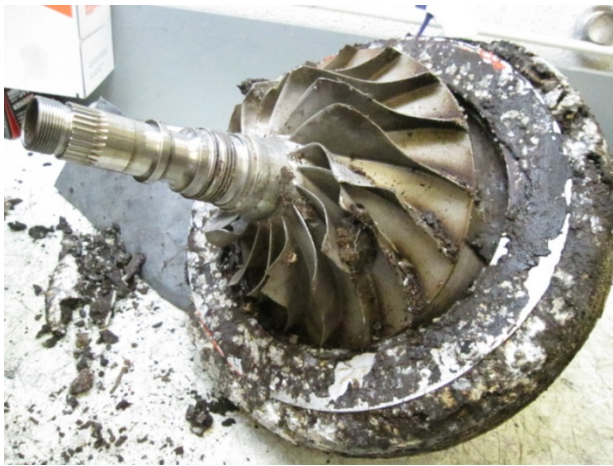
circumferential rub from about the 9:00 to 11:00 o'clock position. All along the inducer part of the shroud were impact marks consistent with foreign object ingestion. The exit area of the shroud exhibited a circumferential scoring mark from the 5:00 to 9:00 o'clock position. All the blades on the 1st-stage impeller were present, several were missing parts of the blade tips, and the majority exhibited some form of leading edge damage. The majority of the blades were bent in the direction opposite rotation; however, there was a group of three adjacent blades that appeared to have their blade contour straightened (**PHOTO 13**). Dirt debris was found between the blades but the essentially the impeller was relatively clean. The aft curvic appeared to be undamaged and 360° circumferential scoring was noted on the aft hub consistent with contact with the inner diameter of the cross over duct housing seal. The 1st-stage compressor diffuser (crossover duct) was packed full of dirt (**PHOTOS 13 AND 14**). The forward part of the crossover duct had become detached from aft portion and remained wedged in accessory gearbox and was not removed for further examination.

PHOTO 13: 1ST-STG IMPELLER BLADE DAMAGE AND COMPRESSOR DIFFUSER PACKED WITH DIRT

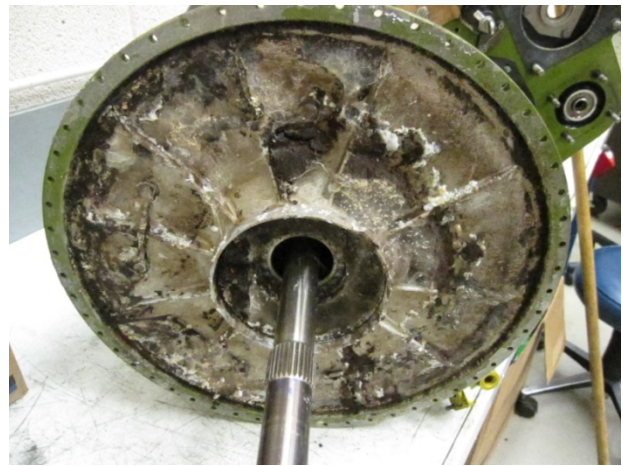
PHOTO 14: AFT SIDE OF COMPRESSOR DIFFUSER DUCT

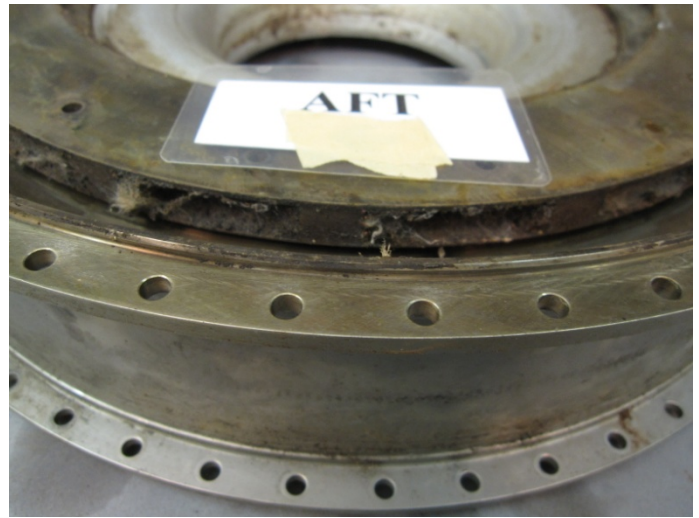
PHOTO 16: 2ND-STAGE COMPRESSOR DIFFUSER ASSEMBLY WAS INTACT AND PACKED WITH DIRT

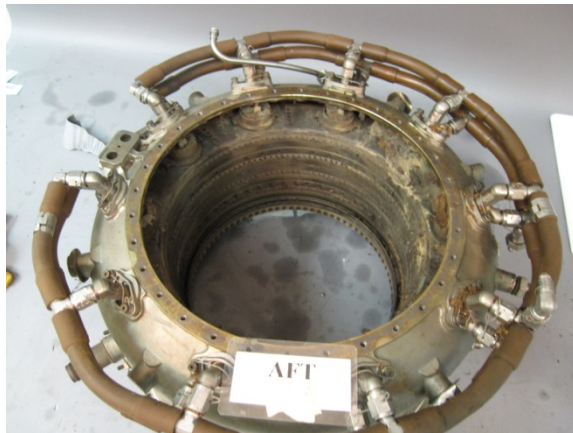
The plenum, combustor chamber, de-swirl vane assembly, and fuel manifolds were removed from the engine as an assembly and were not disassembled any further. The plenum case and combustor chamber were intact and appeared to be undamaged. All fuel nozzles were in place with their bolts installed and safety wired. The fuel manifolds were intact and undamaged – one of the rubber shielding covers exhibited a slice but the manifold was not compromised. There was dirt debris found in various combustion chamber cooling holes, fuel nozzle swirlers, inner diameter seams and skirts of the combustor chamber as well as within the de-swirl vane assembly (**PHOTOS 17 AND 18**). The bleed air port fitting at the 8:00 o'clock position was removed from the plenum and the port was packed with dirt.

PHOTO 17: COMBUSTOR FULL OF DIRT

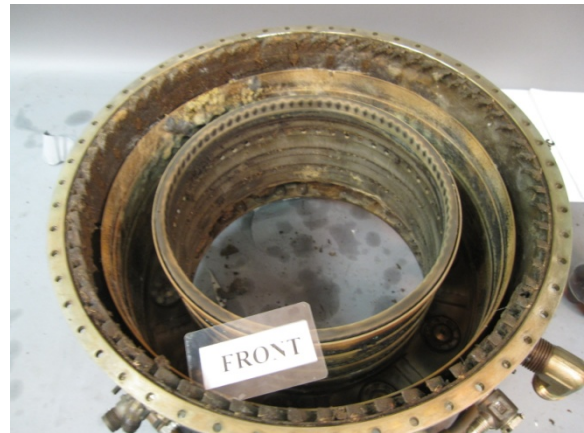
PHOTO 18: COMBUSTOR & DE-SWIRL FULL OF DIRT

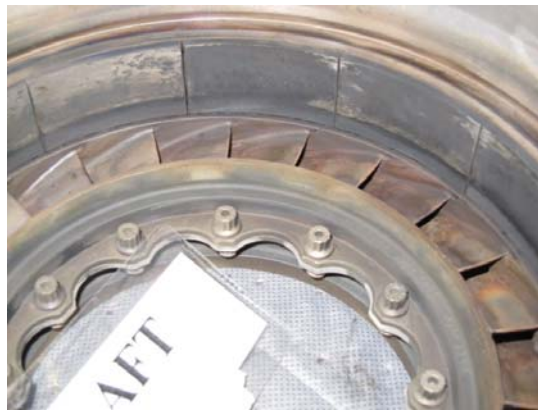
The 1st-stage turbine stator assembly was not disassembled from the vane case. All the vanes were installed and intact within the vane ring. No leading or trailing edge erosion or missing airfoil material was noted. No metal spray was noted on the vanes; however, some sporadic dirt deposits were noted on some of the vane leading edges. The 1st-stage turbine blade tip shrouds were all intact and undamaged. Visually all the shrouds exhibited light rotational non-uniform contact rub or scoring; however, tactile examination revealed no significant raised edges or any appreciable depth of rub (**PHOTO 19**). The vane case exhibited contact wear and slight bluing of the ledge that supports the 2nd-stage turbine stator assembly. Dirt deposits were observed on the outside of the vane case.

PHOTO 19: LIGHT CONTACT SCORING ON THE 1ST-STAGE TURBINE BLADE TIP SHROUDS

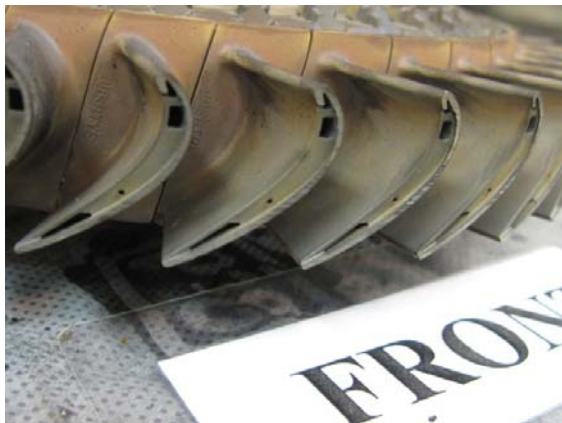
The 1st-stage turbine rotor was intact with all the blades at full length and no leading or trailing edge damage noted. The forward and aft coupling teeth appeared undamaged. No metal spray was noted on the blades. Light rotational scoring was noted on the blade tips consistent with contact from the 1st-stage turbine blade tip shrouds (**PHOTO 20**). Light rotation scoring was also noted on some of the aft blade inner platforms consistent with 2nd-stage turbine stator assembly inner vane support contact (**PHOTO 21**). The scoring was not on all the blade aft platforms, but around a 180° arc.

PHOTO 20: 1ST-STG TURBINE ROTOR BLADE TIP SCORING

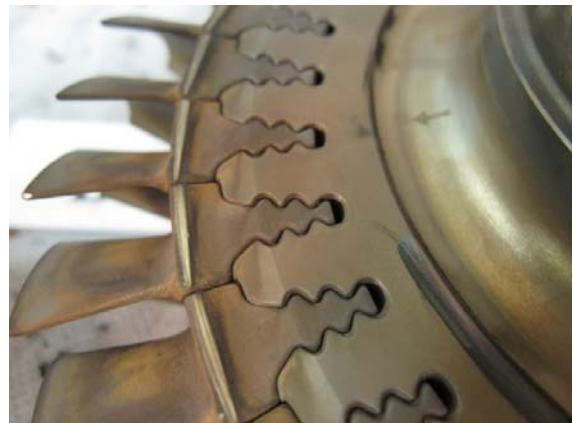
PHOTO 21: AFT INNER PLATFORMS SCORING

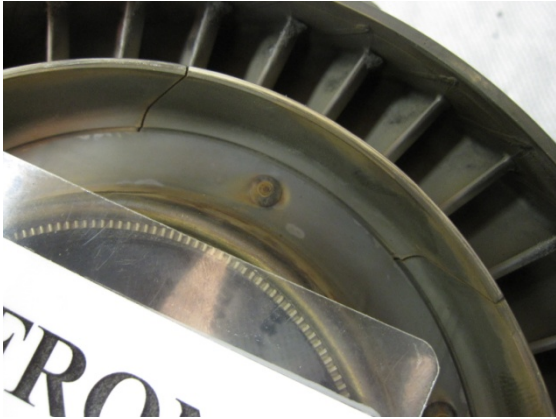
The 2nd-stage turbine stator assembly appeared undamaged and all the vanes were installed and intact within the vane ring. No leading or trailing edge erosion or missing airfoil material was noted. No metal spray was noted on the vanes; however, dirt deposits were noted on both the pressure and suction sides on the majority of the vanes. Light localized rotational scoring was noted on the inner vane support front face consistent with 1st-stage turbine aft platform contact (**PHOTO 22**). Localized in only one area, light rotational contact rub was observed on the 2nd-stage turbine blade tip shroud (**PHOTO 23**). Tactile examination revealed no appreciable depth to the rub. The inner stationary honeycomb seal was in good condition and did not exhibit any deep grooves.

PHOTO 22: LOCALIZED SCORING OF INNER VANE SUPPORT

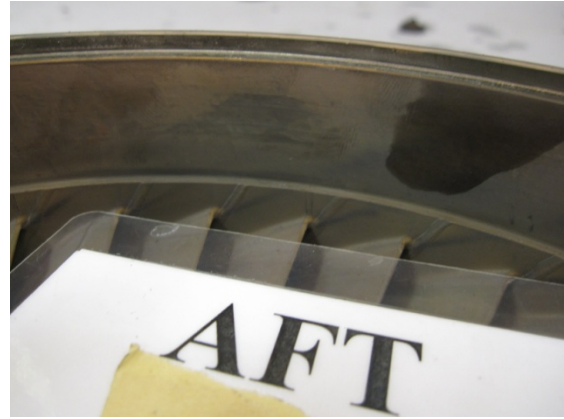
PHOTO 23: LOCALIZED SCORING OF BLADE TIP SHROUD

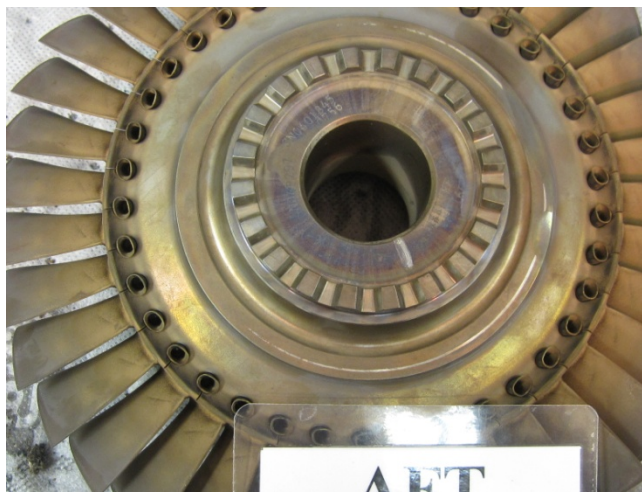
The 2nd-stage turbine rotor was intact with all the blades at full length and no leading or trailing edge damage noted. The forward and aft coupling teeth appeared undamaged. No metal spray was noted on the blades. Light rotational scoring was noted on the blade tips consistent with contact from the 2nd-stage turbine blade tip shroud. Circumferential scoring was noted on the aft side of the disk in the balance weight flange consistent with 3rd-stage stationary airseal forward lip contact; however the scoring was only in two light patches and was not continuous 360° around (**PHOTO 24**). The 2 sets of rotating knife edge seals (a single forward seal and a triple aft seal) exhibited no signs of rolling or impact damage.

PHOTO 24: CIRCUMFERENTIAL SCORING ON THE 2ND-STAGE TURBINE ROTOR BALANCE FLANGE

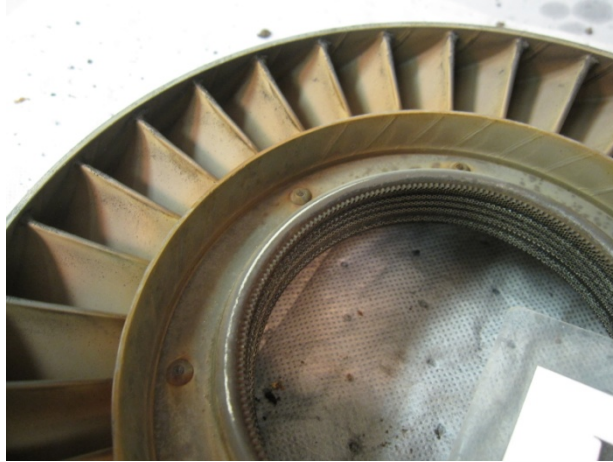
The 3rd-stage turbine stator assembly appeared undamaged and all the vanes were installed and intact within the vane ring. No leading or trailing edge erosion or missing airfoil material was noted. No metal spray was noted on the vanes; however, dirt deposits were noted on the suction side near the leading edge on the majority of the vanes. Circumferential scoring was noted on the forward lip of the 3rd-stage stationary airseal consistent with 2nd-stage turbine rotor balance weight flange contact (**PHOTO 25**). The scoring was continuous 360° around. No rotational rub was noted on the 3rd-stage turbine blade tip shroud. The inner stationary honeycomb seal was in good condition and did not exhibit any deep grooves.

PHOTO 25: CIRCUMFERENTIAL SCORING ON THE FORWARD LIP OF THE 3RD-STAGE STATIONARY AIRSEAL

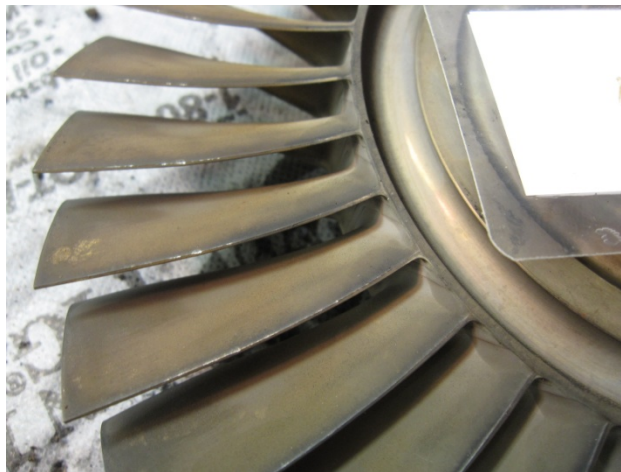
The 3rd-stage turbine rotor was intact with all the blades at full length and no leading edge damage was noted; however, some of the trailing edges exhibited light impact damage that was rough to the touch (**PHOTO 26**). The forward and aft coupling teeth appeared undamaged. No metal spray was noted on the blades. No rotational scoring was noted on the blade tips. The 2 sets of rotating knife edge seals (a single forward seal and a triple aft seal) exhibited no signs of rolling or impact damage.

PHOTO 26: TRAILING EDGE IMPACT DAMAGE ON THE 3RD-STAGE TURBINE ROTOR BLADES

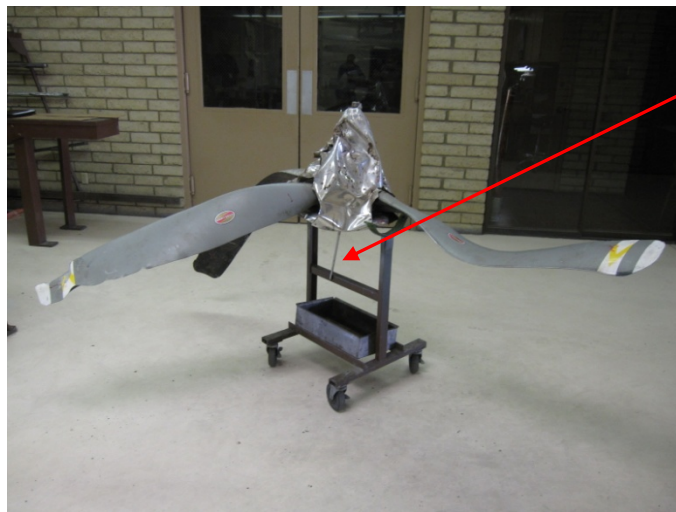
The spinner dome, spinner bulkhead, and three propeller blades remained attached to the propeller hub and the remaining blade was loose. The engine 'Beta' tube was still installed within the propeller hub and was cut so that the propeller could be placed in the holding fixture to facilitate disassembly and inspection (**PHOTO 27**). The propeller blades and their associated pitch change hardware were numbered 1 through 4, aft looking forward, in the clockwise direction with the No. 1 blade position chosen arbitrarily. All position references relating to the propeller in this report uses this numbering convention and was done to streamline the documentation process. The loose propeller blade was labeled as the No. 3 blade. According to the maintenance records, the No. 1 propeller blade was identified as SN H88181, the No. 2 as SN K09526, the No. 3 as SN K09527, and No. 4 as K09529. Since the propeller blades were labeled arbitrarily for documentation purpose, there is a difference between the two numbering systems. The two numbering systems are off by one number in the clockwise direction, hence the No. 1 propeller blade according to the maintenance records is labeled No. 2 for documentation purposes, the No. 2 propeller blade according to the maintenance records is labeled No. 3 for documentation purpose and so on.

PHOTO 27: AS-RECEIVED PROPELLER WITH 'BETA' TUBE STILL INSTALLED

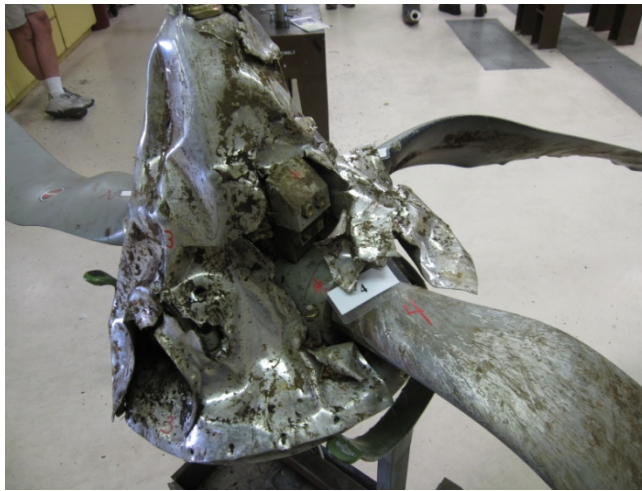
The spinner dome exhibited frontal impact damage, tears, cuts, missing material and was wrapped around the propeller hub and piston. The No. 4 counterweight arm, with the counterweight lug still attached, had broken through the skin of the spinner dome (**PHOTO 28**). All the attachment screws that secure the spinner dome to the spinner bulkhead had been previously removed; however, the spinner dome remained secure around the hub and piston. The spinner bulkhead exhibited impact damage but was intact. The spinner dome was removed to expose the piston, the pitch change mechanisms and the propeller blade attachment hardware.

PHOTO 28: SPINNER DOME DAMAGE WITH THE NO. 4 COUNTERWEIGHT PUNCTURED THROUGH THE SKIN

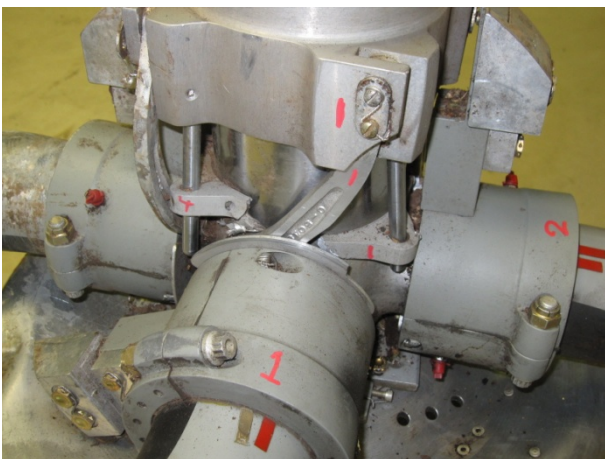
The counterweight for the No. 1 blade position (**PHOTO 29**) was found against the spinner bulkhead (blade had over-travelled in the reverse direction) in the counterclockwise direction looking down the length of the blade towards the hub. The counterweights for the No. 2, 3 and 4 blade positions were all pointing in the forward direction consistent with the reverse blade pitch position (**PHOTOS 29 AND 30**).

PHOTO 29: NOS. 1, 2, & 4 COUNTERWEIGHT POSITION

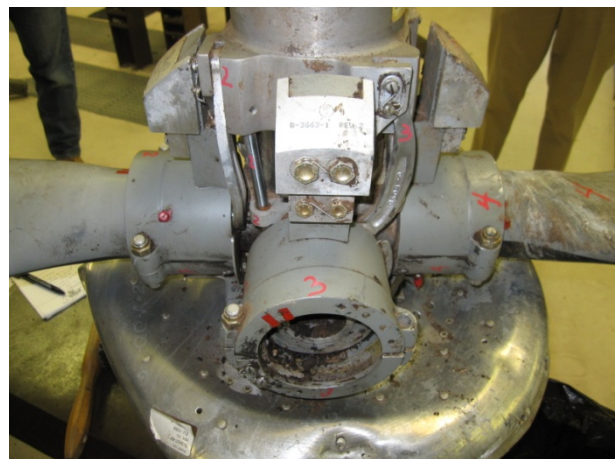
PHOTO 30: NOS. 2, 3, & 4 COUNTERWEIGHT POSITION

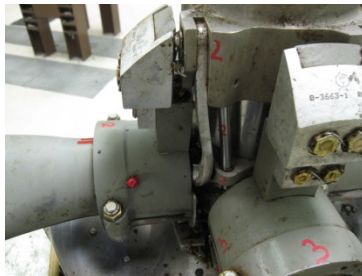
PHOTO 32

All 4 link arms were intact, exhibited some degree of twisting and bending distortion, and were secured to the piston. The No. 1 link arm was the least distorted of all the links arms and was the only one that did not remain engaged with the clamp link screw (**PHOTO 31**). One of the two attachment screws used to secure the No. 4 link arm to the piston was fractured but the screw shank remained installed. Link arms Nos. 2, 3, and 4 were buckled and twisted inwards, with the No. 3 and No. 4 link distorted enough that the link arm contacted the guide collar (**PHOTOS 32, 33, AND 34**).

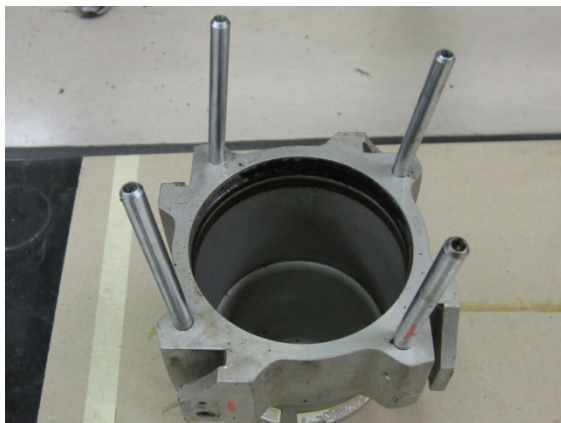
The piston was intact with no breaches or fracture; however, it had rotated in the counterclockwise direction, aft looking forward, about its longitudinal centerline. All 4 piston guide rods were intact, engaged with both the piston and the guide rod collar, and bent/twisted in the counterclockwise direction corresponding to the rotated piston orientation (**PHOTO 35**). The piston extension was measured from the guide rod collar to the piston guide rod flange at the No. 1 guide rod position. The exposed length of the guide rod was about 2.5-inches (**PHOTO 36**).

PHOTO 35: BENT AND TWISTED PISTON RODS

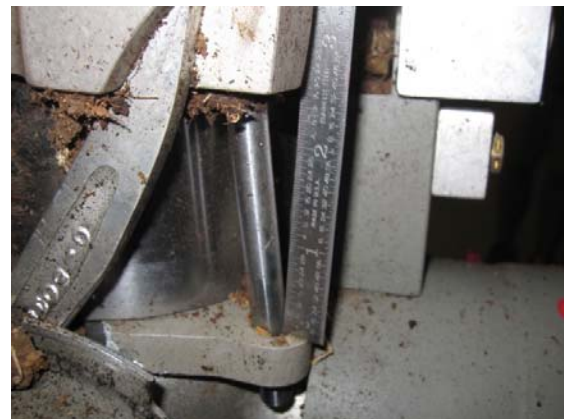
PHOTO 36: PISTON EXTENSION MEASUREMENT

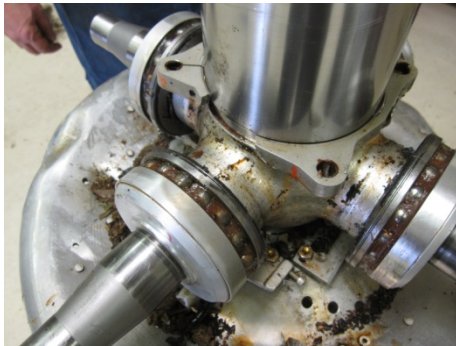
The propeller blade clamps, blades, and the piston were removed exposing the guide rod collar, hub arms, the start locks, the cylinder, and the inside of the piston and blade clamps. The guide rod collar was fractured and missing a section of material between the No. 4 and No. 1 guide rod location (**PHOTO 37**). Deep gouge marks were noted between the No. 1 and No. 2 guide rod location and also No.

**PHOTO 37: FRACTURED GUIDE COLLAR**

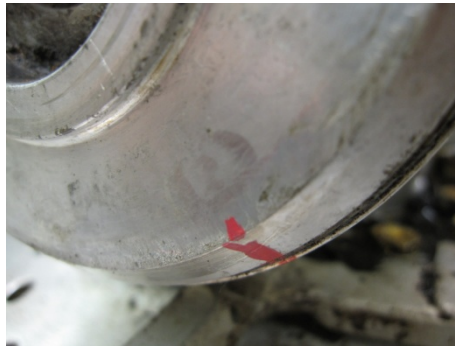
2 and 3 guide rod location. The gouge marks were consistent with the link arm-to-counterweight clamp attachment screw contact. All the propeller blade bearings were present, in good condition, and covered with grease. All the hub arms were in good condition and a faint circular witness mark was noted on the blade contact face (aft side) on the No. 3 and 4 arm that was similar to an inspection stamp found on the butt of the blade (**PHOTOS 38 AND 39**). The angular location of the imprint marks was consistent with the propeller blades at a reverse pitch position. All the blade pilot tubes were present and in good condition except for the No. 3 blade which was fractured with part of the pilot tube installed in the hub arm and in the bore of the blade. All four blade start locks were in-place, intact and were cycled by hand by depressing the spring and the lock sprung back when released. The cylinder was in good condition and exhibited no impact marks; however, the front spring retainer was difficult to remove due to thread binding. The inside of the piston exhibited light indentations consistent with contact from the feather stop screws. These light indentations on the inside of the piston are considered a normal contact pattern.

**PHOTO 38: IMPRESSION ON NO. 3 ARM**

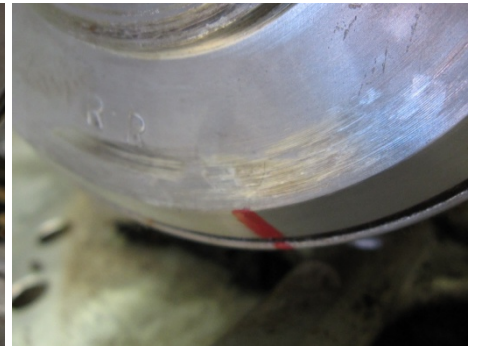
**PHOTO 39: IMPRESSION ON NO. 4 ARM**

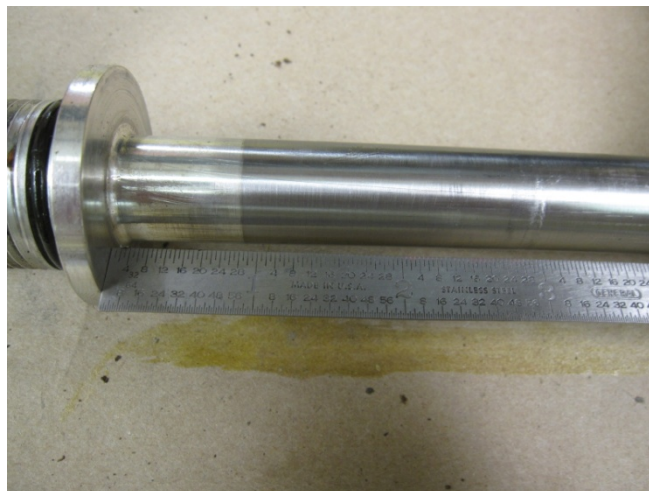
The feather spring assembly was disassembled to expose the spring, reverse pitch stop components, and the change rod. The pitch change rod exhibited a light circumferential score mark that did not extend completely around the rod circumference. The score mark was located about 3-inches from the pitch change rod flange (**PHOTO 40**).

**PHOTO 40: PITCH CHANGE ROD WITH CIRCUMFERENTIAL SCORE MARK**

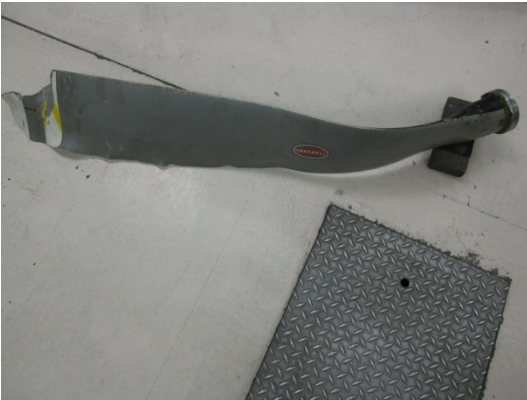
The No. 1 propeller blade was bent aft approximately 45° at about the 1/3 blade span. The leading edge of the blade was missing approximately a 7-inch piece of the blade tip with a portion of the tip curled forward (**PHOTO 41**). The trailing edge exhibited multiple bends and waviness along the outer half of the span. The blade tip paint exhibited some scuffing and paint loss.

PHOTO 41: NO. 1 BLADE AIRFOIL DAMAGE

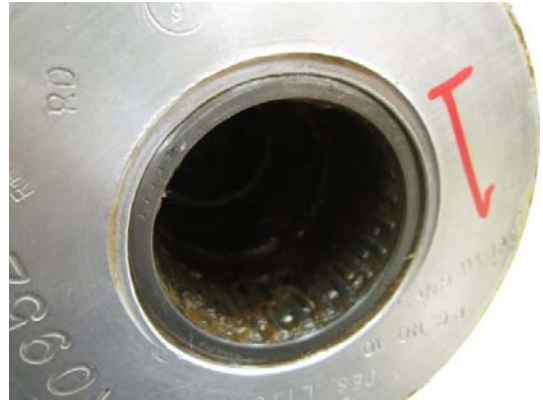
A semi-circular imprint mark was noted around the blade bore located towards the back side of blade (flat side) butt consistent with contact with the raised lip on the hub arm blade contact face (**PHOTO 42**).

PHOTO 42: NO. 1 BLADE BUTT CONTACT IMPRINT

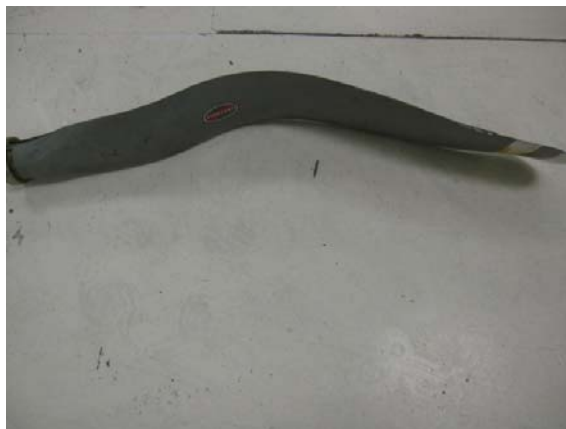
The No. 2 propeller blade was bent aft approximately 20° at about the 1/3 blade span and bent forward approximately 30° at about the mid-blade span (**PHOTO 43**). A 3-inch section of the leading edge was deformed aft about 2-inches from the blade tip. The trailing edge exhibited scoring along the on the outer 1/2 of the blade span. No significant paint damage was noted.

PHOTO 43: NO. 2 BLADE AIRFOIL DAMAGE

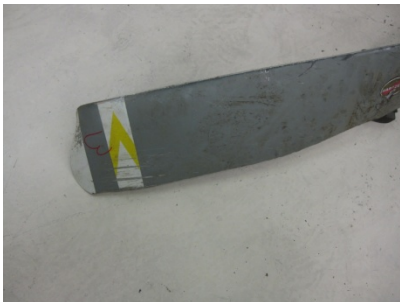
The No. 3 propeller blade had separated from the hub clamp and was found loose. The blade was bent aft approximately 45° at about the $\frac{1}{4}$ blade span and was slightly twisted towards the lower pitch. The outer 3 inches of the blade tip was curled aft (**PHOTO 44**). The leading edge was slightly deformed about $\frac{3}{4}$ span. The blade had significant spanwise and angular scoring on the camber side in the shank area (**PHOTO 45**). The blade tip paint exhibited some spanwise scratches and paint loss.

PHOTO 44: NO. 3 BLADE AIRFOIL TIP CURLED

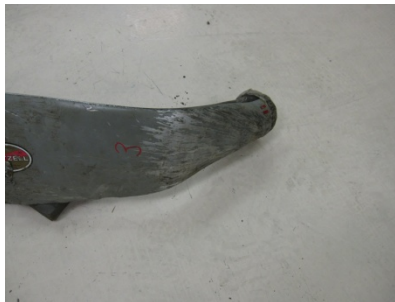
PHOTO 45: AIRFOIL SPANWISE SCRATCHES

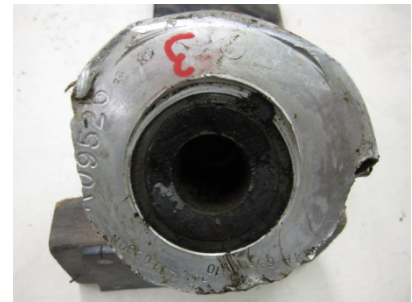
A fractured portion of the hub pilot tube remained inside the blade bore. The entire blade retention shoulder was sheared approximately $\frac{2}{3}$ around its circumference on the front side (camber side) of the blade and an arc-shaped portion of the retention shoulder on the butt end was sheared approximately 20% of the circumference on the aft side of the blade. Similar to the blade butt damage noted on the Nos. 1 and 2 blades, a semi-circular imprint mark was noted around the blade bore located towards the back side of blade butt; however, the depth of the imprint was significantly deeper on the No. 3 than what was noted on the first two (**PHOTO 46**).

PHOTO 46: RETENTION SHOULDER DAMAGE

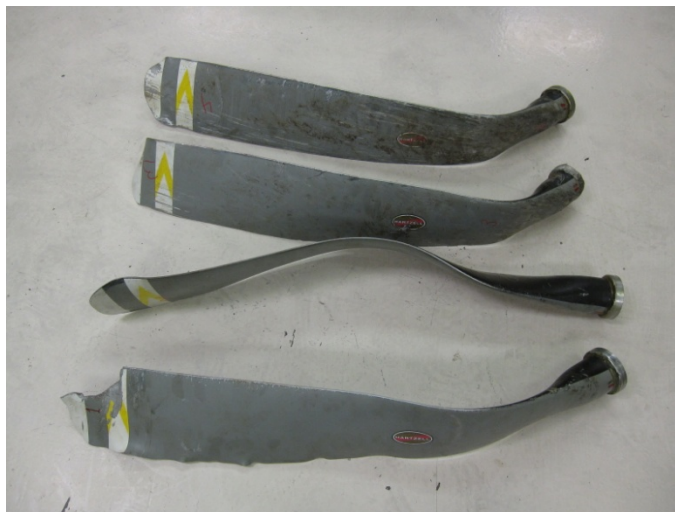
The No. 4 propeller blade was bent aft approximately 45° at about the $\frac{1}{4}$ blade span and was slightly twisted towards the lower pitch similar to the No. 3 blade. The outermost 8 inches of the tip had multiple bends along both the leading and trailing edges. The blade had significant spanwise and angular scoring on the camber side in the shank area. The trailing edge had scoring/tearing on the outer half of the blade. The blade tip paint exhibited some spanwise scratches and paint loss (**PHOTO 47**).

PHOTO 47: NO. 4 PROPELLER DAMAGE (TOP OF PICTURE) SIDE BY SIDE WITH THE OTHER BLADES
