NATIONAL TRANSPORTATION SAFETY BOARD
Office of Aviation Safety
Washington, D.C. 20594

POWERPLANTS GROUP CHAIRMAN'S FACTUAL REPORT

NTSB ID No: DCA01MA034

Location: Aspen, Colorado
Date: March 29, 2001
Time: 1902 mountain standard time (MST)
Airplane: Grumman Gulfstream III, N303GA, Avjet

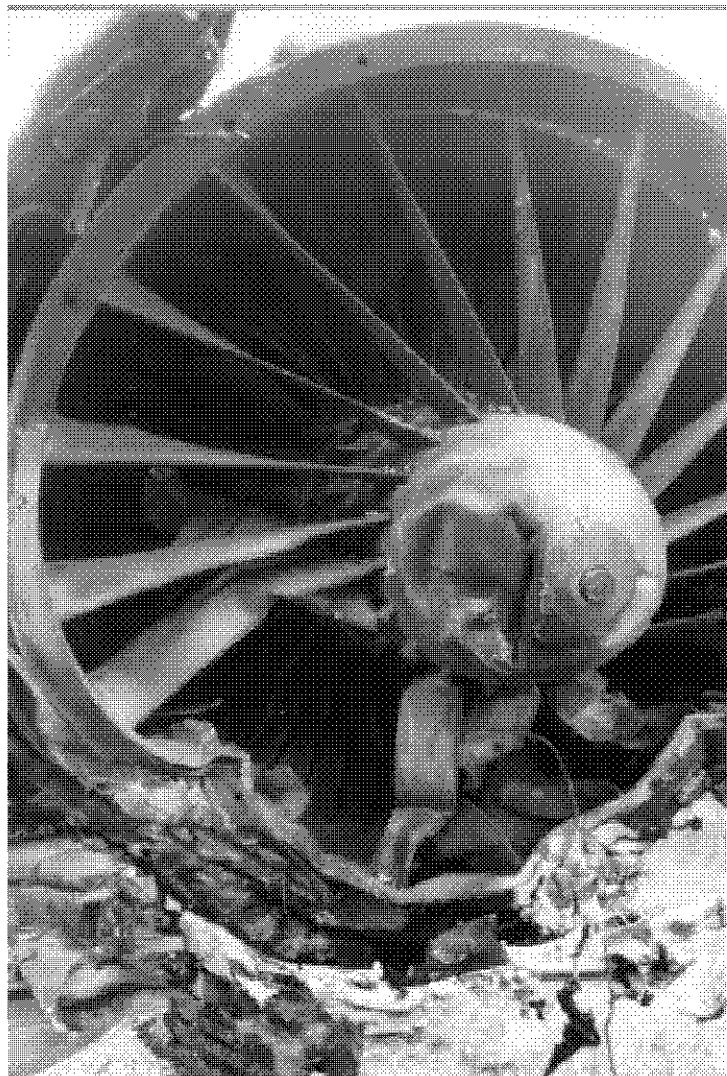
There were no signs of any uncontainments or fires in the compressor section of the engine. The inlet and engine cowlings remained attached to the engine. The inlet was crushed from approximately 1 to 10 o'clock¹ and most of the inlet was folded closed and pushed back to the forward edge of the pylon attachment. The engine front face was crushed in between 3 and 8 o'clock. There were two inlet guide vanes (IGV) missing. Of the IGV's that remained, those in the lower half were bent and torn in the area of the mid-span. The

Photograph 1: No. 1 engine nose fairing and inlet guide vanes.

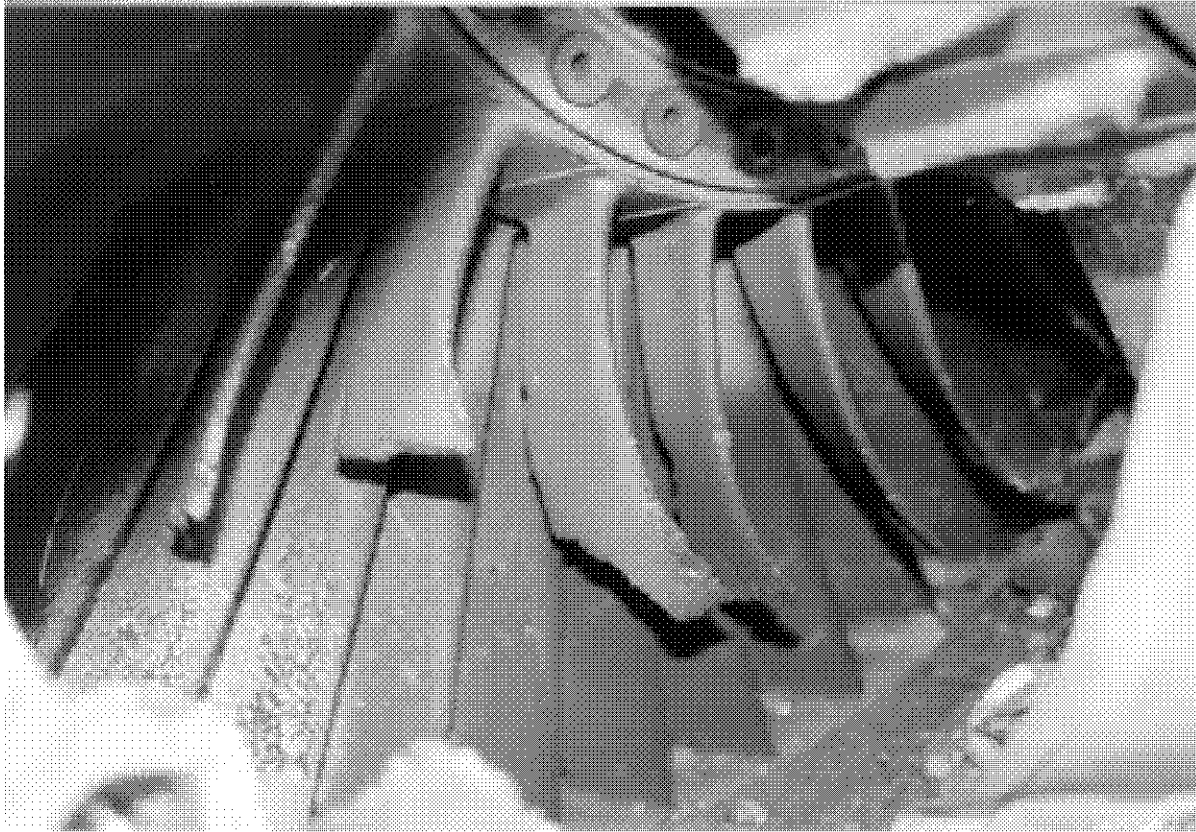
first-stage LPC blades were all broken off just above the platforms and the fracture surfaces had a rough, grainy appearance. The first-stage LPC vanes were missing between 2 and 7 o'clock and some of the remaining vanes were pulled in the direction of rotation, in the area of the mid-span. There was one second-stage LPC blade that was broken off just above the platform and the remaining second-stage LPC blades were all broken at various lengths in the outer half of their spans. All of the remaining second-stage blades had their tips curled and bent in the direction opposite of rotation. All of the second-stage LPC vanes were accounted for and were bent and torn slightly along their leading edges and heavily on their trailing edges. Some of the second-stage LPC vanes were bent in the direction of rotation in the mid-span area. All of the third-stage LPC blades were broken off in the outer third of their spans and had their tips curled and bent in the direction opposite of rotation.

Photograph 2: No. 1 engine, second-stage LPC blades.

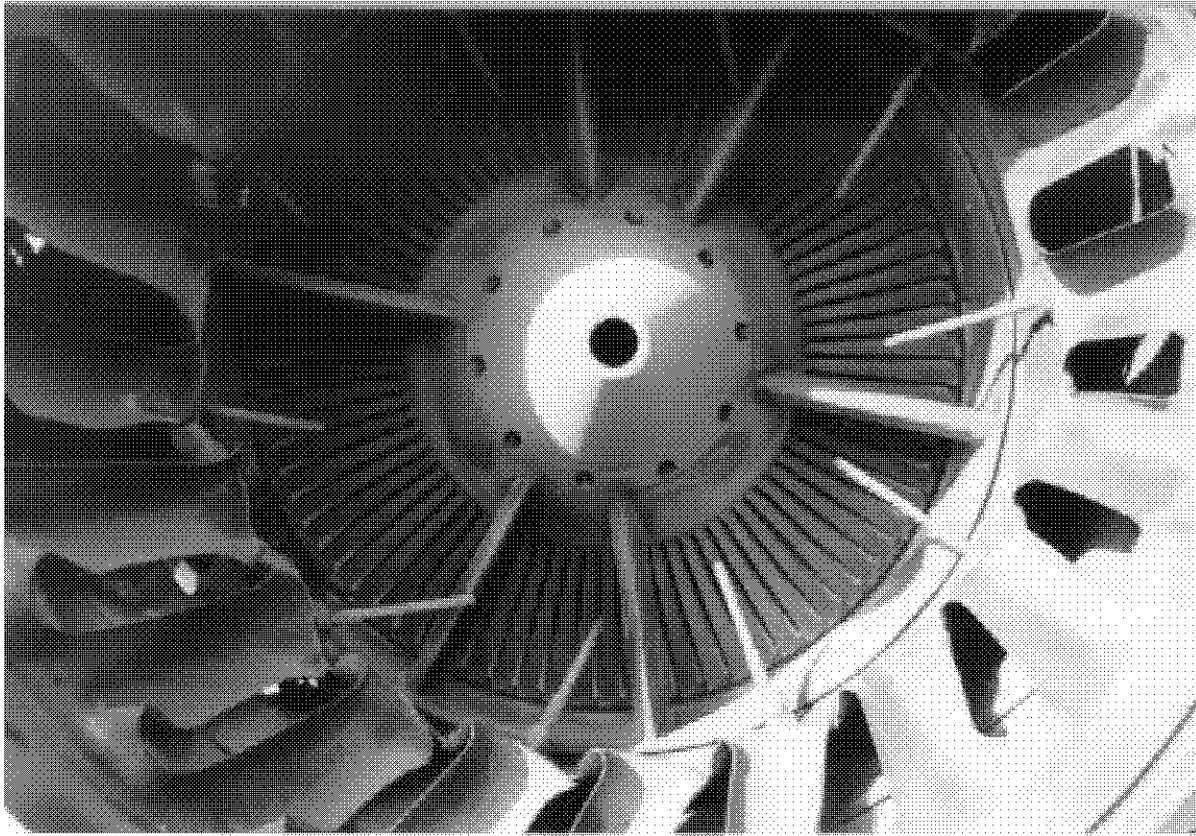
There were no signs of any uncontainments or fires in the turbine section of the engine. The second-stage LPT blades were all intact and undamaged. All of the leading edges of the blades were coated with metal spray on the outboard half of the convex side of the blade and extended out into the tip shrouds. This deposit was built-up heavier in the area of the blade fillet radius. There was metal spray on the second-stage LPT blades. All of the second-stage LPT nozzles were intact and undamaged. There was metal spray on the entire convex side of all the second-stage LPT nozzles that got progressively heavier as it progressed outward. There was metal debris in both the exhaust mixer and in the bypass duct.

Photograph 3: No. 1 engine, second-stage LPT blades

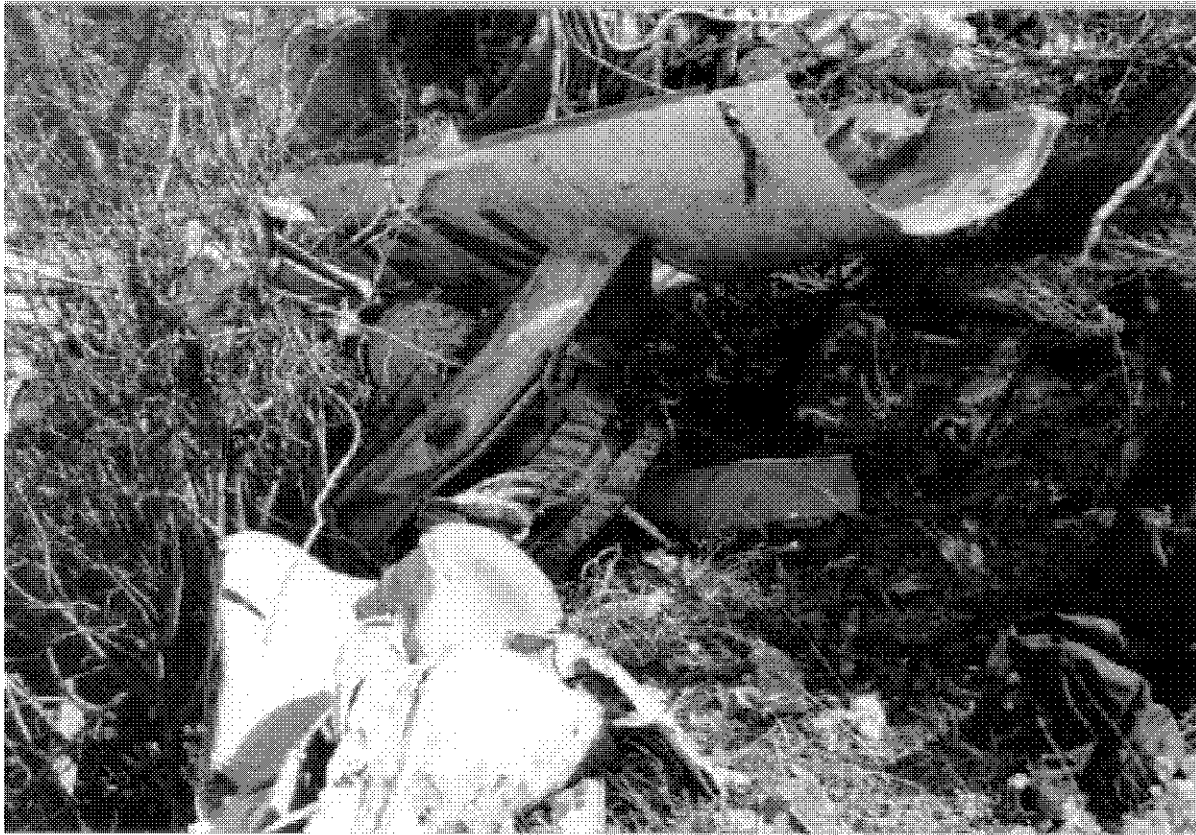
There were no signs of any uncontainments or fires in the compressor section of the engine. The inlet case and front bearing support, along with the first three stages of the LPC, were separated from the rest of the engine and came to rest approximately 15 feet from the remainder of the No. 2 engine. The IGV's were broken off between 4 and 8 o'clock and the remainder were torn on the leading edge at the spinner attachment. All of the first-stage LPC blades were broken off just above the platforms and the fracture surfaces had a rough, grainy appearance. The majority of the first-stage LPC vanes were broken off and the remaining vanes were bent, in the mid-span area, in the direction of rotation.

All of the second-stage LPC blades were broken off just above the platform and the fracture surfaces had a rough, grainy appearance. The majority of second-stage vanes were broken off and those that remained were bent in the direction of rotation. There were ten third-stage LPC blades that remained in their slots. Each of these ten blades was broken off at varying lengths from the mid-span outward and all were bent over in the direction opposite of rotation. All the other third-stage LPC blades were broken off just above the platform and their fracture surfaces had a rough, grainy appearance. The front bearing oil feed tube was still attached to the first three stages of the LPC. The mating flanges of the stage 1-3 LPC spool with the stage 4-5 spool were undamaged and the bolt holes were intact. The bolt heads remained in the stage 4 flange.

Photograph 4: No. 2 engine, LPC stages 1 – 3

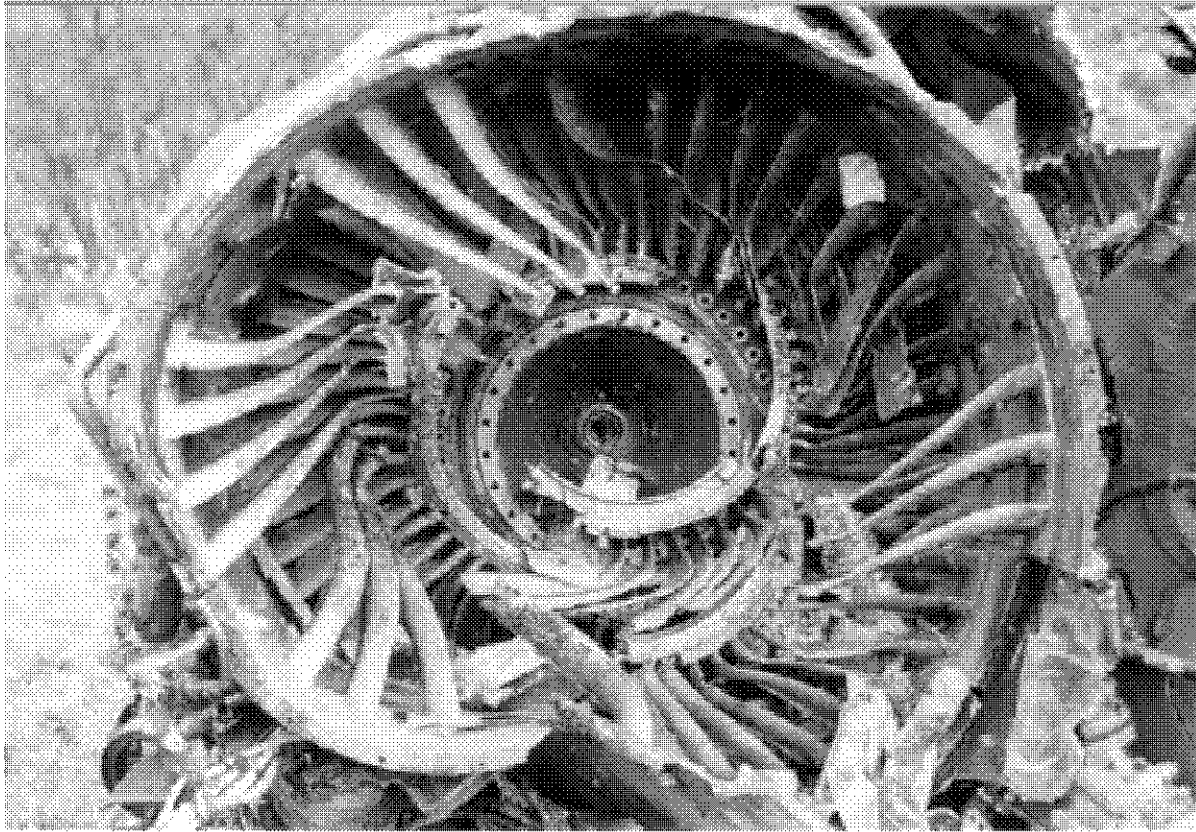
Photograph 5: Engine No. 2, stage-two and stage-three stator vanes

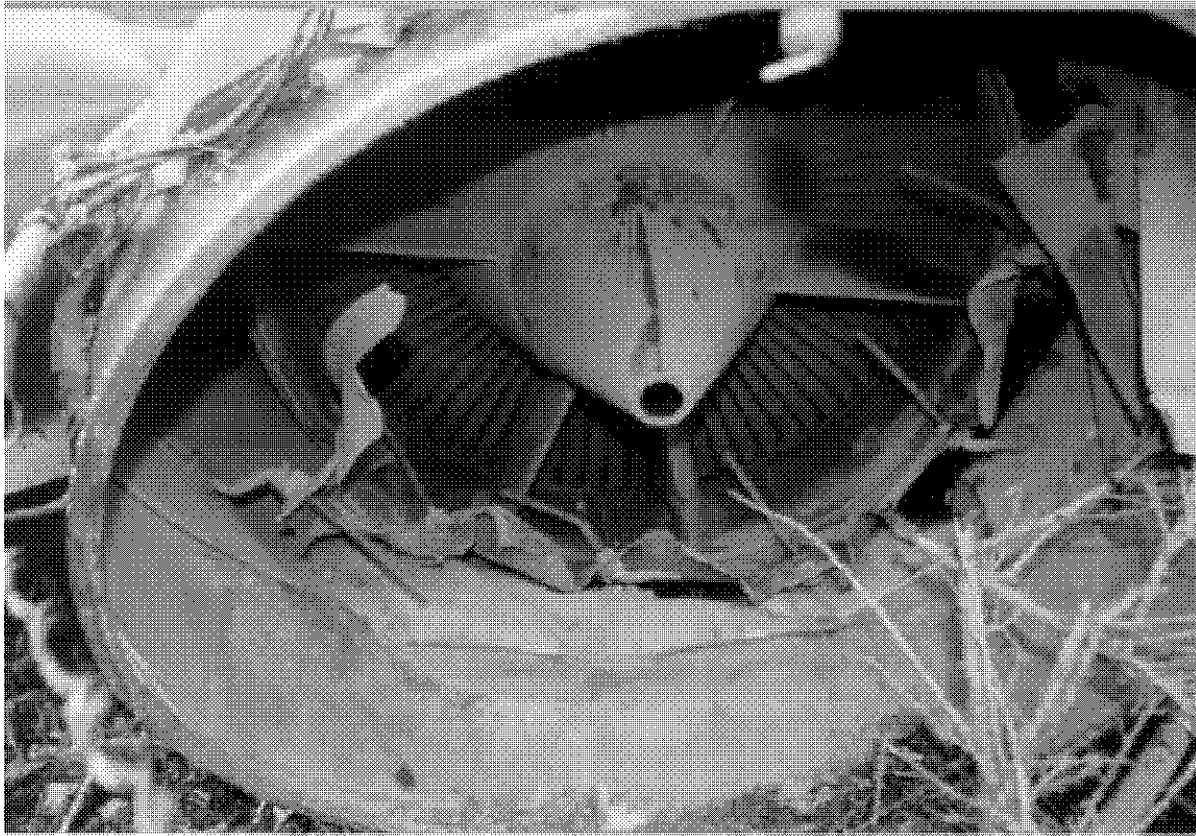
All of the stage-two LPT blades were intact and undamaged. There was light metal spray on the outboard convex side of each of the blades. All of the second-stage LPT nozzles were intact and appeared undamaged. There was heavy metal spray on the entire length of the convex side of each of the second-stage LPT nozzles. The exhaust cone and exhaust support struts were all intact.

Photograph 6: No. 2 engine, second-stage LPT blades

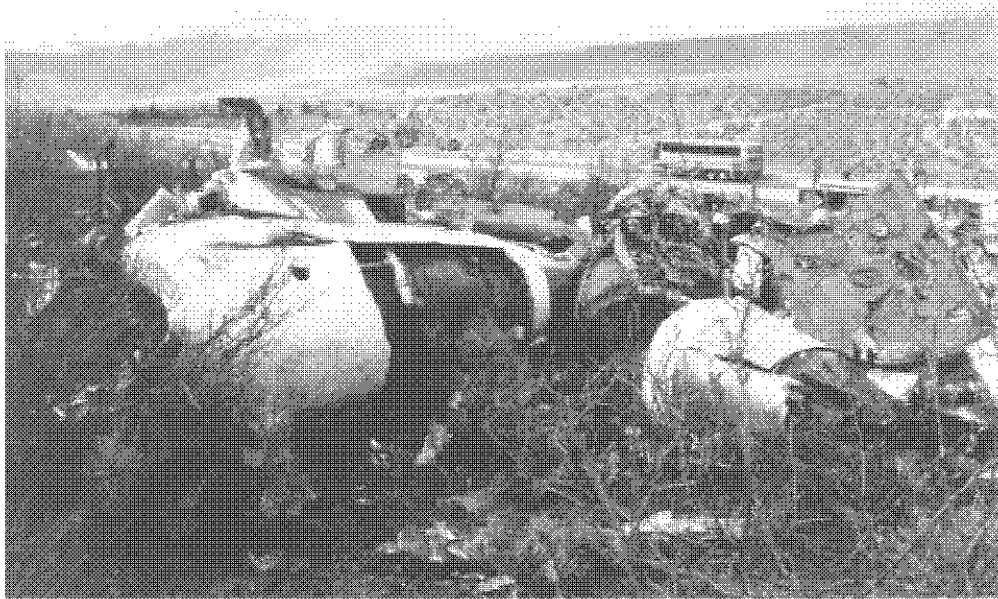
The wreckage was distributed over a southeast heading for approximately 325 feet. The engines came to rest side-by-side, just over the southern ridge of a 70-foot gully, 250 feet from the initial ground contact point.

Photograph 7: No. 1 engine on left, No. 2 engine on right. (View looking north)
