**NATIONAL TRANSPORTATION SAFETY BOARD  
OFFICE OF AVIATION SAFETY  
WASHINGTON, D.C. 20594**

**POWERPLANTS GROUP CHAIRMAN'S FACTUAL REPORT**

NTSB ID No.: DCA02MA001

Aircraft: Airbus Industrie A300-605R, N14053, American Airlines flight 587

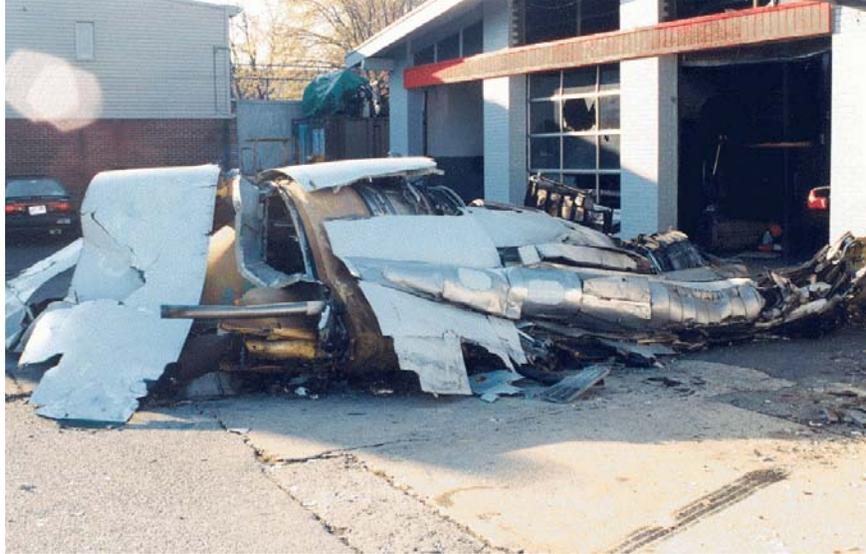
Photo 1: No. 1 engine with pylon still attached in front of gas station

The core of the engine between the fan frame and the LPT case was crushed inward on the left side and the core was bent. Pieces of the translating and core cowl were pushed against the engine's left side, but were mostly broken or cracked around the remainder of the engine with small areas that were burned away. There were no indications of an uncontainment, case rupture, or in-flight fire between the fan case and TRF. There were indications of a ground fire in the vicinity of the accessory gearbox, which was found broken open liberating several of the gears.

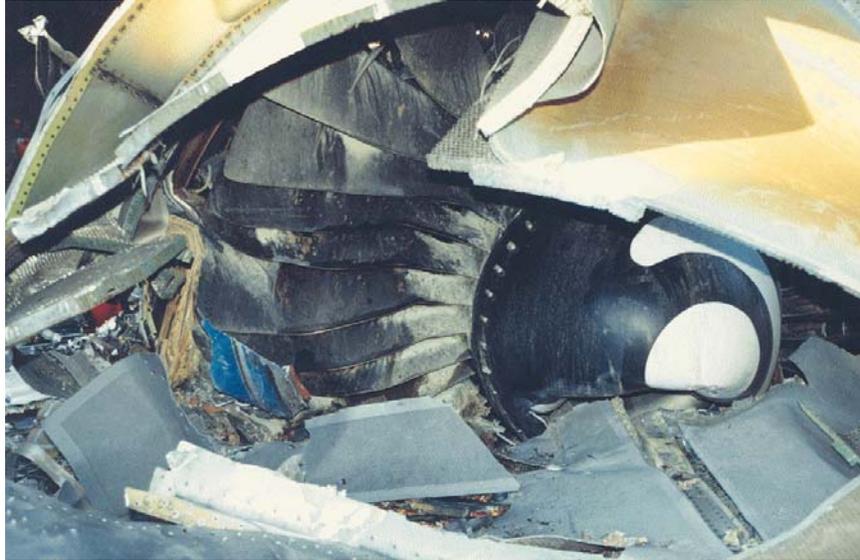
All of the fan blades were in place in the fan disk. There was a continuous arc of fan blades between 5 and 7 o'clock that were fractured transversely across the airfoil between the root platform and the midspan shroud. The remaining fan blades were bent opposite the direction of rotation. The fan blades did not have any soft body impact damage.<sup>7</sup> Additionally, the fan blades did not fluoresce when examined with an ultraviolet light.<sup>8</sup>

Photo 2: Closeup of No. 1 engine's fan blades (FAA)

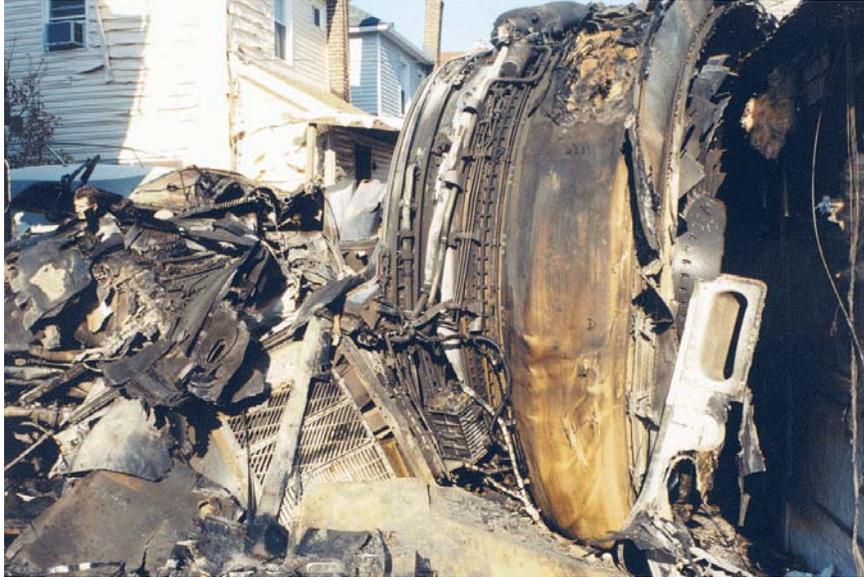
Photo 3: No. 2 engine in back of house

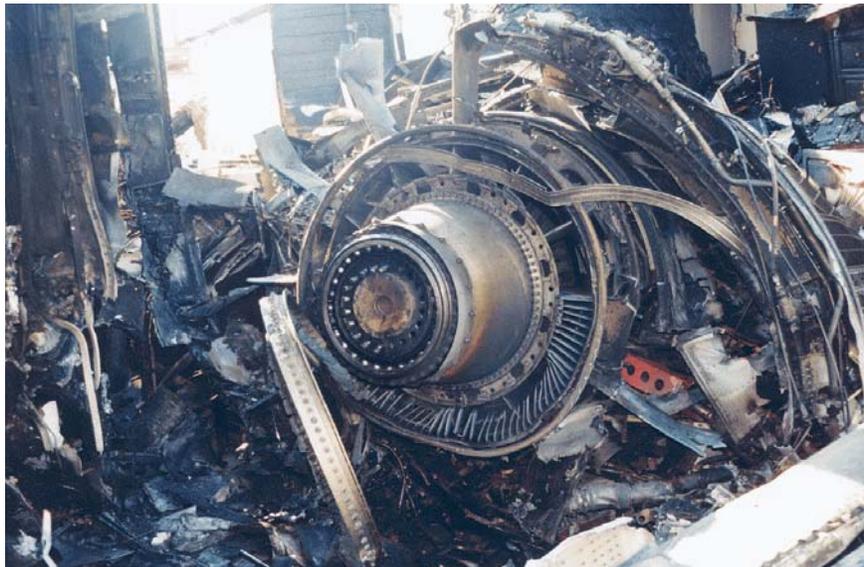
Photo 4: No. 2 engine's core separated from fan

There were pieces of the translating and core cowls that were against the left side of the engine, but the cowls were broken up or burned away from the right side. There were no indications of an uncontainment, case rupture, or in-flight fire.

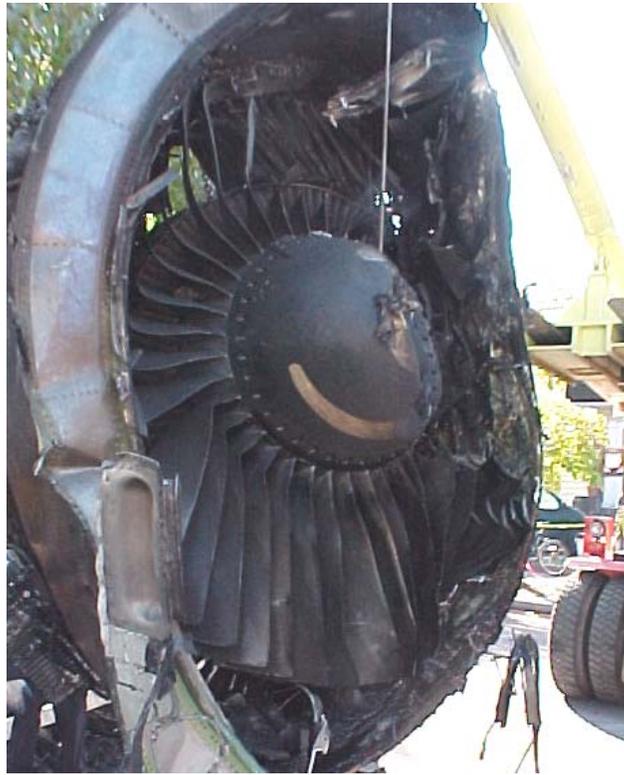
All of the fan blades were in place in the fan disk. There was a 180° arc of fan blades oriented towards the left side of the engine that were fractured transversely across the airfoil from adjacent to the root platform to about 1-inch outboard of the midspan shrouds. The leading edges of the fan blades had only a few small nicks and dents. None of the fan blades had any soft body impact damage. Additionally, the fan blades did not fluoresce when examined with an ultraviolet light.

Photo 5: No. 2 engine's fan blades shown after fan had been picked up (FAA)

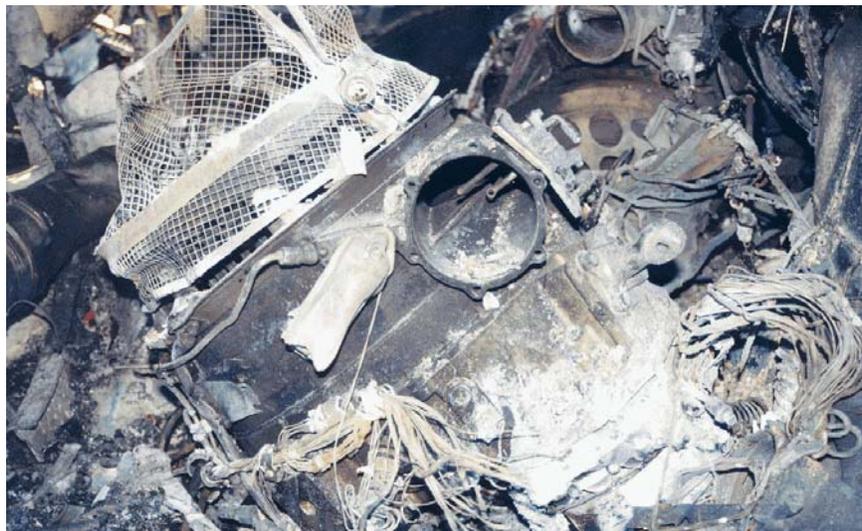
The APU was found in the airplane's tailcone that was found on the southwest corner of Beach 131 Street and Newport Avenue. The APU was broken from its mounts and was found laying in the bottom of the tailcone just inside the opening of the break in the fuselage just forward of the APU's normal position. The tailpipe was separated from the APU and was found on the ground just in back of the tailcone. The APU did not have any indications of an uncontainment or in-flight fire. The area of the tailcone around the normal position of the APU did not have any shrapnel damage.

Photo 6: Auxiliary power unit

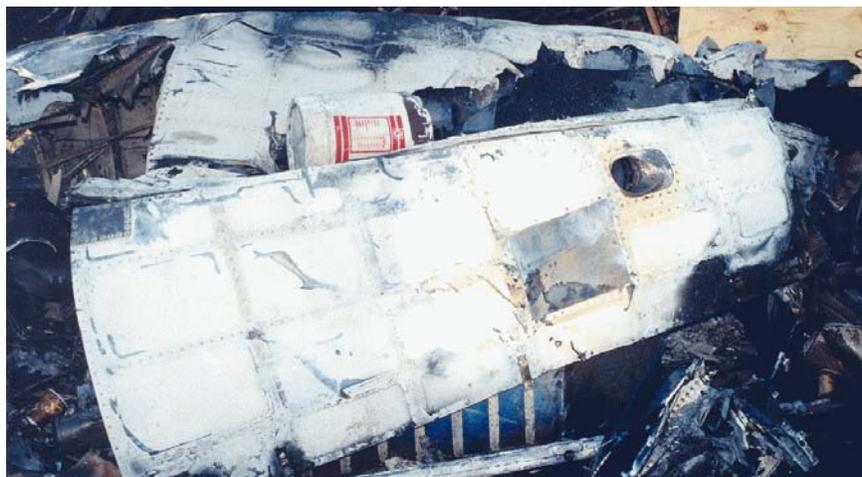
Photo 7: Tailcone over area of APU installation showing no shrapnel damage

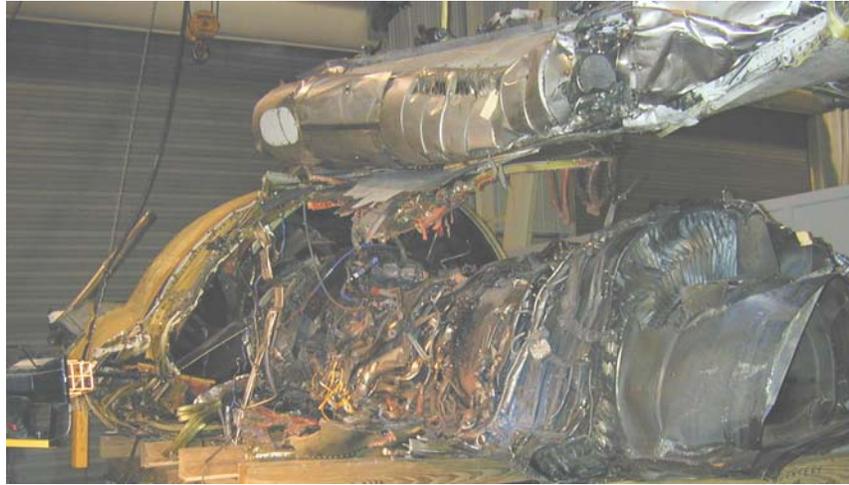
The engine was received with the pylon still in place that was removed to facilitate the disassembly. The engine was crushed on the left side. There was no evidence of an in-flight fire, case rupture, or uncontainment.

Photo 8: As received condition of engine with pylon being removed (American)

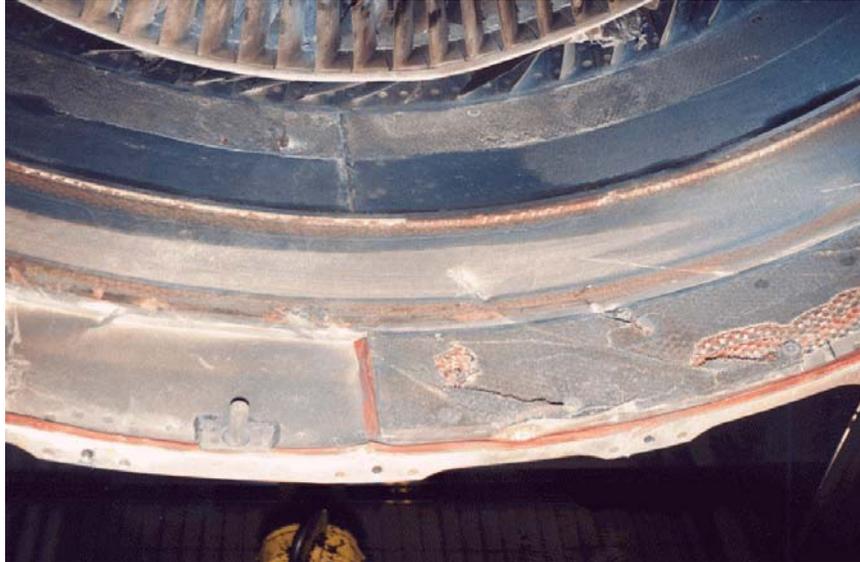
Photo 9: No. 1 engine's fan case and rub strip showing imprint of fan blade tips

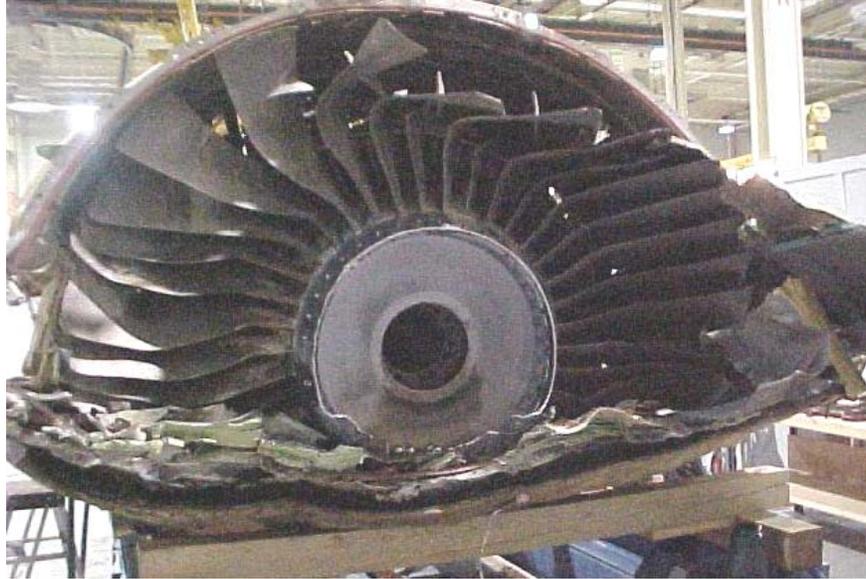
The fan blade dovetails were all in place in the disk. The 10 fan blades that were oriented towards the left side of the engine were fractured transversely across the airfoil adjacent to the blade root platform. All of the remaining fan blades were full length and bent opposite the direction of rotation except for four fan blades, two groups of two adjacent blades that were located almost 180° apart that were fractured across the airfoil around the midspan shroud. The leading edges of the fan blades had a few randomly located small nicks, dents, and tears and no soft body impact damage.

Photo 10: No. 1 engine's fan disk and blades (GE)

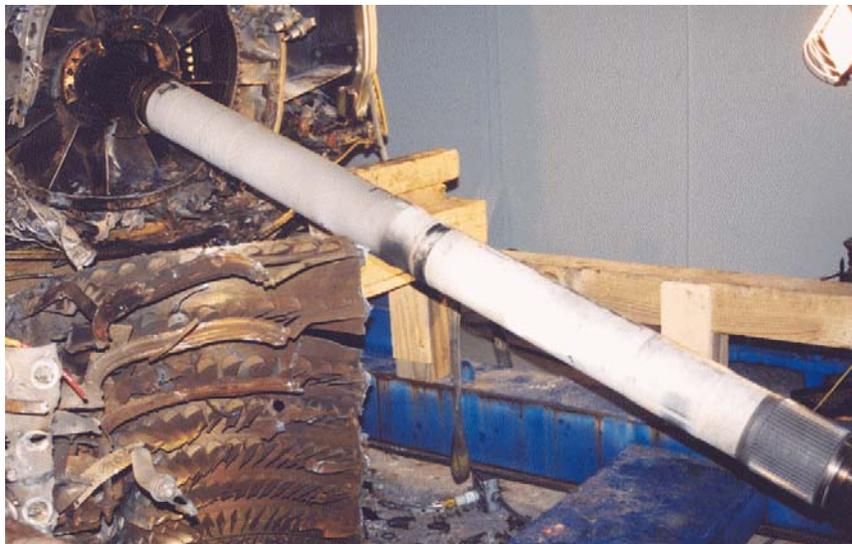
The fan forward shaft and fan mid shaft (FMS) were intact.

Photo 11: No. 1 engine's fan mid shaft

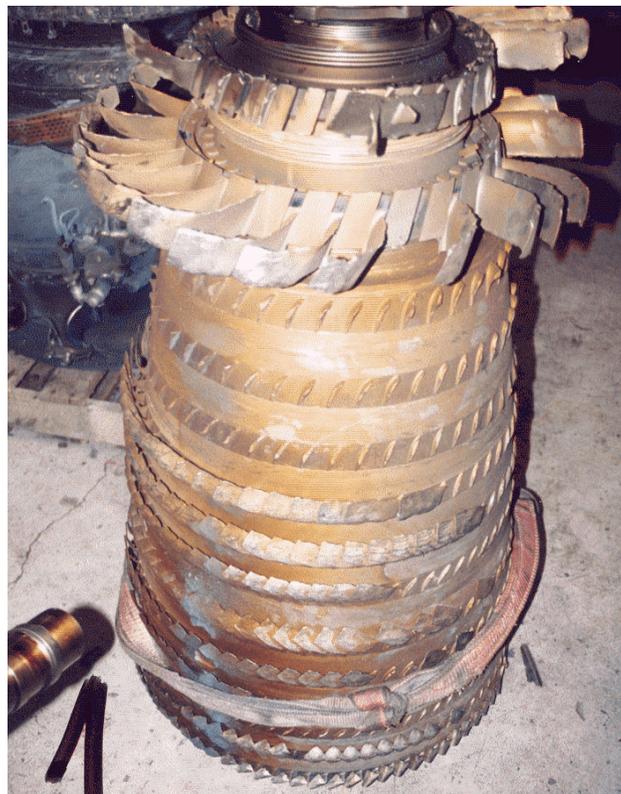
The HPC rotor, stages 1 through 14,<sup>13</sup> was intact except for the HPC stage 11 to 14 spool/shaft cone that was fractured 360° around. The fracture on the spool/shaft cone was irregularly shaped and the fracture surface was coarse and grainy and at a 45° angle to the surface. The blade rub lands on the outside of the HPC rotor had circumferential rub marks. All of the bores and webs on the inside of the HPC rotor were intact.

Photo 12: No. 1 engine's high pressure compressor rotor

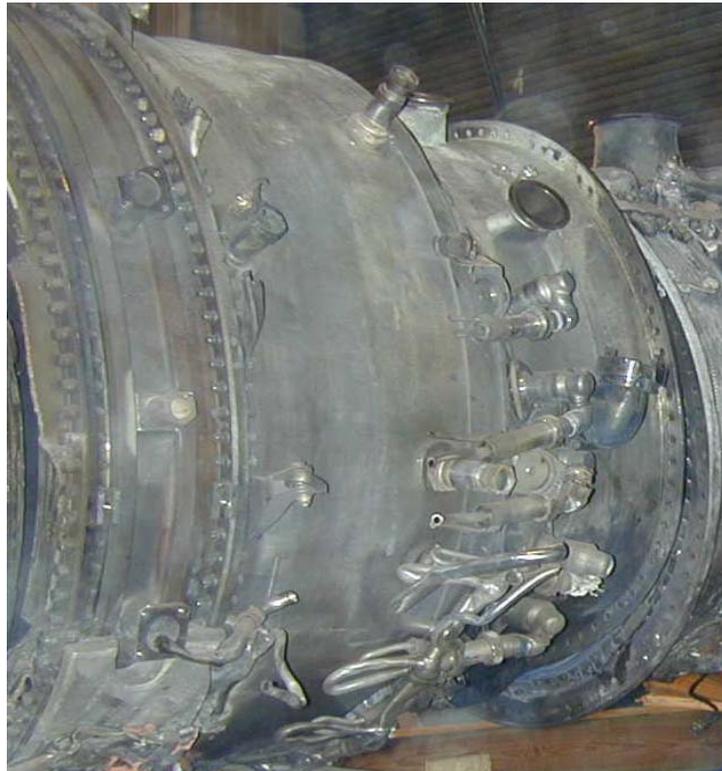
The CRF did not have any indications of thermal distress, case rupture, or in-flight fire. The CRF had a 19-inch long (circumferential) by 1-inch wide (axial) rectangular-shaped hole just aft of the fuel nozzle mount pads from 2 to 4 o'clock. The edges of the hole were not curled outward. The CRF was crushed inward from 6 to 8 o'clock between the front flange and the fuel nozzle mount pads and there were circumferential cracks adjacent to the front flange at 6 o'clock and adjacent to the mount pads at 8 o'clock.

Photo 13: No. 1 engine's compressor rear frame (American)

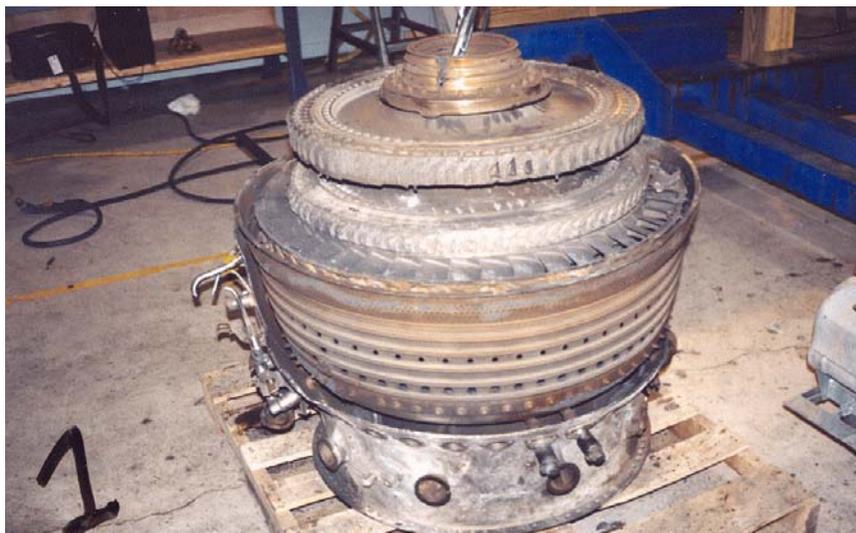
The HPT stage 1 and 2 disks were intact. The disks had circumferential rub marks on the rear faces of the disks' rims.

Photo 14: No. 1 engine's combustor liner and HPT stage 1 and 2 disks

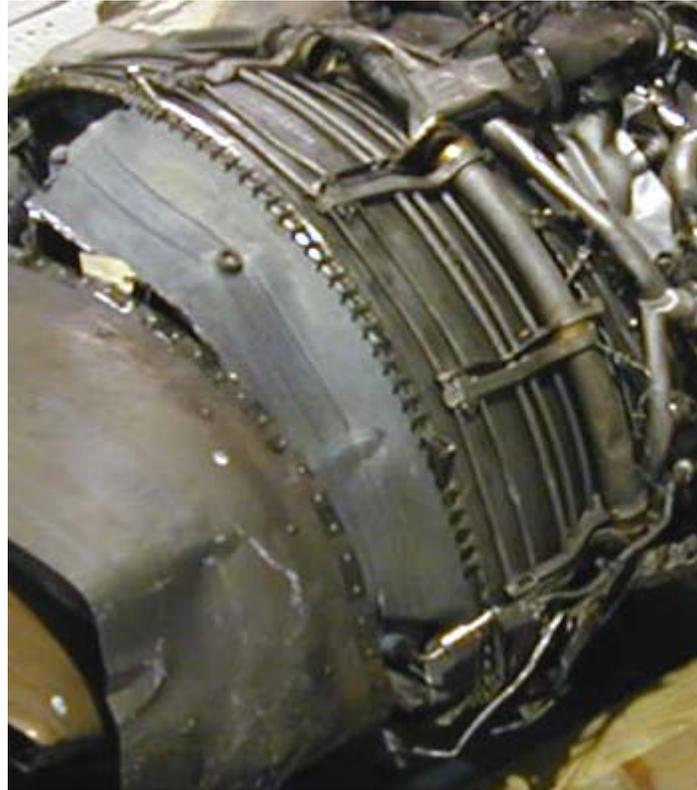
The LPT stator case was crushed inward from 5 to 10 o'clock. The LPT case had a 360° circumferential fracture that varied from 7- to 11-inches rearward from the front flange. The LPT stator case did not have any evidence of an in-flight fire or uncontainment.

Photo 15: No. 1 engine's low pressure turbine case and the broken turbine rear frame (American)

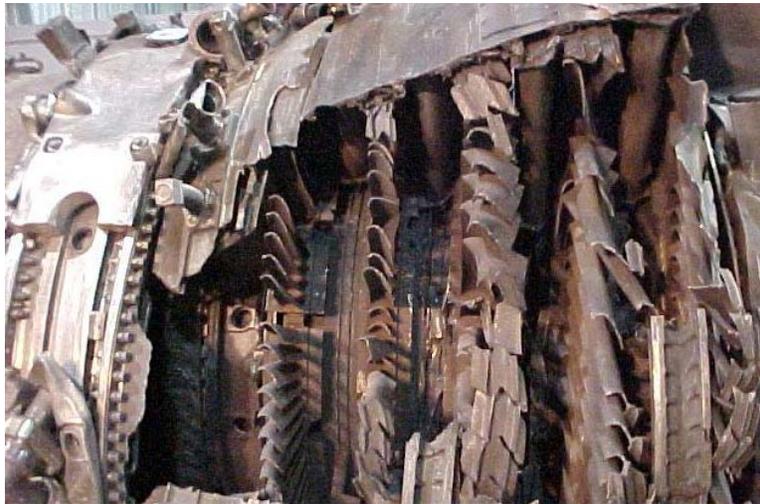
All of the LPT blades were in place in their respective disk blade slots. The LPT stage 1 and 2 blades were almost full length, but were bent slightly and missing the tip shrouds. The LPT stage 3, 4, and 5 were full length except for those blades that were oriented towards the left side of the engine and were broken at various lengths above the blade root platforms. The LPT blades did not have any rub marks or metal spray material on the airfoil surfaces.

Photo 16: No. 1 engine's low pressure turbine case cut away exposing blade and vanes (GE)

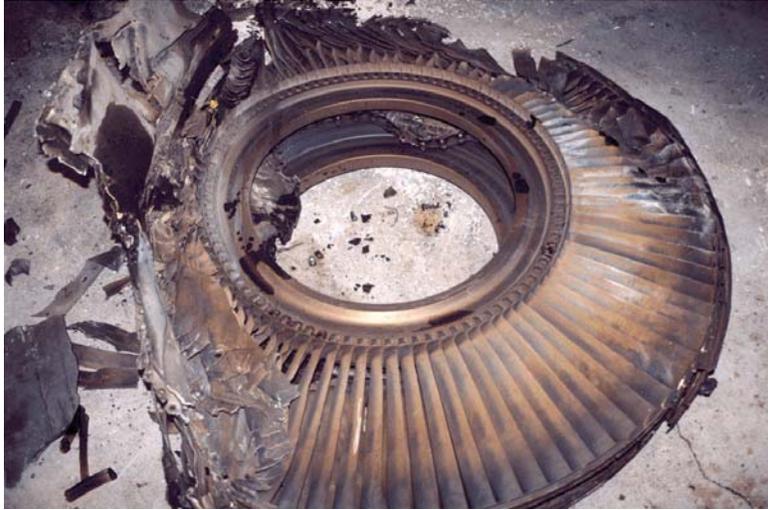
Photo 17: No. 1 engine's LPT stage 5 blades

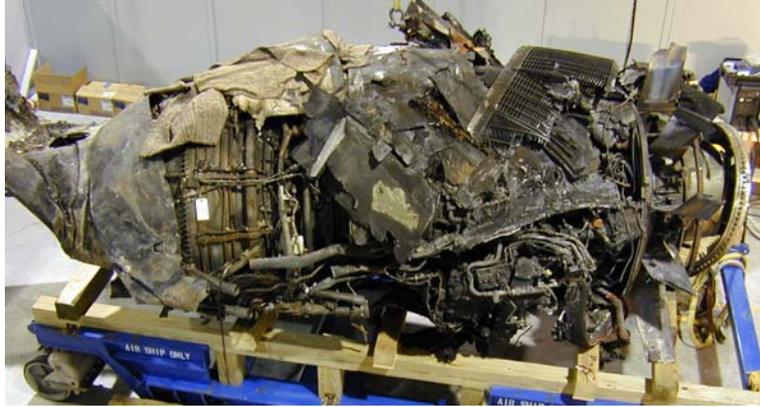
The engine was received in two pieces, the fan and the core, with the pylon still attached to the core. The pylon was removed to facilitate the disassembly. The engine was crushed and bent slightly on the left side around the area of the rear of the HPC. The engine had damage from a ground fire, particularly to the fan module.

Photo 18: As received condition of No. 2 engine minus the fan (American)

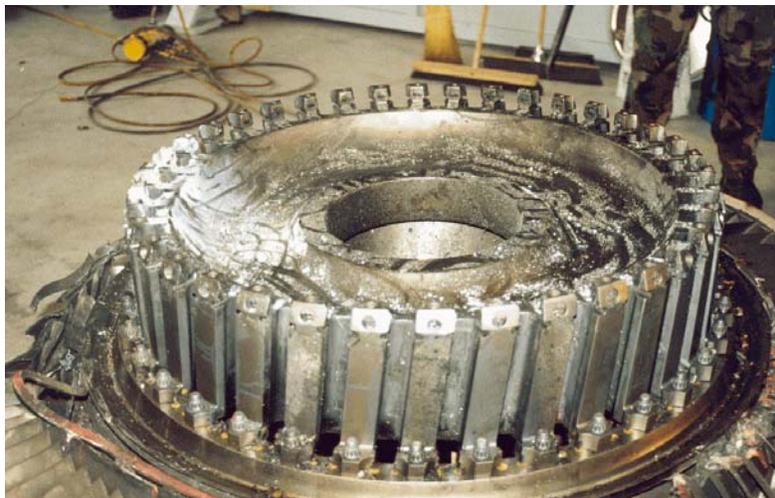
The fan disk was intact, but was separated from the fan forward shaft.

Photo 19: No. 2 engine's fan disk

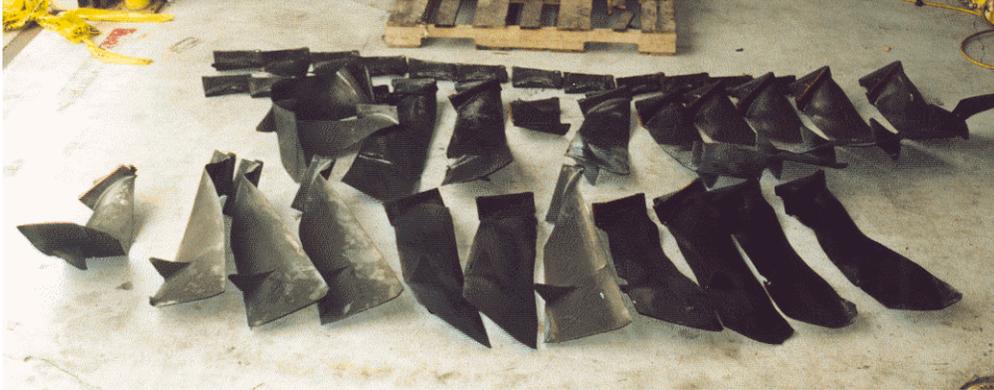
The fan blade dovetails were all in place in the disk. The 16 fan blades that were oriented towards the left side of the engine were fractured adjacent to the root

platform. All of the remaining fan blades were full length and bent randomly, except for one that was fractured near the midspan shroud. The leading edges of the fan blades had a few randomly located nicks and dents.

Photo 20: No. 2 engine's fan blades

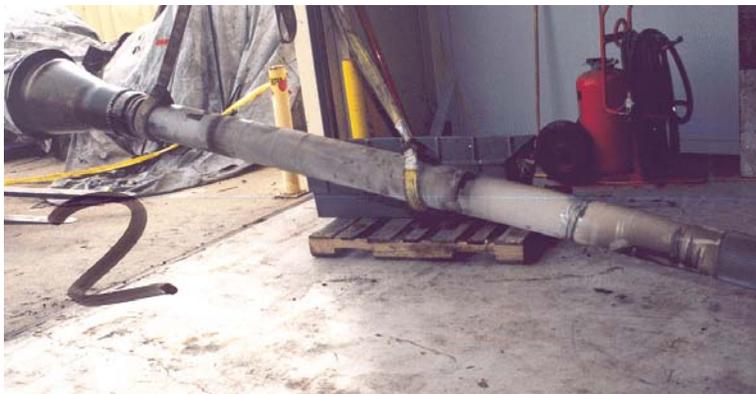
The fan forward shaft and FMS were intact.

Photo 21: No. 2 engine's fan mid shaft

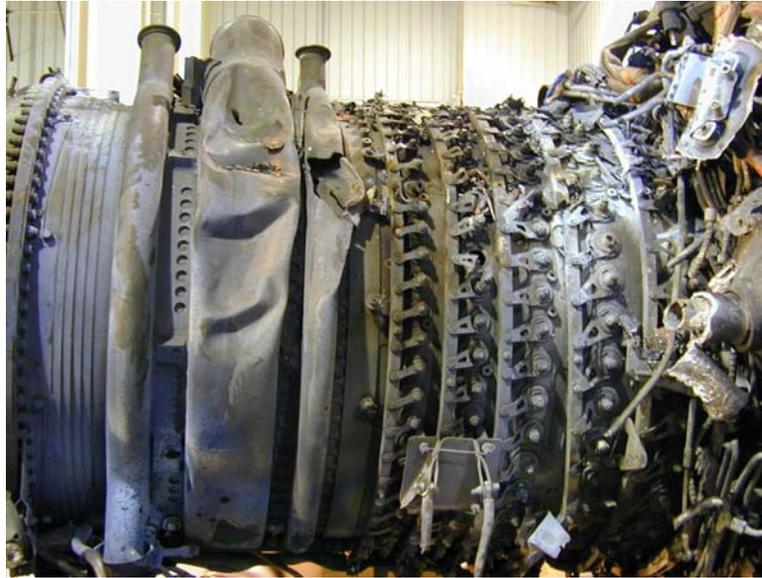
The upper and lower HPC stator cases remained attached to the fan frame and the CRF and the horizontal split lines were secured. The upper and lower HPC stator cases were intact and did not have any indications of an in-flight fire or uncontainment, but the 8<sup>th</sup> and 11<sup>th</sup> stage bleed air manifolds were crushed and buckled from 3 to 12 o'clock. The right and left hand VSV actuation levers were in place and all of the VSV unison rings were still attached. The VSV unison rings were intact and all of the vane levers were in place except for two 5<sup>th</sup> stage VSVs that were missing at 12 and 5 o'clock.

Photo 22: No. 2 engine's high pressure compressor stator case (American)

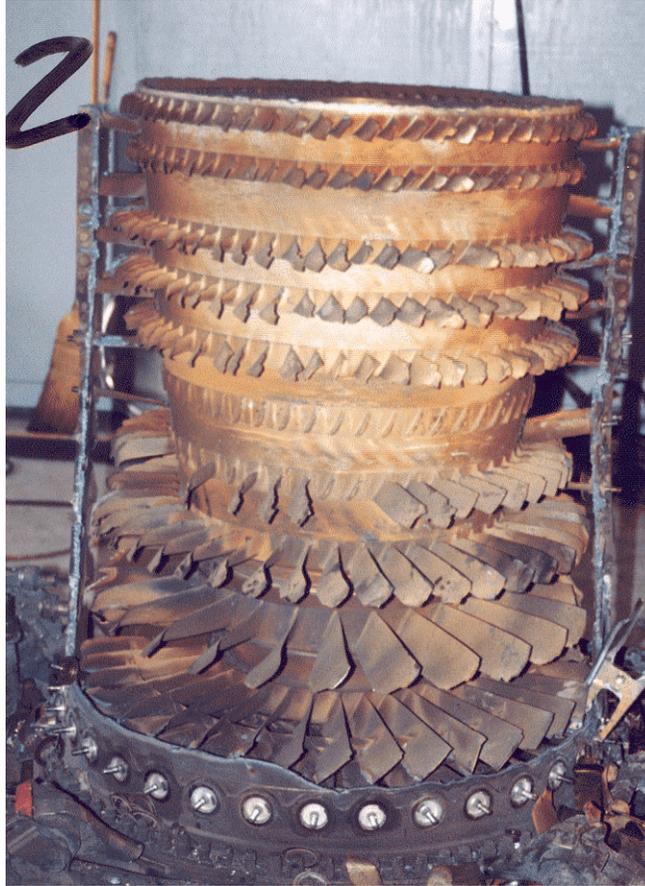
The HPC rotor, stages 1 through 14, was intact. The blade rub lands on the outside of the HPC rotor did not have any circumferential rub marks. All of the webs and bores on the inside of the HPC rotor were intact.

Photo 23: No. 2 engine's high pressure compressor rotor

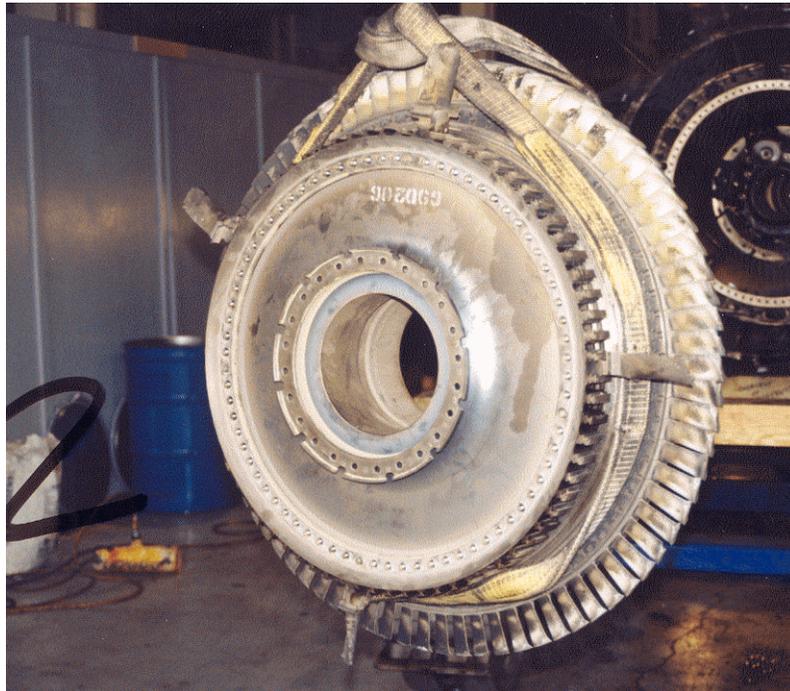
The HPT stage 1 and 2 disks were intact.

Photo 24: No. 2 engine's high pressure turbine stage 1 and 2 disks

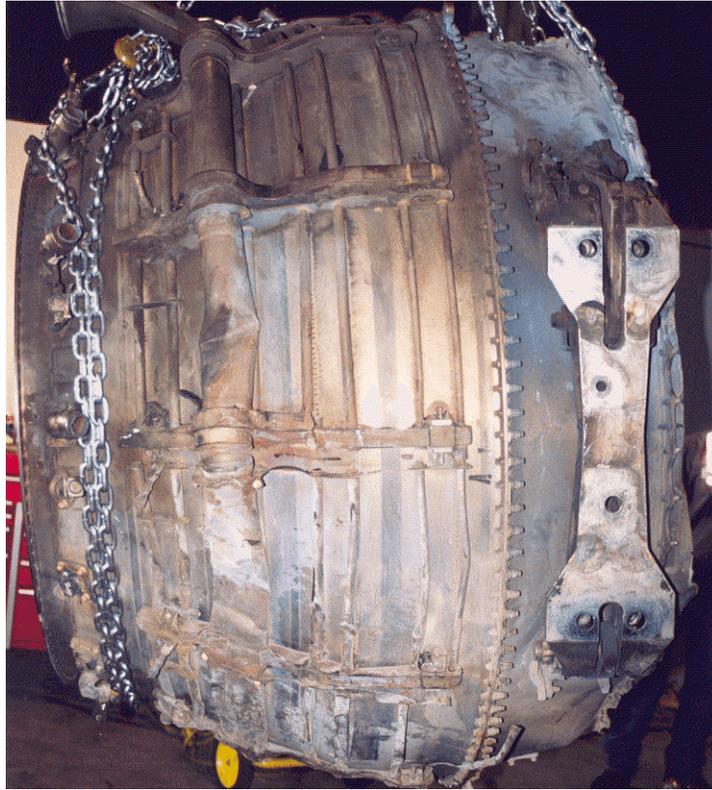
The LPT stator case was intact and remained attached to the HPT stator case and the TRF with all of the bolts in place. The LPT stator case did not have any evidence of an in-flight fire or uncontainment.

Photo 25: No. 2 engine's low pressure turbine case (American)

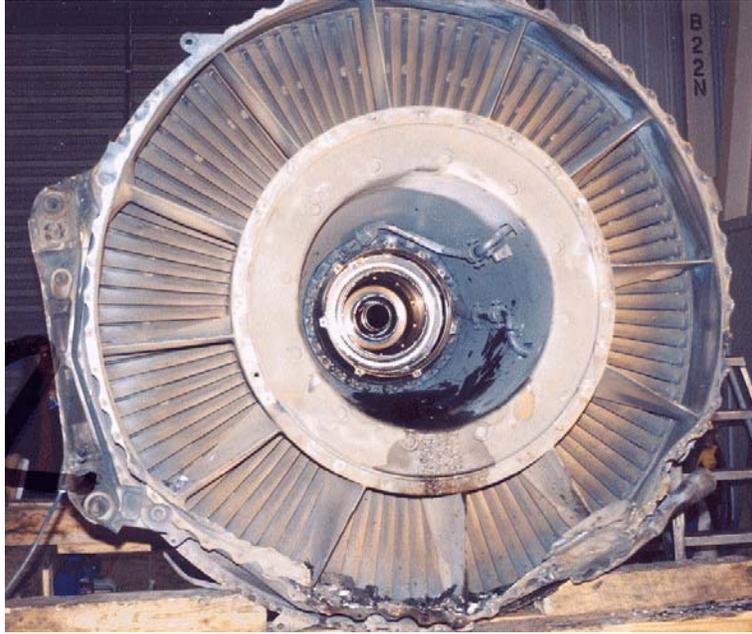
The LPT stage 1 blades were all in place, straight, and did not have any metal spray material on the airfoils. There was an approximately 100° continuous sector of LPT stage 1 blades from 3 to 6 o'clock that had the leading edge of the airfoils up to approximately ½-inch long by ⅛-inch deep and the adjacent tip shroud broken away. The fracture surfaces of the missing material were coarse and grainy and there was no indication of any circumferential rub marks. The LPT stage 5 blades were all in place, straight, and did not have any metal spray on the airfoils.

Photo 26: No. 2 engine's LPT stage 5 blade airfoils

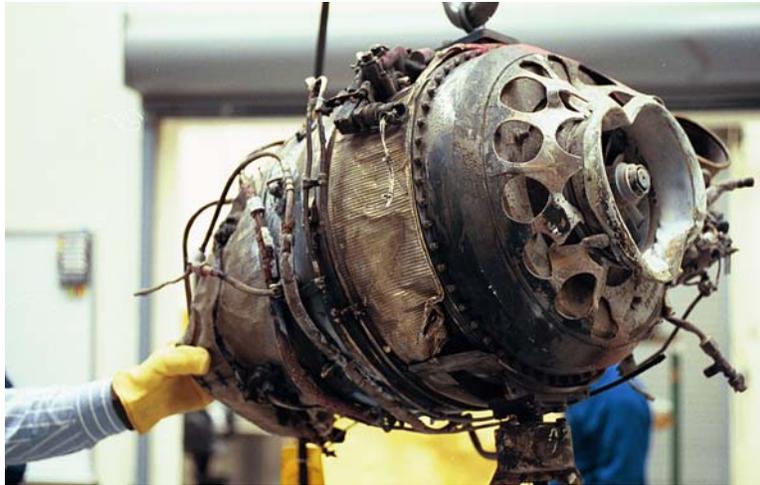
The power section did not have any indications of an in-flight fire, uncontainment, or case rupture.

Photo 27: APU power unit (Honeywell)

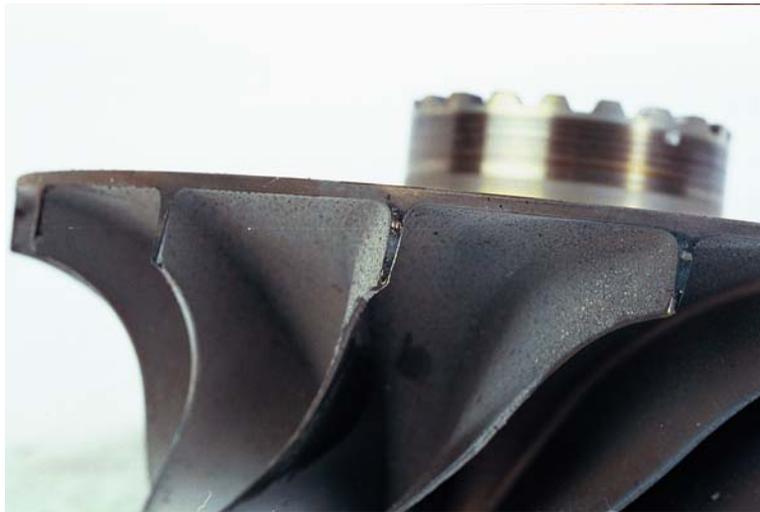
The 1<sup>st</sup> and 2<sup>nd</sup> stage impellers were intact and did not have any circumferential rub marks on the impeller blades. The 1<sup>st</sup> and 2<sup>nd</sup> stage impeller shrouds did not have any circumferential rub marks.

Photo 28: Close up of 1<sup>st</sup> stage impeller showing no circumferential rub marks (Honeywell)

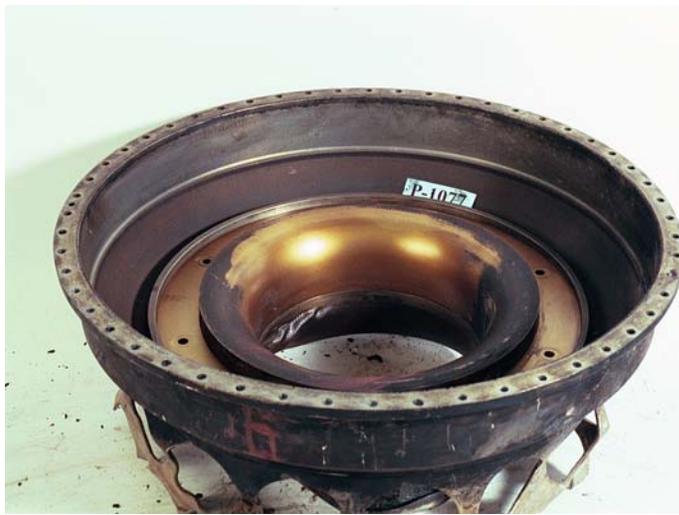
Photo 29: 1<sup>st</sup> stage impeller shroud coated with soot and where soot was wiped away, no impact marks from the impeller (Honeywell)

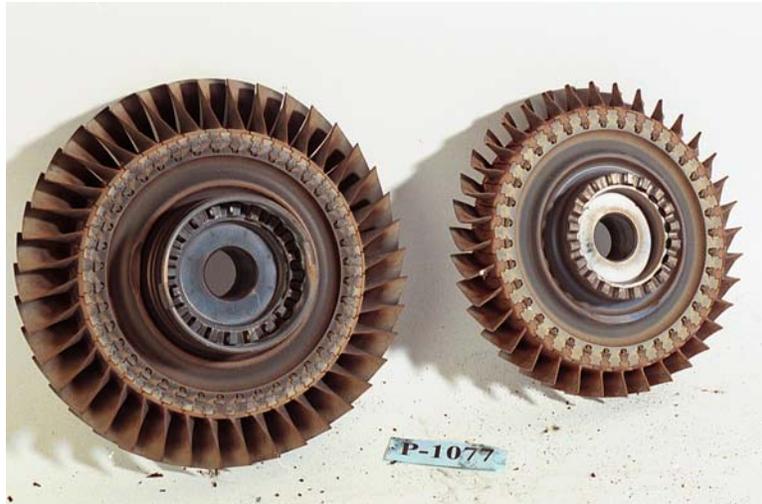
Photo 30: 1<sup>st</sup> and 2<sup>nd</sup> stage turbine disks showing no bent blades (Honeywell)

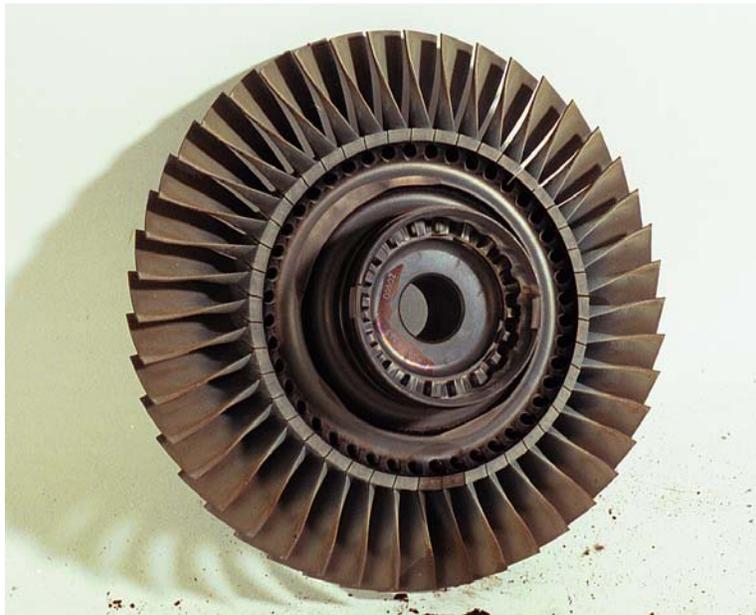
Photo 31: 3<sup>rd</sup> stage turbine wheel (Honeywell)

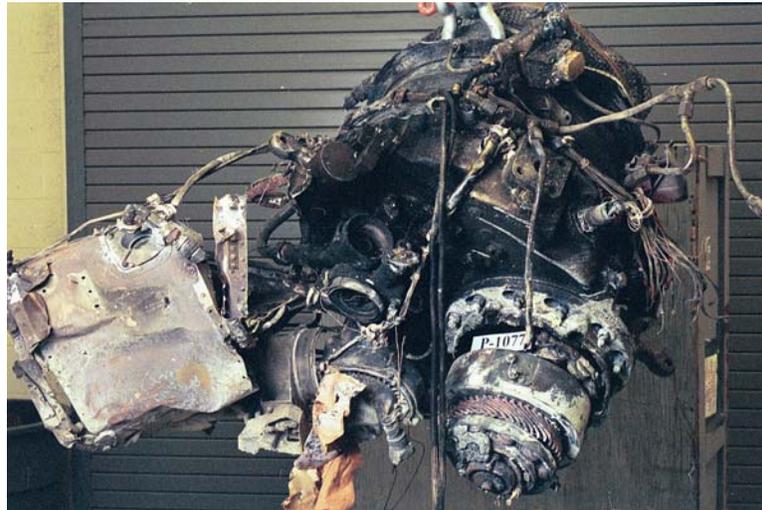
As received, the gearbox and load compressor was separated from the power section. The gearbox and load compressor housing did not have any holes or penetrations, but was sooted. The inlet guide vane actuator was detached. The generator housing was missing, exposing the generator windings. The gearbox was not disassembled. The oil cooler was missing. The filter housing was cracked and the filter bowl was separated from the housing. The gearbox sump was not drained or checked for residual oil.

Photo 32: Gearbox and load compressor broken away from APU power section (Honeywell)

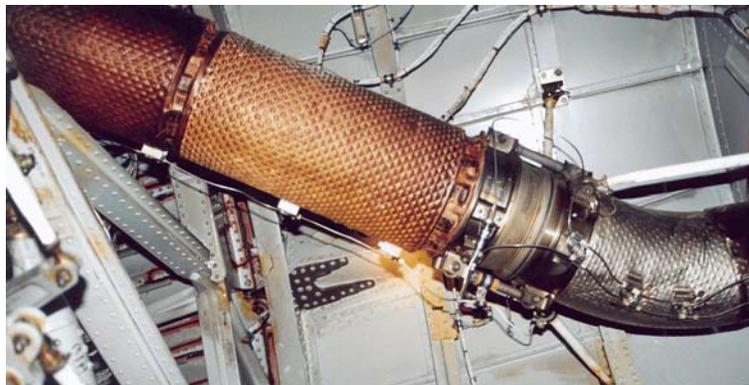
Photo 33: Example of APU bleed air duct exiting firewall in tailcone showing overheat detection wires in American Airlines A300 N70054

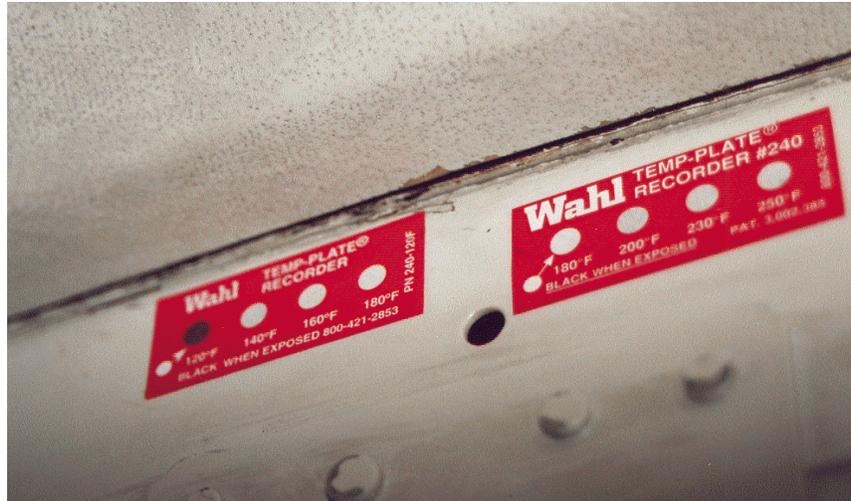
Photo 34: Temp tabs on frame C83 showing exposure to 120°F

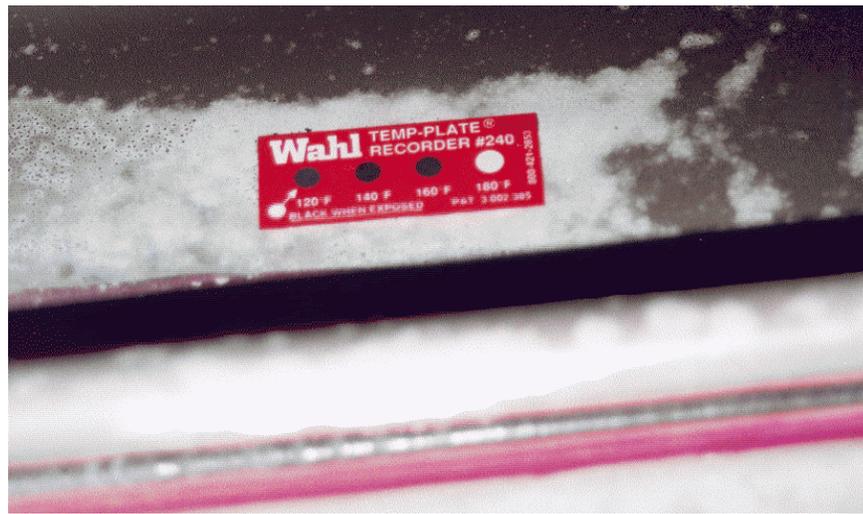
Photo 35: Temp tab over bleed air duct on left side of fuselage showing exposure to 160°F

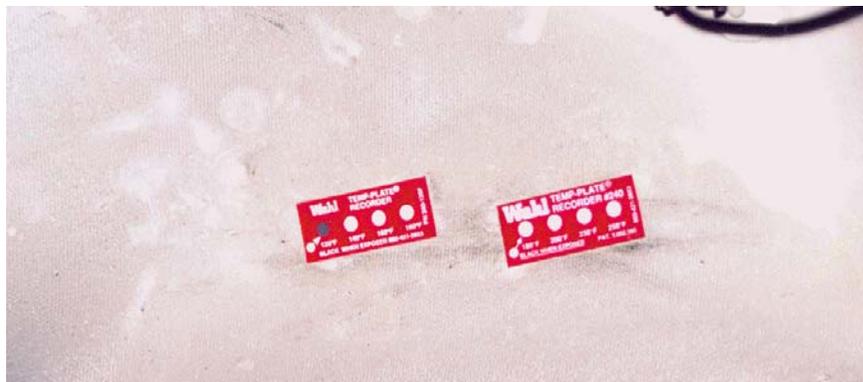
Photo 36: Temp tabs on vertical stabilizer access cover showing exposure to 120°F
