**NATIONAL TRANSPORTATION SAFETY BOARD
OFFICE OF AVIATION SAFETY
WASHINGTON, D.C. 20594**

POWERPLANTS GROUP CHAIRMAN'S FACTUAL REPORT

NTSB ID No.: DCA02MA054

Aircraft: Boeing 727-232F, N497FE, Federal Express flight 1478

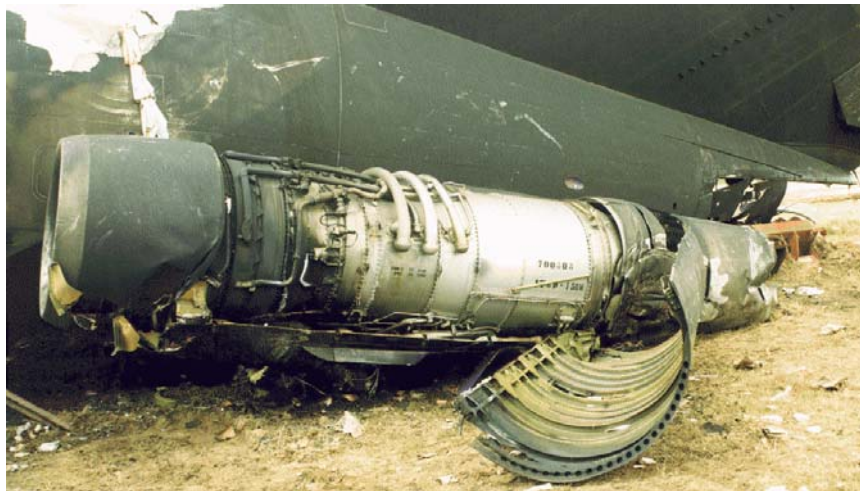
The engine was complete and intact from the inlet cowl to the thrust reverser. There was no evidence of an uncontainment or inflight fire. After the cowlings were removed, the fan cases were found to be sooted back to the compressor intermediate case.

Photo 1: No. 1 engine with cowling removed

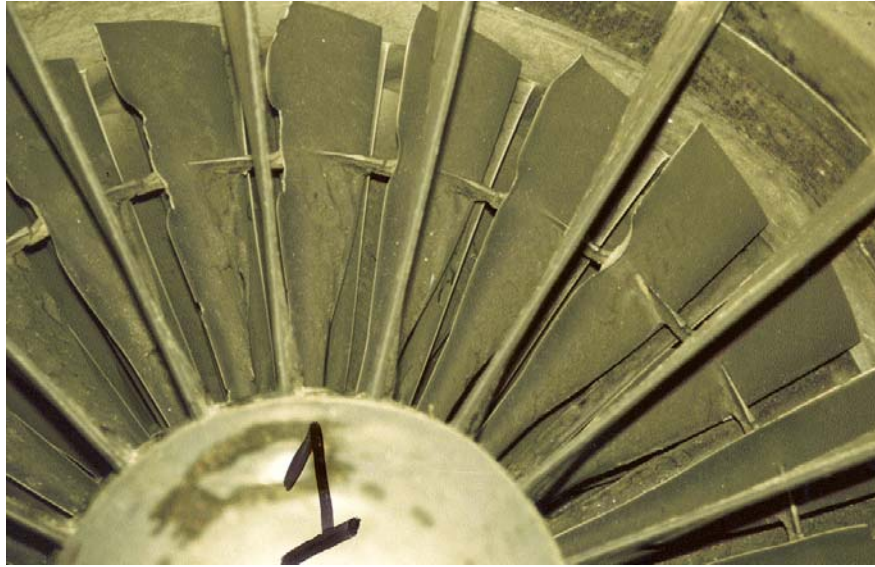
All of the fan blades were in place and intact. Many of the fan blades had soft body impact damage⁷ on the leading edges. The leading edge tip corners were broken off or bent and curled opposite the direction of rotor rotation.⁸ Several fan blades had organic material and dirt pressed against the underside of the midspan shrouds.

There was one fan blade that had the mid span shrouds shingled.⁹ The fan rotor could be rotated by hand.

Photo 2: No. 1 engine's fan blades showing soft body impact damage and organic material on underside of mid span shrouds

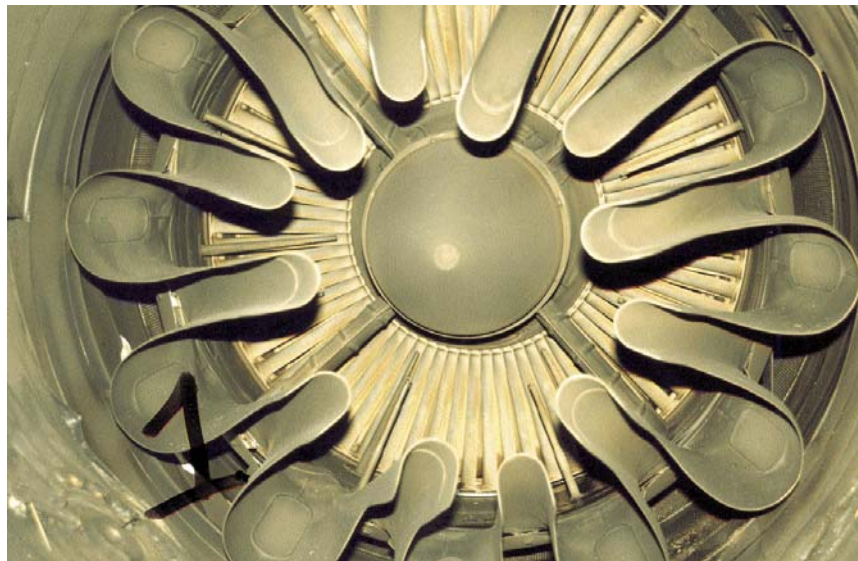
The fourth stage turbine blades were all in place and intact. The tailcone and mixer were still in place. There was no metal spray on the fourth stage turbine blades, tailcone, mixer, or tailpipe.

Photo 3: No. 1 engine's 4th stage turbine blades showing no damage

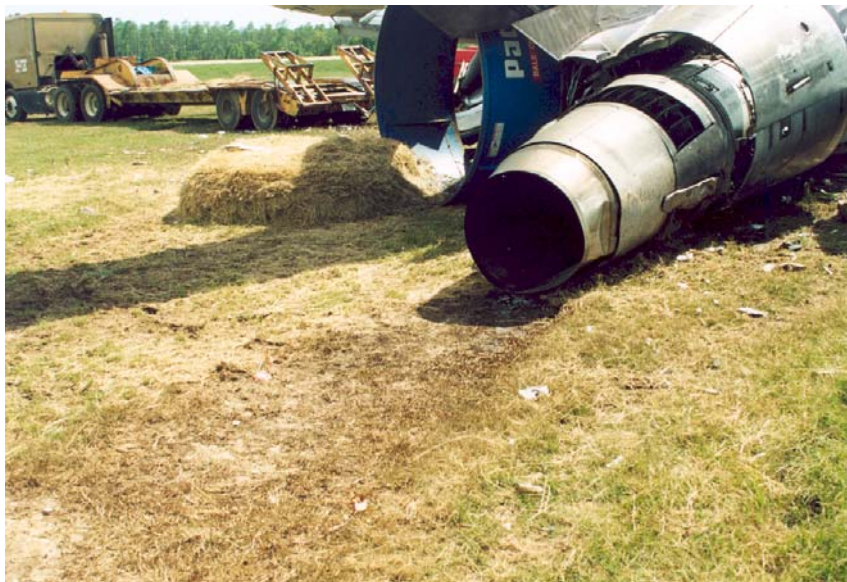
The No. 2 engine was still in the tail of the airplane, but was separated from the airplane at the cone bolts and was laying on the ground on its left side. There was a 14-foot long wedge-shaped area of scorched vegetation extending rearward from the engine's tailpipe.

Photo 4: Area of scorched grass in back of No. 2 engine's exhaust

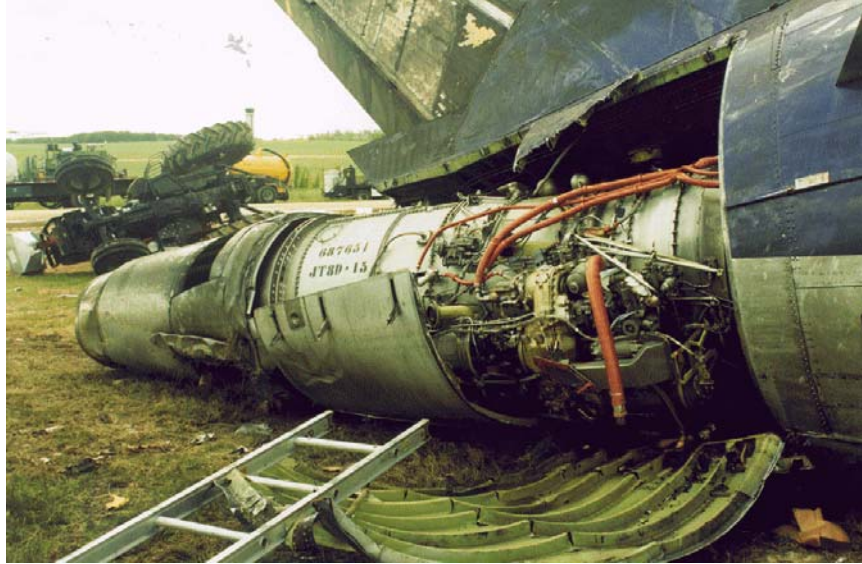
The engine was complete from the inlet case to the thrust reverser. There was no evidence of an uncontainment and the engine did not have any fire damage.

Photo 5: No. 2 engine with cowl removed

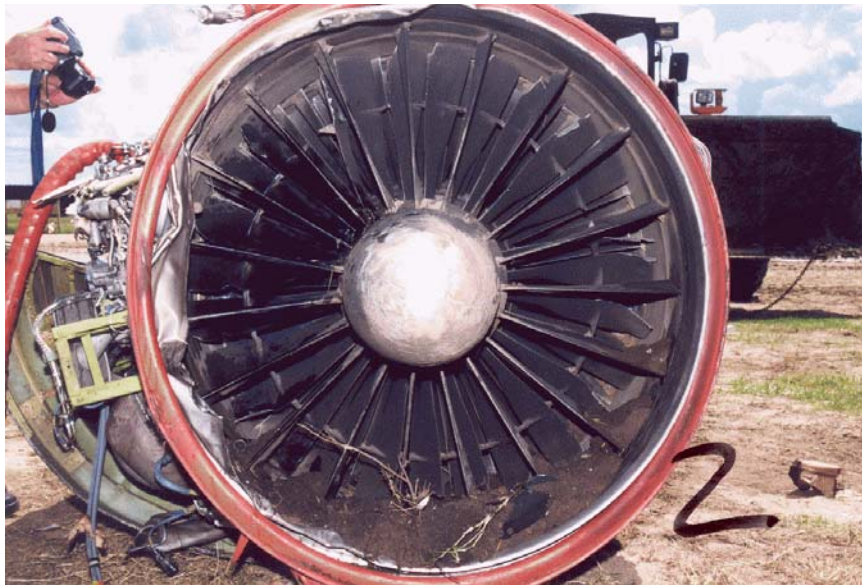
All of the fan blades were in place and intact. Most of the fan blades had the leading edge tip corners bent and curled opposite the direction of rotor rotation. None of the fan blade mid span shrouds were shingled. The fan rotor could be rotated by hand.

Photo 6: No. 2 engine's fan blades showing curled leading edges at the tips (P&W)

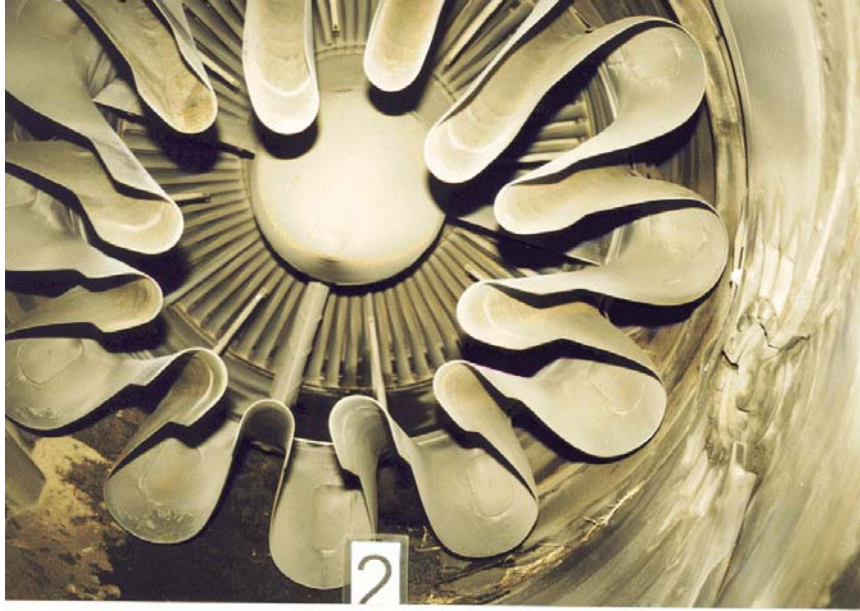
The fourth stage turbine blades were all in place and intact. The tailcone and mixer were still in place. There was no metal spray on the fourth stage turbine blades, tailcone, mixer, or tailpipe.

Photo 7: No. 2 engine's 4th stage turbine blades showing no damage

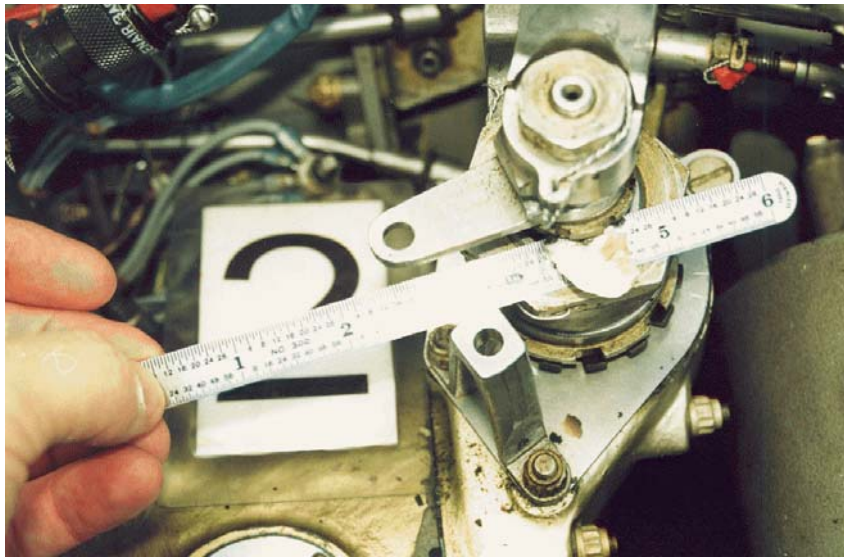
The gearbox assembly remained attached to the engine and all of the accessories remained attached to the gearbox. The throttle linkage was severed, but the fuel control unit throttle arm was in a part power position, 1 ¼-inches from the idle stop. There was fuel in the filter bowl and a sample was collected to be analyzed. Refer to Section 7 for the results of the fuel tests.

Photo 8: No. 2 engine's fuel control throttle arm 1 ¼-inches from idle stop

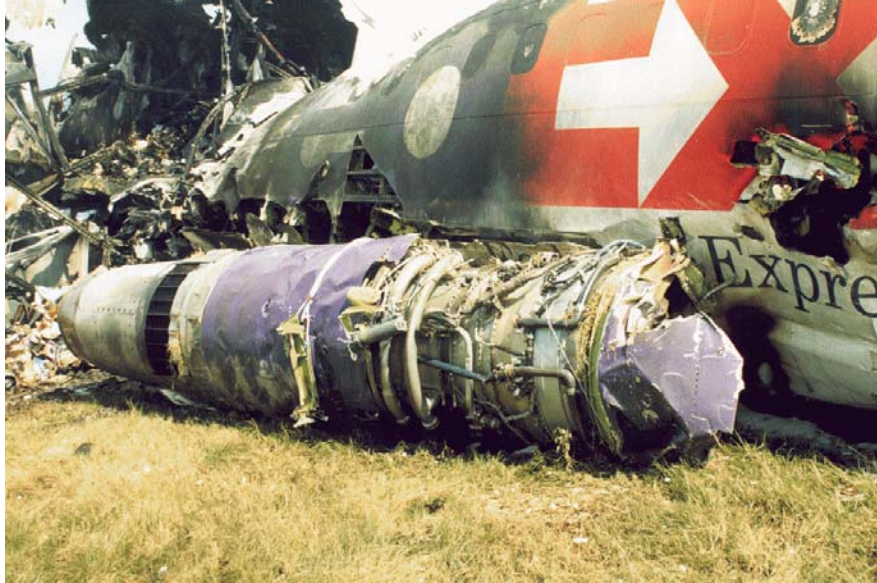
The No. 3 engine was separated from the airplane at the cone bolts. The engine was laying on its right side directly against the right side of the fuselage adjacent to the forward cargo door with the front of the engine facing in the same direction as the airplane.

Photo 9: No. 3 engine on right side of fuselage

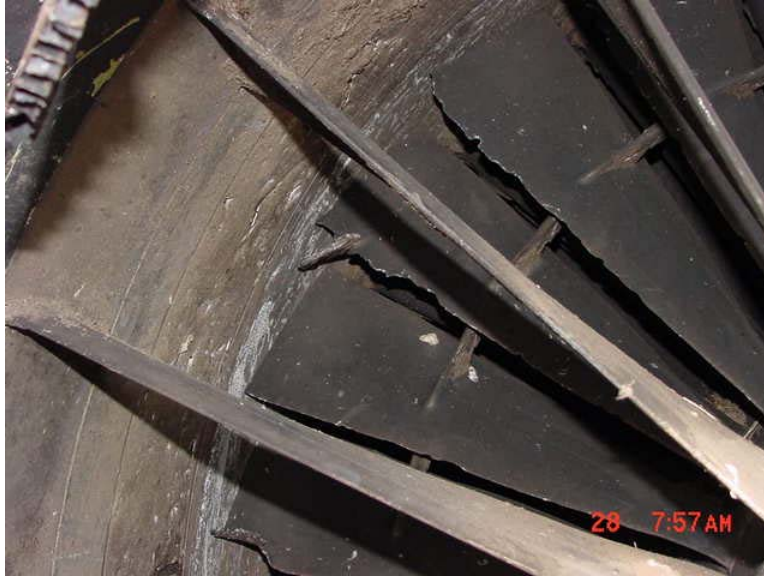
All of the fan blades were in place and intact. All of the fan blades had soft and hard body impact damage¹⁰ to the leading edges. In addition, the leading edge tip corners were bent and curled opposite the direction of rotor rotation. None of the fan blade mid span shrouds were shingled. There was one fan blade that had a piece of metal that was foreign to the engine embedded in the leading edge. The fan rotor could not be rotated.

Photo 10. No. 3 engine's fan blades showing soft body impact damage and metallic object embedded into leading edge of one blade (FedEx)

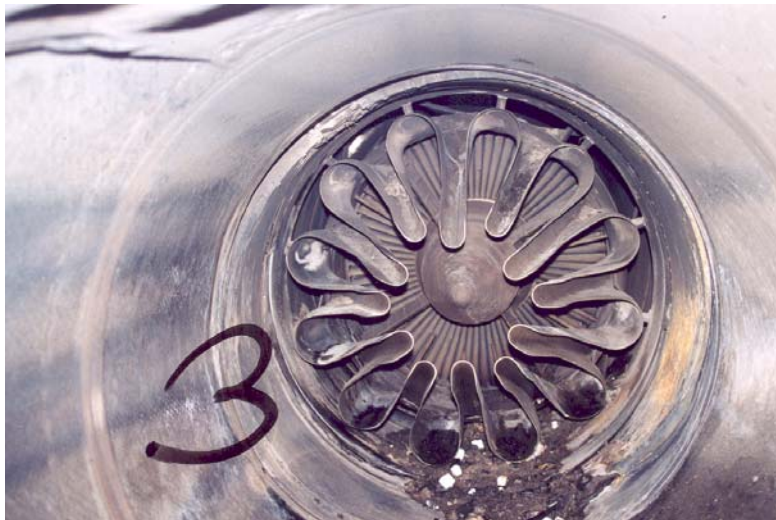
The fourth stage turbine blades were all in place and intact. The tailcone and mixer were still in place. There was no metal spray on the fourth stage turbine blades, tailcone, mixer, or tailpipe.

Photo 11: No. 3 engine's 4th stage turbine blades showing no damage

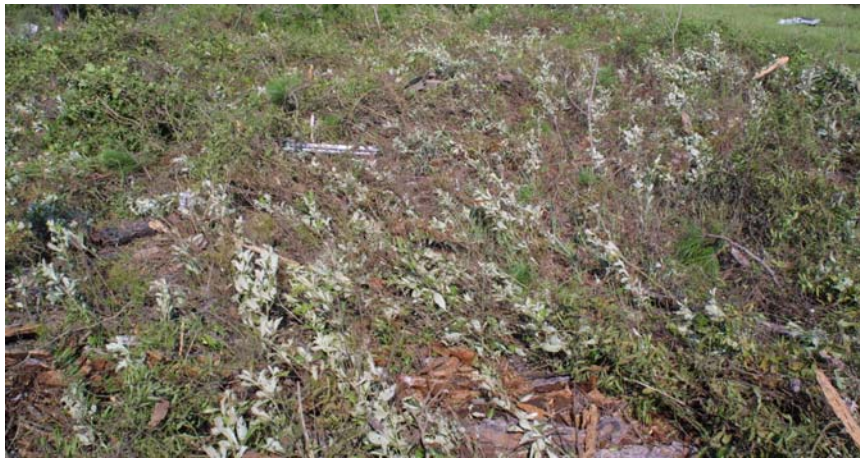
There was a large area just before the point where the airplane touched down beyond the treeline where the trees had been knocked down and the vegetation on the ground was bent over flat opposite the airplane's direction of travel.

Photo 12: Area on ground just before spot where airplane touched down where vegetation was bent over flat opposite the direction of travel of the airplane (Boeing)
