**NATIONAL TRANSPORTATION SAFETY BOARD**  
**Office of Aviation Safety**  
**Washington, D.C. 20594**

**POWERPLANT GROUP CHAIRMAN'S FACTUAL REPORT**

**NTSB No: DCA-06-MA-009**

Location: Chicago Midway Airport, Chicago Illinois  
Date: December 8, 2005  
Time: 1914 central standard time  
Aircraft: Southwest Airlines' Boeing 737-7H4, N471WN, flight No. 1248

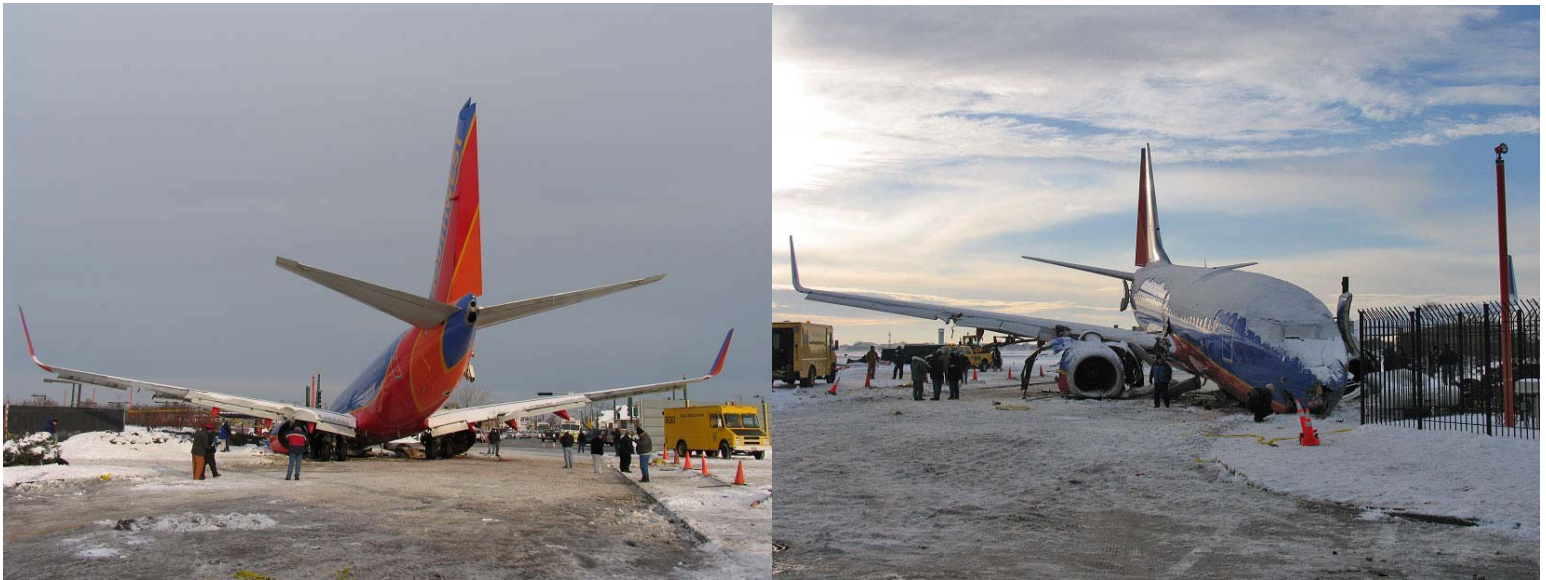
The airplane was found at the south side of intersection between 55<sup>th</sup> Street (east/west direction) and Central Avenue (north/south direction), directly past the end of runway 31C off the airport property (**Photos 1 and 2**). The airplane was found on its nose, both main landing gears, and both engines. Both engines remained attached to their pylon and the pylons remained attached to the airplane.

**PHOTOS 1 AND 2: AC FINAL RESTING POSITION**

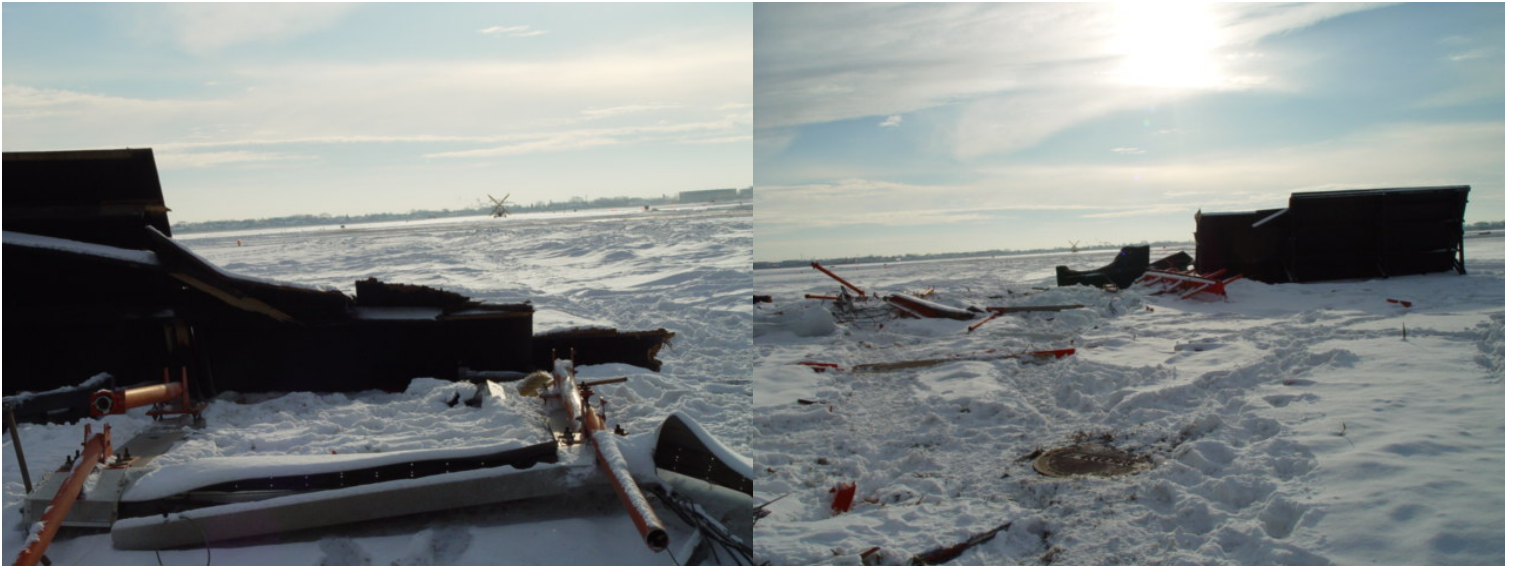
The wooden blast fence at the end of the runway 31C had damage consistent with the size and shape of the engine inlets (**Photos 3 and 4**). The in-situ observations were taken at the location where the airplane came to rest prior to its removal to a hanger on the Midway Airport property where additional examination and documentation occurred.

**PHOTOS 3 AND 4: DAMAGED WOODEN BLAST FENCE AT THE DEPARTURE END OF 31C**

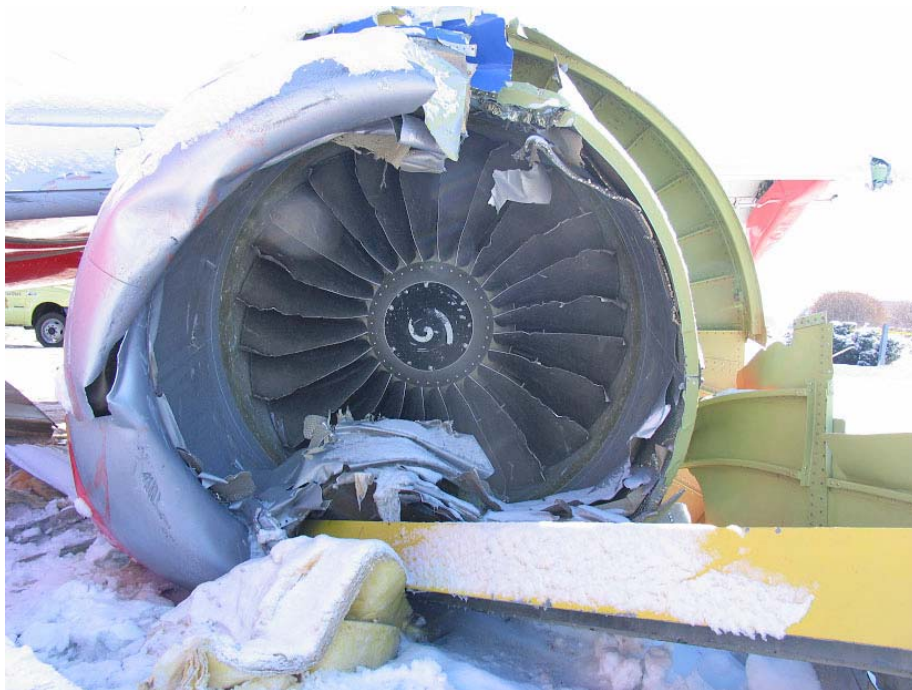
Approximately 50% of the nose cowl outer skin was ripped from the inlet cowl from the 6:00 to 12:00 o'clock position. At the 6:00 o'clock position, an airport perimeter fence pole was found imbedded in the inlet cowl (**Photo 5**). The left-hand fan cowl appears relatively intact except for some leading edge impact damage from the 6:00 to 7:00 o'clock position and in the vicinity of the center latch. The right-hand side fan cowl appears intact except for leading edge impact damage from the 4:00 to 6:00 o'clock position.

**PHOTO 5: FAN SECTION AND INLET OF NO. 1 ENGINE**

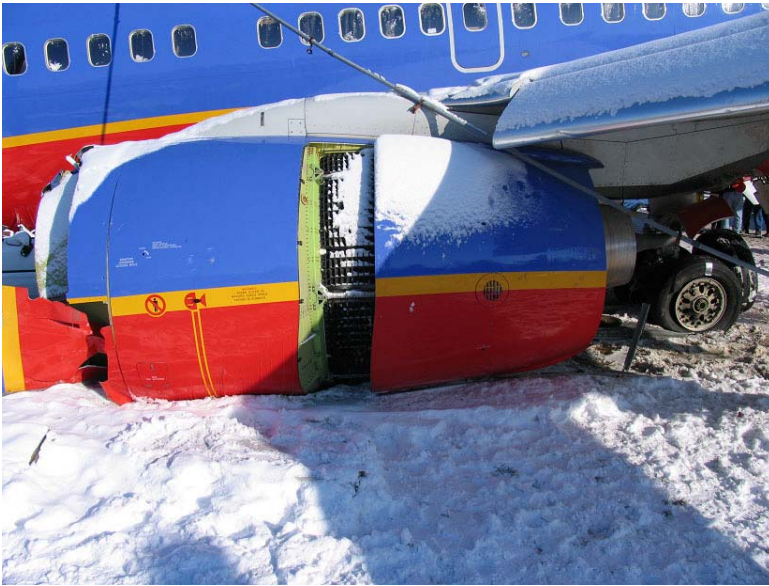
The left-hand translating sleeve was deployed approximately 19.25-inches at the 9:00 o'clock position in-line with the non-locking actuator and 19.75-inches at the 11:30 o'clock position in-line with a locking actuator (**Photo 6**). All the left-hand blocker doors appeared intact, present, and fully deployed. There were no visible gaps between blocker doors (**Photo 7**). Debris consistent with wood chips and fragments was observed on the aft face of the blocker doors<sup>1</sup>, on the translating sleeve inner skin (flow path), the inner duct, and the core exhaust nozzle (**Photo 7**). All the cascades remained installed and were intact. Snow, wood, red metallic, and red rubber debris was noted heavily imbedded within the cascade airflow openings and against the front face of the blocker doors<sup>2</sup>. The left-hand translating sleeve appeared to be mostly still engaged with its lower main track; however, wood was found embedded within the sleeve at approximately the 7:00 o'clock position that locally dislodged the sleeve from the track.

**PHOTO 6: LEFT-HAND SIDE OF NO. 1 ENGINE**

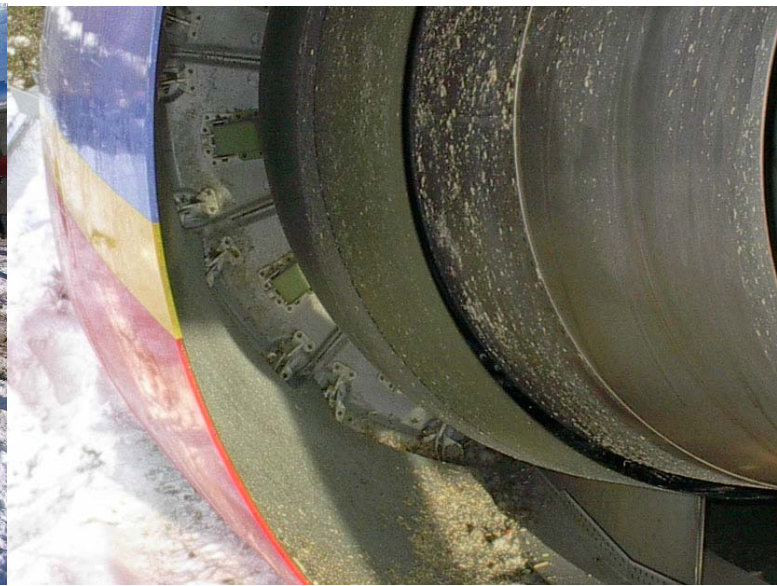
**PHOTO 7: CLOSED BLOCKERS DOORS**

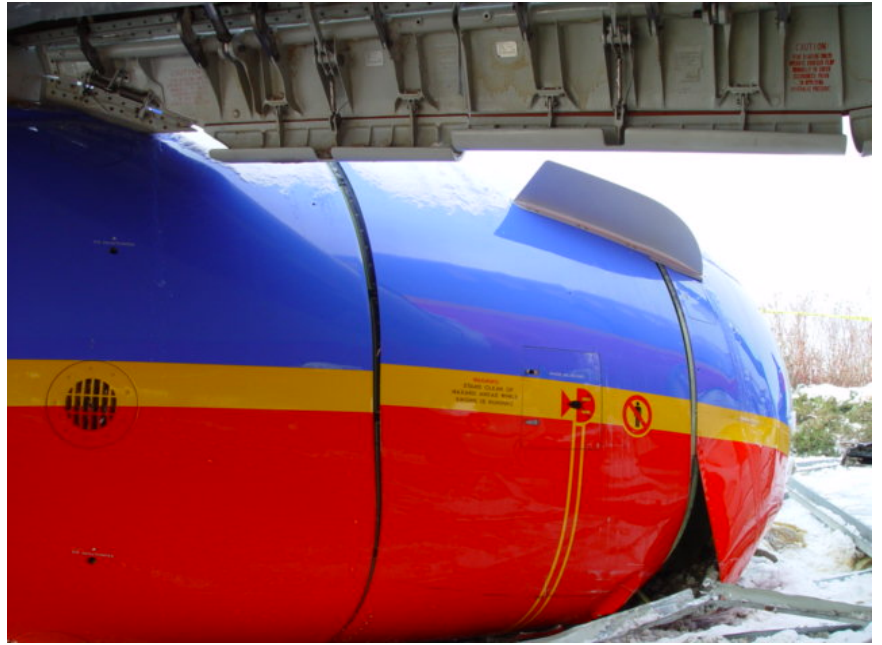
The right-hand translating sleeve appeared to be essentially in the stowed position (**Photo 8**). The translating sleeve was partially seated against the fan cowl at the 5:00 o'clock position; however, a noticeable gap existed between the translating sleeve and the fan cowl that progressively got larger from the 5:00 to 1:00 o'clock position consistent with a canted sleeve. The maximum gap measured 1.5-inches at the 1:00 o'clock position in-line with the locking actuator. All the right-hand blocker doors appeared intact, present and fully stowed. Debris consistent with wood chips and fragments was also observed pinned between the blocker doors and inner skin of the translating sleeve. This same wood debris was observed in the translating sleeve inner skin, the inner duct, and the core exhaust nozzle.

**PHOTO 8: RIGHT-HAND TR - STOWED**

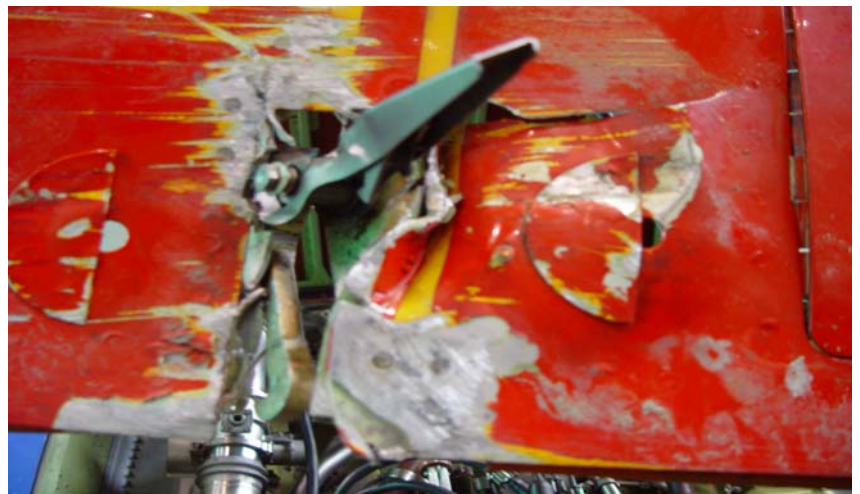
The fan cowls were secure and locked. Three latches are used to secure both fan cowls halves with the latch handles and mechanisms located on the left-hand fan cowl and the latch keepers located on the right-hand fan cowl. All three latches remained attached to the left-hand fan cowl. The forward most and the rearward most latches appeared undamaged while the center latch was heavily damaged and distorted, but intact (**Photo 9**). All three latch keepers were intact and undamaged.

**PHOTO 9: DAMAGED CENTER LATCH**

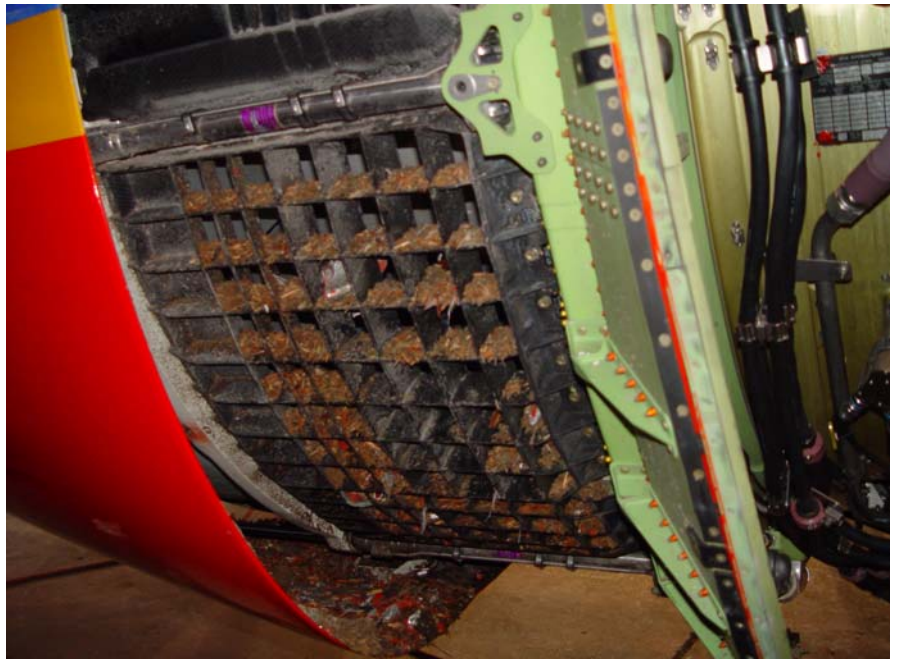
The right-hand translating sleeve was manually driven open and no binding was noted. Snow, wood, red metallic, and red rubber debris was noted imbedded within the cascade airflow openings and against the front face of the blocker doors similar to what was observed on the left-hand side (**Photo 10**). With both translating sleeves open, the lower main tracks and liners for the left- and right-hand TRs were examined and they appeared to be in good condition. The left-hand translating sleeve was not in the fully deployed position and using the synchronizing lock actuator, the sleeve was manually moved aft approximately 1.5 to 2.0-inches from its as-found position. When an attempt was made to manually stow the translating sleeve (move it forward), the sleeve moved forward approximately 1.5 to 2.0 inches (back to its as-found position), became bound, and would not move any farther forward due damage to the lower part of the sleeve.

**PHOTO 10: DEBRIS IN CASCADES**

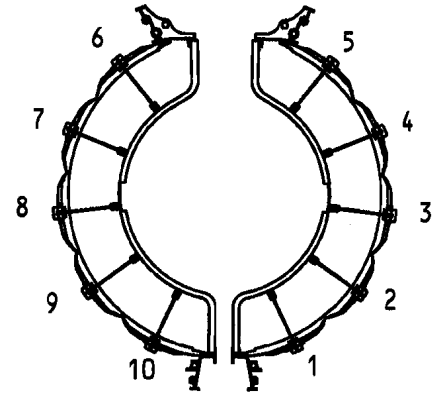
**FIGURE 1: BLOCKER DOOR LOCATIONS**

Examination of the left-hand TR revealed no damage to the blocker doors and their associated hardware; however, on the right-hand side TR, blocker door in the No. 5 position was damaged (See Figure 1). The No. 5 blocker door exhibited a “V”-shaped crack coming from the drag link hinge. The drag link itself was bowed and distorted. All the cascades for both the right- and left-hand sides were intact, present, undamaged and, were verified to be in the correct orientation, position, and part number per the parts manual.

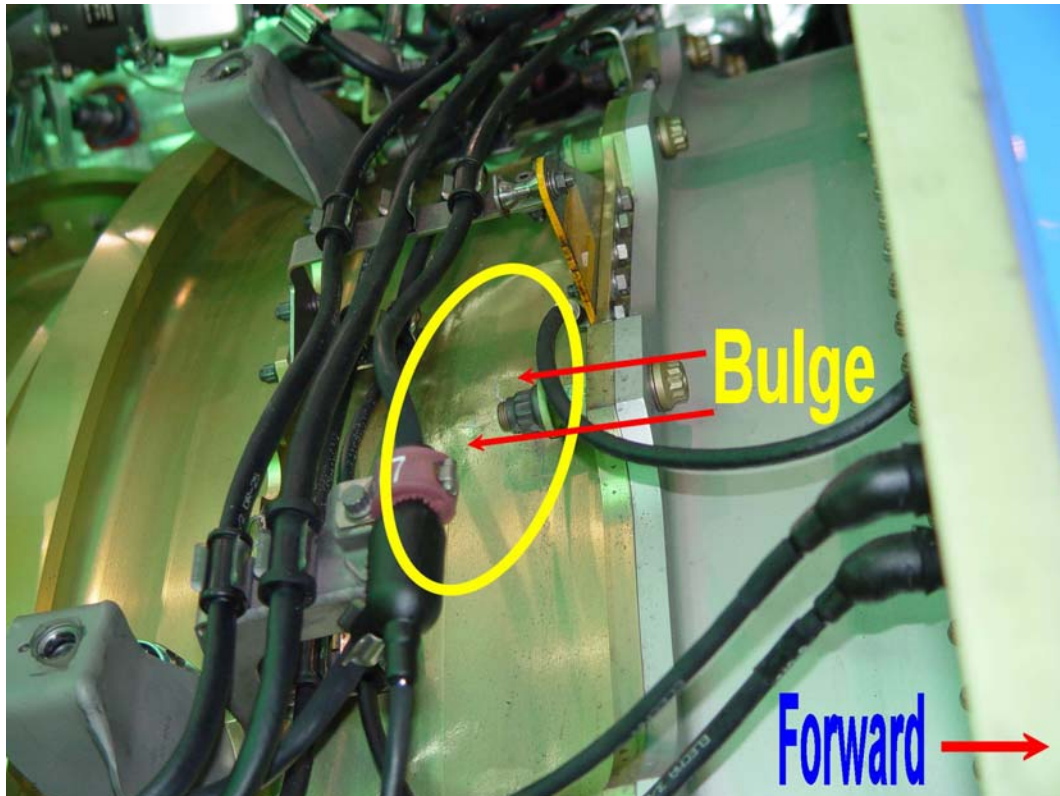
Examination of the engine revealed no exit holes, uncontainments, or signs of fire. The fan case inner contour exhibited many impact marks spanning from the forward flange to the struts of the basic fan frame structure. The fan case was bulged outwards at the 2:30 o'clock position and within the bulge, the case was cracked (**Photo 11**).

**PHOTO 11: BULGE IN FAN CASE**

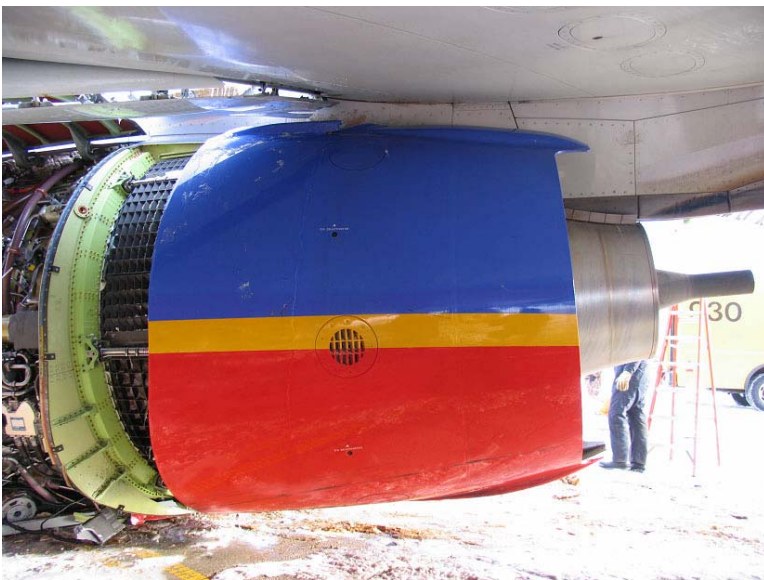
The left-hand translating sleeve was deployed approximately 20.625-inches at the 9:00 o'clock in-line with the non-locking actuator and 21.50-inches at the 11:30 o'clock position in-line with the locking actuator (**Photo 12**). All the left-hand blocker doors appeared intact, present and deployed but not fully. Gaps were visible between blocker doors. Traces of wood debris were noted from the 6:00 to 8:00 o'clock positions on the cowl exhaust nozzle and the translating sleeve inner skin. All the left-hand cascades were intact and present. Snow, wood, red metallic, and red rubber debris were noted to be heavily imbedded within the cascade airflow openings and against the front face of the blocker doors (**Photo 13**).

**PHOTO 12: LEFT-HAND TR DEPLOYED**

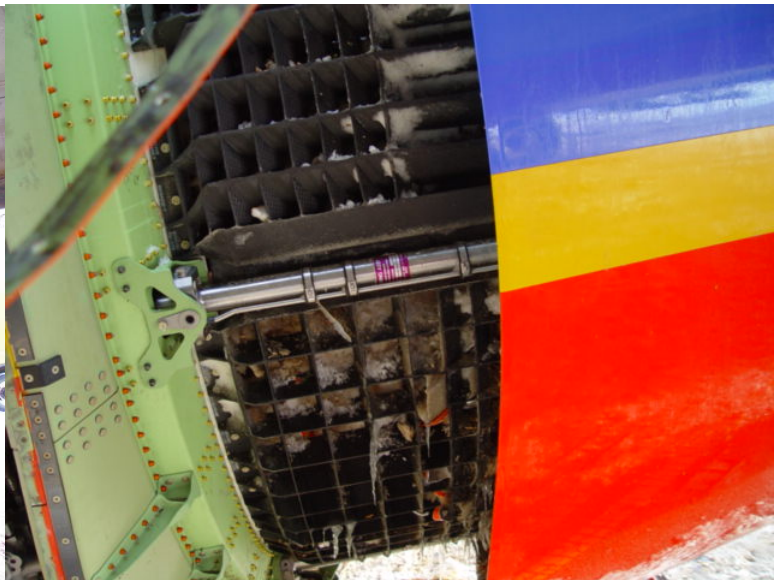
**PHOTO 13: DEBRIS IN THE CASCADES**

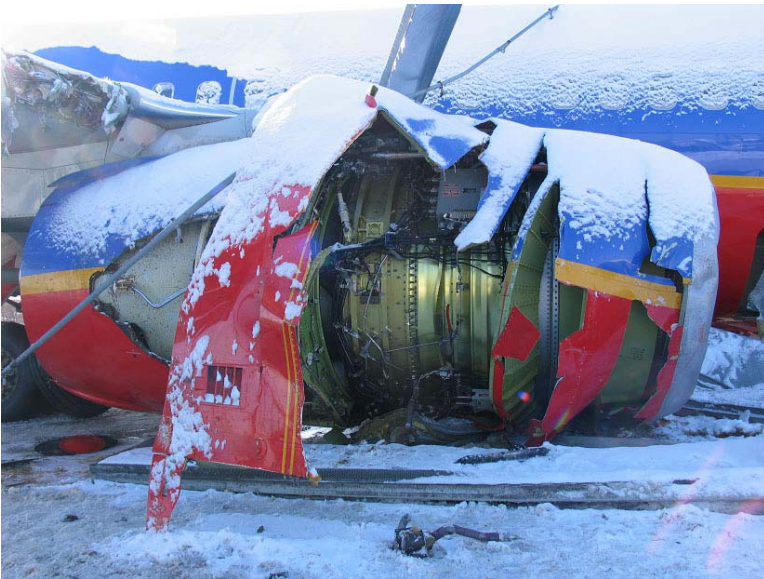
The right-hand translating sleeve was deployed approximately 20.187-inches at the 1:00 o'clock position in-line with the locking actuator. At the 3:00 o'clock position, an approximately 45 x 45-inch triangular section of the translating sleeve was missing (Photos 14 & 17). The edges of the remaining skin piece were torn and exhibited no signs of fire or thermal distress. All the right-hand blocker doors appeared intact, present and deployed but not fully. Gaps were visible between blocker doors and the gaps were greater than those observed on the left-hand side. Debris consistent with wood chips and fragments was noted on the aft face of the blocker doors from the 3:00 to 6:00 o'clock positions and on the translating sleeve inner skin and core exhaust nozzle from the 12:00 to 1:00 o'clock positions. The amount of wood debris found on the right-hand side was significantly more than what was observed on the left-hand side. Several pieces of the right-hand cascades were broken and missing with cascade fragments found in the snow in the vicinity of the right engine. Snow, wood, red metallic, and red rubber debris were noted to be heavily imbedded within the cascade airflow openings and against the front face of the blocker doors. The right-hand torque box separated from the fan frame resulting in the TR separating from the engine (Photo 15). Both translating sleeves appeared to be still engaged with their respective lower main tracks.

**PHOTO 14: RIGHT HAND-COWL & TR DAMAGE**

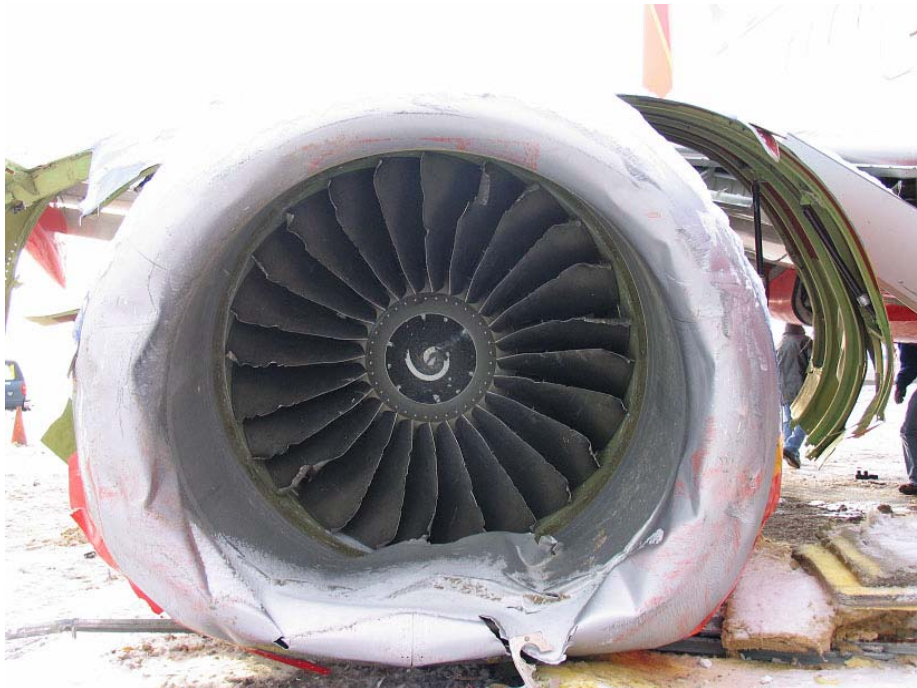
The damage observed on the No. 2 engine was similar to the type of damage observed on the No. 1 engine previously documented in section 2.2.2 *Engine No. 1 Examination In-Situ*. All the fan blades remained installed in the fan disk and leading edges of all the airfoils exhibited impact damage, tears, and missing material (Photo 16). The tips of the airfoil leading edges were curled in the direction opposite rotation. Circumferential rub, in-plane with the fan blade normal running position, was observed in the fan case. The spinner was intact, remained attached to the fan disk, and exhibited scrape marks. All the stage 4 LPT blades were intact, remained installed in the disk, and none exhibited any trailing edge damage. No metallic debris or oil was noted on any of the stage 4 LPT blades or in the LPT case, the turbine frame, or the exhaust nozzle.

**PHOTO 16: FAN SECTION AND INLET OF NO. 2 ENGINE**

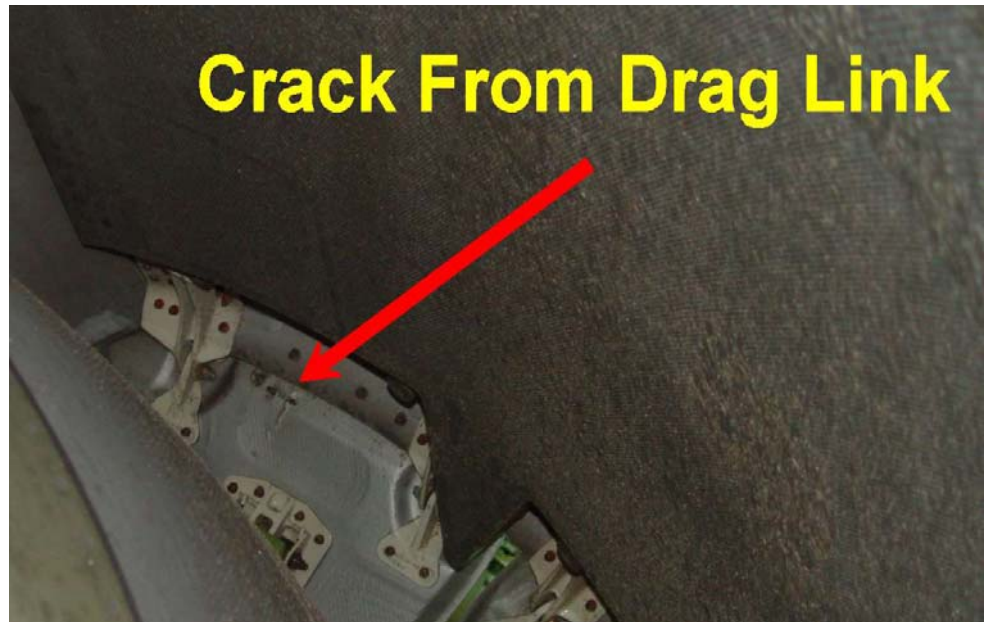
Both the left- and right-hand translating sleeve track appeared to be in good condition. Similar to the No. 1 engine, no blocker door damage was observed on the left-hand TR; however, on the right-hand TR, No. 5 blocker door exhibited a "V" shaped crack coming from the drag link hinge (**Photo 18**). All the cascades for the left- and right-hand TRs were in the correct orientation and position and all the part numbers were verified to be correct in accordance with the maintenance manual except for assembly 320 on the right-hand TR. A section of the cascade assembly 320 was missing where the part number is normally stamped; therefore, the part number could not be verified.

**PHOTO 18: CRACKED BLOCKER DOOR**

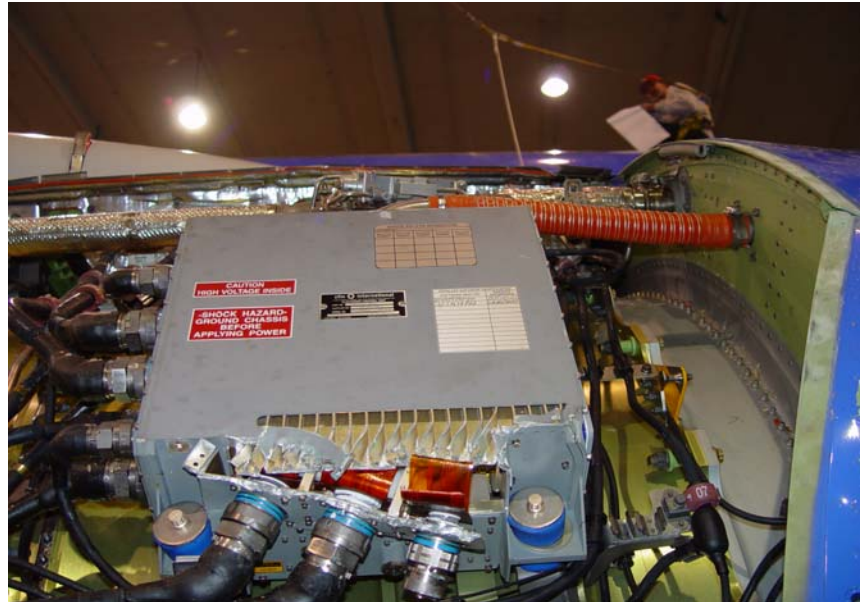
The EEC, P/N 1853M33P06, S/N LMDN9114 was intact but damaged. The forward lower corner was smashed, the lower panel was open exposing the plug inner connections, and some of the cooling fins were pushed over and flattened (**Photo 19**). The EEC was removed and shipped to the BAE Systems Service Center for download of the NVM for fault examination. See section 3.0 *ELECTRONIC ENGINE CONTROL DOWNLOAD* for details.

**PHOTO 19: DAMAGED EEC FROM No. 2 ENGINE**

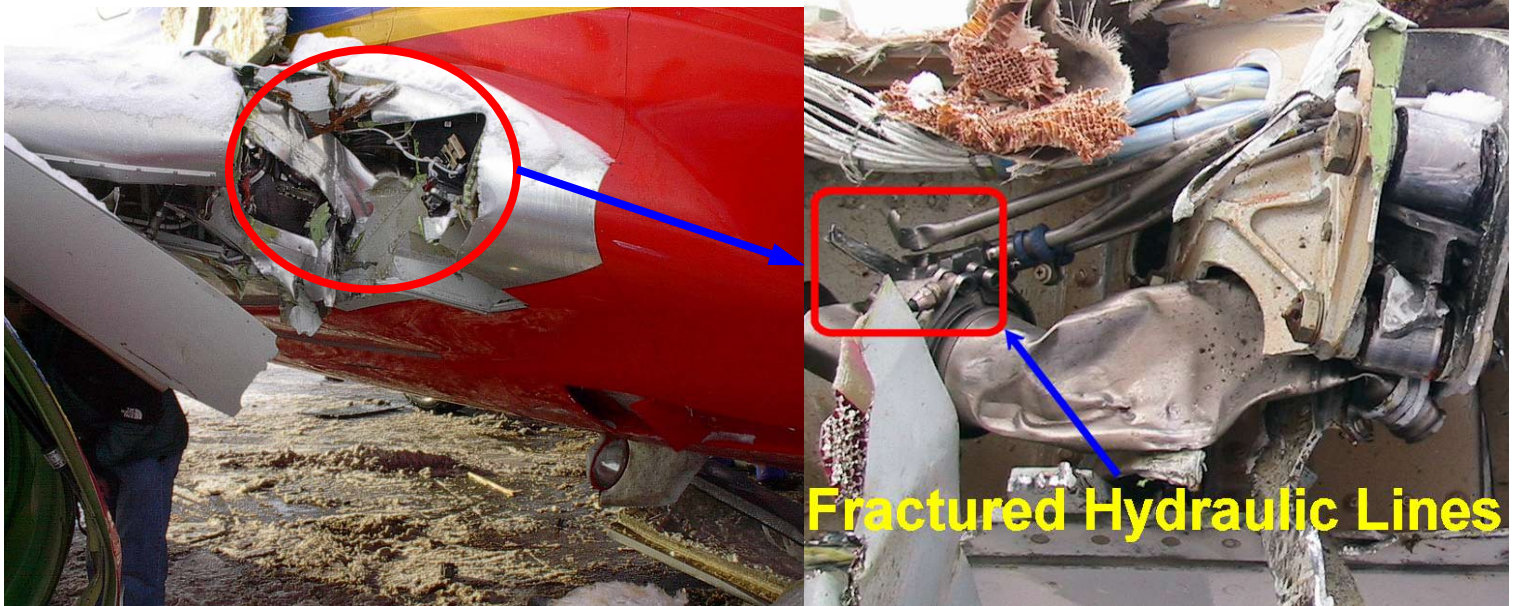
the engine, was performed for each system. No breaches or leaks in any of the hydraulic lines that run from TR 1 control module to the No. 1 engine were noted. All the hydraulic line fittings still had the Boeing torque strip/witness mark intact. The hydraulic lines were not continuous from the TR 2 control module to the No. 2 engine. Both the stow and deploy hydraulic lines were fractured in the area where the right wing sustained impact damage (Photos 19 and 20). No breaches or leaks in any of the hydraulic lines were noted from the TR 2 control module to the area of the wing leading edge impact damage and from the wing leading edge impact damage area to the No. 2 engine.

**PHOTO 19: RIGHT WING LEADING DAMAGE**

**PHOTO 20: FRACTURED TR HYDRAULIC LINES**
