**NATIONAL TRANSPORTATION SAFETY BOARD  
OFFICE OF AVIATION SAFETY  
WASHINGTON, D.C. 20594**

**POWERPLANTS GROUP CHAIRMAN'S FACTUAL REPORT**

NTSB ID: DCA06MA010

Location: Miami, Florida  
Date: December 19, 2005  
Time: 1439 eastern standard time (EST)  
Aircraft: Grumman Mallard G73T, Reg. No. N2969; Operator: Flying Boat, Inc. dba Chalk's Ocean Airways, Flight 101

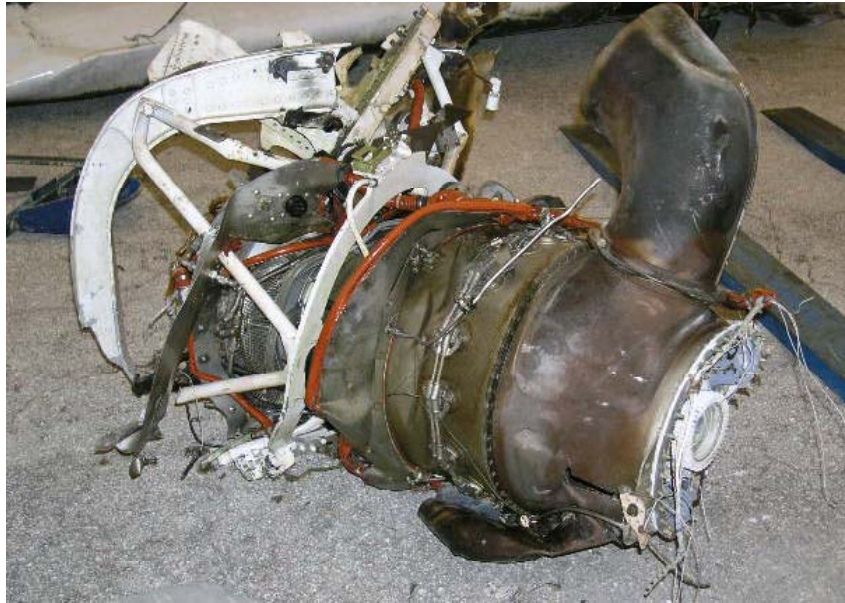
The No. 1 engine was submerged in 15–25 foot salt water for approximately 46 hours. External inspection found no evidence of uncontainment, engine fire, or pre-impact mechanical failure. (See Figure 1.)

Figure 1. No. 1 engine recovered to Watson's Island wharf

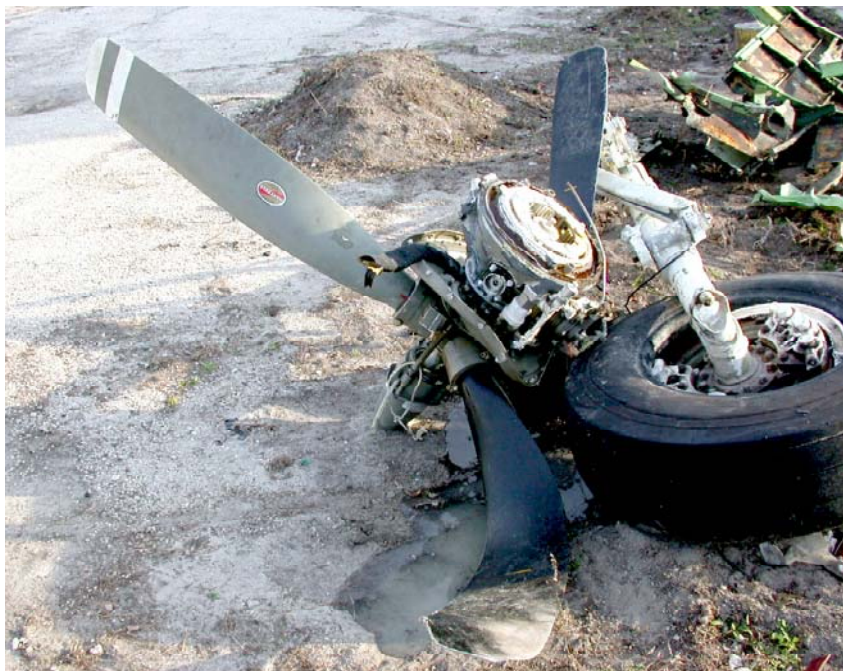
The No. 1 propeller was recovered separately. (See Figure 2.) It had been submerged in 15–25 feet of salt water for approximately 46 hours. The propeller blades and associated hardware were reference marked as L1, L2, and L3.<sup>7</sup>

Figure 2. No. 1 propeller recovered to Watson's Island wharf

The fractured forward section of the engine RGB front housing forward flange remained secured to the propeller hub. The spinner dome was crushed/fragmented on one side and had deformed over the piston. The spinner bulkhead was bent aftward.

The spinner dome was removed. The hub serial number was located between the L1 and L3 blades. The piston/cylinder was separated from the hub but was retained by the L3 link arm and beta rods. The feather spring was extended and the piston/cylinder was at the feather position. The L1 and L2 link arms had disconnected. The L1 blade/clamp had disconnected and the blade could be manually rotated. The L2 and L3 blades/clamps were at extreme reverse pitch positions.<sup>8</sup> All three blades were attached and exhibited aftward bending damage, and the L1 blade has significant tip tearing. There was no evidence of pre-impact mechanical failure.

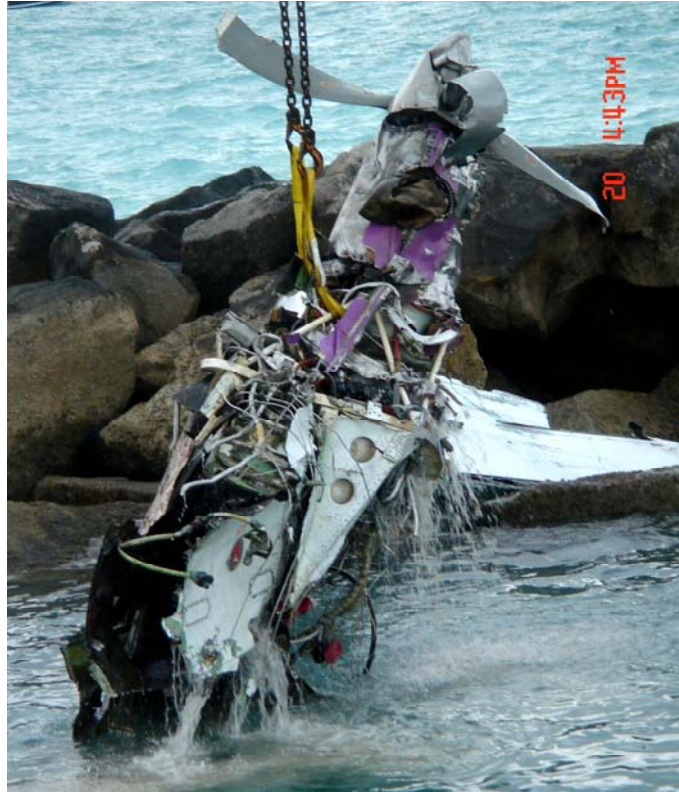
Figure 3. No. 2 engine recovered from Governor's Cut

The No. 2 engine was submerged in 5 – 10 feet salt water for approximately 26 hours. It was recovered still attached to a section of the right wing. (See Figure 2.) The mount structure was deformed. There was no evidence of uncontainment, engine fire, or pre-impact mechanical failure. The compressor 1<sup>st</sup> stage blades were intact. Circumferential scoring could be seen along the shroud.

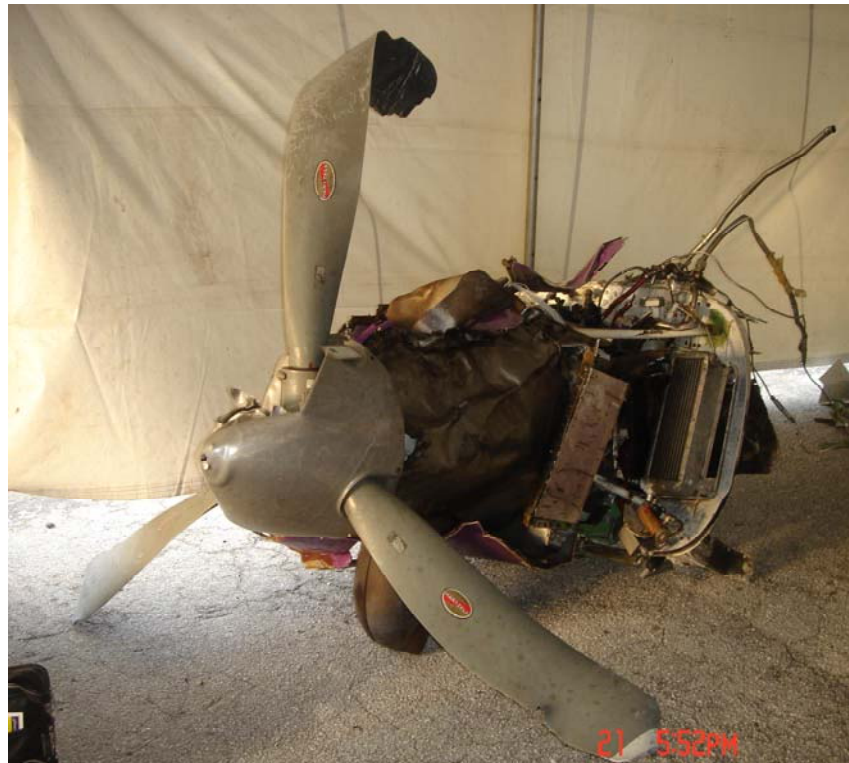
The spinner dome was removed. The hub serial number was located between the R1 and R2 blades. The R1 and R2 link arms had disconnected from their link screws and their blades/clamps were at low pitch positions. The R3 link arm had disconnected from its link screw and the blade/clamp was at an extreme reverse position. The feedback ring was intact; the piston position was  $1 \frac{2}{32}$  inch -  $14/32$ -inch from the beta mechanism flight idle pickup nuts. According to Hartzell, this equates to a piston position that would result in an approximate 32° - 34° blade angle. All three blades were attached and exhibited significant impact damage. There was no evidence of pre-impact mechanical failure. (See Figure 4.)

Figure 4. No. 2 engine and propeller recovered to Watson's Island wharf
