NATIONAL TRANSPORTATION SAFETY BOARD{PRIVATE }
Office of Aviation Safety
Washington, D.C. 20594

POWERPLANT FACTUAL

A. ACCIDENT DCA00MA030

Location : Burbank, California
Date : March 5, 2000
Time : 1811 Pacific Standard Time
Airplane : Southwest Airlines Flight 1455, Boeing 737-3T5, N668SW

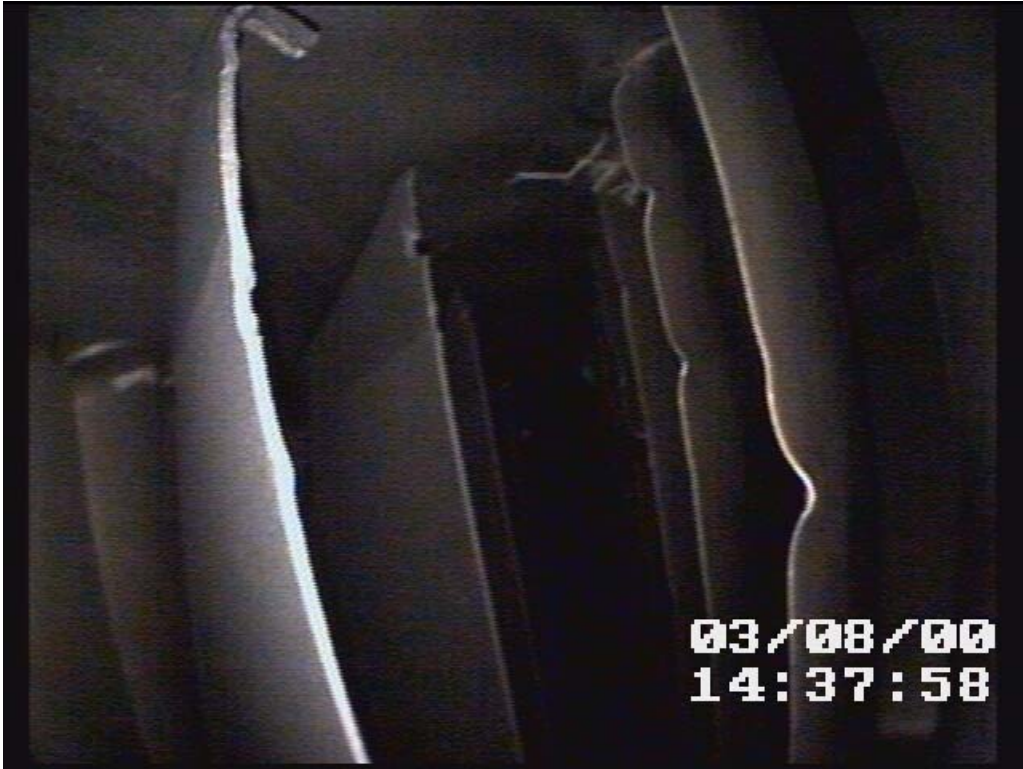
The fan blades and outlet guide vanes on both engines exhibited impact damage, tears and gouges. The No. 1 engine fan blades were described as corn-cobbed which is a failure condition where the disk shreds most or all of its blades. Both engines exhibited considerable blade and vane damage throughout the compressor. The compressor blades and vanes exhibited impact marks, tears, gouging and material loss core (No.1 engine - Photos 1 and 2 and No. 2 engine - Photos 3 and 4). The turbine sections of both engines were in satisfactory condition and were undamaged. The combustion chamber of the No. 1 engine (Photo 5) was free of debris and undamaged. The combustion chamber of the No. 2 engine (Photo 6) exhibited material deposits.

Photo 1: No. 1 engine compressor blade and vane damage

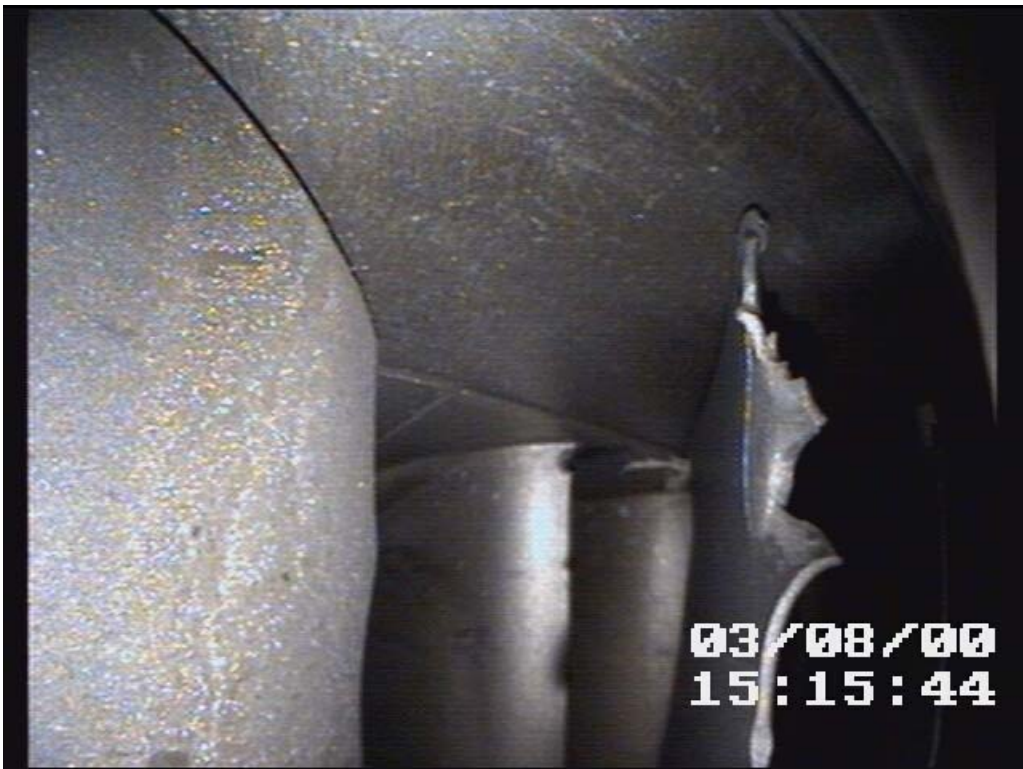
Photo 2: No. 1 engine compressor blade and vane damage

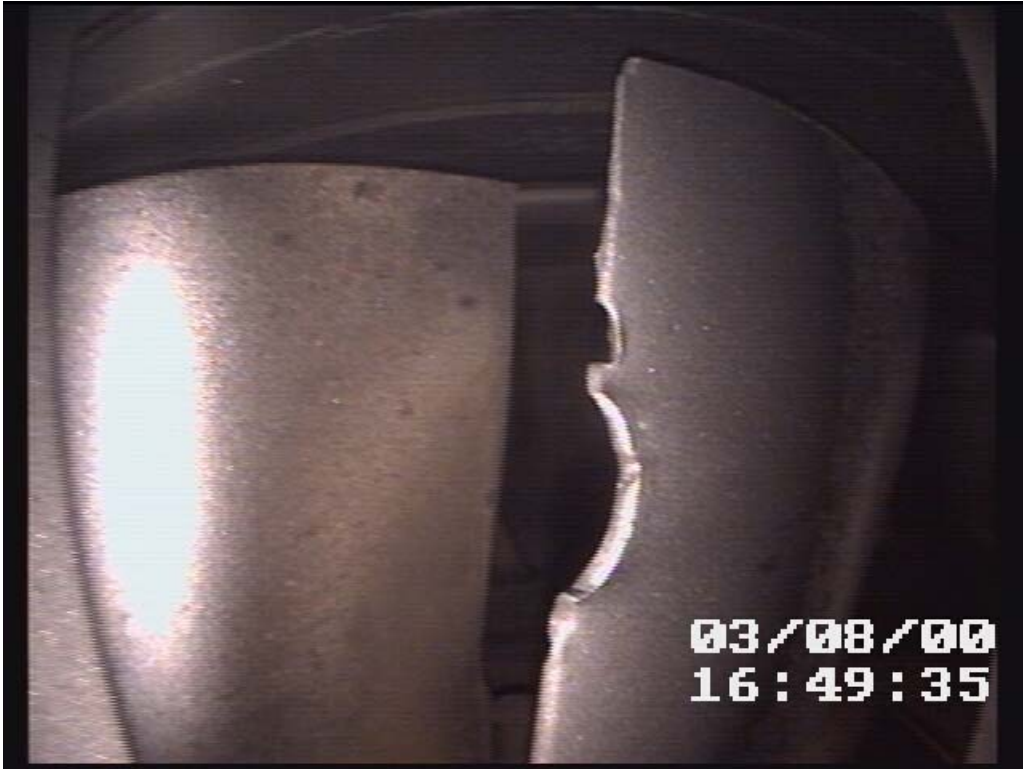
Photo 3: No. 2 engine compressor blade and vane damage

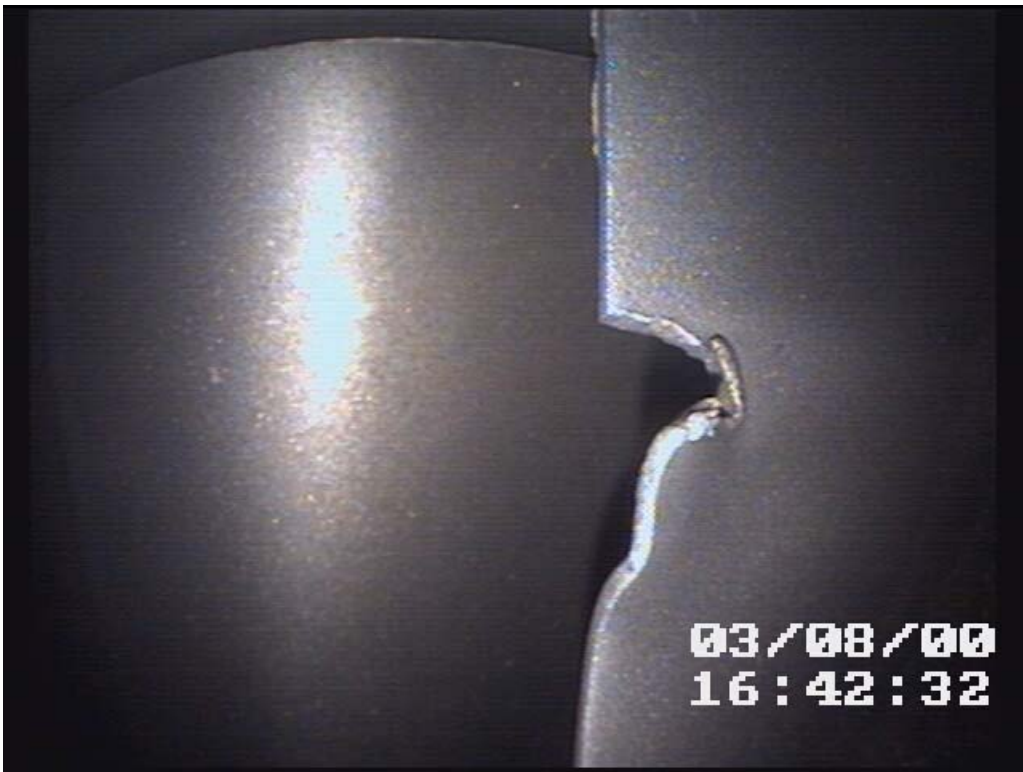
Photo 4: No. 2 engine compressor blade and vane damage

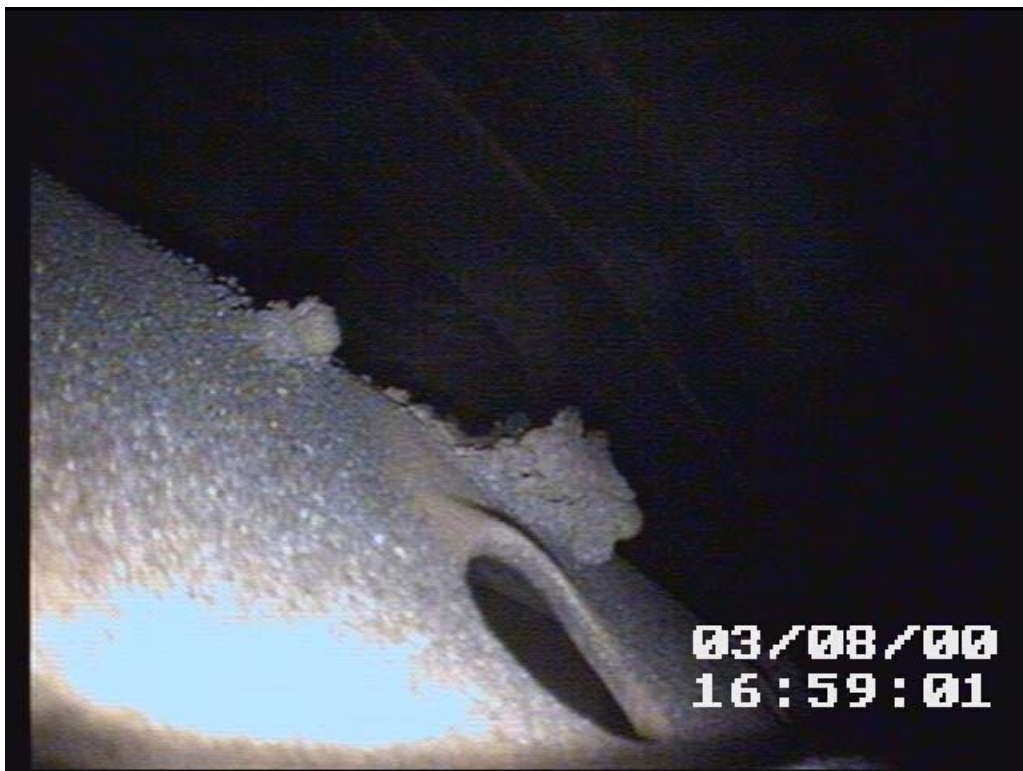
Photo 6: No. 2 engine combustion chamber with material deposits
