**NATIONAL TRANSPORTATION SAFETY BOARD  
OFFICE OF AVIATION SAFETY  
WASHINGTON, D.C. 20594**

**POWERPLANTS GROUP CHAIRMAN'S FACTUAL REPORT**

**NTSB ID No.: ANC-06-FA-018**

Location: Ketchikan, Alaska  
Date: January 25, 2006  
Time: 1250 Alaska Standard Time  
Aircraft: Aero Vodochody L-39MS Registration N104XX

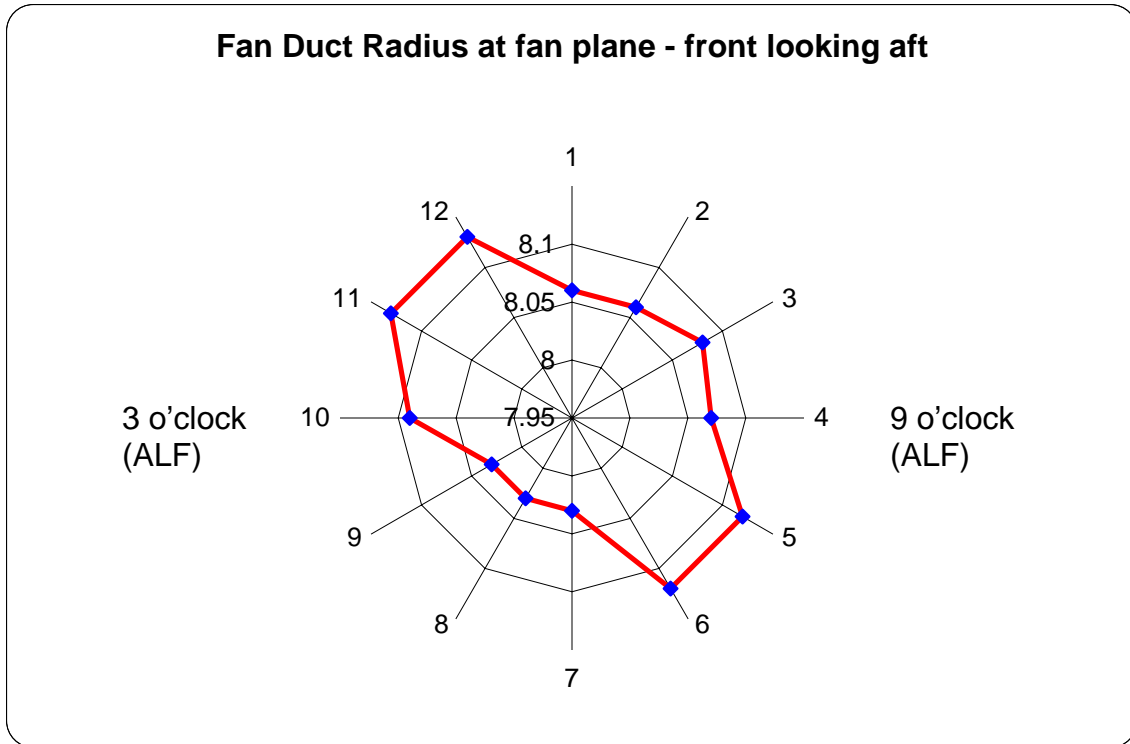
Table 2 – ‘Radar’ Chart of fan shroud diameter

The radius of the fan shroud was measured at 12 locations at 30° intervals. The fan flange was used as a fixture that a steel ruler was held against. The readings were made 3 times and showed repeatable values. The average values of the 3 measurements are in the chart below.

A ‘radar’ type chart illustrates the ovality of the fan shroud from the data above.

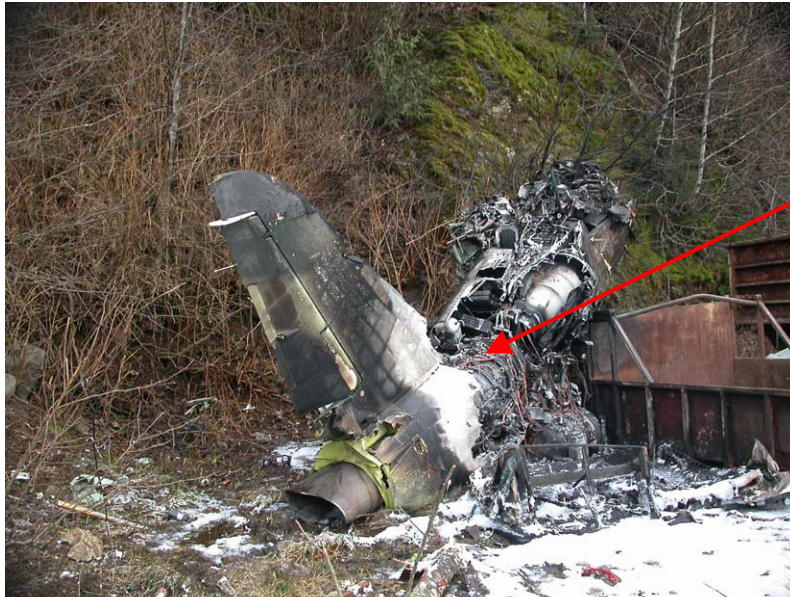
Figure 2 – Aero Vodochody L-39MS, N104XX – On-scene

The aircraft fuselage was found right side up in a 45-degree nose up attitude resting against the base of a steep hill. Most of the mid section of the fuselage was burned as far back as the empennage (Figure 2). The empennage and the vertical tail section were burned and charred. The cockpit was sheared and folded to the left. The resin of the bifurcated airframe composite inlet duct was burned away leaving only the loose fiber fabric.

Engine location

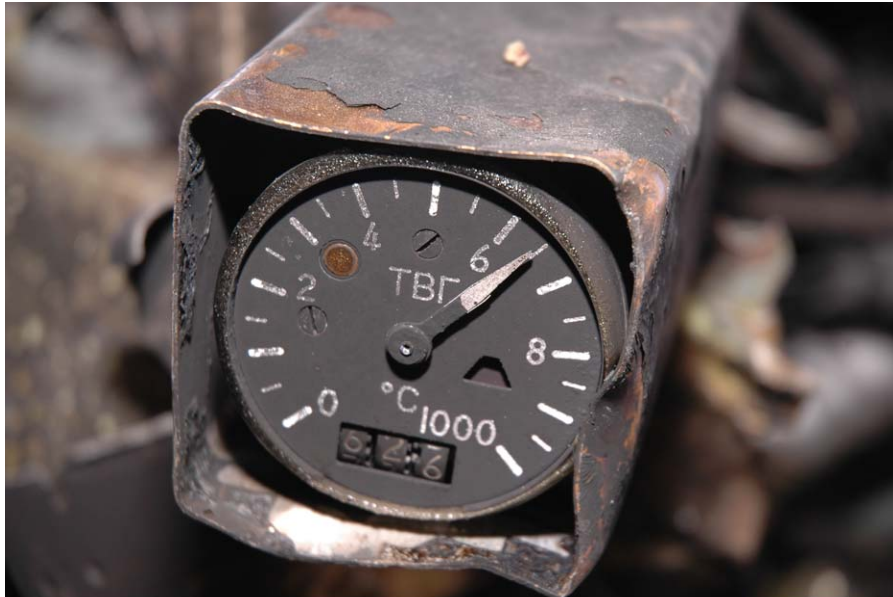
Figure 3 – Engine temperature gauge

Some cockpit instruments could be read. The engine exhaust temperature gauge (Figure 3) indicated approximately 630 degrees centigrade, which corresponds to a normal power setting. The engine oil pressure gauge (Figure 4) indicated approximately 2-1/4 kilopascals per square centimeter, which is within the acceptable range.

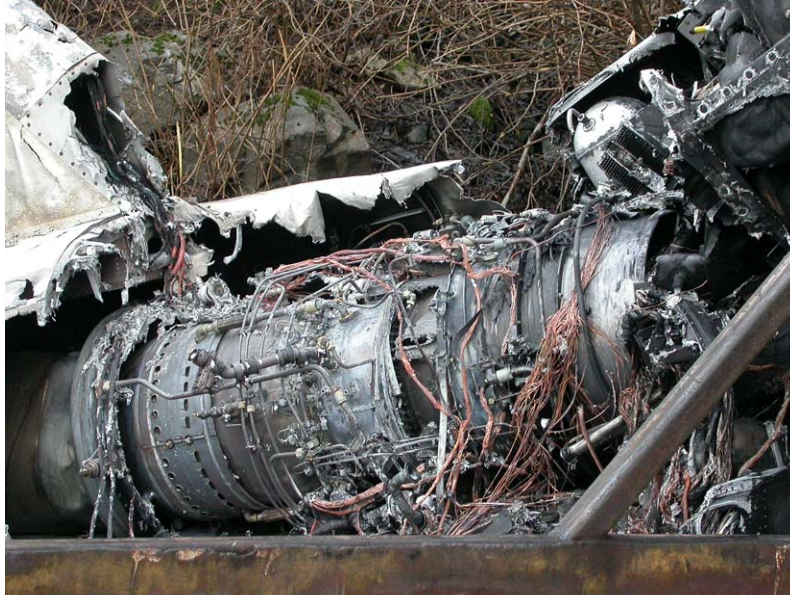
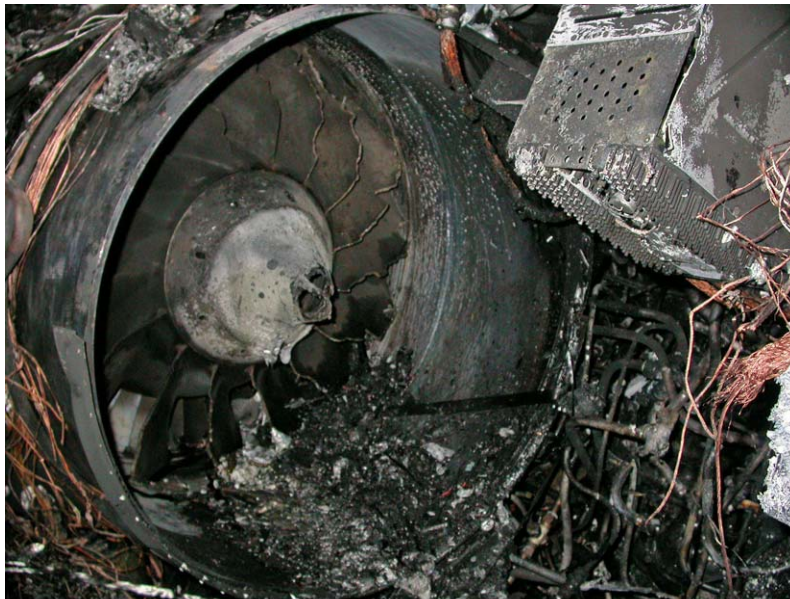
The engine was found in its installed location within the fuselage (Figure 5 & Figure 6). There was no evidence of an uncontained failure. The fan spinner was melted. The fan blades were severely torn and fractured on the leading and trailing edges. A portion of the outer bypass duct was melted.

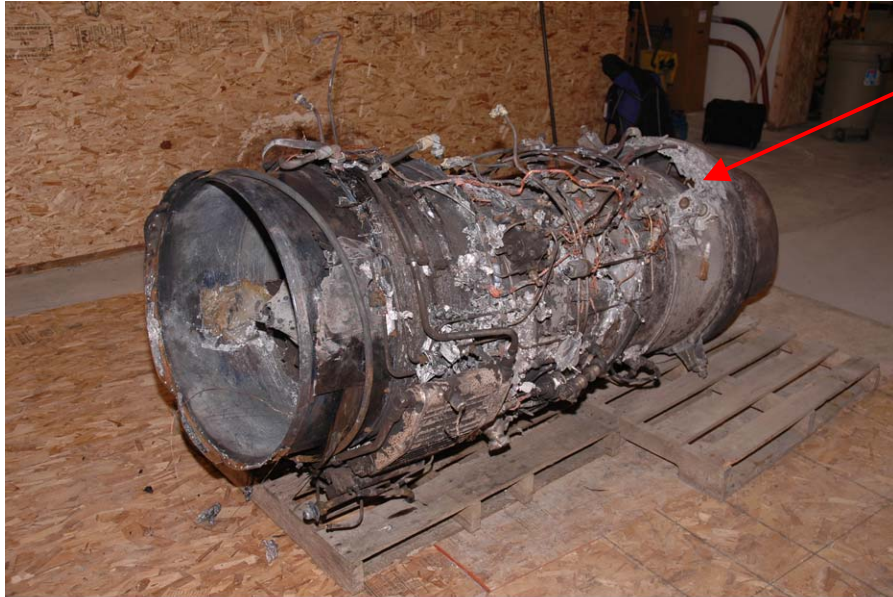
Figure 7 – Povazske Stroguarne DV-2 engine – Top & left side

The engine was on its left-hand side on top of a palette (Figure 7, Figure 8, Figure 9 & Figure 10). The external surfaces of the engine, accessory gearbox and external accessories were coated with soot (Figure 11). The right side of the engine sustained considerable damage consistent with an external fire. The outer bypass duct, between the fan case aft flange and in front of the rear bearing housing, was burned and melted on the right side of the engine (Figure 12). There was no evidence of an in-flight fire. The engine core was generally intact from the inlet case to the fan exhaust duct. A 1-foot long segment of the aircraft exhaust duct was still attached to the aft exhaust flange. Approximately half the circumference of this duct was buckled. The fan containment ring portion of the fan inlet consists of the metal cylinder of the housing wrapped with black fibrous material around the outside (Figure 13). This fibrous material was burned on the right side of the engine. The insulation on the electrical wires on the right side of the engine was melted. The right corner of the accessory gearbox was fractured but the gearbox was otherwise intact.

Outer bypass  
duct melted

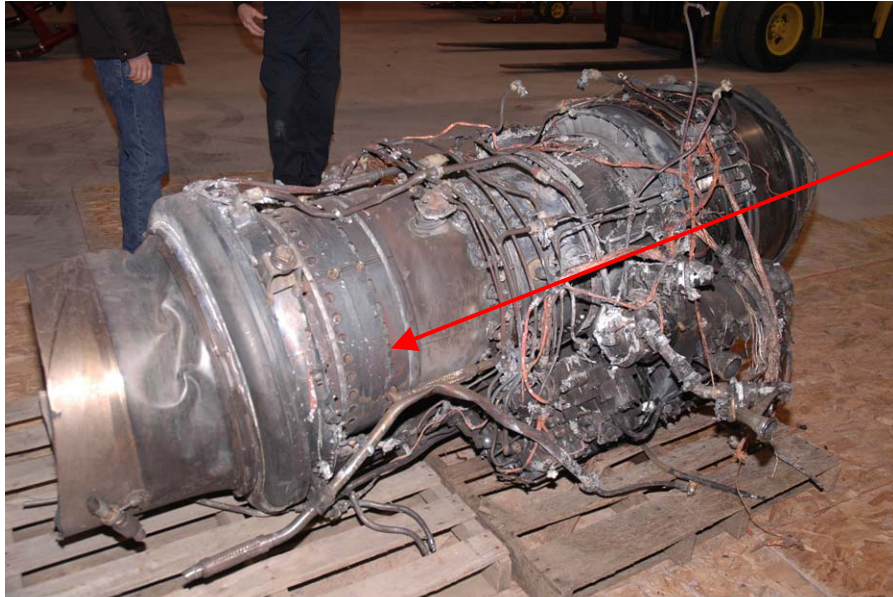
Figure 9 – Povazske Stroguarne DV-2 engine – Bottom & right side

Inner bypass duct is visible.  
Outer bypass duct melted

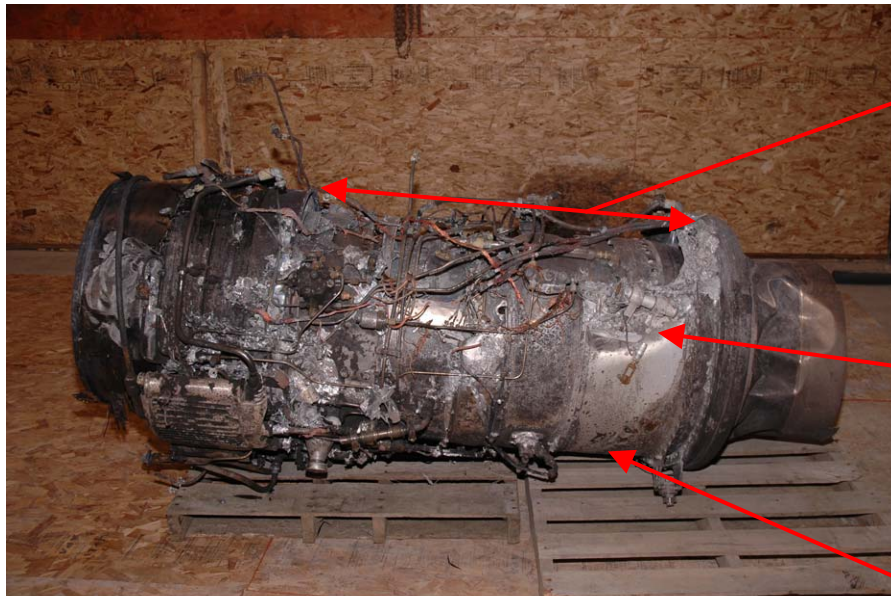
Figure 12 – Povazske Stroguarne DV-2 engine – Top view

Fan duct is missing along this length

Outer fan duct melted

Outer fan duct is complete on this side

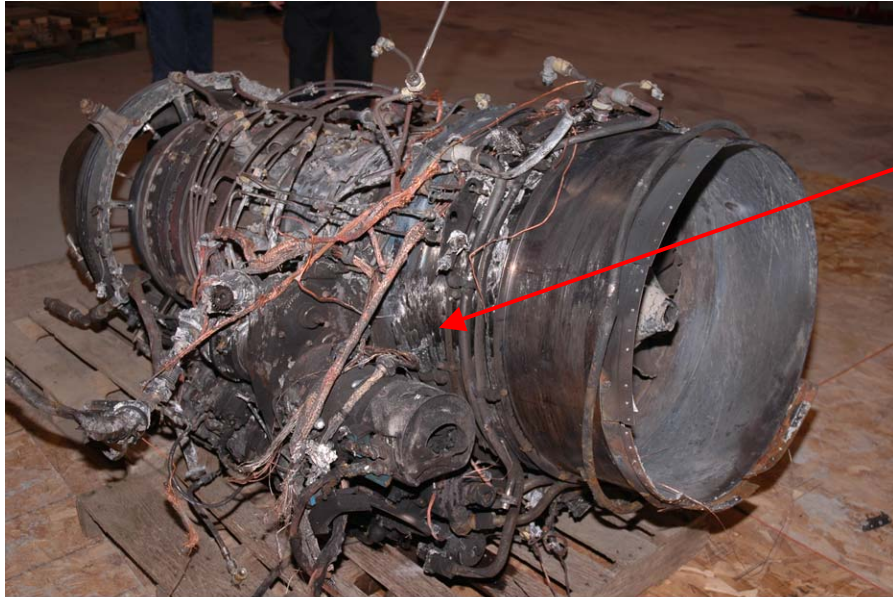
Figure 13 – Povazske Stroguarne DV-2 engine – Fan containment ring

Charred  
fibrous  
material

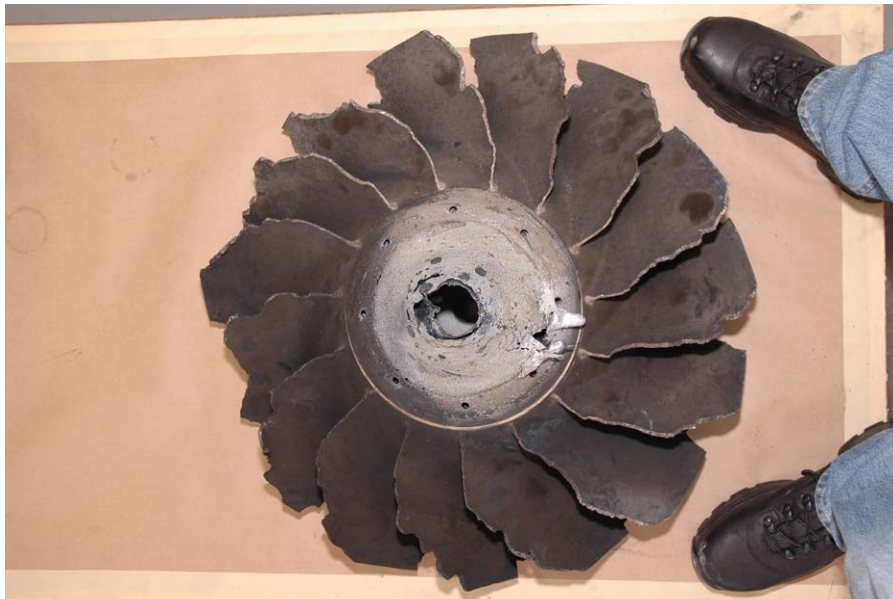
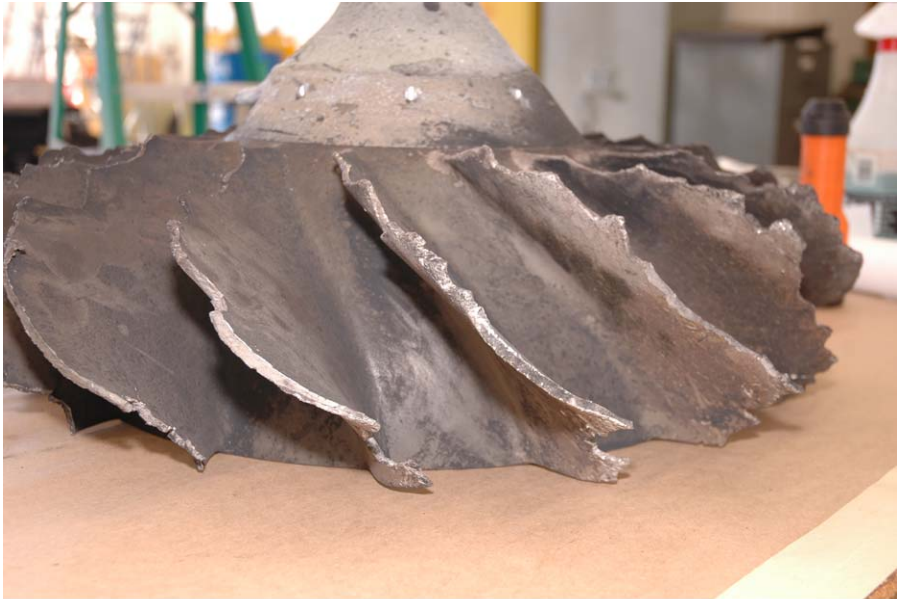
The fan blisk<sup>2</sup> was generally intact (Figure 14). The outer leading and trailing edge corners of all the blades were battered and fractured (Figure 15). Some of these fractures were jagged, sharp-edged and exhibited large material loss. The liberated pieces were not recovered. Twelve blades still had the mid chord portion of their tip still intact (Figure 16) but scored. Three blades were missing their tip (Figure 17). The entire spans of all the blades were battered (Figure 18). All displaced material on the fractures was deformed in the direction opposite of rotation (Figure 19). Approximately  $\frac{1}{3}$  of the fan blade material of each blade was missing.

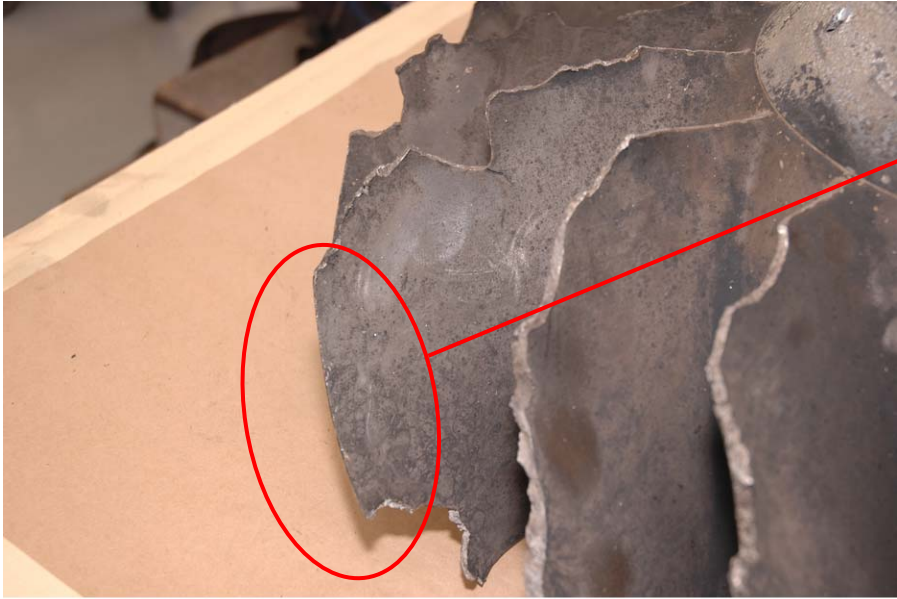
Figure 16 – Fan blisk – chord segment intact

Fan blisk  
blade tip  
intact

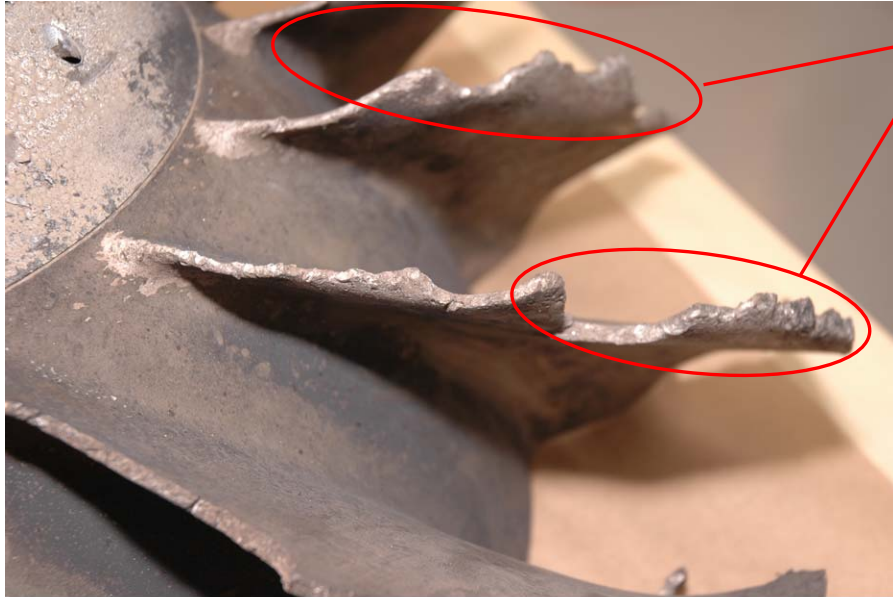
Figure 17 – Fan blisk – chord fractured

Complete chord at tip is missing

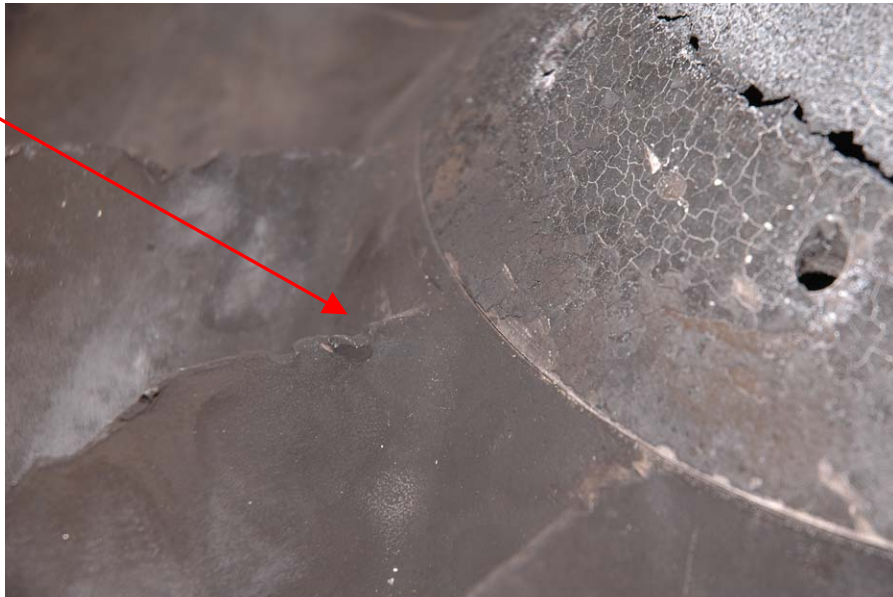
Figure 18 – Leading edge battered on inner diameter of fan blade

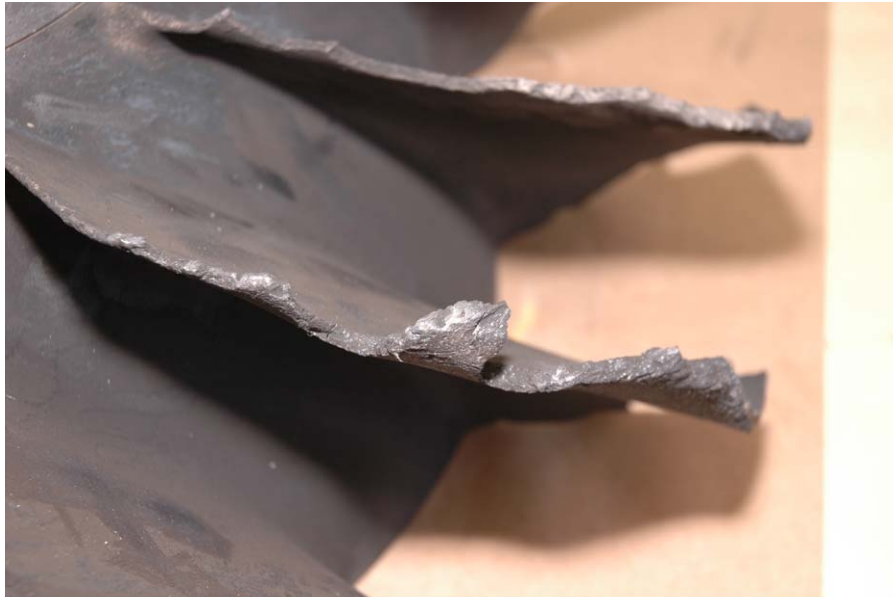
Figure 19 – Fan blade material bent in direction opposite of rotation

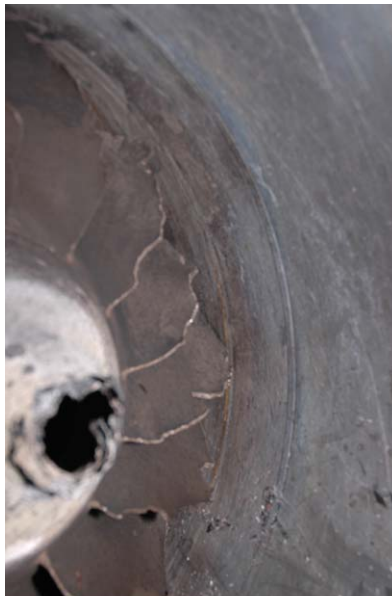
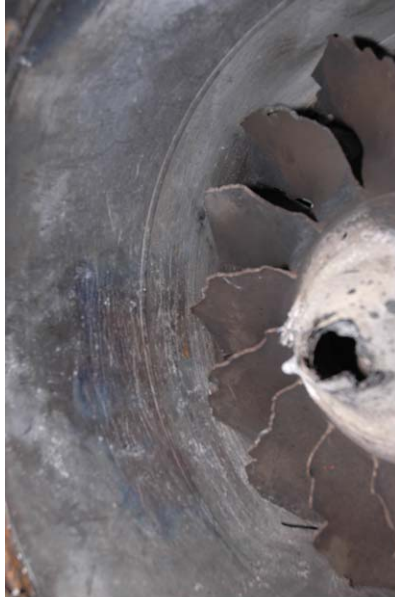
The fan shroud was intact. Heavy rotational scoring was observed at the 3 and 9 o'clock positions (ALF)<sup>1</sup> on the inner diameter of the shroud where the fan disk normally operates (Figure 20 & Figure 21). There were multiple intermittent scraping deposits at various angles of a metal consistent with the fan blade material from the inlet shroud front flange to just ahead of the fan plane (Figure 22).

Figure 20 – Fan shroud – Rotational scoring at 3 o'clock position

Figure 21 - Fan shroud – Rotational scoring at 9 o'clock position

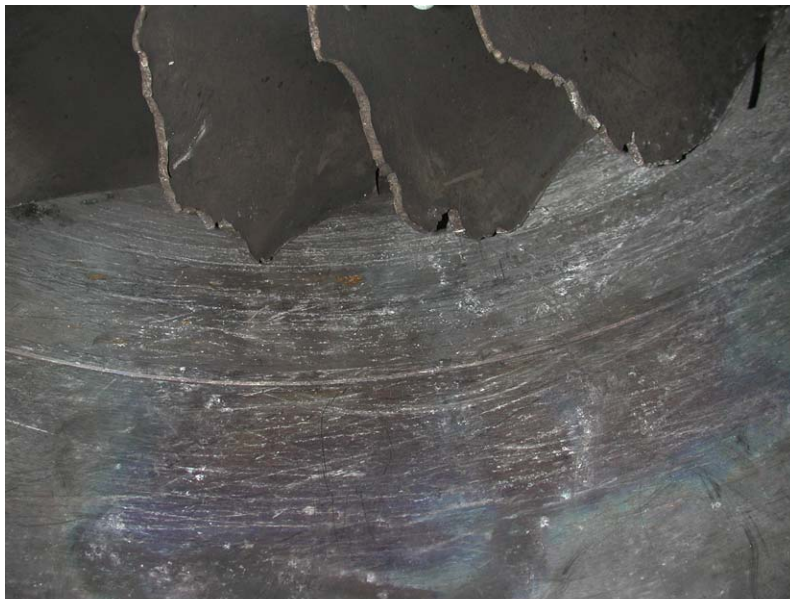
Figure 22 – Fan shroud – non-orthogonal intermittent bright metal deposits ahead of fan plane

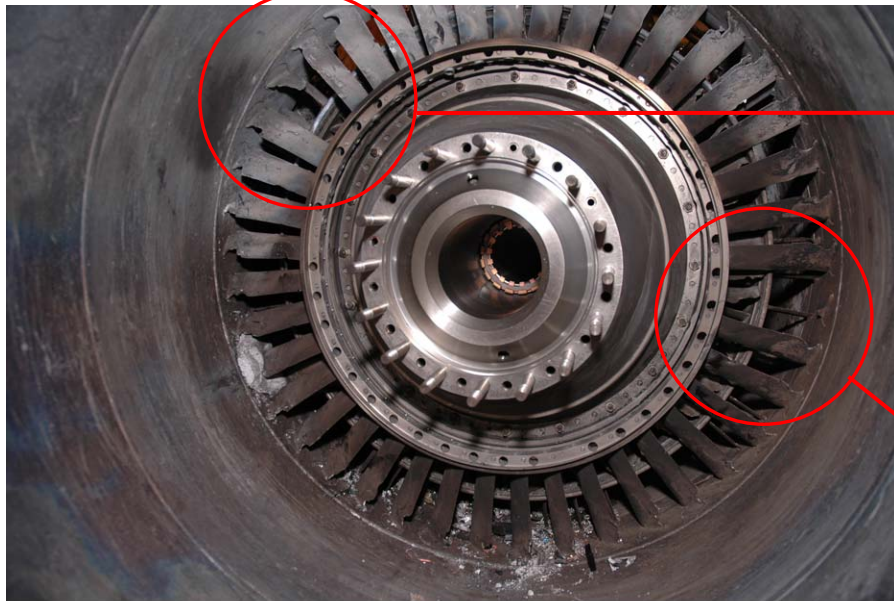
Figure 23 – 1<sup>st</sup> stage stator vanes – Forward looking aft - Fan removed

The leading edges of all the 1<sup>st</sup> stage stator vanes were torn near the outer platform (Figure 23 & Figure 24).

Two vanes located at the 2 and 9 o'clock locations were fractured. These vanes are firmly attached to the outer fan shroud via the platform feature and are allowed to float in the inner fan shroud using a dowel and hole system. The inner vane platforms have a dowel and the inner fan shroud pilots them with a hole and plastic sleeve arrangement.

Missing 1<sup>st</sup>  
stage stator  
vane at 2  
o'clock  
position

Missing 1<sup>st</sup>  
stage stator  
vane at 9  
o'clock  
position

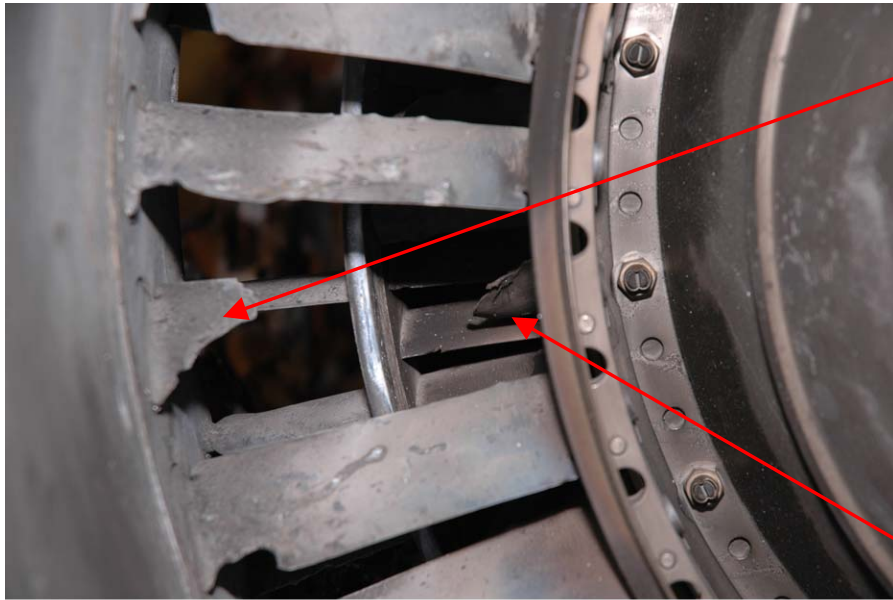
Figure 25 – 1<sup>st</sup> stage stator vanes – Forward looking aft – detail of fractured vane 2 o'clock position

Most of the vane at the 2 o'clock position was missing. The remaining outer platform had a ½ inch long jagged segment of the vane still attached (Figure 25). No remains of the inner vane platform were recovered. The plastic piloting sleeve on the inner fan shroud was still in its location.

Approximately half of the first stage supercharger rotor blades were fractured at the mid span or less in a random pattern (Figure 25 & Figure 26). All the other blades were torn at the leading edge and some were bent in the direction opposite of rotation at their root. All the leading edges of the second stage supercharger stator vanes and rotor blades were torn.

Vane segment still attached to outer platform

1<sup>st</sup> stage supercharger blades fractured

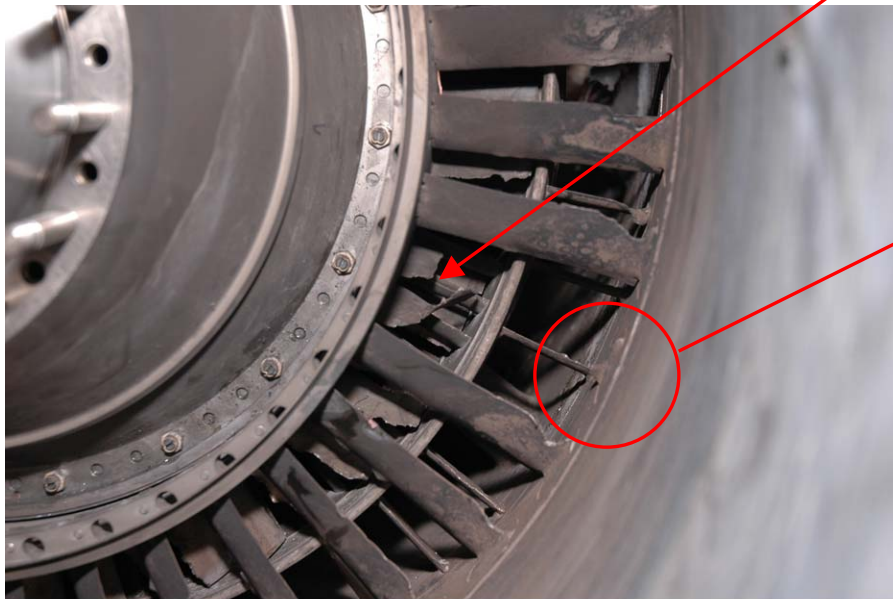
Figure 26 – 1<sup>st</sup> stage stator vanes – Forward looking aft – detail of fractured vane at 9 o'clock position

Most of the vane at the 9 o'clock position was missing. The vane had fractured flush to the outer platform (Figure 26). No remains of the inner vane platform and dowel pin were recovered. The plastic piloting sleeve on the inner fan shroud was still in its location. There were impact marks on the outer surface of the inner fan shroud near the

Vane fractured flush to outer platform

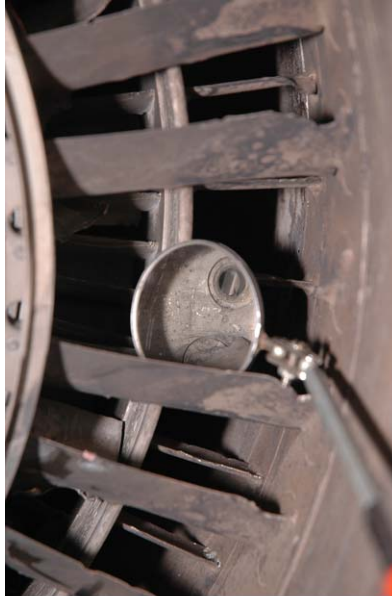
dowel pin piloting hole (Figure 27). The surface of the inner shroud of the missing vane at the 2 o'clock position did not exhibit these marks.

Figure 27 – Inner 1<sup>st</sup> stage stator vane shroud at 9 o'clock position – impact marks

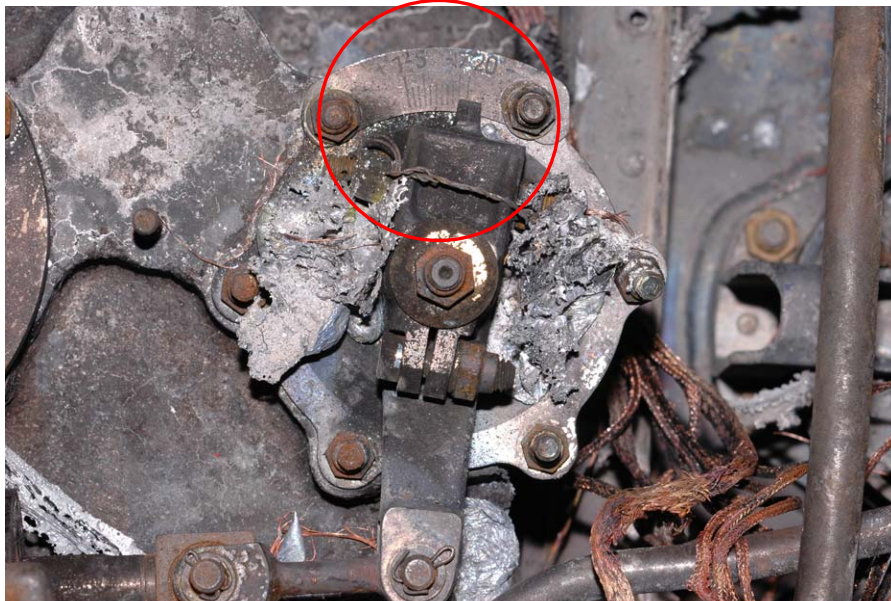
Figure 28 – Variable guide vane actuator indicator

The variable guide vanes, levers and synchronizing ring could be moved by hand with some difficulty. Once detached from the mechanism, the variable guide vane actuator piston was free to move. The variable guide vane position indicator was at 20° (Figure 28), which corresponds to a normal engine power setting.

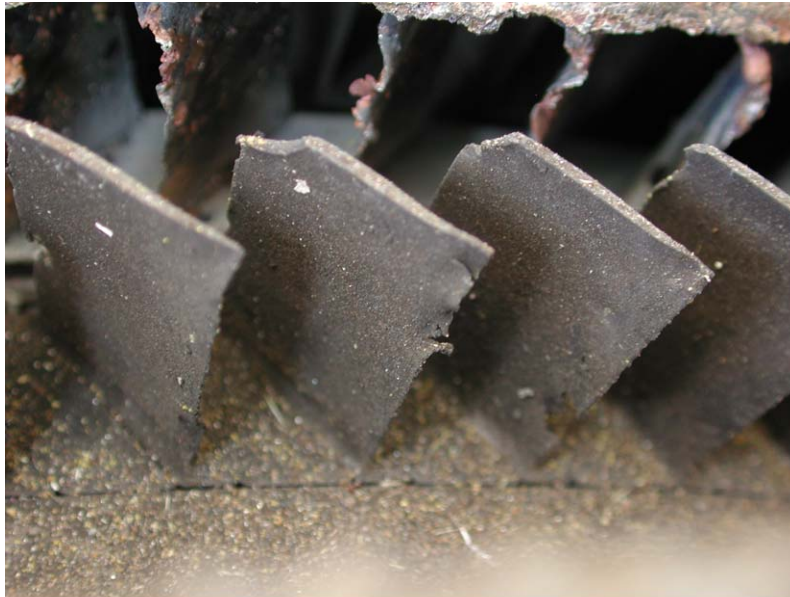
The high-pressure compressor case was intact except on the upper right quadrant that was burned. A hole was cut into the compressor case to allow visual examination of the variable guide vanes and the first stage compressor rotor. The trailing edges of several variable guide vanes were torn (Figure 29). The leading edges and trailing edges of the first stage compressor rotor were torn.

Figure 29 – Typical vane and blade edge tearing

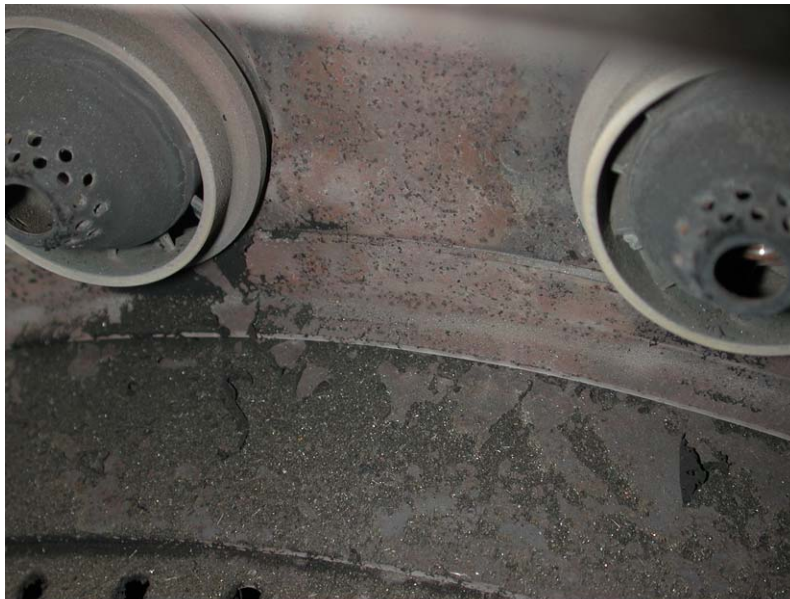
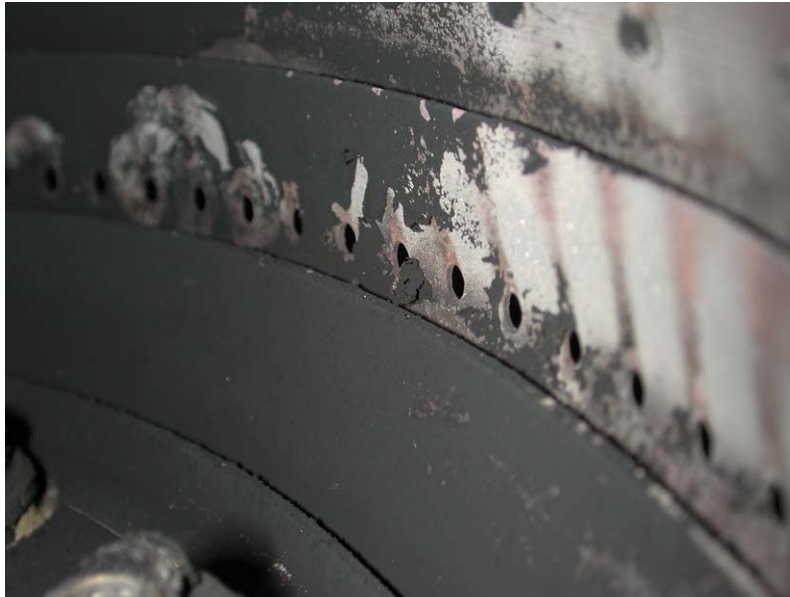
A hole was cut into the combustor plenum and the combustor liner. No metal spatter was found in the combustor (Figure 30). The combustor liner appeared to be undamaged (Figure 31).

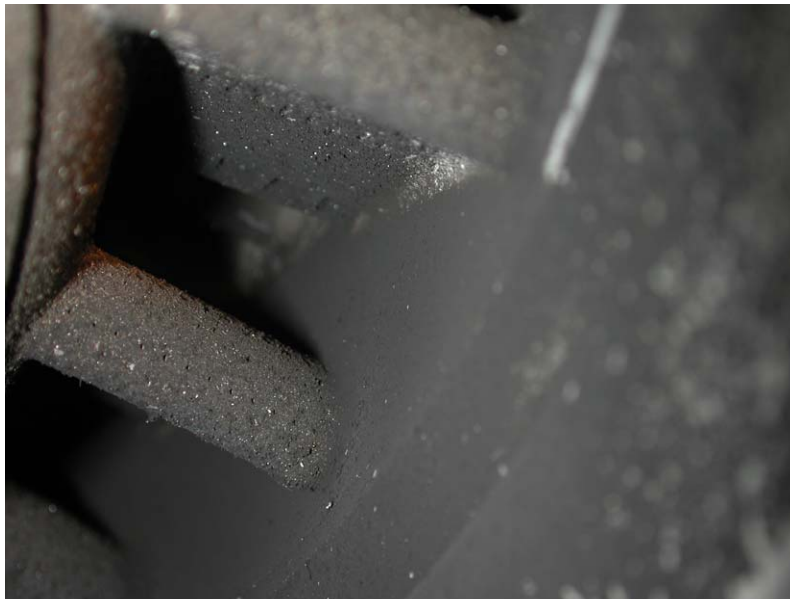
Figure 32 – High pressure turbine nozzle

The high-pressure turbine case was intact and the high-pressure turbine assembly was not disassembled. The high-pressure turbine nozzle was examined through the hole cut into the combustion chamber (Figure 32). The vanes appeared to be undamaged and there was no evidence of metal spray. The high-pressure turbine was examined using a borescope. The blades appeared to be undamaged and there was no evidence of metal spray.

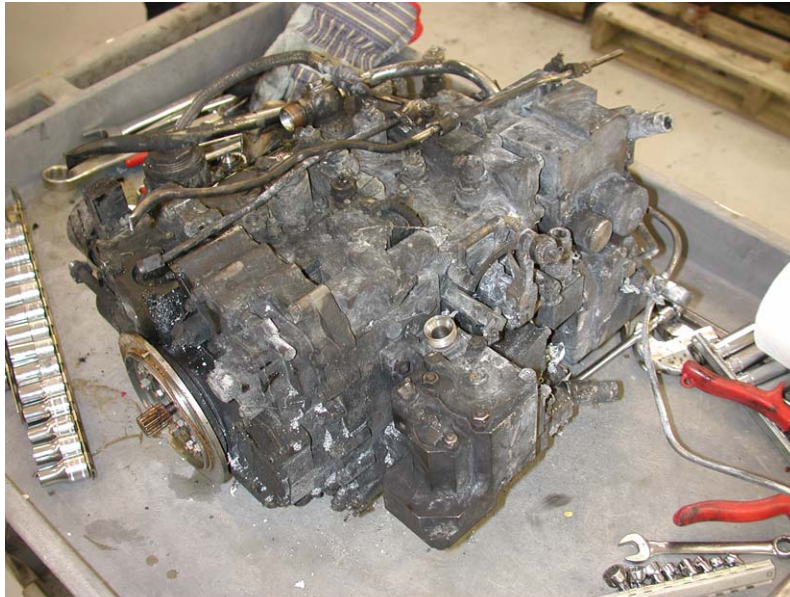
Figure 33 – Fuel control unit

The fuel control unit was covered in soot but appeared otherwise undamaged (Figure 33). The fuel control input lever was in the 82° position (Figure 34), which corresponds to approximately a flight idle power setting. When the fuel control unit was removed from the engine, fuel ran out of the fittings. The fuel control input spline was intact and oil wetted and it rotated easily by hand (Figure 35).

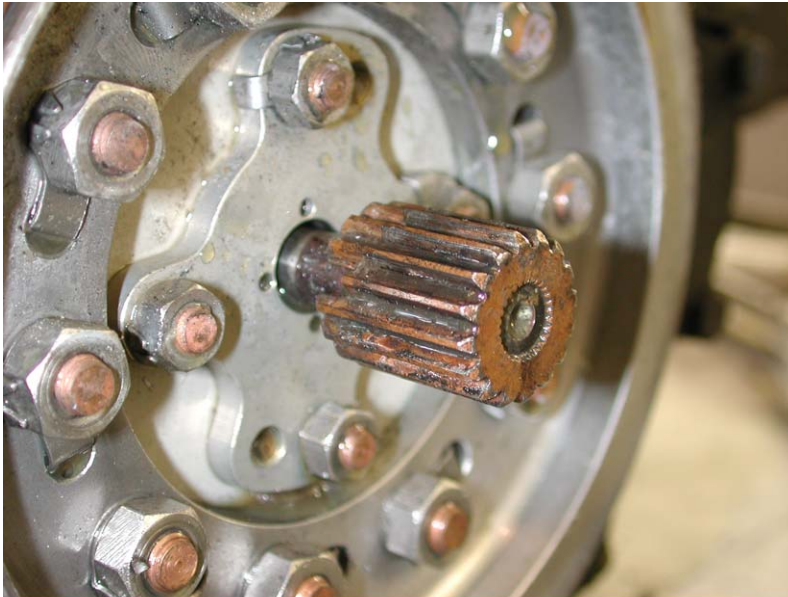
Figure 35 – Fuel control input spline

Bright scale location indicates no soot deposit.

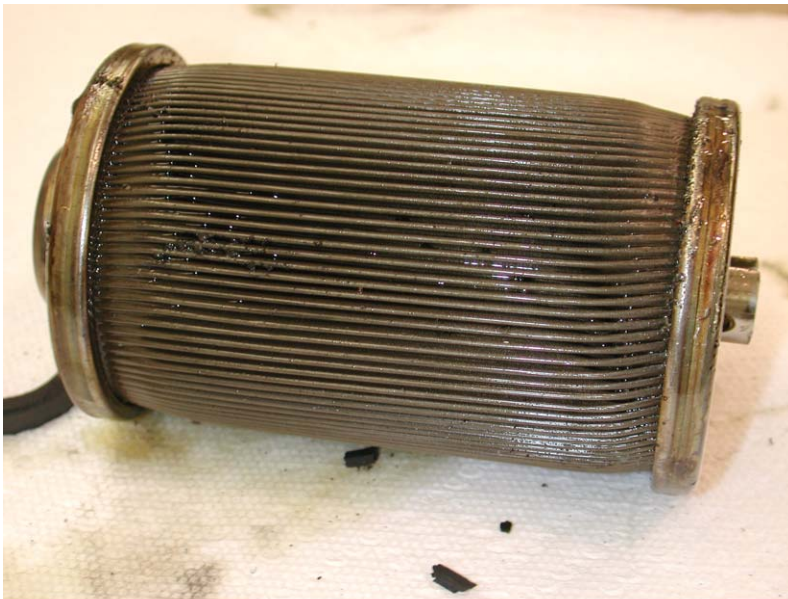
Figure 36 – Fuel filter

The fuel filter it was removed and appeared to be clean and free of debris (Figure 36).

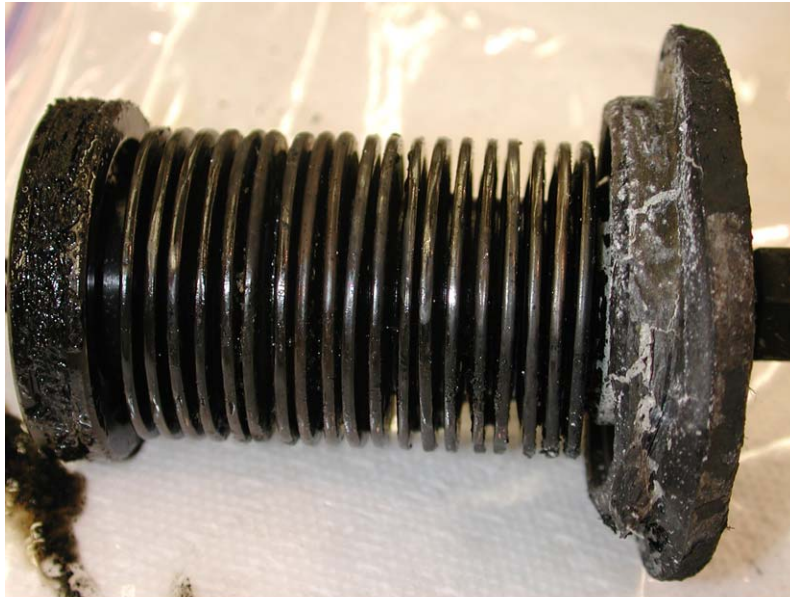
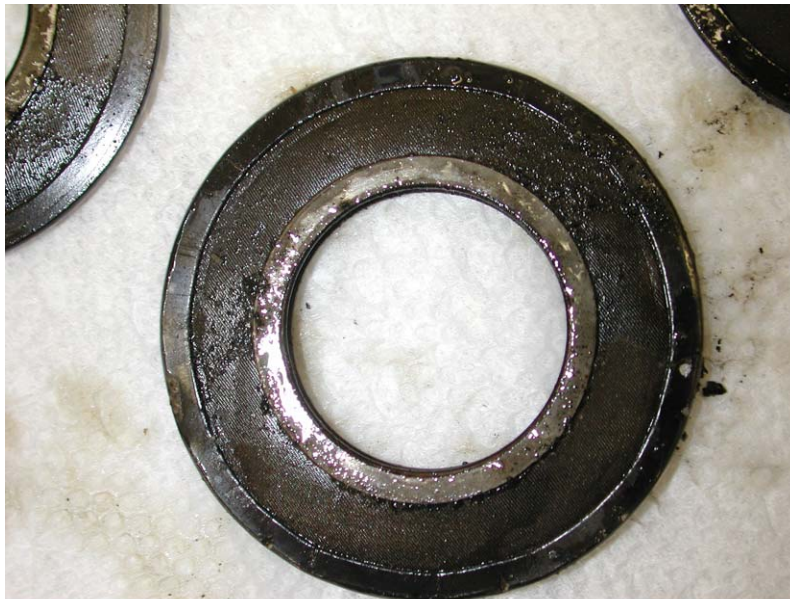
The oil pump housing was fractured but contained residual oil. The oil filter was removed and its elements separated and examined (Figure 37). The filter elements were black and contained minor debris but were otherwise unremarkable (Figure 38). The oil chip detector exhibited signs of overheating but it contained no significant debris (Figure 39).

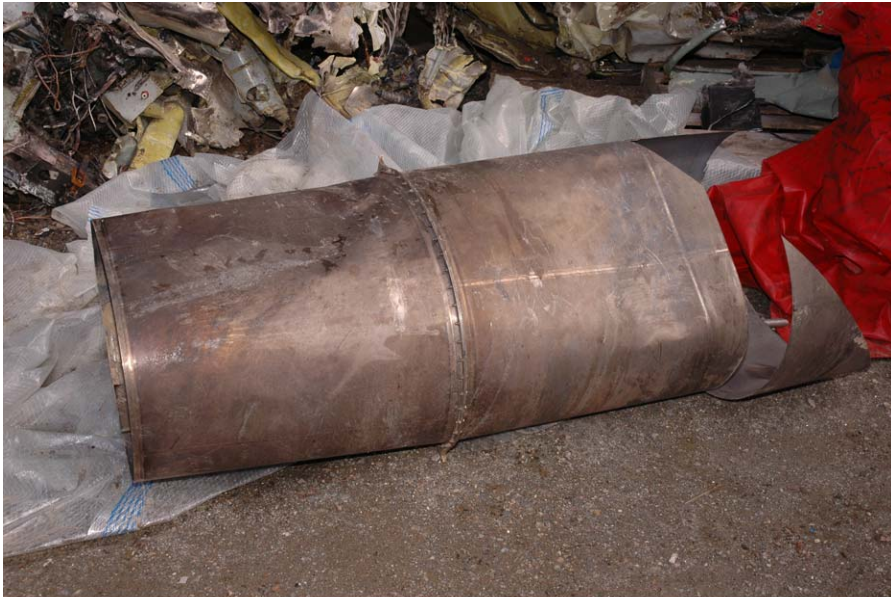
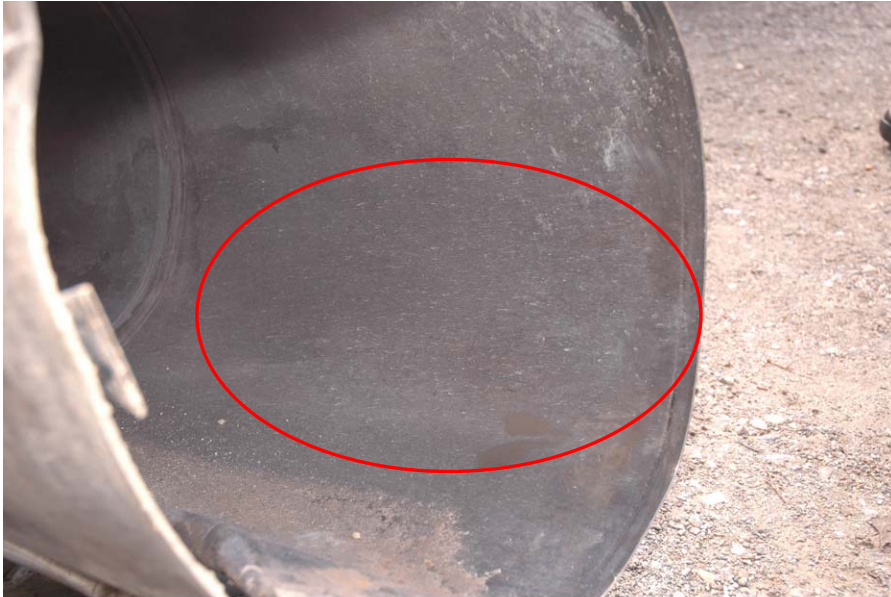
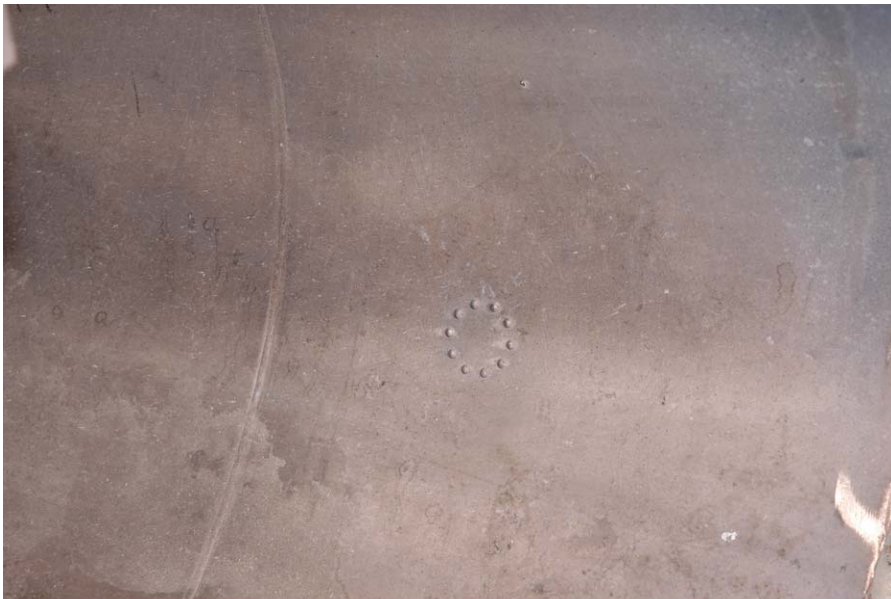
There were multiple intermittent scraping deposits at various angles of a soft metal consistent with the fan blade material on the inside of the airframe exhaust duct ([Figure 40](#), [Figure 41](#) & [Figure 42](#)).
