**NATIONAL TRANSPORTATION SAFETY BOARD
OFFICE OF AVIATION SAFETY
WASHINGTON, D.C. 20594**

POWERPLANTS GROUP CHAIRMAN'S FACTUAL REPORT

NTSB ID No.: DCA-06-MA-064

Location: Lexington, Kentucky
Date: August 27, 2006
Time: 0607 eastern daylight time
Aircraft: Bombardier CL-600-2B19 (CRJ-100)
Registration N431CA

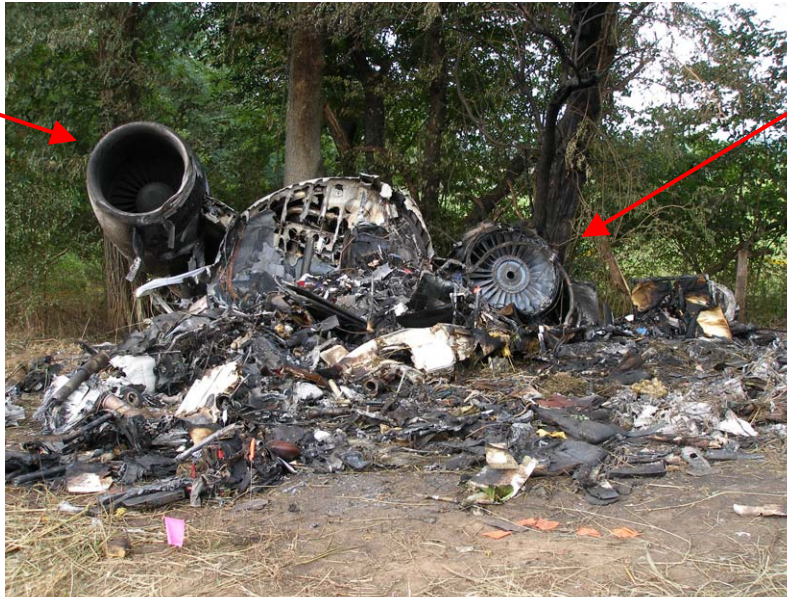
Figure 2 – Aft fuselage showing engines and pylons – Front view

The aircraft was found right side up just outside of the airport property. The aft fuselage had separated from the main fuselage and was resting against a fence and a tree. Both engines and pylons were still attached to the aft fuselage (Figure 2). The aft fuselage was rolled to the left and the left-hand (No. 1) engine was resting against the ground. The center line of the right-hand engine (No. 2) was approximately 8 feet above the ground. An external visual examination of both engines in-situ revealed no sign of uncontainment or pre-impact fire.

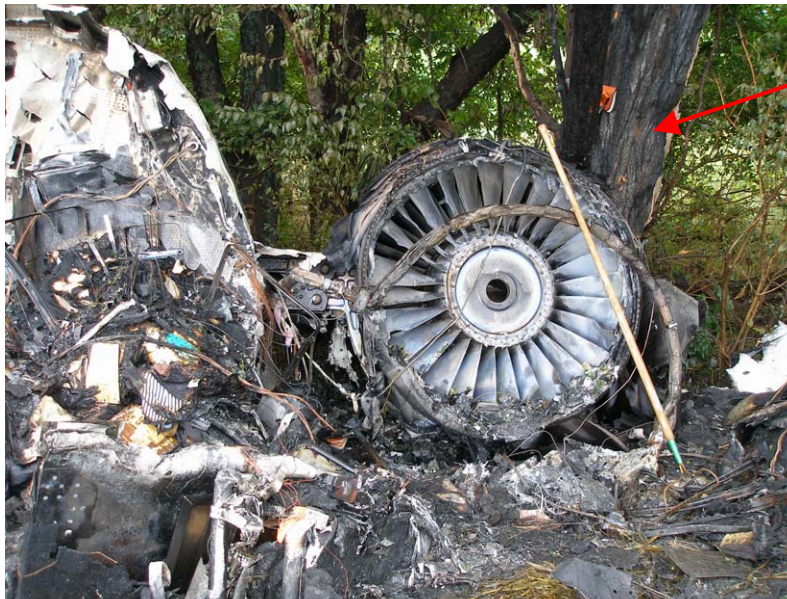
Figure 3 - Left-hand engine – Front View

The outboard of the nacelle was resting against an approximately 2-foot diameter tree (Figure 3) and the aft plane of the exhaust nozzle fairing rested against a wire fence (Figure 4).

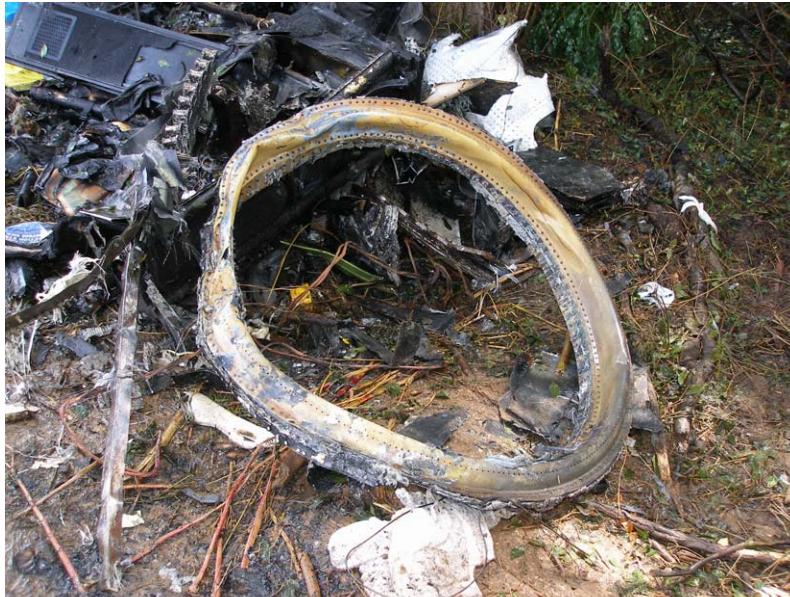
Figure 5 – Left-hand engine – Anti-ice D-duct

The nose inlet cowl was separated from the engine and was missing. The anti-ice D-duct was found about 6 feet forward of the engine and slightly to the left (Figure 5). The composite upper access cowl was separated from the nacelle, the resin was not present and the fibers were loose and scorched (Figure 6 & Figure 7). The thrust reverser cascades were exposed and one cascade assembly at the 11 o'clock position was fractured (Figure 8). The thrust reverser blocker doors were in the stowed position (Figure 9). Three of the four thrust reverser ball jackscrews were found on the ground at the front of the engine and all were in the reverser stowed position. Most of the upper translating cowl door was missing. The core cowl doors and exhaust nozzle fairing were intact and dented between the 5 to 9 o'clock position (Figure 4). The aft lip of the exhaust nozzle fairing was buckled and folded inwards at the 6 o'clock position (Figure 15).

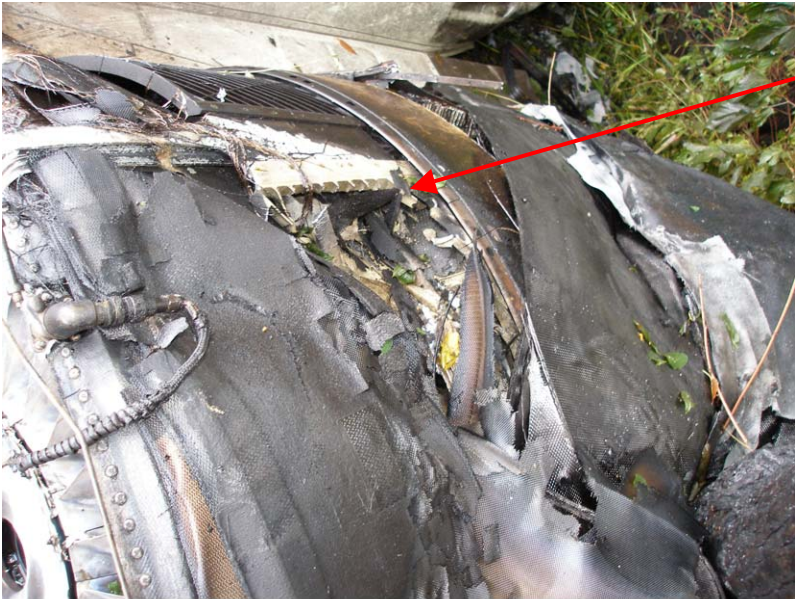
Figure 8 – Left-hand engine - Fractured thrust reverser cascades

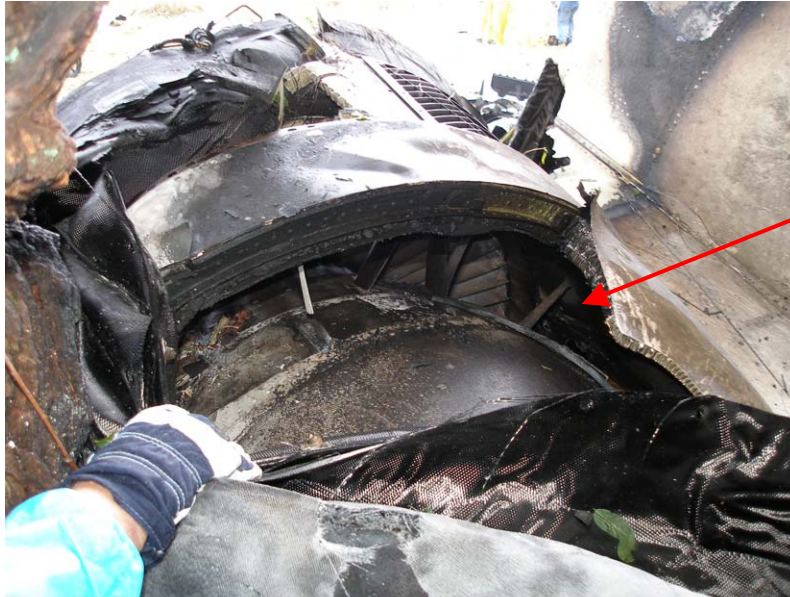
Figure 9 – Left-hand engine – Thrust reverser blocker doors stowed

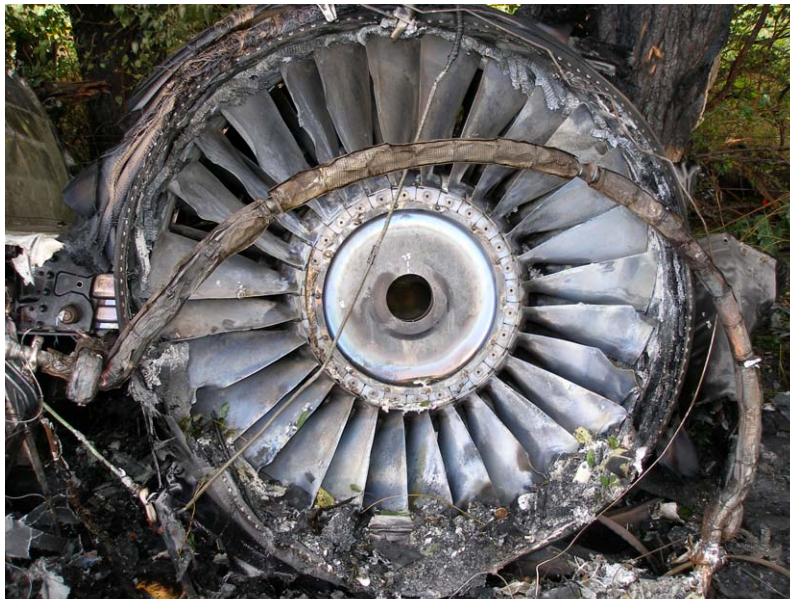
Figure 10 – Left-hand engine - Fan

The fan could not be turned by hand (Figure 10). The spinner was missing and metal slag was found at its attachment studs (Figure 11). All fan blades were present, in place and had evidence of soft body impact on the leading edges (Figure 12 & Figure 13) with the displaced material bent in the direction opposite of rotation. There were several blades that also exhibited hard body damage or tears at the leading edges. The displaced material of one blade was in the direction of rotation, while all the others were displaced in the direction opposite of rotation. Five consecutive blades were bent just above the blade root platform: Three in the direction of rotation and 2 in the direction opposite of rotation. All fan outlet guide vanes (OGV) were present and in their locations. The fan case abradable strip was missing, and the honeycomb backing material was present, deformed and heat damaged. The fan containment Kevlar wrap was burned thru approximately 180 degrees at the bottom (Figure 14). The fan containment Kevlar wrap at the top 180 degrees was charred but in its location. The epoxy impregnated Kevlar environmental protection barrier of the fan containment Kevlar wrap was missing. The 4th

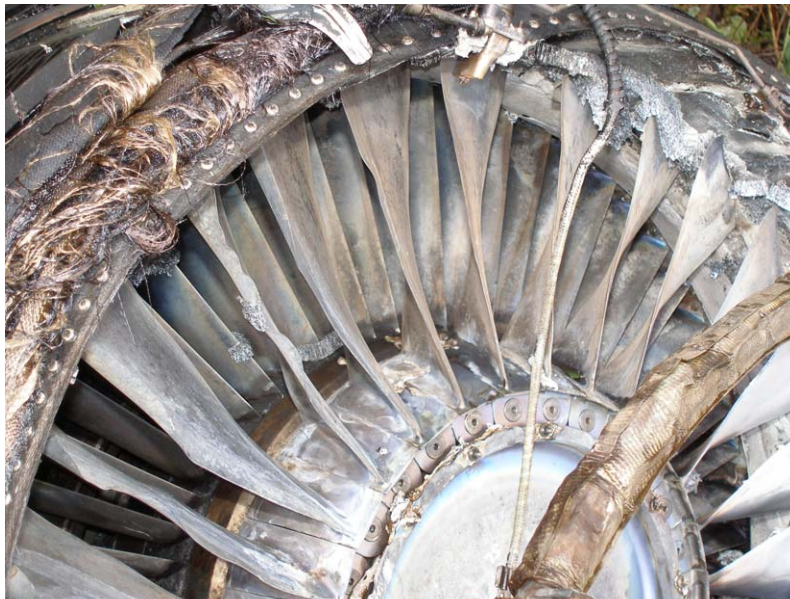
Figure 12 – Left-hand engine – Fan blades – soft body damage

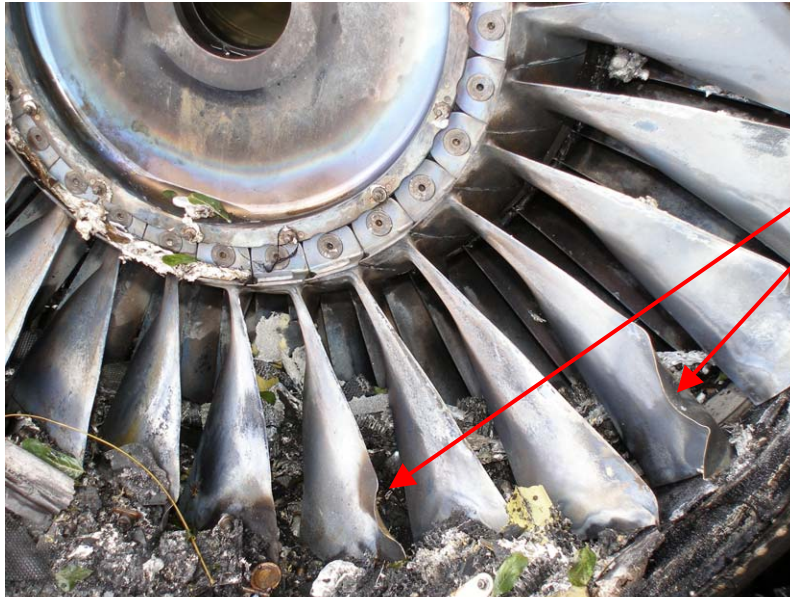
Figure 13 – Left-hand engine – Fan blades

Soft body
impact
damage

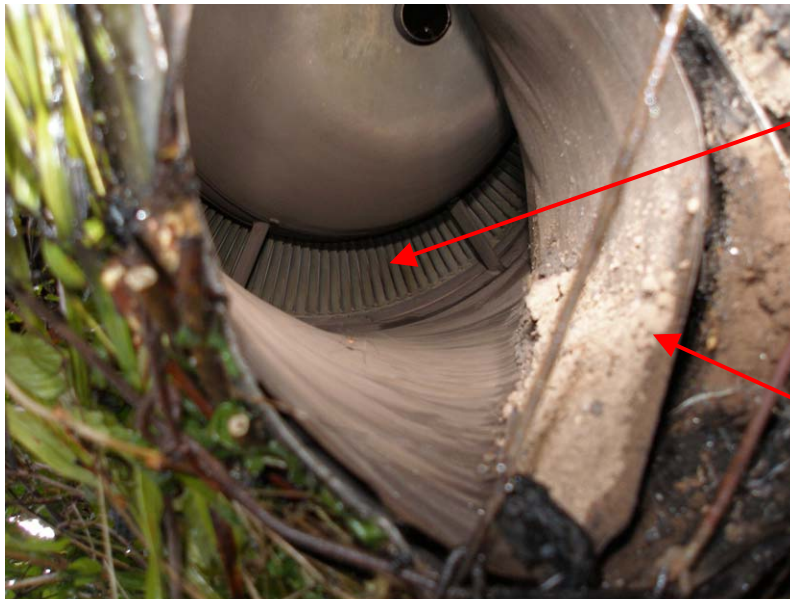
Figure 15 – Left-hand engine - 4th Low pressure turbine (LPT) stage

low pressure turbine (LPT) stage blades that were visible through the exhaust nozzle appeared to be undamaged (Figure 15).

Buckled
exhaust
nozzle
fairing

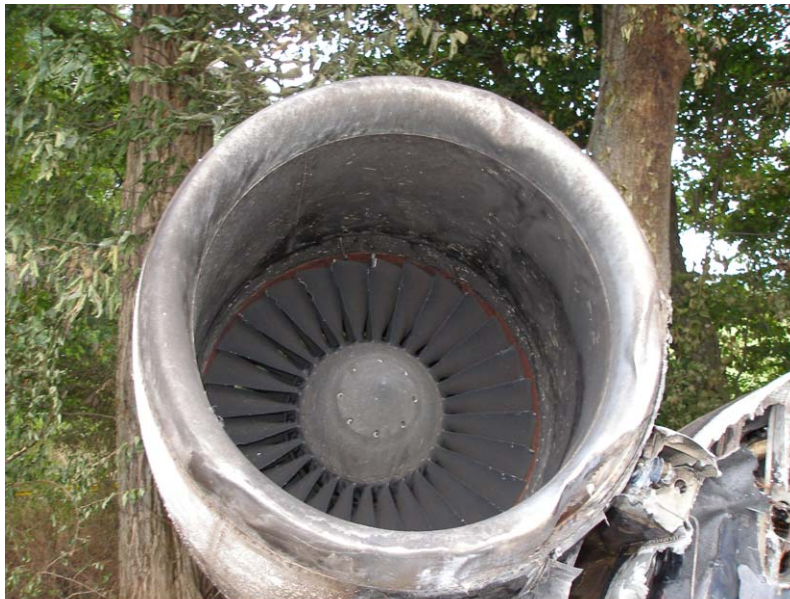
Figure 16 – Right-hand engine – Front View

The entire inlet lipskin was covered with soot and was deformed and buckled between the 6 o'clock to the 9 o'clock location and at the 11 o'clock location (Figure 16 & Figure 17). The inlet inner barrel sound attenuation surface displayed impact marks through 360 degrees for its entire length (Figure 18). The inner diameter of the anti ice lip was still attached to the front edge of the inner barrel along the entire circumference and all the rivets were still in their location.

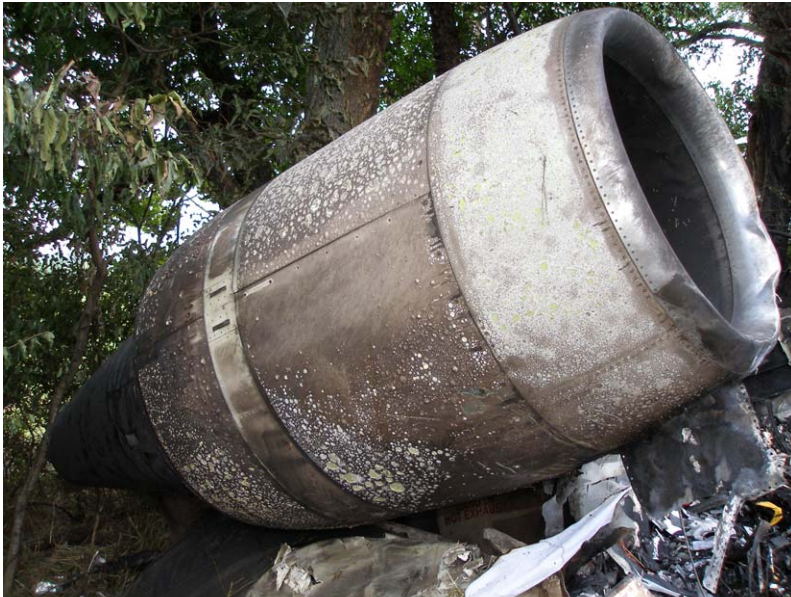
Figure 17 – Right-hand engine – Nacelle outboard side

The entire length of the outer nacelle skin from the 12 to the 6 o'clock position (outboard section) exhibited paint blisters (Figure 17). There were random patches where the paint was burned away and the primer was exposed but there was no burn or soot indications along the axis of the engine. All fasteners were intact and all latches were secured from the leading edge of the inlet to the trailing edge of the translating cowl doors. The outer nacelle skin between the 6 and 12 o'clock position (inboard section) was heavily fire damaged, exposing the composite core from the inlet leading edge to approximately 4 feet aft (Figure 19). Aft of this location the remaining nacelle skin features were similar to the outboard skin. The translating cowl door and the blocker doors were in the stowed position (Figure 20).

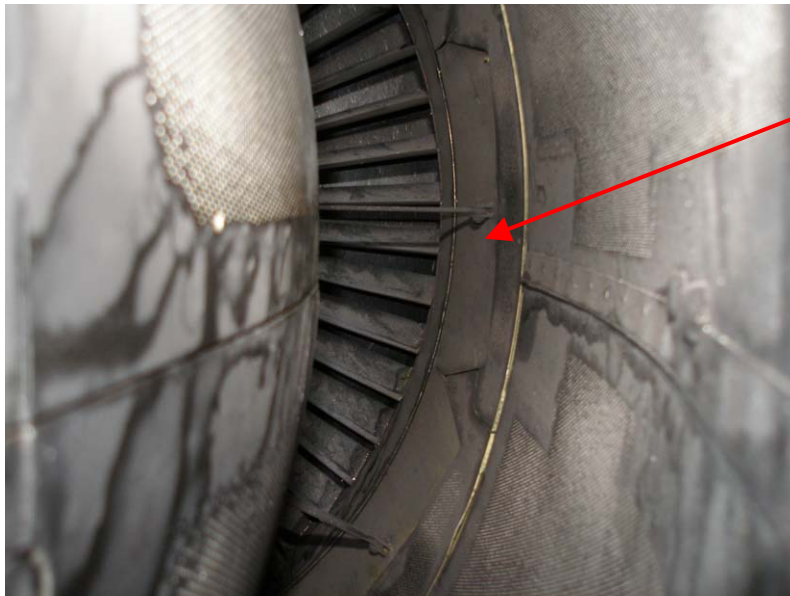
Figure 20 - Right-hand engine – Thrust reverser blocker doors stowed

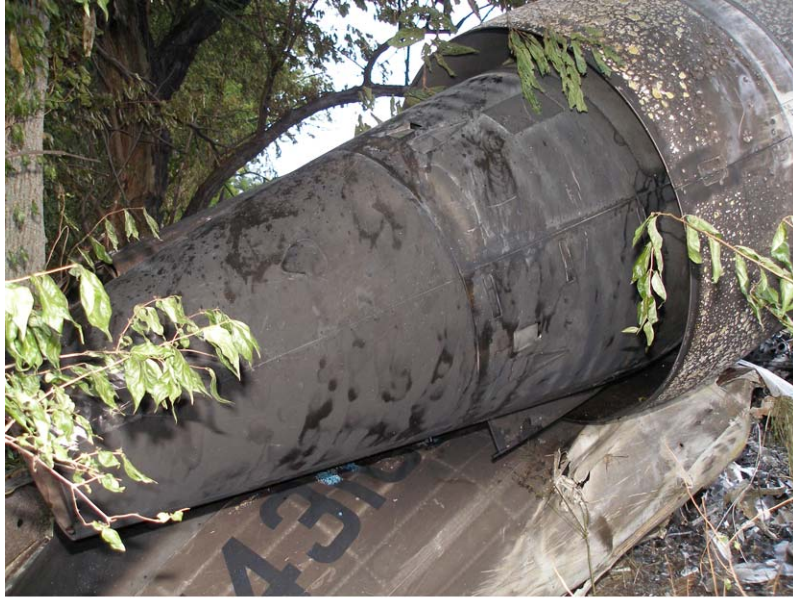
Figure 21 – Right-hand engine - Core cowl doors and the exhaust nozzle fairing

The core cowl doors and the exhaust nozzle fairing were intact and covered with soot (Figure 21). The latches on the cowl doors were in place and secured. The exhaust nozzle fairing was dented at the trailing edge at the 3 o'clock position. The translating cowl door aft edge appeared to be concentric with the core cowling.

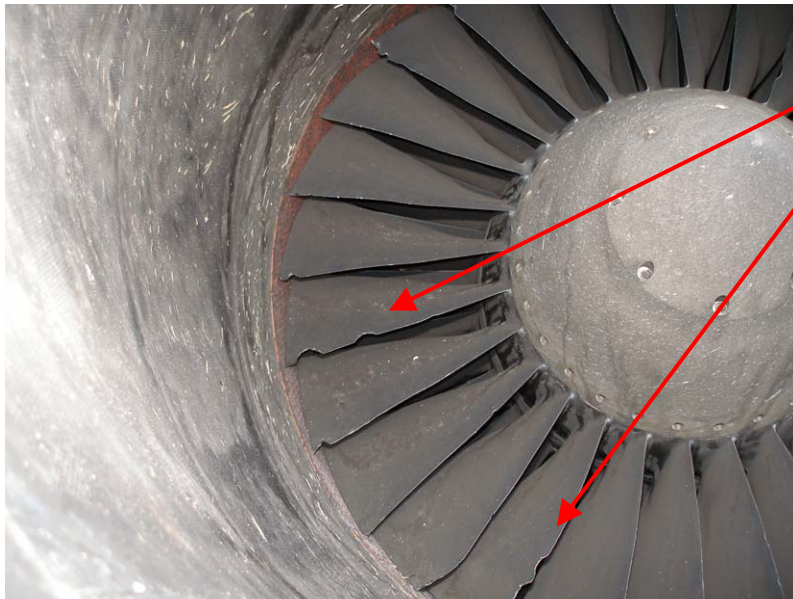
All fan blades were present and in place on the fan disk. Many of the fan blades had evidence of soft body impact on the leading edges (Figure 22). There were several blades that had tears at the leading edges (Figure 23). The displaced material was bent in the direction opposite of rotation. The fan case abradable strip was present and was circumferentially scored at the plane of the fan blades. The fan OGV appeared to be undamaged. The 4th stage low pressure turbine (LPT) rotor could be rotated freely and the fan rotated concurrently. The 4th stage LPT blades appeared to be undamaged (Figure 24). No metal spray was observed on the blades.

Figure 22 – Right-hand engine – Fan blades with ‘soft’ impact damage

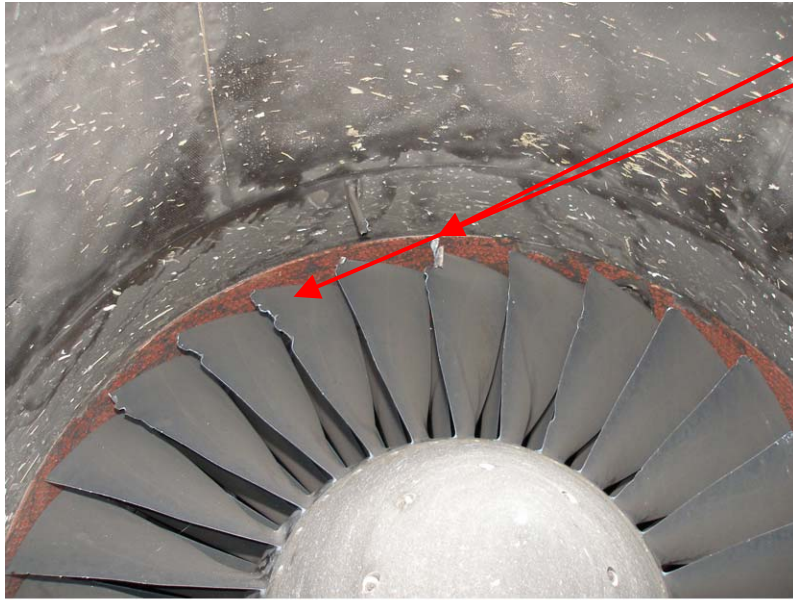
Figure 23 – Right-hand engine – Fan blades with hard impact damage tears
