NATIONAL TRANSPORTATION SAFETY BOARD
OFFICE OF AVIATION SAFETY
WASHINGTON, D.C. 20594

POWERPLANTS GROUP CHAIRMAN'S REPORT

NTSB ID: DCA07MA003

Location: Manhattan, New York
Date: October 11, 2006
Time: 1442 Eastern Standard Time (EST)
Aircraft: Cirrus Design SR-20, Reg. No. N929CD, Operator: Cory Lidle

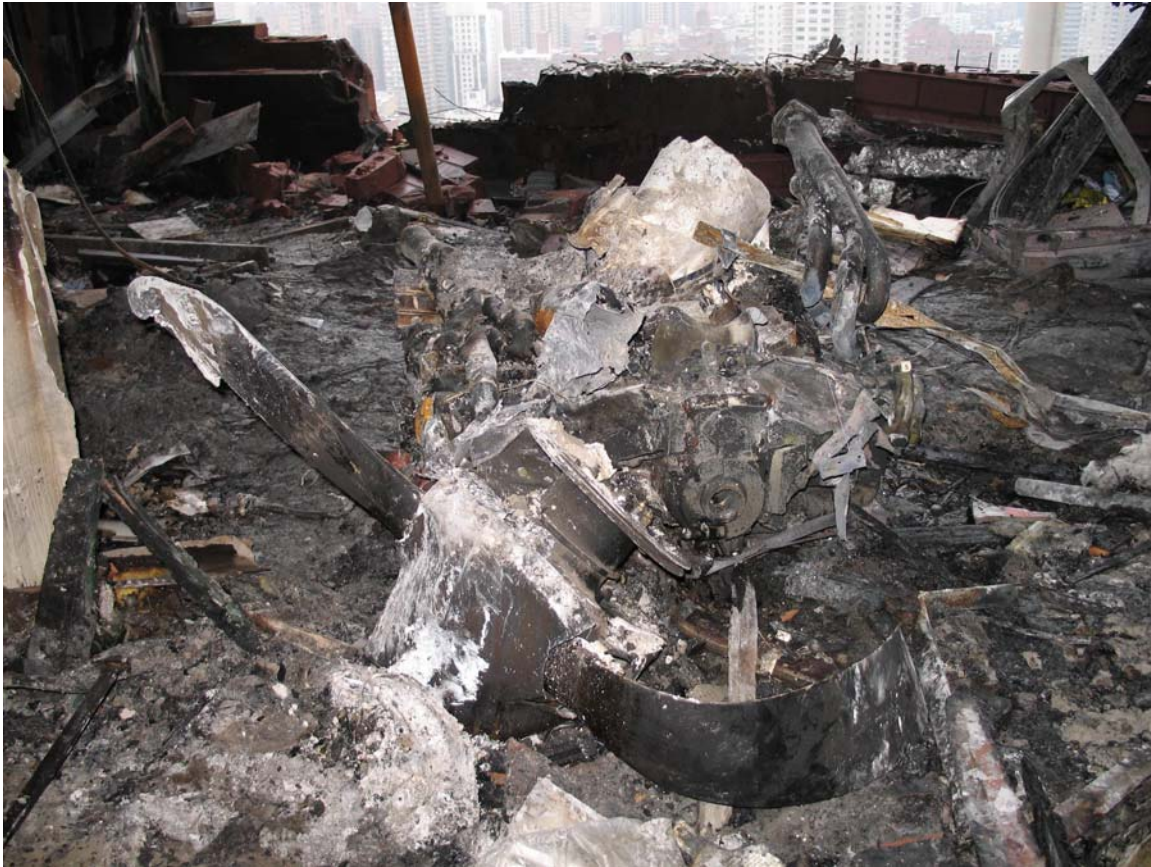
The airplane’s engine and propeller were found inside a room on the 32nd floor of the Belair condominium building at 524 E. 72nd Street, Manhattan. (See Figure 1.) The interior wall, and an approximate 5 ft x 2 ft section of the lower right exterior wall beneath a large north-facing window frame were collapsed into the room. The interior wall was destroyed. The engine and propeller were lying about eight feet beyond the north wall in the middle of the room at an approximate 160° heading.⁵ The room was grossly damaged by fire and firefighting efforts, and the engine and propeller were coated with ash, debris, and fire-extinguishing agent.⁶

Figure 1. Engine and propeller on 32nd floor of the Belair condominium building

The engine was inverted. It was thermally damaged, with a large portion of the oil sump missing. The propeller was separated from the engine.

The propeller had separated just aft of the engine crankshaft forward flange (propeller flange), and was lying close to the front of the engine. The broken end of the propeller flange was retained under the propeller mounting hardware. Approximately 50% of the #1 blade was missing, with the remaining stub showing melting damage. The #2 blade was underneath the propeller and engine, where it had been protected from the fire. It was intact, and its blade tip was curled aft, twisted toward low pitch, and showed rotational scoring. There was some light leading edge (LE) damage. The #3 blade was missing about 25% of its length, with its stub end showing melting damage; its remaining length had a large-radius, forward bend, and LE gouging damage.

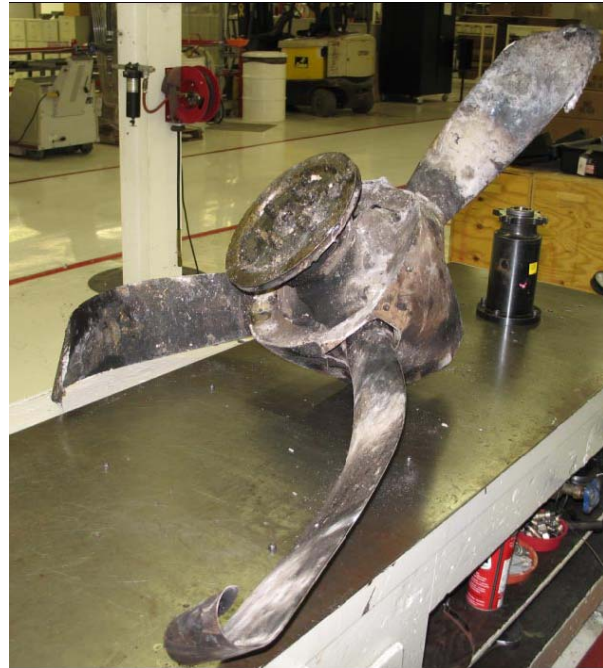
Ash, soot, and fire-extinguishing agent were deposited on the propeller surfaces. (See Figure 2.) The #1 blade was positioned at a low angle; the #2 blade was positioned at a low/ reverse angle; the #3 blade was turned approximately 90° toward a higher blade angle, and was cocked aftward. The hub serial number was marked between the #1 and the #2 blades.⁷ The spinner dome was crushed onto the cylinder; no twisting deformation was noted. The propeller flange, retained by mounting hardware, had separated in the radius immediately aft of the flange. The fracture surface was jagged and had a grainy appearance with a smaller area of shiny, smeared metal consistent with the compression side of an overstress bending fracture. There were multiple spiral cracks outboard of the fracture. (See Figure 3.)

Figure 2. Propeller S/N FP1685B

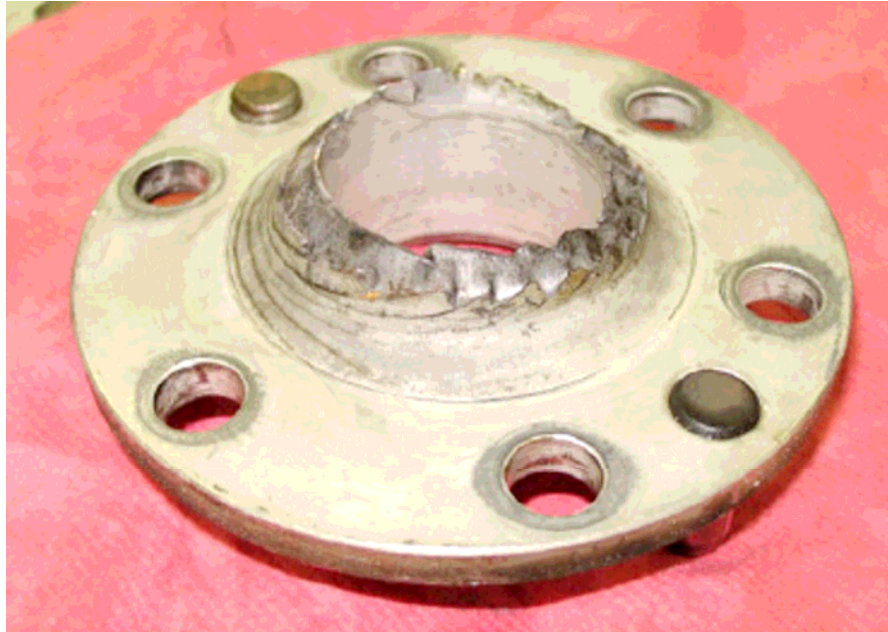
Figure 3. Propeller flange fracture

The crankshaft was fractured just aft of the flange radius. The separated forward section was examined by the NTSB materials lab. (See Paragraph 5.0.)¹⁷ The crankshaft connecting rods journals, main journals and thrust surfaces were undamaged and showed no evidence of abnormal wear or lubrication distress. The crankshaft counterweight pins, plates and snap rings were intact. The crankshaft hanger blades were undamaged and had free and unrestricted movement. The crankshaft cluster gear was intact and showed normal wear. The gear bolts were tight and safetied, and the gear teeth were undamaged. Visual inspection of the oil transfer passages found no restrictions, and the oil transfer plug was tight and in position. The forward end of the crankshaft was cleaned and sprayed with dye penetrant developer, revealing 45° axial spiral fractures along the OD.

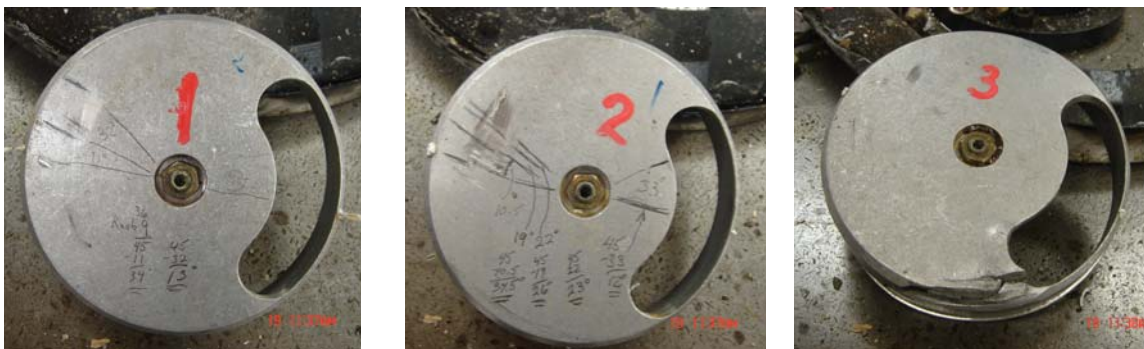
There were marks on all preload plates consistent with contact with the fork. The #3 preload plate was distorted and cracked at the high blade angle end of its slot. (See Figure 4c.)

Figure 4. Preload plate marks and calculations (a) #1 blade preload plate; (b) #2 blade preload plate; (c) #3 blade preload plate

Equivalent blade angles¹⁰ were determined from the preload plate witness marks based on their locations with respect to the hub parting line. (See Figure 4.) A mark found on the inside wall of the # 2 preload plate slot was consistent with impact by the pitch change knob.

<i>plate</i>	<i>witness mark</i>	<i>calculation</i>	<i>equivalent blade angle</i> ¹¹
#1	fork mark at 11° fork mark at 32°	45° - 11° 45° - 32°	34° 13°
#2	fork mark at 10.5° fork mark at 19° fork mark at 22° knob mark at 33°	45° - 10.5° 45° - 19° 45° - 22° 45° - 33°	34.5° 26° 23° 12°
#3	no usable marks

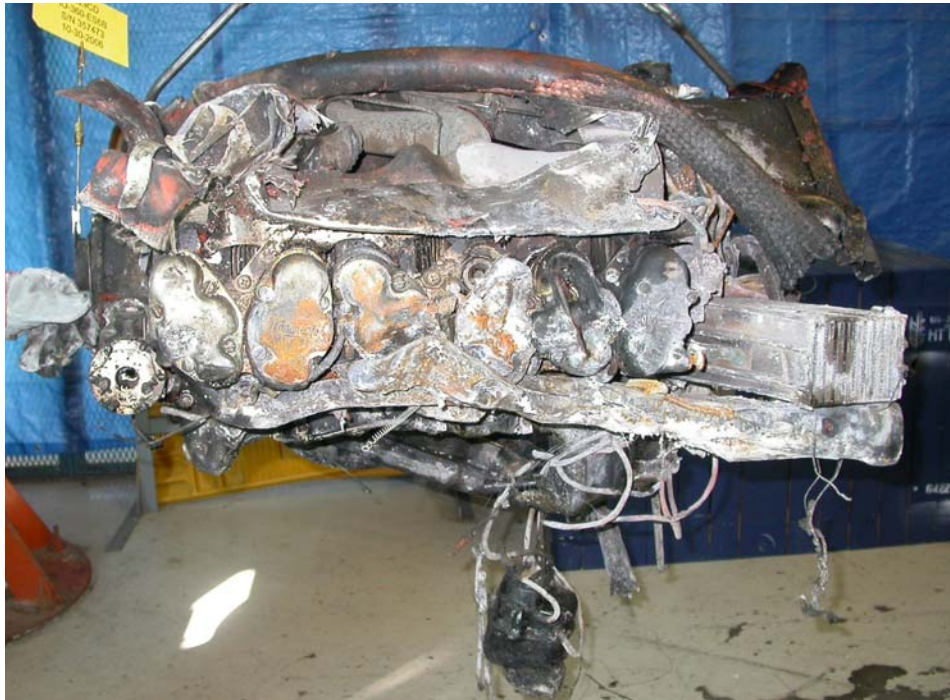
The induction system was intact and was not thermally damaged. The LH (2-4-6) side of the induction system displayed numerous dents, and the #6 cylinder head mating flange was damaged. The RH (1-3-5) side was undamaged. Visual inspection of all air passages found no internal restrictions. The manifold pressure transducer and a section of the wiring harness remained attached to the induction system.

The RH exhaust riser assembly exit flange was distorted and the #5 mount flange was bent; the exhaust assembly was otherwise intact, and there was no evidence of exhaust leakage. Visual examination of the passages found no restrictions. The heater muff was damaged and was distorted around the RH muffler. The muffler was moderately deformed but appeared intact, and the cone showed no restriction. The LH exhaust riser assembly was crushed. The #2 exhaust riser flange was cut away to allow removal of the LH riser assembly. An exhaust thermocouple probe was located on the #6 exhaust riser. The LH muffler was flattened and the heater muff was severely deformed. (See Figure 5.)

Figure 5. Crush and contact damage to LH side of engine

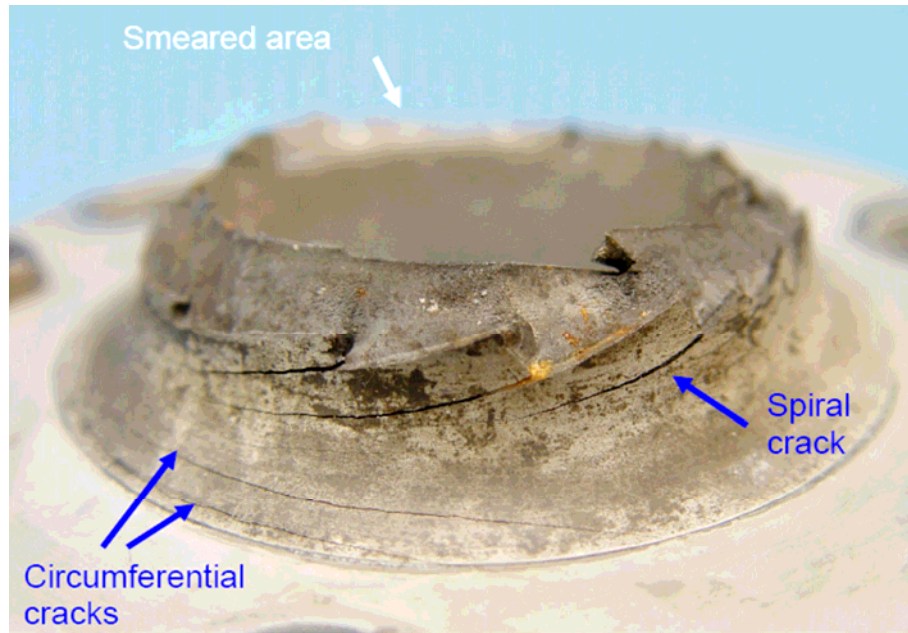
The propeller flange fracture surface was submitted to the NTSB materials lab for evaluation.¹⁸ The lab reported that the fracture exhibited features generally in a jagged slant plane with a matte gray appearance consistent with overstress fracture. Slant plane features were located around approximately 330°. The remaining 30° portion of the fracture had a shiny, smeared appearance consistent with compression side of an overstress bending fracture. Spiral cracks were observed in the outer diameter hardened layer adjacent to the fracture, approximately 180° around the circumference, approximately opposite from the smeared area. The cracks intersected jagged features of the fracture. The direction of the spiral was consistent with fracture under torsion loading, where the aft side of the fracture rotated clock wise (as viewed looking forward) relative to the forward side of the fracture. On the inner diameter of the crankshaft adjacent to the fracture and slightly clockwise from the smeared area, parallel circumferential cracks were observed and also consistent with bending. Further to the clockwise direction on the inner diameter, angled cracks were observed in the hardened layer that intersected jagged features on the fracture surface and turned circumferential near the crack tips. On the outer diameter near where the radius intersected the flange, nearly parallel circumferential cracks turning toward the radial direction near the crack tips were observed. These cracks were centered slightly clockwise from the position opposite the smeared area on the fracture surface.

Figure 6. Propeller flange fracture. *NTSB Materials Lab Image # 0610A00955, Project # 200610021*
