NATIONAL TRANSPORTATION SAFETY BOARD
Office of Aviation Safety
Washington, D.C. 20594

POWERPLANT GROUP CHAIRMAN'S FACTUAL REPORT

NTSB No: ERA13MA139

Aircraft: Beechcraft 390 Premier 1A, Registration No. N777VG

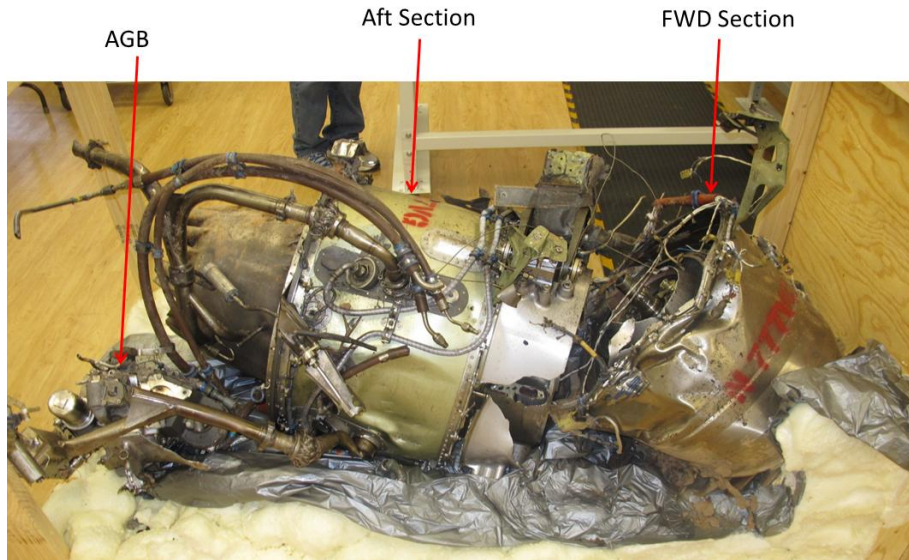
Photo 1- Right Side of Engine, as Received

The engine was uncrated and exhibited extensive impact damage but there were no indications of under cowl fire or uncontainment. The engine core was received split in two separate sections at the forward interstage case flange and the LPT shaft was sheared (**Photos 1, 2 and 3**). The forward section consisted of the fan and IP compressor assemblies. The aft section included the HPC impeller assembly aft to the exhaust mixer lobes. The AGB and attached accessories including the starter, fuel-oil cooler and oil lube pump were separated from the AGB mount pad, but remained tethered to the engine by wiring harnesses. The hydromechanical unit (HMU) and fuel pump were separated from the engine but also remained tethered by wiring. The rear bypass duct was not shipped with the engine.

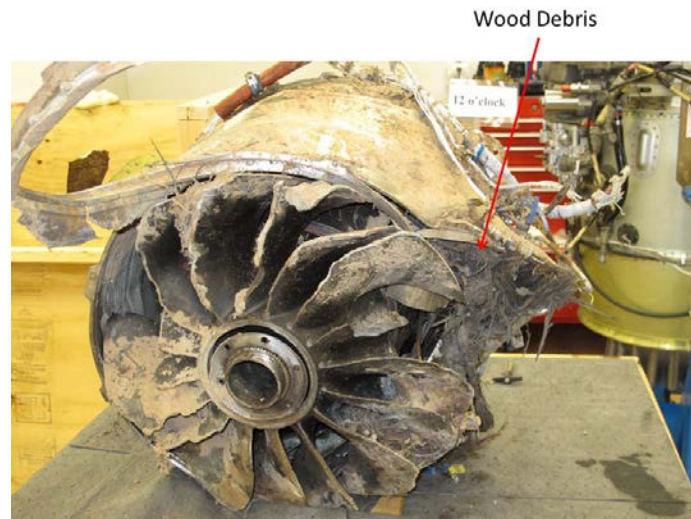
The fan exhibited blade tip bending opposite the direction of rotation with multiple blades fractured near the root.² The fan blades were coated with debris including dirt and airframe honeycomb material. The case and insert assembly that surrounds the fan was compacted and torn in the aft direction from 6 to 11 o'clock with shredded wood fibers wedged between the case and compressor (**Photo 4**).

Photo 4- Fan Damage, Organic Debris Lodged Between Fan and Compressor Case

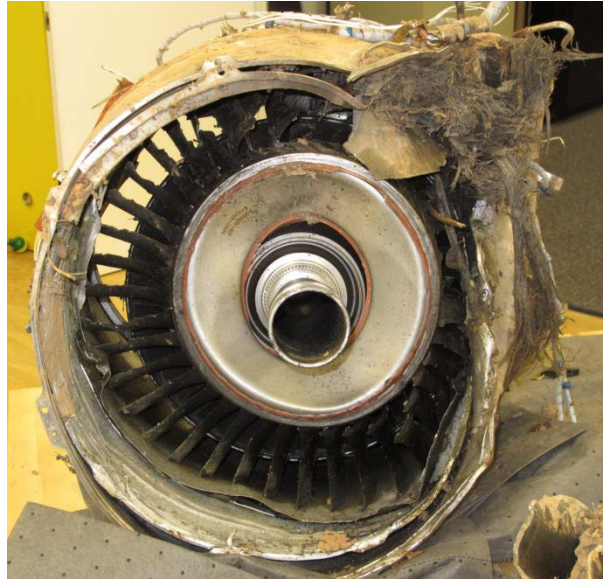
Photo 5- Compressor Fan Stator Assembly

The 1st stage compressor stator vanes exhibited leading and trailing edge tearing 360 degrees around, with vanes separated from 3 to 8 o'clock (**Photo 5**). The assembly was covered with a thick coating of dirt and debris. The stator center hub was ovalized consistent with a hard impact.

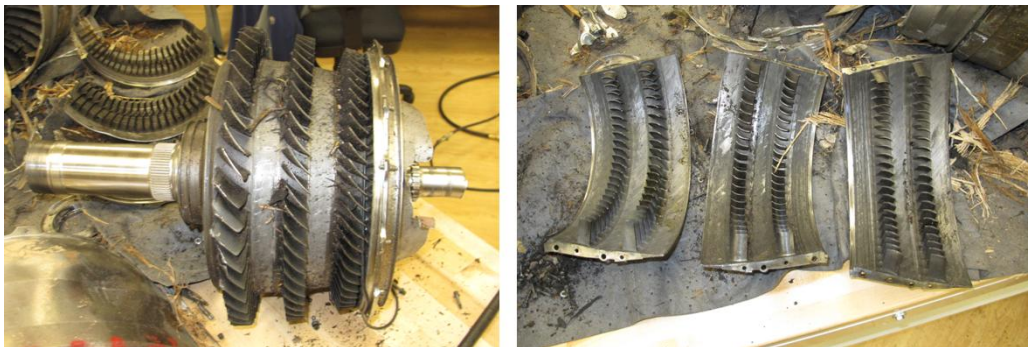
Photo 6- IP Compressor Rotor and Stators

The IP compressor rotor had impact damage and tearing on all 1st stage blades. The IP compressor rotor blade tips and compressor spool had rub marks with corresponding rub marks on the stator lands and vane tips. The IP compressor was covered in debris and wood fibers throughout all stages (**Photo 6**).

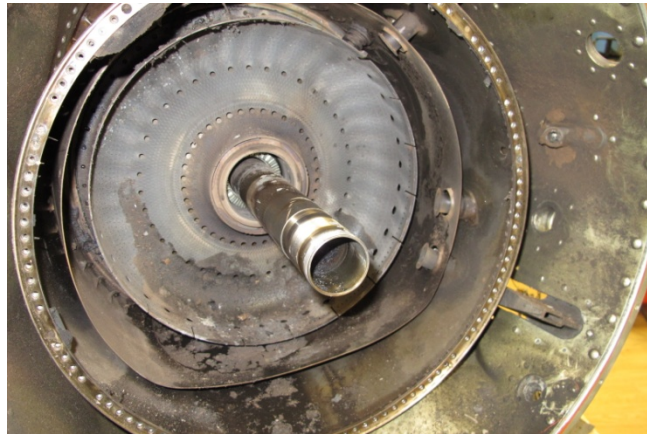
Photo 7- Combustor Assembly

The combustion nozzle assembly and cover were intact but discolored consistent with debris ingestion and water submersion. The diffuser inner wall was buckled at 6 o'clock and water was pooled in low spots of the diffuser case (**Photo 7**). The fuel slinger system was intact and in good condition. The electrode depth was measured on the right and left igniter plugs in accordance with the Williams International FJ44-2A line maintenance manual and determined to be within serviceable limits. Due to impact damage, the igniter plugs had to be cut out of the engine so a spark check could not be performed.

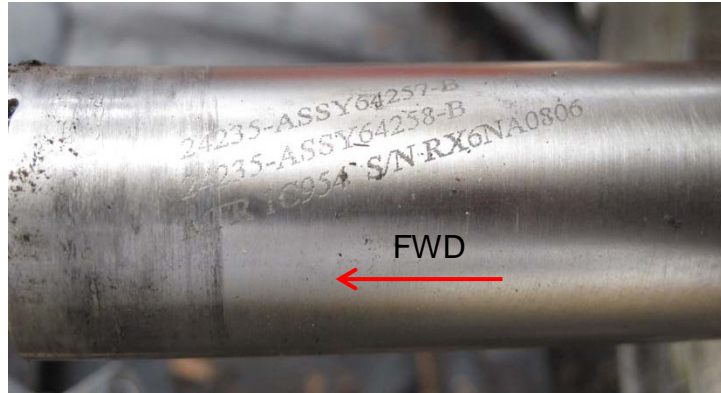
The LPT 1st and 2nd stage rotor and nozzle assemblies were intact. All components in the assembly were covered in dirt and debris. The aft section of the LPT shaft was removed from the engine (front half sheared) and exhibited twisting (**Photo 8**). The direction of shaft twist was consistent with a sudden stoppage of the fan.

Photo 8- LPT Shaft Twisting (Part Etching Should Be Straight)

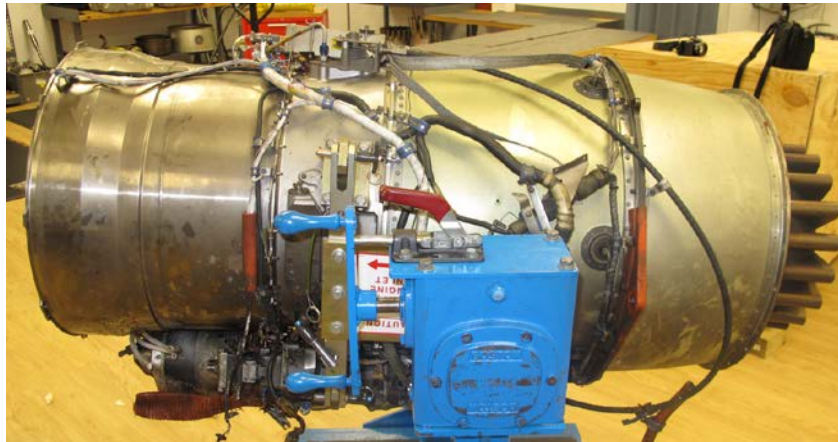
Photo 9- Left Hand Side of Engine with Airframe Components, Exhaust, and Inlet Cases Removed

The engine was uncrated and airframe components were removed to facilitate installation into a maintenance stand (**Photos 9 and 10**). The exterior of the engine exhibited no indications of under cowl fire or uncontainment.

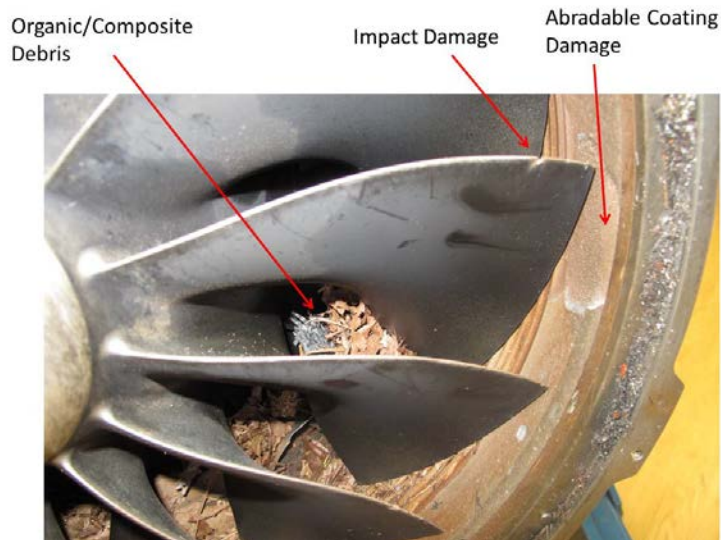
During a visual inspection of the compressor inlet, organic debris and composite material remnants were seen behind the fan, into the rear stages of IP compressor. Multiple compressor fan blades had foreign object impact damage along the leading edge. The fan case abradable coating was rubbed and/or gouged around the case circumference, consistent with fan blade contact (**Photo 11**).

Photo 11- Compressor Inlet Fan Damage

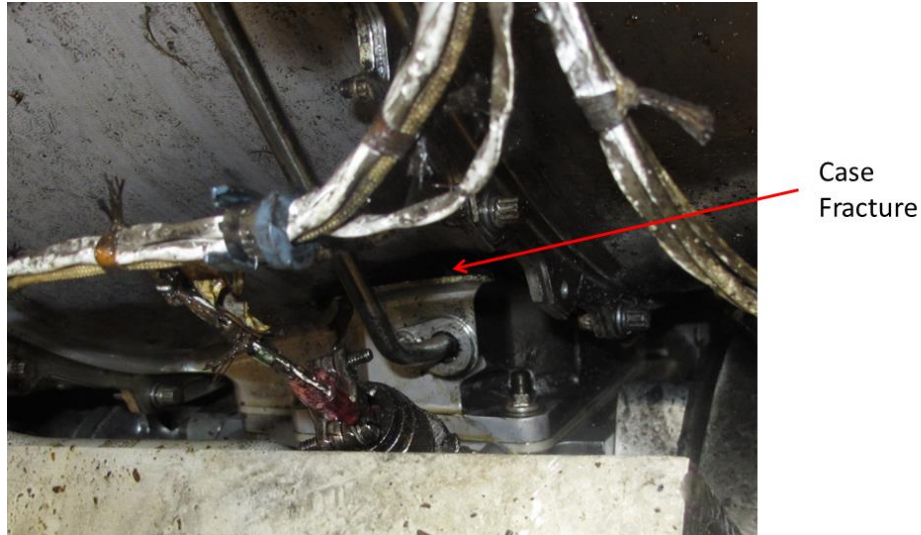
The interstage case housing exhibited an open split fracture that transitioned into a series of cracks at approximately the 6 o'clock position. The fracture allowed the AGB to partially pull away from the engine (**Photo 12**). The forward bypass duct also exhibited impact damage at 6 o'clock causing inward buckling of the duct case.

Photo 12- Interstage Case Split Fracture

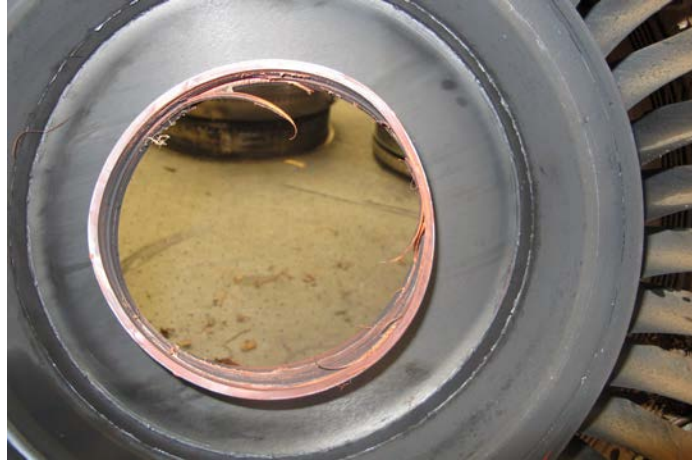
Photo 13- Compressor Fan Stator Inner Diameter

The fan was removed and exhibited blade tip rub 360 degrees around. The 1st stage compressor stator had discoloration on both the vane pressure and suction sides that was easily removed with a cloth and light pressure. The inner diameter of the fan stator hub was unevenly worn and air seal rubber material was shredded (**Photo 13**).

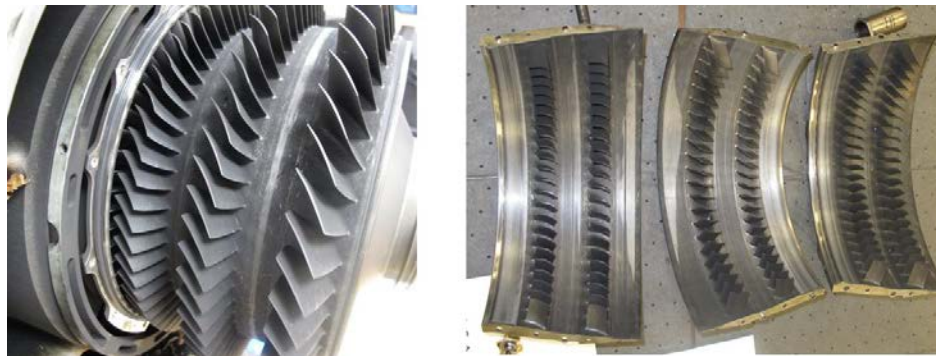
The IP compressor was intact but exhibited rubs on the compressor rotor blade tips and spool with corresponding rub marks on the compressor stator lands and vane tips (**Photo 14**). All stages of the IP compressor were coated with a layer of dirt and debris. The No. 1, 1 ½ and 2 bearings were all oil wetted and spun freely.

Photo 14- IP Compressor Rotor and Stator Rubs

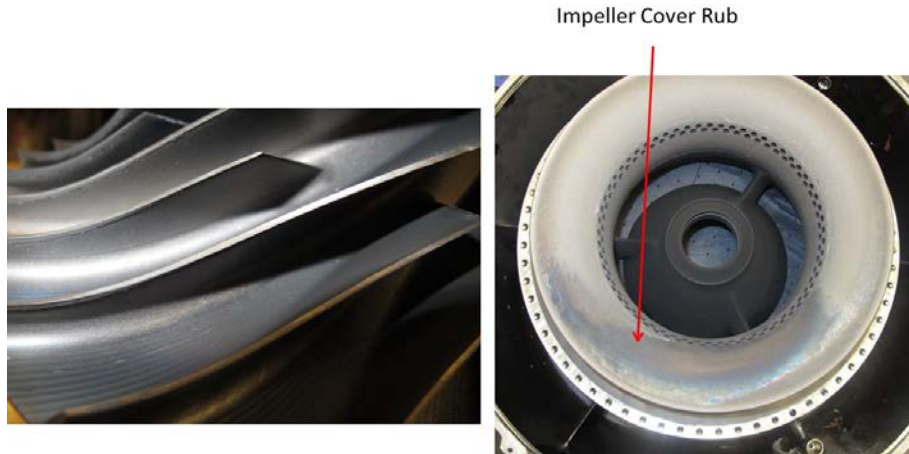
The HPC impeller exhibited blade tip rubs 360 degrees around. The impeller cover had a rub from 5 to 8 o'clock consistent with impeller contact (**Photo 15**). The location of the damage on the impeller cover was coincident with the damage noted on the interstage case.

Photo 15- Centrifugal Compressor Impeller and Cover Rub

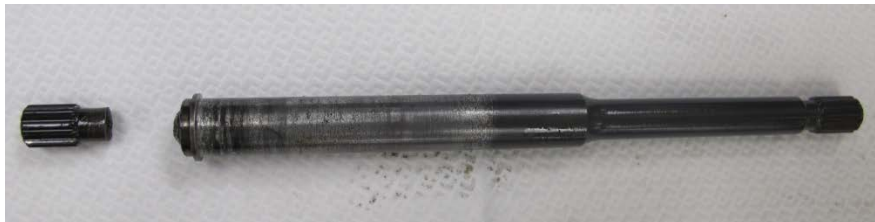
The AGB tower shaft was sheared and the lower spline section remained engaged in the AGB (**Photo 16**). Impact damage and thermal discoloration was noted on the AGB second reduction bearing housing consistent with tower shaft contact during rotation (**Photo 17**). The fuel pump assembly was removed from the engine and it was noted that both the fuel inlet port and fuel filter had separated from the assembly during impact (**Photo 18**).

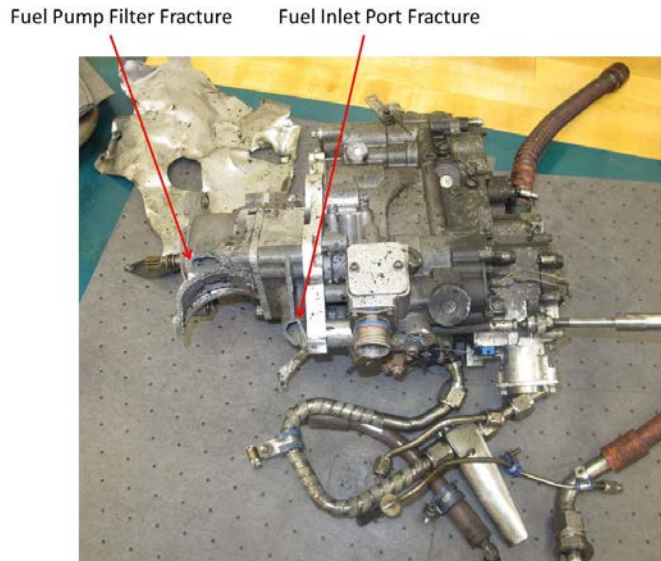
Photo 18- Damaged Fuel Pump

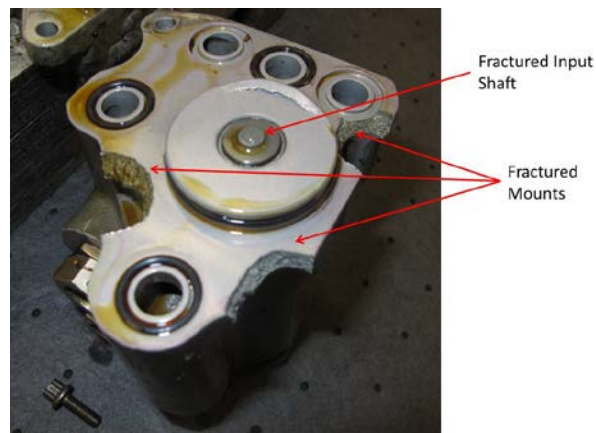
The oil lube and scavenge pump had three of the four mounting flange attachment points fractured and was held in place by a single mounting flange and nut. The oil lube pump input shaft from the gearbox was sheared (**Photo 19**).

Photo 19- Damaged Lube and Scavenge Pump

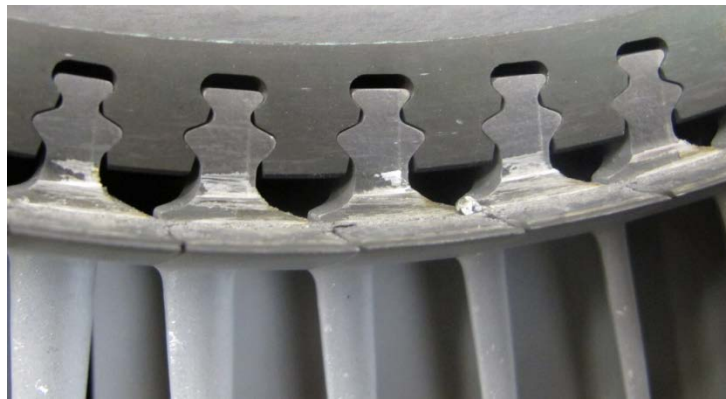
The LPT 1st and 2nd stage rotor and nozzle assemblies were intact. The forward side of the LPT 1st stage disk had a 360 degree rub along the blade fir tree platforms with a corresponding rub on the LPT 1st stage nozzle hub consistent with a forward axial shift (**Photo 20**). The LPT trip sensor was not engaged/tripped indicating the LPT did not shift in the aft direction.³

Photo 20- LPT 1st Stage Blade Fir Tree Platform Rub Marks
