NATIONAL TRANSPORTATION SAFETY BOARD
OFFICE OF AVIATION SAFETY
WASHINGTON, D.C. 20594

POWERPLANTS GROUP CHAIRMAN'S FACTUAL REPORT
NTSB ID: DCA13MA133

Location: Birmingham, Alabama
Date: August 14, 2013
Time: 0447 Central Daylight Time (CDT)
Aircraft: Airbus 300-600, United Parcel Service flight 1354, N155UP

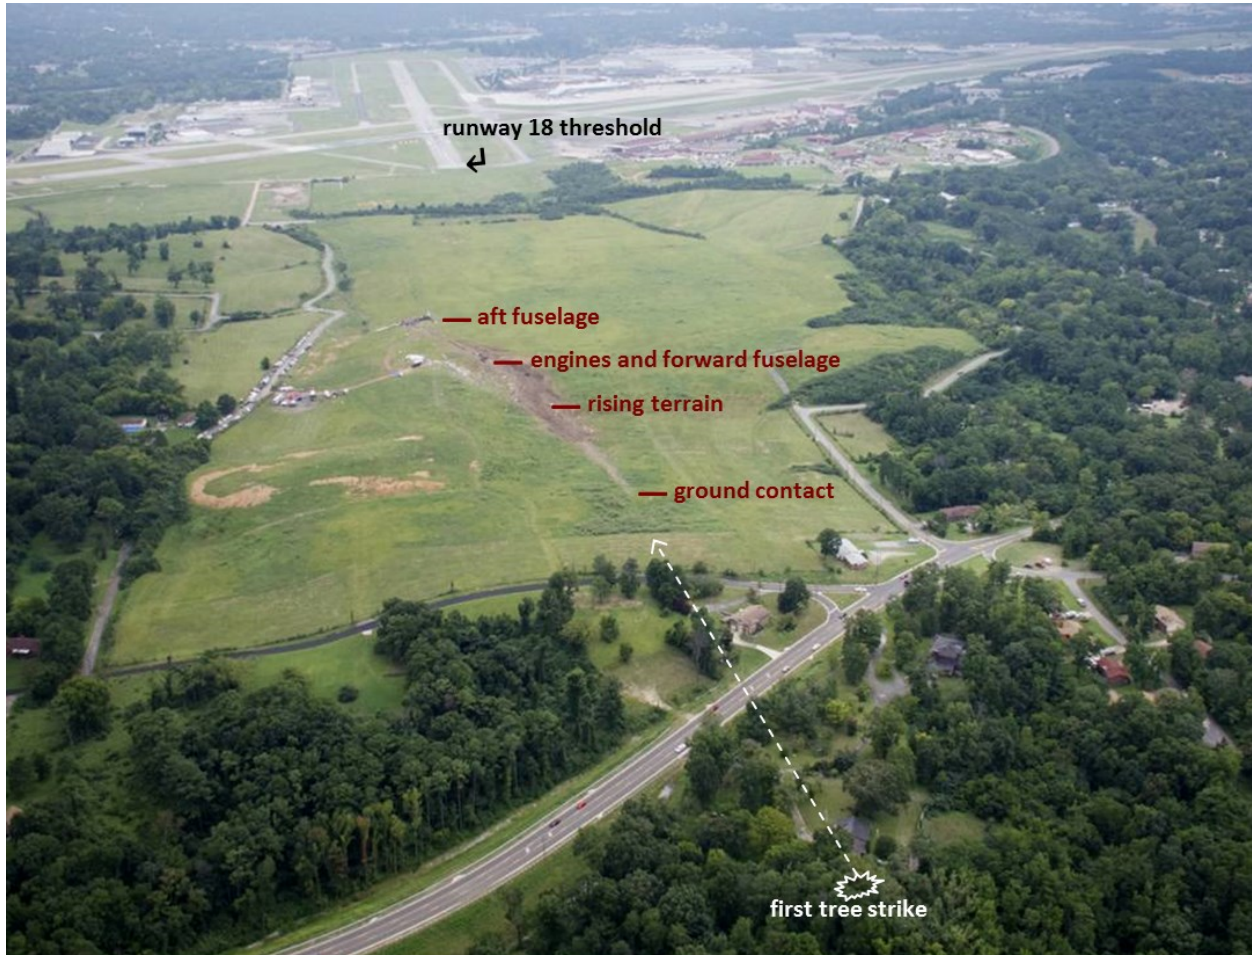
An aerial survey of the airplane's flight path identified the initial point of impact as a tree strike in a forested area 6,440 feet due north of the runway 18 threshold.² Ground scars indicated that the airplane contacted the ground 1,416 feet from the initial tree strike and collided with rising terrain about 360 feet further south. The forward section of the fuselage came to rest 4,070 feet north of the runway 18 threshold. Both engines were located about 1,000 feet northwest of the forward fuselage section. The aft fuselage, right wing, and empennage were found 3,650 feet north of the runway 18 threshold. See Figure 2.

Figure 2. Overview of accident site showing the airplane's energy path

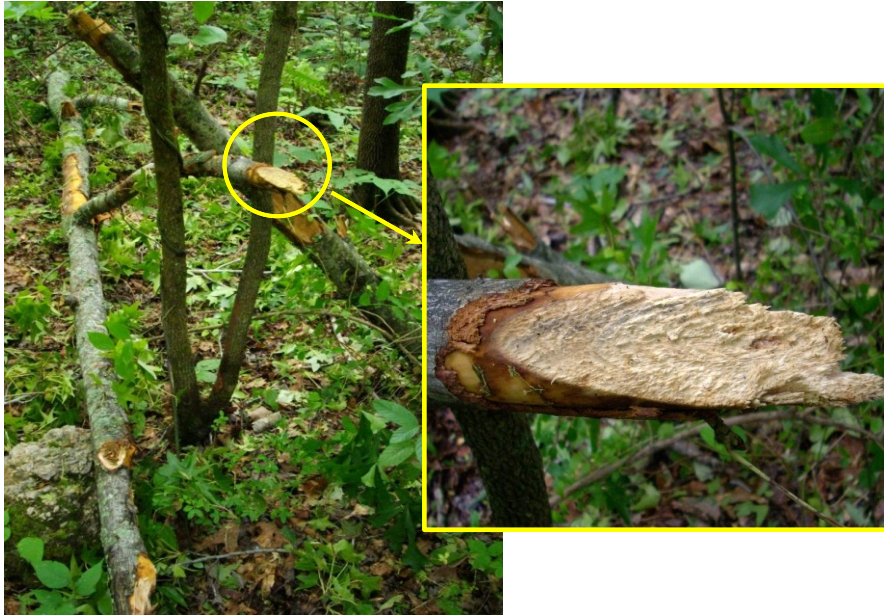
Tree limbs and pieces of nacelle and wing material and were found on the forest floor and caught in trees at the initial point of impact. Many of the tree limbs displayed cleanly cut ends and areas of missing bark. See Figure 3.

Figure 3. Cleanly cut 2-inch diameter tree limb found at the initial tree strike area

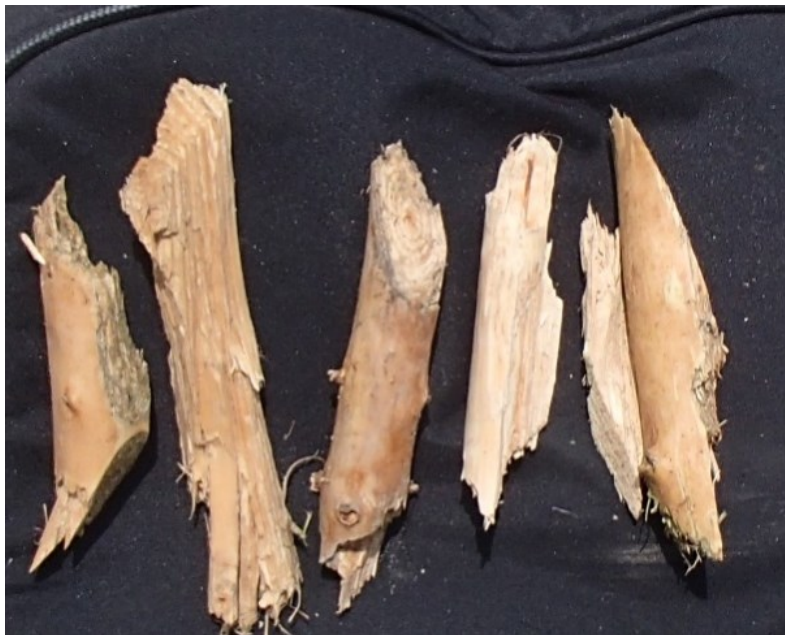
A large number of tree branch segments, stripped of bark and of similar lengths (4 to 6 inches), and having clean, angled cuts on one or both ends were also noted in this area. See Figure 4.

Figure 4. Examples of the branch segments found near damaged trees

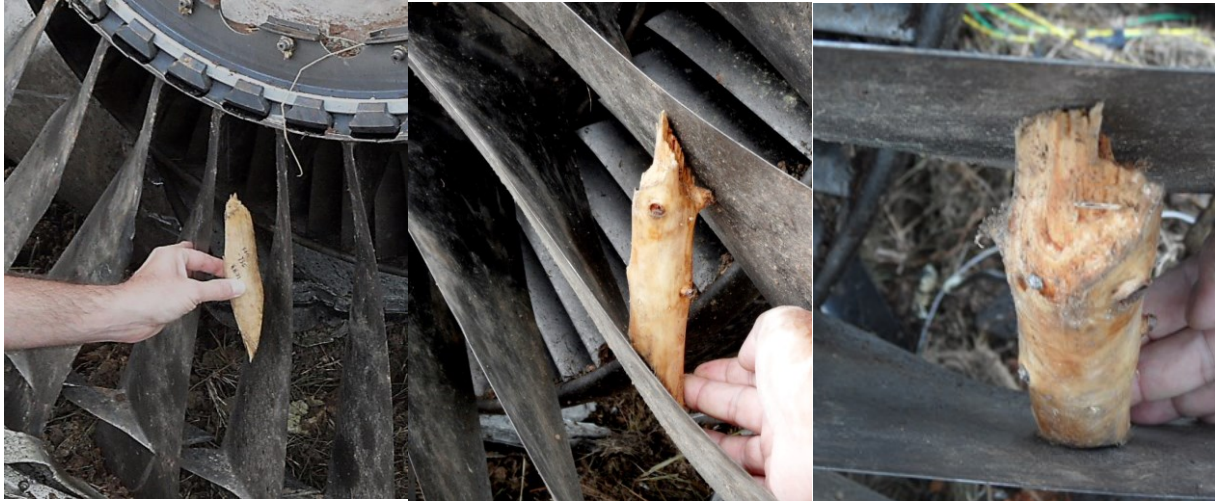
The lengths and cut angles of the branch segment were consistent with the geometry of the PW4158 engine fan (See Figure 5), suggesting that the segments were produced when tree limbs were ingested by the engine and cut by the fan blades (“processed”). See Figure 6.

Figure 5. PW4000 fan inlet and “processed” branch segments

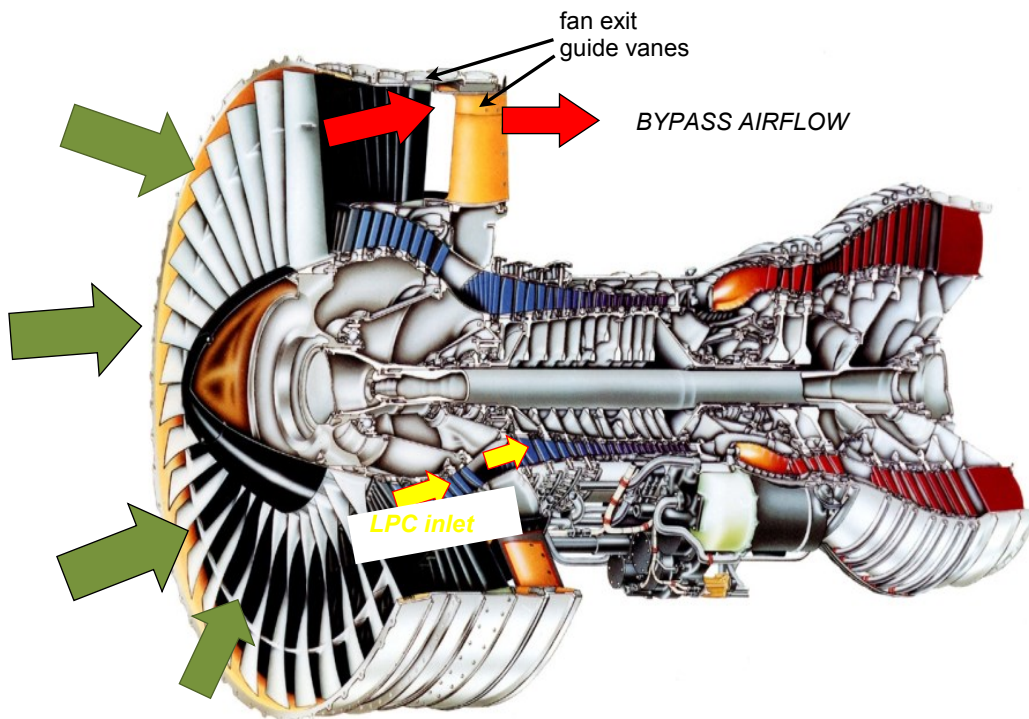
Figure 6. Cutaway view of PW4000 showing engine ingestion paths

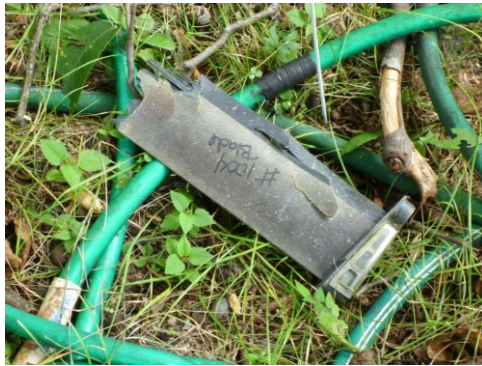
South of the forested area, a series of 15 additional tree and telephone pole strikes indicated that the airplane flew low over the residential area for about 950 feet, to the airport perimeter fence. The northernmost of the tree strikes was a large pine tree located close to the southern edge of the forested area, 6,254 feet north and three feet west of the runway 18 threshold centerline. “Processed” branch segments were found near the pine. Nacelle and engine fragments, including most of a fan exit guide vane, a 10.6-inch by 6.0-inch piece of inlet cowl lip skin, and a fragment of engine inlet cowl outer barrel skin were recovered about 50 feet east of the pine tree strike, also near the forest edge. See Figures 7 through 9.

Figure 7. Fan exit guide vane fragment

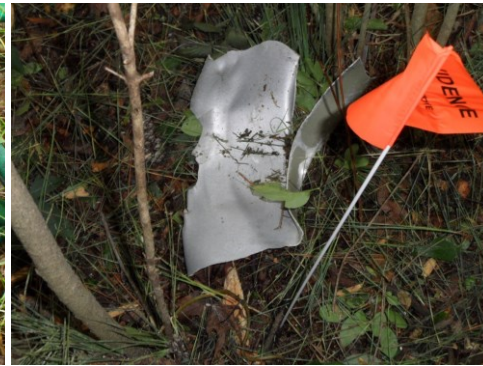
Figure 8. Inlet cowl lip skin fragment

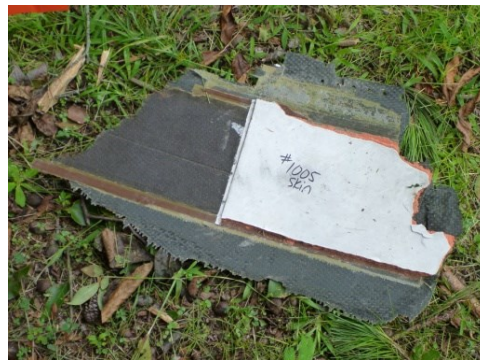
Figure 9. Inlet cowl outer barrel skin fragment

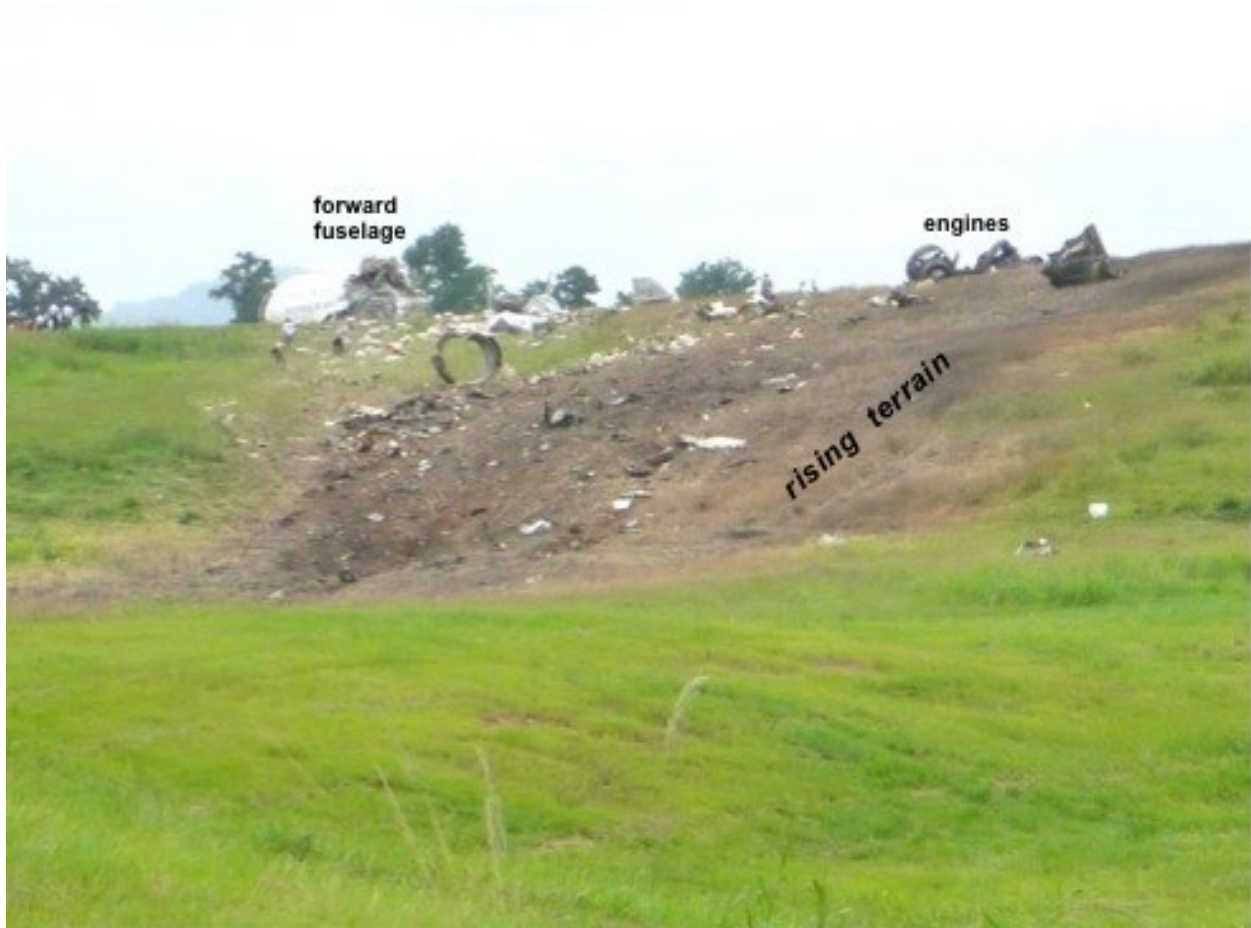
runway 18 threshold. The ground scar indicated that the airplane struck the ground, travelled about 470 feet further south and collided with upward-sloping terrain. Deep furrows and depressions were found in the slope ground scar. See Figure 10. Blackened vegetation and the odor of fuel indicated that a ground fire had occurred in this area.

Figure 10. Abruptly rising terrain about 470 feet south of the first ground scar

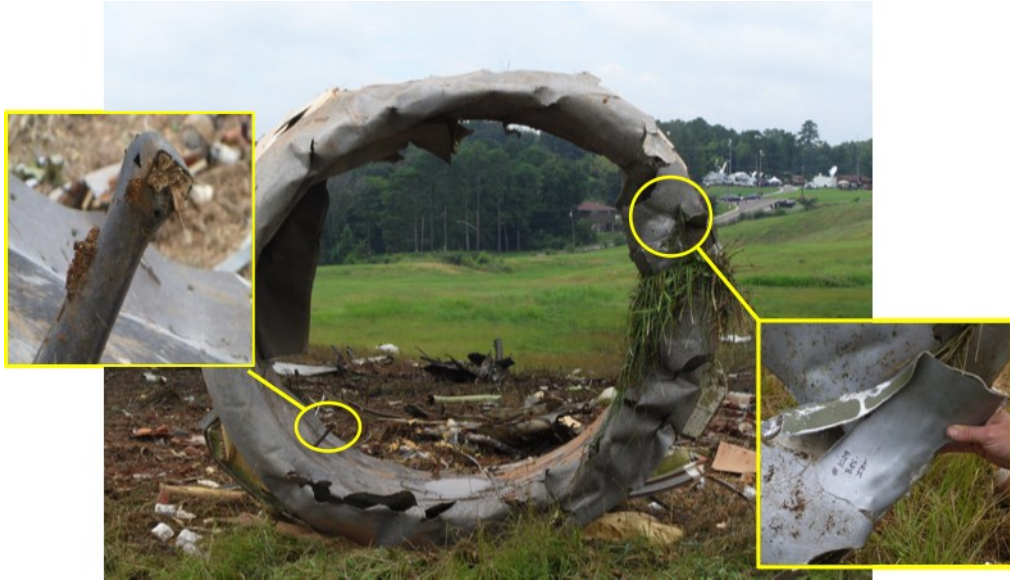
The amount of nacelle and engine debris increased considerably beyond the base of the rising terrain. Engine nacelle and thrust reverser components were found embedded in several of the depressions. Thrust reverser cascade and translating cowl material began to appear, along with additional fan exit guide vanes. An engine inlet cowl with an intact P2T2 probe was found on the rising terrain. The S/N of the P2T2 probe identified the inlet cowl as No. 1 engine material. The probe was clogged with wood debris. The 10.6-inch by 6.0-inch inlet cowl lip skin fragment found near the initial tree strike was matched to a missing section of the No. 1 engine cowl lip. See Figure 11.

Figure 11. No.1 inlet cowl showing wood jammed in P2T2 probe and missing skin fragment

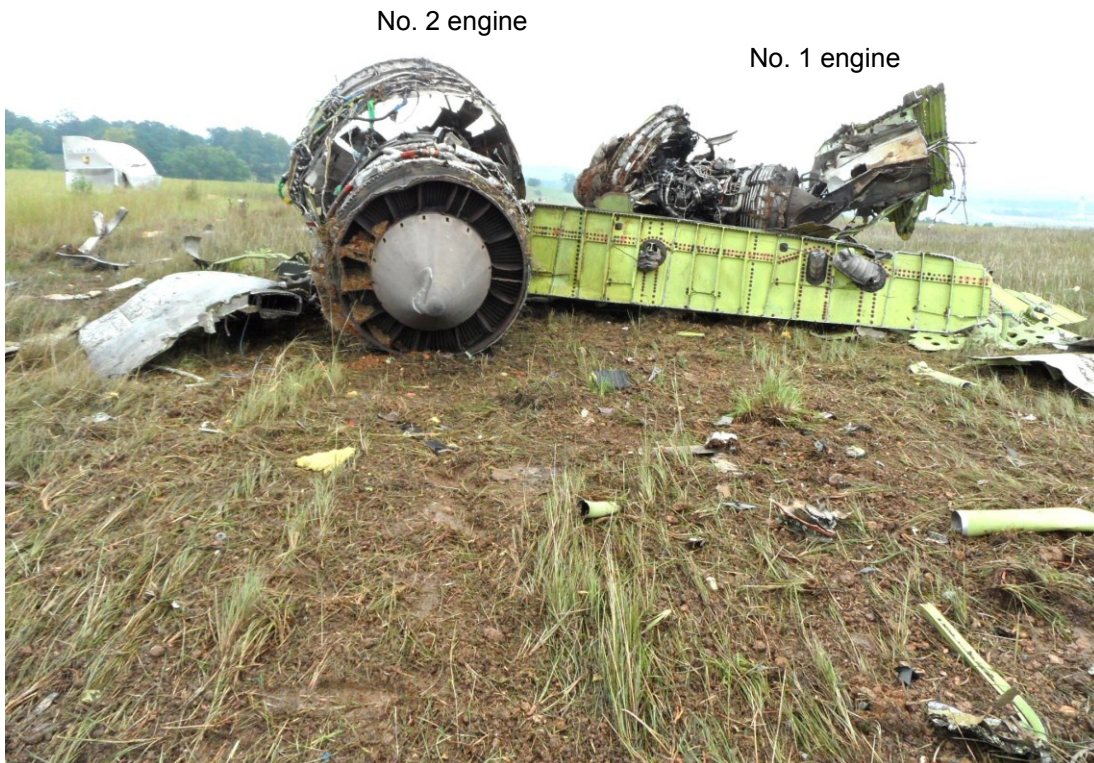
The forward section of the airplane fuselage was found on top of the slope. The engines were found resting about 1,000 feet northwest of the forward fuselage section, 4,070 feet north of the runway 18 threshold and about 25 feet apart. See Figures 12 and 13.

Figure 12. View of the engines, looking southeast

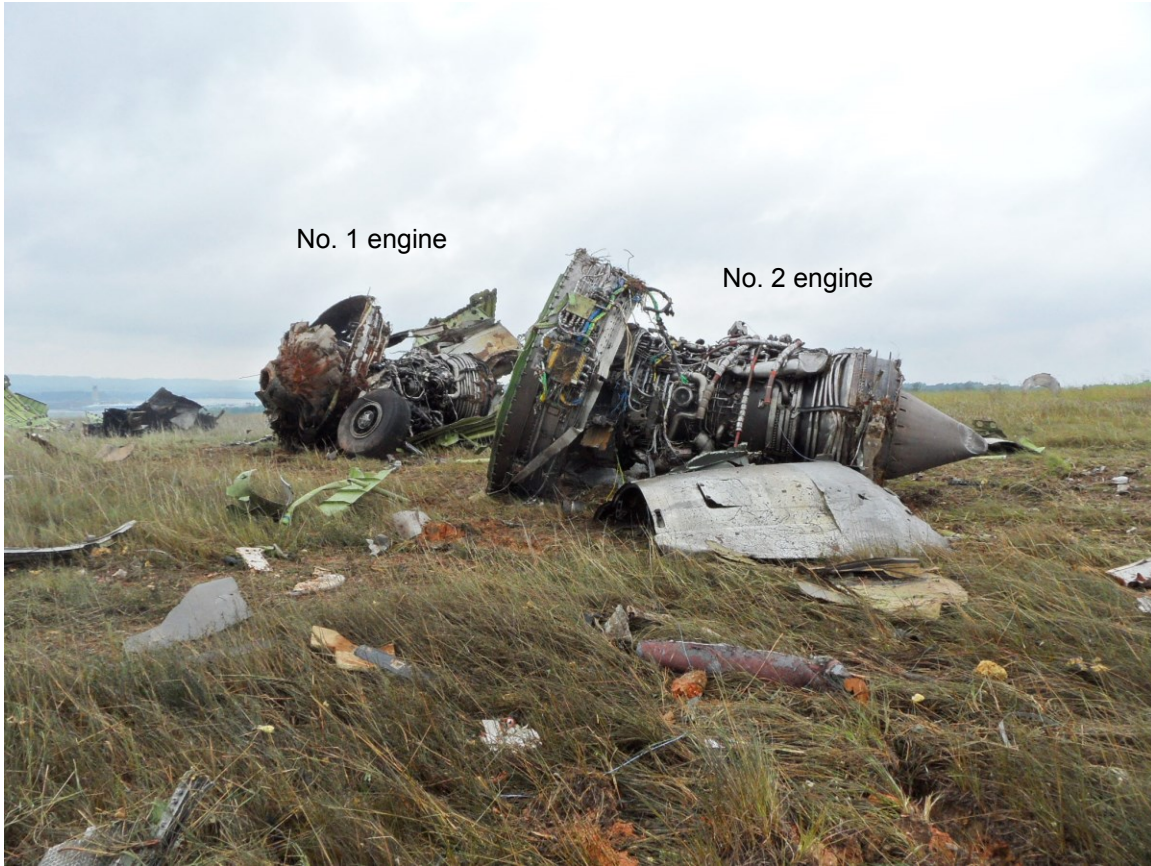
Figure 13. View of the engines, looking southwest

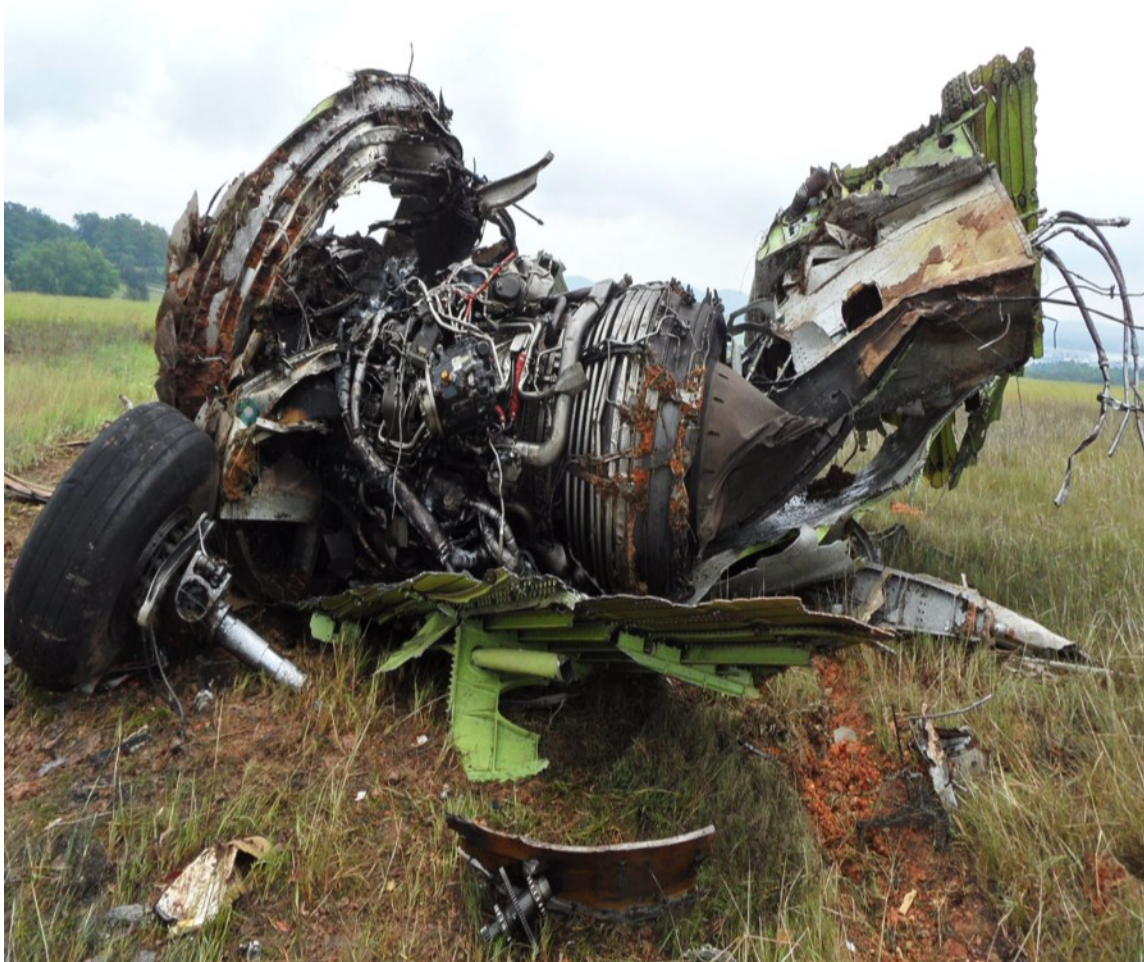
The engine data plate located on the fan case identified the No. 1 engine. It was resting on its (3 o'clock³) side. The pylon and a small section of wing remained attached to the engine. See Figure 14. The engine showed no indication of uncontainment or pre-impact fire.

Figure 14. Left side view of the No. 1 engine

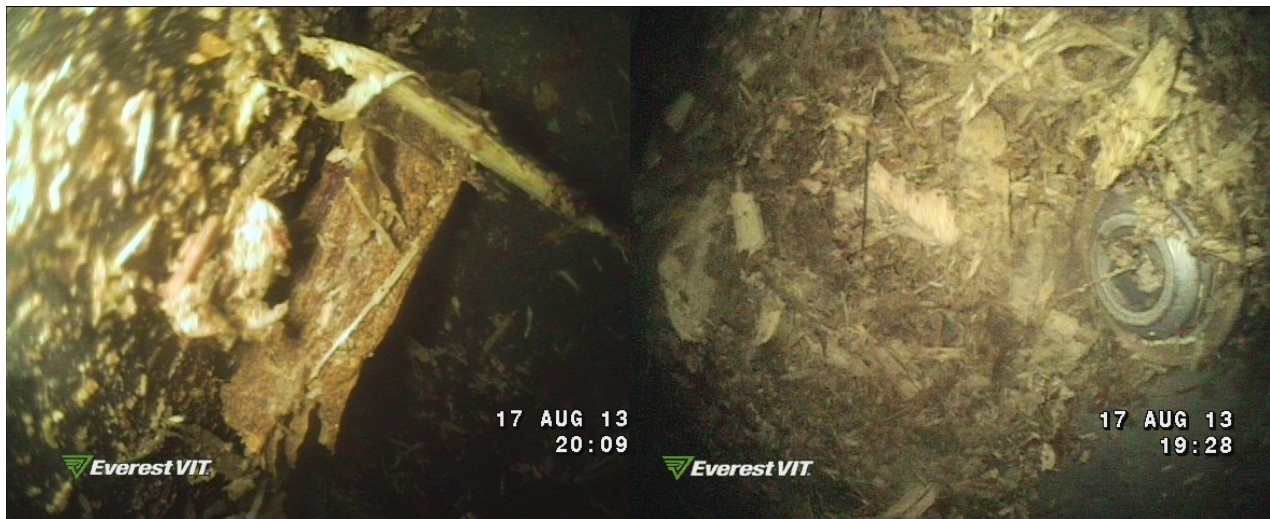
Local (no rotation) borescope inspections (BSI) were performed through the LPC inlet and the 2.5 bleed port. Large masses of wood shavings were observed inside the LPC. See Figure 15. There was no evidence of rotational contact between the LPC rotor and adjacent stationary structures in the inspected areas.

Figure 15. Borescope images taken inside the No. 1 engine low pressure compressor

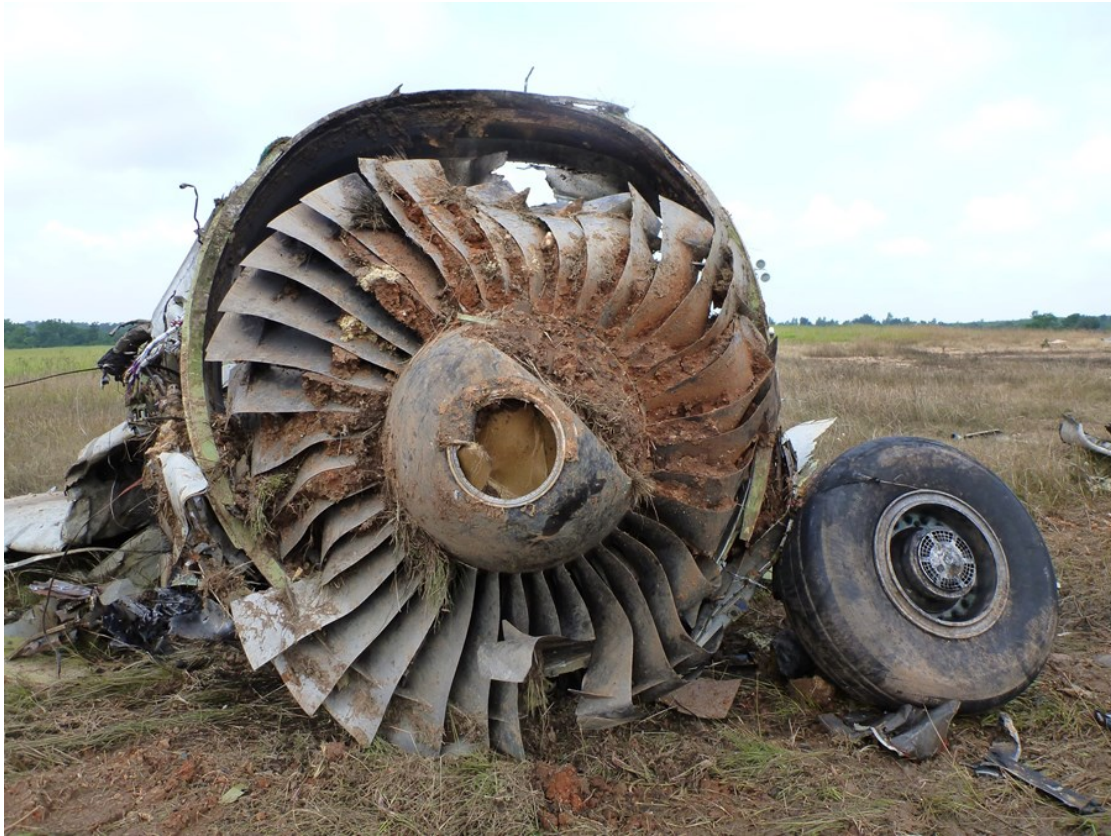
All of the No. 1 engine intermediate case struts except the 12 o'clock strut were fractured and the fan case was leaning aft, with the most pronounced lean at 8 o'clock. The spinner was caved in and the spinner cap was inside the cone segment of the spinner. See Figure 16.

Figure 16. No. 1 engine fan inlet

Between 4 and 1 o'clock, the No. 1 engine fan blades were severely bent aft and in the direction of rotation and both the fan and the LPC were packed with soil. The soil in the fan section and LPC appeared consistent with the soil at the ground scar in the slope (red clay, grass and small stones). Six blades between 1 and 3 o'clock showed only minor damage. Five consecutive fan blades between 3 and 4 o'clock were bent S-shaped. Three blades (at 1, 3 and 8 o'clock) were fractured inboard of the midspan shroud. Multiple fan leading edges exhibited soft body damage. Two or three blades were missing leading edge tip material. Several small tree branches were observed behind the fan within the fan case. The portions of the fan abrasion lining available for inspection exhibited several radial, linear impact marks and no circumferential rubbing. Most of the fan exit guide vanes were liberated.

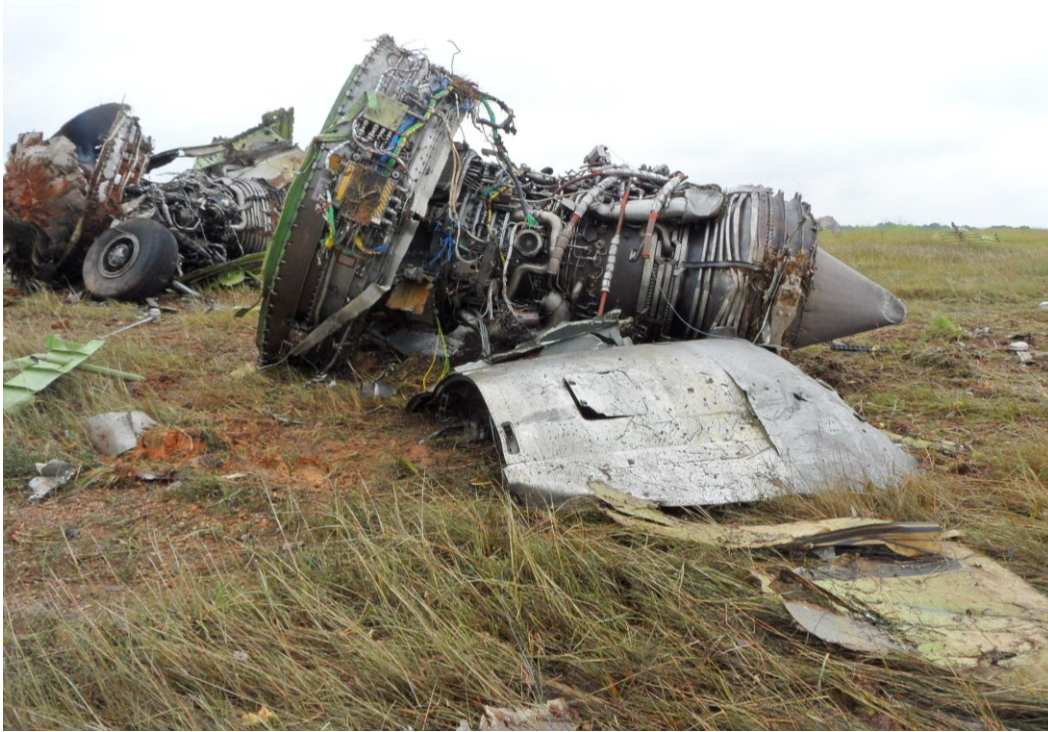
All nacelle components had been shed. See Figure 17.

Figure 17. Right side view of the No. 2 engine

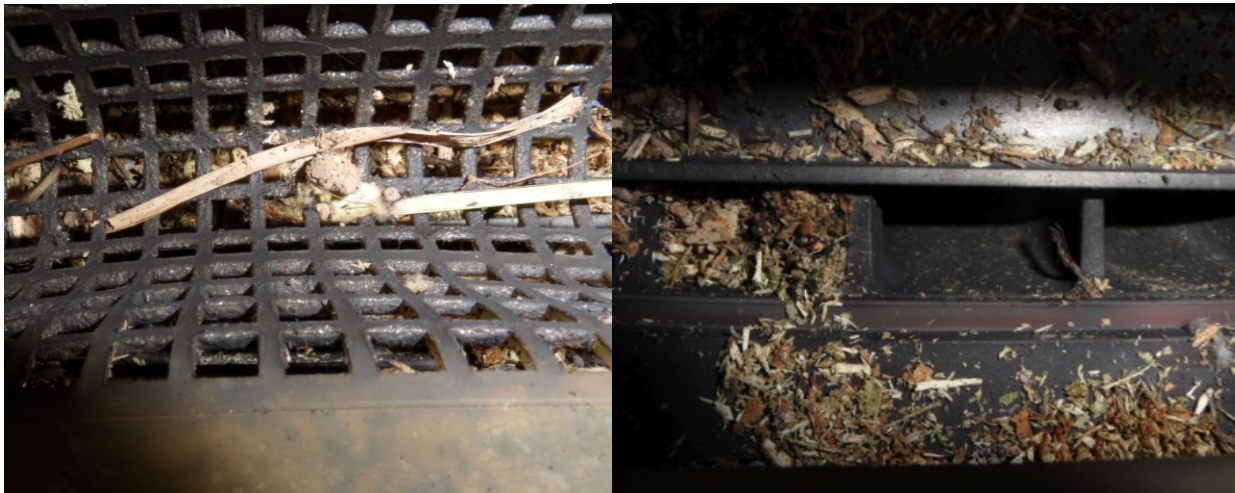
The No. 2 engine LPC inlet was blocked by soil between 1 and 6 o'clock. The gearbox was fractured. The fuel pump housing was fractured at the interstage fuel filter, and it and adjacent components were thermally damaged. The EEC housing was fractured. The VSV actuator rod was extended about 1 3/8 inches. The No. 2.5 bleed was in the open position. Many of the observable 2.5 bleed ports were full of wood shavings and leaves. See Figure 18. The exit screen of the right 2.9 bleed valve was partially blocked by wood shavings. See Figure 19.

Figure 18. Wood debris at No. 2 engine 2.5 bleed screen and ports

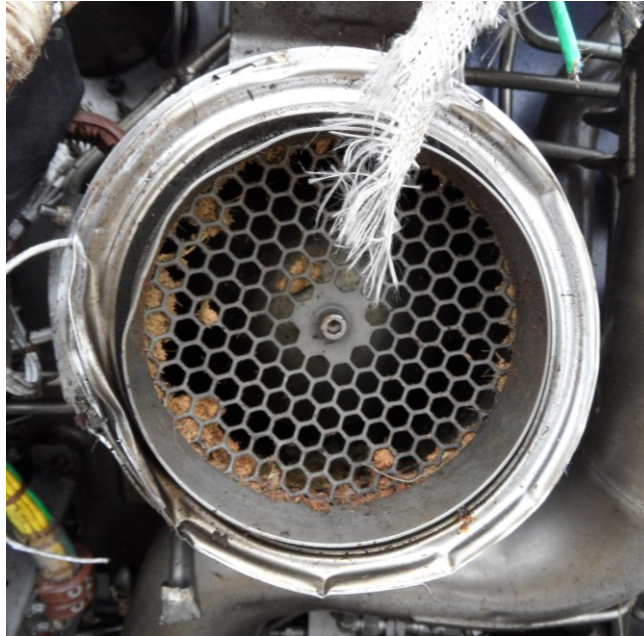
Figure 19. Wood debris captured by the No. 2 engine 2.9 bleed valve exit screen

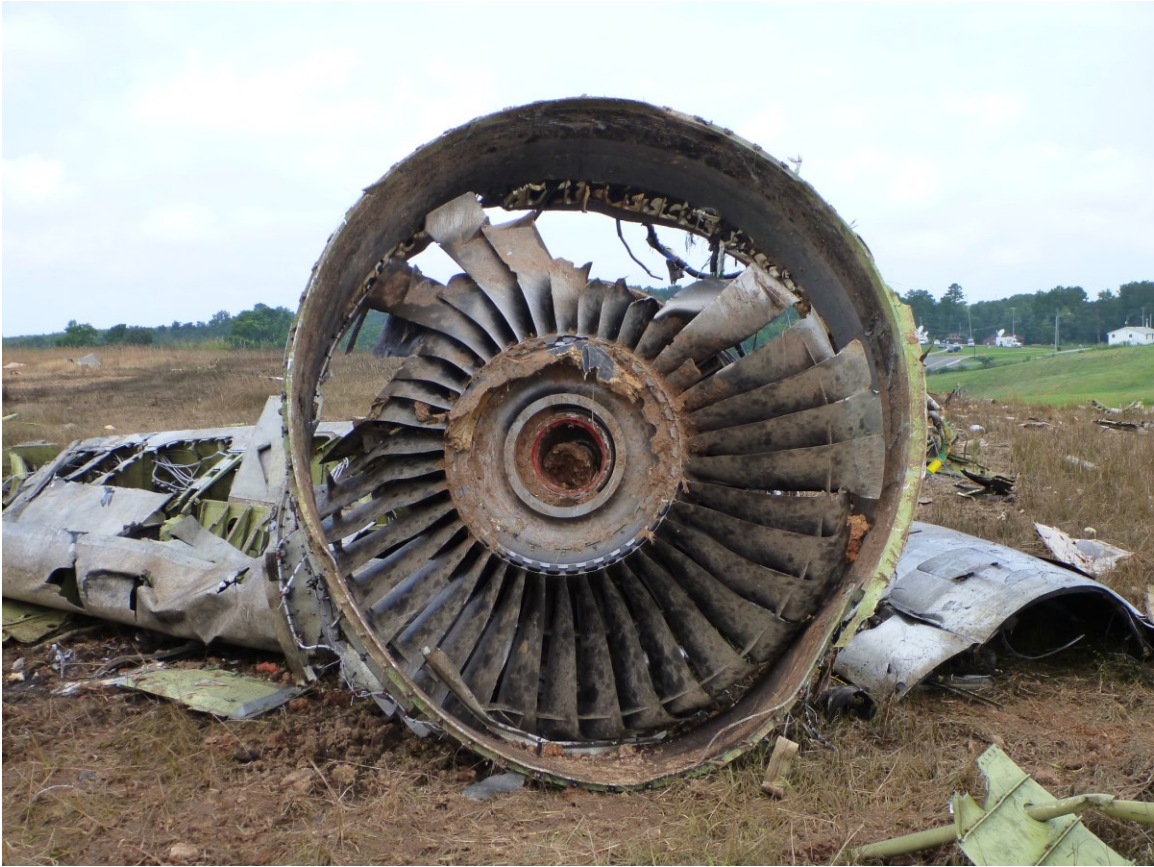
There was relatively minor damage to three consecutive No. 2 engine fan blades from 12 to 1 o'clock (relative to the engine core)⁶. An arc of blades between 1 and 6 o'clock were severely deformed, with ten fractured; all were bent aft and in the direction of rotation. Seven consecutive blades between 6 and 8 o'clock showed relatively minor damage. The blades between 8 and 12 o'clock were bent in the direction of rotation outboard of the midspan shroud. Multiple blade leading edges showed soft body impact damage. The spinner was liberated and was found nearby in a deformed condition. All of the fan exit guide vanes were liberated. The fan abrasable lining had several radial, linear impact marks but exhibited no heavy circumferential rubbing. See Figure 20.

Figure 20. Inlet view of No. 2 engine
