**NATIONAL TRANSPORTATION SAFETY BOARD
Office of Aviation Safety
Washington, D.C. 20594**

POWERPLANTS GROUP CHAIRMAN'S FACTUAL REPORT

DCA97MA059

Aircraft: McDonnell Douglas DC-8-61, N27US, Fine Air

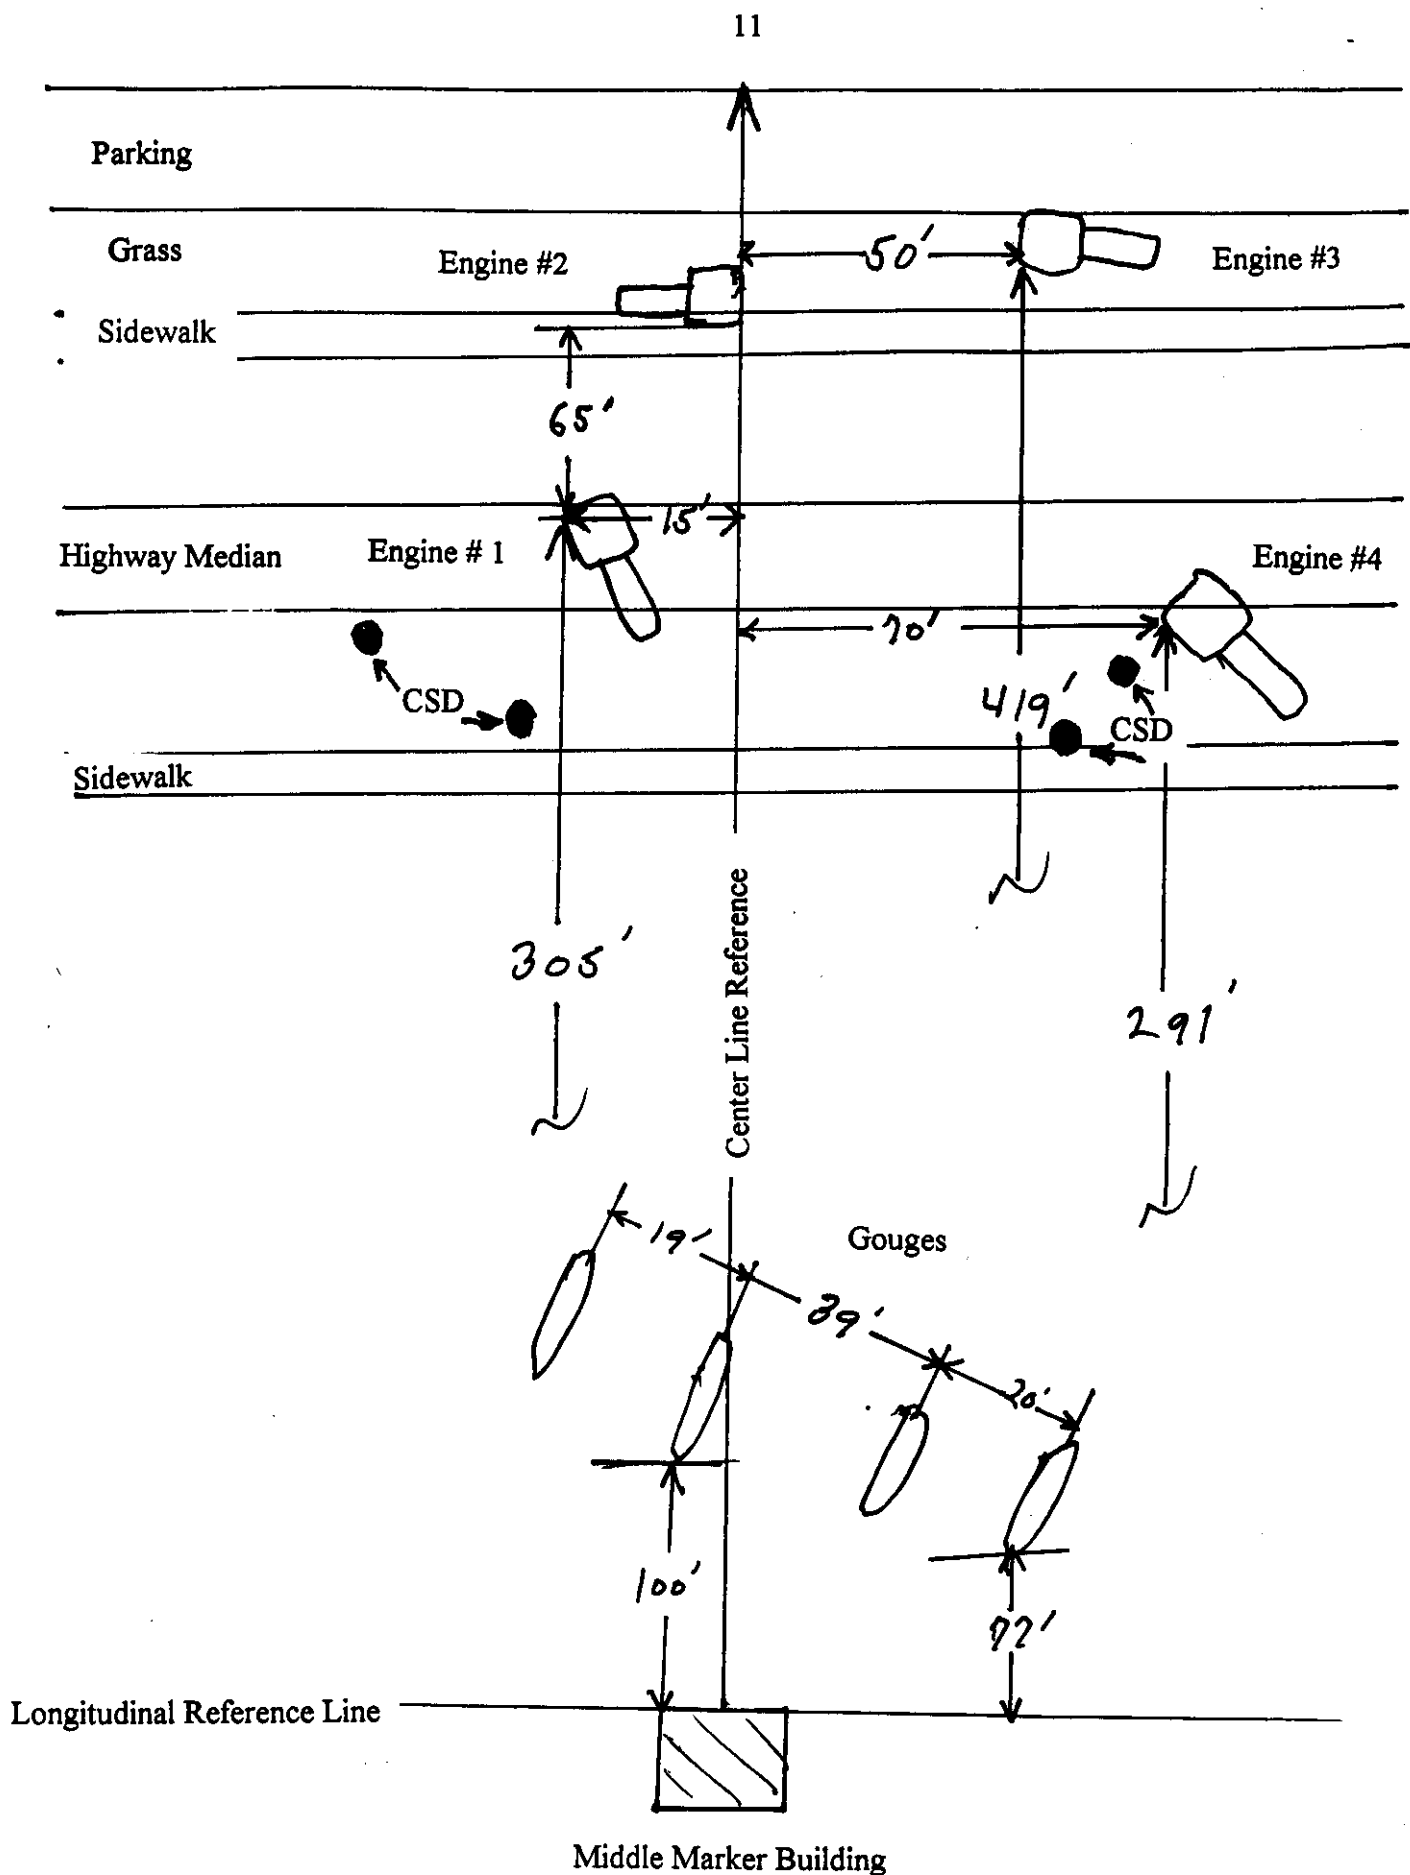
Figure 1. Engine Wreckage Diagram

The powerplants group was formed and began the examination of the engines at the accident site on August 8, 1997. All four of the engine assemblies were found separated from the airplane. Engine subassemblies, portions of cowling, and various rotating fan and turbine blades were found in multiple locations around the crash site. Figure 1 shows the primary engine wreckage locations in respect to the airplane point of impact. Four parallel ground depressions or grooves averaging approximately 3 feet wide by 7 feet long were found in the soil approximately 77 feet west of the facing wall of the building. The lateral separation of the grooves are consistent with the installed engine positions on the airplane. Groups of fractured and deformed turbine blades and vanes were found in the vicinity of each of the depressions. The engines separated from the pylons by fracture of either the aft engine attach point or tearing of the pylon structure to which the engine mounts were attached. All engines had significant denting at the 6 o'clock position on the turbine nozzle case that intruded into the turbine blades' plane of rotation. There was significant bending and fracture on the turbine blades of all four engines. The fan, compressor, and combustion chamber cases of all of the engines suffered much less damage than the turbines. There was no evidence of penetrations of the engine cases. The outer nacelle panels and pylons indicated varied exposure to heat that burned and blistered the paint but there was no damage consistent with an in-flight fire involving the engine. The thrust reversers were separated from all the engines and only one of the assemblies was found intact enough to establish that it was fully stowed at impact.

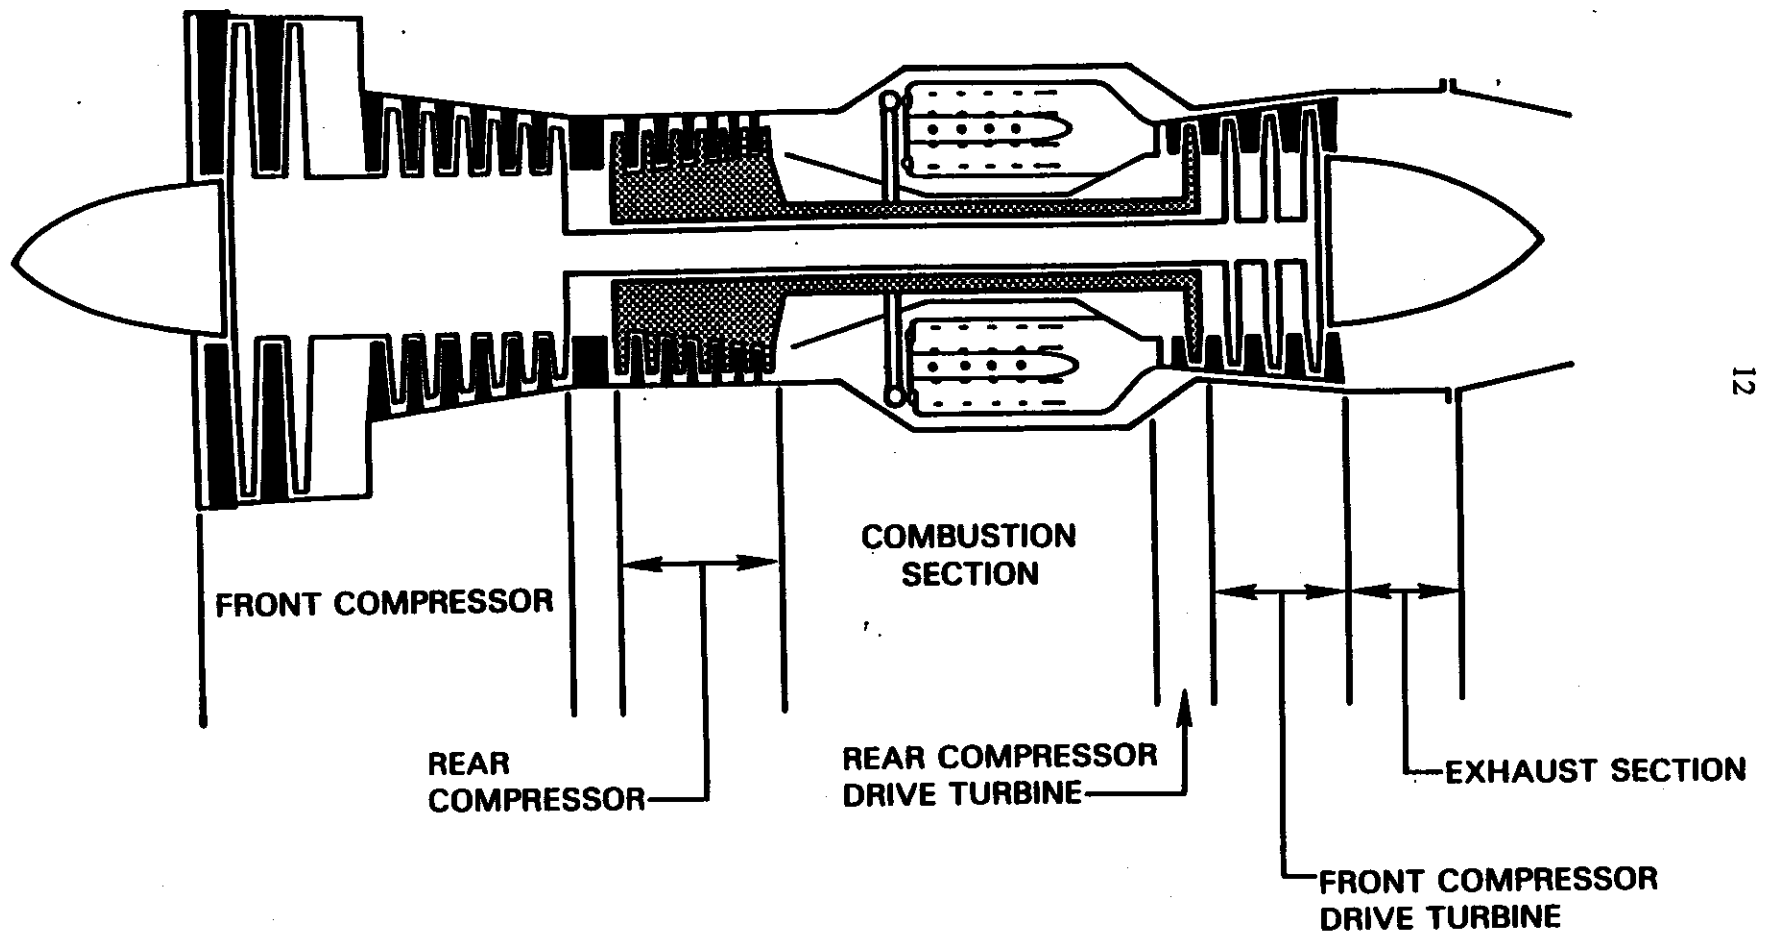
FIGURE 2. Pratt & Whitney JT3D-3B Engine Cross Section

The airplane was powered by four Pratt & Whitney JT3D-3B engines that were equipped with fan and core thrust reversers. This model of the JT3D weighs approximately 4,340 pounds and delivers a maximum thrust of up to 18,000 pounds. It is an axial flow turbofan engine having a multistage split compressor, an 8-can combustion chamber, and a split 4-stage reaction-impulse turbine. (Figure 2).
