POWERPLANT GROUP CHAIRMAN'S FACTUAL REPORT

NTSB No: DCA-08-MA-098

Location: Columbia Metropolitan Airport, South Carolina
Date: September 19, 2008
Time: 2353 eastern daylight time
Aircraft: Global Exec Aviation Learjet LR-60, Registration Number N999LJ, Serial No. 314

Pratt & Whitney Canada Service Investigation Accident/Incident Report No. 08-128

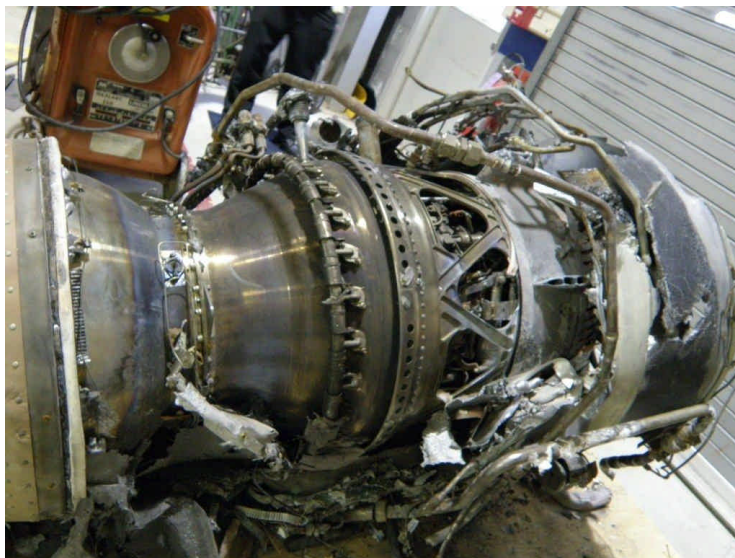
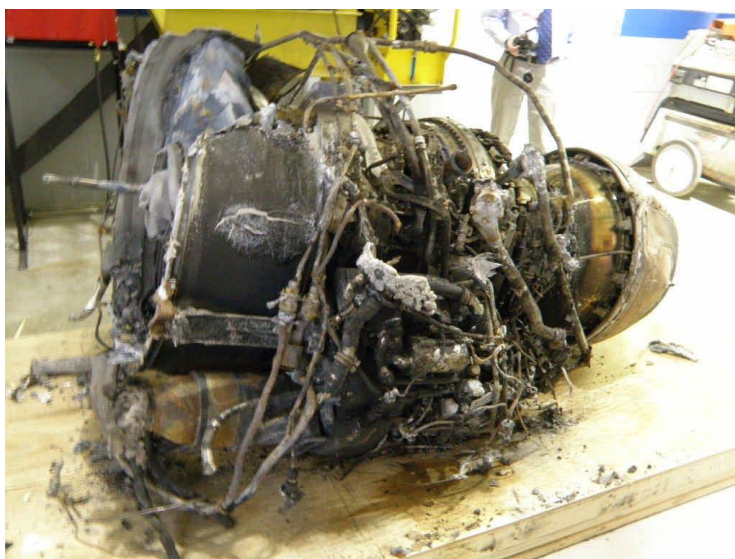
The engine was received in a shipping container and was opened with FAA oversight. The engine displayed fire damage that was more pronounced on the front and upper sections of the engine (Ref. Photo No. 1 & 2). The Engine Data Plate's surface was burnt, but the engraved information was legible. The engine serial number was confirmed to be CA0484.

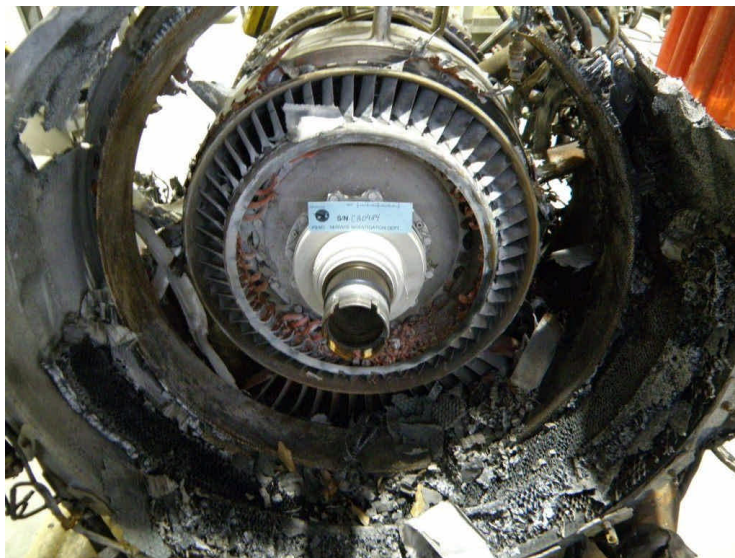
Photo No. 3

Fan Case: The internal lining of the case had mostly disintegrated from fire damage (Ref. Photo No. 3). The area from the 10-12 o'clock position of the case had disintegrated; the remaining portion of the case was distorted and discoloured. The Kevlar containment wrap had delaminated from the case and had disintegrated from the 10-12 o'clock position.

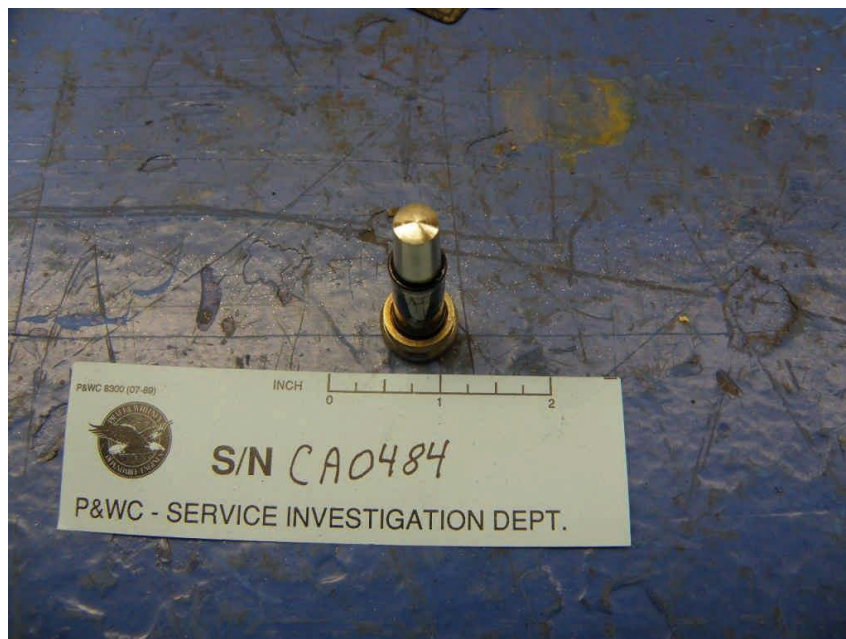
Photo No. 4

The linkage and cable were complete. The fuel shut off valve housing was distorted/damaged from the fire. The plunger pin was removed from the exhaust duct and did not show any contact with the low pressure turbine retention nut. This would indicate there was no rearward displacement of the low-pressure compressor shaft and the shut off valve did not actuate.

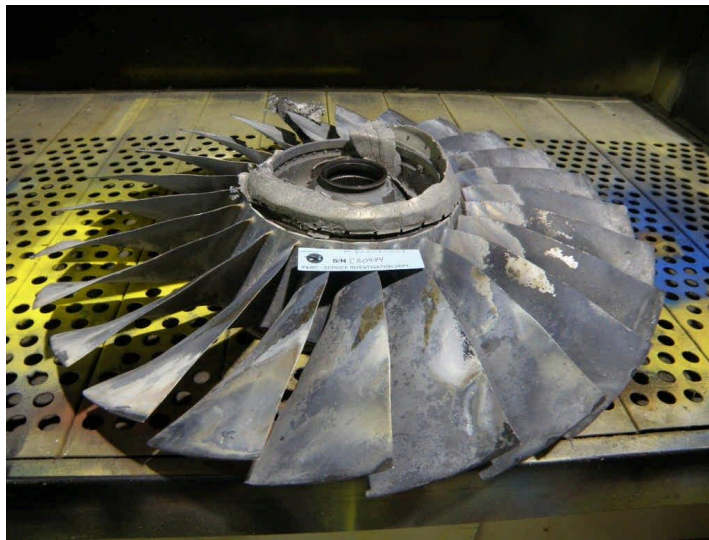
Photo No. 5

LP Compressor Fan: The low-pressure compressor rotated freely by hand pressure. The majority of the nose cone had disintegrated from fire damage (Ref. Photo No. 5). The fan had a dark gray coloured soot residue on the blades (Ref. Photo No. 5). There was no foreign object damage noted to the leading edge of the blades. The blade tips displayed very light witness marks from contact with the abradable fan shroud and are considered normal.

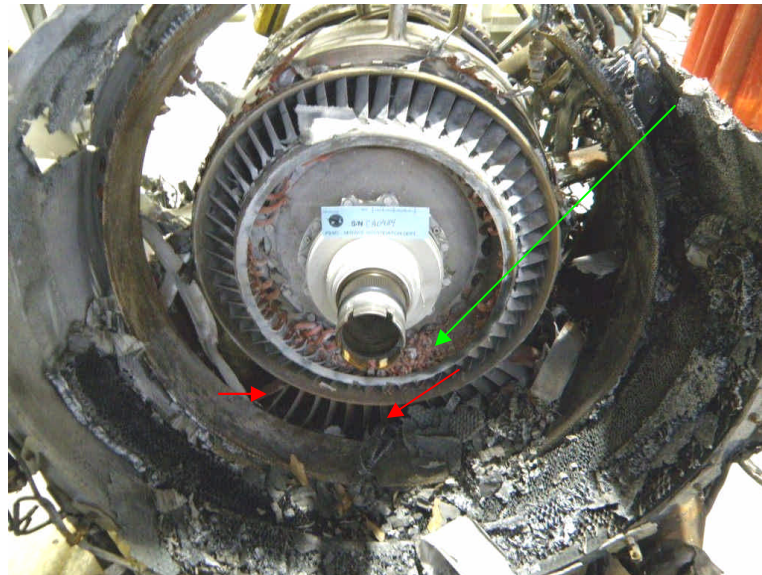
Photo No. 6

Fan Exit Stator: The majority of the airfoils were disintegrated except from the 3 to 5 o'clock position (Ref. Photo No. 6, Red Arrows). The upper regions of both the inner and outer shrouds were disintegrated.

Compressor Core Stator: The stator had a greyish coloured residue and was intact except the rubber grommets on the inner shroud had deteriorated (Ref. Photo No. 6, Green Arrow).

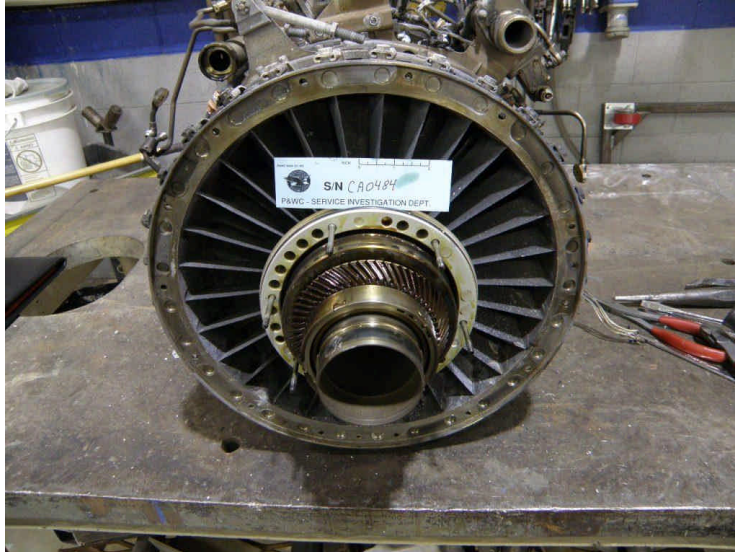
Photo No. 7

Variable Inlet Guide Vanes: The vanes were found in an open position (Ref. Photo No. 7). Both sets of vanes could not be actuated by hand. The linear stator vane actuator was removed; the inlet and 1st stage variable guide vanes were actuated by hand. The inlet guide vanes were covered with a black soot residue and had a greyish coloured splatter on most of the vanes.

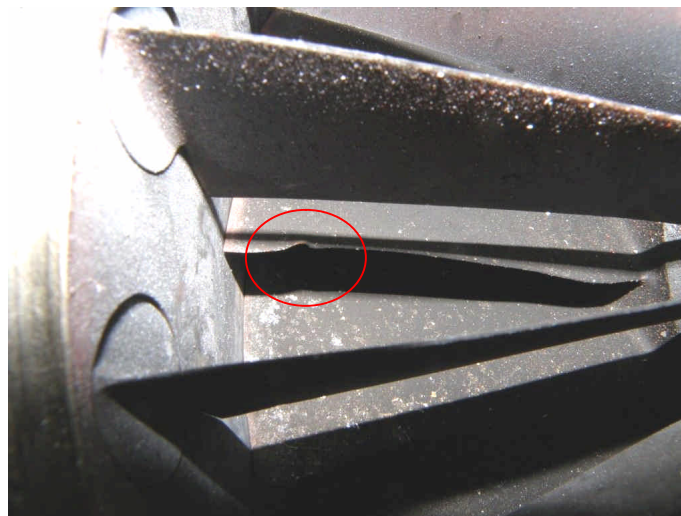
Photo No. 8

The left-hand engine's low-pressure and high-pressure compressors were rotated manually and rotated freely. It could not be determined if the dents on two 1st stage blades of the high-pressure compressor rotor were pre existing or if they occurred during the event. The soot covered, heat discolouration, melted, obliterated, and damaged components were attributed to the external fire. The organic debris found in the combustor suggests the engine had rotation during the event in order to ingest the organic debris. The fuel shut off plunger pin did not exhibit any scoring on the face indicating the fuel shut off valve had not been activated by turbine displacement.

1st Stage Compressor Rotor: The rotor exhibited two dented blades (Ref. Photo No. 8). The blades were covered with a black soot residue and had a greyish coloured splatter on several of the airfoils.

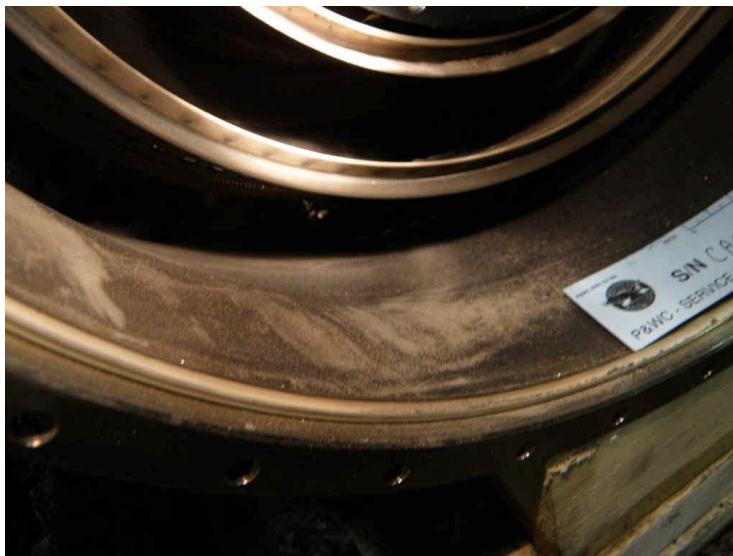
Photo No. 9

Combustor Case: Covered with a black soot residue. The case appeared to be in good condition with no evidence of being penetrated. There was a significant amount of sand between the combustion chamber liner and the case, with several particles adjacent to the low-pressure turbine housing flange (Ref. Photo No. 9).

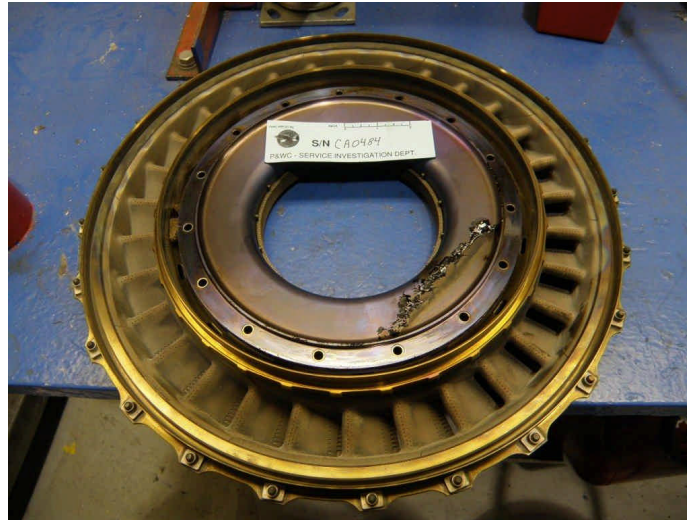
Photo No. 10

1st Stage HP Turbine Guide Vane Ring: Oil staining/residue was evident on the baffle (Ref. Photo No. 10). The vane and outer shroud had numerous sand particles adhered to the surfaces. The components were in good condition.

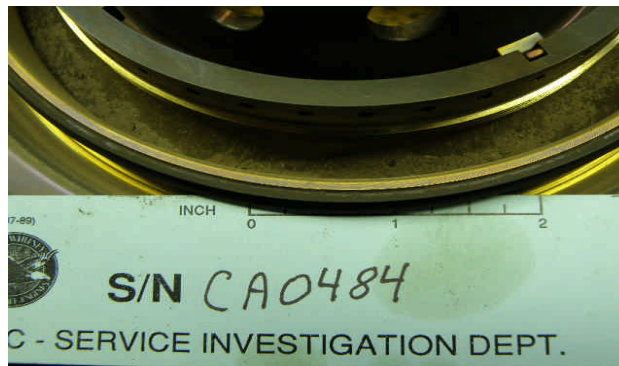
Photo No. 11

1st Stage HP Turbine: The components were in good condition. There was sand between the front cover and the disk (Ref. Photo No. 11).

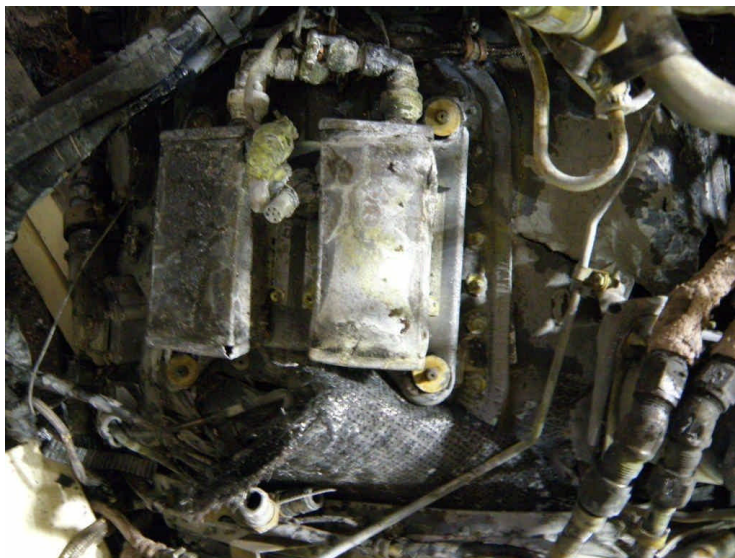
Photo No. 12

Exciter Box: Both boxes were blackened and one was bulged from exposure to the fire (Ref. Photo No. 12).

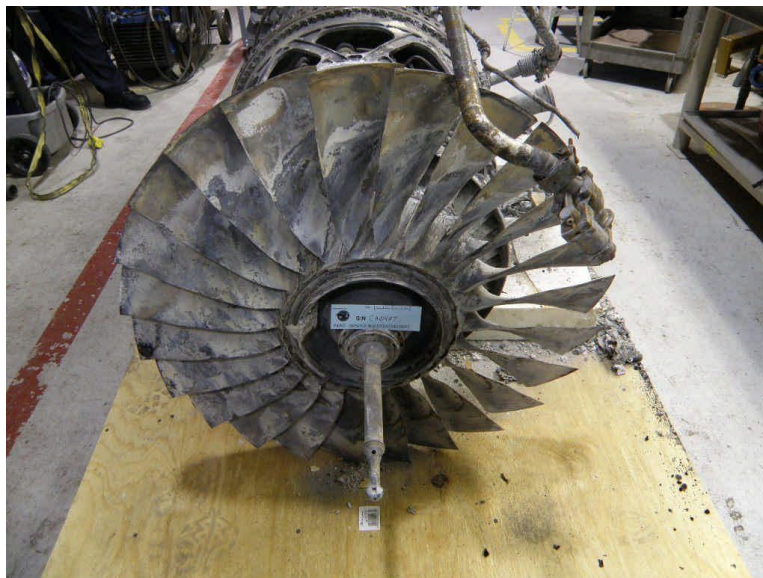
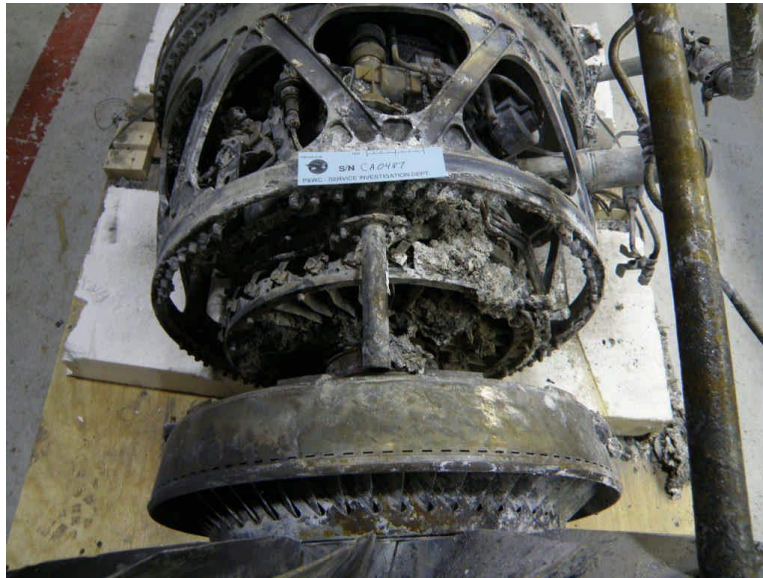
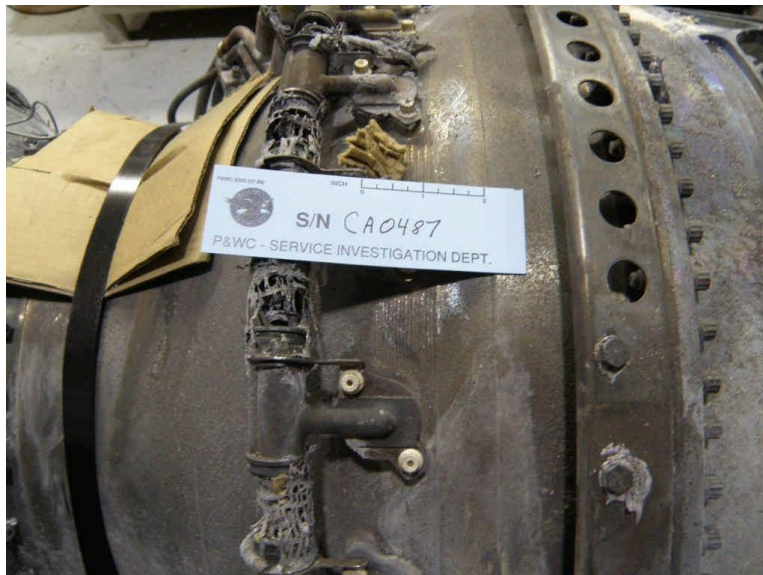
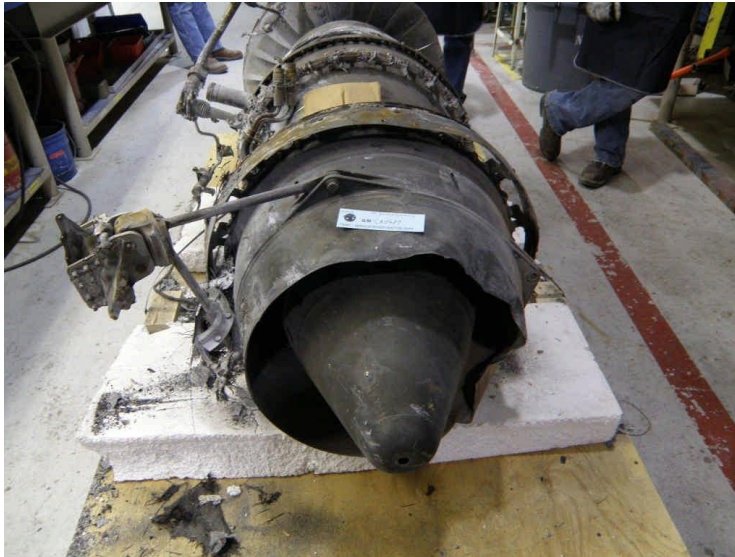
The engine was received in a shipping container and was opened with FAA oversight. The engine displayed extensive fire damage. The fan case, intermediate case, bypass ducts, and the accessory gearbox housing were completely obliterated by the event fire (Ref. Photo No. 13-16). The engine data plate was not received with the engine.

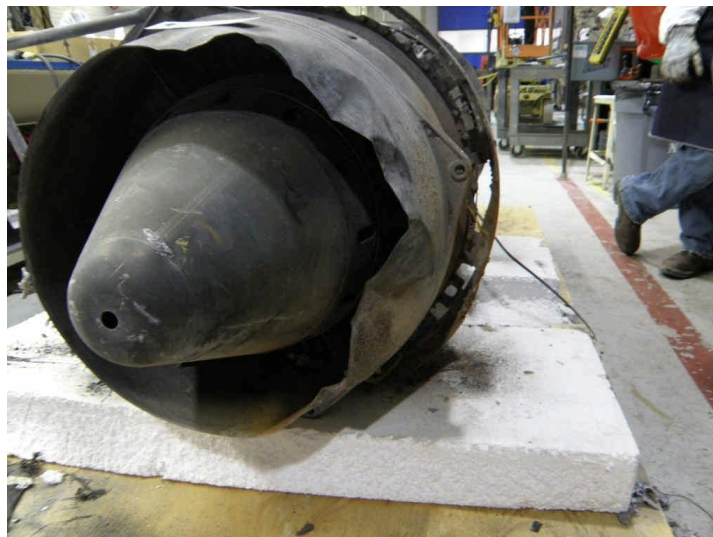
Photo No. 17

Exhaust Duct: The rear faring of the case was bent and was externally discoloured from the fire (Ref. Photo No. 17). There was no evidence of any impact damage on the gas path exposed surfaces.

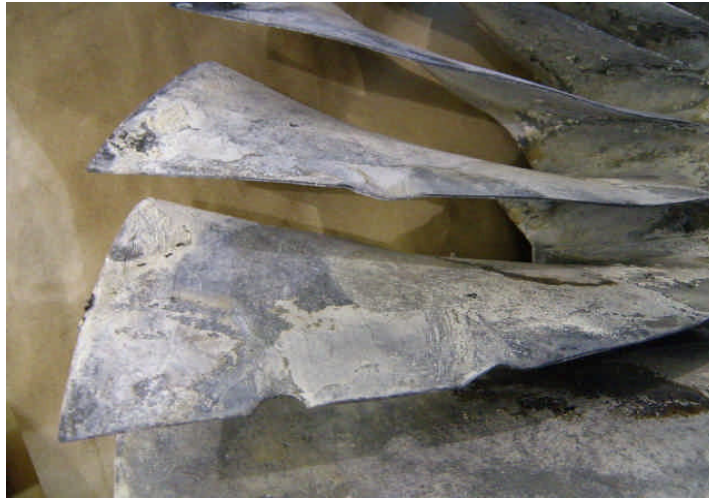
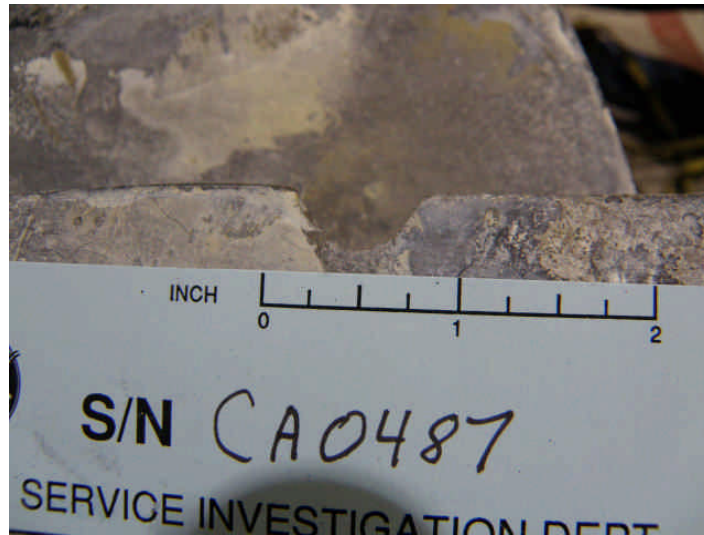
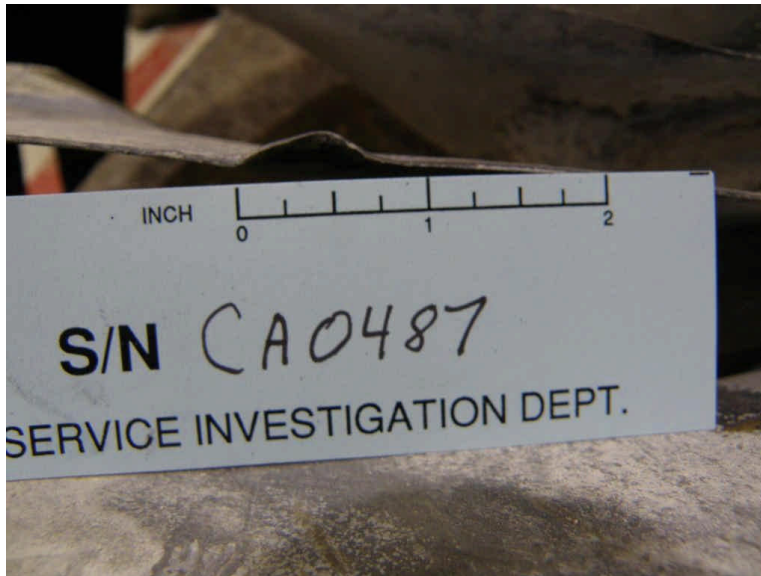
The right-hand engine's low-pressure compressor was capable of being rotated manually when the engine was suspended from a hoist. The high-pressure compressor was not capable of rotation. It could not be determined if the dents on the fan blades were pre existing or if they occurred during the event. The soot covered, heat discolouration, melted, obliterated, and damaged components were attributed to the external fire. The organic debris found in the combustor suggests the engine had rotation during the event in order to ingest the organic debris. The fuel shut off plunger pin did not exhibit any scoring on the face indicating the fuel shut off valve had not been activated by turbine displacement.

LP Compressor Fan: All of the blades were discoloured. Two blades exhibited impact damage (Ref. Photo 18). One blade exhibited impact in the downstream direction. The other blade showed impact damage in the downstream direction (Ref. Photo No. 19) and impact damage in the upstream direction (Ref. Photo No. 20). Three blades also exhibited minor impact damage to the trailing edge of the blades. The blade tips exhibited very light rubbing witness marks.

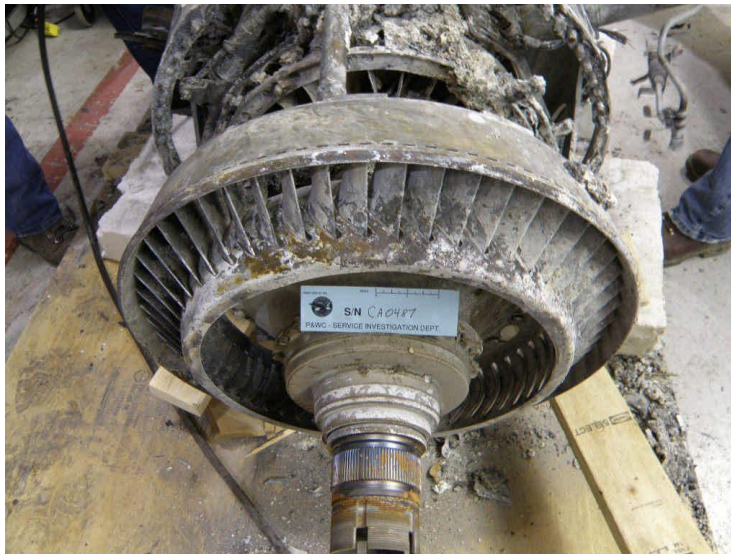
Photo No. 21

Compressor Core Stator: The stator was intact except the rubber grommets were completely obliterated from the fire. The stator was discoloured from the fire (Ref. Photo No. 21).

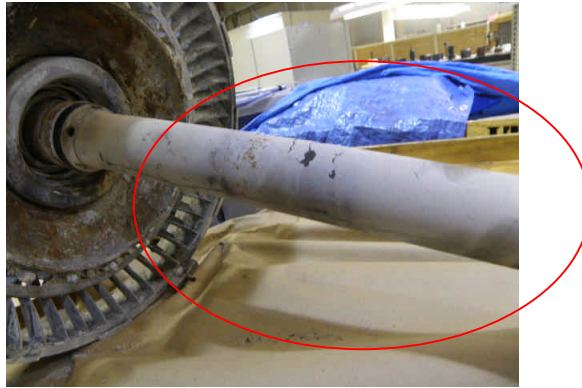
Photo No. 22

LP Compressor Shaft: The fan assembly splines and nut threads were corroded. The coating was discoloured and peeling at the centre section of the shaft (Ref. Photo No. 22).

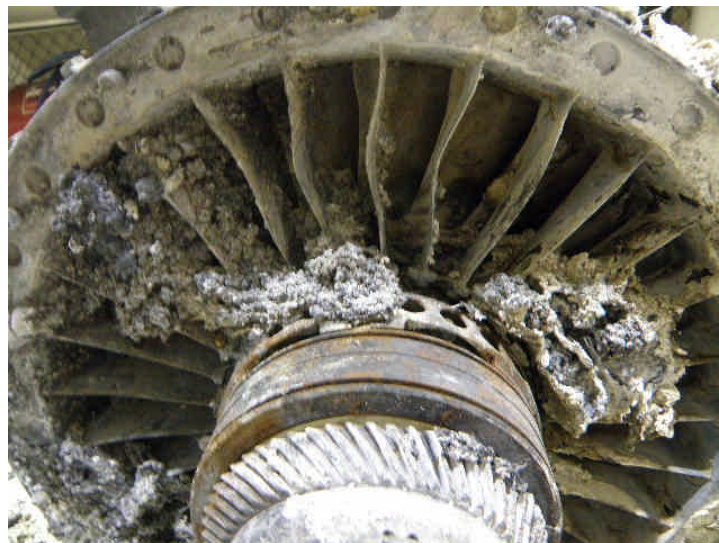
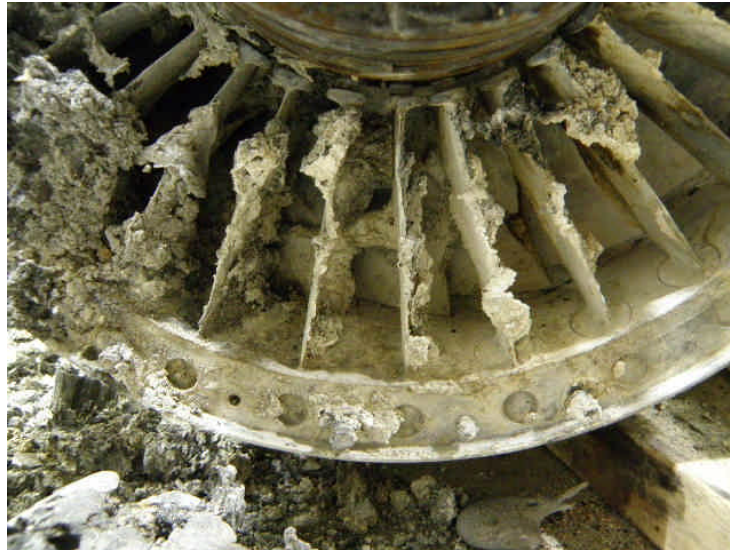
Variable Inlet Guide Vanes: The vanes were in the open position. Several of the airfoils were distorted from the fire and melted/burnt debris was evident (Ref. Photo No. 23 & 24).

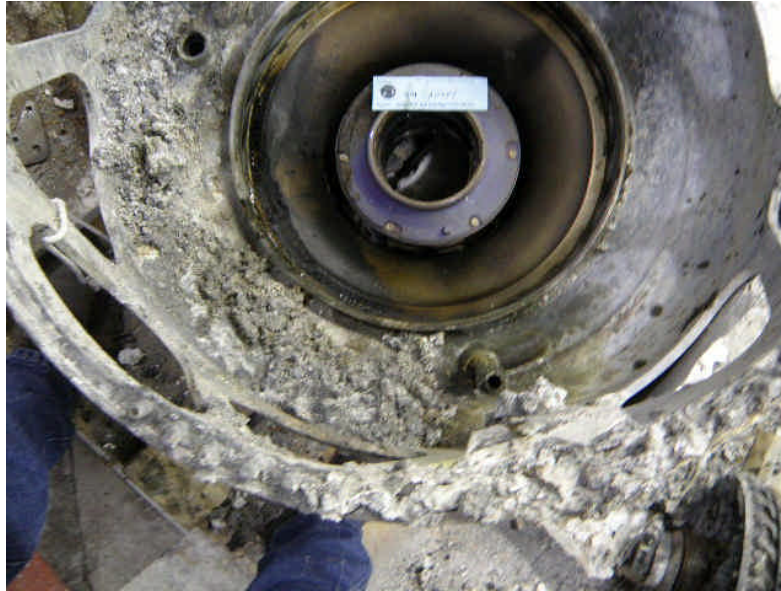
Photo No. 25

Gas Generator Case: The case was intact but was discoloured from the fire (Ref. Photo No. 25)

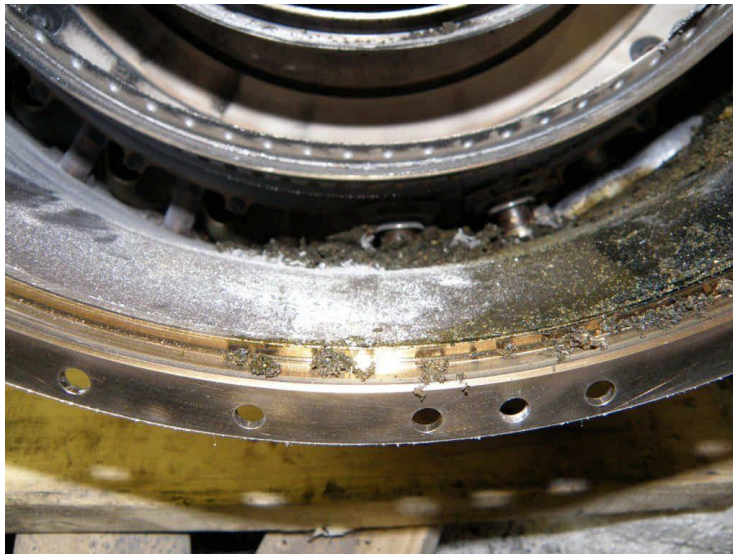
Photo No. 26

Combustor Case: The case was intact but was discoloured from the fire and was not penetrated. Organic matter was observed between the case and the combustion chamber liner (Ref. Photo No. 26).

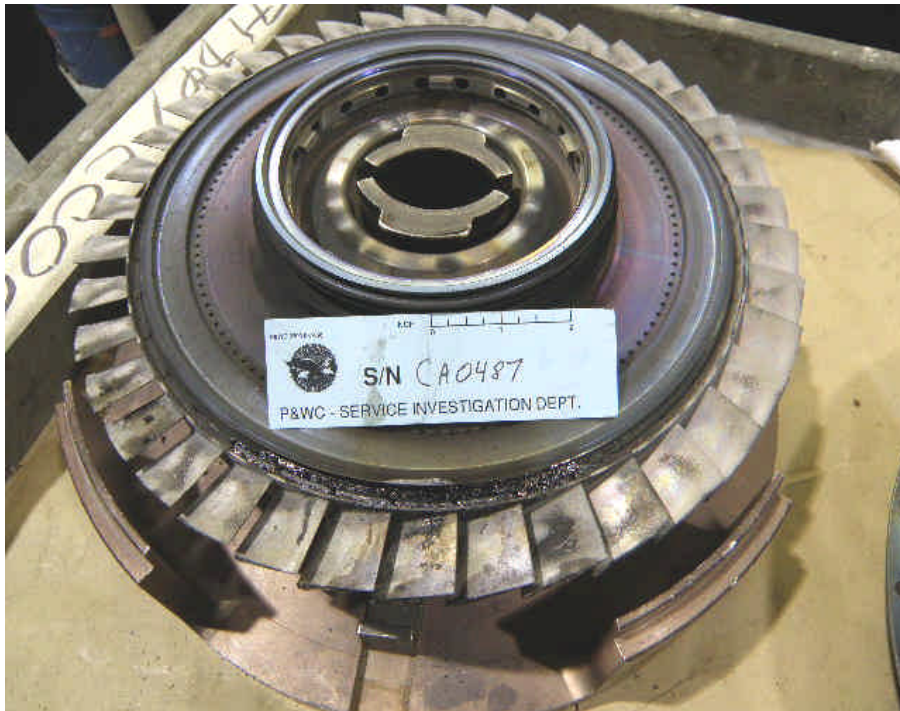
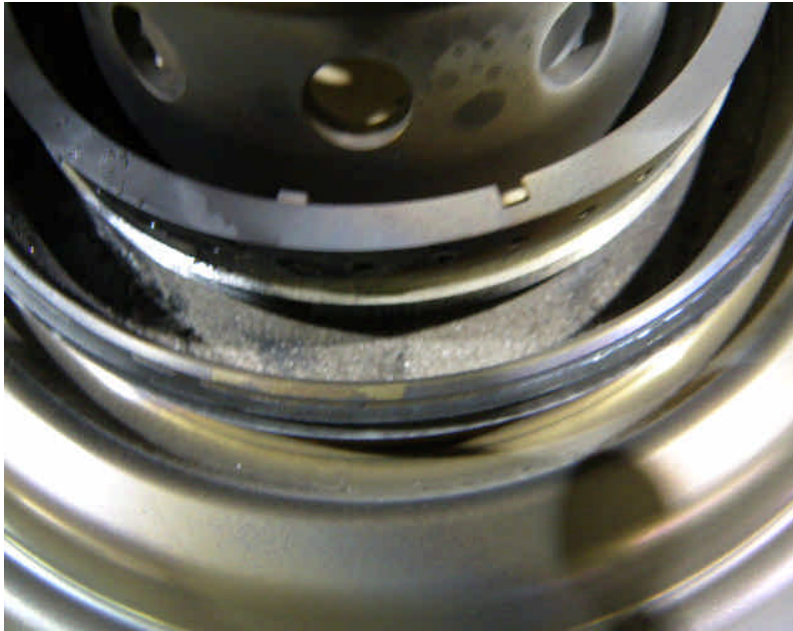
1st Stage HP Turbine: The turbine had some oil staining (Ref. Photo No. 27) and sand was noted between the front cover and the disk (Ref. Photo No. 28).

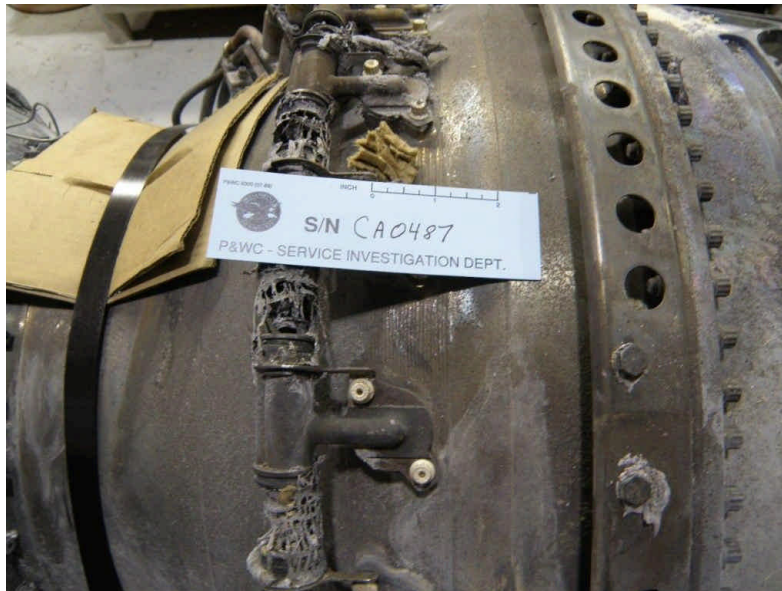
Photo No. 29

Fuel Nozzles: The fuel nozzles were not removed. The fuel manifold outer tubes from 9-3 o'clock positions were obliterated from the fire and the centre of two of the inner fuel manifold tubes were also obliterated from the fire (Ref. Photo No. 29).
