**NATIONAL TRANSPORTATION SAFETY BOARD  
OFFICE OF AVIATION SAFETY  
WASHINGTON, D.C. 20594**

**POWERPLANTS GROUP CHAIRMAN'S FACTUAL REPORT OF INVESTIGATION**

NTSB ID No.: DCA97MA017

Location: Monroe, Michigan  
Date: January 9, 1997  
Time: 1554 eastern standard time (EST)  
Aircraft: Embraer EMB-120RT, N265CA, Comair, Flight No. 3272

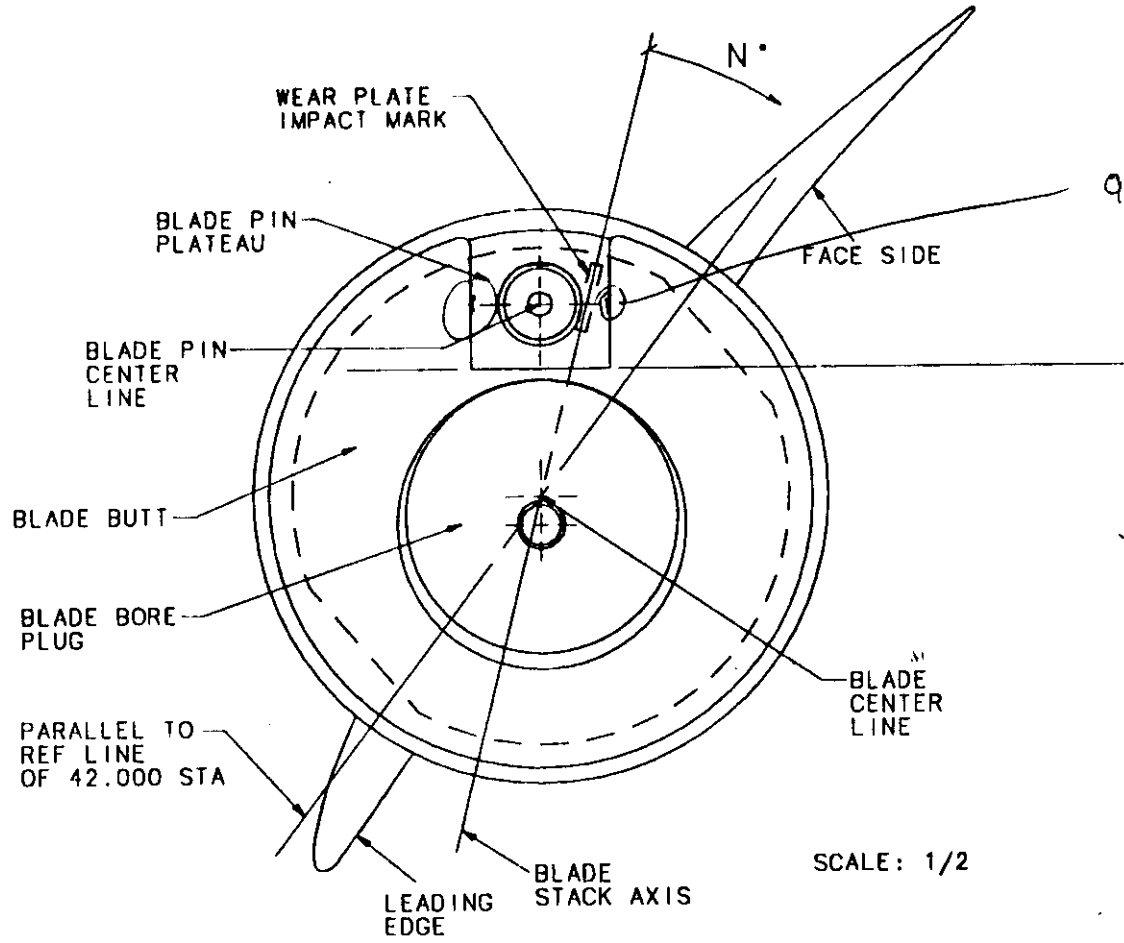
ATTACHMENT 1

92° @ 2 LOCATION  
LIGHT MARKS

92 MEASURED  
- 53  
39° @ P42

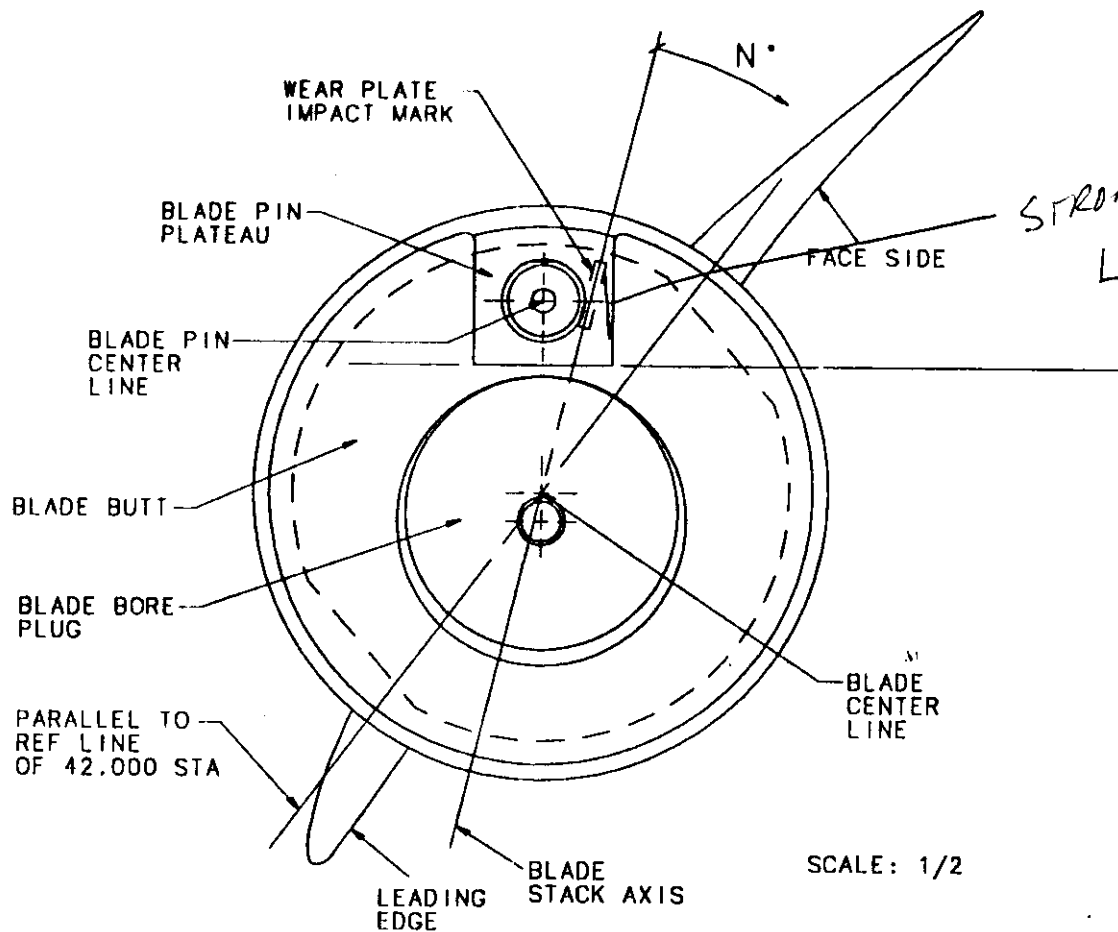
ATTACHMENT 2

BLADE PN: RF11AA1-6A  
 BLADE SN: 887784  
 INSTALLED LCTN: L4  
 SITE LCTN: L1

91  
 - 53  
 -----  
 38°

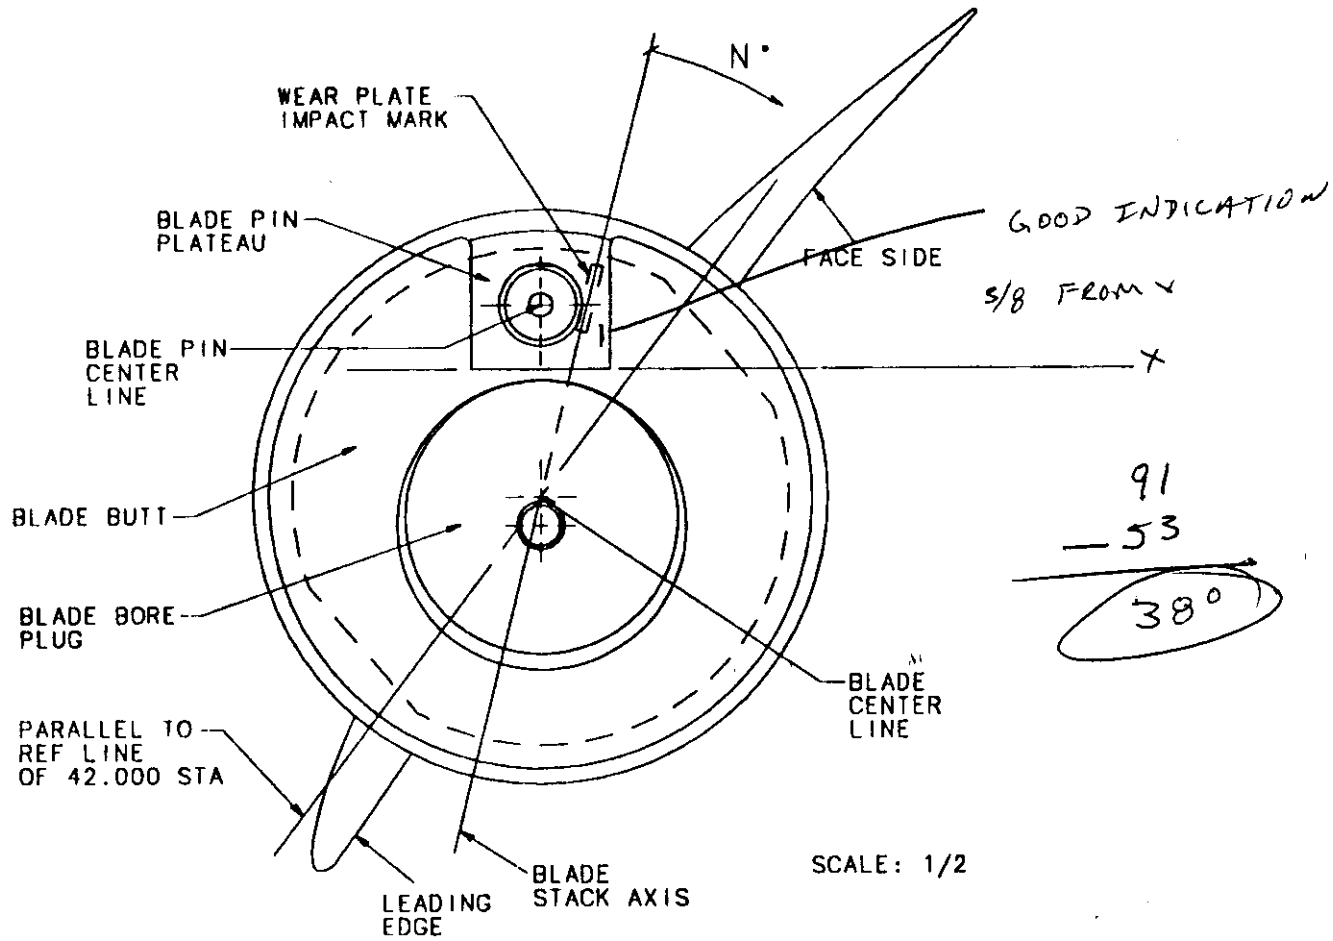
ATTACHMENT 3

BLADE PN: RF11AA1-6A  
 BLADE SN: 887779  
 INSTALLED LCTN: L3  
 SITE LCTN: L2

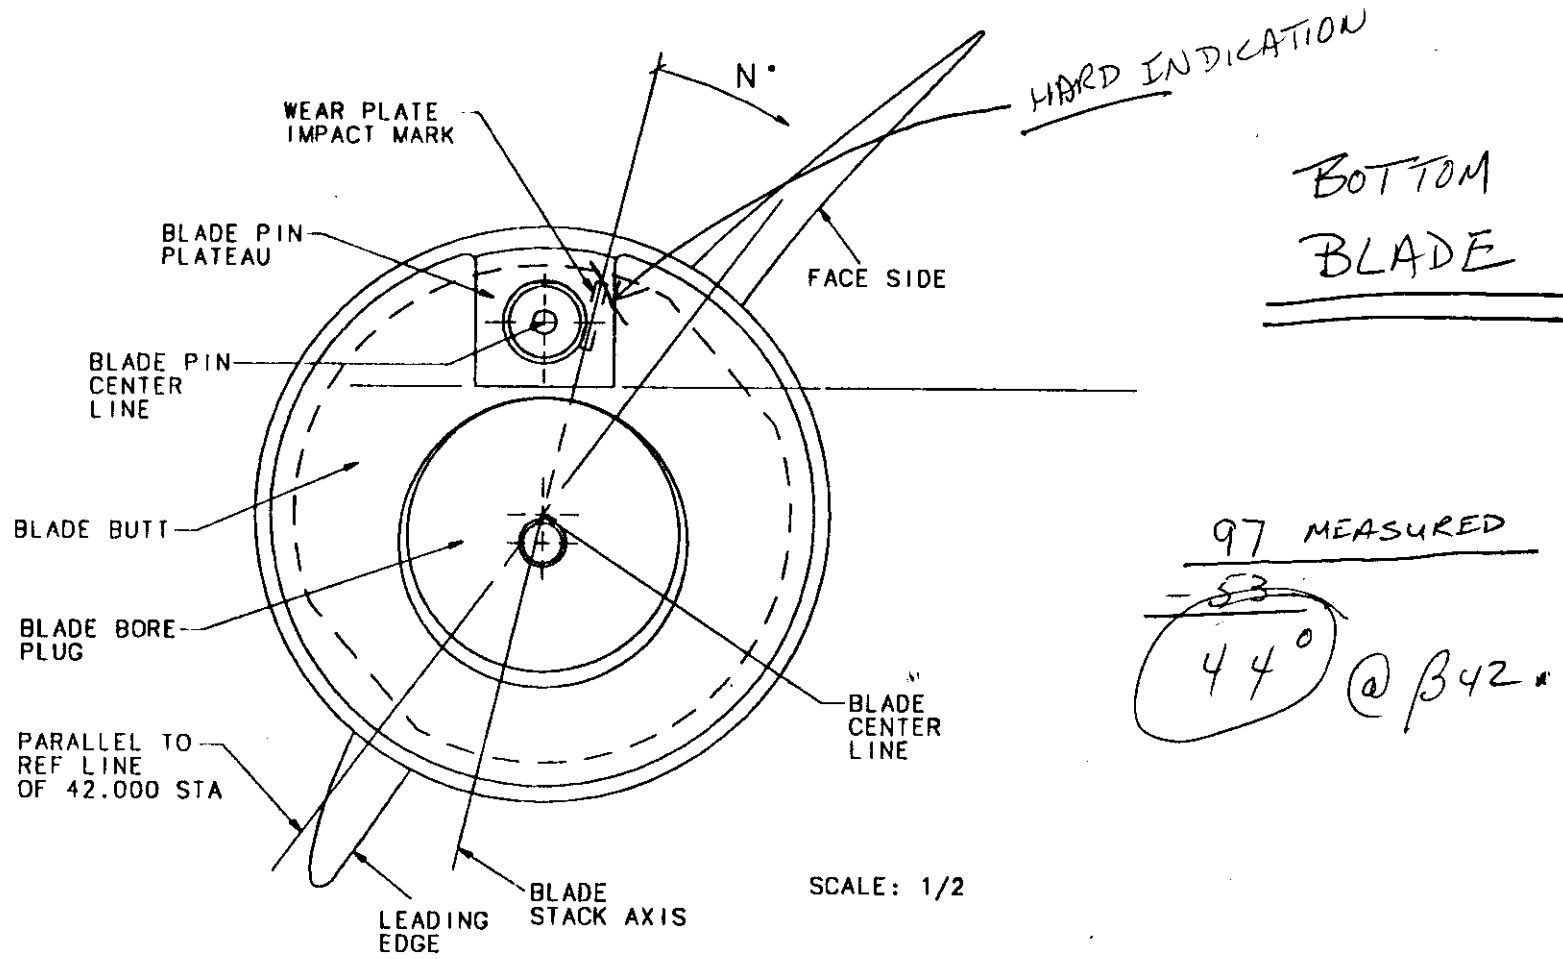
BLADE PN: RFC11A1-6A  
 BLADE SN: 887782  
 INSTALLED LCTN: L2  
 SITE LCTN: L3

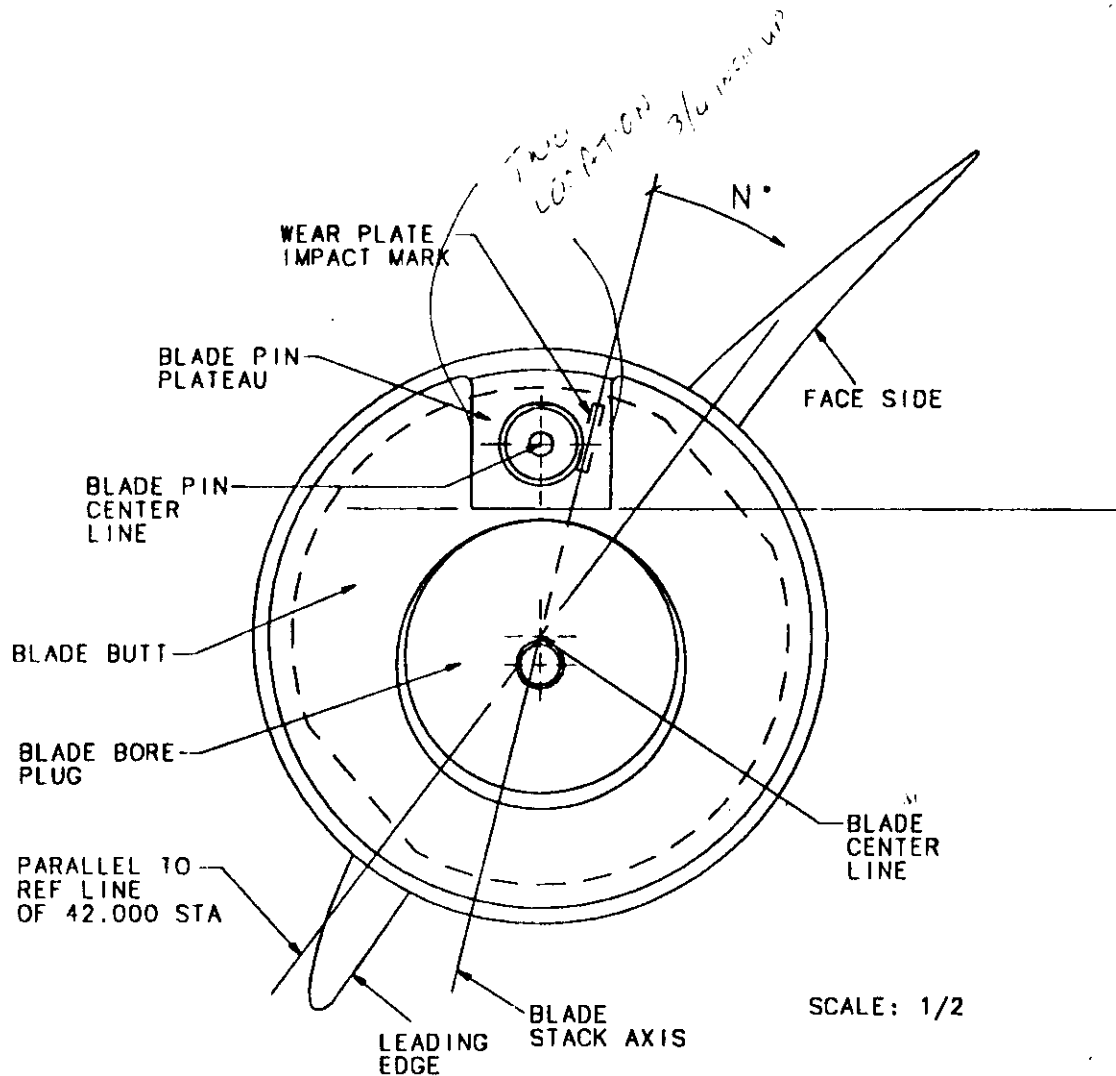
ATTACHMENT 4

BLADE PN: RFC11AA1-6A  
 BLADE SN: 88779Z  
 INSTALLED LCTN: L1  
 SITE LCTN: L4

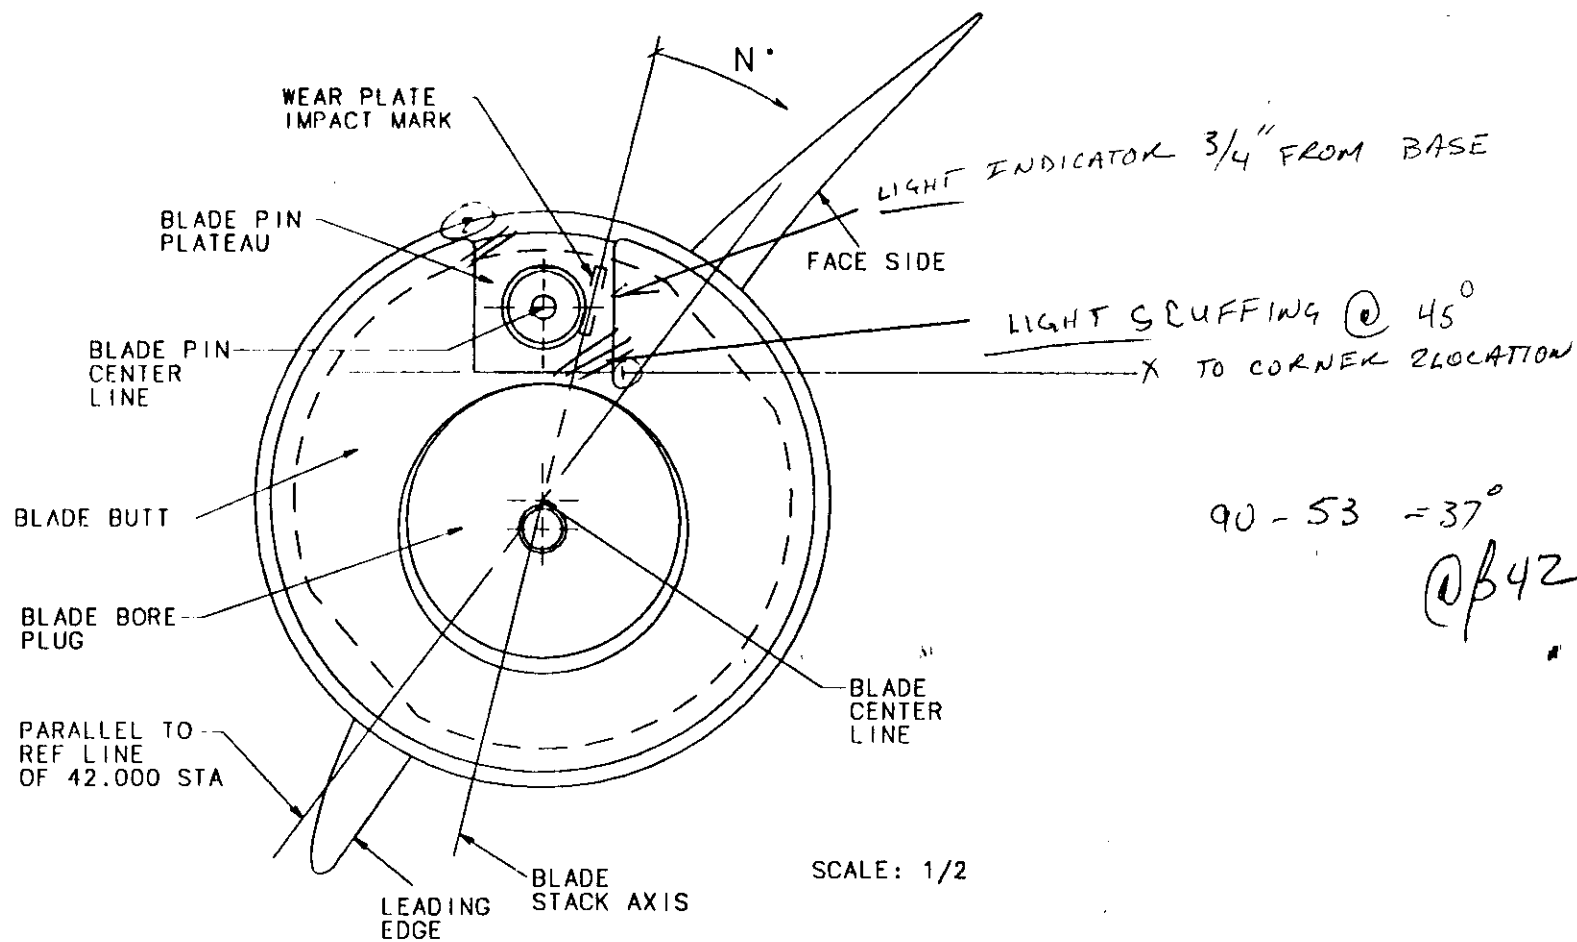
Attachment 5

BLADE PN: RFC11N1-6A  
 BLADE SN: 872581  
 INSTALLED LCTN: R1  
 SITE LCTN: R1

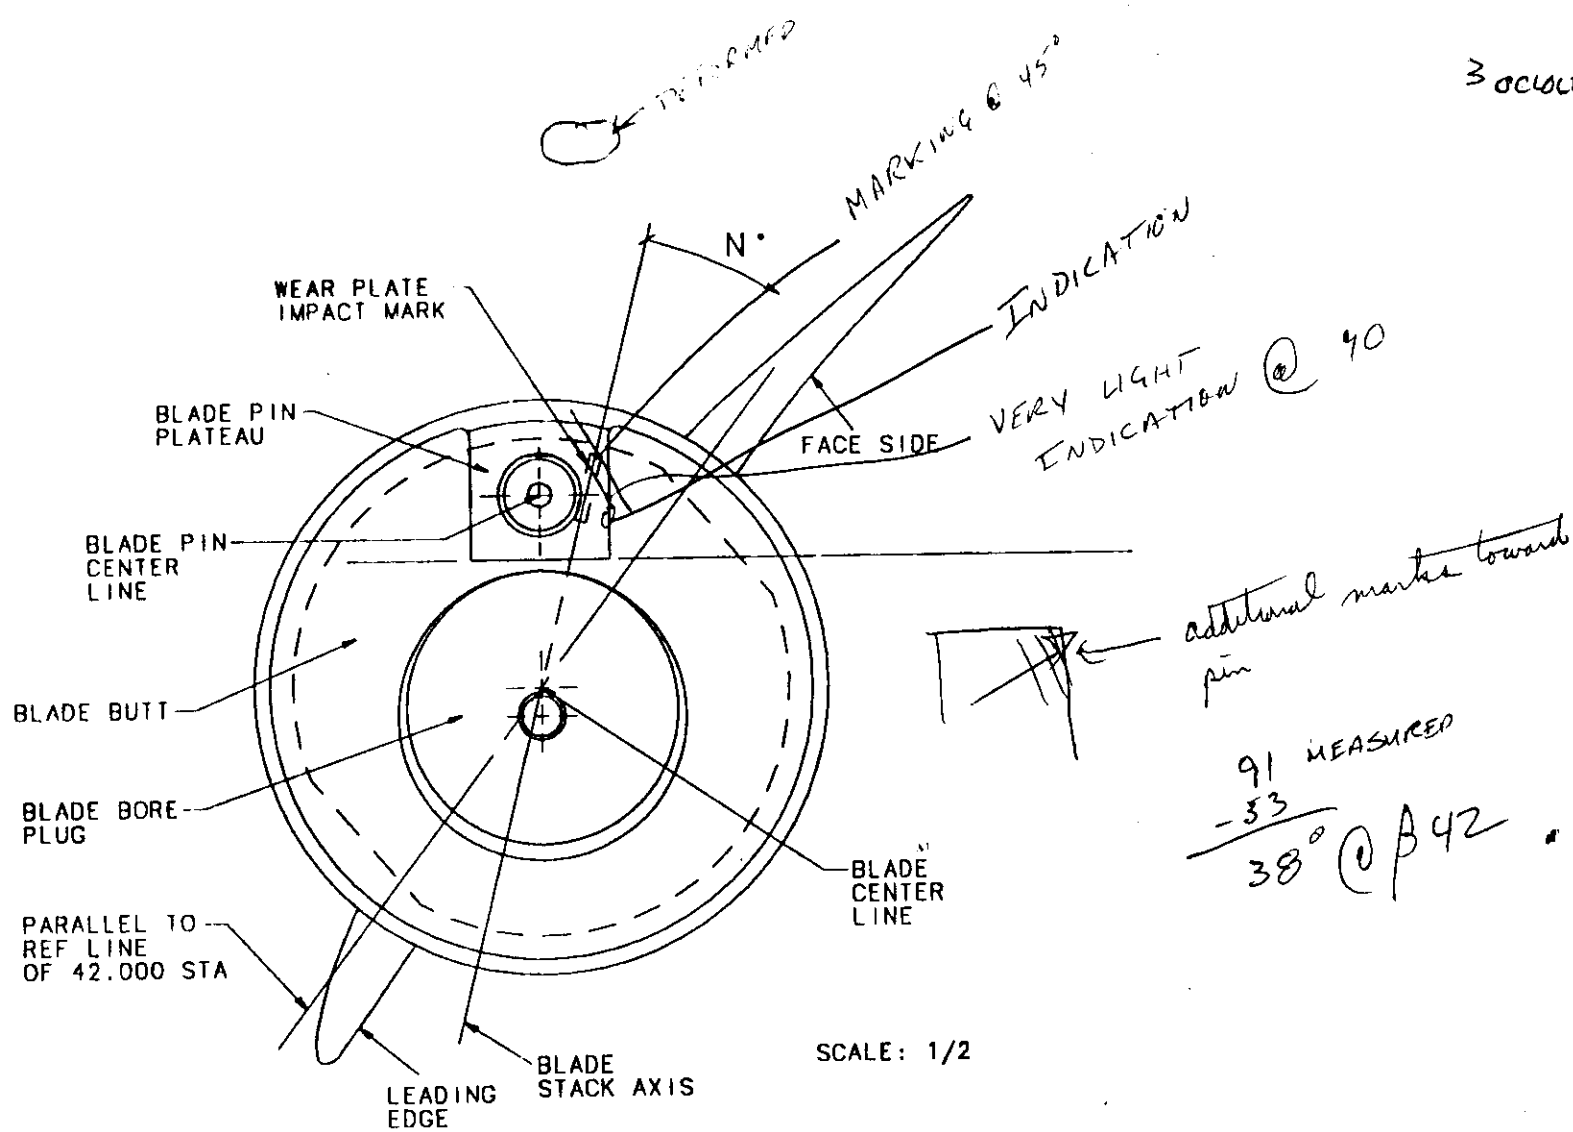
ATTACHMENT 7

BLADE PN: RFC1111-6A  
 BLADE SN: 868008  
 INSTALLED LCTN: R2  
 SITE LCTN: R2

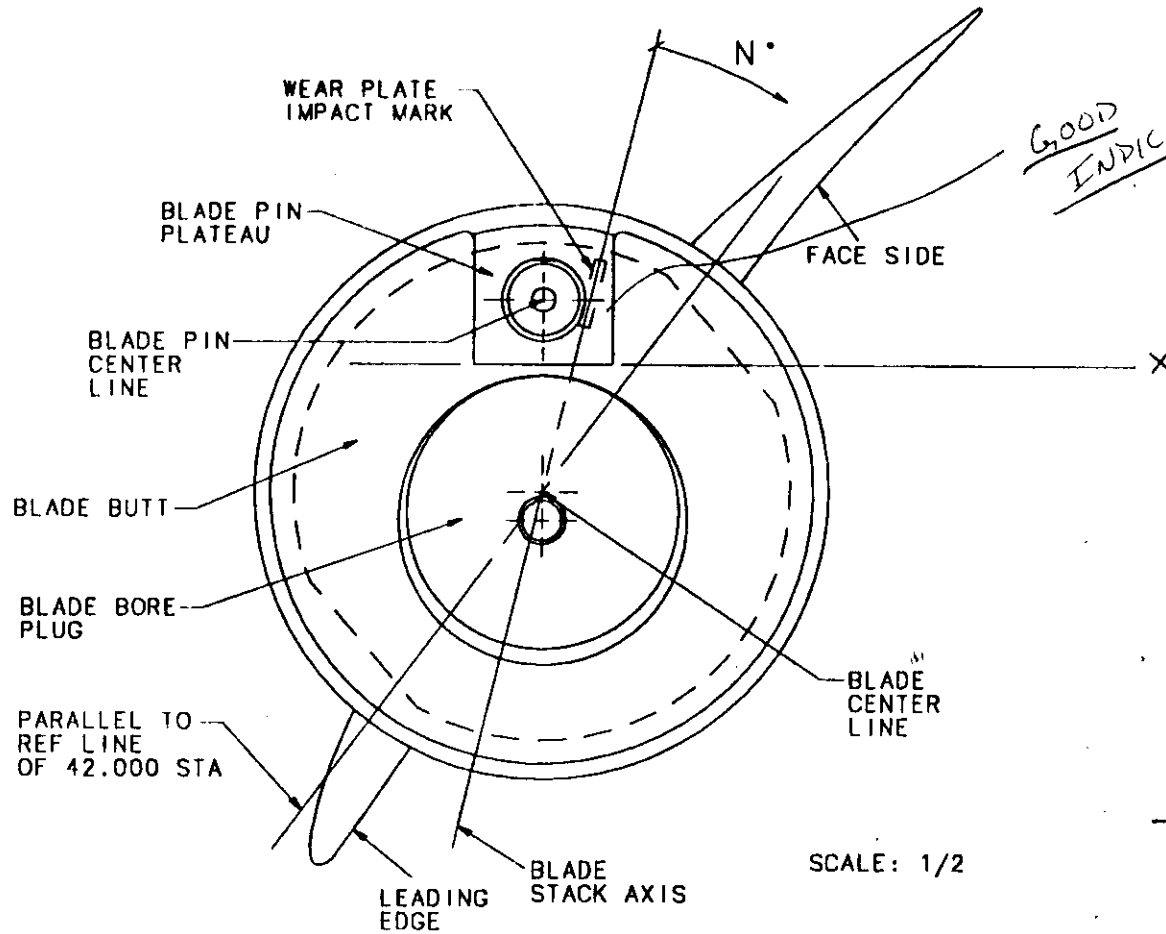
SITE LCTN: R3

6 o'clock  
LOW  
BLADE

GOOD  
INDICATION

$$\begin{array}{r}
 91^\circ \\
 - 53^\circ \\
 \hline
 38^\circ @ 42 \text{ STA}
 \end{array}$$
