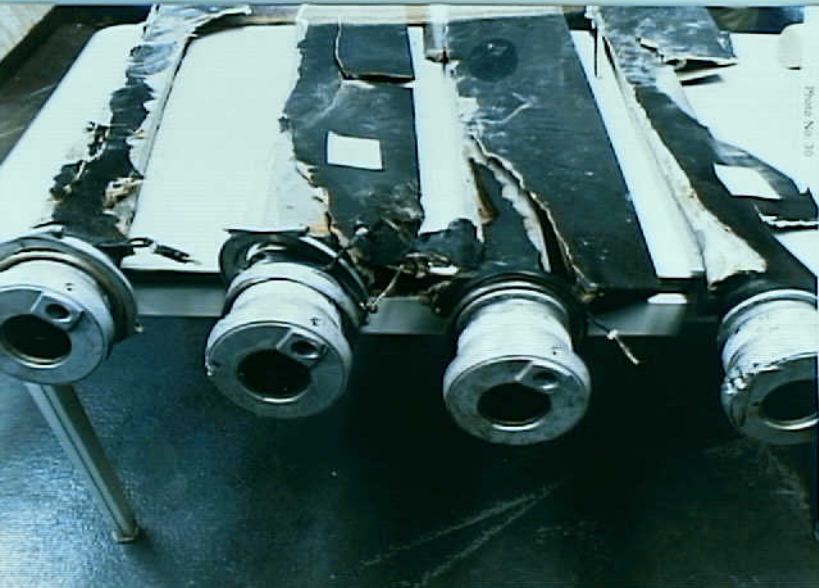
Powerplants 8 - Photo 30. Right propeller blades showing damage to leading edge and missing deicing
