NATIONAL TRANSPORTATION SAFETY BOARD
Office of Aviation Safety
Washington, D.C. 20594

POWERPLANT FACTUAL REPORT

NTSB No: ENG11IA043

Aircraft: McDonnell Douglas DC-9-51, Registration No. N676MC, Delta Air Lines

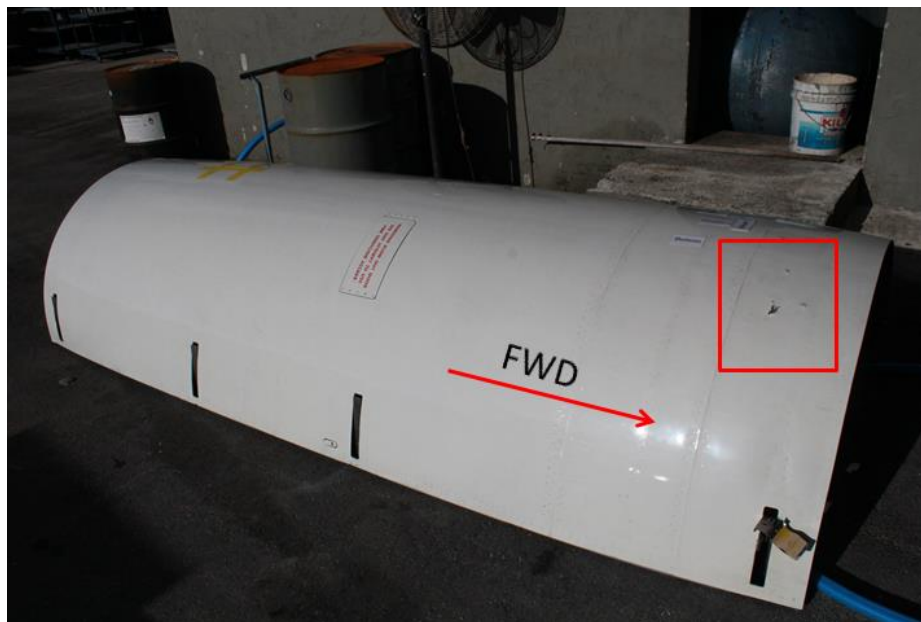
Photo 1- Upper Cowling Damage

The upper cowling exhibited multiple dents and penetrations 6 to 8 inches aft of the cowl leading edge, from the 1 to 2 o'clock positions (**Photo 1**). The largest cowl penetration point aligned with a hole in the engine case aft of the B1 flange (**Photo 2**). The lower cowling was intact and in good condition.

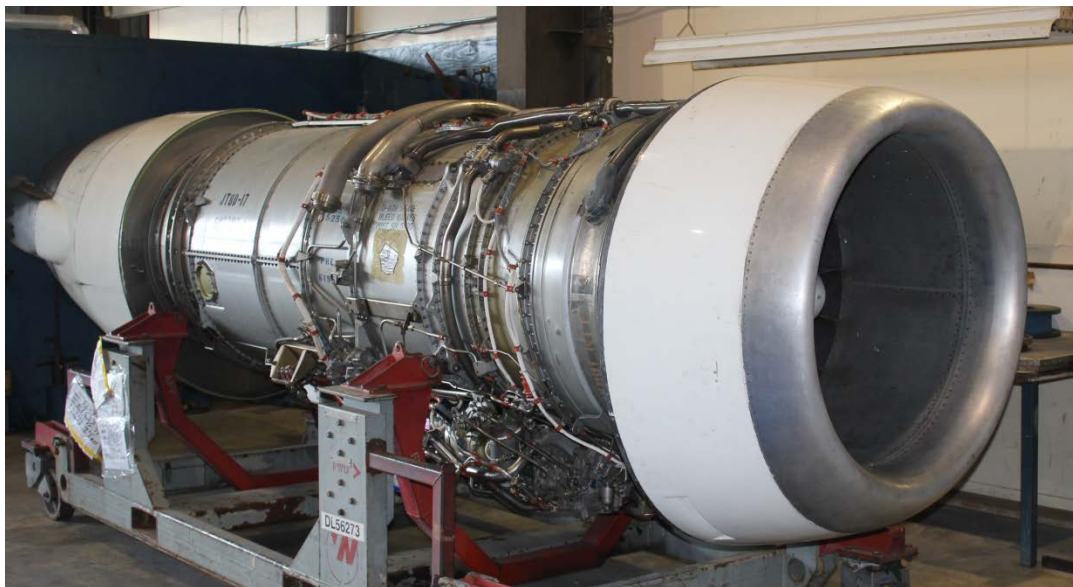
Photo 3- Right Side of Engine, As Received

The engine was kept in its shipping stand for inspection and limited disassembly (**Photos 3 and 4**). The engine did not exhibit indications of an under cowl fire but had multiple compressor case breaches. A case penetration was located at the hush kit inlet extension, aft of the B flange at the 1 o'clock position (**Photo 5**). Small non-penetrating interior impacts were located in the same axial location from the 2 to 4 o'clock and 6 to 12 o'clock positions. Between the C and D flanges, there was a non-penetrating case dent 8 inches in length at the 2 o'clock position. Between the D and E flanges there was a small dent at the 2 o'clock position, a small penetration at the 5 o'clock position, and an airfoil fragment was found sticking out of the case at the 6 o'clock position. There were multiple small case dents with cracks extending from the dent impacts between the 1 and 5 o'clock positions.

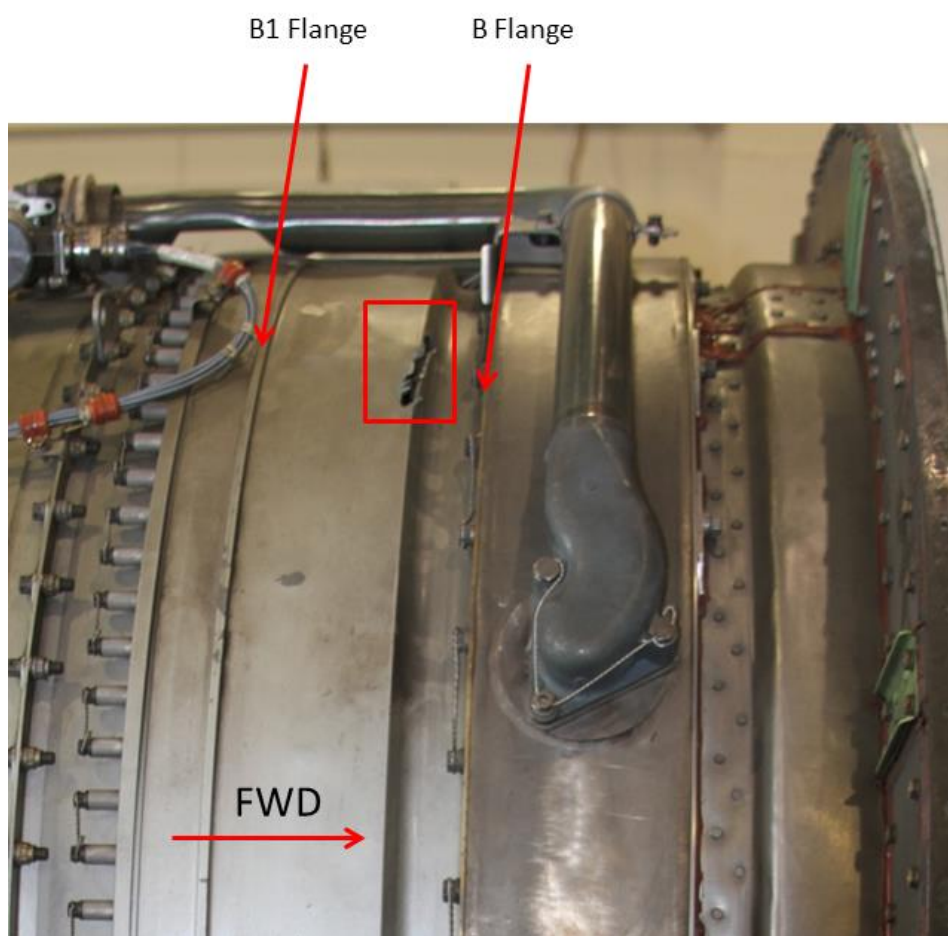
Photo 5- Compressor Case Puncture, Aft of B Flange

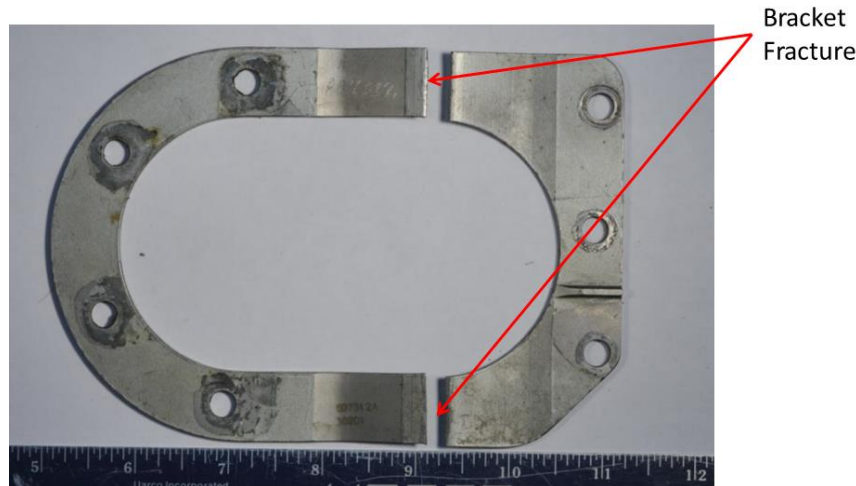
The fuel control, generator, hydraulic pump and other external components were intact and in place with no visible damage. The fuel oil cooler aft mounting bracket was buckled and fractured at two locations (**Photo 6**). The fuel oil cooler oil outlet tube was dented near the quick engine change throttle flex cable bracket, which had been removed prior to engine shipment. The forward nut on the oil pressure transmitter was found loose.

Photo 6-Fuel Oil Cooler Aft Mounting Bracket, Fractured Two Locations

The fuel oil cooler aft mounting bracket fracture surfaces exhibited smearing and ductile dimples consistent with rapid tensile overload.

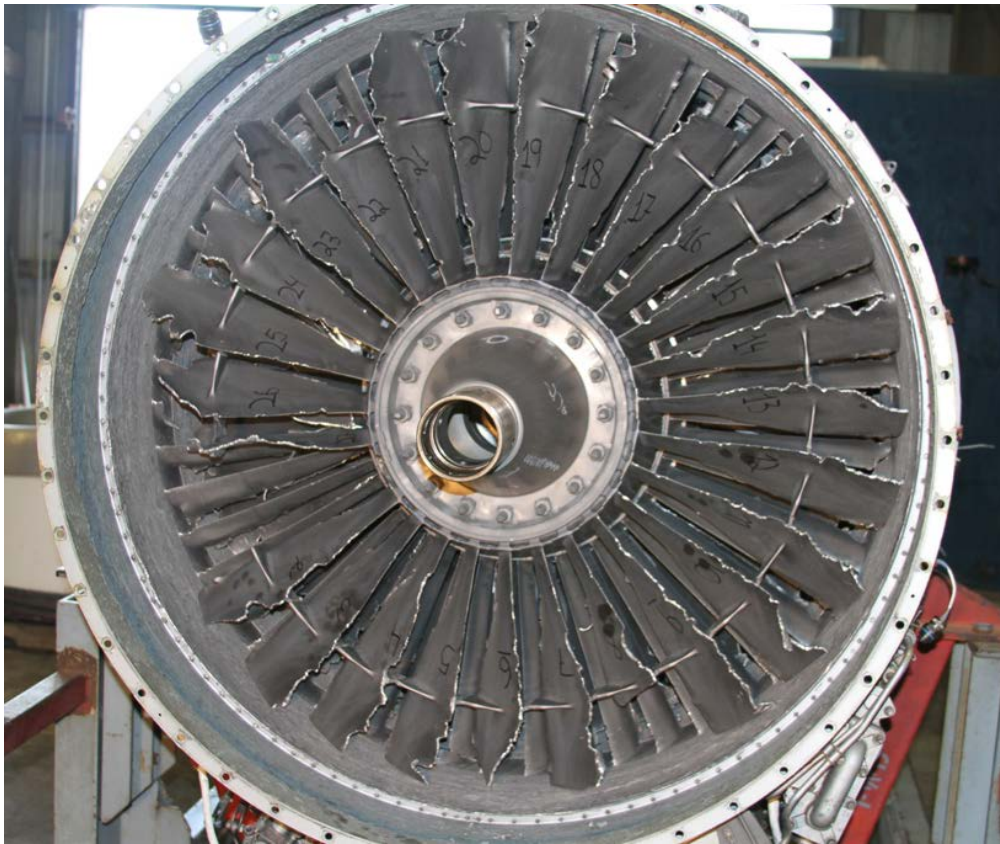
The fan rotor exhibited extensive damage, and one fan blade was separated below the platform. The separated blade root was still present in the fan hub blade slot (**Photos 7 and 8**). Two sections of the separated blade airfoil were recovered within the engine at ATL and sent in a separate box with other collected engine debris. The separated blade was labeled as blade No. 1 and the remaining 26 blades were numbered sequentially in the clockwise direction.

Photo 7- Fan Rotor Damage

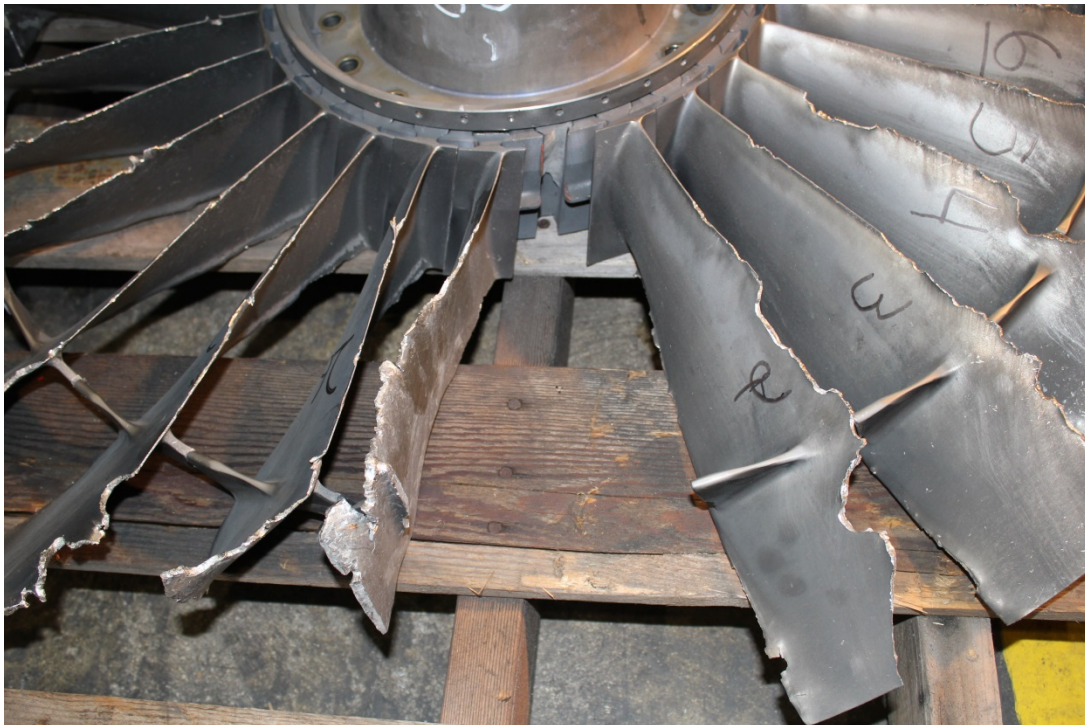
Photo 8- Fractured Fan Blade, Blade Root Still Present in Slot

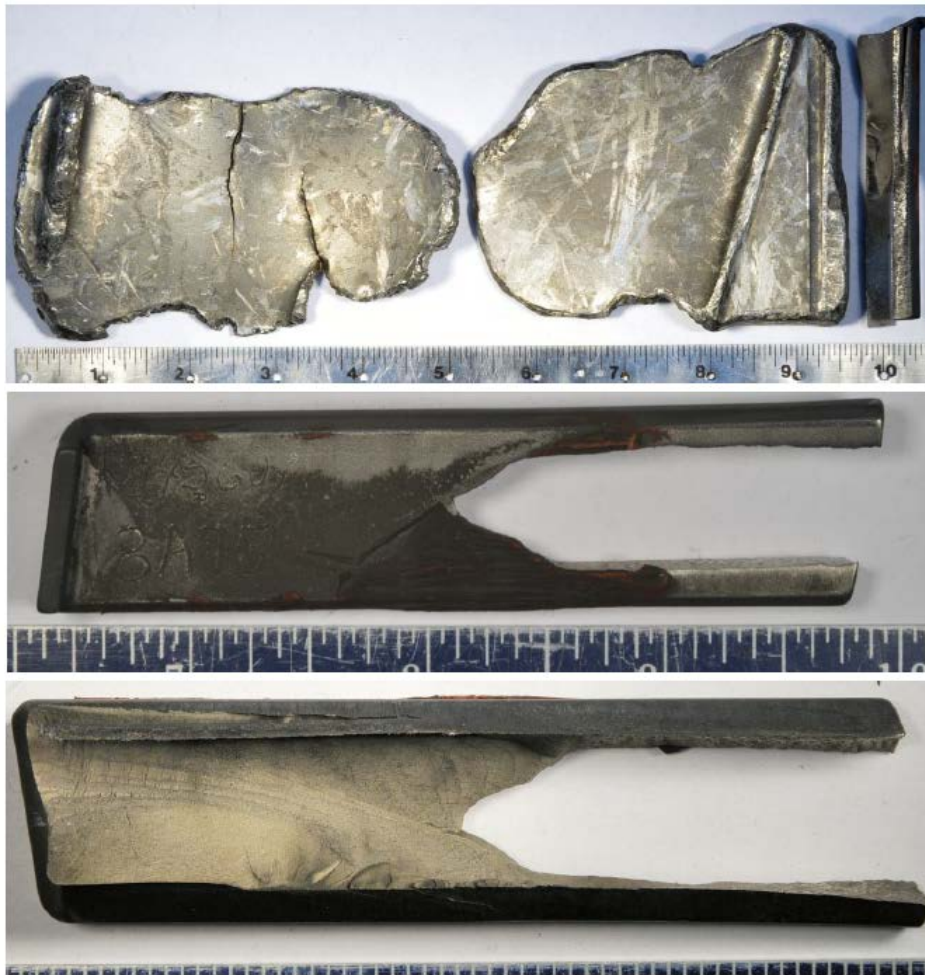
Visual and binocular examination of the separated No. 1 fan blade pieces identified two chord-wise fractures, one at the root and a second just below the blade mid-span (**Photo 9**). The root fracture origin was located approximately 0.9375 inch aft of the leading edge on the suction side of the blade. Examination by scanning electron microscope noted feathery cleavage features progressing from the origin consistent with high cycle fatigue. No anomalies were identified around the crack origin that may have contributed to the blade failure. The failure mode of the two airfoil sections could not be determined due to secondary damage to the fracture surfaces.

Photo 9- Fractured No. 1 Fan Blade Recovered in Three Pieces

P&W has identified excessive leading edge erosion as a contributing factor in fan blade high cycle fatigue fractures due to a flutter like vibratory response it causes in the blade. According to the P&W JT8D-17 repair manual during the blade overhaul procedure each individual blade must be removed from the fan disk and measured to ensure the chord length at multiple locations along the blade span are within allowable limits. If the fan blade meets minimum chord length requirements, a combination of tools are used to reshape the leading edge profile to optimize aerodynamic performance. A nominal leading edge thickness measurement between 0.024 and 0.030 inches at a point 0.030 inches from the leading edge of the blade is required for the fan blade scraping tool to properly seat on the blade surface. If the fan blade leading edge thickness measurements exceed 0.030 inches, sanders and files are used to decrease the thickness to nominal levels. Fan blade leading edge erosion, thickness and radius measurements collected from the incident engine are listed in **Table 1**. A complete copy of the P&W materials report is available as **attachment 1** to this report.

Pratt & Whitney released JT8D maintenance advisory notice, MAN-JT8D-2-06, on November 20, 2006. The notice recommends leading edge fan blade refurbishment every 4000 cycles to ensure the aerodynamic properties of the blade are maintained and is critical in avoiding excess erosion levels that cause increased blade vibration and high cycle fatigue cracks. The FAA subsequently released AD 2010-21-17 with an effective date of November 12, 2010 mandating fan blade leading edge overhaul after 4,000 cycles since the last blade overhaul was performed.
