**NATIONAL TRANSPORTATION SAFETY BOARD
OFFICE OF AVIATION SAFETY
WASHINGTON, D.C. 20594**

POWERPLANTS GROUP CHAIRMAN'S FACTUAL REPORT

NTSB ID No.: ERA15FA221

Location: West Columbia, South Carolina
Date: May 23, 2015
Time: 0921 Eastern Daylight Time
Aircraft: BR Legend LLC, Turbine Legend, N42BR

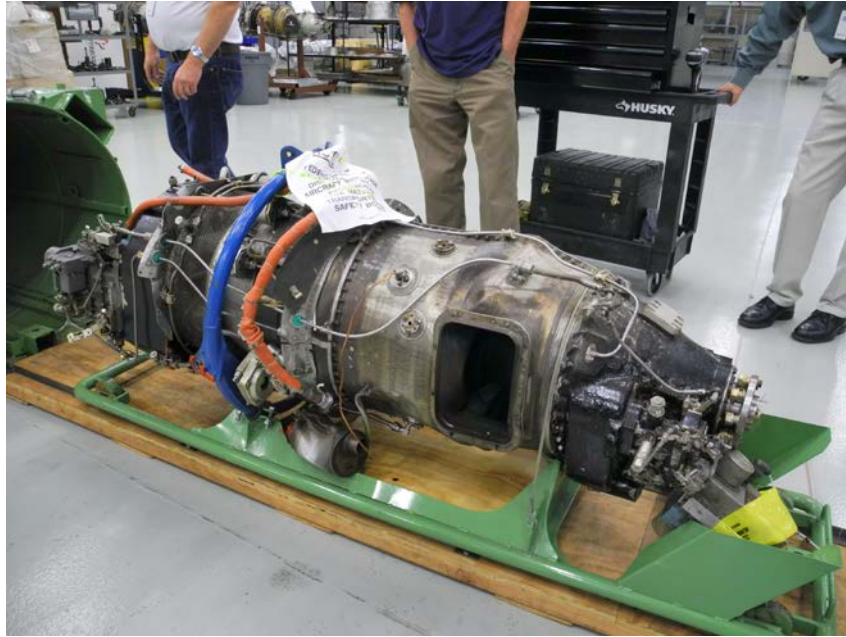
The exhaust case was intact; however, it was buckled around 270 degrees, with the damage occurring from the 10 to 7 o'clock² location. The buckling direction was generally outwards except around the right-hand exhaust stub where the direction was inward. The resultant of the buckling was an overall bending condition of the exhaust case which displaced the propeller shaft at the front of reduction gearbox (RGB) by approximately 1 inch to the right (Figure 8). Additionally, the angle of the RGB was changed by approximately 5 degrees to the right. The two exhaust flanges were intact; however, the right-hand stub and flange were deformed and buckled. The two RGB oil transfer tubes below the exhaust case were bent inwards. The inter-turbine temperature (ITT) connectors and boss were still installed in the exhaust case, and appeared to be undamaged. The propeller shaft could not be turned by hand.

Figure 8 – Exhaust Case Deformation

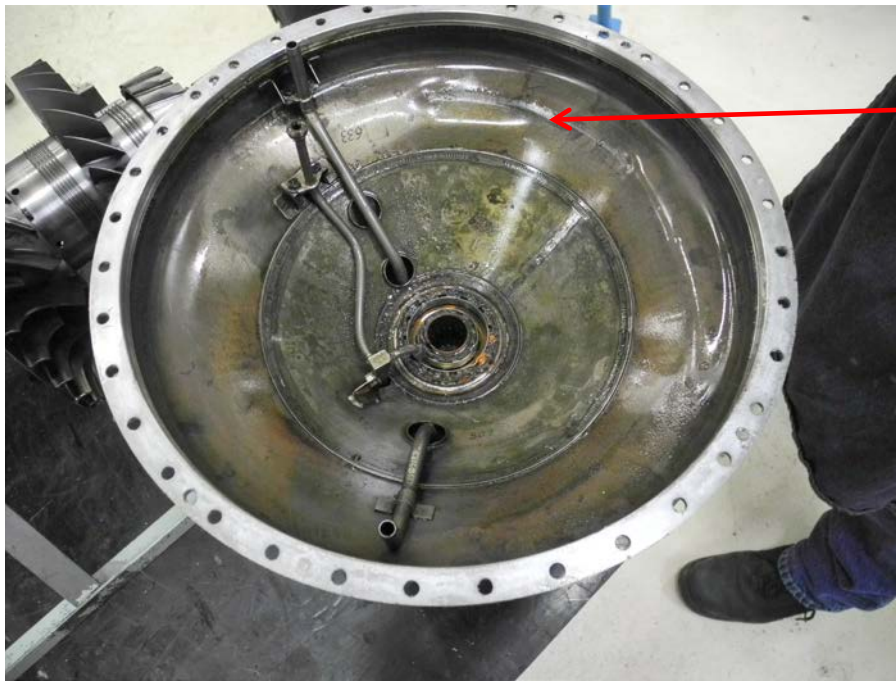
Arc
Shaped
Impact
Mark

Figure 24 – Reduction Gear Support Diaphragm

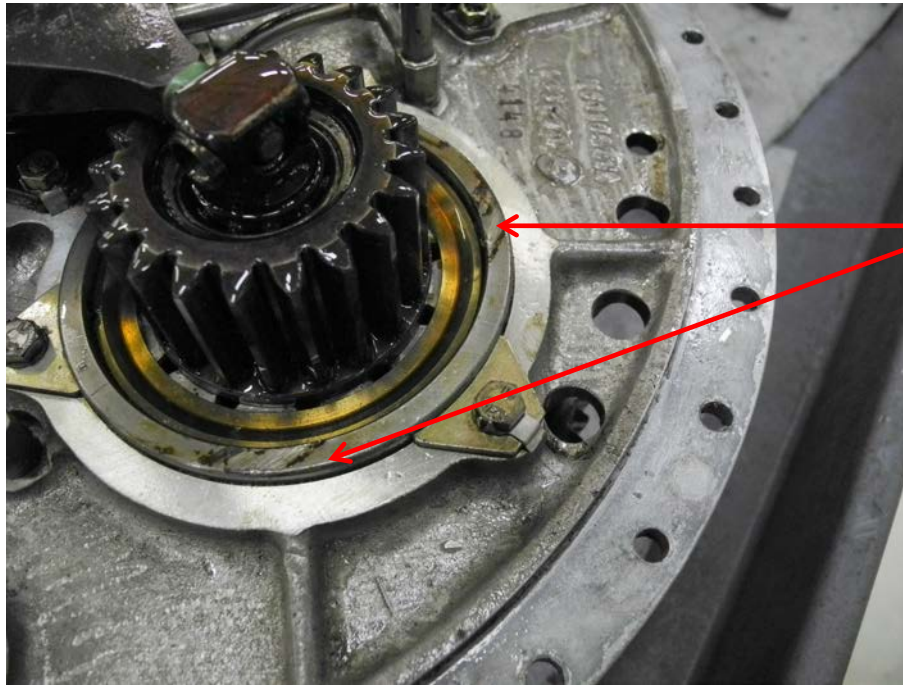
Rotational Score Marks Consistent with Contact Against Propeller Ring Gear

Figure 26 – Propeller Ring Gear – Rotational Scoring

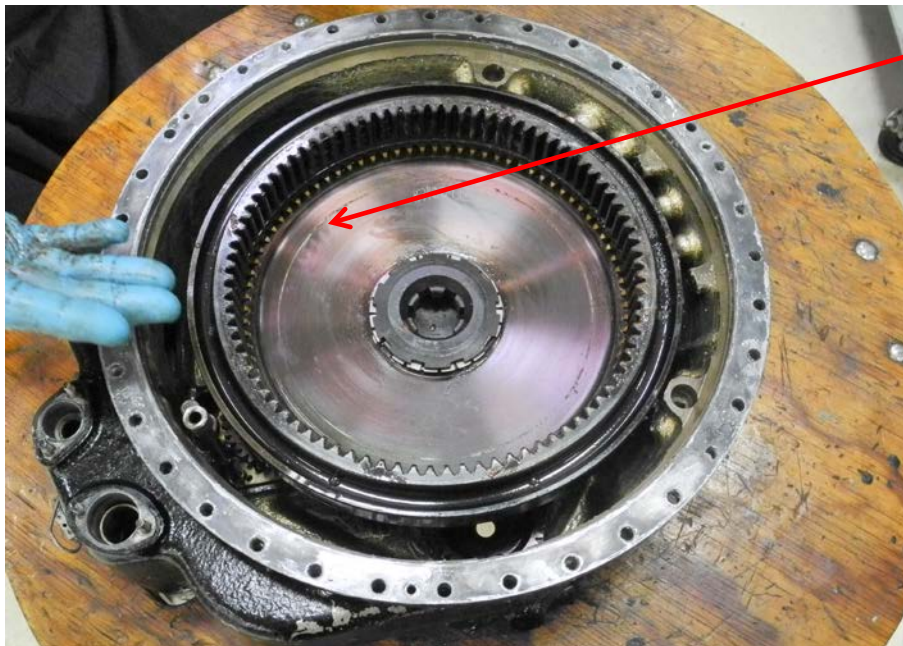
Rotational Scoring, Consistent with Contact Against the Tripod Gear Shaft Ends

Figure 27 - Tripod Gear Shaft Ends

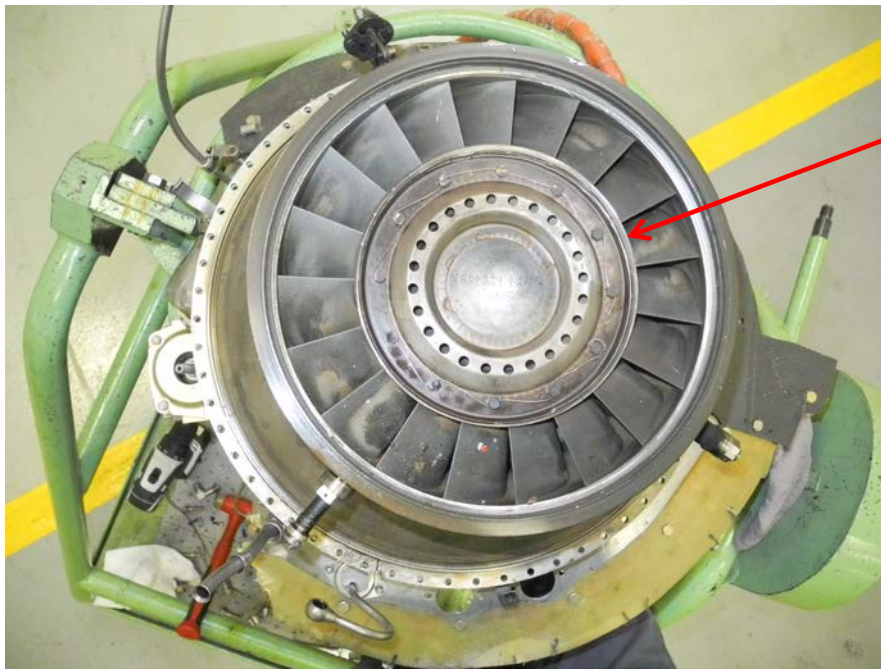
The GGT was intact and undamaged (Figure 32). No evidence of circumferential scoring could be observed. The GGT shroud was intact and undamaged. The GGT front roller bearing (N205) cage (Figure 33) was offset due to axial impact, which prevented the GGT rotor from rotating. Otherwise the bearing was intact.

Rotational Scoring

Figure 32 - Gas Generator Turbine (GGT) - Undamaged

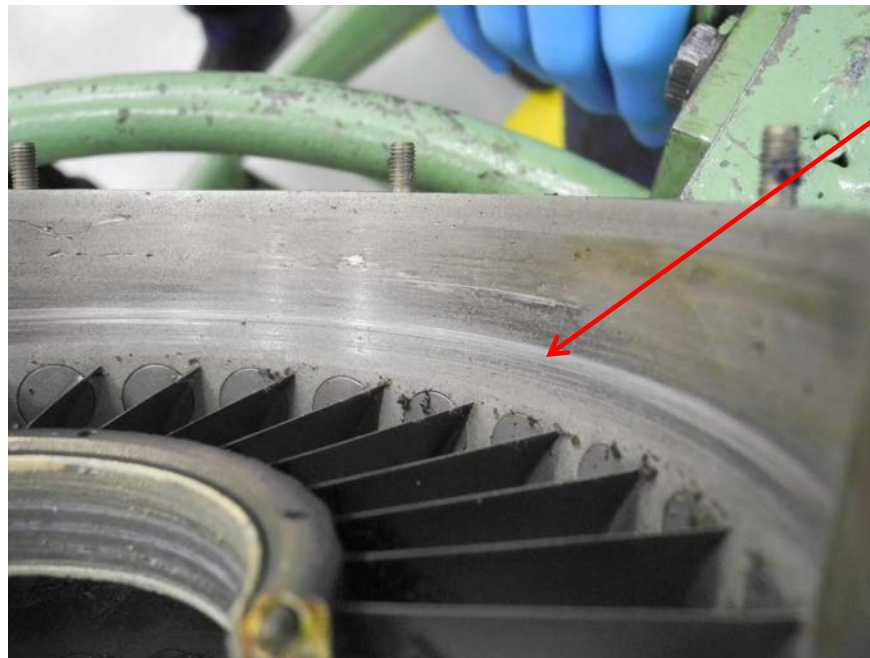
Scored Near the Trailing Edges of the 1st Stage Compressor Blades

Figure 38 – 2nd Stage Axial Compressor Shroud

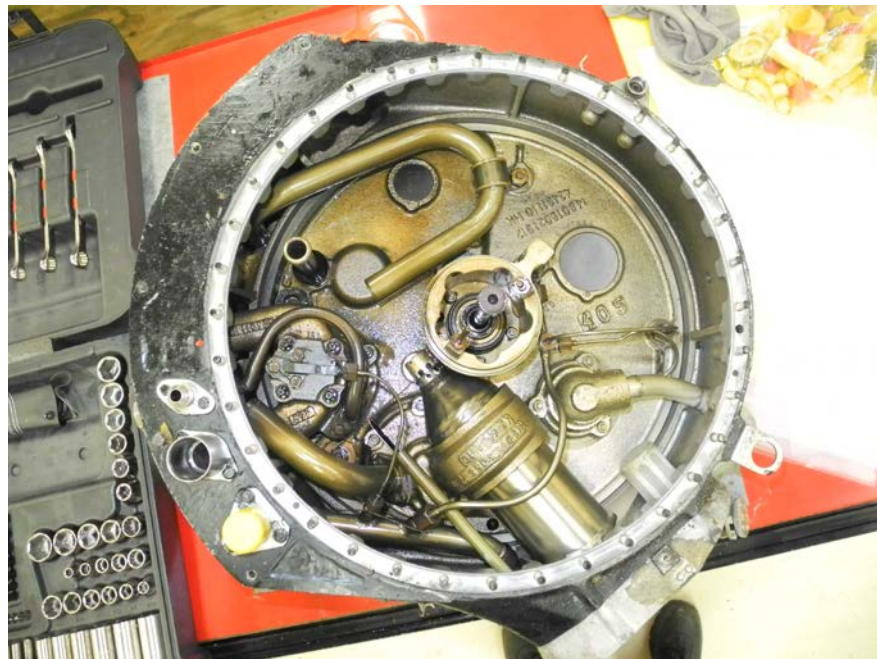
Figure 41 - Ignitor P/N 2201.03-8, S/N 297-8

The ignitor boxes were intact and slightly dented. The two boxes were P/N 2201.03-8, one unit (Figure 41) was S/N 297-8, the other (Figure 42) S/N 1168-0. There was rust colored corrosion on the contactor points of both units, consistent with immersion in water. The ignitor boxes were bench tested and neither could produce a spark in an exemplar plug. Ignitor box S/N 1168-0 showed evidence of internal coil movement, consistent with overheating and being operated with too long a duty cycle.

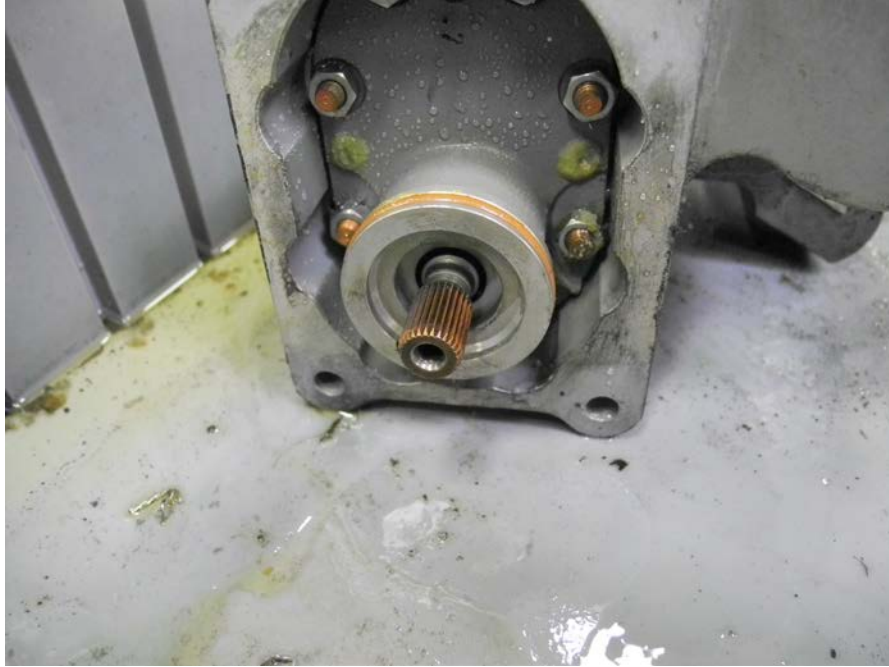
Dis-assembly of the FP did not present any technical difficulties and did not reveal any water-inundated related corrosion (Figure 46). The needle bearings of both gear shafts were undamaged. The gear teeth involute surfaces were undamaged; however, both side faces of the gears were rotationally scored due to contact against the brass side-sealing plates (Figure 47), consistent with having been rotated without fuel in the cavity. The side-sealing plates exhibited pit marks, consistent with the damage caused by the effects of cavitation³. Additionally, the lip near the inlet in the aluminum housing was similarly pitted (Figure 48), also consistent with the effects of cavitation.

Figure 46 - Fuel Pump – Cover & Pump Elements

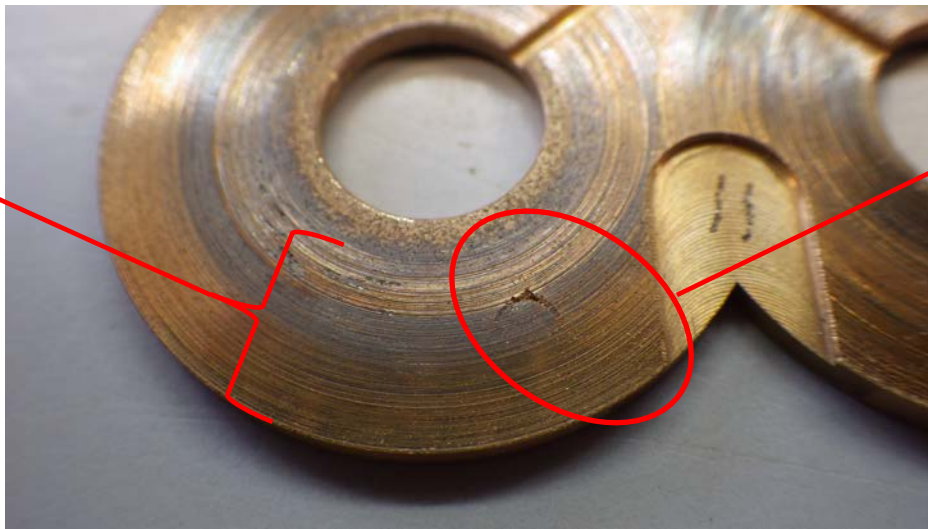
GE Aviation Czech and Jihostroj fuel system engineering staff stated that if low fuel pressure was encountered by the fuel pump, evidence of cavitation would be found in the inlet area of the fuel pump. It was also stated that a low fuel pump entry pressure would affect the stability of engine operation. Referencing a similar single-engine application, GE Aviation Czech engineering stated that the GE H80 (Walter M601) powered Thrush 510G installation has a common fuel system with the event airplane. The Thrush, a certified airplane in the restricted category, is equipped with dual (redundant, parallel) fuel boost pumps, intended to positively supply the engine fuel pump with pressure in case of a single boost pump failure.

Pitting Pattern Consistent with Cavitation

Figure 48 - Cavitation On Pump Gear Housing Inlet Edges

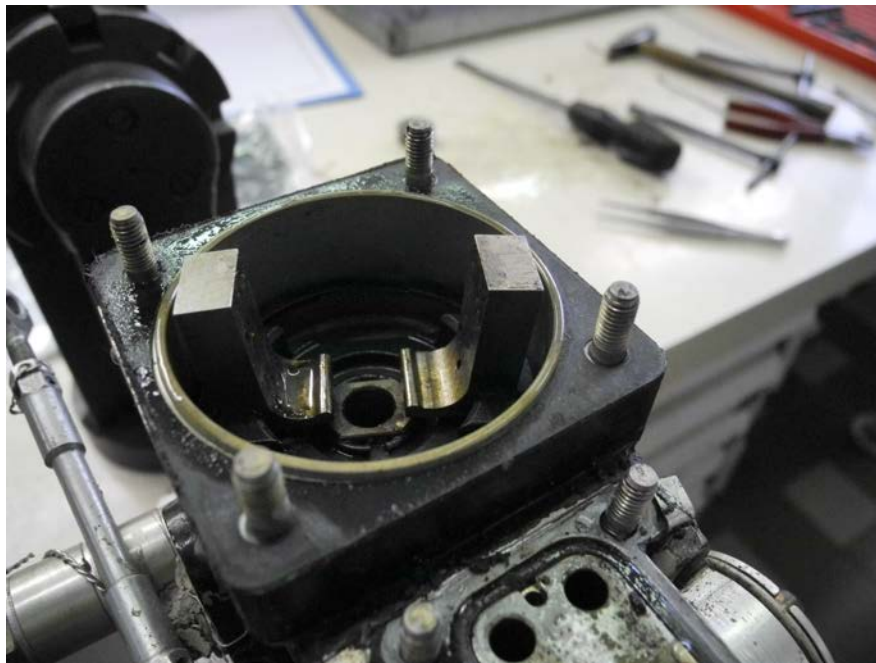
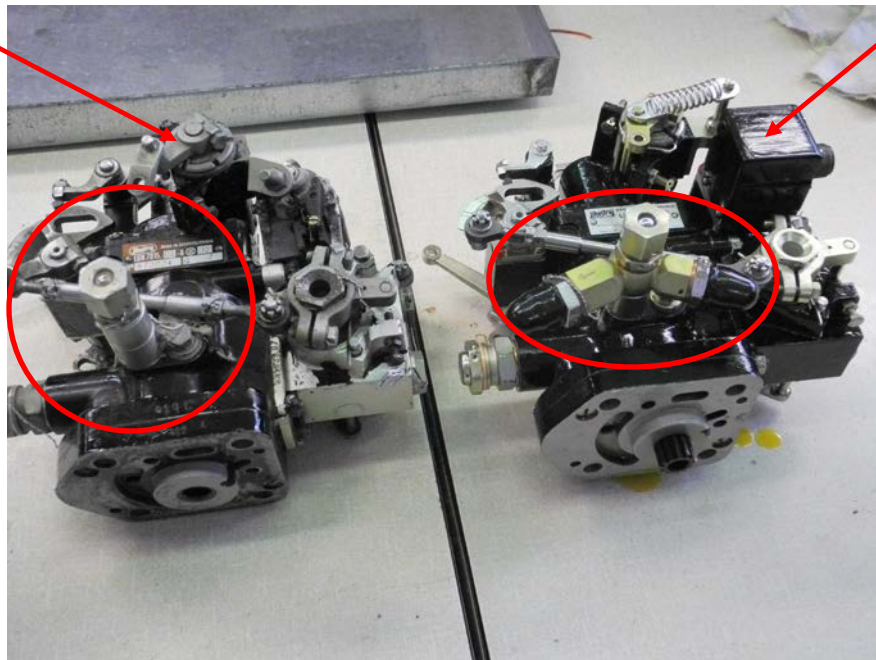
The propeller governor features an oil pressure port which is intended to allow oil pressure from the electric feathering pump to feather the propeller in the event of an engine failure that results in the loss of oil pressure. This port was intentionally blocked (Figure 62) as part of the engine installation design.

Figure 62 – Emergency Electric Feathering Pump Oil Pressure Port - Blocked

Event PCU S/N 873024 with Blocked Emergency Electric Feathering Pump Fitting

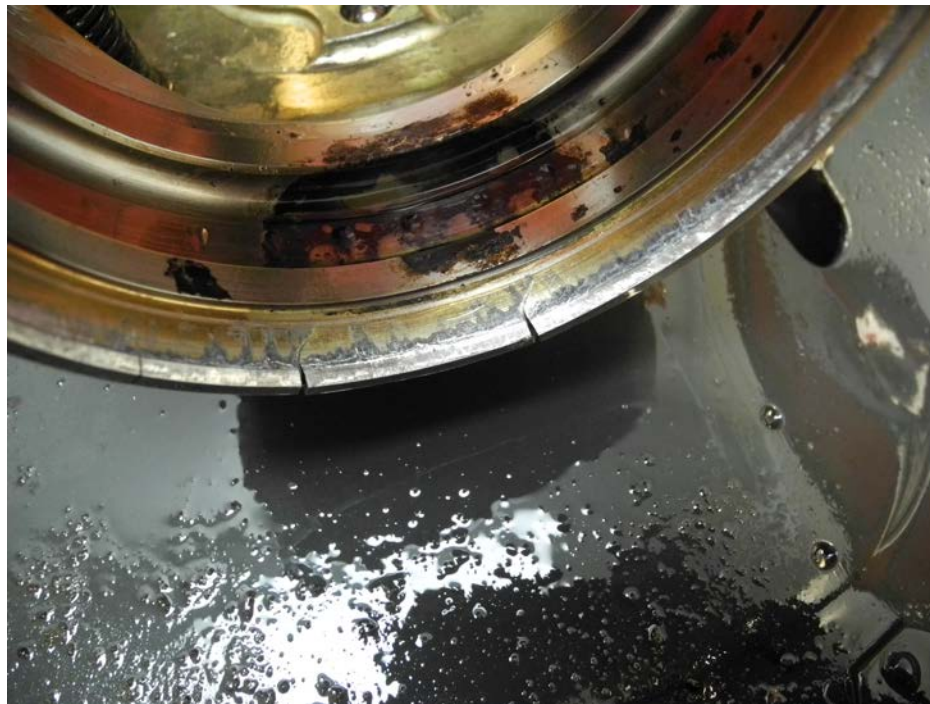
The blade bushings and pitch change blocks were all intact (Figure 72); however, there was mild corrosion on the inner race surface of one bushing, consistent with post-accident contact with water. All the ball bearings and their elastomeric spacers were present and undamaged (Figure 73), except for several that exhibited mild post-accident corrosion. The hub was intact; however, the blade bushing sleeves were fractured at the outer aft lips, consistent with a large axially aftward levered loading of the propeller blades (Figure 74). Additionally, spherical indentations from ball bearing, consistent with static overload were observed on the aft side of outer races (Figure 75).

Figure 75 – Indentations on Aft Side of Outer Race from Ball Bearing
