NATIONAL TRANSPORTATION SAFETY BOARD
Office of Aviation Safety
Washington, D.C. 20594

POWERPLANTS GROUP CHAIRMAN'S FACTUAL REPORT

NTSB ID No.: WPR17FA179

Location: Rio Linda, California
Date: August 3, 2017
Time: 1503 Pacific Daylight Time
Aircraft: Michaelian, Lancair IV-TP, N420M

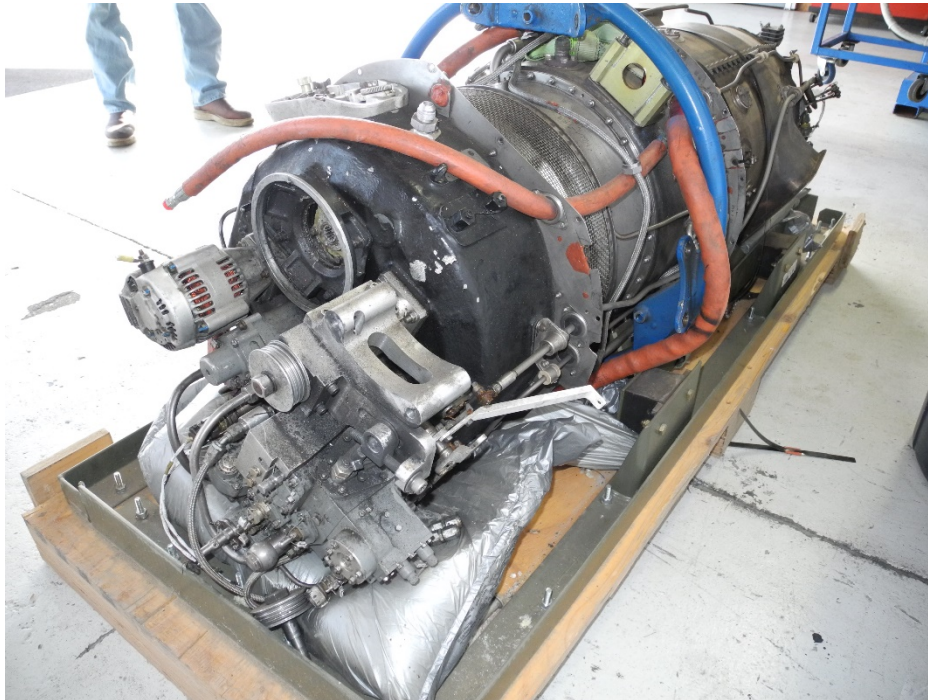
undamaged. The left hand and upper airframe elastomeric engine mounts were fractured, and the inner elastomers were not present, while the right hand was intact ([Photo 7](#)).

Photo 7 – Engine Mounts – Two Fractured and Without Elastomer

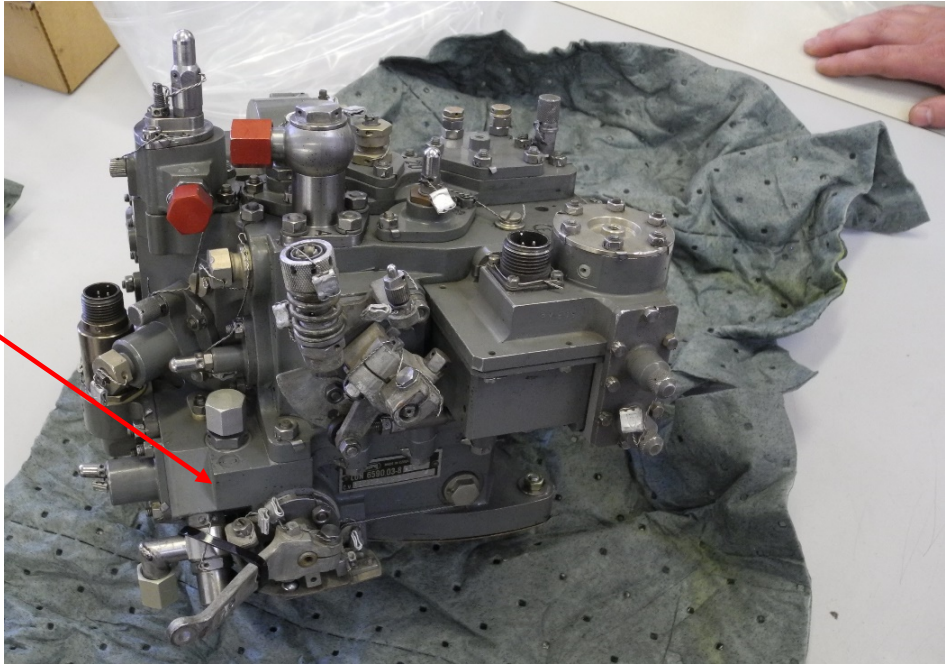
The FCU was received in a cardboard box (Photo 12) which was opened in the presence of the NTSB. A receiving inspection revealed that the FCU was generally intact (Photo 13); however, the ball-and-spring stop mechanism of the cutoff & EOR lever on the lower aft outer quadrant was deformed and not functioning (Photo 14). Internal fuel pressure against the cutoff valve causes a small torque (approximately 11 inch-pounds) on the cutoff shaft, which constantly twists the shut-off lever towards the off position. Normal friction in the airframe control cables and levers is greater than the internal torque and the cockpit cutoff lever normally stays in place. To prevent an inadvertent cutoff due to vibration, the external ball-and-spring mechanism acts as a detent stop. Because there were no discernable impact marks, it was unknown if this deformation existed before the accident.

Photo 14 - Ball-and-Spring Stop Mechanism of the Cutoff & EOR Lever - Deformed and Not Functional

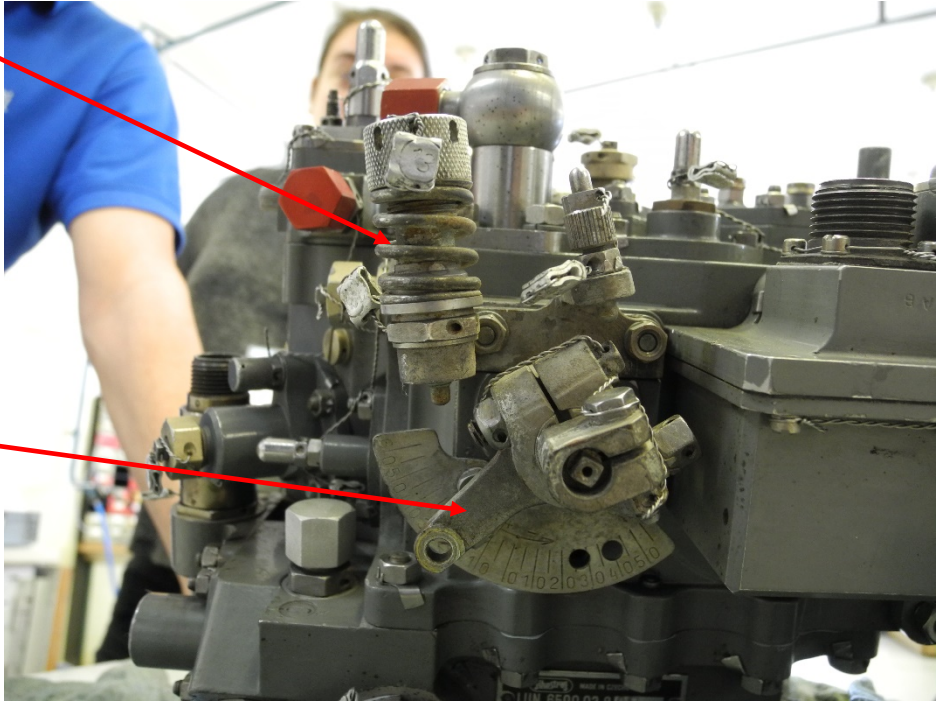
missing (Photo 16), indicating that emergency maximum power position had been selected at some time since the last overhaul of the FCU.

Photo 16 - Witness Cap - Missing

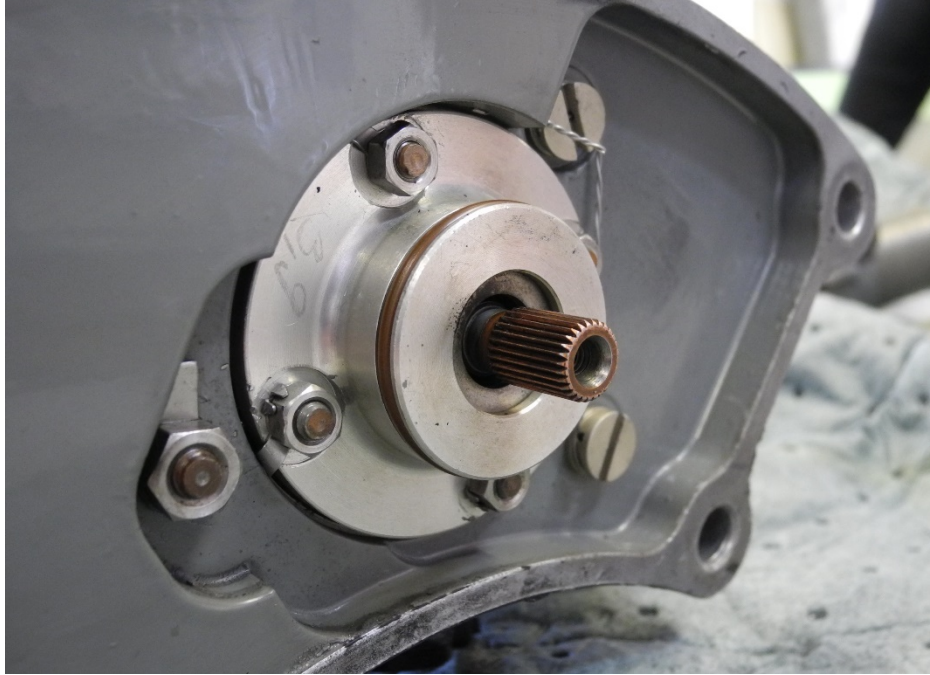
Non-standard fasteners were observed on the fuel-in flange and the #20 adjuster cover plate (Photo 18). During manufacture or overhaul, Jihostroj lock-wires all the adjuster screws of the FCU and then places a unique lead security crimped seal on the lock wire to identify modifications to the original settings. The following adjusters did not have the original crimped seal: The adjusting screws No. 33 – main metering plunger sleeve position (Photo 19), No. 40 – adjustment for start maximum fuel flow, No. 41 – adjustment for start fuel flow acceleration, and No. 50 – adjustment for minimum fuel flow during start (Photo 20).

Photo 18 - Non-standard Fasteners. Hex Bolts Instead of Studs & Nuts

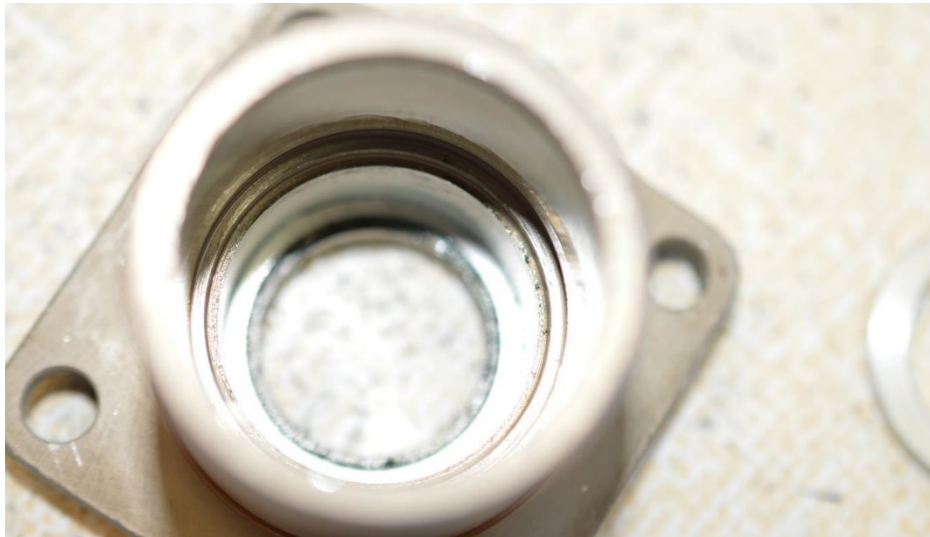
The start fuel flow assembly was disassembled, revealing corrosion on the rubber diaphragm and spring (Photo 23). The diaphragm was intact; however, it was slightly soft. The discrepancy may have been consistent with a slow start condition and caused compensating adjustments.

Photo 23 - Rubber Diaphragm and Spring - Corroded

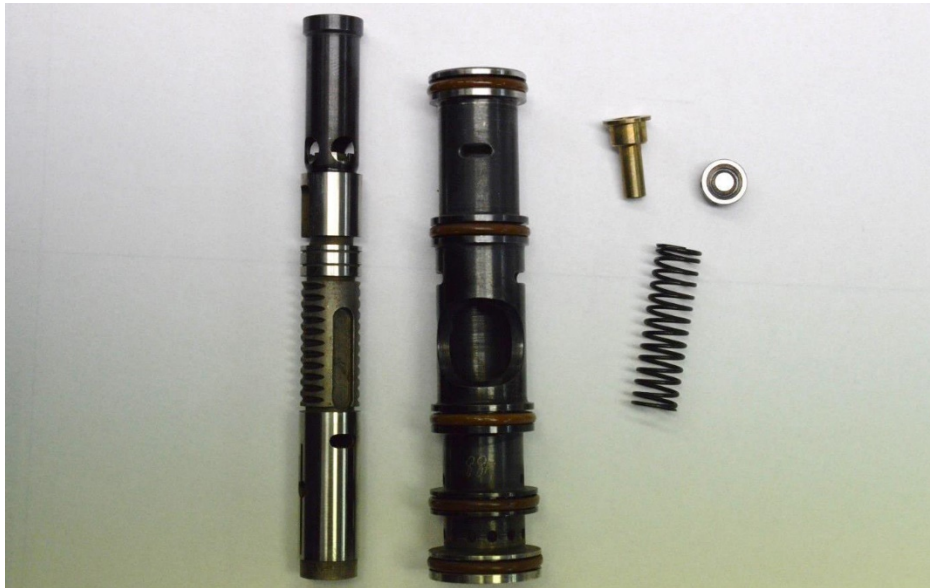
The emergency metering valve assembly was removed from the FCU and examined and found to be intact and undamaged (Photo 26). The pressure regulating valve of the EOR circuit was removed from the FCU housing (Photo 27) and minor corrosion was observed on the active spool outer surface; however, the spool moved freely in its sleeve. The fuel cutoff valve was removed from the FCU housing, examined

Photo 27 - Pressure Regulating Valve of the Emergency Circuit – Minor Corrosion

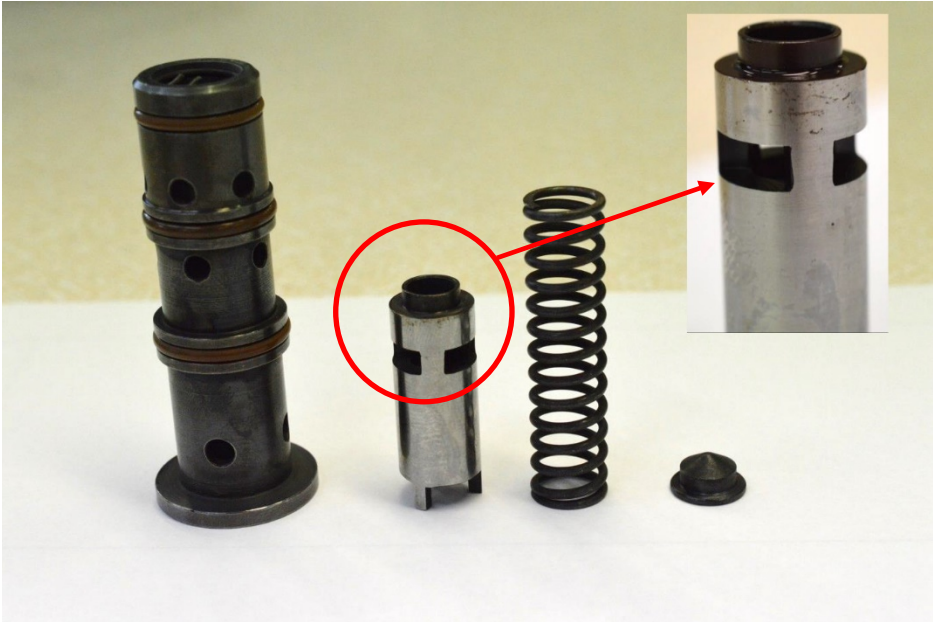
and found to be intact, however a small amount of corrosion was observed on the internal sleeve, but it did not affect the operation of the valve, which moved freely in the sleeve (Photo 28). According to the manufacturer, the corrosion observed in this valve is not common, but is consistent with the component being stored for an extended time without proper preservation. It could also be caused by the presence of water in fuel. The emergency circuit solenoid valve was removed (Photo 29) and functionally tested, passing the minimum switching voltage of 17 volts (V) and drop-off voltage of 15 V.

Photo 28 - Fuel Cutoff Valve

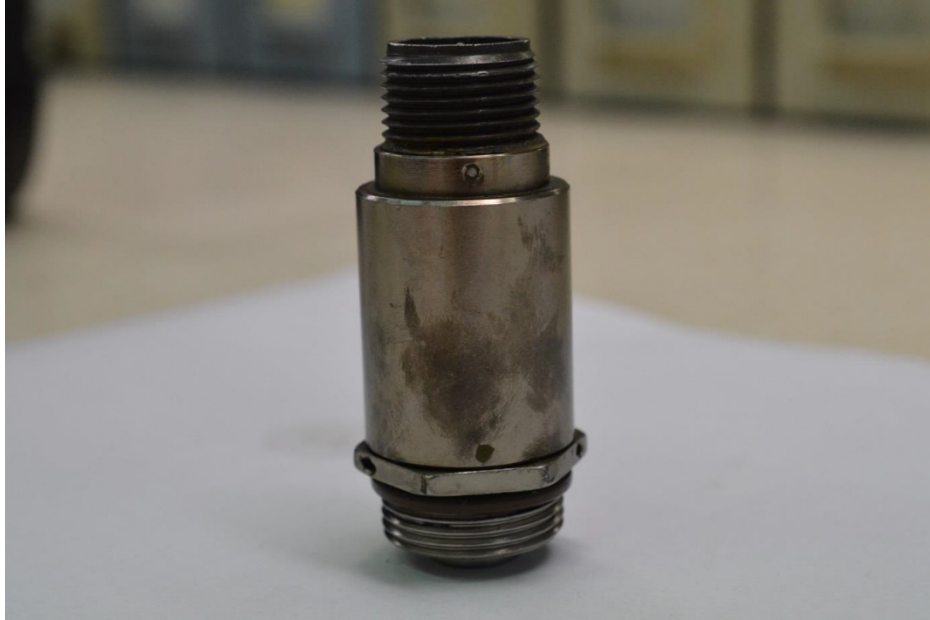
The emergency check valve assembly (Ref. Figure 3, item 6b) was removed and the drain poppet valve seat examined (Photo 30), revealing an asymmetrically worn seat. This is consistent with the fuel leak observed during the engine testing in Deland, Florida. Jihostroj technical advisors stated that this was a very deep imprint and is consistent with an FCU that had sustained an extended time of disuse and non-preservation. Leakage from the drain poppet valve influences the engine only during the starting process and manifests itself as high ITT or even flames from the exhaust during start.

Photo 30 - Emergency Poppet Valve

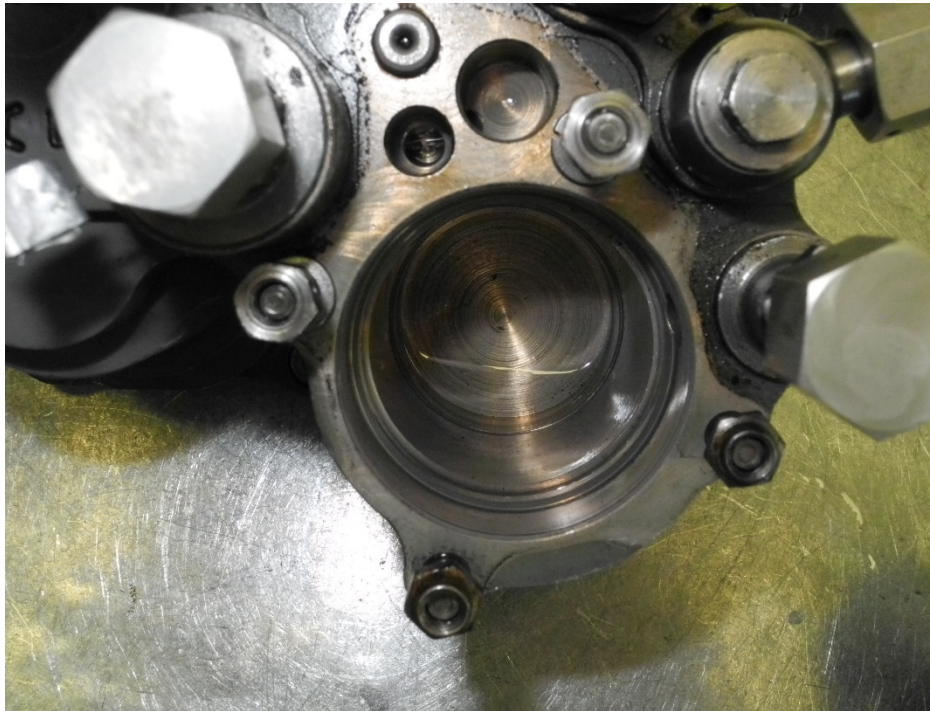
Photo 35 - Torch Ignitor Flow Restrictor Transfer Tube – Torn O-ring

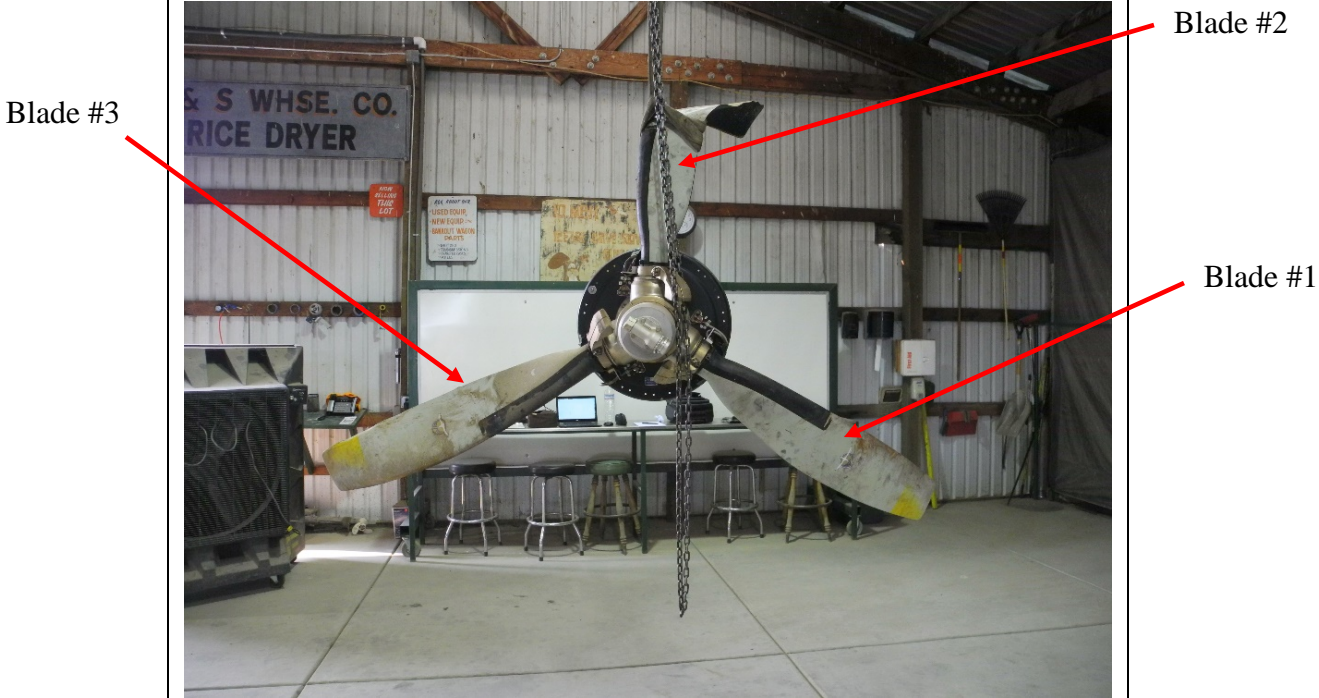
Photo 46 - Propeller Blades – General Damage

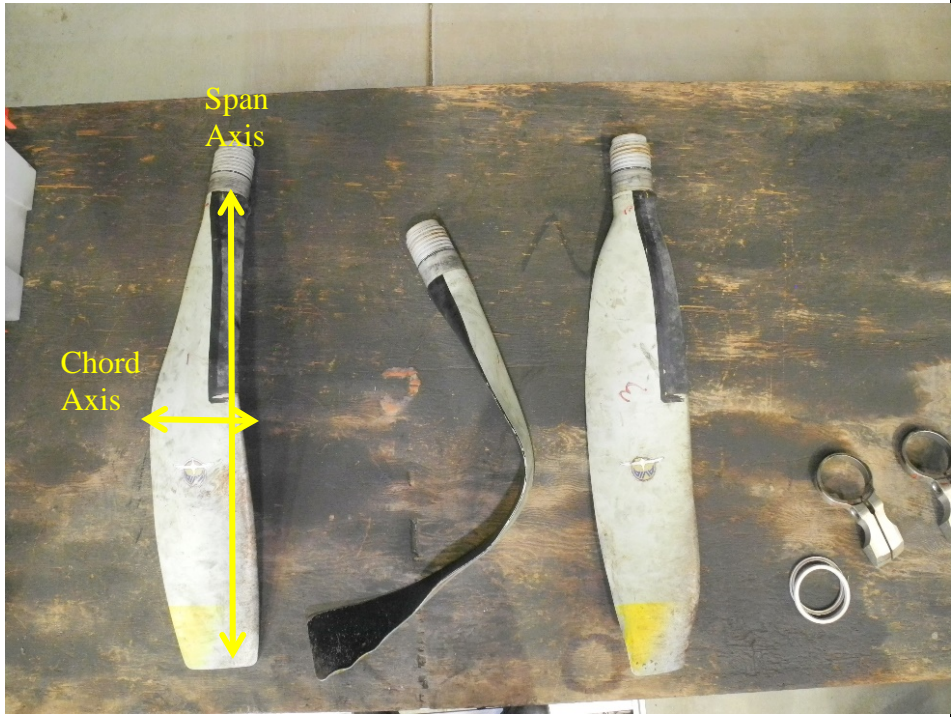
Photo 47 – Typical Damage to Blades

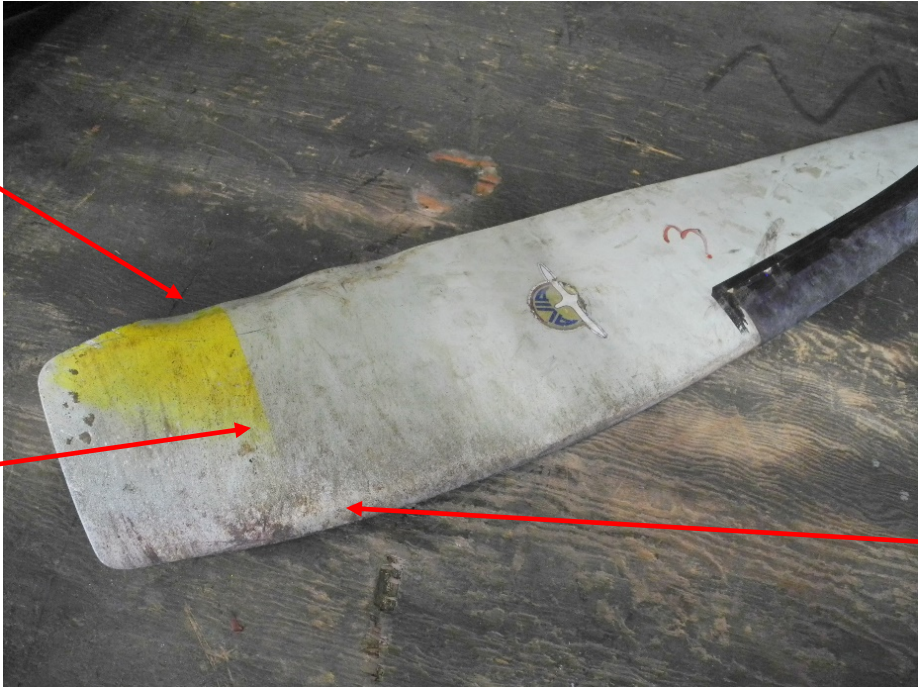
The face side of the blades had been previously marked with the numbers 1,2 and 3 so this numbering system was used. All the blades had a single, large radius bend at the mid-span in the chord axis; blades #1 and #3 were slightly bent backwards while #2 was bent backwards to approximately 75 degrees (Photo 46). There was no evidence of positive blade twisting along the span axis, which is normally observed when the propeller is being driven with engine power at impact. The leading edges of all the blades, although abraded from normal use, displayed no evidence of soft or hard body impact damage (Photo 47). The trailing edges of blades #2 and #3 were deformed. There were no rotational score marks on the face or camber sides of the blades, which are usually present if the propeller is turning under power during impact. The camber side of all the blades exhibited thin red lines in the chord direction approximately 10 -1/8 inches in from the tips (Photo 48).

Deformation on Trailing Edge

No Rotational Scoring Marks on Convex Side

No Impact Marks on Leading Edges

Photo 48 - Camber Side of the Propeller Blade #3

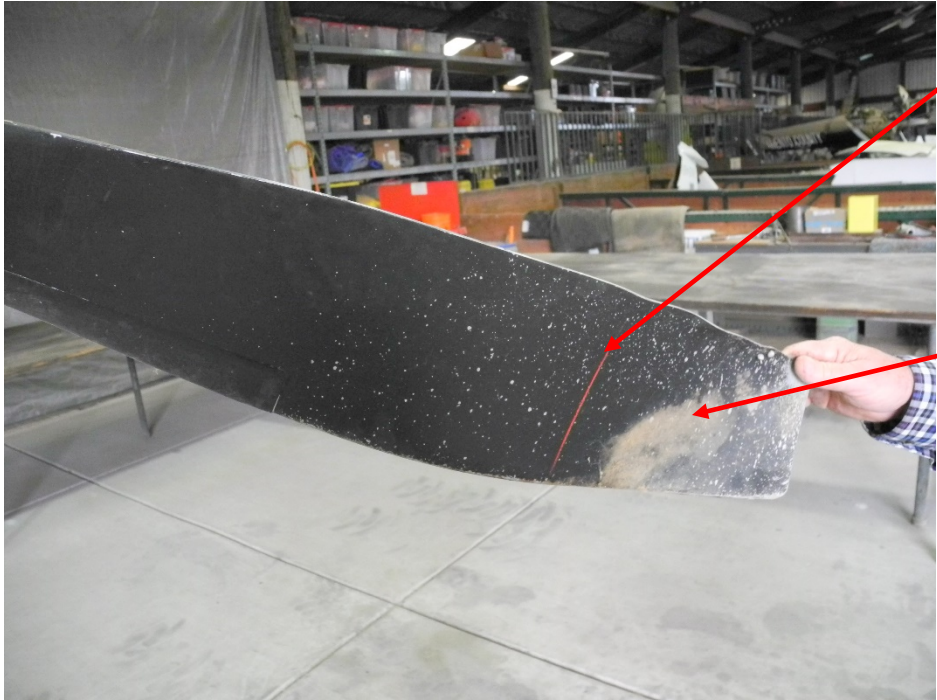
Photo 49 - Blade #1 – Alignment Scribe Marks – Mis-aligned

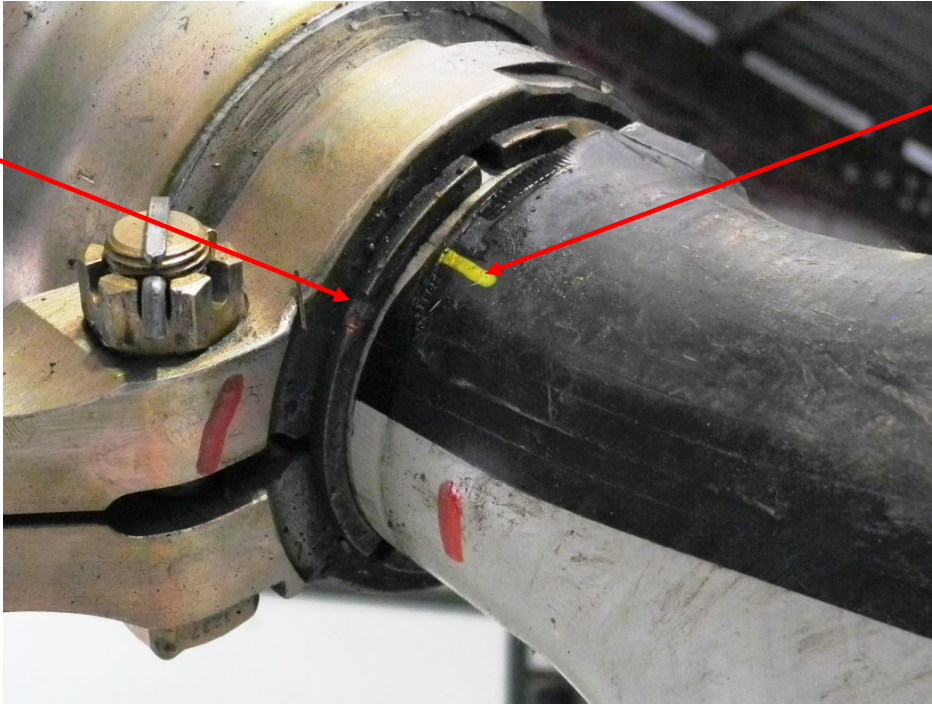
Photo 50 - Blade #2 – Alignment Scribe Marks – Mis-aligned

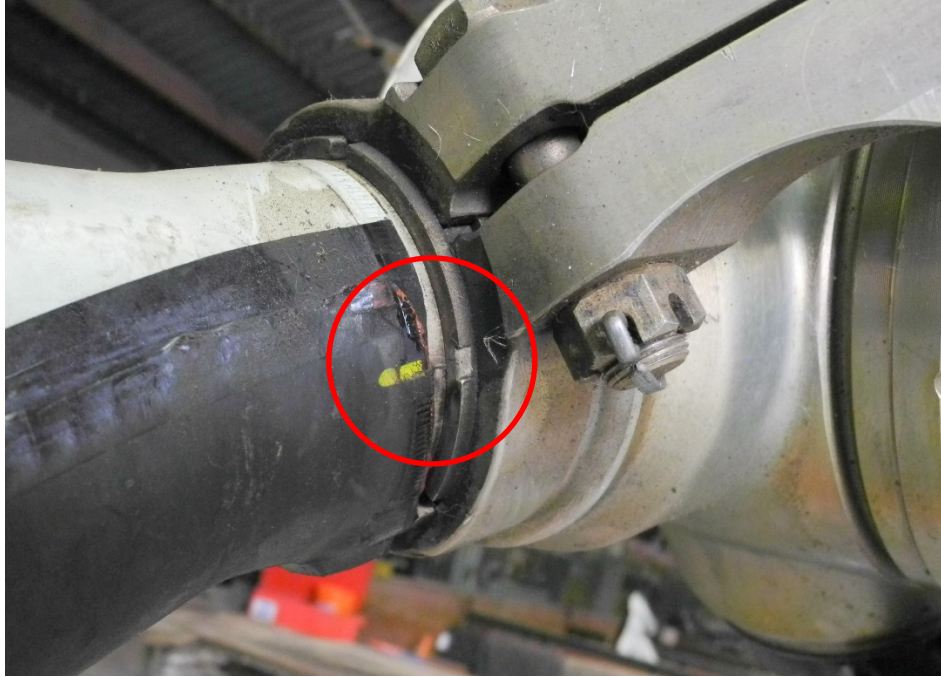
The outer flange of the bearing ring (3) (Ref. [Figure 1](#)) becomes sheared when the moment on the propeller blade bushing is forced beyond its structural limits during impact with an object ([Photo 52](#)). Analysis of the damage to the bearing ring can therefore be used to determine the location of the blade during impact because the bearing ring has a known alignment with the propeller. The alignment is established with a notch on the bearing ring (3) ([Photo 53](#)), which is indexed to a mating pin on the counterweight/clamp (9) ([Photo 54](#)). Via a slot, the counterweight/clamp is, in turn, indexed to the blade bushing (5) key ([Photo 55](#)).

Photo 52 - Bearing Ring Blade #2 – Flange is Sheared

Bearing Ring
Flange - Sheared

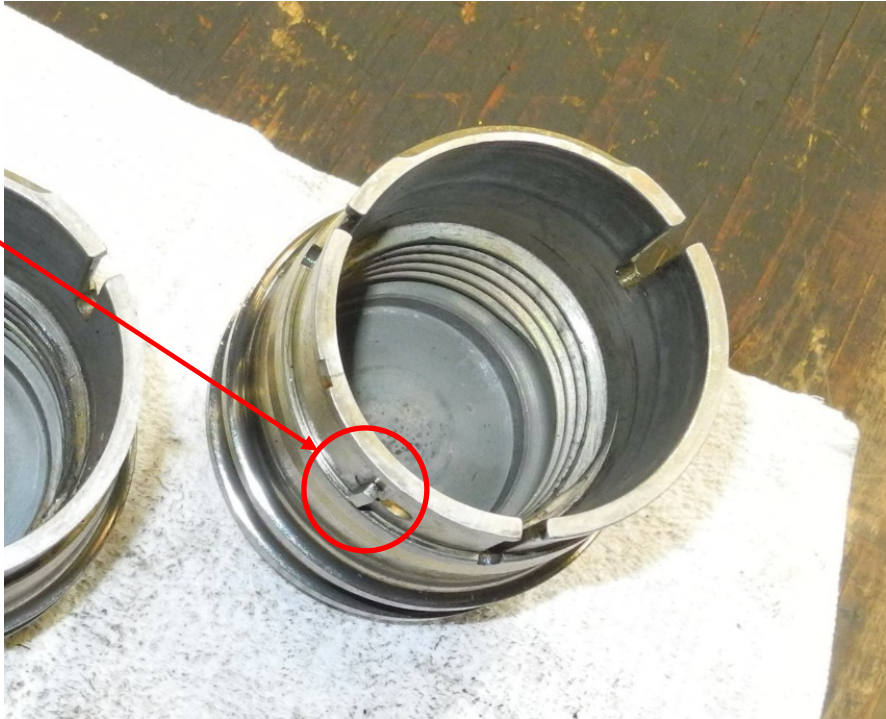
A geometric analysis of shear damage to the bearing ring (2) ([Photo 56](#)) by the manufacturer concluded that the blades were at the minimum flight angle (low pitch stop) of approximately 18 - 20 degrees or fine pitch.

Photo 56 - #2 Propeller Bearing Ring

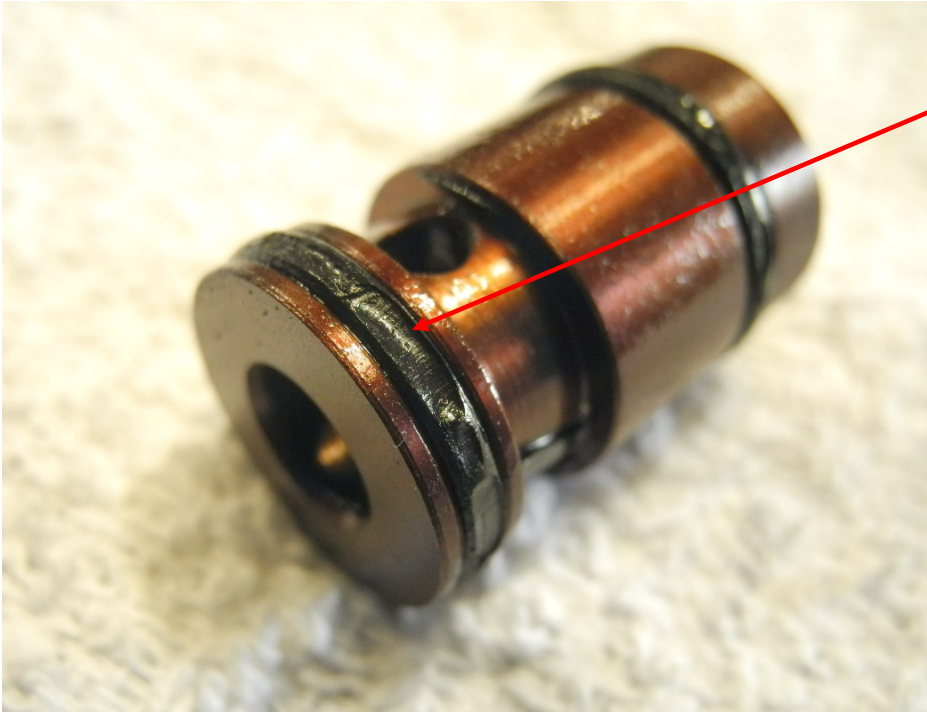
Sheared O-Ring

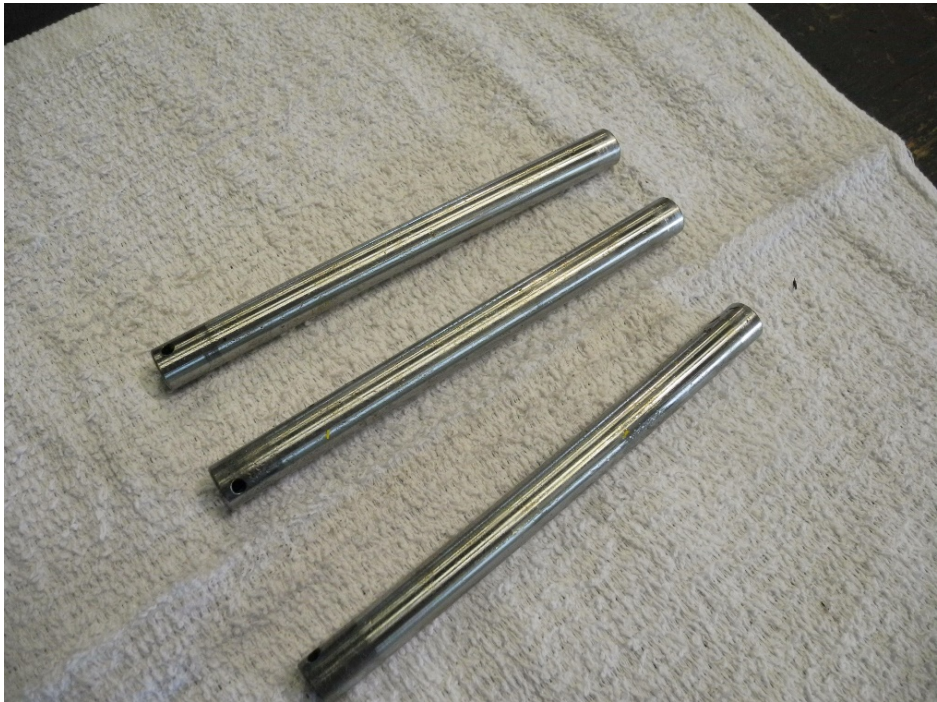
Photo 66 - Fork – Wear from Pitch Change Blocks

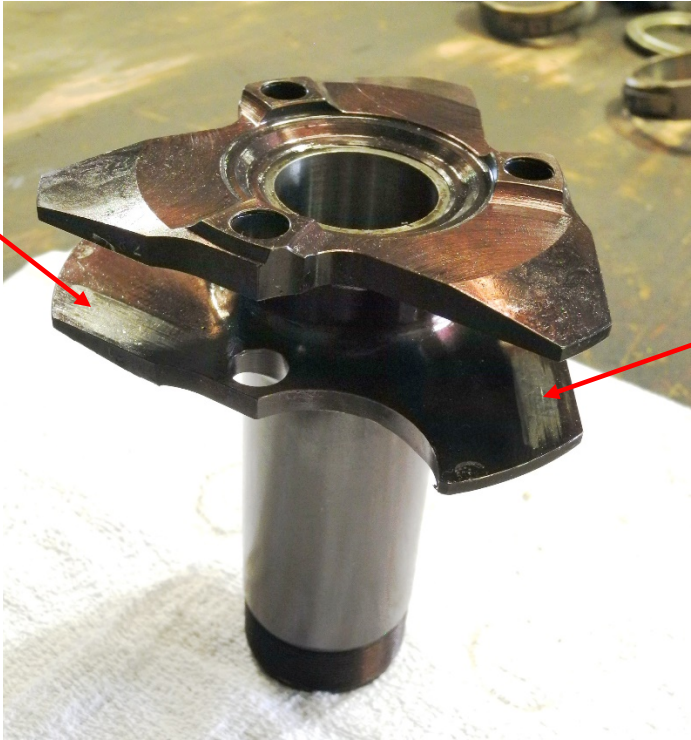
Photo 67 - Detail of Fork Flange Wear from Pitch Change Blocks

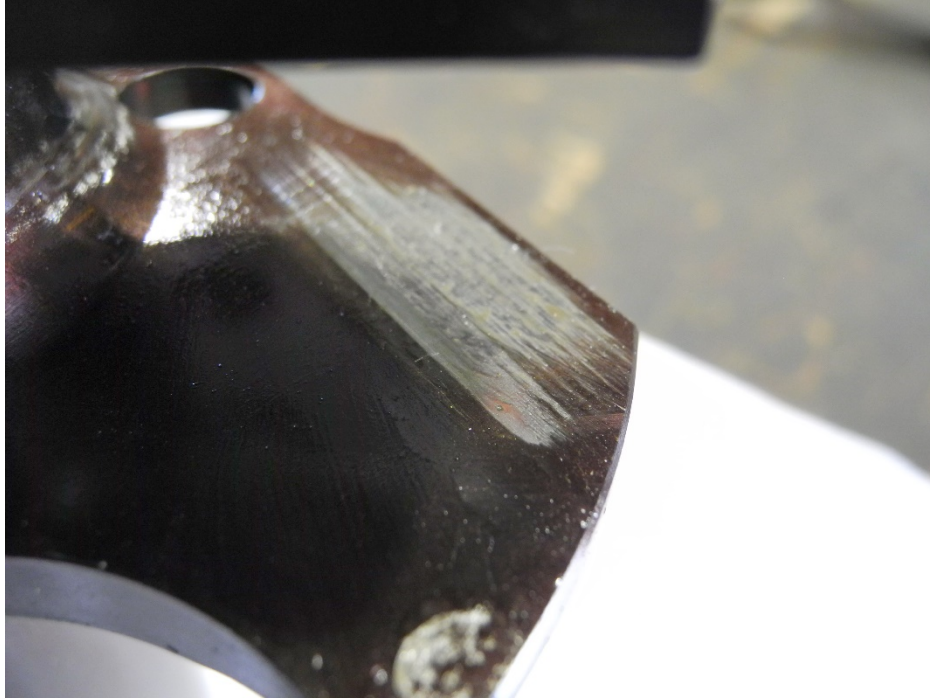
Photo 68 - Fork Front Surface - Dented
