**NATIONAL TRANSPORTATION SAFETY BOARD**  
**Office of Aviation Safety**  
**Washington, D.C. 20594**

**POWERPLANT GROUP CHAIRMAN'S FACTUAL REPORT**

**NTSB No: ENG14IA001**

Aircraft: Spirit Airlines Airbus A319, Registration No. N516NK, Flight 165

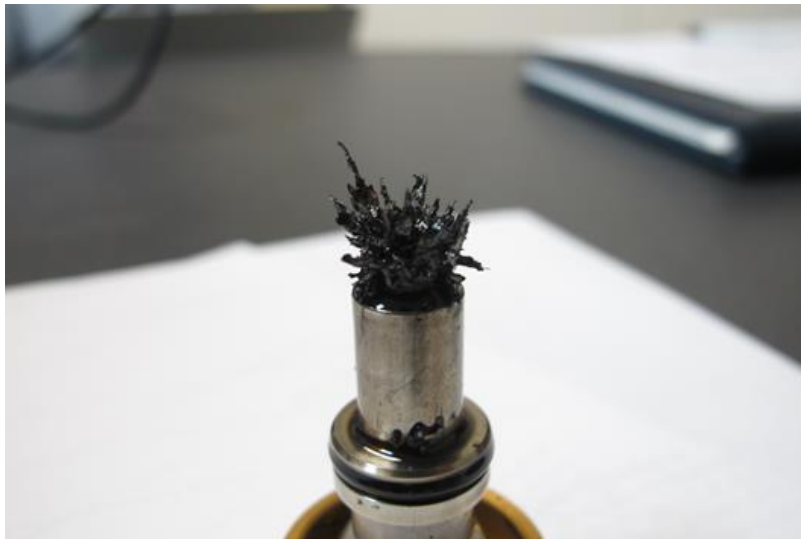
The investigative team arrived at DFW on October 16, 2013 to document the condition of the aircraft and No. 1 engine. The aircraft was quarantined on the tarmac in front of the NKS maintenance hangar. Prior to the team's arrival, the engine cowls had been raised and the engine borescope and magnetic chip detector plugs had been removed by NKS maintenance crews (**Photo 1**). The master magnetic chip detector plug located in the oil tank had accumulated a significant amount of metal shavings and debris (**Photo 2**).

**Photo 2- Main Chip Detector Plug with Metal Shavings and Debris**

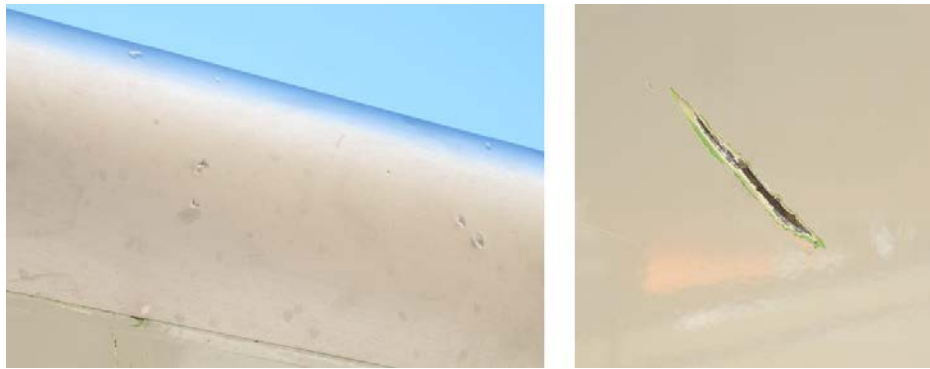
Minor impact damage was observed on the aft engine fairing, left wing fairing (canoe) and the leading edge of the left horizontal stabilizer (**Photo 3**). The impacts did not penetrate the outer panel or affect the underlying structure.

**Photo 3- Impact Marks on the Horizontal Stabilizer Leading Edge**

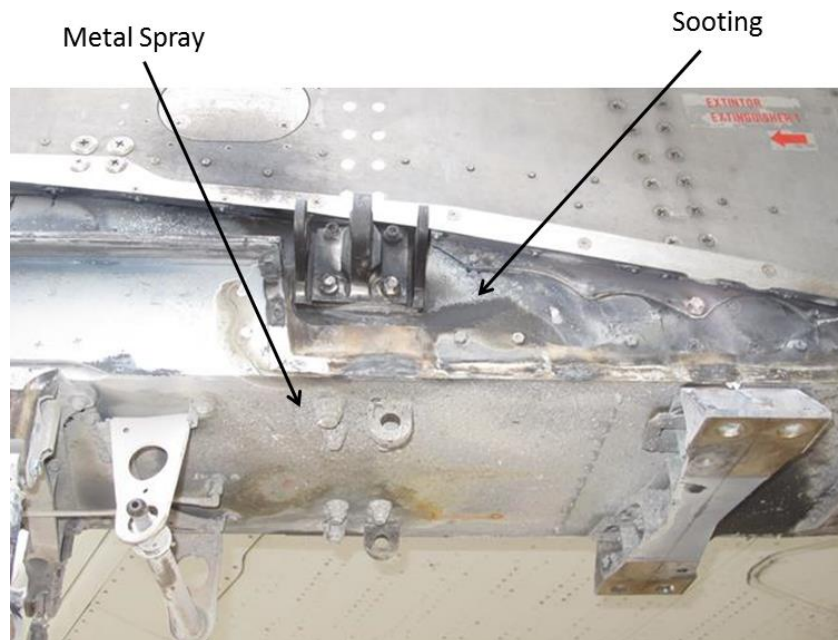
The No. 1 engine pylon exhibited sooting and substantial metal splatter in areas above the LPT (**Photo 4**). The pylon structure was deemed to be beyond repair limits by Airbus and was removed and replaced.

**Photo 4- No. 1 Engine Pylon Damage Including Sooting and Metal Spray**

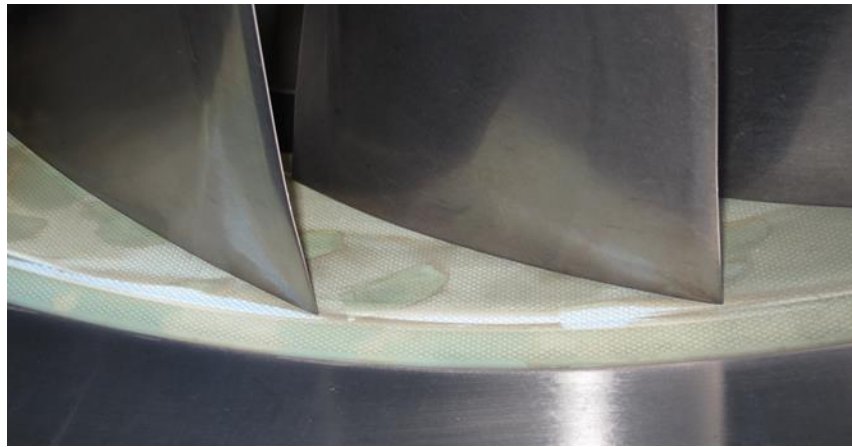
The fan was intact and spun freely without binding. The fan case rub strip exhibited light tip rub circumferentially from the 4 to 11 o'clock positions along the fan blade leading edge and 360 degrees around at the trailing edge (**Photo 5**). Visible fan exit guide vanes and LPC inlet guide vanes were in good condition.

**Photo 5- Fan Rub Strip Damage**

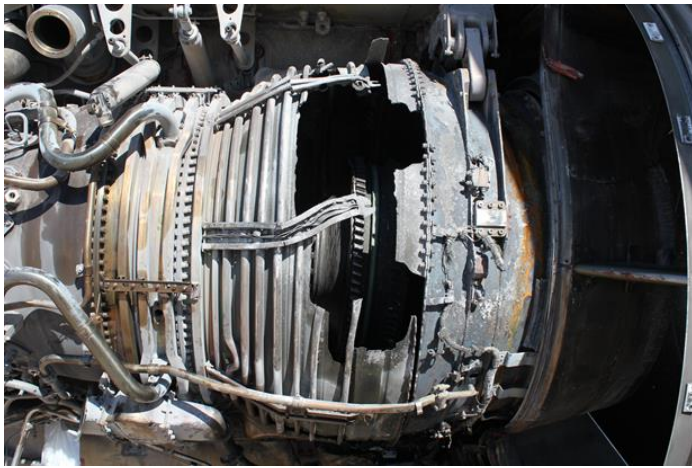
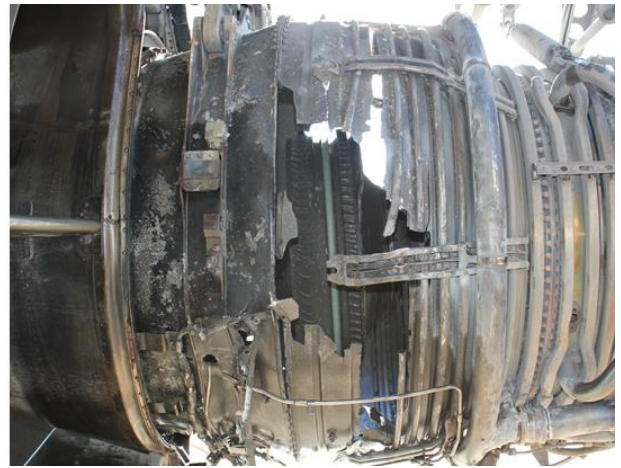
The LPT case was missing material from the 8:30 to 4 o'clock positions circumferentially and axially from the N flange to 10 inches forward of the P flange (**Photo 6**). A fragment of the LPT case remained attached to the P flange from the 11 to 1 o'clock positions when the exhaust was separated from the engine (**Photo 7**). The remaining sections of the LPT case had metal splatter on external surfaces. The LPT cooling case manifold exhibited impact damage and was fractured at the lug position 3 inches forward of the P flange.

**Photo 6- LPT and TEC Damage (L) Left Side of Engine (R) Right Side of Engine**

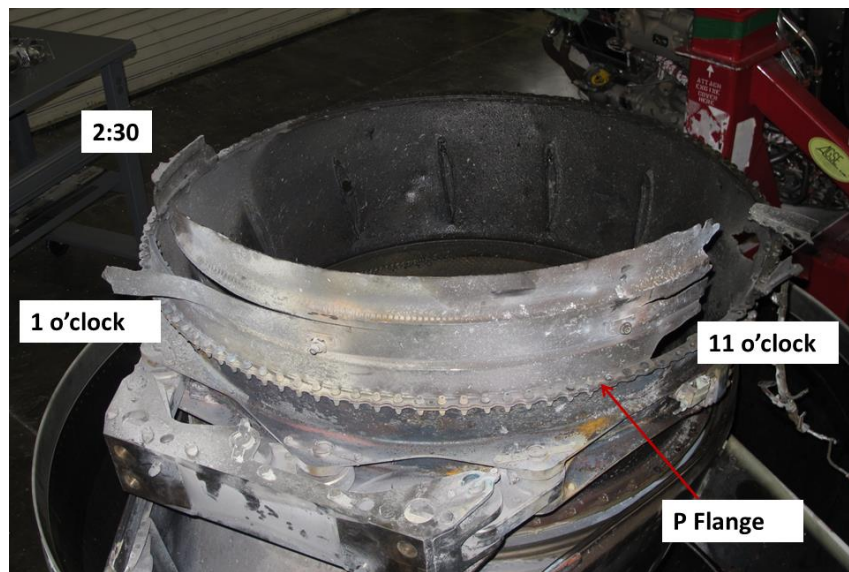
**Photo 7- LPT Case Material Attached to P Flange**

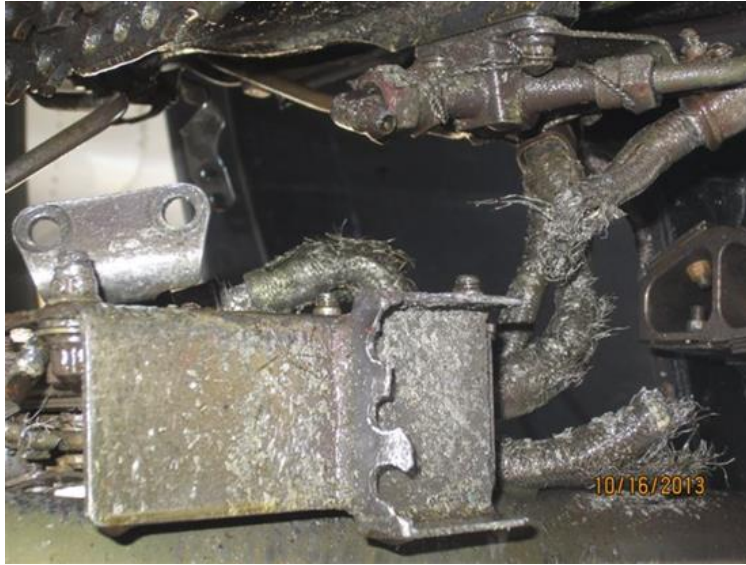
The TEC struts, center body and No. 5 bearing compartment were separated and missing from the engine. The EGT harness was severed in multiple locations and the wire insulation was damaged with metal splatter adhered to the remaining probes and wire. The EGT harness junction box was detached from the flange and resting at the 6 o'clock position on the No. 4 bearing buffer cooler exhaust tube (**Photo 8**). The fire detection loop around the turbine exhaust case was intact but the support brackets were loose. The No. 5 bearing oil scavenge line was detached but the safety wire connection remained intact and no damage was noted to the male fitting threads. A hole was present in the TEC at the oil scavenge tube fitting (**Photo 9**). The TEC had a 1.5 inch puncture at the 7:30 position, 2.5 inches aft of the P flange with cracks extending from the puncture consistent with thermal damage. The P flange was missing 5 bolts at the 10:30 position and all bolts were missing from the 1 to 9 o'clock positions. All but 6 of the remaining 29 P flange bolts were loose and the attaching nuts had started to back off the bolt threads. When the P flange was viewed from below it was noted that the LPT case had shifted below the turbine exhaust case so the case flanges no longer lined up (**Photo 10**). The bottom of the turbine exhaust case was oil wetted.

**Photo 8- EGT Harness Junction Box, Damaged Harness**

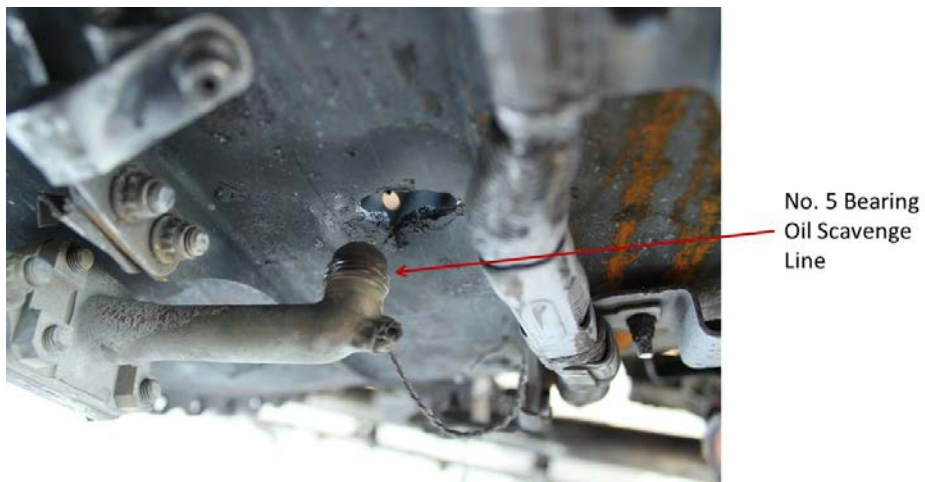
**Photo 9- No. 5 Bearing Oil Scavenge Line**

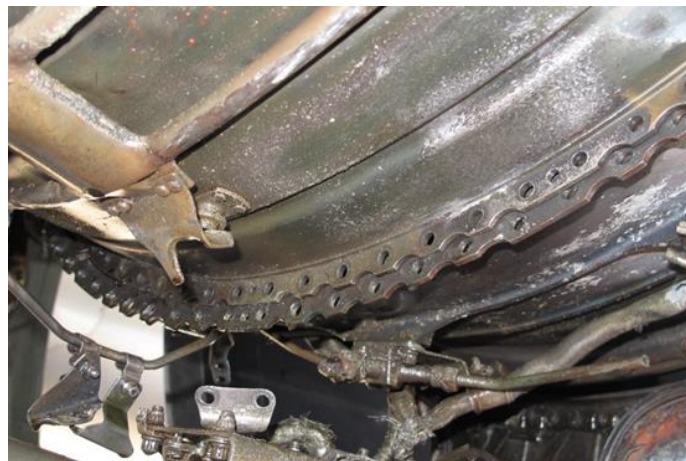
**Photo 10- P Flange Shift Between LPT Case and Turbine Exhaust Case**

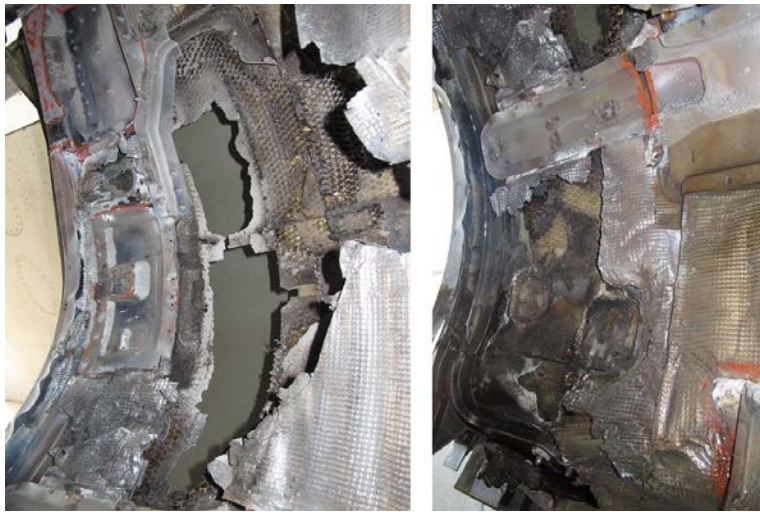
The inner barrel C-duct was breached and missing material coincident with the material missing from the LPT case. The material breaches measured 25 inches circumferentially and 5 inches axially on the left side of the engine and 19 inches circumferentially and 11 inches axially on the right hand side of the engine (**Photo 11**).

**Photo 11- Missing Material and Thermal Damage to Left Side C-Duct**

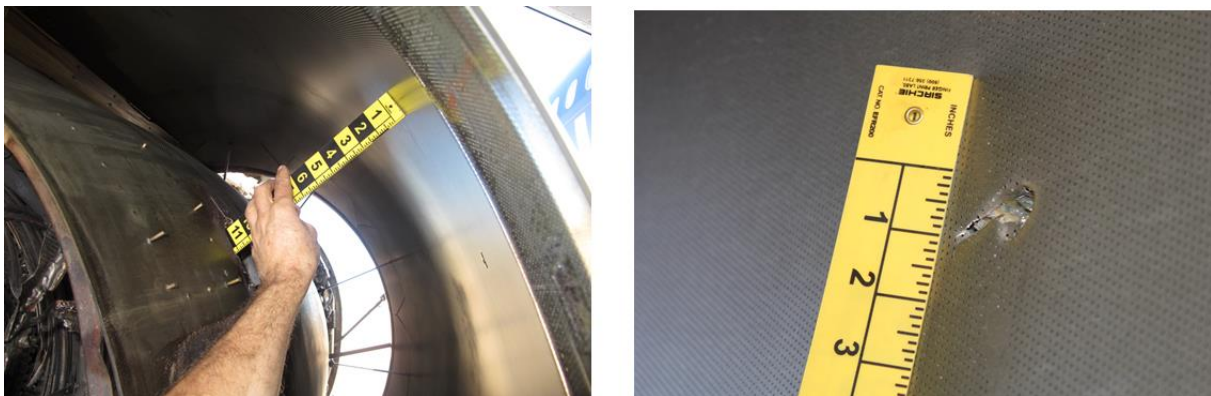
The left and right hand thrust reverser (TR) cowls were intact without breaches or indications of thermal damage. An impact mark into the left hand TR cowl was present at the 9 o'clock position but it did not breach the cowl and no bulging was noted on the outer cowl surface. The right hand TR cowl had an impact mark at the 2:30 position, approximately 16 inches from the aft edge that did not breach the cowl but did result in a bulge on the outside surface (**Photo 12**). A second impact mark was identified at the 4:30 position, approximately 3 inches from the aft edge and did not result in any deformation to the cowl outer surface.

**Photo 12- Right Hand Thrust Reverser Cowl Trajectory and Impact**

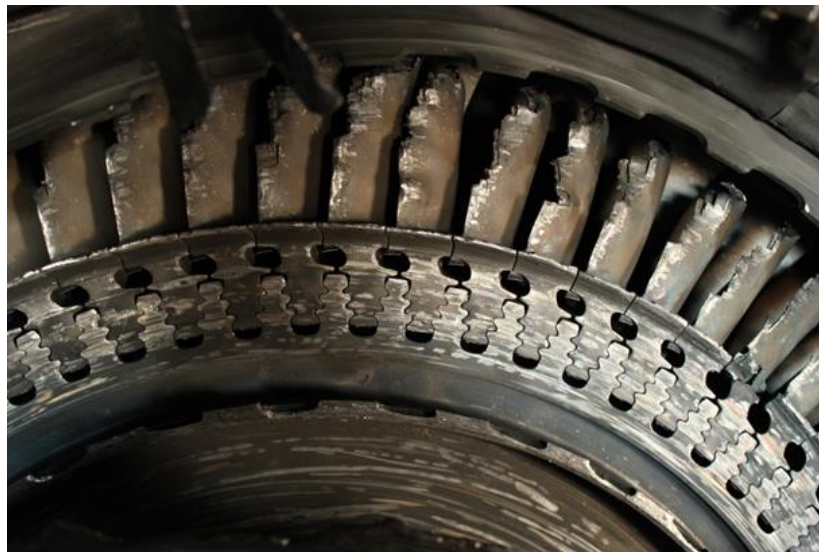
After removal of the engine from the airframe a more thorough evaluation of the turbine sections was conducted. The HPT 2<sup>nd</sup> stage vanes were visible through the HPT 2<sup>nd</sup> stage blades and were intact and in good condition with light uniform metal splatter 360 degrees around. The HPT 2<sup>nd</sup> stage blades were present but exhibited impact damage and smearing against the direction of rotation, concentrated on the trailing edge around the disk (**Photo 13**). Three HPT 2<sup>nd</sup> stage turbine blade airfoils were fractured transversely at the platform but the blade roots remained in the disk slots. Six blades, including the blade roots were separated from the disk. Four of the six blades were later found loose within the engine. The HPT 2<sup>nd</sup> stage disk web and bore exhibited circumferential gouging and scoring 360 degrees around. The HPT 2<sup>nd</sup> stage rear side plate was fractured, deformed, and out of position. The side plate locks were gouged and missing material. The HPT nut and lock ring were in place. The HPT outer air seal was missing from the 5:30 to 11:30 positions.

**Photo 13- HPT 2<sup>nd</sup> Stage Turbine Disk Damage**

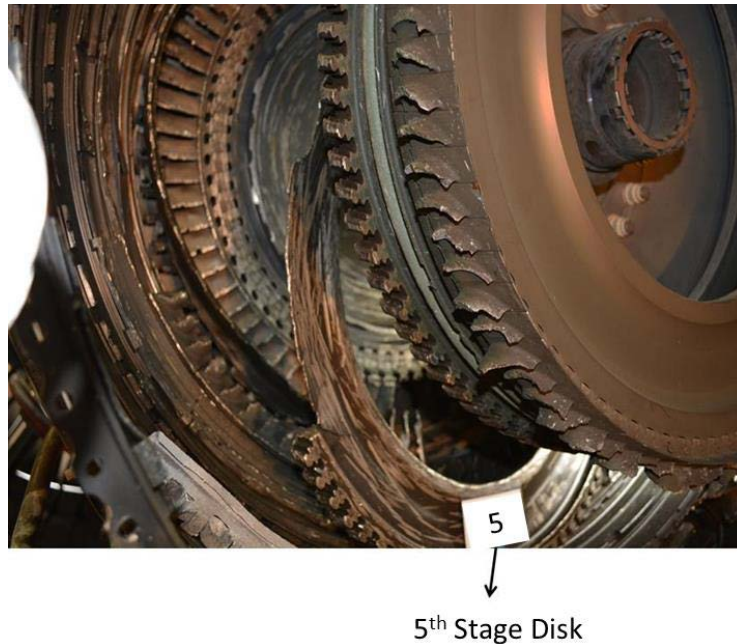
blade attachments. The disk was detached from the LPT 6<sup>th</sup> stage disk and was hanging on the LPT shaft (**Photo 14**).

**Photo 14- LPT 5<sup>th</sup> Stage Disk Displaced and Hanging on LPT Shaft**

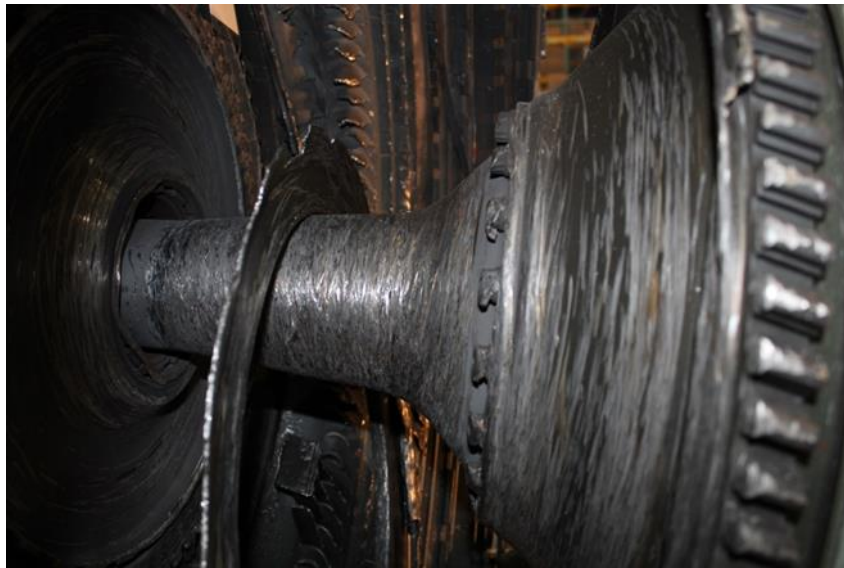
The LPT shaft was heavily scored/gouged 360 degrees around axially from the HPT 2<sup>nd</sup> stage bore to the LPT 6<sup>th</sup> stage disk (**Photo 15**). The knife edge seal between the LPT 6<sup>th</sup> and 7<sup>th</sup> stage disks was present with minor nicks and dents around the circumference.

**Photo 15- LPT Shaft and LPT 6<sup>th</sup> Stage Disk Hub Scoring Damage**

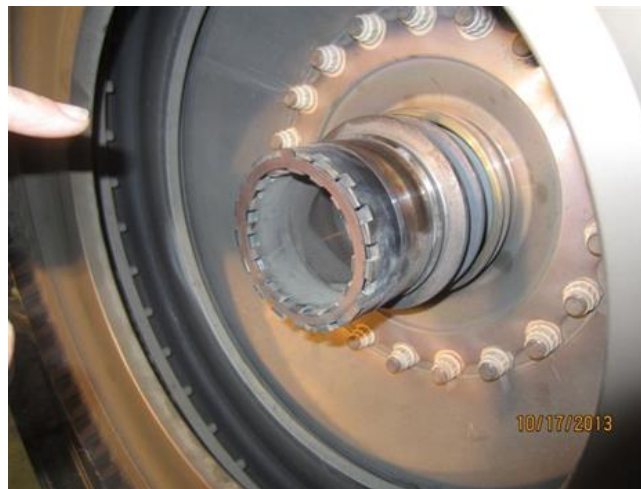
The LPT 7<sup>th</sup> stage vanes were missing and not recovered. The LPT 7<sup>th</sup> stage disk was present but all airfoils were sheared at the blade root just above the platform with blade roots secure in the disk. The aft side of the 7<sup>th</sup> stage disk was in good condition. Carbon seal fragments were found resting at 6 o'clock inside the 6<sup>th</sup> to 7<sup>th</sup> stage bore cavity. The aft end of the LPT shaft was in good condition and the internal plug was intact and secure. The No. 5 bearing rollers and outer race were missing. The inner race was present and undamaged. The No. 5 bearing lock nut and ring were in good condition but slightly displaced in the aft direction (**Photo 16**). The No. 5 bearing and bearing housing were not recovered.

**Photo 16- No. 5 Bearing, Rollers and Outer Race Missing. No. 5 Bearing Lock Ring and Nut Intact**

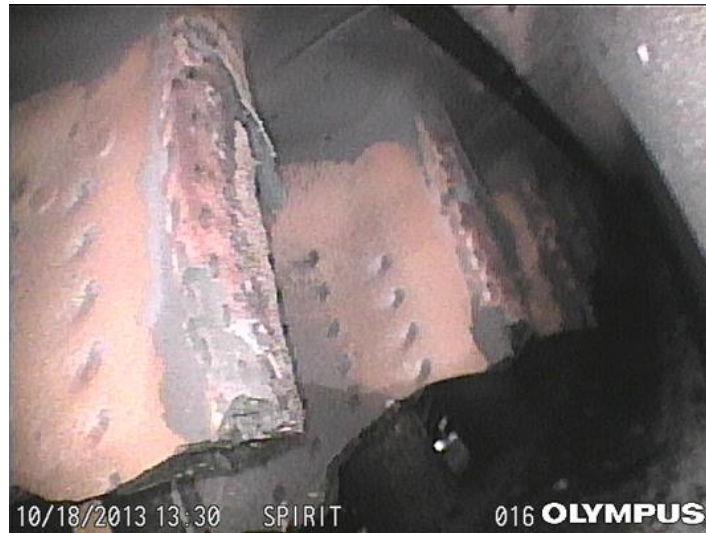
but were otherwise in good mechanical condition with the exception of a group of approximately six consecutive airfoils with various amounts of material missing from the tip (**Photo 17**). The HPT 1<sup>st</sup> stage blade outer air seal appeared to be in good condition with no significant rub. The HPT 2<sup>nd</sup> stage vanes were intact and in good condition.

**Photo 17- HPT 1<sup>st</sup> Stage Blade Airfoil Tip Damage**

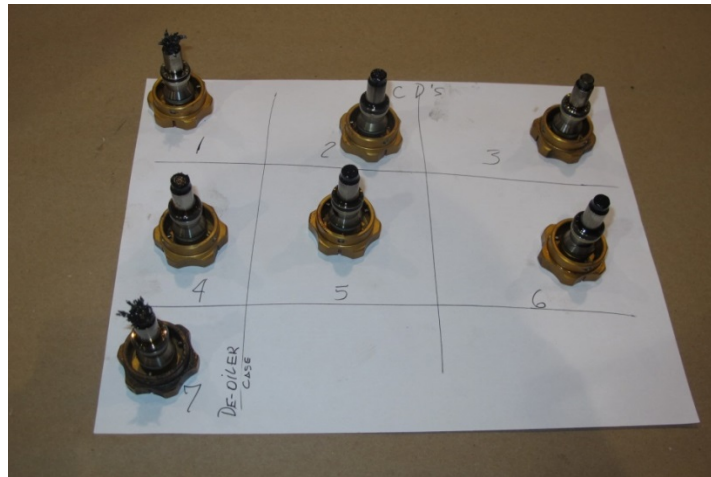
The remaining magnetic chip detector plugs were removed and evaluated for metal debris. The main engine oil tank and de-oiler plugs had a buildup of metal shavings and the remaining plugs were clean (**Photo 20**).

**Photo 20- Magnetic Chip Detector Plugs, Main Oil Tank (1) and De-Oiler Plugs (7) With Debris**

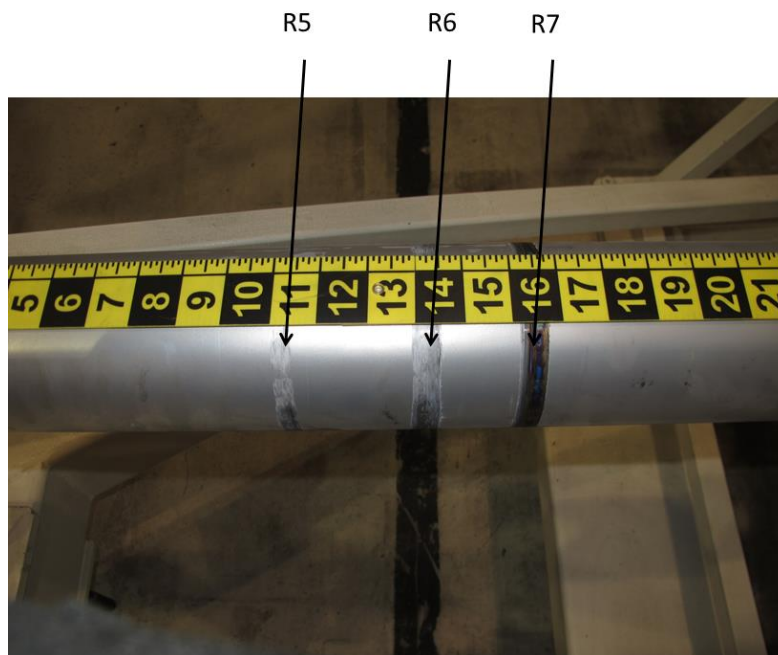
**Photo 22- Circumferential Rubs on the FWD End of the LPT Shaft, Corresponding Contact Points Labeled**

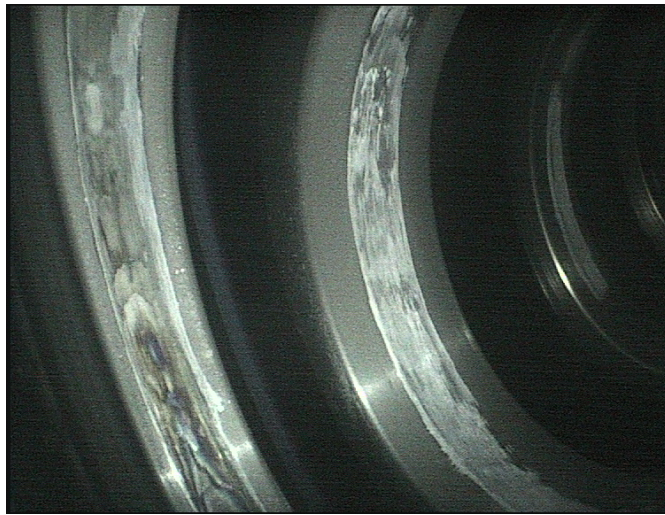
**Photo 23- Borescope Photos Inside High Pressure Shaft, Rubs on HPC Disk Bores**

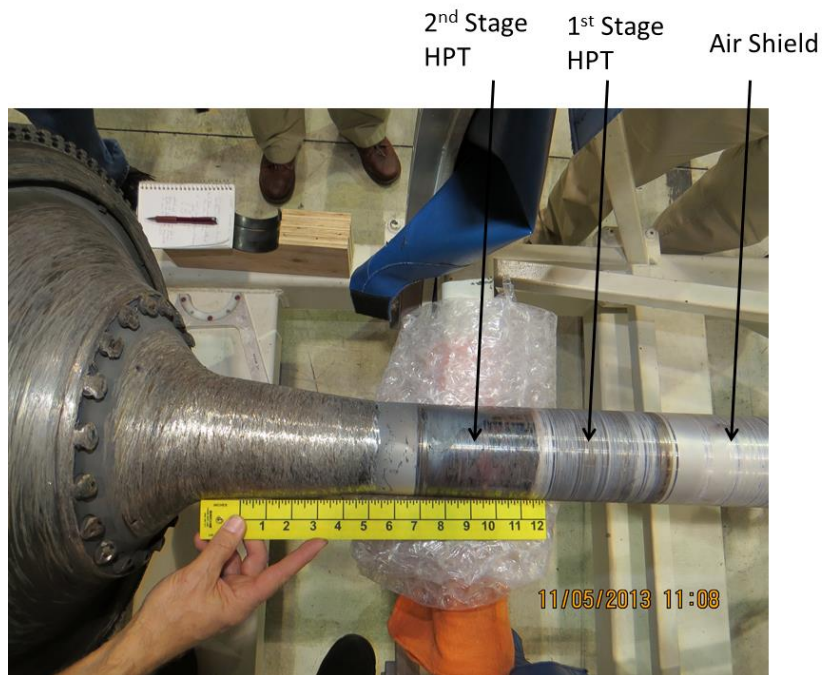
LPT shaft where the LPT disks are normally positioned exhibited heavy gouging and scoring 360 degrees around with material damage most concentrated over a 180 degree area. A ruler was placed on each side of the shaft and a gap comparison check confirmed that the shaft was bent (**Photo 25**).

**Photo 24- Circumferential LPT Shaft Rub/Scoring, Corresponding Contact Points Labeled**

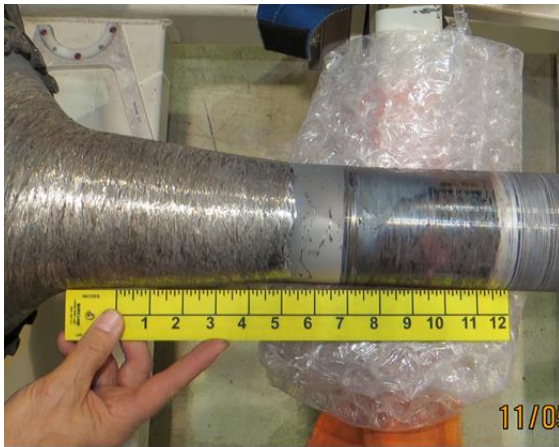
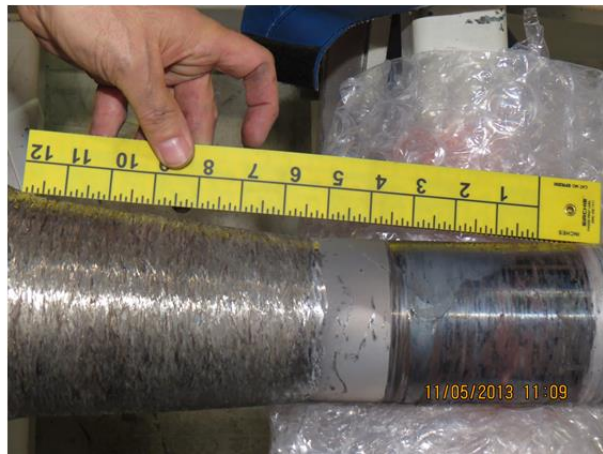
**Photo 25- LPT Shaft- Gap Between Ruler and Shaft to Show Shaft Bend**

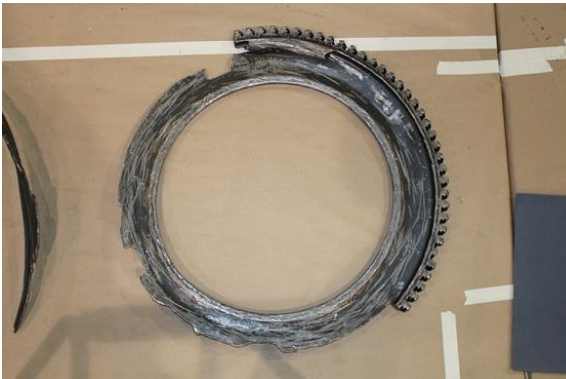
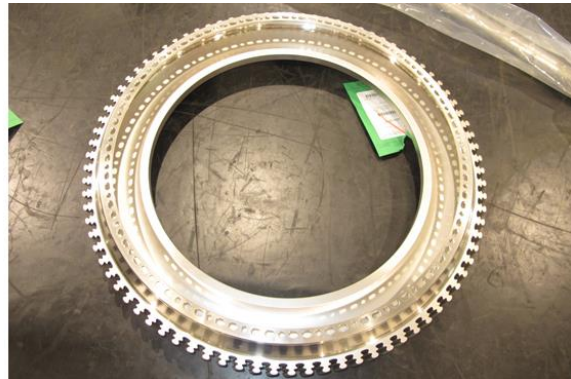
The LPT 5<sup>th</sup> stage disk was missing 240 degrees of blade attachment slots (**Photo 26**). The disk webbing exhibited heavy gouging on the forward and aft sides. The inner diameter disk bore was mushroomed consistent with LPT shaft impact. Multiple cracks were present on the disk web originating from the outer rim. The forward disk attachment wing was present in two sections, 30 degrees and 20 degrees in circumference. Both sections exhibited impact damage that flattened the wing into the disk web. The aft disk attachment wing was present over a 30 degree section and exhibited impact damage that caused it to roll inward towards the blade attachments (**Photo 27**).

**Photo 26- LPT 5<sup>th</sup> Stage Disk, (L) As Removed From Engine (R) New Disk**

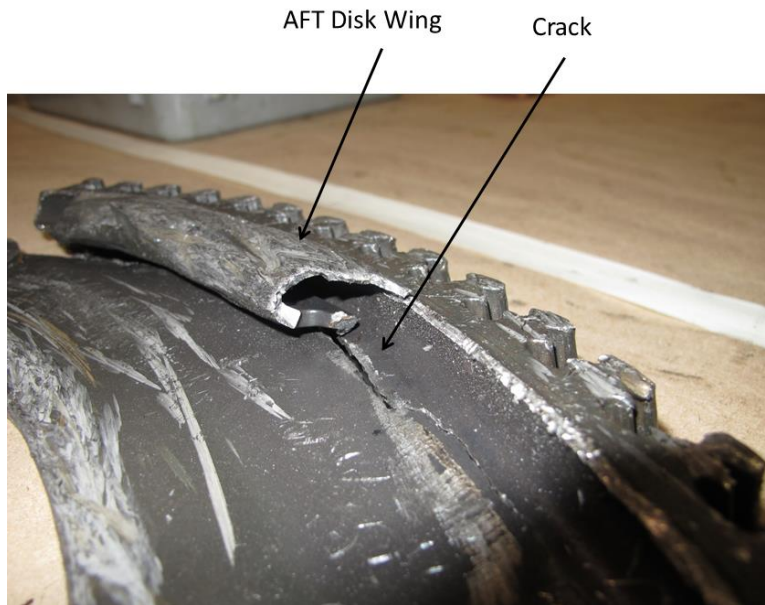
**Photo 27- LPT 5<sup>th</sup> Stage Disk Damage, Disk Wing Rolled Inward**

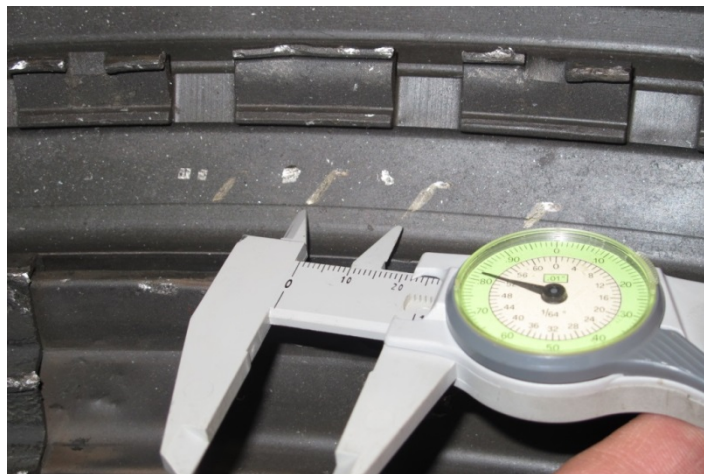
The LPT 3<sup>rd</sup> stage vane fracture surfaces were shiny and less oxidized than other fracture surfaces within the case. Impact marks were identified on the LPT 3<sup>rd</sup> stage vane heat shield and LPT case where vane segments were missing (**Photo 28**). Impact mark spacing on the LPT 3<sup>rd</sup> stage vane heat shield was consistent with LPT blade attachment spacing based on caliper measurements.

**Photo 28- Impact Marks Along 3<sup>rd</sup> Stage Vane Track, Vanes, and Heat Shield Missing**

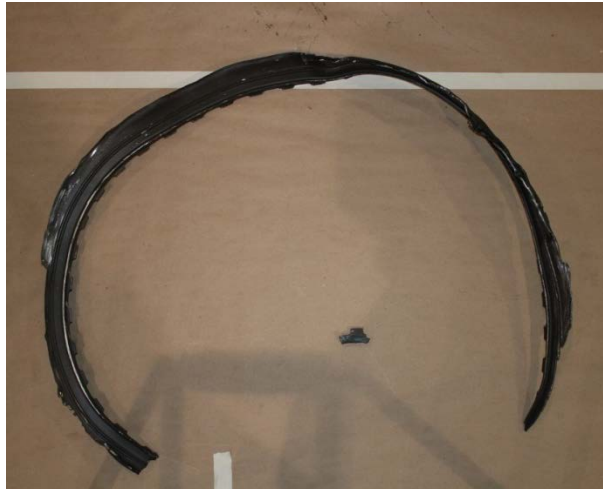
The HPT 2<sup>nd</sup> stage blade retaining ring had separated allowing it to expand into a “U” shape. The ring exhibited impact deformation 360 degrees around with material loss and rub noted along the separated edges (**Photo 29**). All 32 bayonet tabs were present, confirming that the entire ring circumference was recovered.

**Photo 29- HPT 2<sup>nd</sup> Stage Blade Retaining Ring**

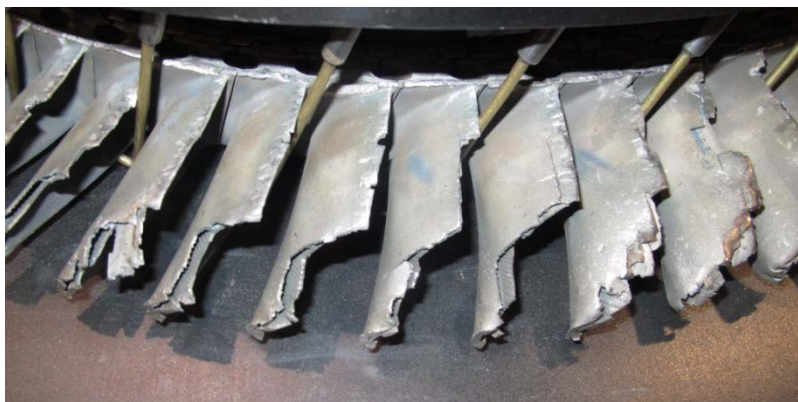
The HPT 2<sup>nd</sup> stage turbine blades had trailing edge impact damage and material loss around the rotor (**Photo 30**). The aft surface of the disk web and blade attachment slots exhibited scoring 360 degrees around. Three HPT 2<sup>nd</sup> stage blades were fractured transversely below the platform at positions 45, 51, 52, as numbered during teardown, and the blade roots remained within the disk blade slot. Six consecutive blades were missing located at positions 2-7, four of which were found in the debris just aft of the HPT. The forward side of the HPT 2<sup>nd</sup> stage disk was oil streaked. The HPT 2<sup>nd</sup> stage metering plugs were intact and in place.

**Photo 30- HPT 2<sup>nd</sup> Stage Blade Damage, Blades Secured in Fixture**

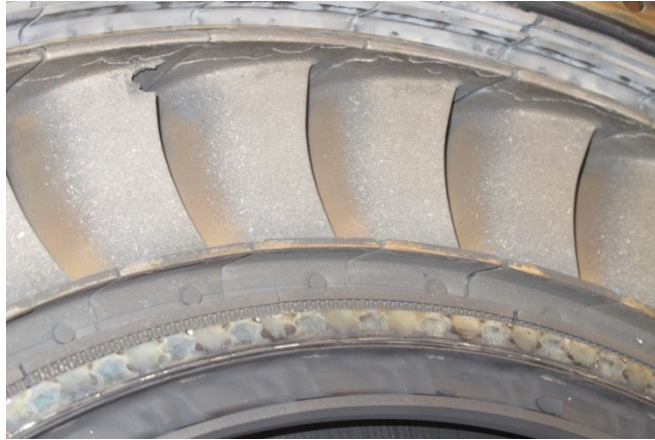
The HPT 2<sup>nd</sup> stage nozzle vanes had rub on the forward inner vane platform around the circumference, consistent with HPT 1<sup>st</sup> stage turbine blade discourager seal (guitar pick) contact. All vanes had metal spray on both pressure and suction surfaces. Multiple vanes exhibited impact damage along the trailing edge outer diameter (**Photo 31**).

**Photo 31- HPT 2<sup>nd</sup> Stage Nozzle, Trailing Edge Impact Damage and Metal Spray**

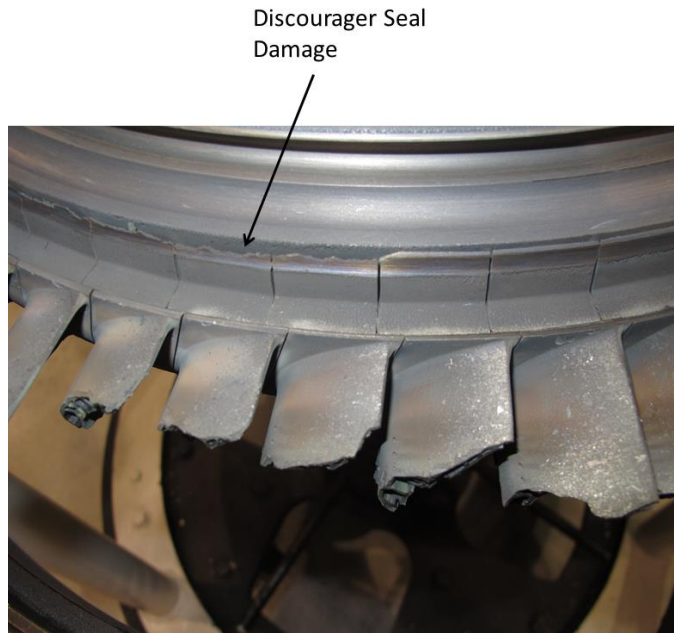
Ten consecutive HPT 1<sup>st</sup> stage turbine blades were missing material. The greatest material loss occurred at approximately 50% of blade span and material loss on subsequent nine blades decreased progressively to only the leading edge tip. All remaining blades exhibited heavy tip rub. The circumferential location of the fractured blades was consistent with heavy rub identified on other rotating components. All blades had metal spray on the leading and trailing edges. The trailing edge blade platform had rub 360 degrees around the disk. The trailing edge discourager seal (guitar pick) had 360 degree rub most concentrated over a 180 degree arc (**Photo 32**). The HPT stage 1-to-2 air seal web had baked on oil residue and sooting on the forward and aft surfaces. Baked oil residue had collected along the outer seal diameter lip and flaked off to the touch (**Photo 33**). Oil wetting was also noted along the seal inner bore. The knife edge seals along the 1-to-2 air seal outer diameter were intact with evidence of rub. The HPT 1<sup>st</sup> stage air seal (Tangential On Board Injector - TOBI) exhibited approximately a 180 degree rub on the forward surface consistent with contact from the static discourager seal. The aft side of the disk was oil streaked. The HPT 1<sup>st</sup> stage metering plugs were intact and in place.

**Photo 32- HPT 1<sup>st</sup> Stage Blade Tip Damage**

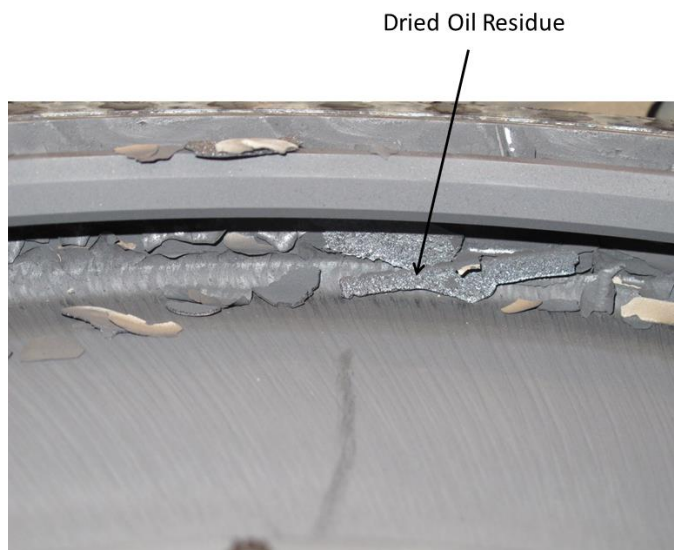
**Photo 33- 1-to-2 Seal Oil Residue**

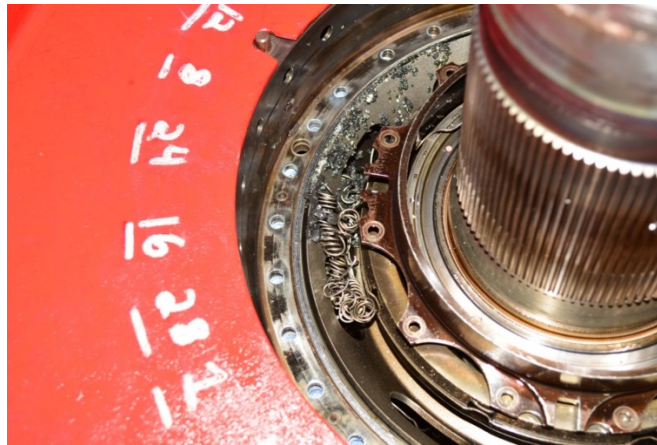
flakes, carbon seal fragments, and safety wire were found between the No. 4 bearing support and No. 4 bearing rear cooling duct at the 6 o'clock position. A length of uncoiled carbon seal carrier spring was found between the carrier and seal land (**Photo 34**). Oil wetting was noted at 6 o'clock running down the rear No. 4 heat shield cover originating from the No. 4 bearing housing. The aft No. 4 bearing carbon seal was fragmented and seal springs were dislodged and bundled at 6 o'clock. The external No. 4 bearing compartment surfaces were coated in soot.

**Photo 34- No. 4 Bearing Aft Compartment Debris**

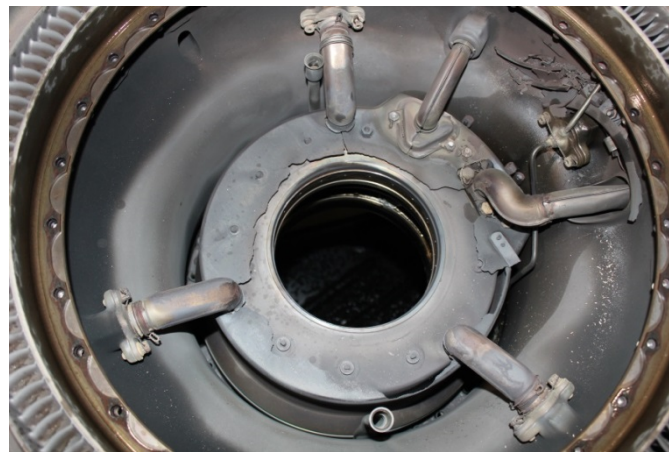
The No. 4 bearing forward compartment heat shield was fractured and missing material. Multiple heat shield studs were found fractured with nuts still attached. One heat shield stud with nut attached remained intact securing remaining sections of the heat shield in place. Two buffer air tubes heat shields were found loose with safety wire present but not in place on the cooling duct end. One buffer air tube heat shield was missing safety wire on the cooling duct end (**Photo 35**).

**Photo 35- No. 4 Bearing Forward Compartment Heat Shield Damage**

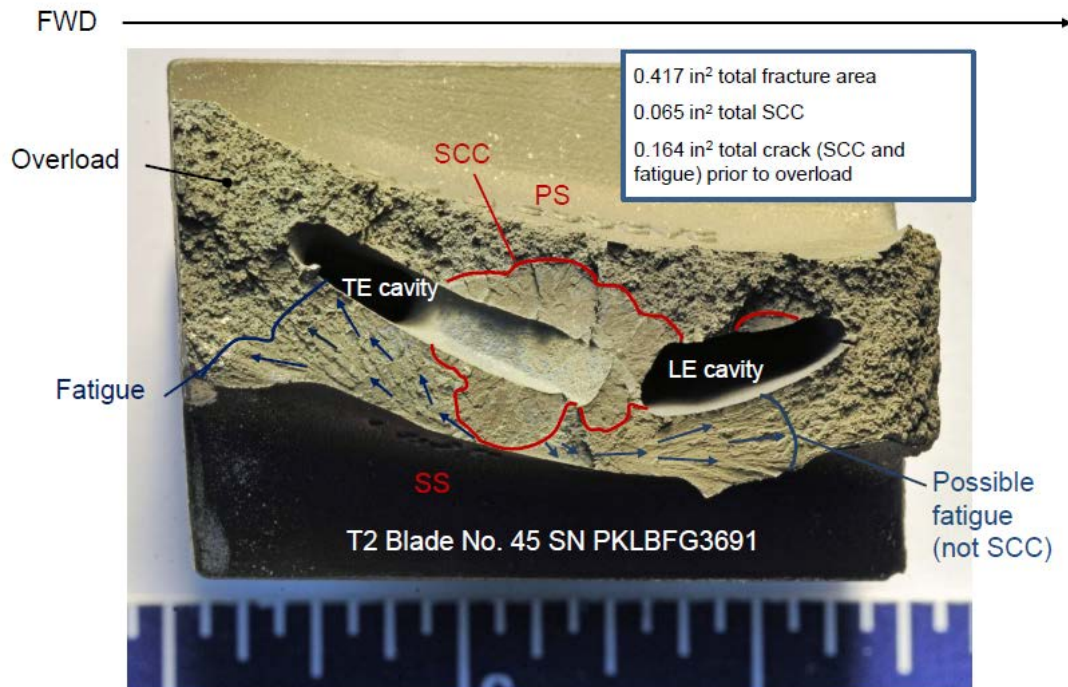
Seventy of the 72 HPT 2<sup>nd</sup> stage blades were submitted for analysis. Three of the 70 blades exhibited below platform fractures. The fracture surfaces were covered with dark deposits with low aspect ratio cracks in the trailing edge cavity of the J-channel rib (**Photo 36**)<sup>5</sup>. According the P&W materials lab, the crack morphology was consistent with SCC of nickel superalloys. Electron microprobe (EMP) and scanning electron microscope (SEM)/energy dispersive spectroscopy (EDS) were used to analyze the oxidation/corrosion products on the fracture surfaces and secondary cracks. The product was found to be predominantly comprised of oxidized base metal elements but sulfur deposits were found on each crack location that was examined. The source of the sulfur could not be determined.

**Photo 36- HPT 2<sup>nd</sup> Stage Blade Fracture Surface, Stress Corrosion Cracks Labeled**

Non-destructive examination methods including x-ray and borescope of the remaining 67 blades identified various levels of SCC in the J-channel cooling air cavity of 38 blades. All 67 blades were subsequently sectioned for more thorough examination and a total of 41 were found to exhibit under platform cracks.

In response to the findings from this incident, IAE developed and released additional inspection and repair procedures for V2500 series engine HPT 2<sup>nd</sup> stage blades. The new procedures require x-ray and borescope inspections of the J-channel cooling air cavity for cracks. IAE also proposed coating the internal passages with an aluminide corrosion preventative coating beginning in late 2014.

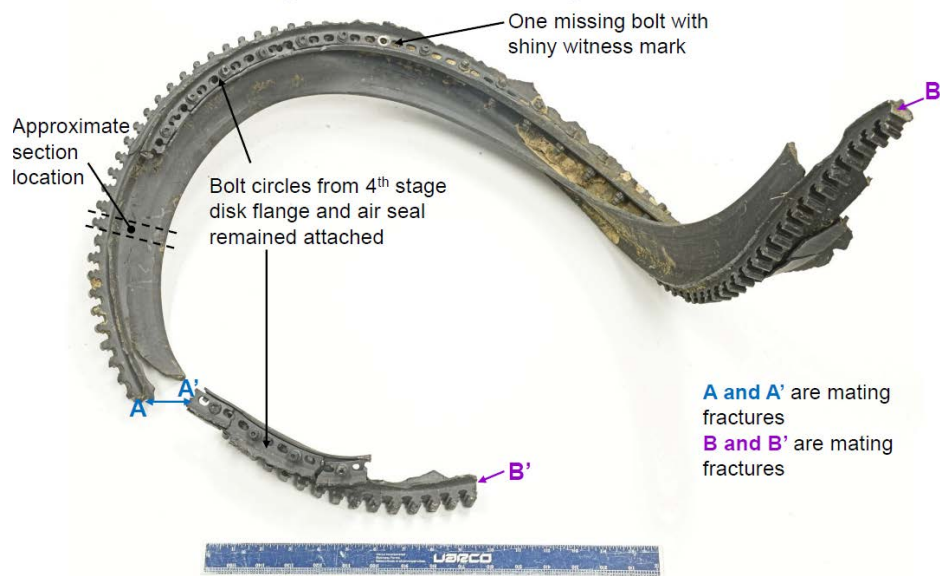
Two fragments of the LPT 3<sup>rd</sup> stage disk were recovered during a search in rural Texas and shipped to P&W for analysis. The larger of the two fragments measured 52 inches circumferentially and was twisted. The smaller fragment measured 9.5 inches circumferentially. The ends of the smaller piece mated with those on the large piece and the total circumference of the two fragments accounted for the entire disk outer rim (**Photo 37**). Binocular examination of the fracture surfaces found rough, granular features consistent with a mixture of tensile overload and stress rupture failure modes with no evidence of fatigue.

**Photo 37- Recovered HPT 3<sup>rd</sup> Stage Disk Rim**

Hardness measurements were taken at multiple points along the disk rim and ranged from 87.5-95.3 HRB, well below the 40 HRC minimum for heated treated Inconel 718. The recorded hardness values are consistent with metal temperature exposure in excess of 1700°F (927°C).

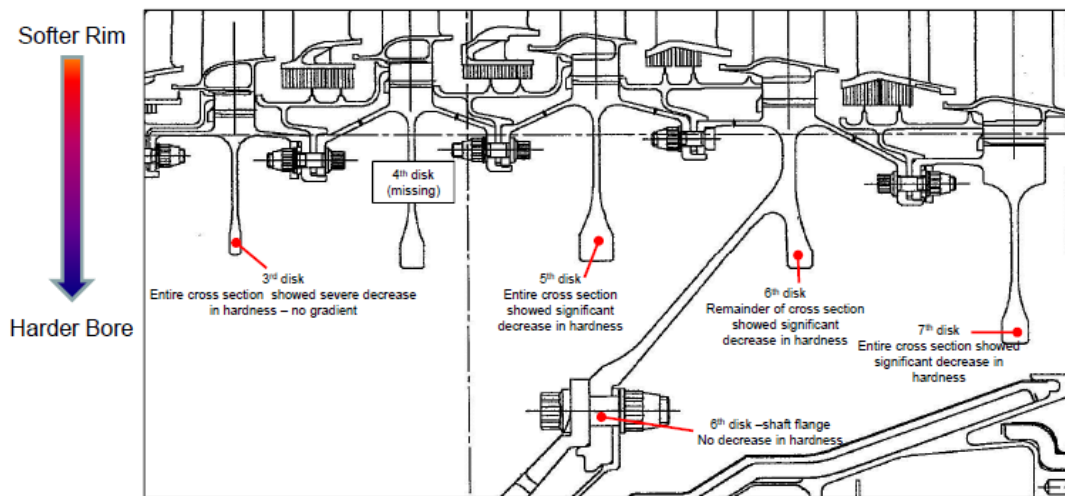
To better understand how the LPT 3<sup>rd</sup> and 4<sup>th</sup> stage disks separated from the engine, hardness measurements were compared at each stage. These measurements provide an approximate gas path temperature exposure for each disk as well a temperature gradient at multiple points radially along each disk to estimate the LPT bore cavity temperature profile. The LPT 3<sup>rd</sup> stage disk exhibited the largest drop of hardness across the entire component. Hardness levels in each stage further aft in the LPT were progressively higher with the bore section of each stage exhibiting higher hardness values than the outer rim sections (**Figure 2**).

**Figure 2- Low Pressure Turbine Hardness Along the Gaspath**

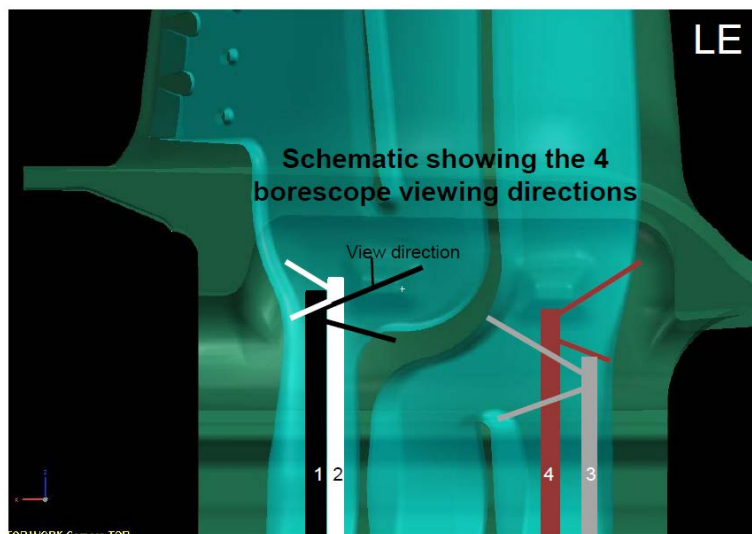
**Figure 4- HPT 2<sup>nd</sup> Stage Blade J-Channel Cooling Air Cavity Borescope Inspection**

Following the event P&W/IAE revised their HPT 2<sup>nd</sup> stage blade inspection criteria in an effort to better detect internal cracks during blade repair/overhaul. Blades are x-rayed and then the internal cavities are borescoped to inspect for evidence of surface defects (**Figure 3**). P&W is also developing an aluminide coating for the internal cavities of HPT 2<sup>nd</sup> stage blades to protect against corrosive deposits that they hope to field in late 2014.
