**NATIONAL TRANSPORTATION SAFETY BOARD
OFFICE OF AVIATION SAFETY
WASHINGTON, D.C. 20594**

**POWERPLANTS GROUP CHAIRMAN'S FACTUAL REPORT
NTSB ID: CEN16MA036**

Location: Akron, Ohio
Date: November 10, 2015
Time: 1452 eastern standard time
Aircraft: British Aerospace HS 125-700A, Reg. No. N237WR

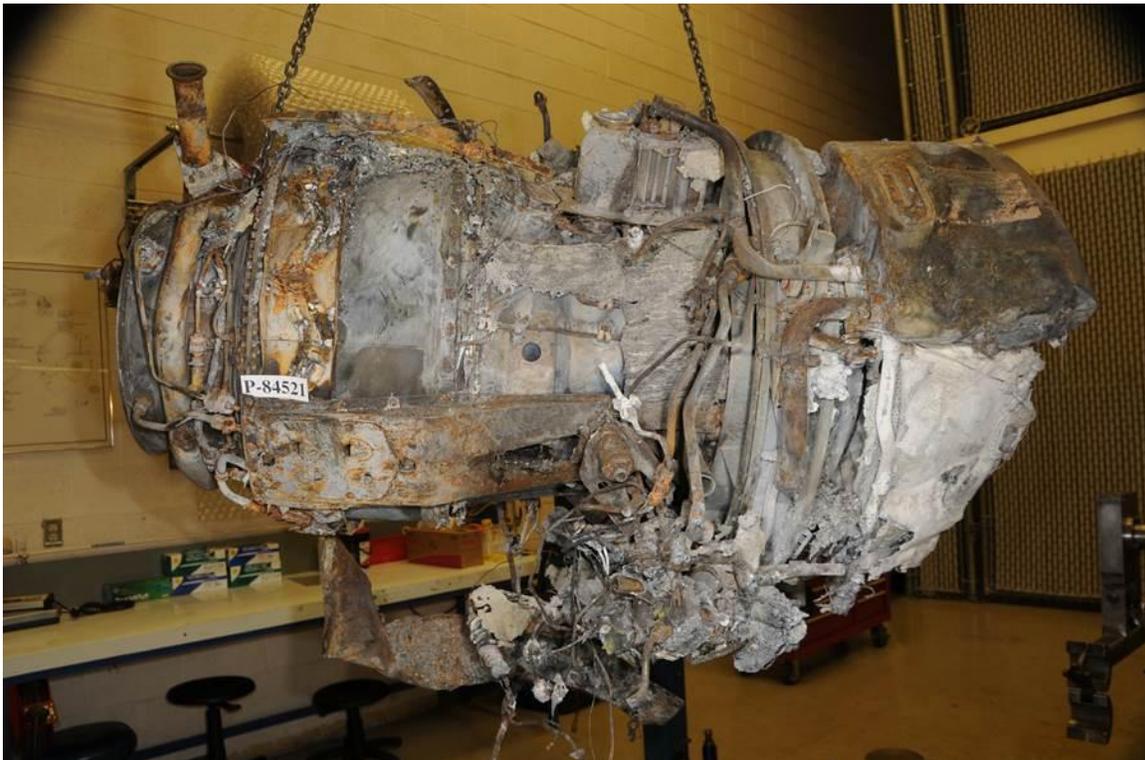
The engine was substantially fire damaged. The spinner and portions of the fan inlet were thermally consumed. Much of the accessory drive section was thermally destroyed and the fuel control unit (FCU), fuel pump, and fuel heater, also fire damaged, remained attached to the engine by tubing. A package of material recovered from the vicinity of the engine included steel accessory drive train and accessory parts including the bevel takeoff gear, fuel control and oil pump components and the fuel and oil filter elements. The steel components were examined with no anomalies noted. Thermal damage prevented assessment of the fuel filter and oil filter elements.

The air/oil cooler was slightly deformed between 9 and 3 o'clock⁴, thermally damaged with substantial portions missing between 3 and 6 o'clock, and missing between 6 and 9 o'clock. The engine casings were structurally intact with no evidence of uncontainment or burn-through. Terrain debris, resolidified metal, and building material fragments were present in the fan gas path. The fan blade leading edges (LEs) were torn and battered consistent with foreign object damage (FOD). Viewed through the exhaust, the LPT S3 showed no obvious damage. The engine low pressure rotor would not rotate by hand either at the fan or at the LPT. See Figure 1.

Figure 1. Right side view of P-84521

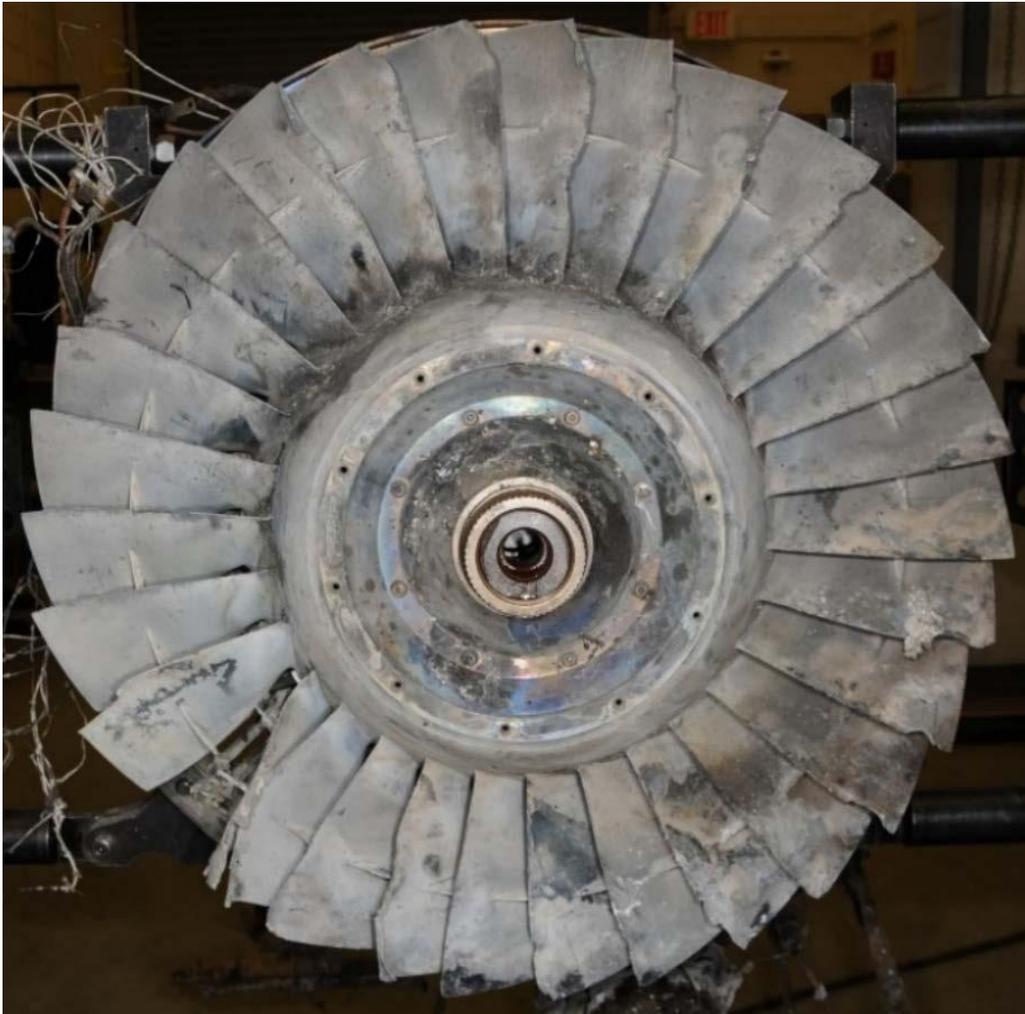
The fan blades, which are of titanium alloy construction, displayed tip damage and multiple LE nicks and tears. One blade was bent. The bent blade and the LE tears were deformed in the direction opposite of fan rotation. See Figure 2.

Figure 2. Forward face of fan showing blade damage

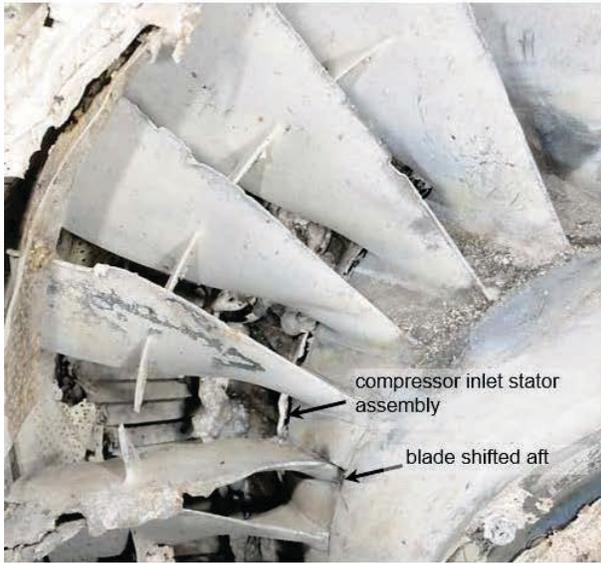
The midspan dampers of the bent blade and an adjacent blade were deformed and the bent blade had displaced aft in the disk retention slot. See Figure 3. The aft platform edge of the displaced

Figure 3. Detail of fan forward face showing displaced blade

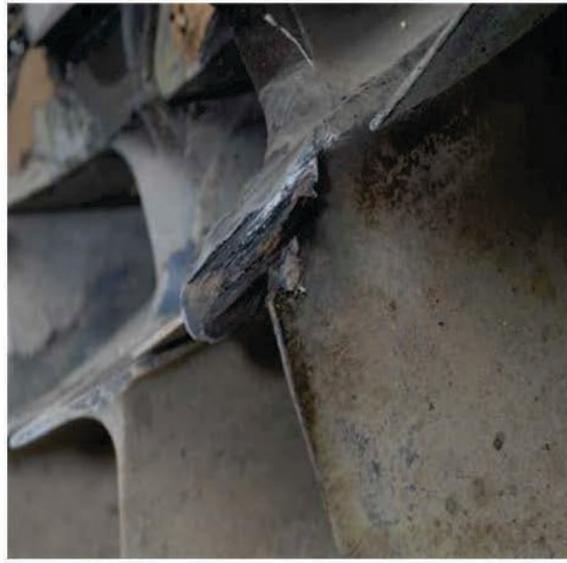
blade was radially deformed and exhibited heavy scoring damage. See Figure 4.

Figure 4. Deformed aft platform edge of displaced fan blade

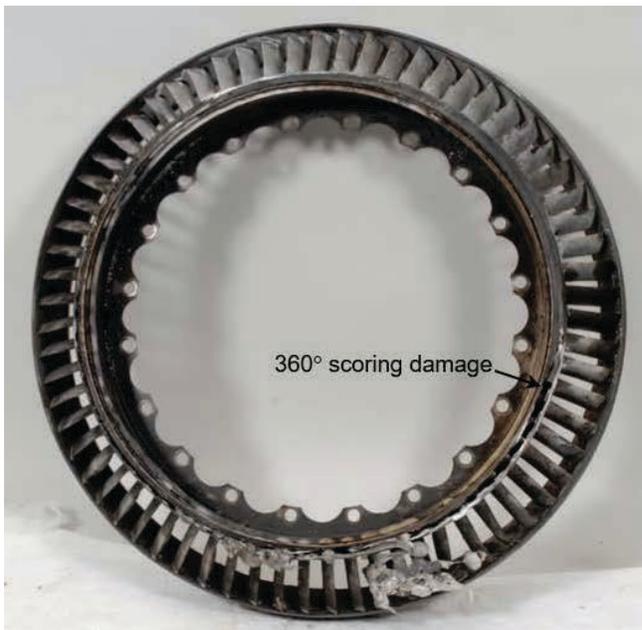
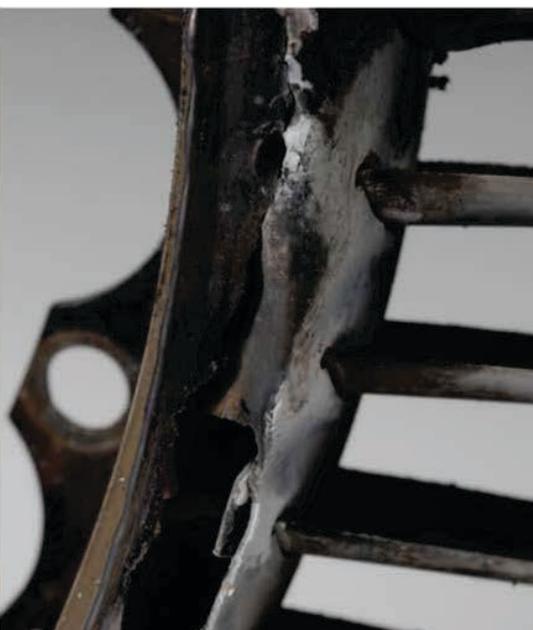
The compressor inlet stator assembly exhibited heavy 360° scoring along its inner shroud forward edge. See Figure 5. Several compressor inlet stator vanes displayed impact marks characteristic of FOD. Twelve vanes were bulged/deformed.

Figure 5. Forward side of the compressor inlet stator assembly showing overall (a) and detail (b) views of 360° inner shroud scoring damage

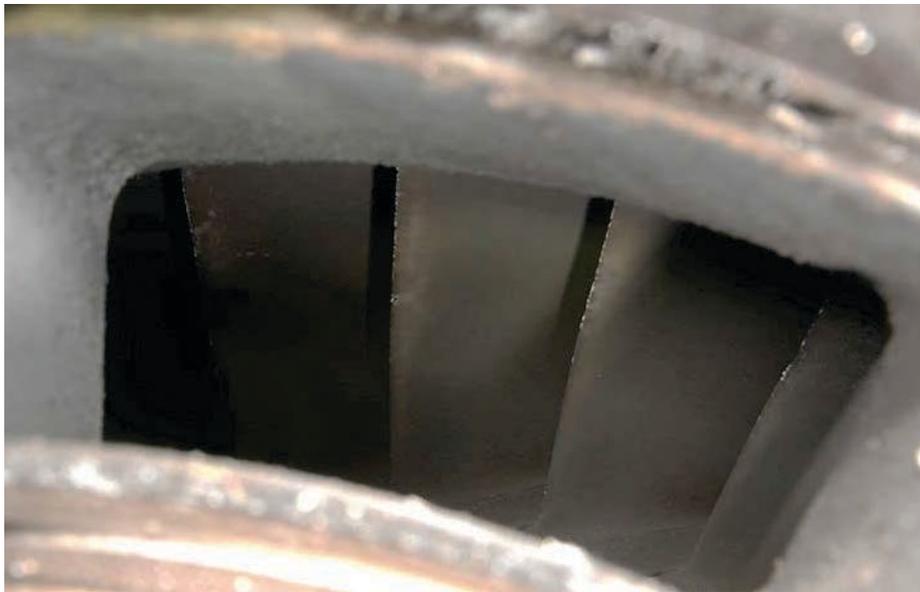
The LPC first stage (S1) blades, which are of titanium construction, exhibited light LE damage consistent with FOD. See Figure 6. The LPC was not disassembled.

Figure 6. LPC S1 LE damage

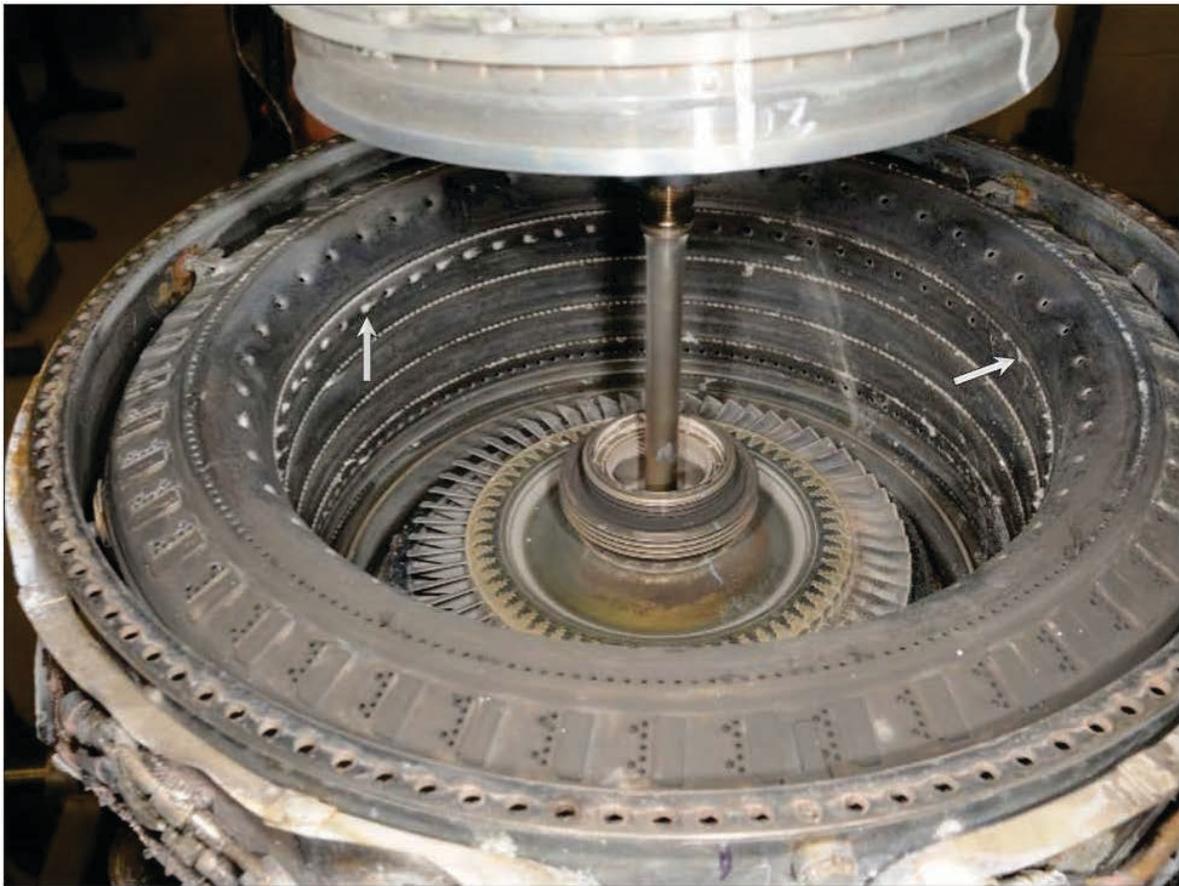
The inner and outer transition liners and deswirl vane appeared structurally intact. There was a heavy soot deposit on the combustor outside surface between 10 and 2 o'clock. An off-white fibrous substance resembling insulation fiberglass was present at most of the combustion liner air cooling/dilution holes. See Figure 7.

Figure 7. Fibrous debris lodged in combustion liner air holes

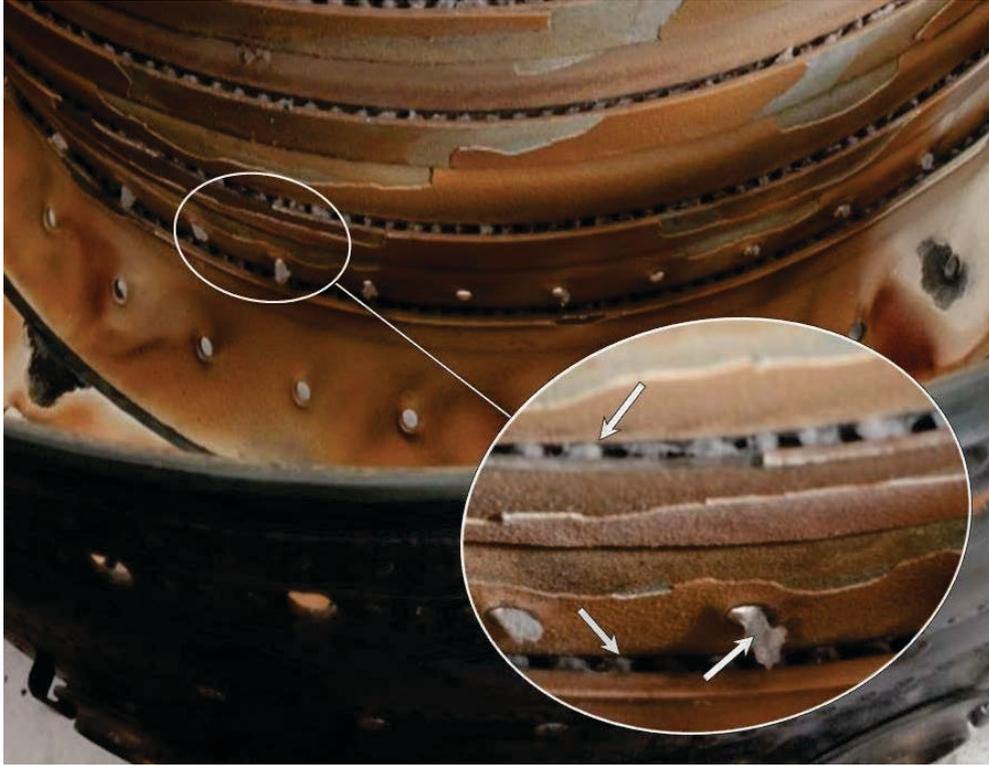
The fibrous debris protruded into the combustion chamber consistent with being carried through the engine in pressurized engine airflow. The debris was uncharred. See Figure 8.

Figure 8. Fibrous debris inside combustor

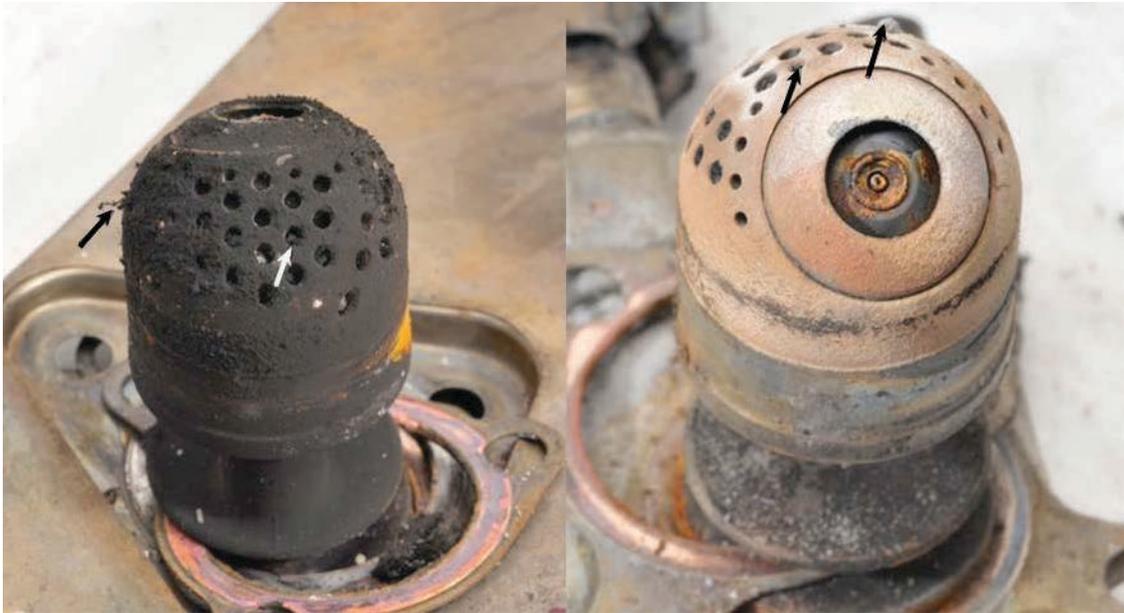
A similar off-white fibrous substance protruded from the fuel nozzle air shroud orifices. The fuel nozzles exhibited light corrosion and the nozzles installed between 10 and 2 o'clock (nozzles 11, 12 and 1) were heavily sooted. See Figure 9.

Figure 9. Fibrous debris protruding from fuel nozzle air shroud orifices

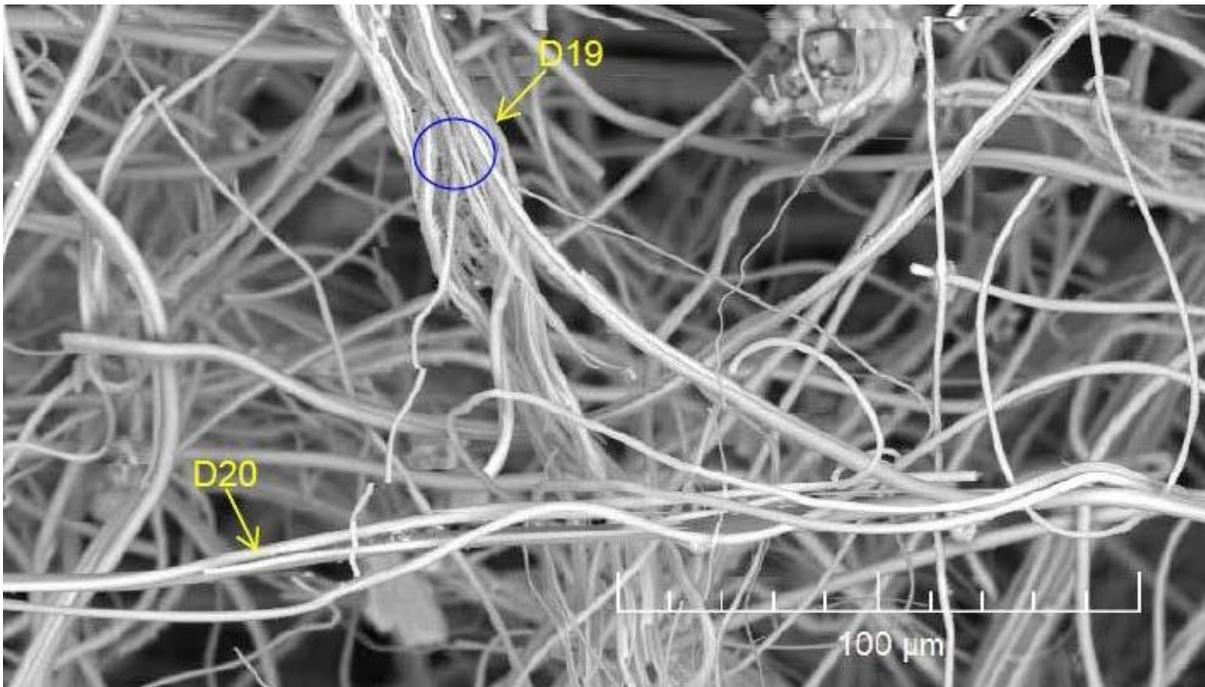
A sample of the fibrous substance was submitted to a Honeywell materials lab for examination. Energy-dispersive X-ray spectroscopy (EDS) of the fiber component revealed a spectrum high in silicon and oxygen. The chemical analysis and general macroscopic examination of the fibers strongly suggested that the substance was fiberglass consistent with building insulation material. See Figures 10 and 11.

Figure 10. Scanning electron microscope image of fibrous substance found in P-84521 combustor

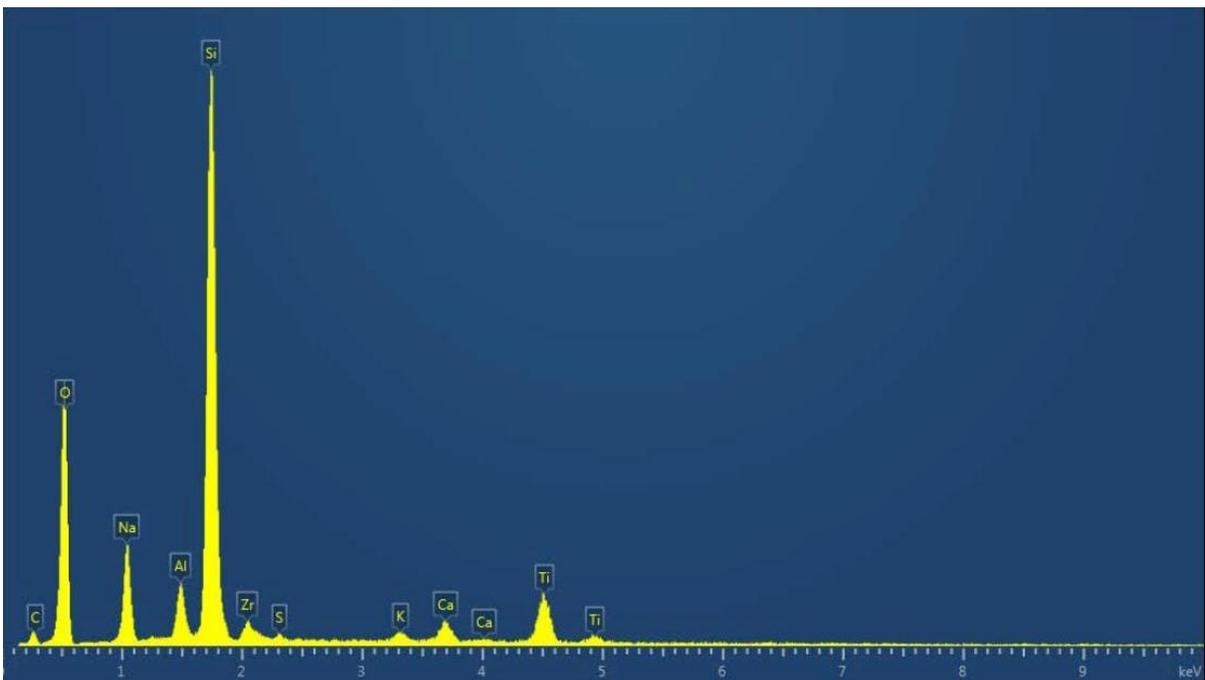
Figure 11. EDS of fibrous substance showing a spectrum rich in silicon and oxygen

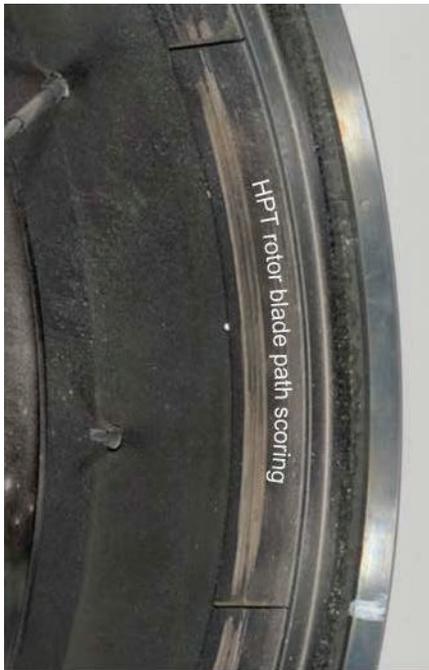
The HPT blade tip shroud segments were rotationally scored. See Figure 12.

Figure 12. HPT blade path scoring

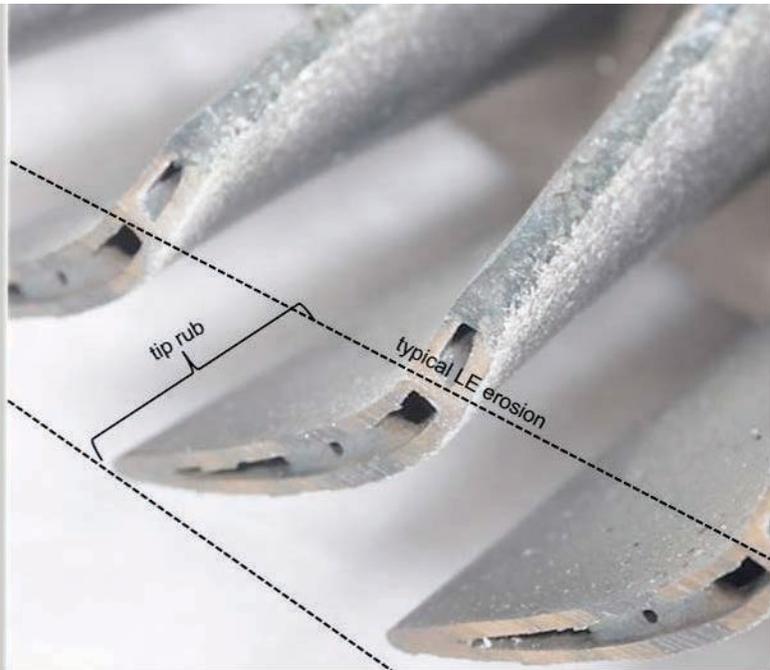
The HPT rotor blades exhibited LE tip erosion damage.⁵ The blade tips were also circumferentially scored. See Figure 13. The circumferential scoring was consistent with the scoring observed on the HPT tip shroud segments. Both the erosion and the tip rub had further exposed the blade cooling passages.

Figure 13. HPT blade tip scoring damage

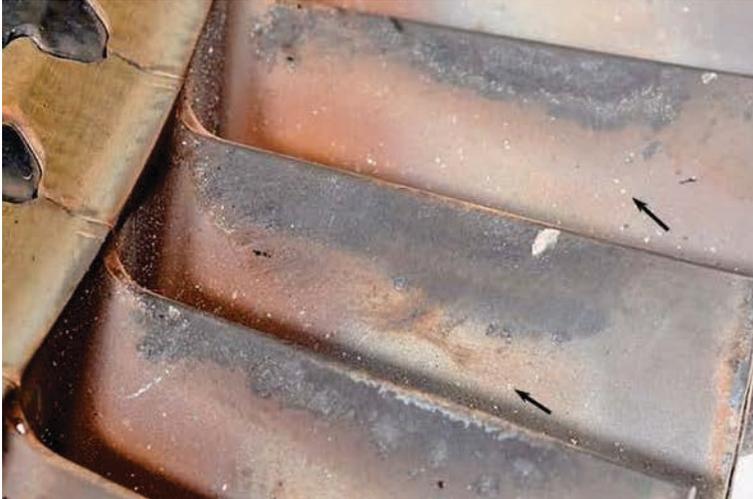
A light spray of shiny, silver-colored deposits was observed on the suction side of several HPT rotor blade airfoils. See Figure 14. The deposits were smooth, spread out, and appeared fused to the blade material. See Figure 15 for an exemplar deposit microphotograph.

Figure 14. HPT rotor showing silver-colored deposits

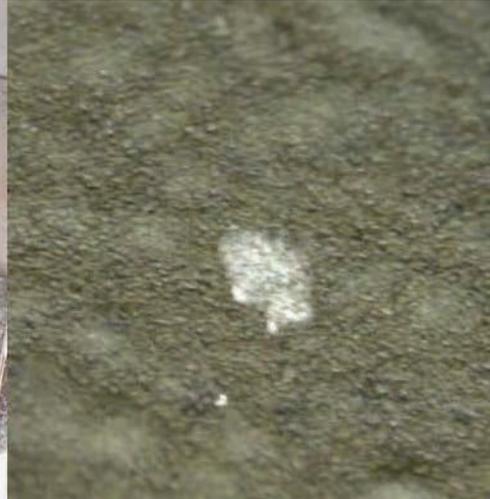
Figure 15. Exemplar microphotograph of silver-colored deposit (P-84169 LPT S1)

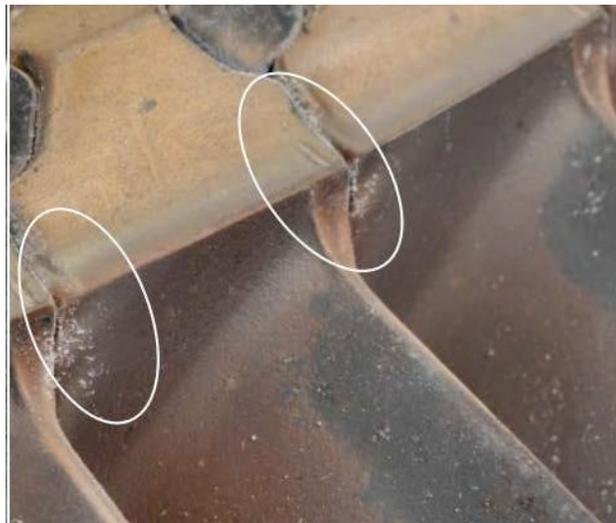
A light-colored substance was observed at the blade platform mating edges/secondary air flow exits. See Figure 16. The HPT forward curvic coupler and seal were undamaged. The HPT aft curvic coupler was undamaged.

Figure 16. HPT blade platform deposits

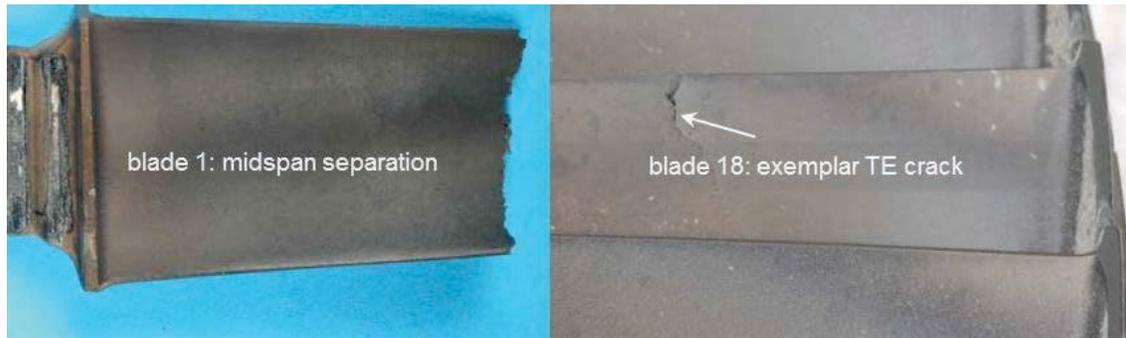
The LPT S1 rotor blade tip shrouds were scored. One blade was separated mid-span and four blades exhibited mid-span TE cracks. Several adjacent blades were lightly dented. The blade separation fracture surface was dark-colored. No blade/shroud tip section fragments were found. See Figure 17.

Figure 17. LPT S1 blade separation (blade 1); exemplar TE crack (blade 18)

The LPT S1 rotor blades were examined at a Honeywell materials lab. Examination of the separated blade fracture surface found no evidence of fatigue. The finer fracture features were obscured by oxidation. Secondary intergranular cracks were observed below the fracture surface at some locations. Cross-sections of the fracture revealed oxidation and alloy depletion along the fracture surface consistent with a creep/stress rupture fracture mechanism. EDS of the blade determined that the base material was as specified. Examination of TE cracks revealed similar oxidation and alloy depletion consistent with creep/stress rupture.

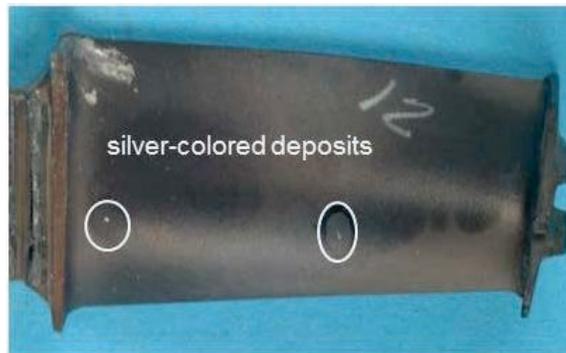
There was a light spray of shiny, silver-colored deposits on the suction sides and LEs of several LPT S1 blades that appeared fused to the airfoil surfaces. See Figure 18.

Figure 18. Silver-colored blade deposits

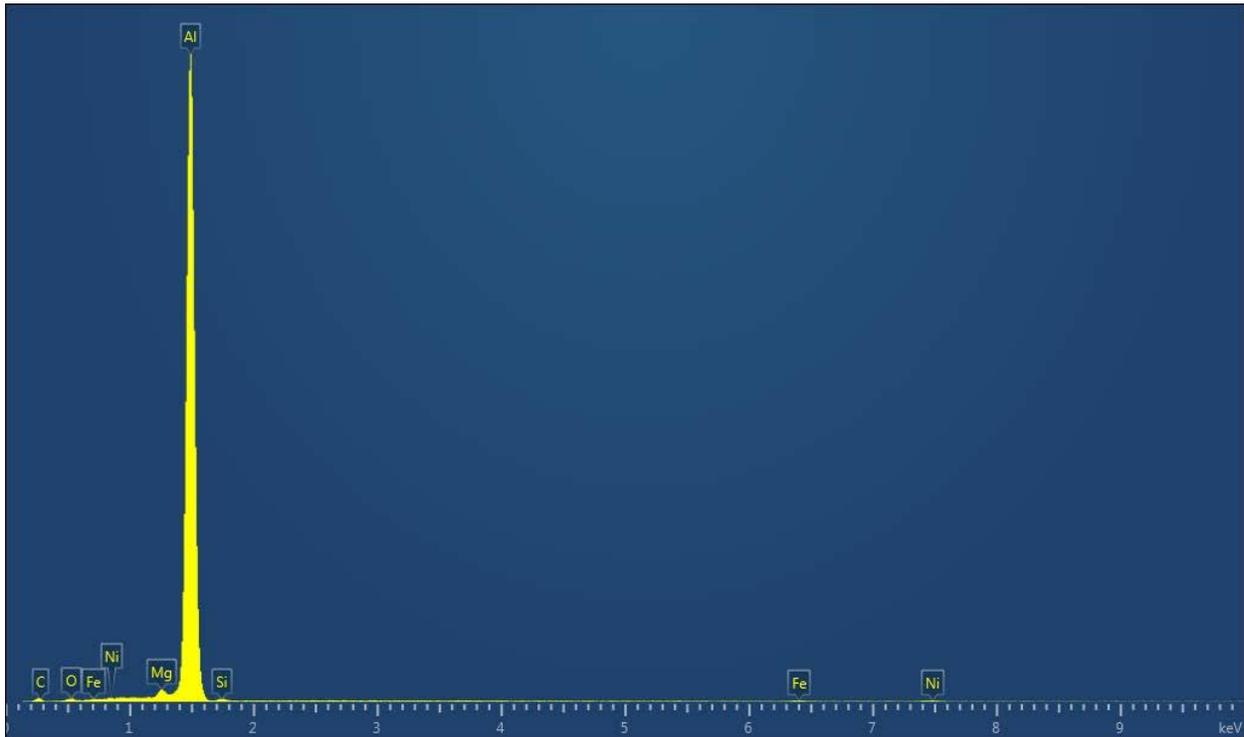
EDS analysis of the silver-colored deposits produced spectra rich in aluminum. See Figure 19.

Figure 19. EDS spectrum of LPT S1 rotor blade deposits showing a spectrum rich in aluminum with lesser concentrations of magnesium, silicon, iron, nickel, and oxygen

The EDS result indicated that aluminide particles entered the engine gas stream while combustion was occurring.

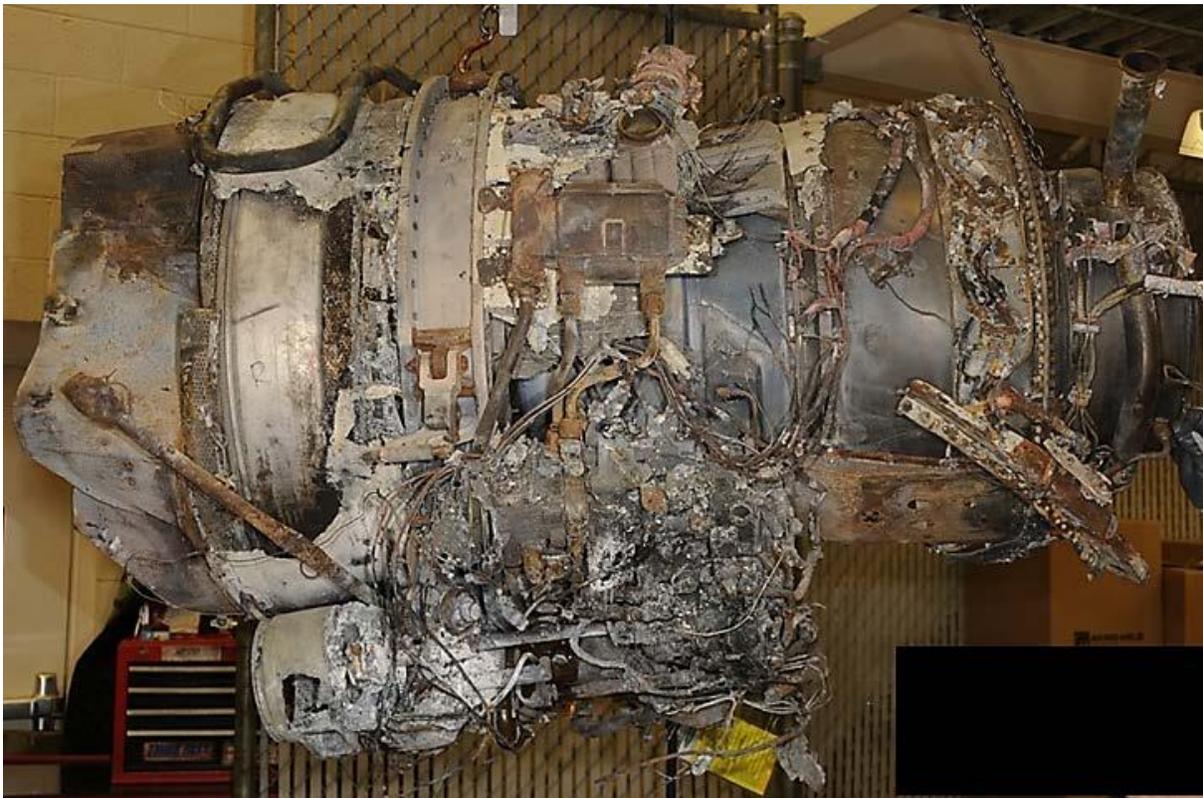
The engine was substantially fire damaged. The forward portion of the spinner and the left side of the accessory gearbox housing were thermally consumed. The inside of the oil filter housing was dry and varnished with no obvious contaminants. The oil filter element was clean. The chip detector tip was corroded. No ferrous slivers or buildup were found on the chip detector. The right engine cases appeared structurally intact with no evidence of uncontainment or burn-through. The air/oil cooler was fractured and partially missing between 6 and 9 o'clock. See Figure 20.

Figure 20. Left side view of P-84169

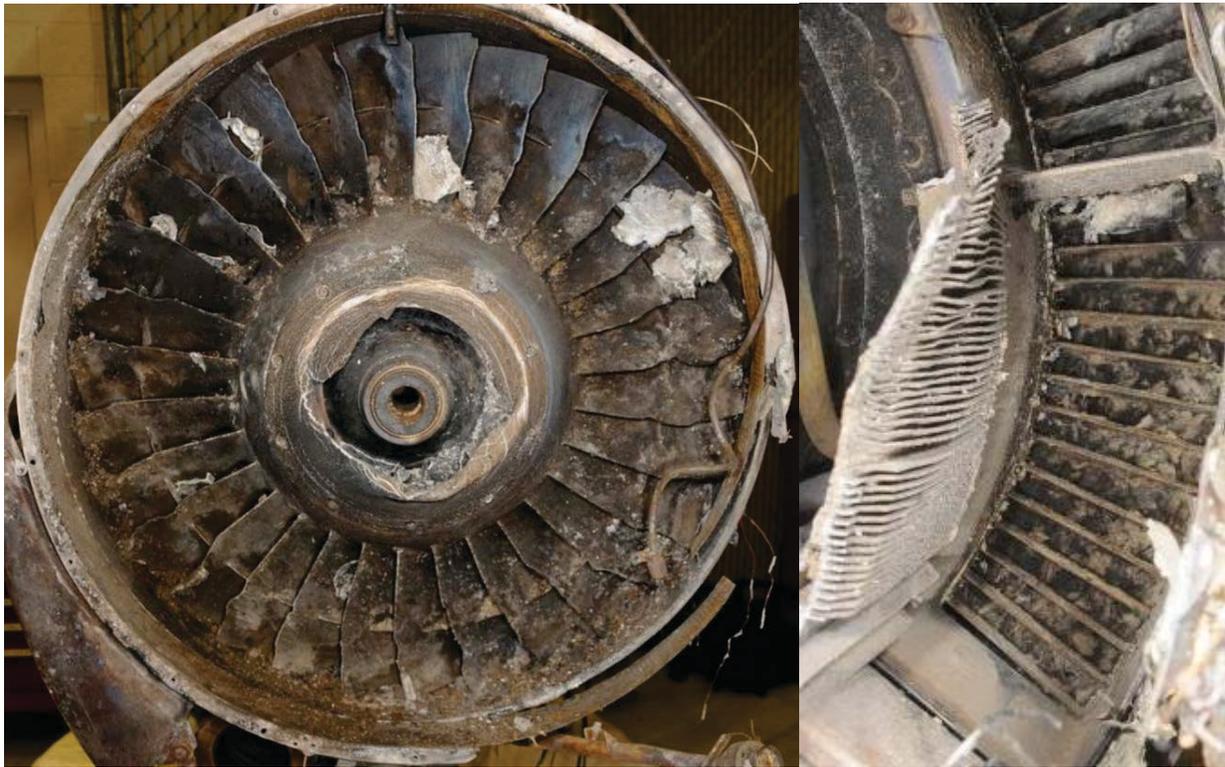
The LEs and tips of the fan blades were torn and battered with material breakouts and curling opposite the direction of fan rotation. A large quantity of terrain debris and some resolidified metal were present in the inlet and between the fan blades. See Figure 21.

Figure 21. Front view of P-84169 assembly (fan housing removed)

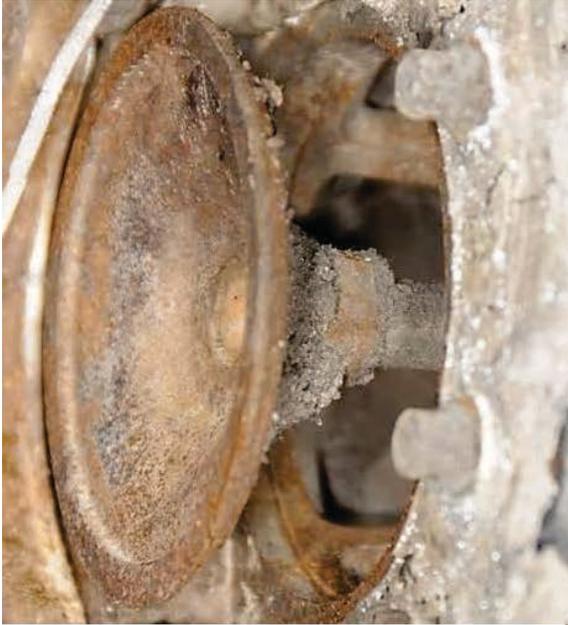
The underside of the LPC surge bleed valve was coated with a thick layer of a spongy, soil-like substance. See Figure 23. Similar contamination was noted at the customer LPC bleed port.

Figure 23. Debris coating bleed valve stem

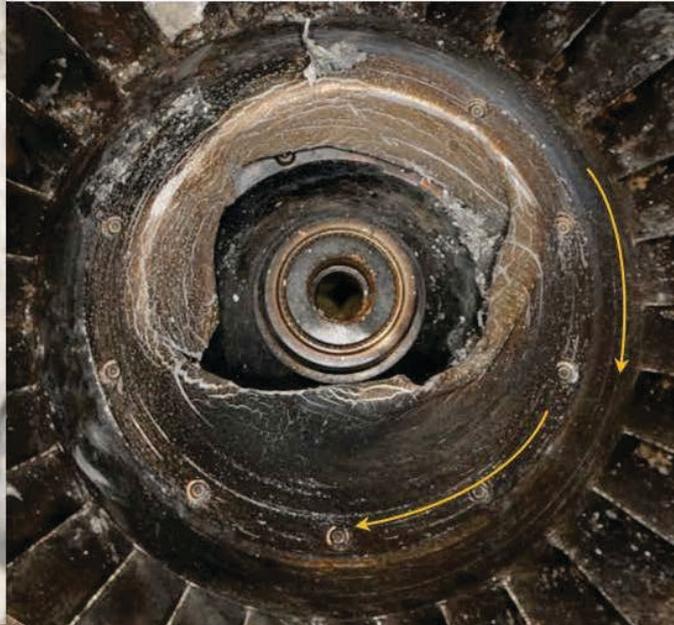
The spinner tip was destroyed by fire and the forward section had collapsed. Circumferentially-oriented scoring was observed on the aft spinner section. See Figure 23.

The spinner support was intact. Its outside surface was heat-roughened and displayed circumferentially-oriented scoring. See Figure 24.

Figure 24. Circumferential spinner and spinner support scoring

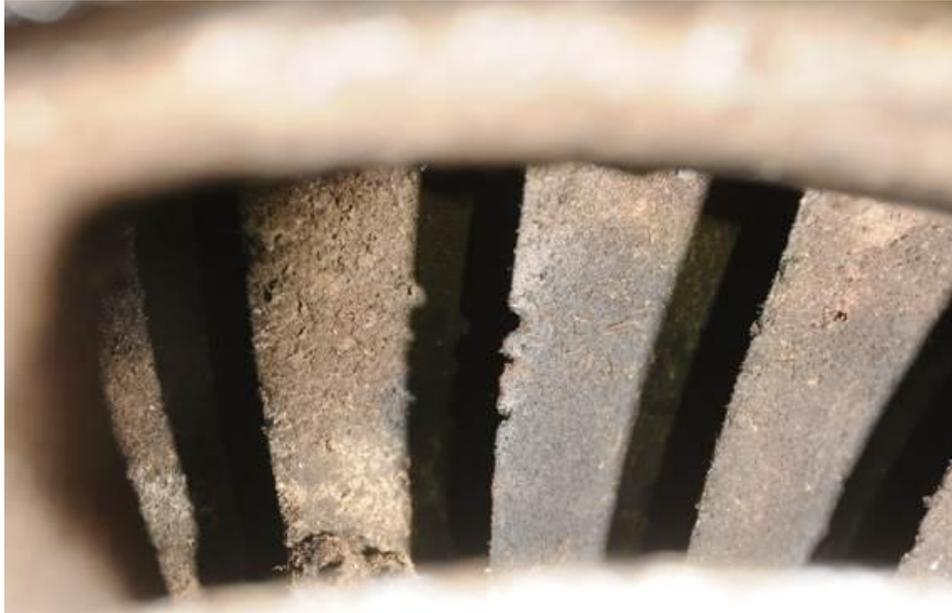
The LPC S1 blade LEs displayed significant dents, nicks, and tears consistent with FOD. The blades were thickly coated with a substance similar to the debris found on the underside of the bleed valve stem. See Figure 25. The LPC was not disassembled.

Figure 25. LPC S1 airfoils thickly coated with debris and showing severe LE damage

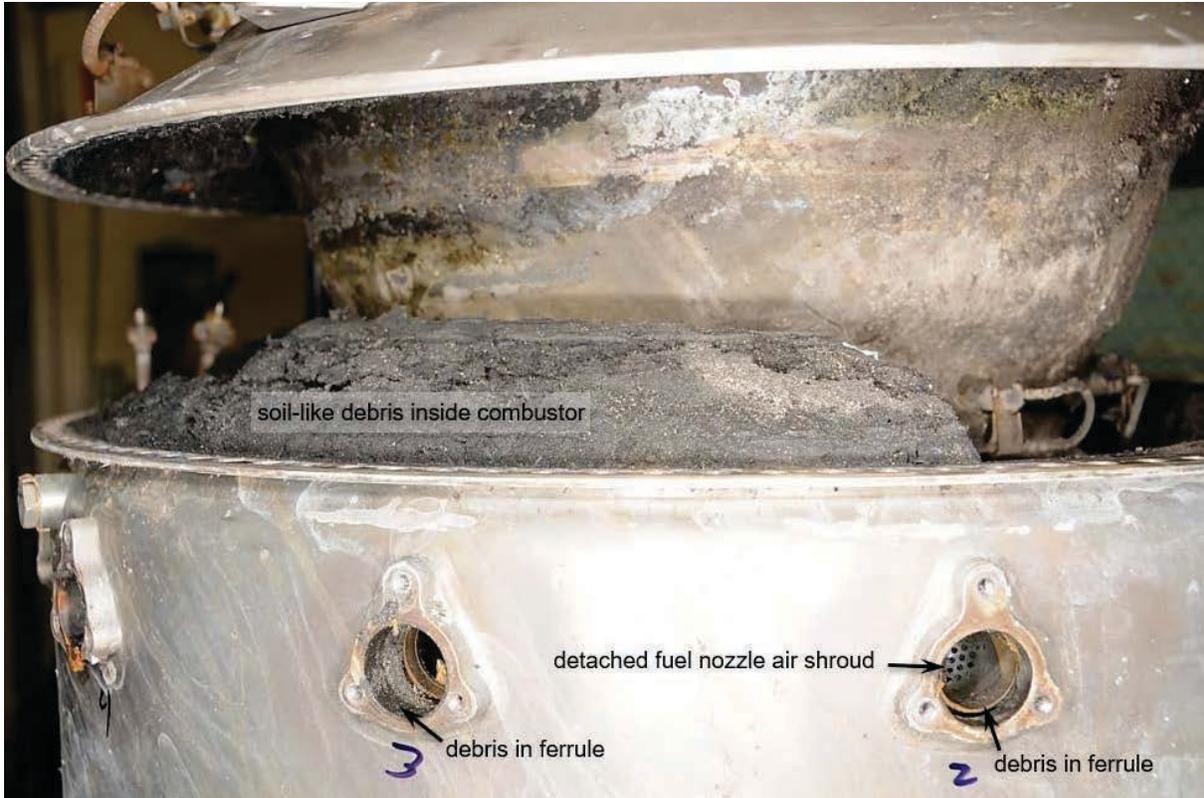
A large annular mound of debris had formed between the combustor and plenum wall. See Figure 26. The debris was soil-like with a fine-tilth consistency and was hosting fungus/mold growth, but it appeared “puffed up” and was adhered together.

Figure 26. Combustor showing soil-like debris formation. Detached air shrouds and debris can be seen inside several fuel nozzle ferrules

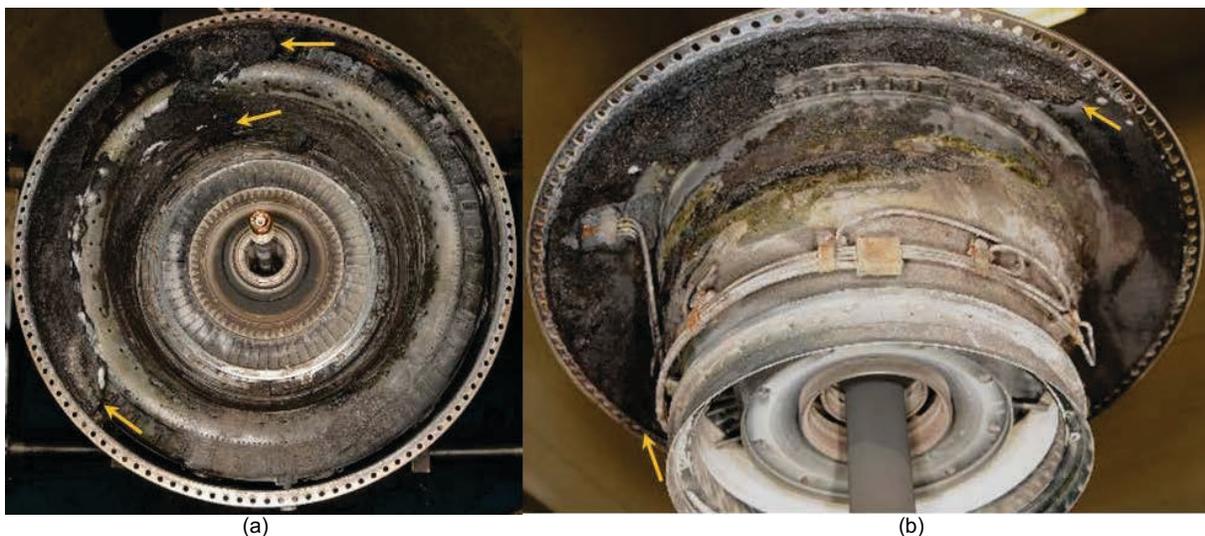
Portions of the mound remained with the interstage transition duct when it was separated from the engine. See Figure 27. The combustion liner was not removed from the plenum.

Figure 27. Showing annular formation of debris adhering to plenum at (a) combustor and (b) interstage transition duct following flange separation

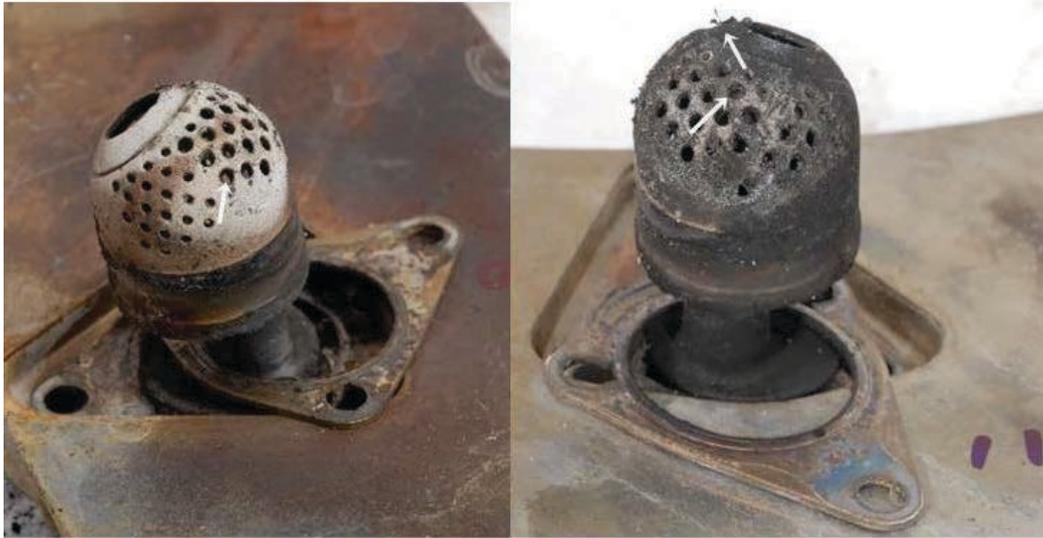
The fuel nozzle tips were corroded. Fibrous deposits were found protruding from the fuel nozzle air orifices. See Figure 28.

Figure 28. Foreign debris blocking and protruding from fuel nozzle air orifices

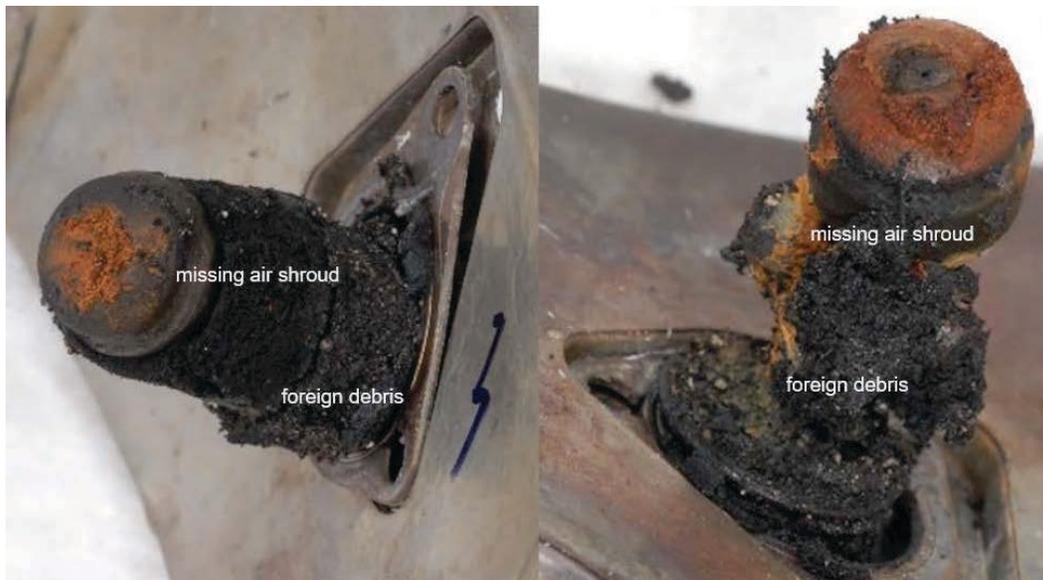
The air shrouds of several nozzles detached during removal and remained inserted in the plenum case ferrules. The nozzles with detached air shrouds appeared scorched and displayed formations of fibrous/soil debris that appeared to have filled the space underneath the air shrouds. See Figure 29. Sections of these debris formations had displaced and collected at the base of the fuel nozzles or remained inside the plenum ferrule. See Figure 26.

Figure 29. Fuel nozzles with separated air shrouds showing intact and displaced debris formation
