NATIONAL TRANSPORTATION SAFETY BOARD
Office of Aviation Safety
Washington, D.C. 20594

POWERPLANT GROUP CHAIRMAN'S FACTUAL REPORT

NTSB No: ENG14IA005

Location: St. Louis, Missouri
Date: December 23, 2013
Time: Approximately 1605 local time
Aircraft: Southwest Boeing 737-3H4, Registration Number N360SW

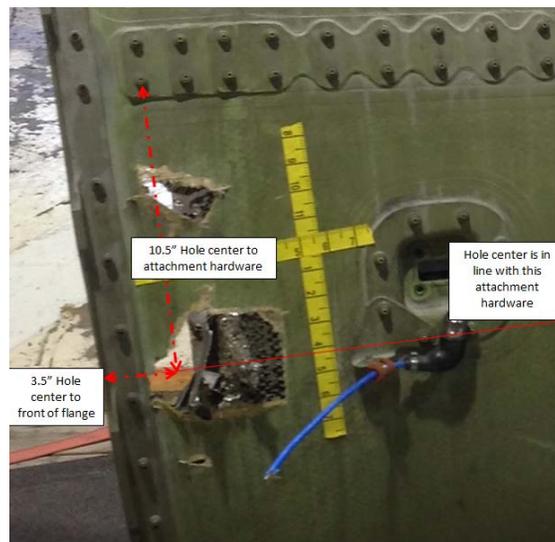
Figure 2 – Hole Locations in Inner Cowling

Locations of the penetration holes on the inlet cowl were measured and recorded on [Figure 2](#), [Figure 3](#), and [Figure 4](#). Boeing engineering used these measurements to estimate the external trajectory of the uncontained fan blade.

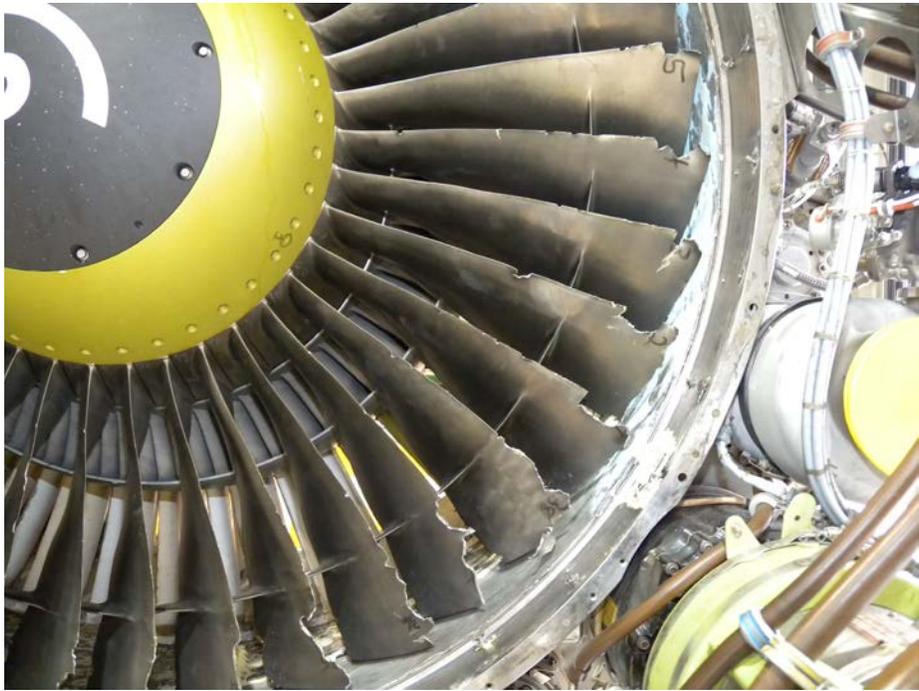
Photo 13 – Fan Blade No. 15

Blade 15 was the leading blade in the operational direction of rotation (Photo 13). A typical blade for the CFM56-3 is approximately 17 inches long at the mid chord. Blade 15 was fractured in a jagged manner at approximately 6 inches outboard from the blade platform. Visual examination of the fracture surface appeared consistent with overload failure. No evidence or features consistent with fatigue were found. There were no nicks on the blade; however, there was a tear on the trailing corner. The leading edge exhibited 3 large-radius ripples, consistent with soft-body damage³ (Photo 9). Matching fracture surfaces of the recovered fan blade fragments with the fracture surface of blade 15 revealed that one of the fragments corresponded with the outer portion of the blade. The fragment of the No. 15 blade was in a lozenged shape approximately 6 inches x 4 inches. It was battered on all surfaces and did not include the mid-span shroud (Photo 15).

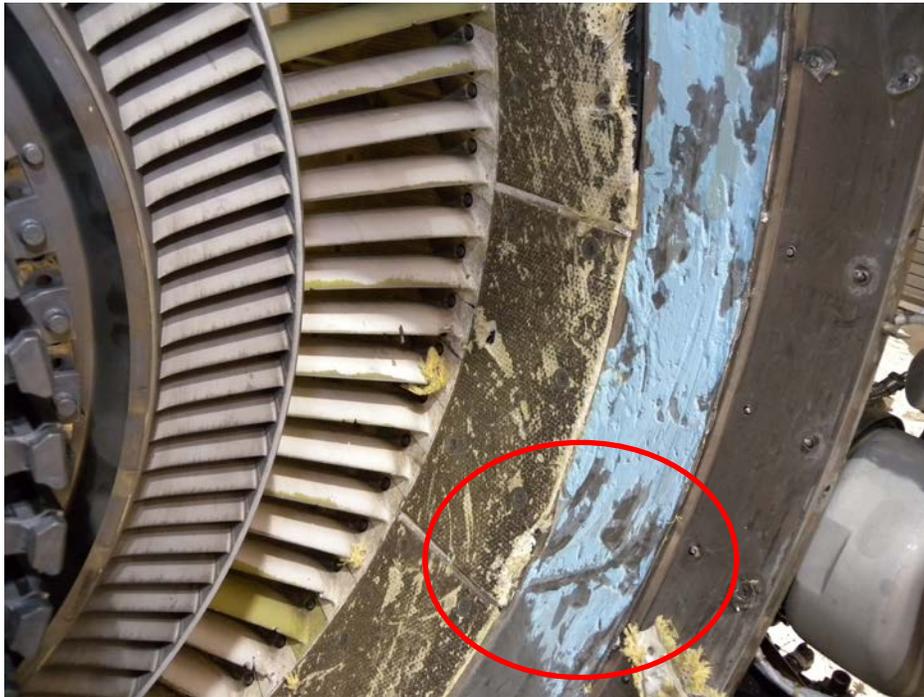
Photo 23 – Dent in Plane of Forward Acoustic Panel

The fan case was also dented at the 1:45 o'clock location in the plane of the forward acoustic panel (Photo 23). The dent size was approximately 1 inch circumferentially x 1 inch axially x 0.05 inches radially.

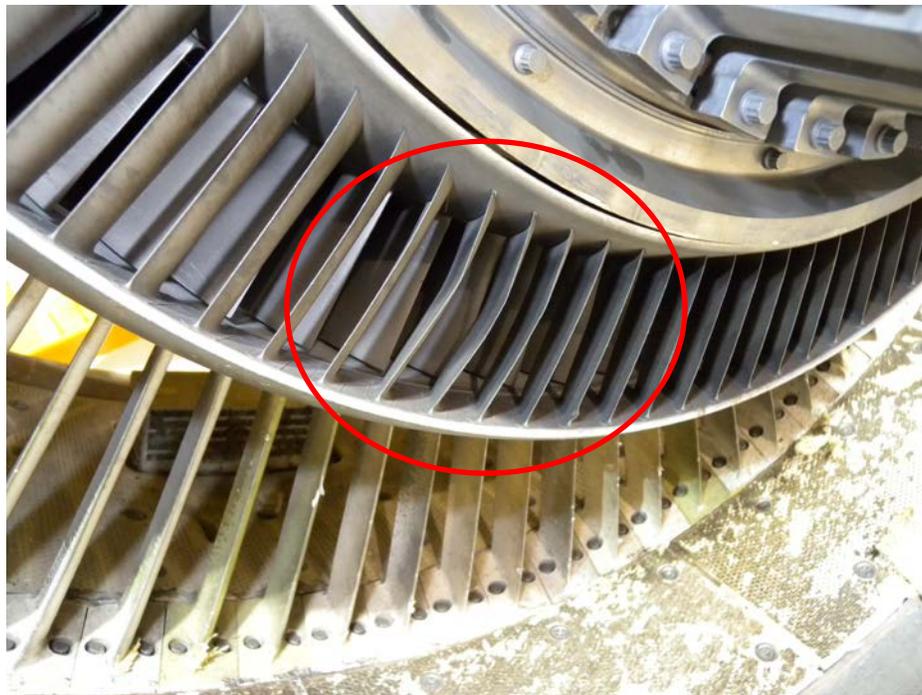
Photo 25 – Damage to 3rd Stage Booster Blade

Borescope examination of the 2nd and 3rd stage booster and the 1st stage HPC revealed evidence of hard-body material ingestion into the booster; there were cuts and tears on several rotor blade leading edges on each stage ([Photo 25](#)).

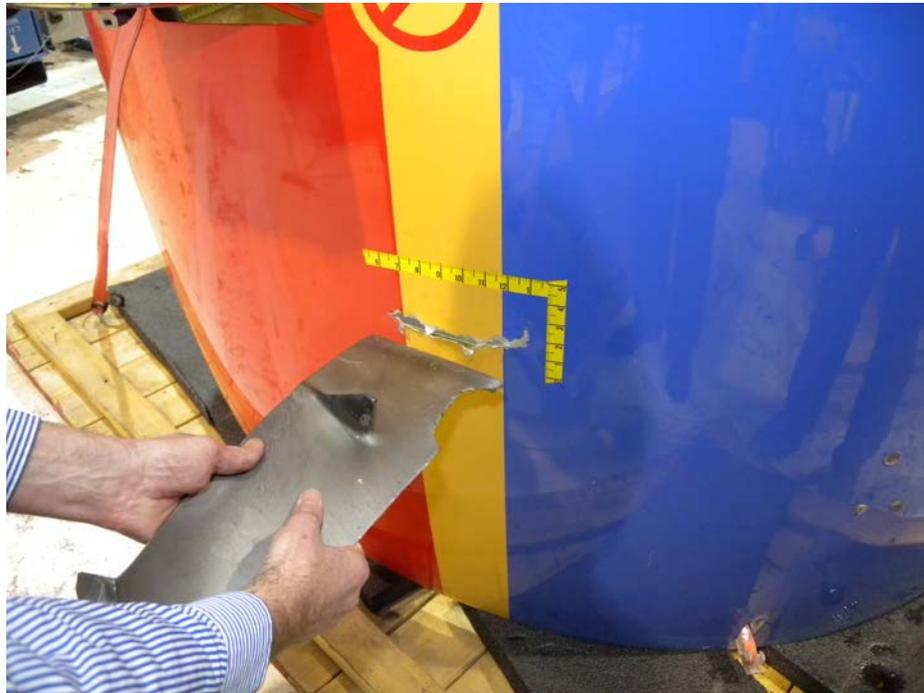
Photo 32 – Hole in Outboard Fan Cowl

The nacelle outboard fan cowl had a hole at 3:00 o'clock which aligned with the hole in the inner barrel at similar clock location ([Photo 32](#)). The hole was approximately 7 inches circumferentially x 0.5 inches wide and shaped similarly to a fan blade chord section, consistent with a piece of fan blade passing thru edgewise. The exiting direction of the uncontained fan blade particle was outboard and no damage to the fuselage was reported.
