NATIONAL TRANSPORTATION SAFETY BOARD
OFFICE OF AVIATION SAFETY
WASHINGTON, D.C. 20594

POWERPLANTS GROUP CHAIRMAN'S FACTUAL REPORT

NTSB ID No.: DCA18IA092

Location: Honolulu, Hawaii
Date: February 13, 2018
Time: 1200 Hawaiian standard time
Aircraft: Boeing 777-222, N773UA, United Airlines flight 1175

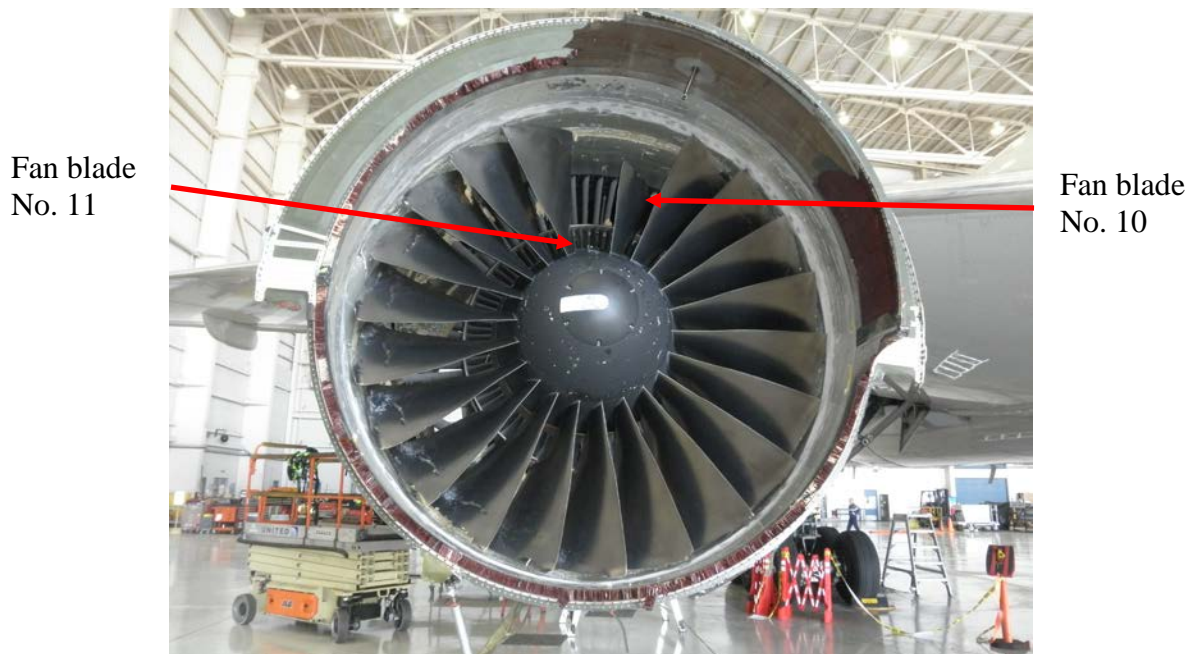
trailing edge. The fracture surface along the concave side of the airfoil had a sawtooth pattern that was about 45° to the surface of the airfoil. (Photos Nos. 2, 3, and 4) The fracture surfaces on the five internal ribs were flat and had elliptical-shaped marks. The fracture surface along the convex side was primarily smooth except at the leading and trailing edges where the fracture surfaces were at an approximate 45° angle to the surface of the airfoil. The elliptical-shaped marks did not appear to break out to the concave surface of the airfoil. The flat fracture surface did appear to break out onto the convex airfoil surface between ribs Nos. 1 and 5. The internal ribs were not separated. (Photo No. 5) There was a discolored area on the aft convex side corner of rib No. 4. There appeared to be a ratchet mark⁷ within the discolored area. (Photo No. 6) The blade's dove tail root was intact. The contact surfaces of the blade root had some visible wear. There was also wear on either side of the airfoil that corresponded to the edges of the spacers that were between the blades. The base of the blade root was marked with ASSY 55A901 that had been crossed out and reidentified as 55A801. The blade root was also marked with the blade's serial number, CBDUAT7364, that corresponded to the serial number for blade No. 11 in the engine's maintenance records.

Photo No. 2: View of front of engine showing the two fractured fan blades, Nos. 10 and 11.

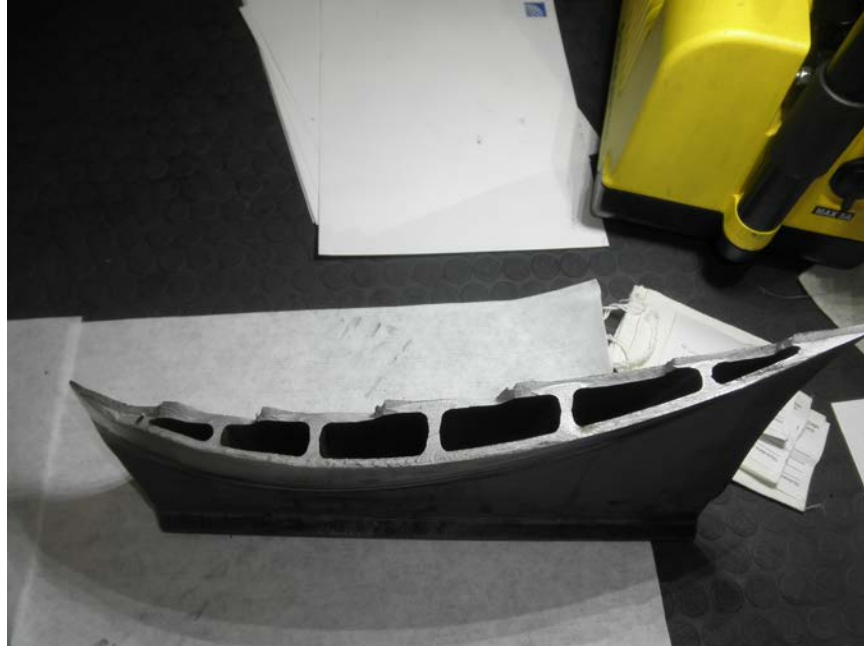
Photo No. 3: View of No. 11 fan blade showing fracture surface.

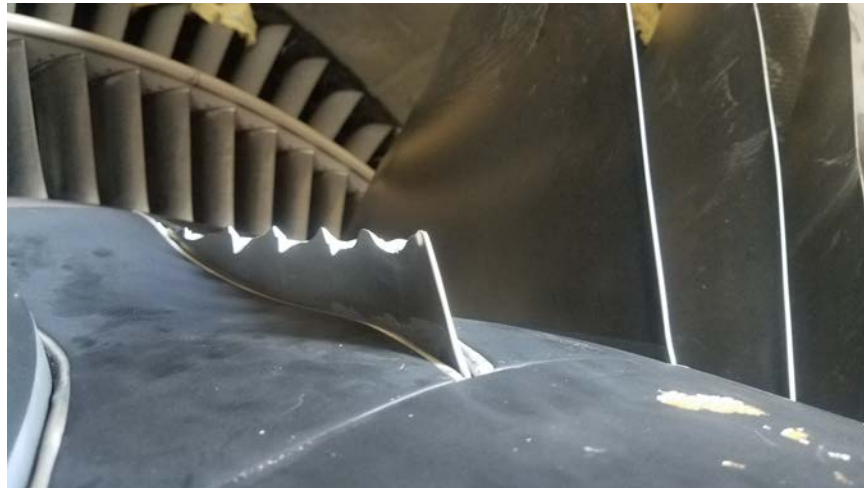
Photo No. 4: View of No. 11 fan blade showing sawtooth fracture pattern and the fracture surface being at about a 45° angle to the airfoil. (Boeing)

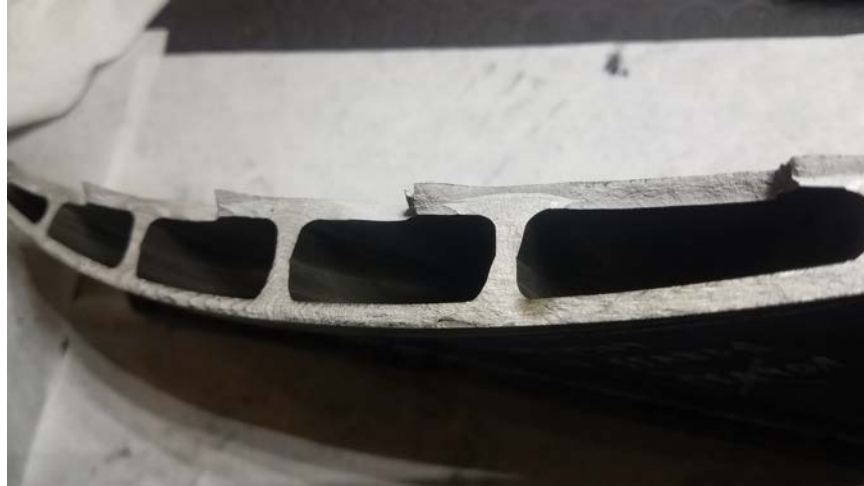
Photo No. 5: View of fracture surface showing elliptical marks and the internal ribs not being split. (Boeing)

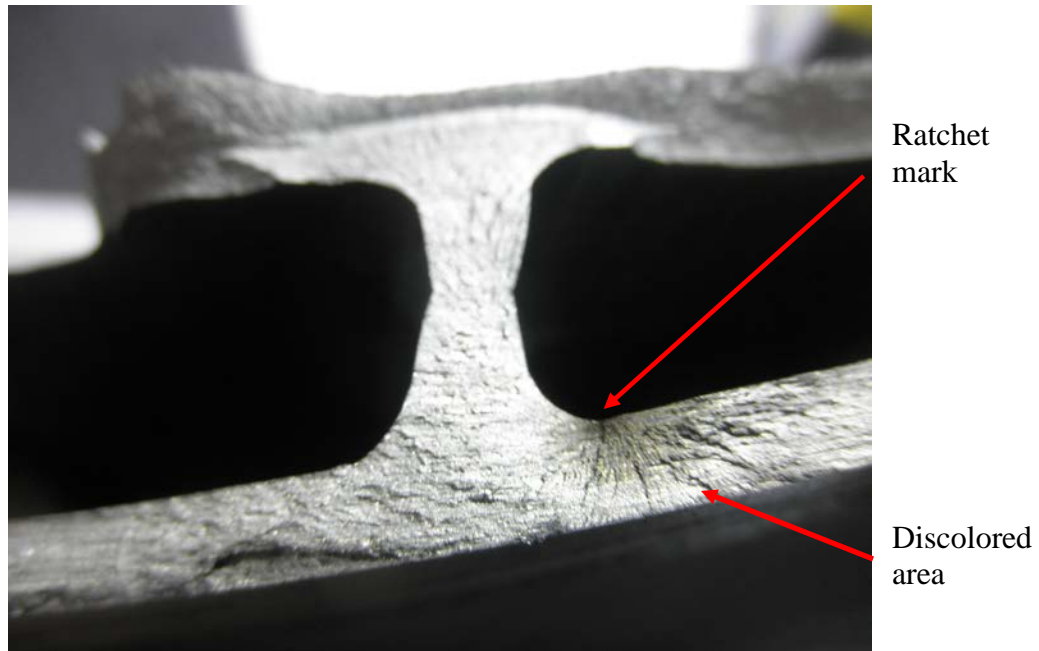
Photo No. 6: Close up view of fracture surface showing discolored area and ratchet mark radiating from an interior surface of the fan blade.

The metallurgical examination revealed that fan blade No. 11 had the airfoil separate transversely from the root section about 4.5-inches from the root bottom at the leading edge and about 8-inches from the root bottom at the trailing edge. The examination revealed a low cycle fatigue (LCF) fracture that had originated about 6.7-inches outboard from the blade root bottom on the interior wall of cavity FA adjacent to the airfoil's convex wall and the internal rib separating cavities EA and FA.¹⁰ The origin of the fatigue was subsurface, about one or two

grains deep within an area that had been smeared by secondary rub damage. Near the origin, the surface finish of the internal cavity exceeded the specification by 4μ-inches. The examination revealed that all of the other geometric features that were reviewed were within the specified limits. The examination also revealed that the fan blade's material conformed to the requirements for the specified titanium alloy. The recovered pieces of fan blade No. 11, the root section and a piece of the airfoil, weighed 24.6 pounds in comparison to 33.6 pounds for an exemplar fan blade.

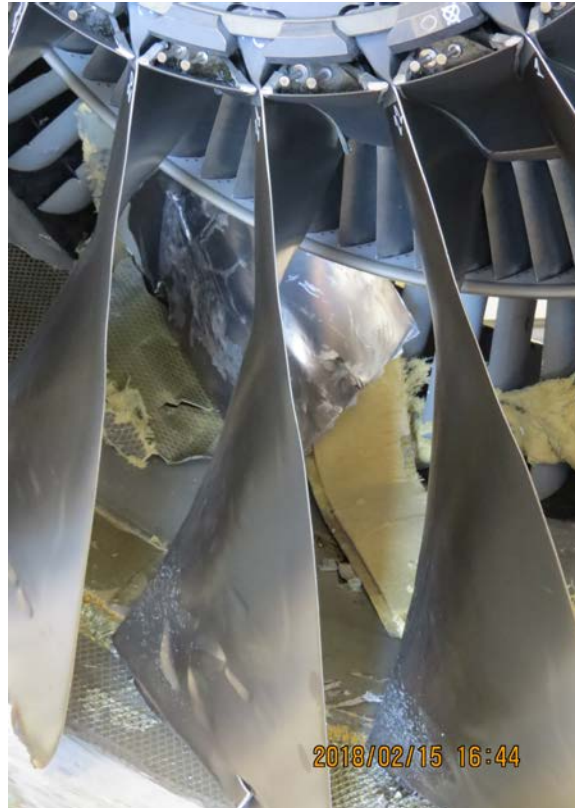
There was a piece of fan blade found up against the leading edges of the fan exit guide vanes at about 4 o'clock.⁸ (Photo No. 7) This piece of fan blade was about 15-inches wide chord wise and 23-inches long radial that had a fracture surface on the inner end that corresponded to the fracture surface on blade No. 11. (Photo No. 8) There was a 2-inch wide radial by 1.5-inch deep chordwise gouge in the leading edge that was about a 50° angle to the axis of the engine. (Photo No. 9) At the outer end of the blade, the leading edge was curled in the direction of rotation and the trailing edge was bent opposite the direction of rotation. The

Photo No. 7: View between fan blades showing fragment of fan blade No. 11 against fan exit guide vanes. (P&W)

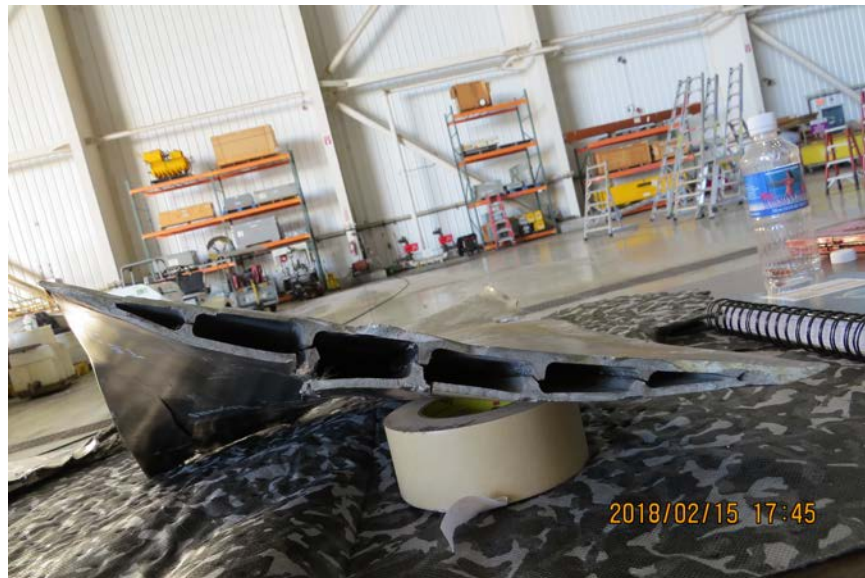
Photo No. 8: View of fracture surface on fragment from fan blade No. 11 showing how it corresponded to fracture surface on inboard end of blade. (P&W)

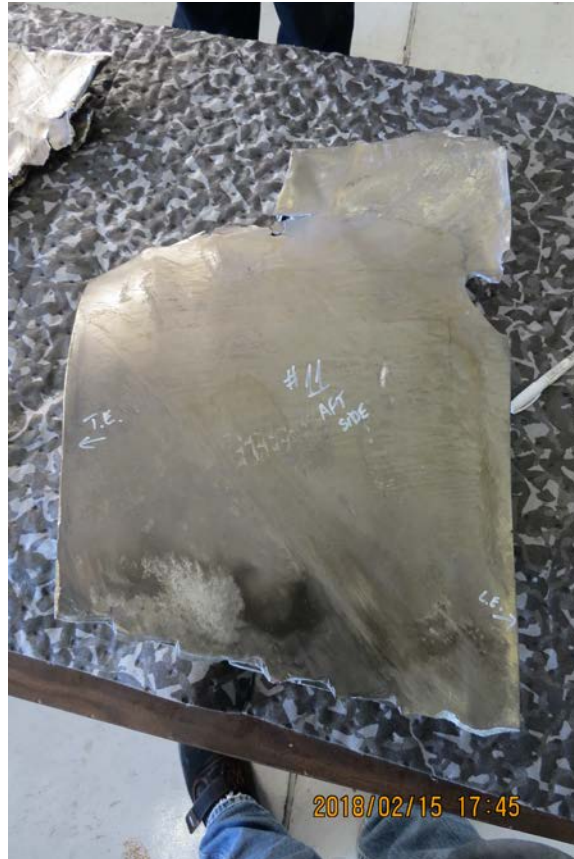
Photo No. 9: Fragment of fan blade No. 11 recovered from fan exit guide vanes. (P&W)

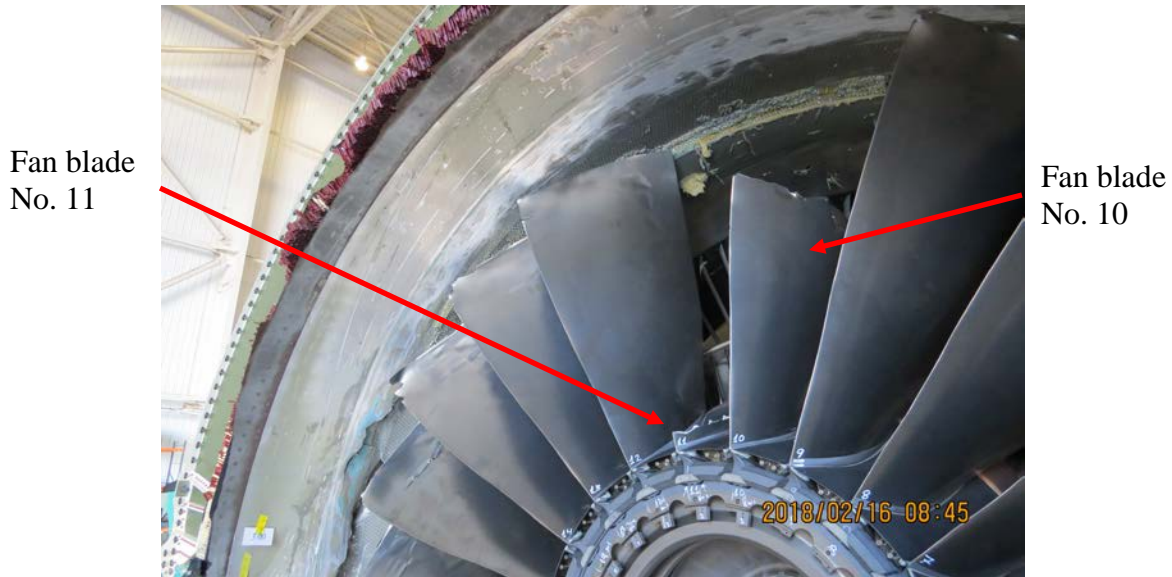
The fan blade in position No. 10 was fractured transversely across the airfoil about 24-inches above the spacers. (Photo No. 10) The fan blade's leading edge had some minor dents on

the leading edge. The concave side of the airfoil had a cross hatch mark on the surface indicative of the fan blade's internal structure and there were two large dents with airfoil surface split adjacent to the dent. The fracture surfaces on the end of the blade were coarse and grainy and they were at an approximate 45° angle to the surface of the blade.

Photo No. 10: View of fractured fan blades Nos. 10 and 11. (P&W)

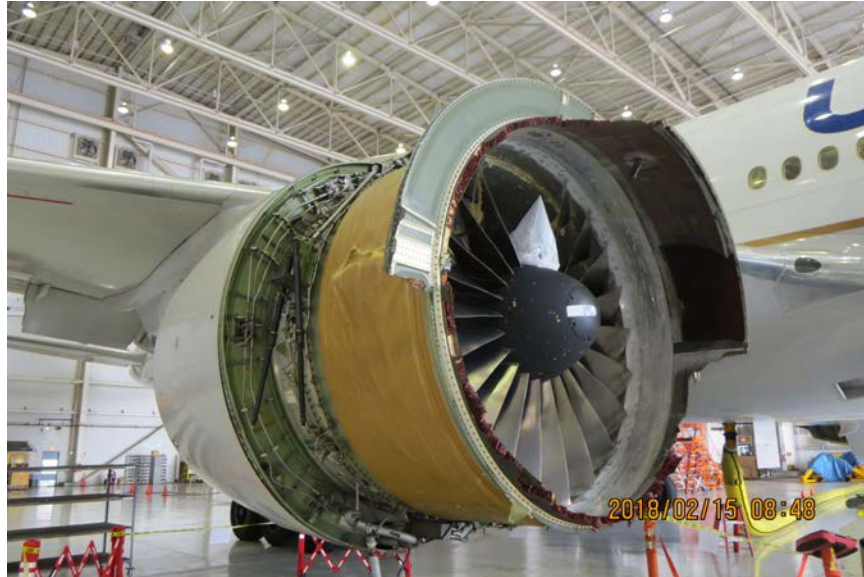
The initial examination of the airplane and engine at HNL revealed the inlet duct's lip, forward bulkhead, and part of the inner and outer barrel were missing. The left and right fan cowls were both missing. (Photo No. 11) The U.S. Coast Guard (USCG) was requested to search the presumed area of the incident. The USCG responded that they did not have any assets in that area. But the USCG did issue a Notice to Mariners for any ships in the presumed area of the incident to be alert for any debris and to report any sightings. However, there were no reports of any debris being sighted.

Photo No. 11: View of the right engine from the right front showing what remained of the inlet duct. White plastic was placed over the broken blades to protect the fracture surfaces. (P&W)

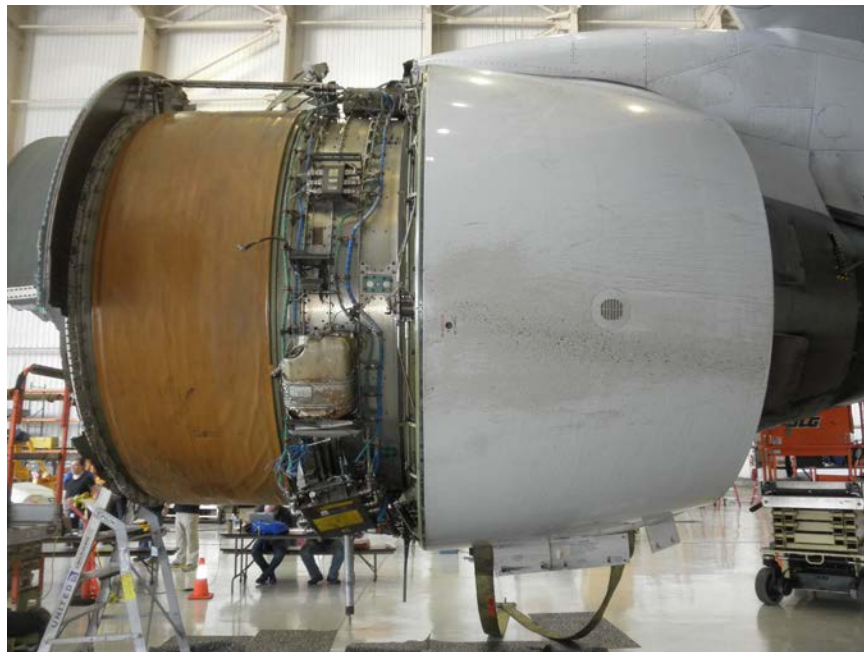
For comparison purposes to show how much of inlet duct and the cowlings were missing, photographs of the No. 2 engine's left and right side and the undamaged left engine's left side are provided. (Photos Nos. 12, 13, and 14.)

Photo No. 12: Left side of engine and cowling.

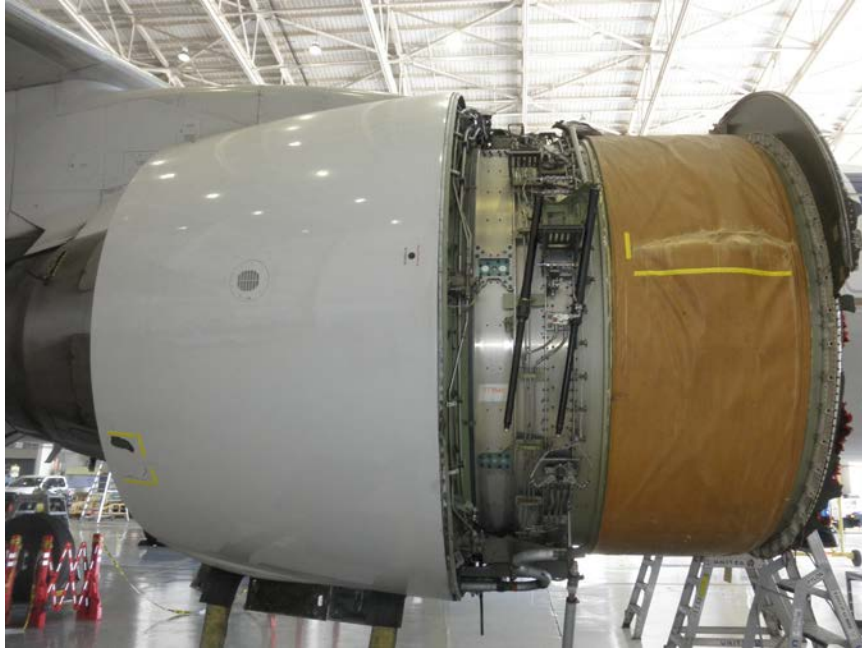
Photo No. 13: Right side of engine and cowling.

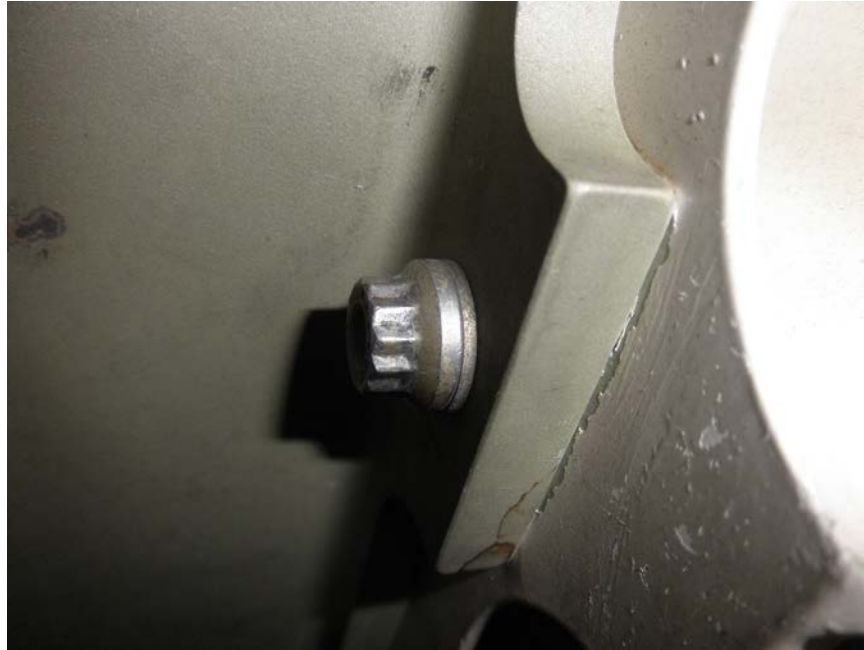
cowl was fitted back onto the engine, the examination of the bulkhead flange, which mates to the engine's A-flange, did not show any indications of deformation or elongation of the bolt holes. However, the paint on the inlet duct rear flange adjacent to the front face of A-flange was scraped up slightly. (Photo No. 15) Only the aft bulkhead and portions of the inner and outer barrel remained attached to the engine.

Photo No. 15: Close up of rear face of inlet duct showing paint scraped up adjacent to the engine's fan case front flange.

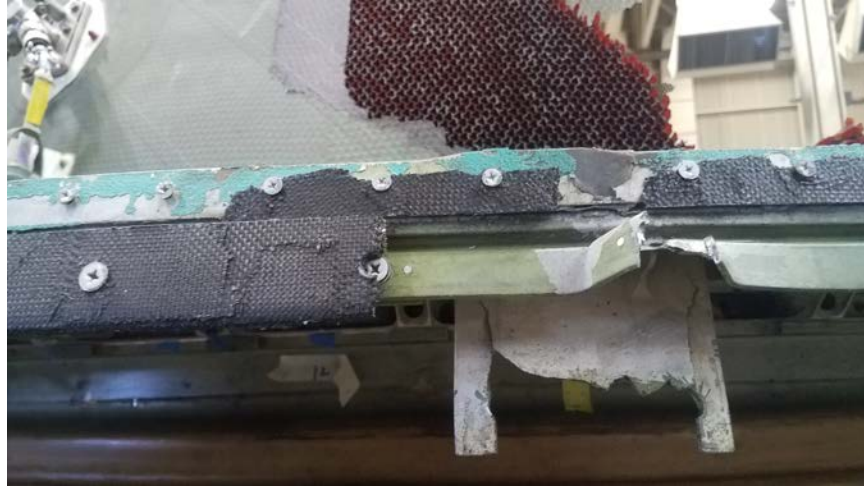
The inlet assembly, upper half, data plate was affixed to the upper aft bulkhead's web and showed PN 314W3010-30AA, SN 000009. The upper aft bulkhead's outer stiffener was torn and deformed at about 12:30 o'clock above where the fan cowl support beam fittings are attached. (Photo No. 16) The outer barrel to the outer stiffener fasteners were intact and tight, except for those that were removed at HNL. The fasteners were removed at HNL for shipment of the engine and inlet duct to SFO. The inner barrel to the inner stiffener fasteners were intact and tight. The bulkhead's web had three approximately 3-inch long cracks near the stiffener at about 9:45, 10:00, and 10:30 o'clock. The inner stiffener appeared to be undamaged. The upper portions of the fan cowl support beam support fittings were fractured and missing. The aft bulkhead's splice fittings at 3 and 9 o'clock did not have any apparent damage. (Photo No. 17) The P2/T2 sensor was fractured at the B-nut fitting and the bonding strap was separated from its bracket.

Photo No. 16: View of the upper aft bulkhead's outer stiffener was torn and deformed. (Boeing)

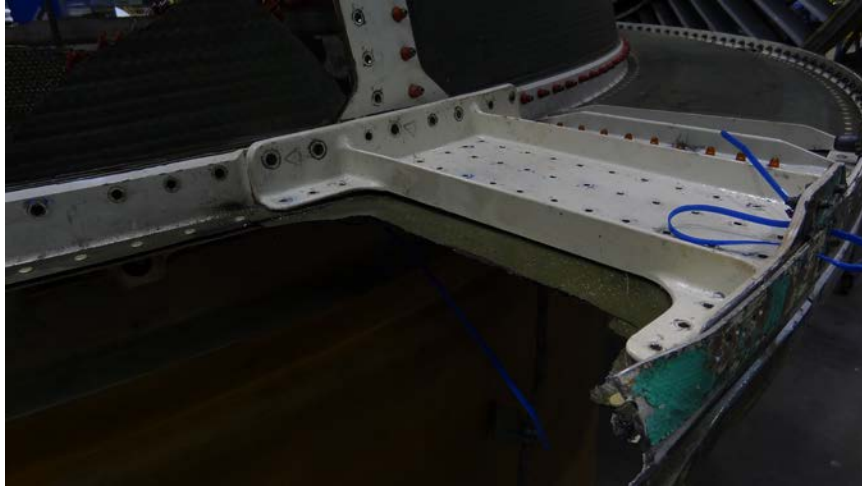
The inlet assembly, lower half, data plate was affixed to the lower aft bulkhead's web and showed PN 314W3010-30AA, SN 000009. The bulkhead's web was missing except for portions that remained attached to and in the proximity of the splice fittings and an approximately 1.5-inch piece of the web edge band that was still attached to the inner stiffener. (Refer to Photo No. 17) The inner barrel-to-inner stiffener fasteners were intact and tight, except at about 8 o'clock as noted in the fan containment section. (Refer to Section 7.2) The outer stiffener was missing except for the pieces that were still attached to the splice plates near the splices. There was an approximately 5.5-inch long piece of the outer stiffener at about 3 o'clock that remained attached to the splice plate, lower edge that was twisted in a clockwise direction as viewed from below, and bent radially inward. (Refer to Photo No. 17) The outer stiffener had about 7.5-inches remaining attached to the splice plate at about 9 o'clock and was bent in a counterclockwise direction as viewed from below. (Photo No. 18) The inner stiffener was damaged by the anti-ice duct attachment bracket at about 5 o'clock.

Photo No. 18: View of the outer stiffener remaining attached to the splice plate. (Boeing)

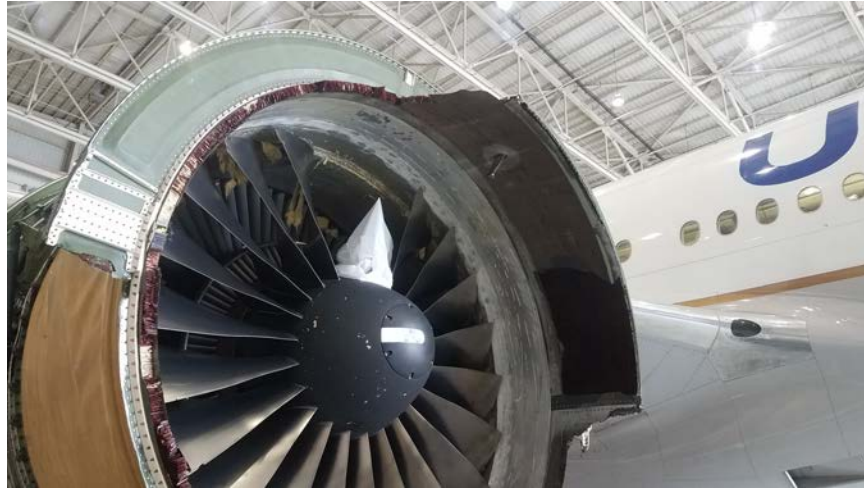
Most of the upper inner barrel composite material remained attached to the aft bulkhead from about 9 to 12 o'clock. (Photo No. 19) The forward edge band of the panel that was attached to the forward bulkhead was missing. The P2T2 probe was still attached in this section. There was a piece of the upper inner barrel, that varied in width between about 1- to 5-inches wide, from about 12 to 3 o'clock that remained attached to the upper aft bulkhead. The perforated face sheet was intact from about 10 to 12 o'clock. Most of the perforated face sheet over the open cell honeycomb was missing from about 9 to 10 o'clock, though the face sheet and honeycomb in the solid core remained. The edges of the inner and outer face sheets showed fractures and delaminations. The edges of the exposed core appeared ragged.

Photo No. 19: View showing that most of the upper inner barrel composite material remained attached to the aft bulkhead from about 9 to 12 o'clock. (Boeing)

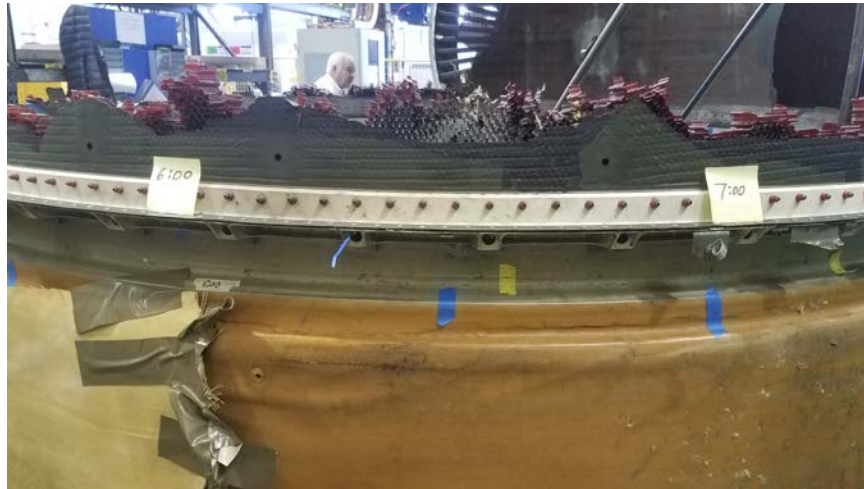
There was a portion of the lower inner barrel's composite panel that varied in length from about 2- to 7-inches that remained attached to the aft bulkhead inner stiffener. (Photo No. 20) The edges of the face sheets had areas of fractures and fractures with delaminations. Adjacent to the splice fitting at 9 o'clock, there were about 5-inches of the non-perforated face sheet was missing although the core was still attached to the aft bulkhead inner stiffener and the fasteners were intact. (Refer to Photo No. 19)

Photo No. 20: View of a portion of the lower inner barrel's composite panel that varied in length that remained attached to the aft bulkhead inner stiffener. (Boeing)

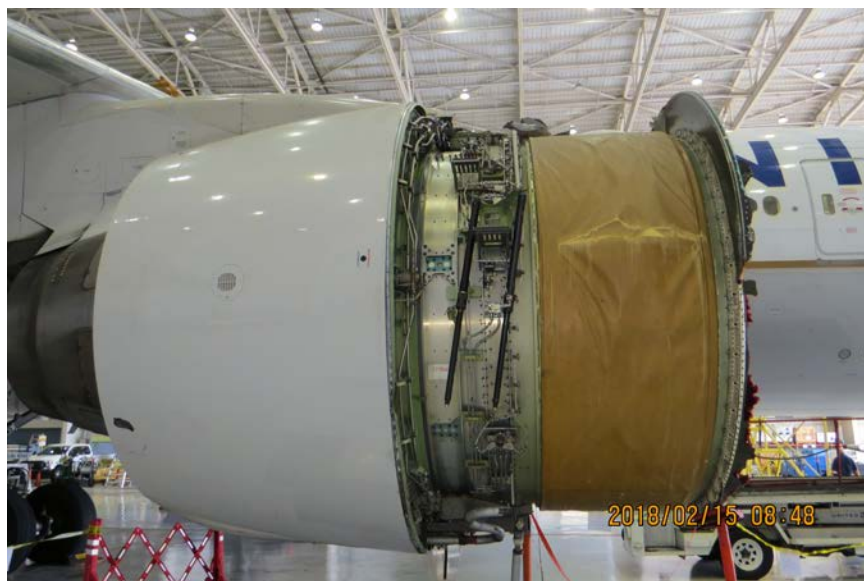
The Kevlar® environmental wrap was in place around the fan case. The Kevlar environmental wrap had an approximately 35-inch long axial tear at about 3 o'clock that was between about 5.5- and 40.4-inches aft of A-flange. (Photo 23) The outermost layer of the Kevlar under the environmental wrap was visible through the tear and there was an area that was approximately 3-inch axial by 2-inch circumferential about 15-inches aft of A-flange that had a frayed appearance and there were tears and separations. The Kevlar environmental wrap had a wrinkled appearance between about 1 and 5 o'clock with outward bulging of the belt between about 2 and 4 o'clock. The maximum deformation of the Kevlar environmental wrap was about 2.5-inches at about 3 o'clock. (Photo No. 24) The location of the maximum deformation of the wrap was coincident with the approximately 34-inch long crack on the inside of the fan case.

Photo No. 23: View of Kevlar wrap showing tear. (P&W)

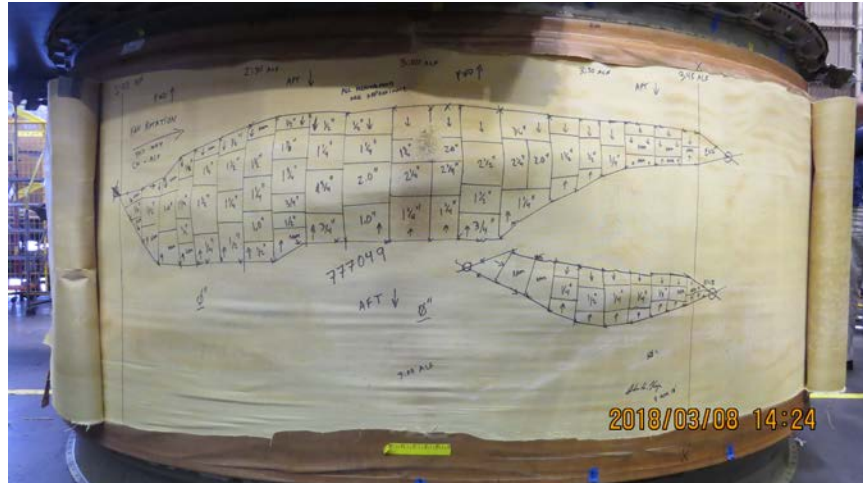
Photo No. 24: View of side of fan containment case showing deformation. (P&W)

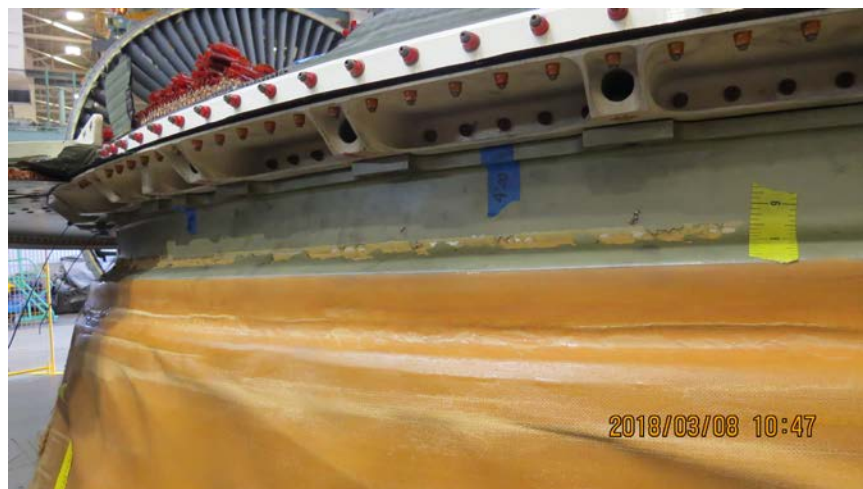
On the forward edge of the Kevlar belt, the glue/epoxy and green-colored paint was cracked intermittently around the entire circumference. Between about 1:45 and 4:15 o'clock, there was a continuous sector of chipped and missing glue/epoxy and paint. (Photo No. 25) In the center of the area of continuous chipped and missing glue/epoxy, at about 3 to 3:30 o'clock, the glue/epoxy was separated axially about 0.3-inches consistent with the front part of the belt having moved aft. In the transition radius between the two diameters of the Kevlar belts about 3.25-inches aft of A-flange, there was cracking of the glue/epoxy over much of the circumference. Between about 2:30 and 3:30 o'clock, the cracking was the most extensive with pieces of the glue/epoxy chipped, flaking away, or missing. In this area, the front of the belt appeared to have been displaced outward such that the transition radius area was deformed into a conical shape with the most deformation at about 3 o'clock. (Photo No. 26)

Photo No. 25: View of front of forward edge of Kevlar wrap showing chipped and cracked paint. (P&W)

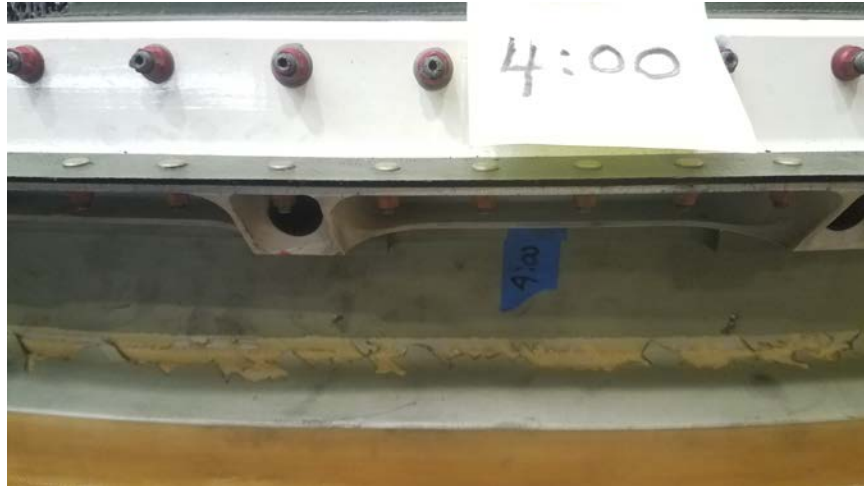
Photo No. 26: View of front of forward edge of Kevlar wrap showing chipped paint and aft movement of wrap. (P&W)

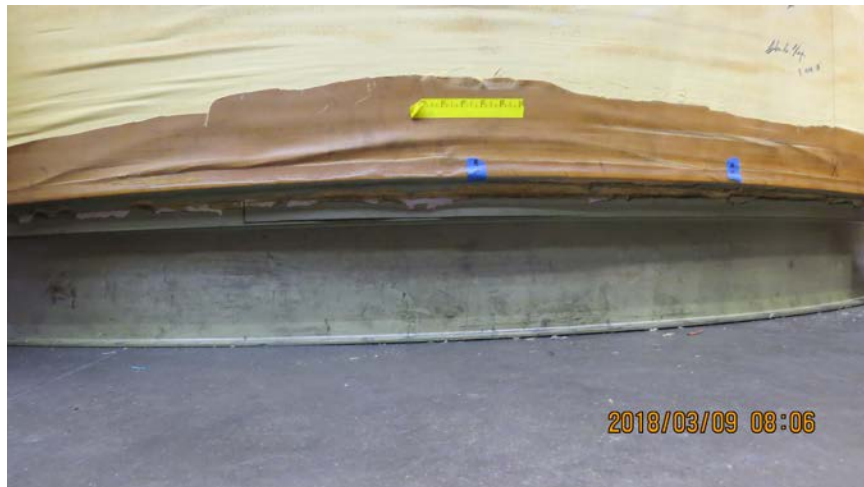
On the aft edge of the Kevlar belt, the green paint over the glue/epoxy was cracked around the entire circumference. Between about 12:30 and 6:30 o'clock, the crack was open, and the glue/epoxy was broken. Within this area, the front of the belt was displaced forward with the maximum displacement being about 0.75-inches at about 3 o'clock and tapering to no displacement at the ends of the sector at about 12:30 and 6:30 o'clock. (Photo No. 27)

Photo No. 27: View of aft edge of the Kevlar wrap showing the crack in the epoxy. (P&W)

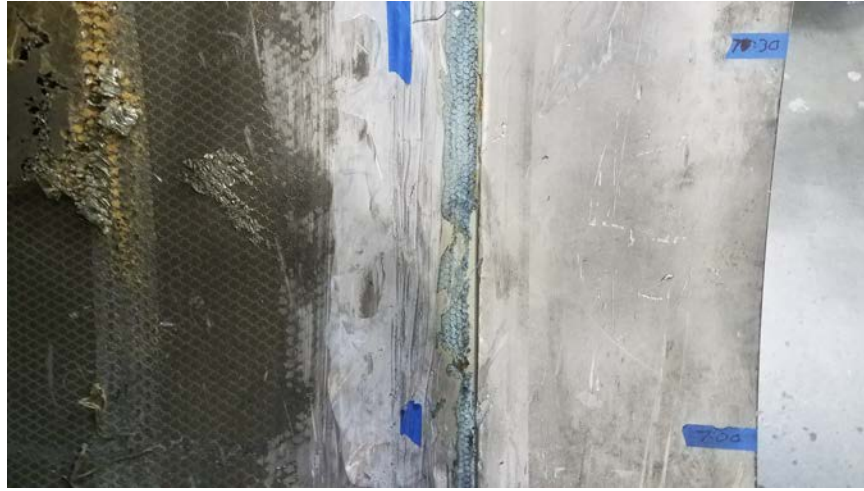
Photo No. 28: View of the fan blade rub strip showing the circumferential rub marks and the remains of the blue rub strip. (P&W)

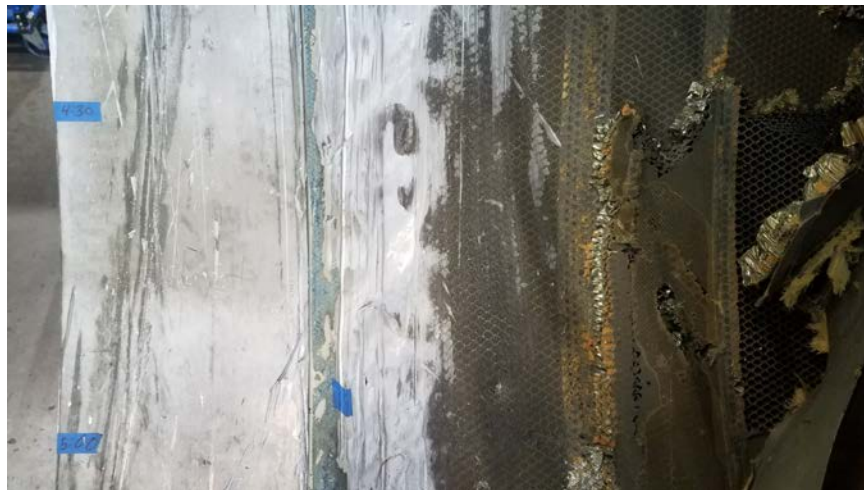
o'clock, only the glue in the honeycomb pattern remained on the aft rub strip area. (Photo No. 29)

Photo No. 29: View of fan blade rub strip showing only the honeycomb glue remaining. (P&W)

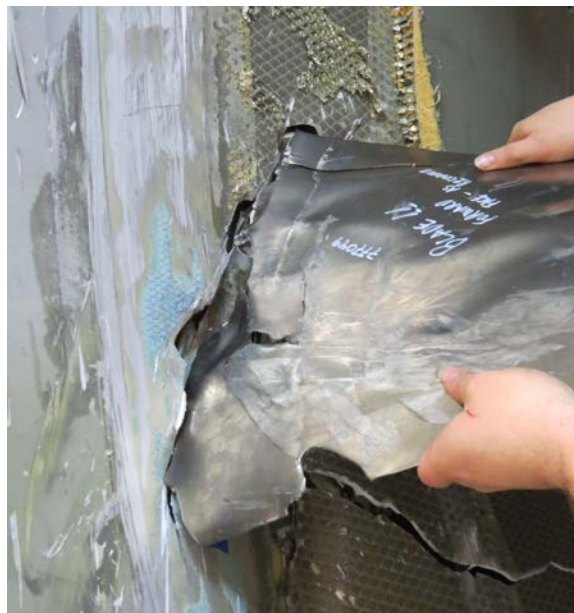
Photo No. 30: View of broken tip of fan blade No. 11 matched to hole in fan case. (P&W)

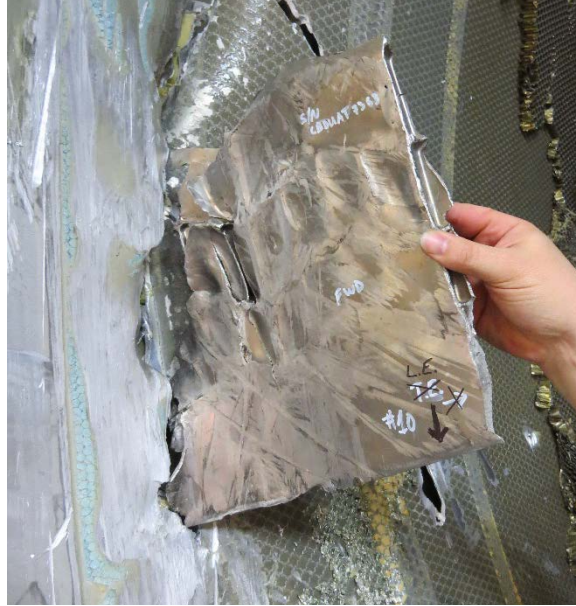
Photo No. 31: View of broken piece of fan blade No. 10 matched to hole in the fan case. (P&W)

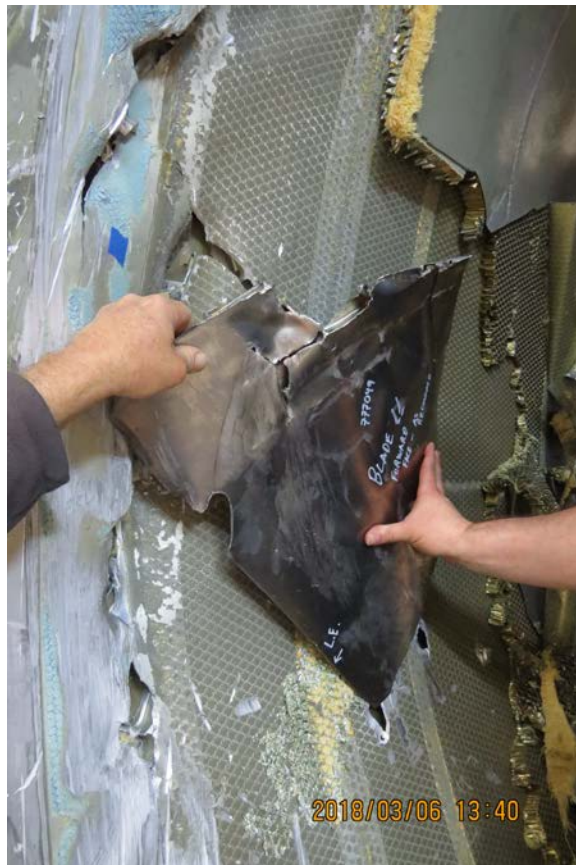
of the engine. The crack was located between about 27.2-inches aft of A-flange at about 2:15 o'clock and about 13-inches aft of A-flange at about 3 o'clock. The case on the aft side of the crack was deformed outward. The case in this area did not have any circumferential scoring on the forward part of the fan blades' plane of rotation. The Kevlar belt was visible through the crack, but it did not have any visible penetrations. The geometry of the crack corresponded with the geometry on the fractured end of fan blade No. 11 that was recovered from the behind the fan rotor during the on-scene examination of the engine at HNL. (Photo No. 30) The second area of damage consisted of two irregular meandering cracks between about 2:45 and 3:45 o'clock. One of the cracks was about 34-inches long at an angle of about 10° to 15° from the engine's axis and was located about 19.2-inches aft of A-flange at about 2:45 o'clock and about 15.5-inches aft of A-flange at about 3:45 o'clock. The second crack was about 28-inches long at an angle of about 45° to the engine's axis and was located about 14.2-inches aft of A-flange at 2:40 o'clock and about 35-inches aft of A-flange at 3 o'clock. The two cracks in this area intersected at about 3 o'clock. The crack in the first and second areas of damage intersected at about 2:45 o'clock. The fan case aft of the 34-inch long crack was deformed outward. The inner layers of the Kevlar wrap that were visible through the crack were cut. The geometry of the 34-inch long crack corresponded to the geometry of the piece of fan blade No.10 that was recovered from the fan exit guide vanes at HNL. (Photo No. 31) The third area of damage were two holes in the fan case just aft of the fan rotor's plan of rotation at about 3:30 o'clock. The first hole was about 3.5-inches circumferential by 1-inch axial about 29.7-inches aft of A-flange. The second hole was about 2-inches circumferential by 0.5-inches axial about 34.5 inches aft of A-flange. The geometry of the edge of the forward hole corresponded to the geometry of a fragment from fan blade No. 10 while the geometry of the aft hole corresponded to the geometry of a fragment from fan blade No. 11. (Photo No. 32)

Photo No. 32: View of broken tip of fan blade No. 11 matched to second hole in fan case. (P&W)

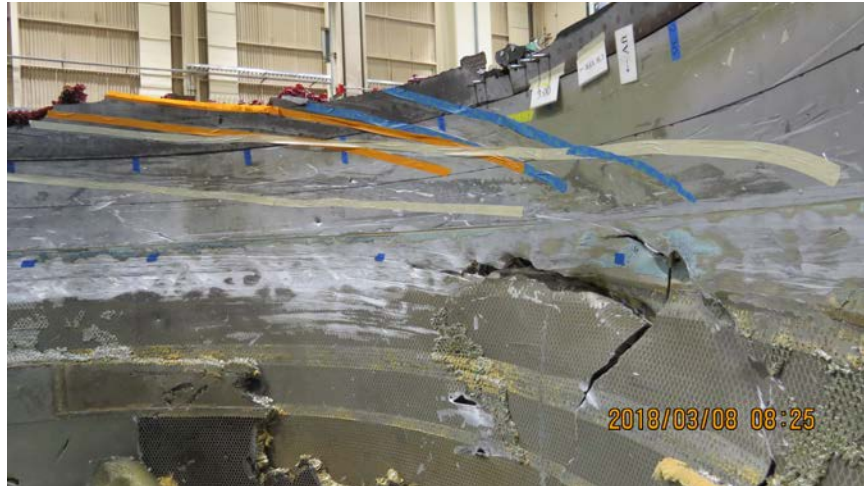
Photo No. 33: View of inside of the fan case showing the three tracks that spiral across the fan case onto the inlet duct. (P&W)

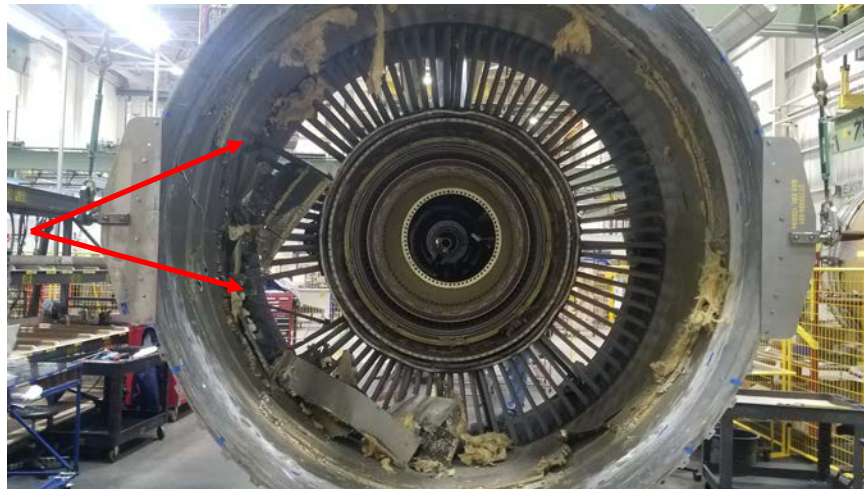
The fan exit guide vanes were all in place except for one vane at about 1 o'clock and three consecutive vanes at about 4 o'clock. There was one exit vane adjacent to the three that were missing that was separated at the inner end, but remained attached at the outer end. (Photo No. 37) Between about 3:30 and 5 o'clock, the inner ends of the fan exit guide vanes were displaced rearward. (Photo No. 38)

Photo No. 37: View of front of fan exit guide vanes showing locations of missing vanes.
(Boeing)

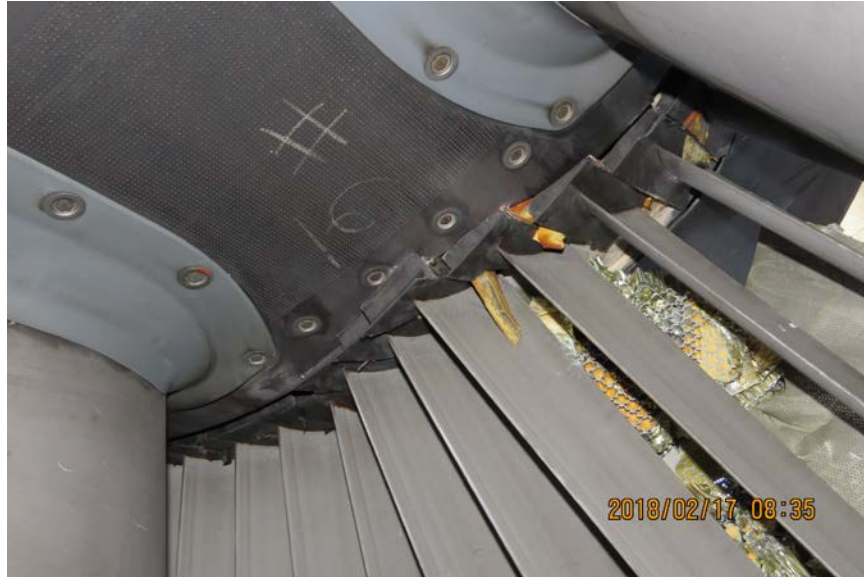
Photo No. 38: Close up view of inboard ends of fan exit guide vanes displaced rearward.
(P&W)

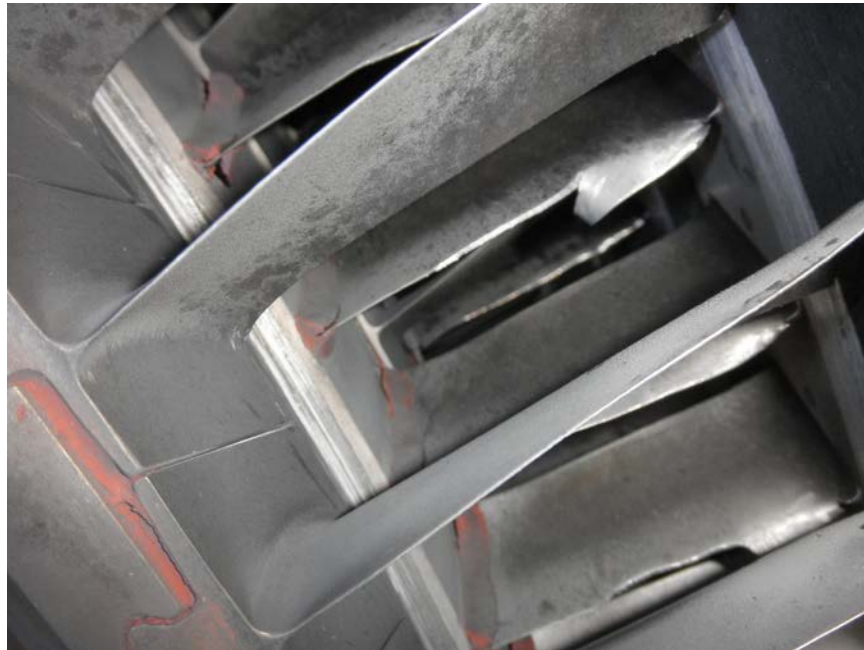
Photo No. 40: Close up of 3rd and 4th stage compressor blades and 3rd stage compressor vanes showing damage to the airfoils.

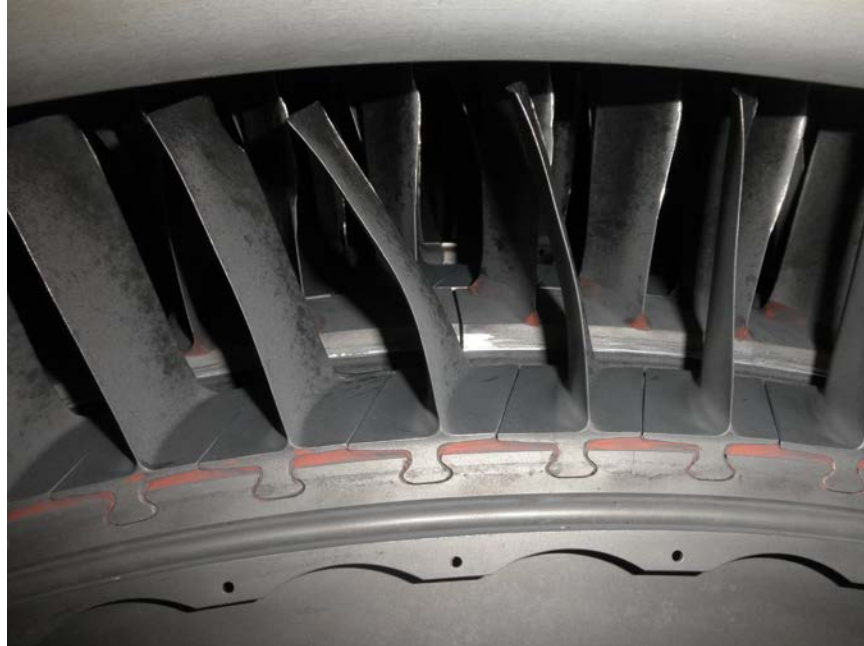
Photo No. 41: Close up of 4th stage LPC blades that were bent opposite the direction of rotation.

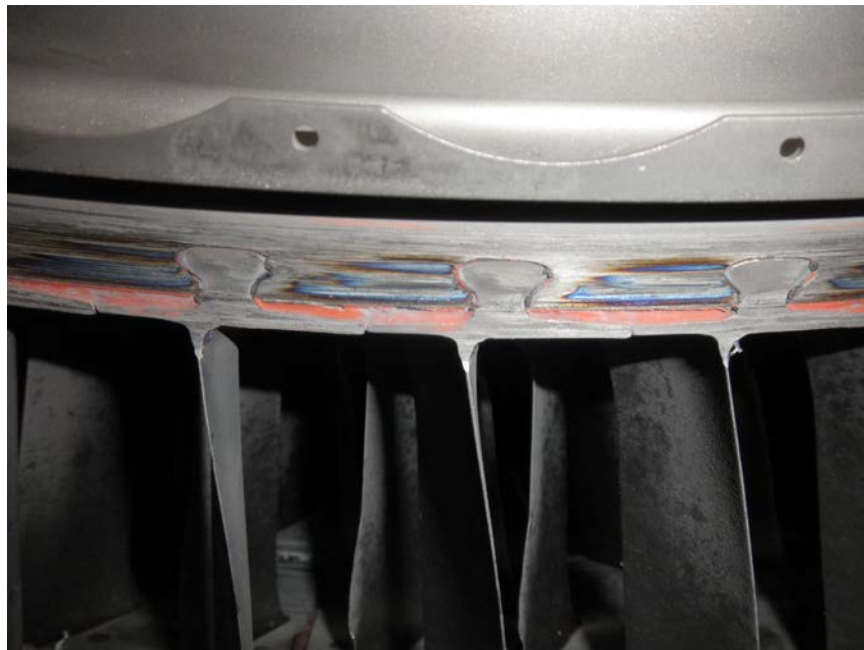
Photo No. 42: Close up of rub mark with heat discoloration on rear of LPC drum and 4th stage compressor blade roots.

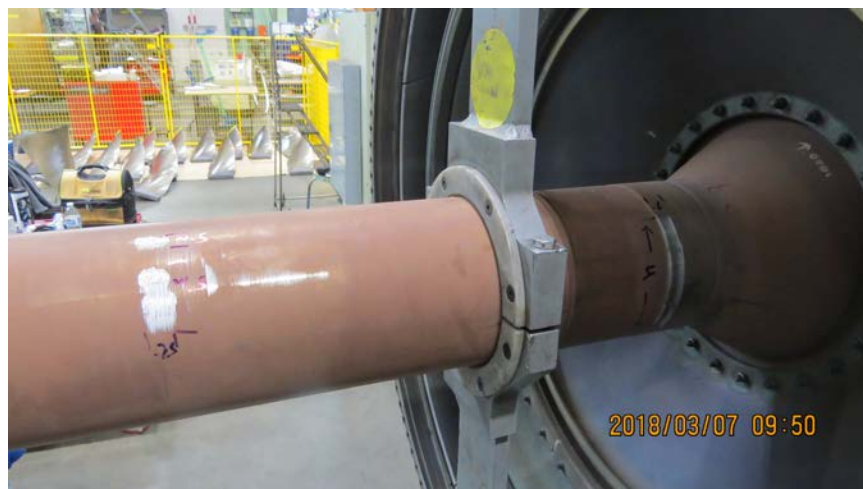
Photo No. 43: View of LPT shaft showing circumferential rub marks. (P&W)

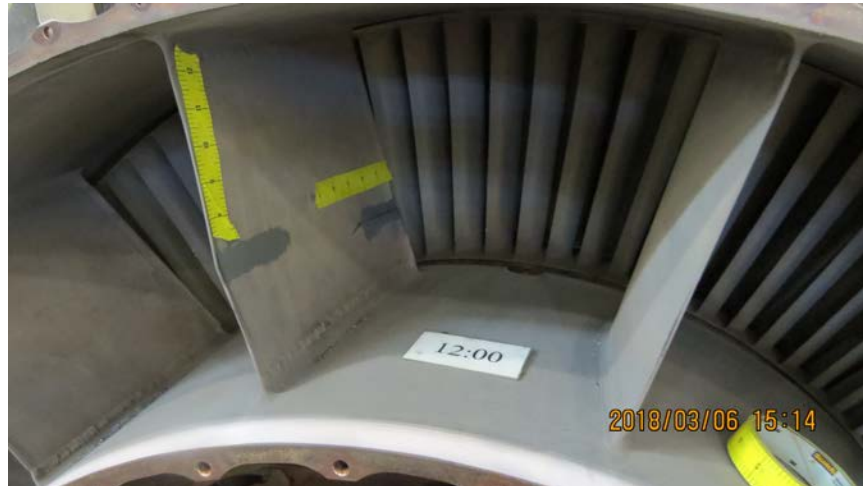
Photo No. 44: View of buckled turbine exhaust case strut. Also shown are the 9th stage turbine blades showing that they are all intact.(P&W)

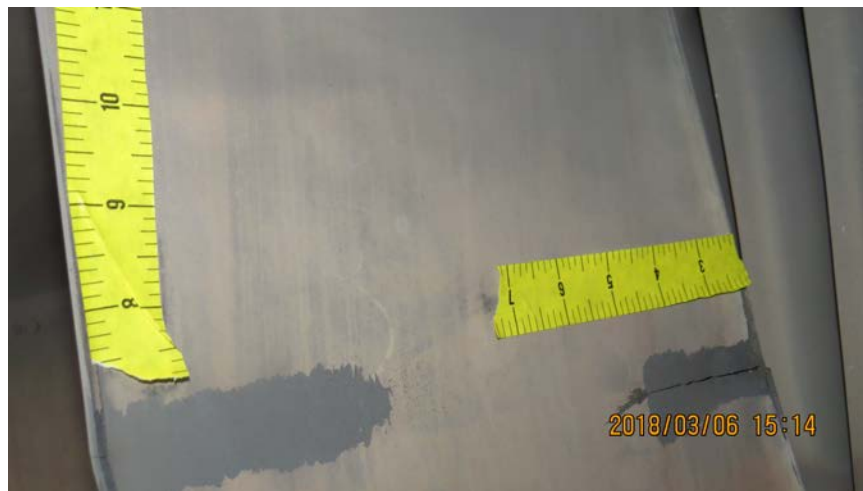
Photo No. 45: Close up of buckled turbine exhaust case strut showing leading and trailing edge cracks. (P&W)

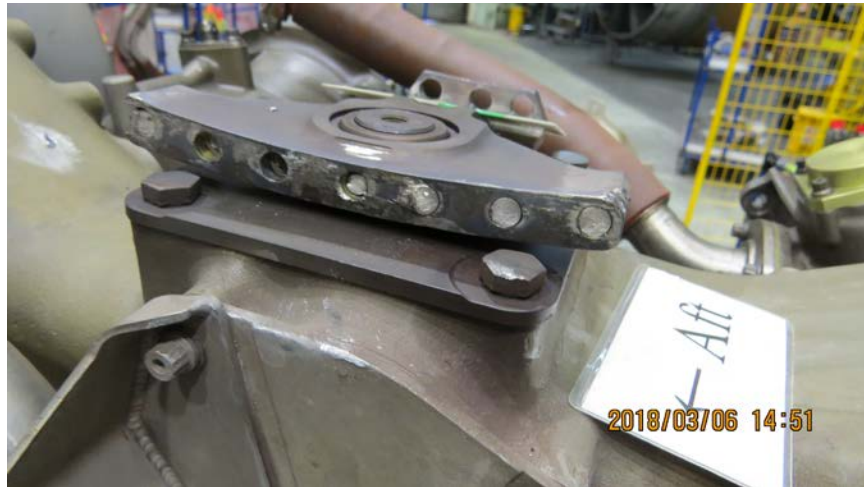
Photo No. 46: View of the engine gearbox attachment flange showing all seven mating bolts fractured. (P&W)
