NATIONAL TRANSPORTATION SAFETY BOARD
OFFICE OF AVIATION SAFETY
WASHINGTON, D.C. 20594

POWERPLANTS GROUP CHAIRMAN'S FACTUAL REPORT

NTSB ID No.: DCA18IA092

Location: Honolulu, Hawaii
Date: February 13, 2018
Time: 1200 Hawaiian standard time
Aircraft: Boeing 777-222, N773UA, United Airlines flight 1175

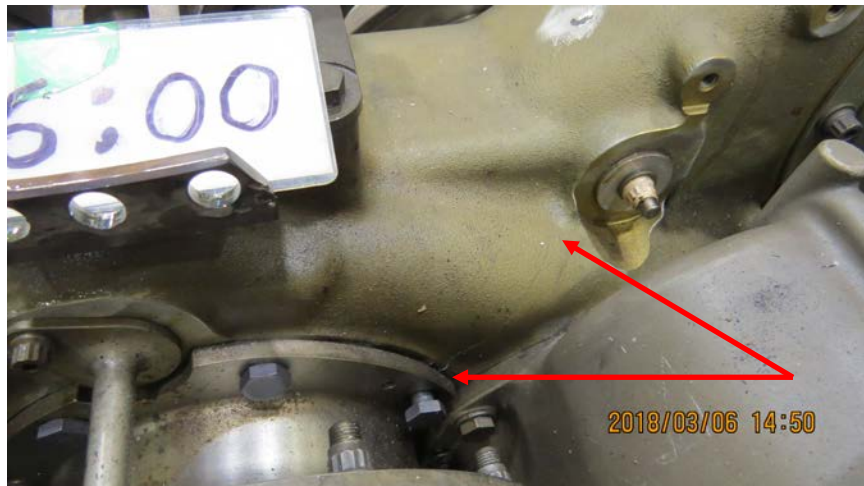
Photo No. 47: Close up showing crack on front of gearbox from lay shaft drive pad. (P&W)

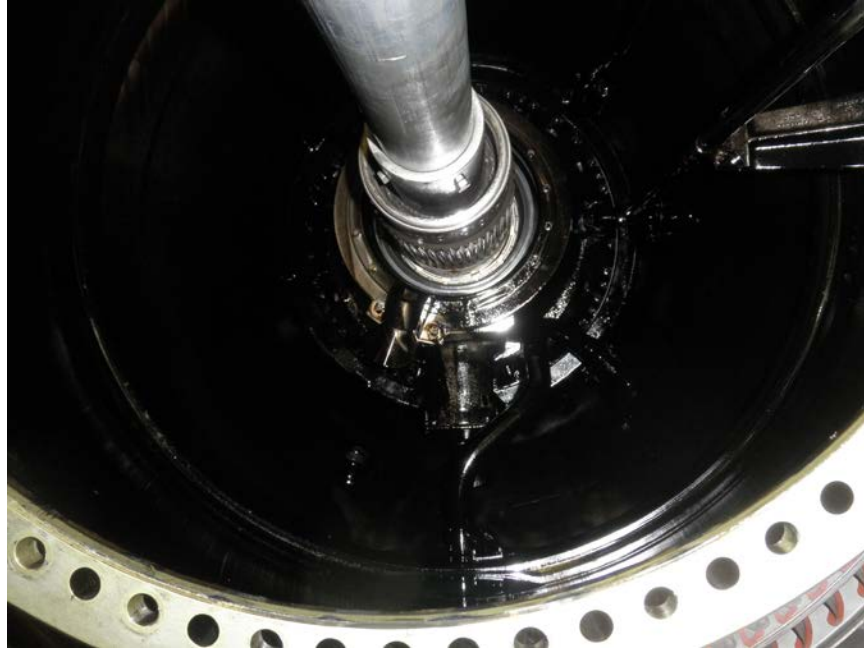
Photo No. 48: Interior of Nos. 1, 1 1/2, and 2 bearing compartment showing black color.

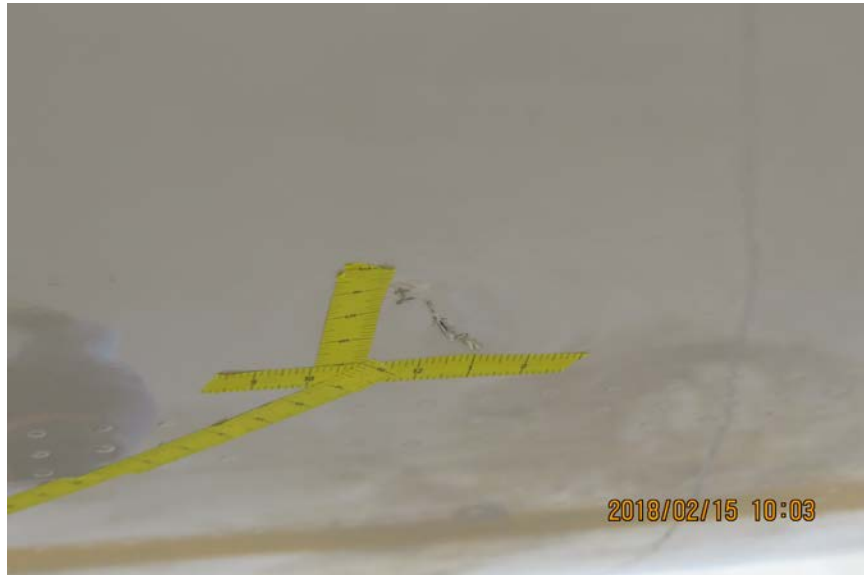
Photo No. 56: View of dent and crack in fuselage skin at BSTA 730. (P&W)

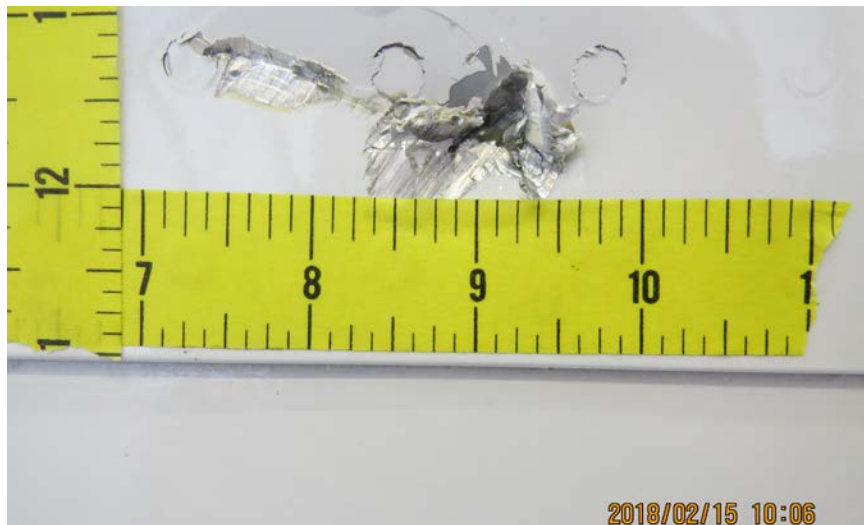
Photo No. 57: View of gouge in fuselage skin at BSTA 913. (P&W)

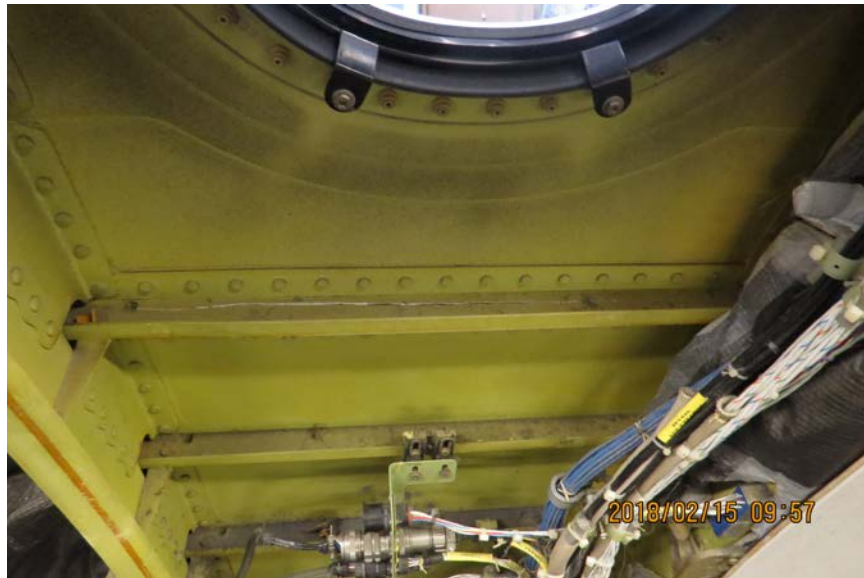
Photo No. 58: View of top of bent and cracked zee stringer at BSTA 913. (P&W)

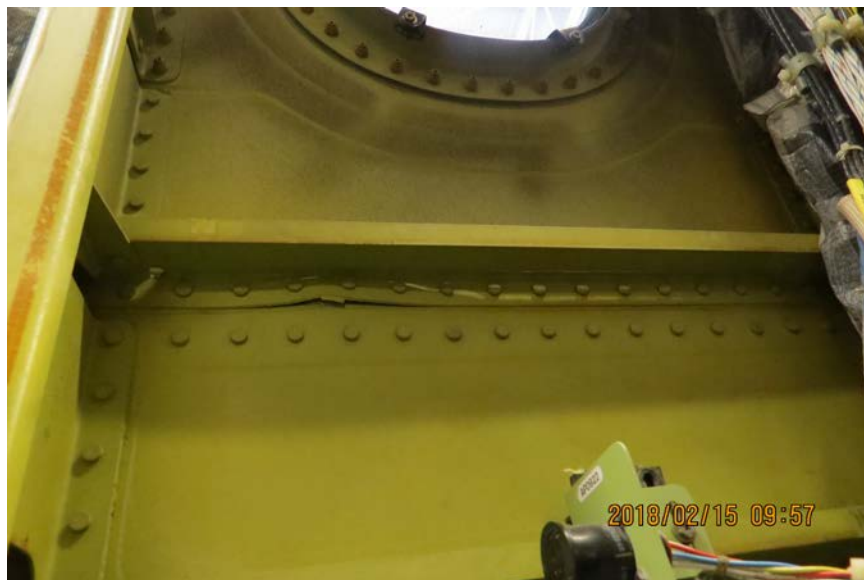
Photo No. 59: View of underside of bent and cracked zee stringer at BSTA 913. (P&W)

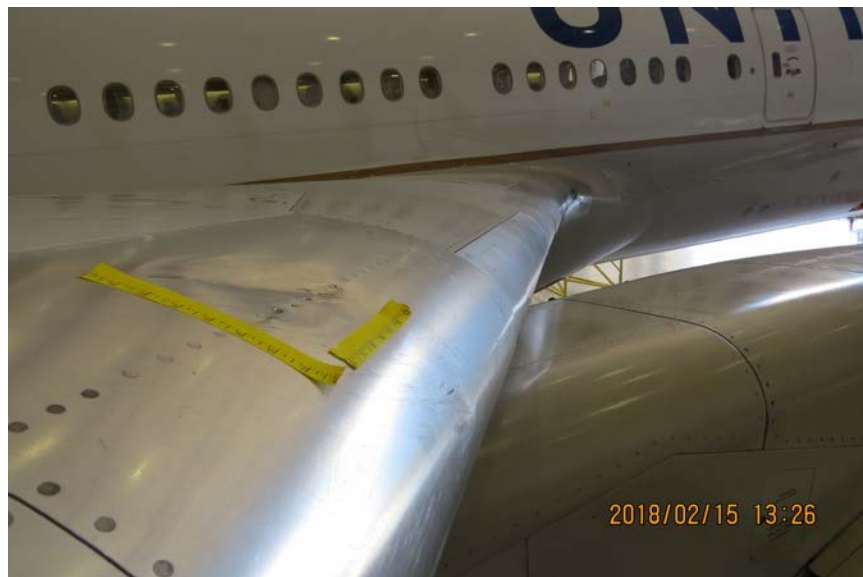
Photo No. 60: Dent in leading edge slat outboard of right engine. (P&W)

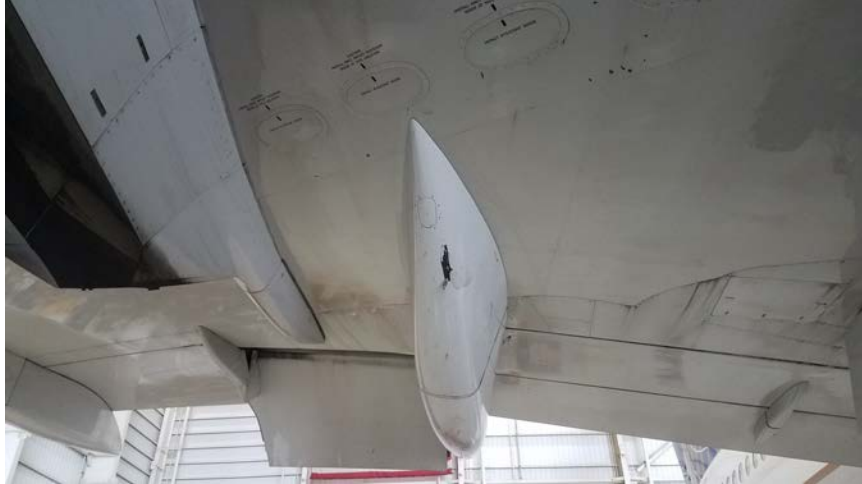
Photo No. 61: Gouge in the inboard flap's outboard flap track canoe fairing. (Boeing)
