NATIONAL TRANSPORTATION SAFETY BOARD
Office of Aviation Safety
Washington, D.C. 20594

POWERPLANT GROUP CHAIRMAN'S FACTUAL REPORT
NTSB No: ENG19IA013

Location: Orlando International Airport (MCO) – Orlando, Florida

Aircraft: Boeing 737-924, N30401, United Airlines Flight 1768

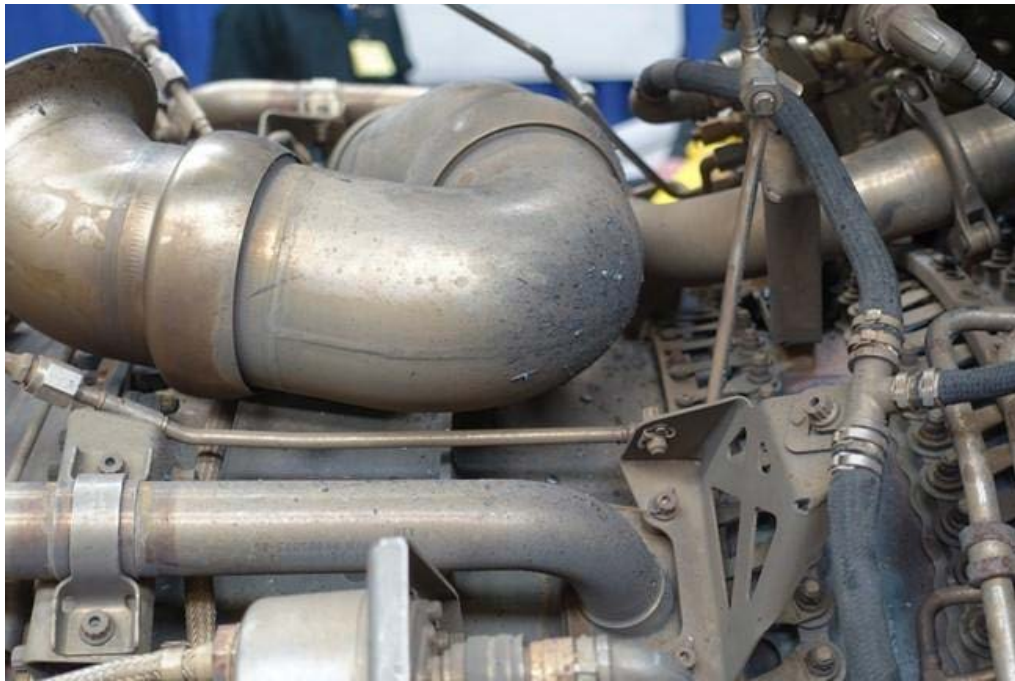
The engine had no visible indications of undercowl fire or high energy uncontainment. The LPC fan blades were all intact and in good condition, and the fan spun smoothly with concurrent rotation of the low pressure turbine. A light surface rub was noted on the fan blade rub strip between the 6 and 10 o'clock positions, but the rub marks did not appear fresh. The engine had a circumferential burn through in plane with the HPC S1 rotor. External accessories and wiring obstructed a clear view of all HPC case surfaces, but case burn through was visible between the 9 and 6 o'clock positions. There was metal spray on external components, lines, and ducting in close proximity to the case burn through holes. The components and wiring did not exhibit signs of thermal damage or discoloration (**Photo 5**) with the exception of the J10 harness cloth braid. Very light metal spray was observed on the low pressure turbine case.

Photo 5- Metal Spray on Ducting Adjacent to Case Burn through (12 o'clock)

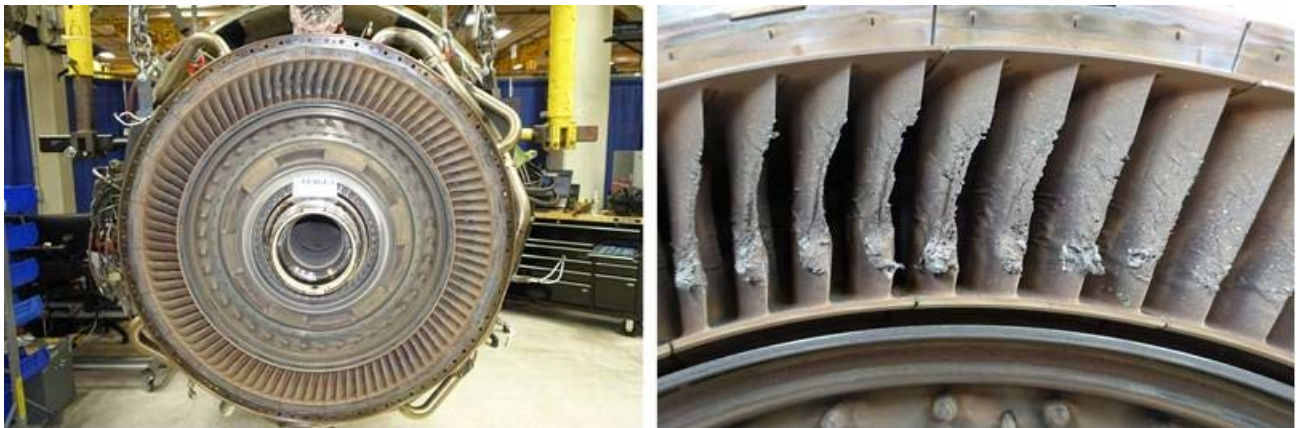
All LPT S1 nozzle vanes were present, but the vanes exhibited thermal distress, most concentrated between the 11 and 1 o'clock positions. At these locations, the vane trailing edges showed indications of melting and material loss. The remaining vanes had varying degrees of suction side blade surface wrinkling (**Photo 6**).

Photo 6- LPT S1 Nozzle Vane Trailing Edge, (R) Close up at 12 o'clock

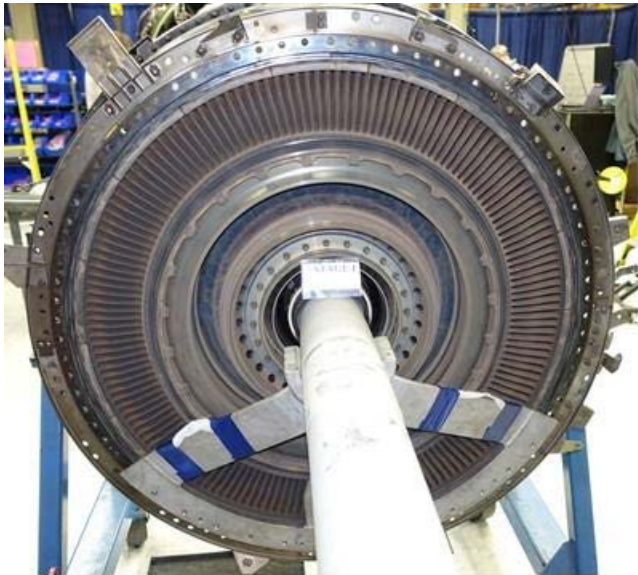
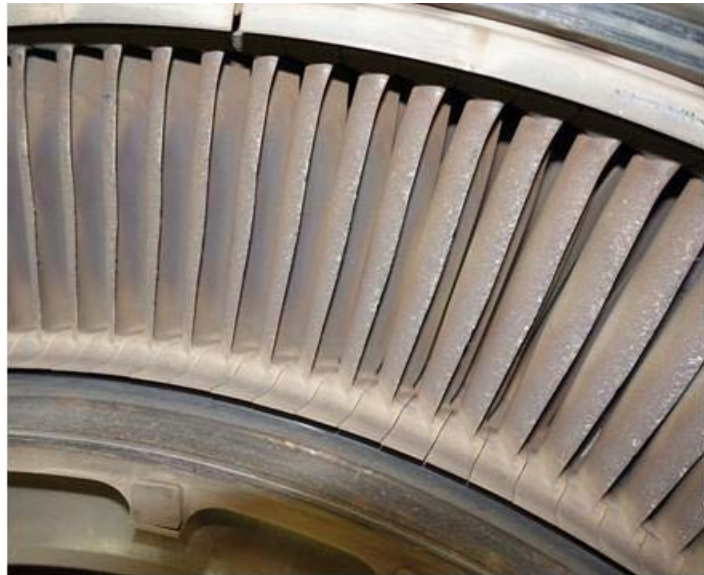
Photo 7- LPT S1 Rotor Leading Edge

The LPT S1 blades were all present and complete. Light/minor impact marks and a small amount of fine metal debris accumulation and metal splatter was observed on the leading edge along the length of the blade span (**Photo 7**). The LPT S2 nozzle vanes visible through the LPT S1 rotor appeared to be intact and in good condition. The trailing edge of the visible LPT S4 blades were also intact and in good condition. The LPT shaft had a light circumferential rub mark 360 degrees around the shaft that appeared shiny, about 12 inches forward of the S1 disk. The rub marks on the shaft were coincident with the axial position of the core air rotor duct. Light impact marks were also noted on the forward end of the LPT shaft,

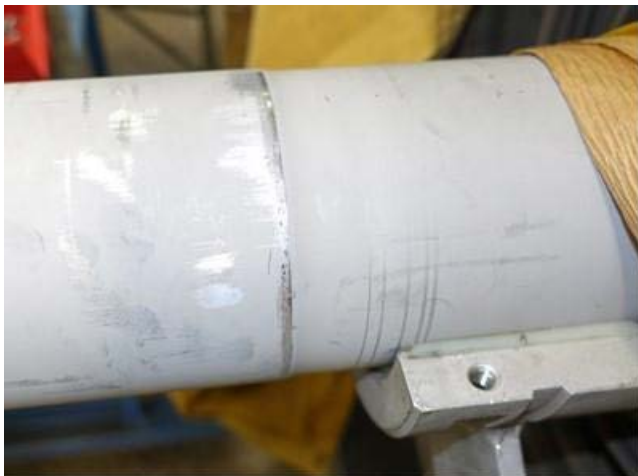
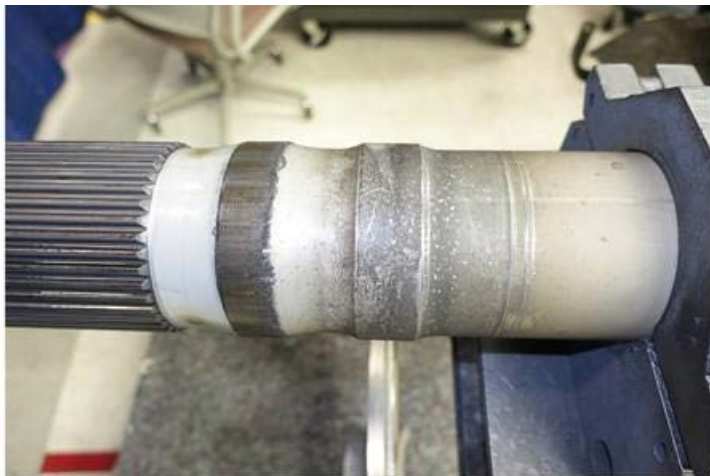
just aft of the coupling splines coincident with the axial position of the booster sump pressurization air ducts (**Photo 8**). Metal flakes/debris were found in the area in and around the No. 4 bearing. Samples were collected by the GE Aviation Materials Laboratory for analysis (**Photo 9**). The No. 4 bearing roller elements were oil wetted and spun smoothly. When the bearing outer race was removed, two pieces of foreign debris were recovered from the race surface (**Photo 10**).

Photo 8- (L) LPT Shaft Rub, (R) LPT Shaft Light Impact Marks

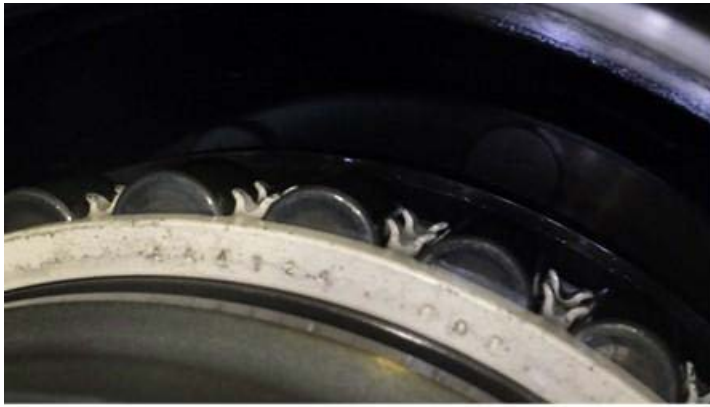
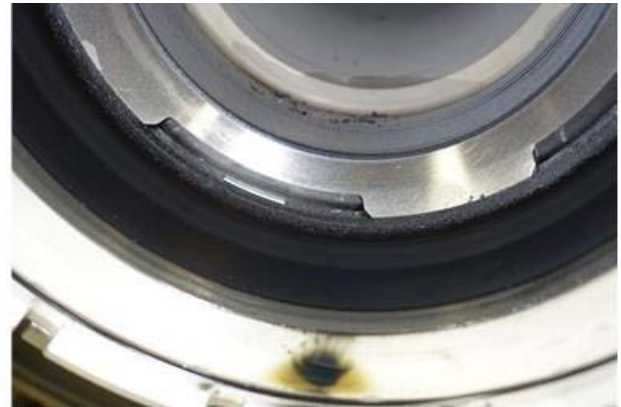
Photo 9- No. 4 Bearing, Metal Debris

The metal flakes collected in the aft sump region were analyzed and RBD⁴ modified steel and silver plating were identified. Both of these materials are present in the No. 4 bearing assembly. The metal that was collected on the forward sump MCD was identified as M50Ni1, also a bearing material. The complete Metallurgical Investigation Report is available in the investigation docket. The NTSB Materials Laboratory assisted in development of the metallurgy workscope and concurred with the findings and conclusions in the final report.

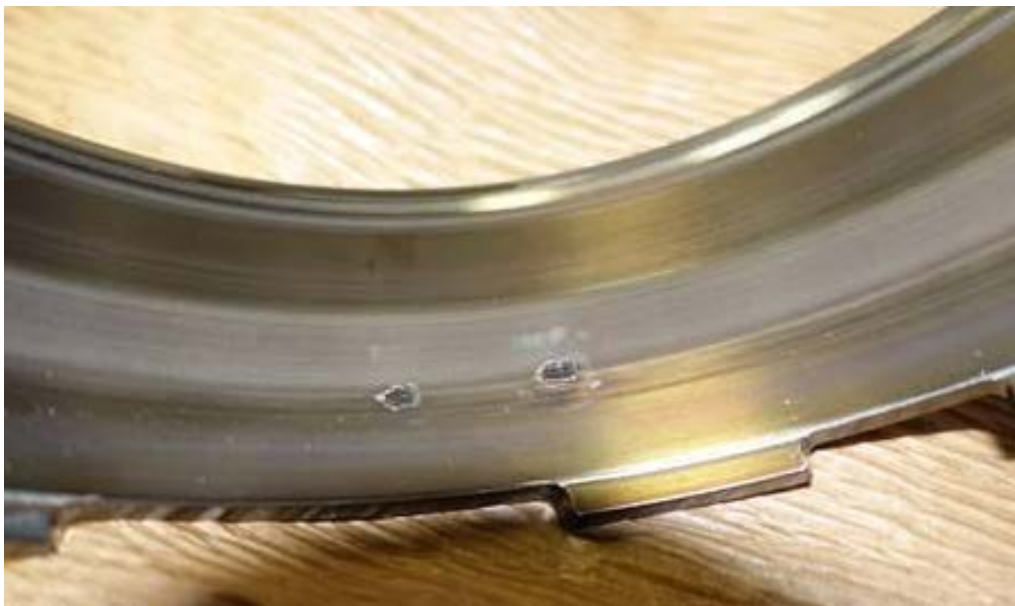
Photo 10- No. 4 Bearing Outer Race Debris

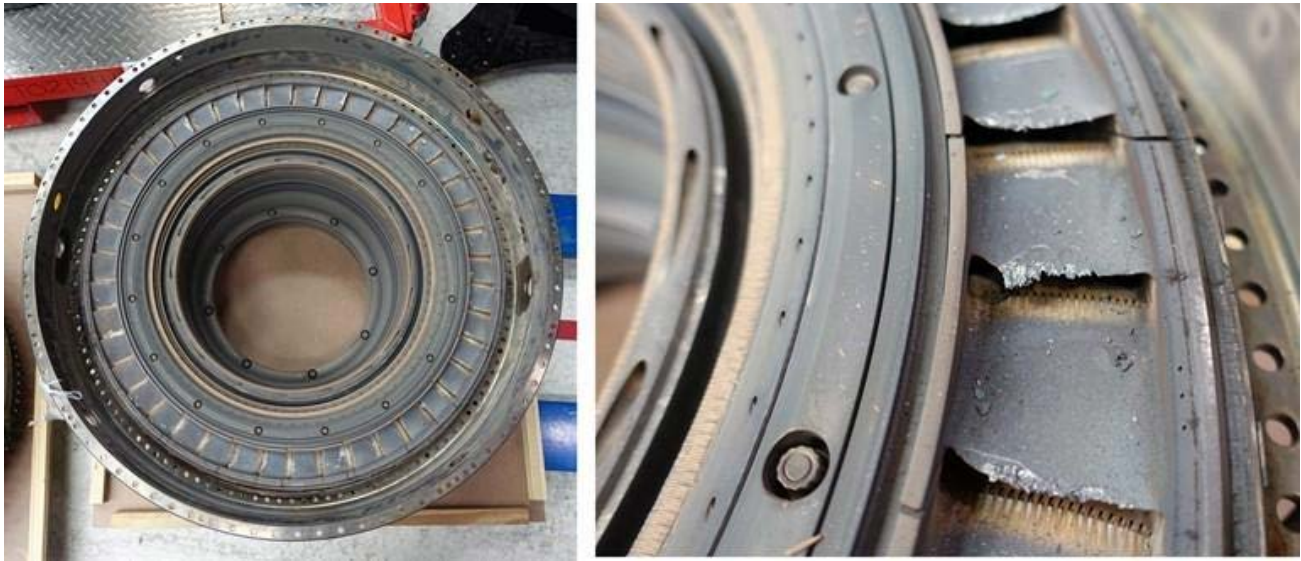
The HPT S1 nozzle vanes were all complete but exhibited trailing edge thermal distress and impact damage along the length of the vane span (**Photo 11**). Loose metal debris was resting at the inner and outer vane platforms. The HPT S1 rotor blades were all present, but leading edge thermal damage including areas of missing thermal barrier coating was noted. All HPT S1 blade trailing edges also exhibited thermal damage including material loss at the blade tips. Metal spray was present on the convex side of all blades (**Photo 12**).

Photo 11- HPT S1 Nozzle, (R) Trailing Edge

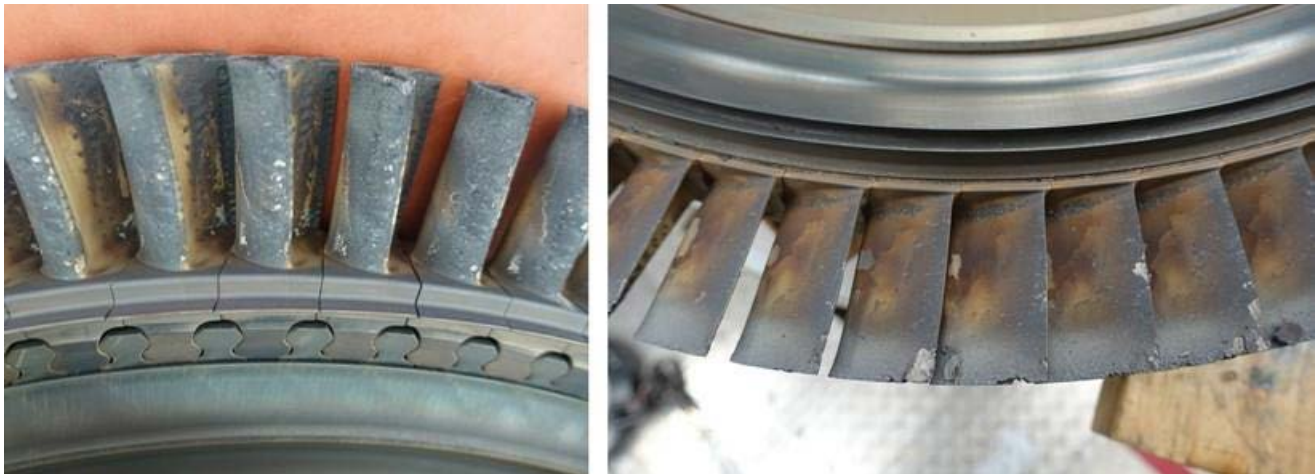
Photo 12- HPT S1 Blades (L) Leading Edge, (R) Trailing Edge

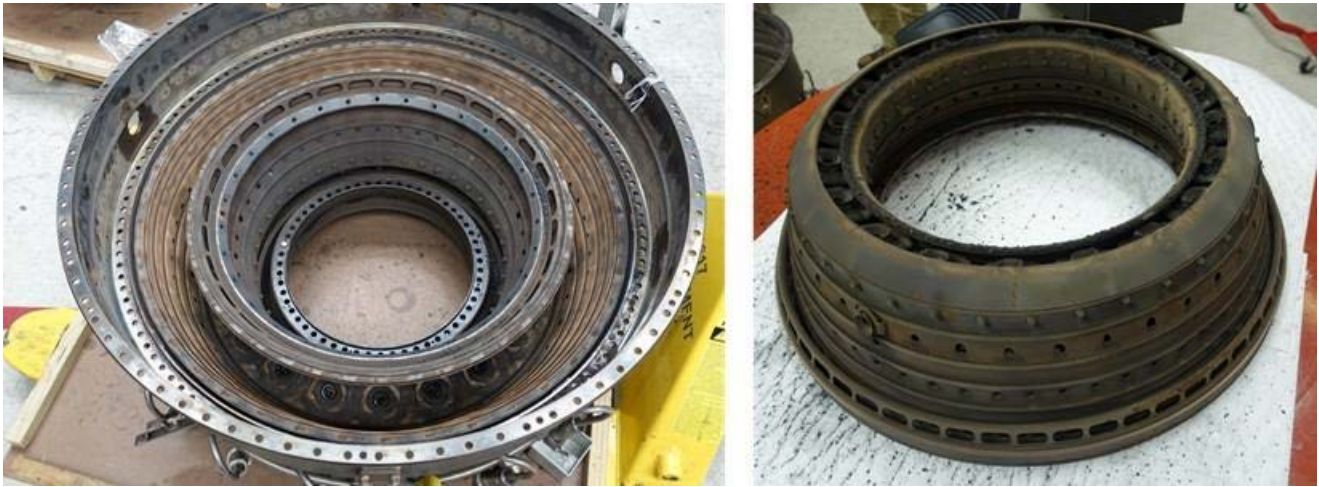
Photo 13- Combustion Liner

The combustion liner was intact and did not show indications of burn through or localized hot spots. The liner had some discoloration that was considered normal for service run engines according to CFM International (**Photo 13**). Fine metal debris that was accumulated in the liner was removed and examined. Metal fragments were collected in the combustor discharge nozzle. Both combustor igniters were mechanically damaged.

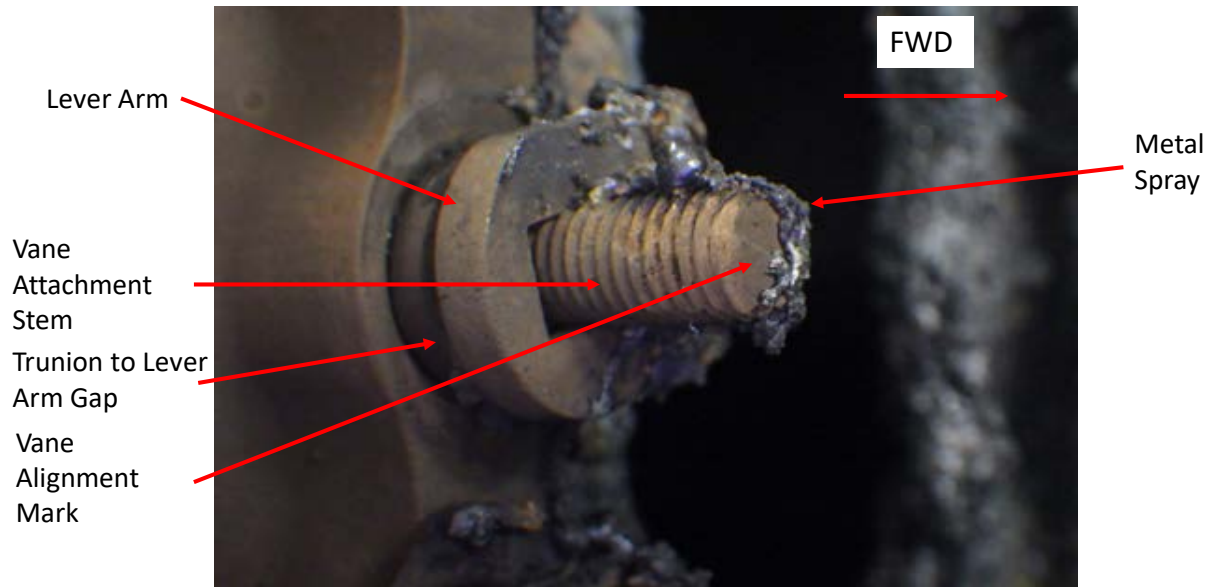
During a visual inspection of the HPC cases after external component removal, one S1 VSV trunnion stem, identified as VSV #33, retaining nut was found missing at the 2 o'clock position (**Photo 14**). A majority of the VSV #33 lever arm was separated near the trunnion stem but the remaining intact portion of the lever arm was displaced and no longer engaged with the trunnion D-head. The trunnion D-head acts as an anti-rotation feature to ensure the VSVs rotate in unison. An alignment mark on the top of the trunnion stem was at a different angle relative to the rest of the trunnion stems in the stage. The threaded trunnion stem exhibited metal splatter on the forward facing side. The HPC stator case bridge connectors were intact and secure. The Inlet Guide Vane (IGV) lever arms were complete and secure on both the top and bottom cases, but multiple IGV lever arms were separated and missing near the vane trunnion stem. All IGV, S1, S2 and S3 VSV lever arms were labeled with a marker beginning at the 9 o'clock split line in the clockwise direction. The missing VSV lever arms are listed below in **Table 1**. Panoramic photos were taken of each stator case half to flatten out the case arc (**Photos 15, 16**). The S1 VSV actuation ring was consumed at multiple points where there was case burn through. The actuation rings for the other stages were complete but exhibited thermal damage in areas in proximity to the HPC case burn through. There was a circumferential crack on the HPC stator case, in plane with the S3 rotor, from the 12 to 2 o'clock positions. The IGV and S1 actuation hardware was removed to better examine and document the case burn through. The HPC stator had three IGV vanes still present in the outer platform and six additional vanes remained in the separated IGV inner shroud. The vanes exhibited deformation, material loss and thermal distress. All remaining HPC vanes were separated and missing and a thick layer of metal slag was adhered to the interior surface of both the HPC stator top and bottom case halves (**Photo 17, 18**).

Photo 14- S1 VSV #33 Stem with Missing Retaining Nut

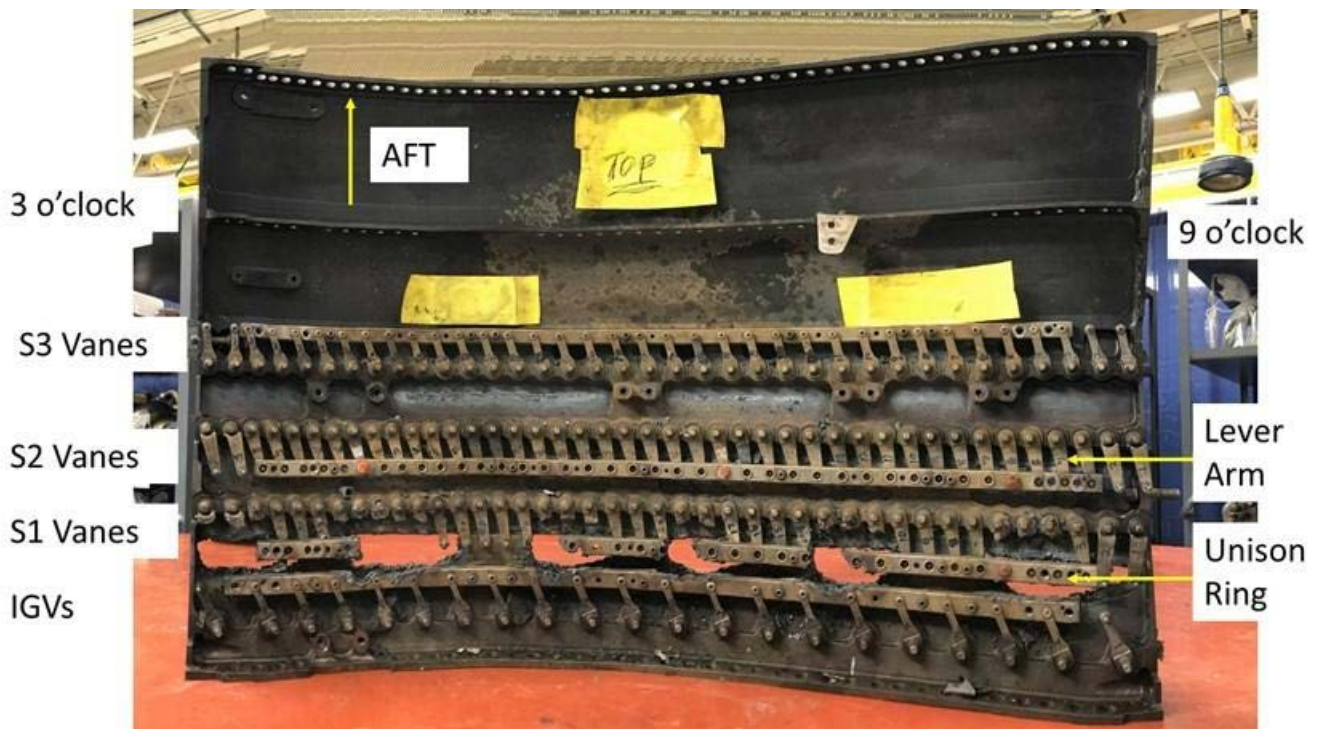
Photo 15- Panoramic Photo of HPC Stator Case (Exterior), Top Half

As noted in the initial observations, the HPC stator case had burn through in plane with the S1 rotor blade path. The burn through was observed around the case but was not continuous and was estimated have affected approximately 60% of the circumference. HPC case material remained intact around the rub button pads³ and at the HPC stator case split flange.

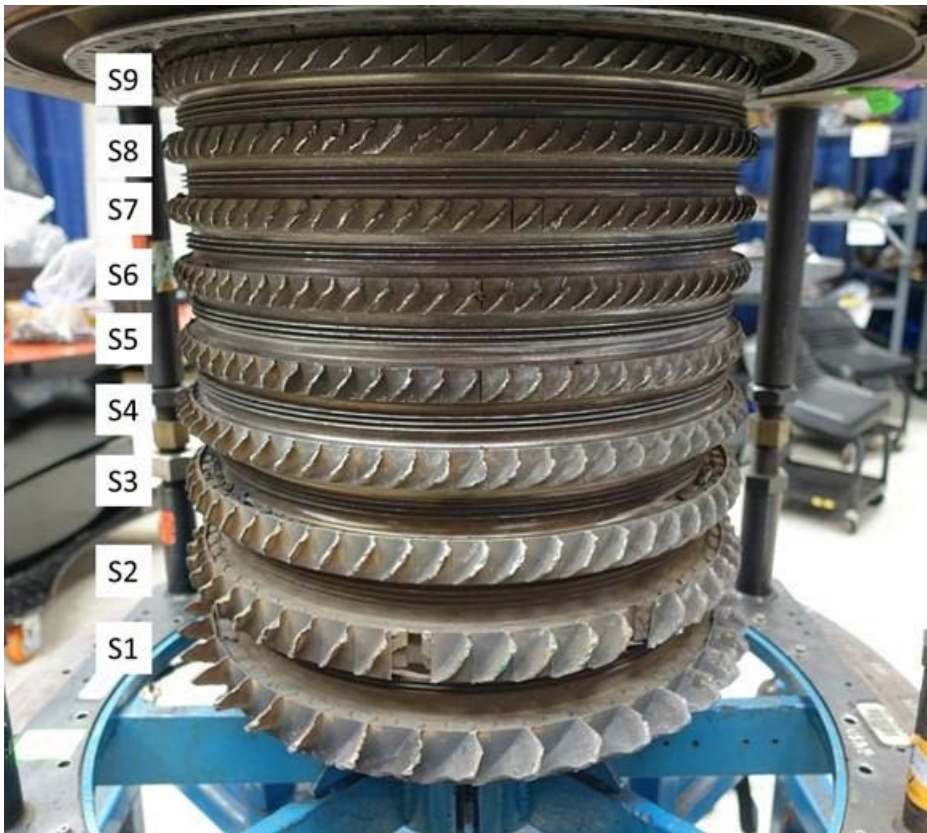
Photo 19- HPC Rotor

When the stator case halves were removed to expose the HPC rotor, loose metal debris fell into a collection tarp placed on the ground. The debris that was recovered was mostly fine metal grit, but deformed vanes, vane shrouds and vane trunnions were also identified. The S1 HPC rotor blades were all present but exhibited substantial impact and thermal damage (**Photo 19**). The S1 blade leading edges were missing material leaving a wave like shape from the blade platform to blade tip. All remaining S1 blades were about the same shape around the disk and measured about 1 inch from the platform to the blade tip.

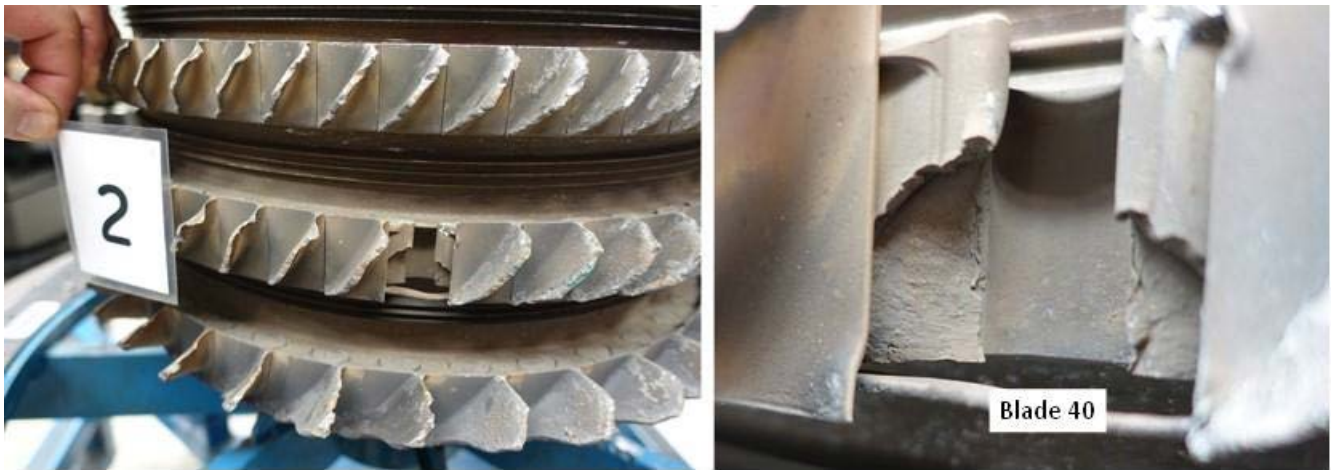
The HPC S2 blades also exhibited mechanical and thermal damage. A total of eight blades, including the blade dovetails were separated and missing (**Photo 20**). All remaining blades had a rounded/tombstone shape and measured about 1/2 inch from blade platform to tip. The separated blades all had fractured disk posts on either one or both sides of the blade dovetail disk slot. The blades were numbered beginning with the blade directly forward of the spool drain hole in the clockwise direction. The missing blade numbers, retaining ring condition, and disk post fracture direction are shown in **Table 2**. A complete documentation of the S2 disk posts fracture condition is included in the GE Aviation Materials Laboratory report.

Photo 20- HPC S2 Missing Blade 40, Fractured Disk Posts

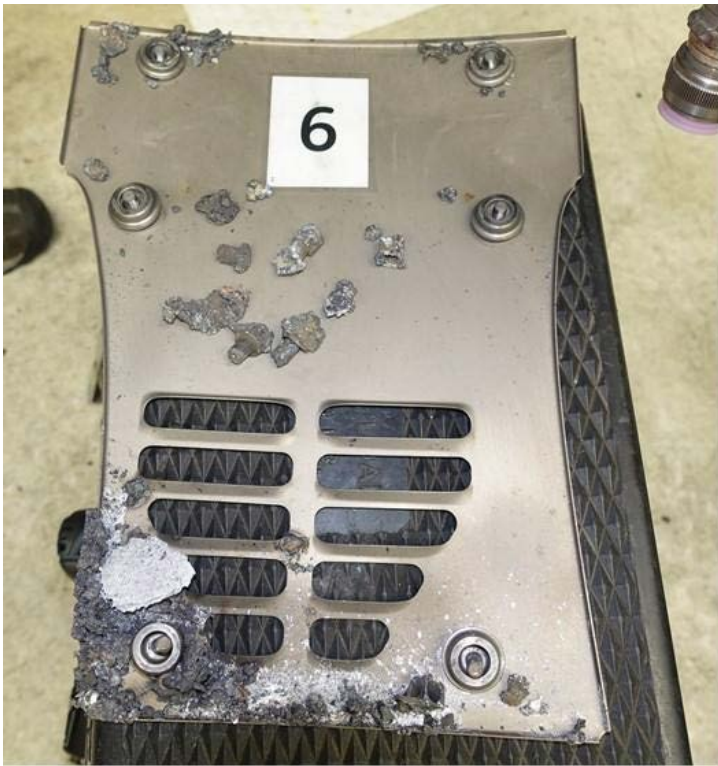
The fan frame struts leading to the HPC had metal spray on the trailing edge and loose metal debris resting along the bottom of the frame against the struts. Each of the VBV louvers were removed and metal spray and loose debris were present in the VBV ports, most concentrated along the bottom half of the engine (**Photo 21**). A loose bolt was found in the VBV louver at the 7 o'clock position. The side of the bolt

Photo 21- VBV Louver, 6 o'clock

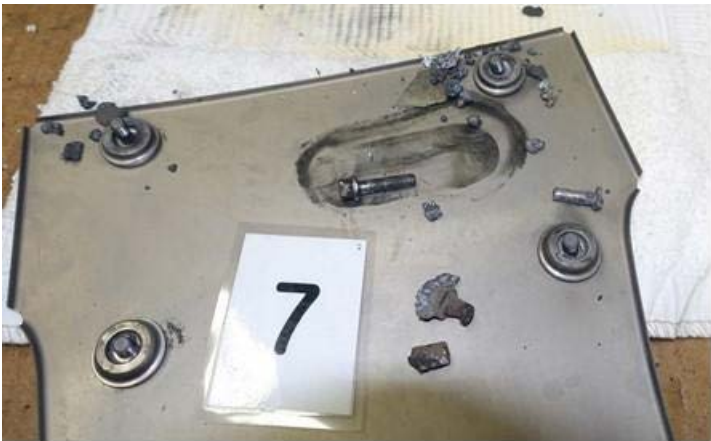
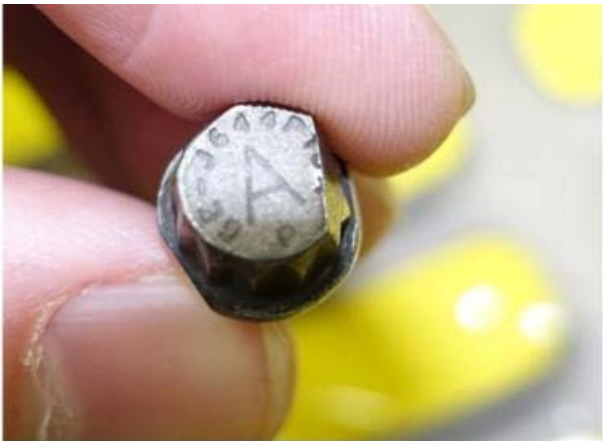
head was flattened/rubbed, and an oval/racetrack pattern was worn into the louver where the bolt was resting (**Photo 22**). The source of the loose bolt was not identified. The VBV doors were in the open position at the start of the exam. An IGV was wedged in the 8 o'clock VBV door. The VBV's were cycled by pressurizing the VBV actuators, they closed fully and opened uniformly.

Photo 22- Louver 7 Rub and Loose Bolt

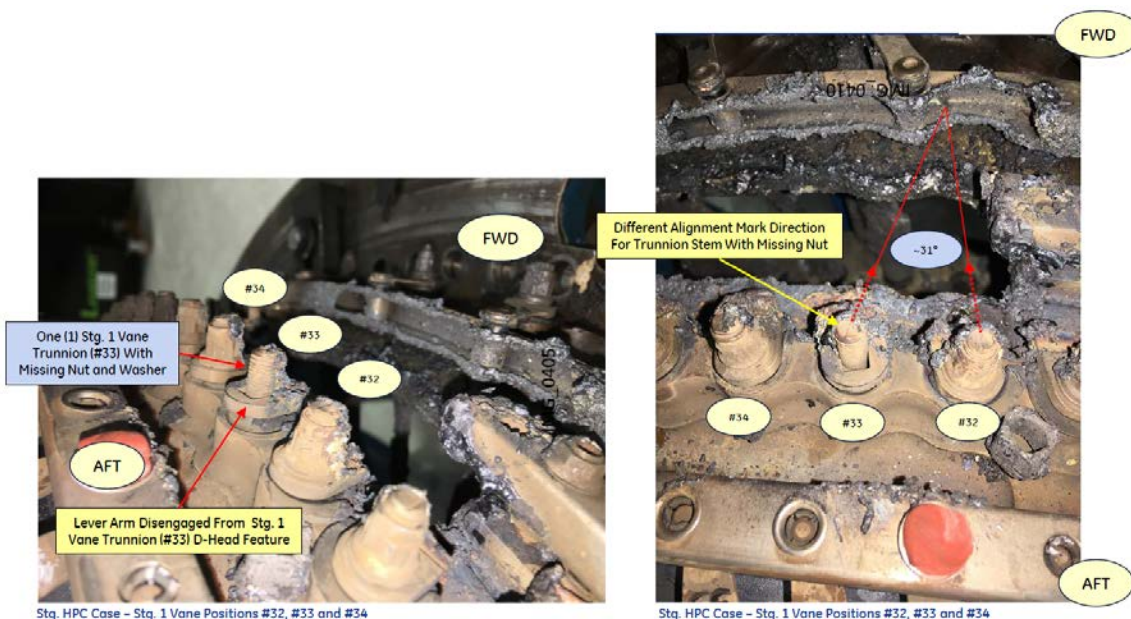
Photo 23- HPC S1 VSV Trunnion #33 (Photos courtesy of GE Aviation)

Visual and binocular examination of the HPC S1 VSV (#33) trunnion stem confirmed that the missing washer and retaining nut identified during the engine teardown resulted in disengagement of the lever arm from the trunnion D-head allowing the vane to go off-schedule approximately 31 degrees relative to the other S1 VSVs (**Photo 23**). The VSV #33 trunnion stem had a uniform coating of dirt/debris along the full length of the stem consistent with engine operation over an extended period of time without a washer and retaining nut (**Photo 24**). The laboratory also identified witness marks on VSV #33 indicating that a washer and retaining nut were present at some point, but it could not be determined when the parts separated.

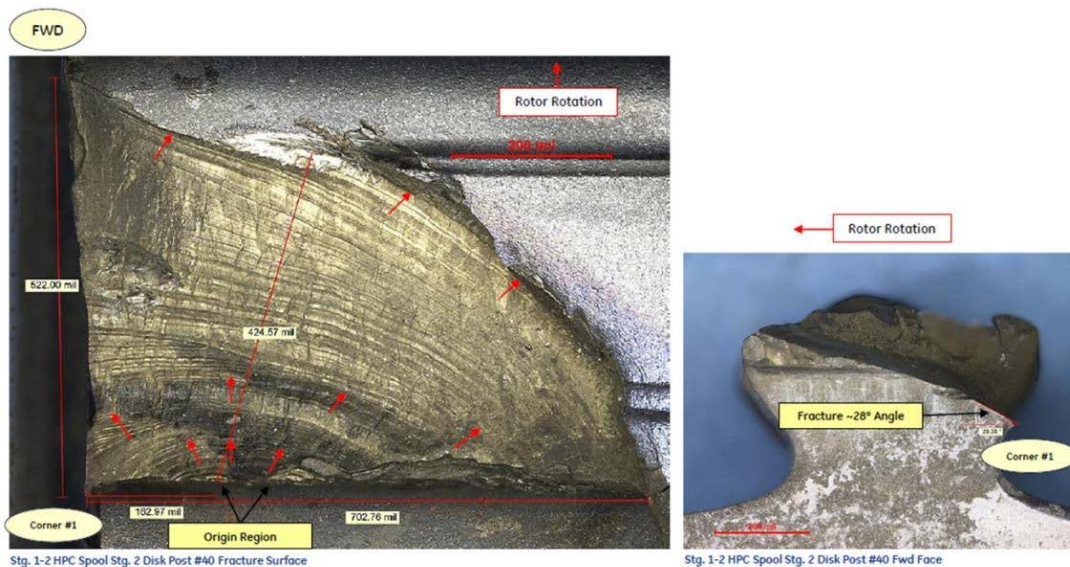
The HPC S2 disk posts fracture morphology was consistent with a lower alternating stress, high cycle fatigue (HCF) and/or mixed-mode low cycle fatigue (LCF)/HCF mechanisms. The primary initiation occurred adjacent to the forward right corner (corner #1) of the disk posts (**Photo 25**). A metallographic examination through a crack origin on one of the S2 disk posts did not identify any material anomalies or stress risers. The material microstructure was consistent with properly processed beta forged Ti-17 material as specified in the engineering drawing.

Photo 25- HPC S2 Disk Post #40, (L) Visible Fatigue Beachmarks, (R) Fracture Angle (Photos courtesy of GE Aviation)
