NATIONAL TRANSPORTATION SAFETY BOARD

Powerplants Sub- Group Chairman’s Factual Report of Investigation

A. ACCIDENT CEN13FA196

Location: South Bend, Indiana
Date: March 17, 2013
Time: 1623 Eastern Daylight Time
Aircraft: Hawker Beechcraft Corporation Model 390 Premier 1A,
 N26DK

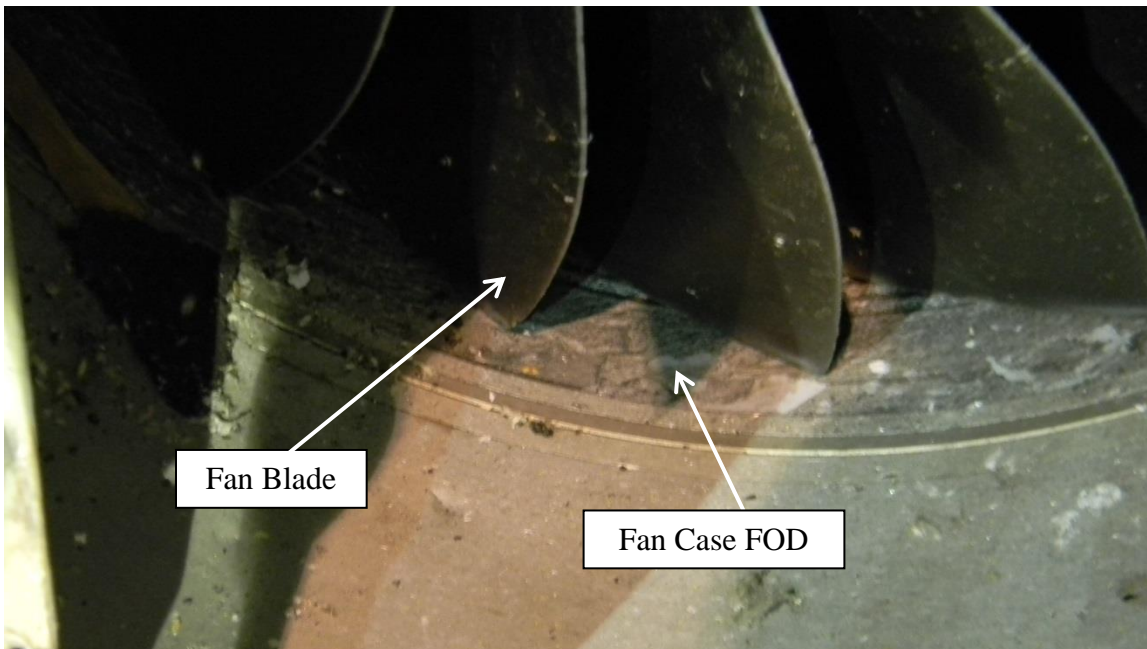
The detailed examination of the fan revealed evidence of leading edge foreign object damage (FOD), consistent with ingestion of debris during the accident sequence. However, the fan could still be rotated by hand. Circumferential scratches, but no FOD were noted on the spinner, consistent with engine rotation at impact. Please see Figures 1 and 2.

Figure 1 - FOD in the fan and fan case, for Left Engine.

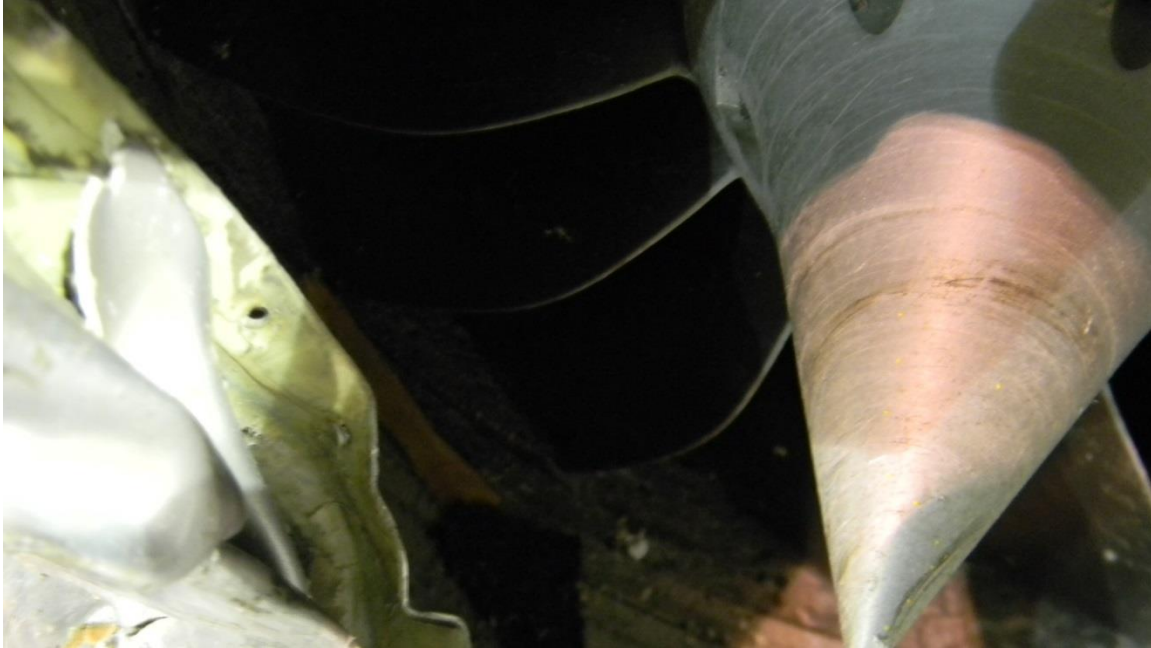
Figure 2 - Left Engine spinner and inlet. Note circumferential scratches on the spinner and lack of FOD, evidence consistent with engine rotation at impact.

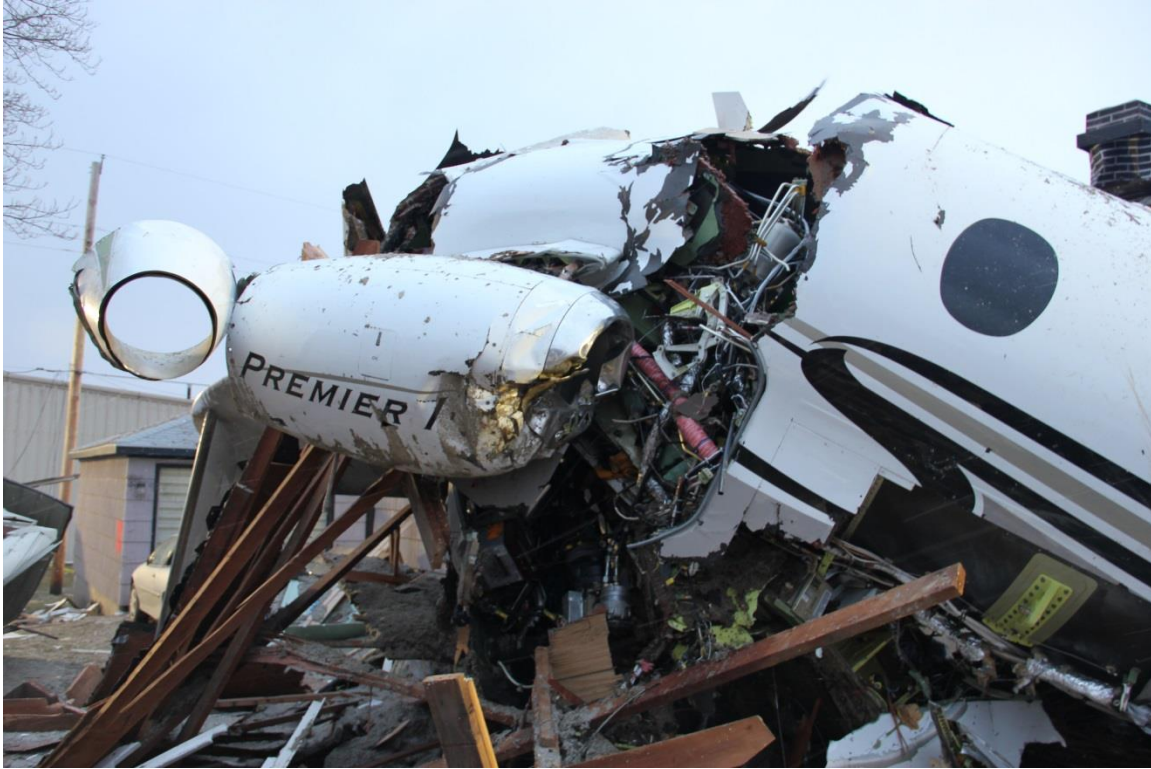
The accident site inspection of the engine revealed that the inlet leading edge had been impacted and crushed into the fan from approximately the 3 to 9 o'clock position FLA. There was visible damage to the cowling and supporting structure but the extent could not be determined on site. See Figure 3.

Figure 3 - Right hand engine at the accident site.

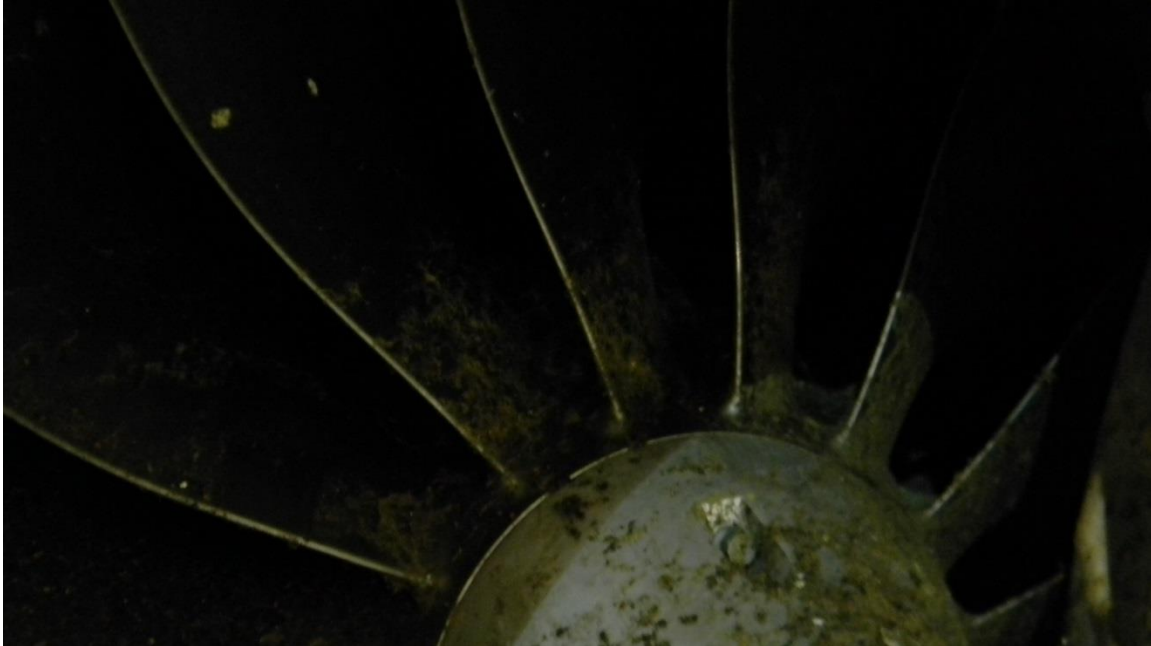
The interior of the cowling contained attic insulation, pieces of home roofing shingles, pieces of wood, and other unidentified debris. However, the fan showed no visible evidence of leading edge foreign object damage that would be consistent with ingestion of debris during the accident sequence by a rotating fan. See Figures 4 and 5.

Figure 4 - Right hand engine fan blades and spinner. Note debris on fan blades and spinner, evidence consistent with no engine rotation during impact sequence.

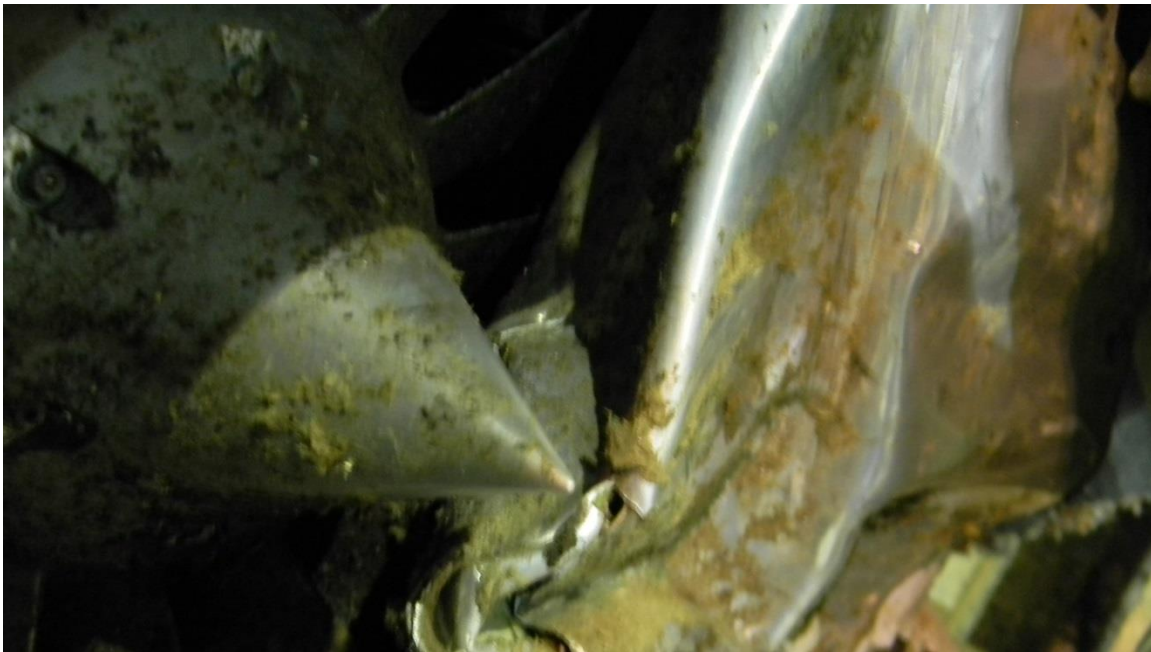
Figure 5- Right hand engine inlet, fan blades and spinner. Note debris deposited on fan blades, spinner and inlet, evidence consistent with no engine rotation during impact sequence.
