Service Investigation
Accident / Incident Report

Report No.:16-157

**Aero Smart Solutions Inc.
Lancair Evolution & Registration No. N38DM
Allen County, Kansas
October 1st 2016
PT6A-42
S/N 93158**

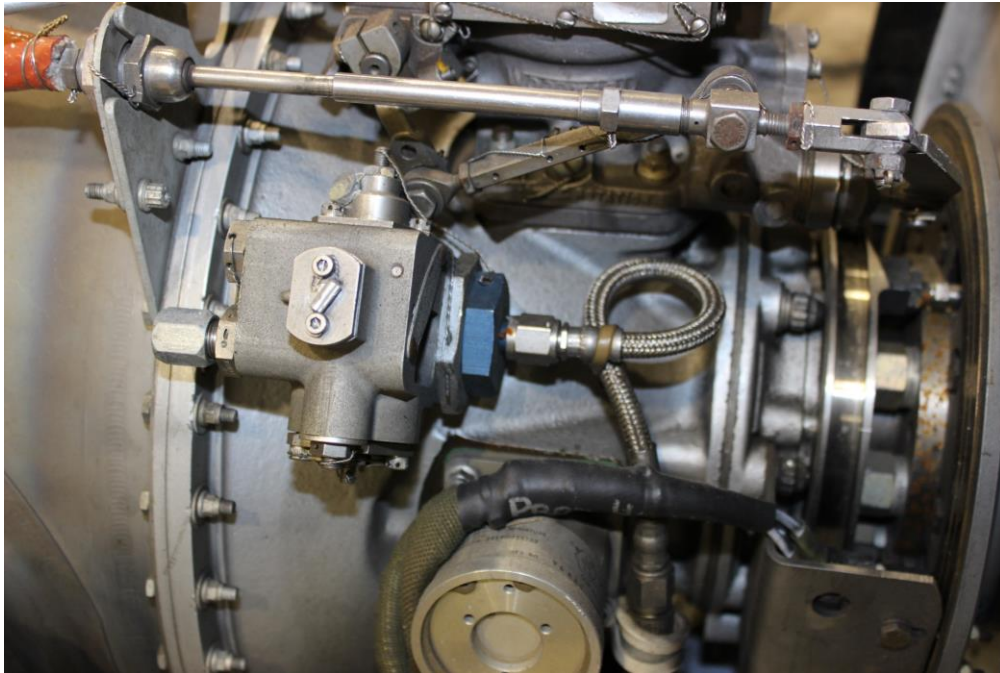
Photo No. 7

Reduction Gearbox: No visible external distress was noted on the gearbox (Ref. Photo No. 7).

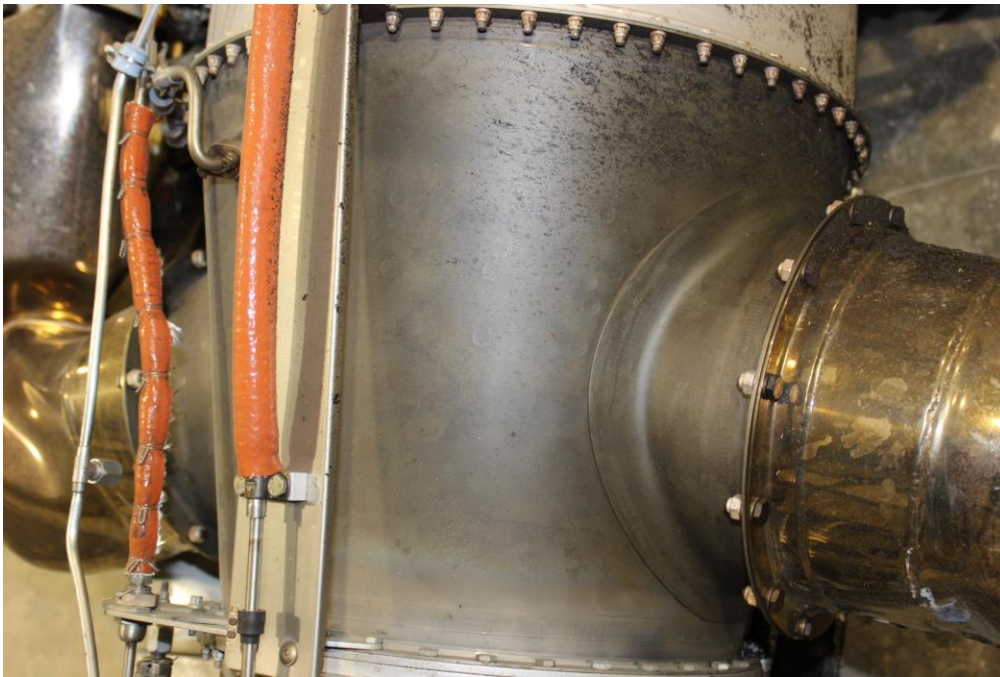
Photo No. 8

Exhaust Duct: Some dark stains were evident on the left hand side of the duct adjacent to the gas generator mating flange (Ref. Photo No. 8). The right hand exhaust stack was bent.

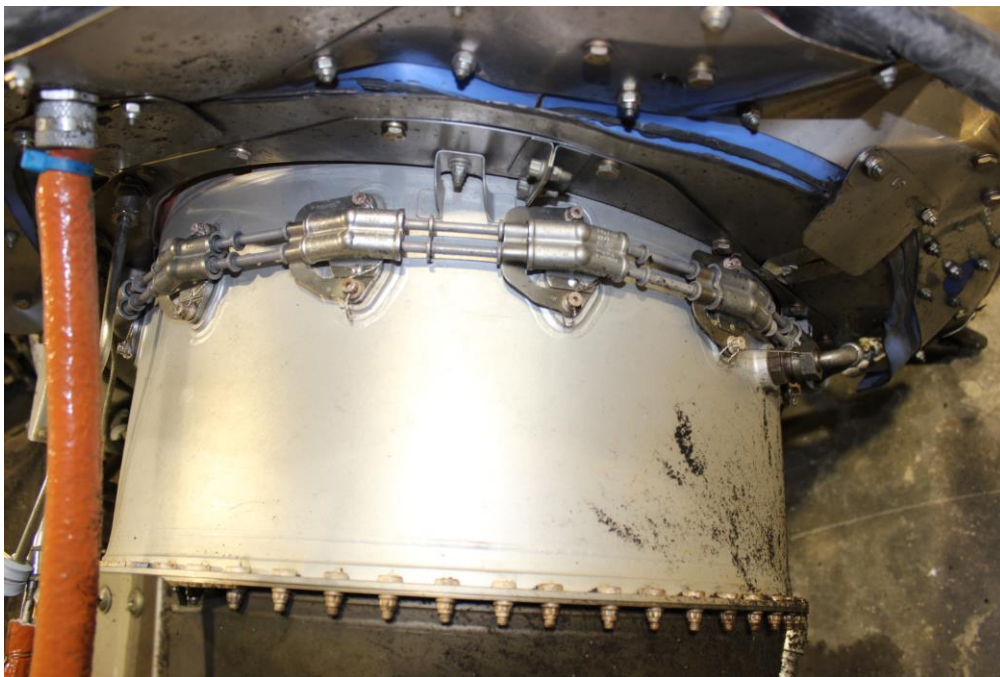
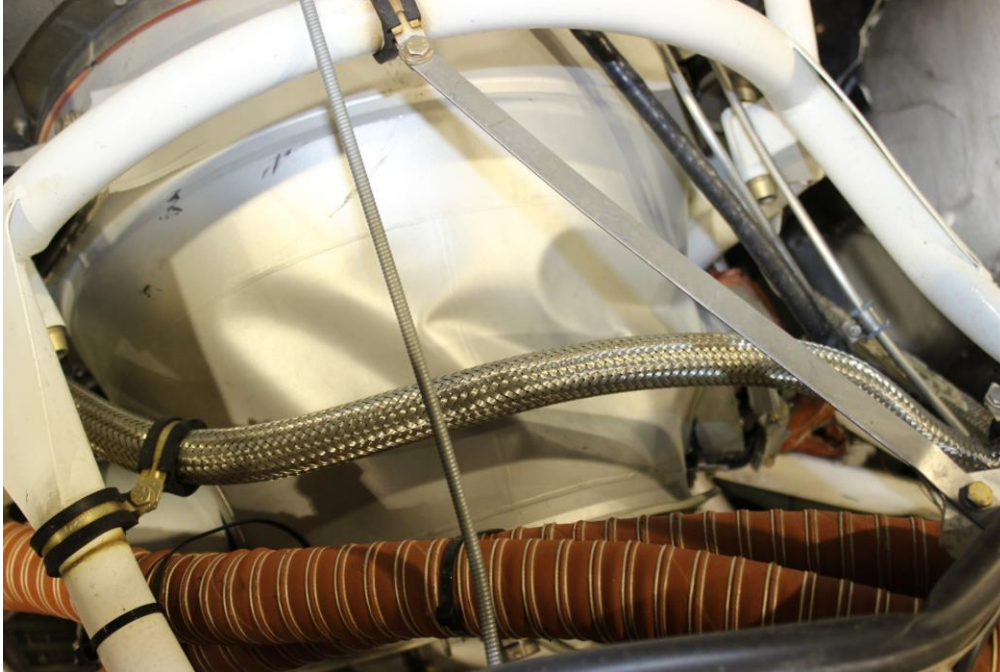
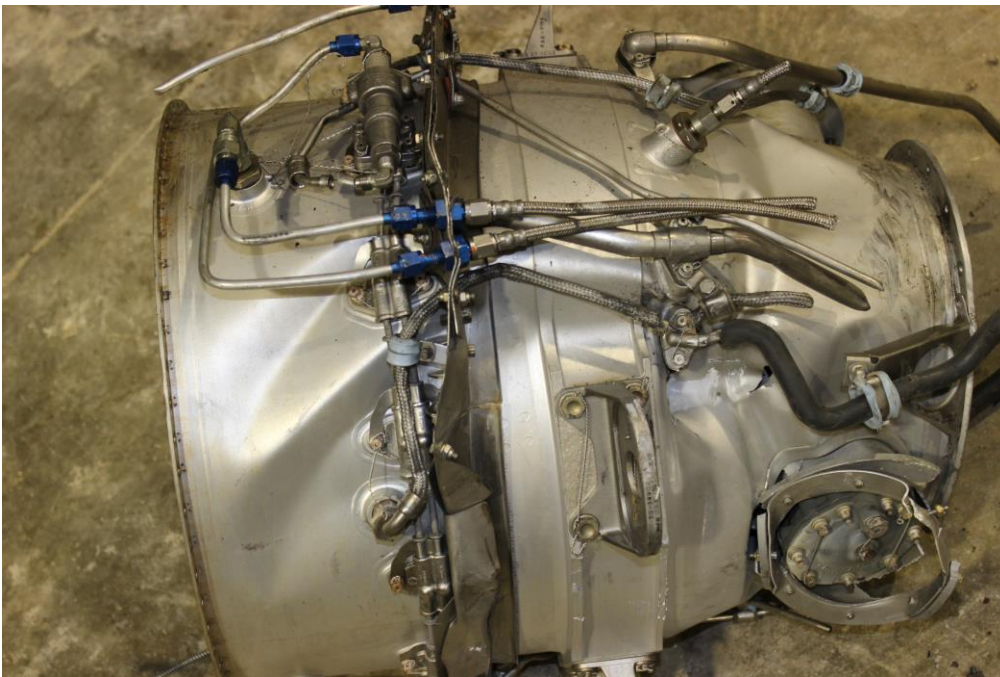
Gas Generator Case: The case was compressed, bent, and torn from the impact with unknown objects during the forced landing. (Ref. Photos No. 9 to 11).

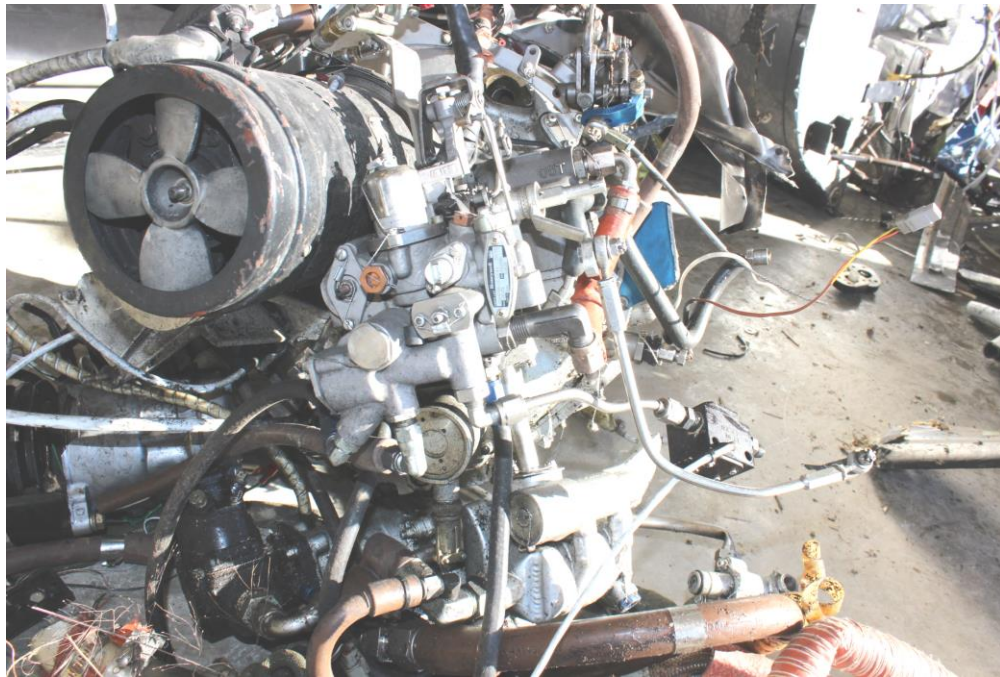
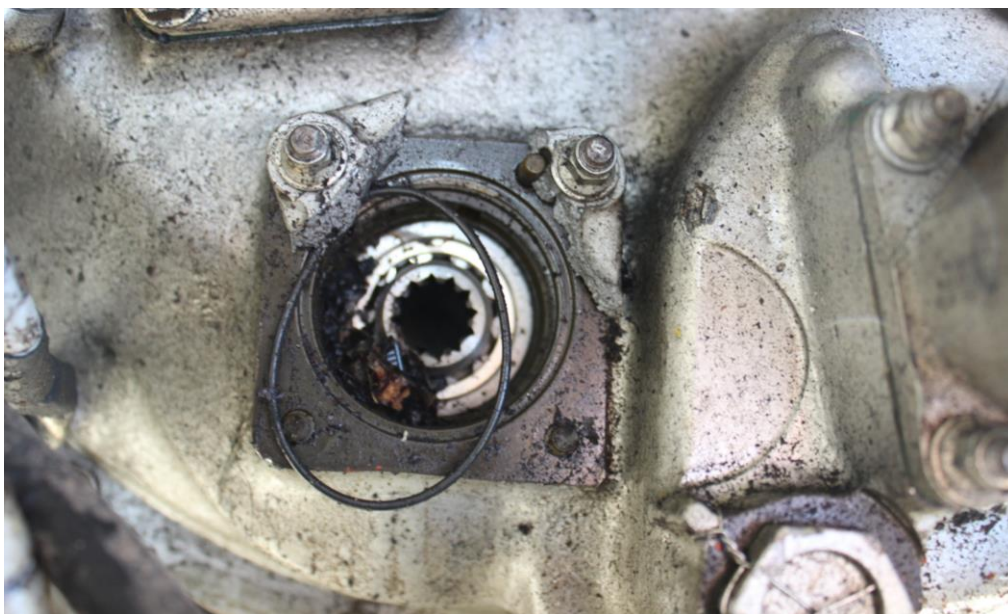
Accessory Gearbox: Two of the studs on the external scavenge oil pump mounting pad were fractured due to the pumps separating from the gearbox (Ref. Photos No. 12 & 13).

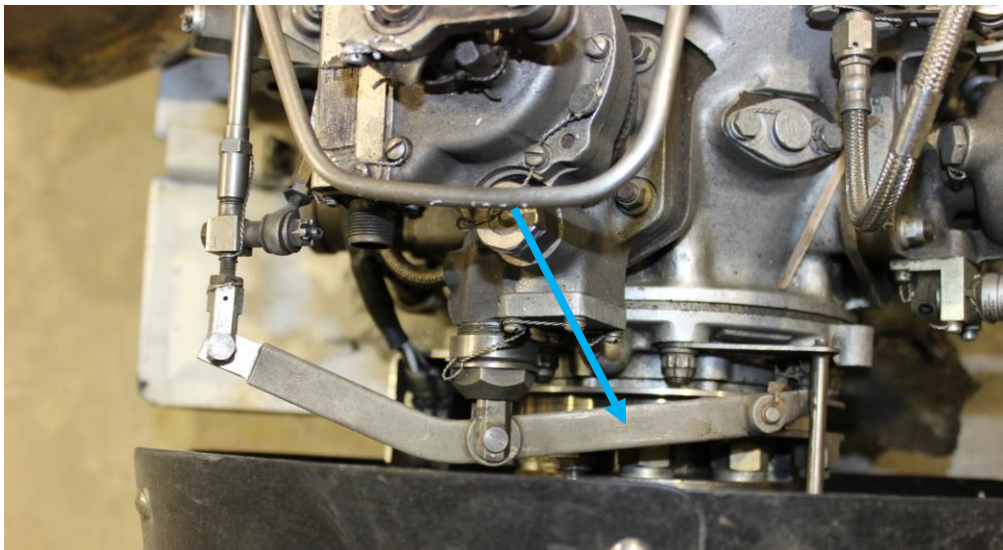
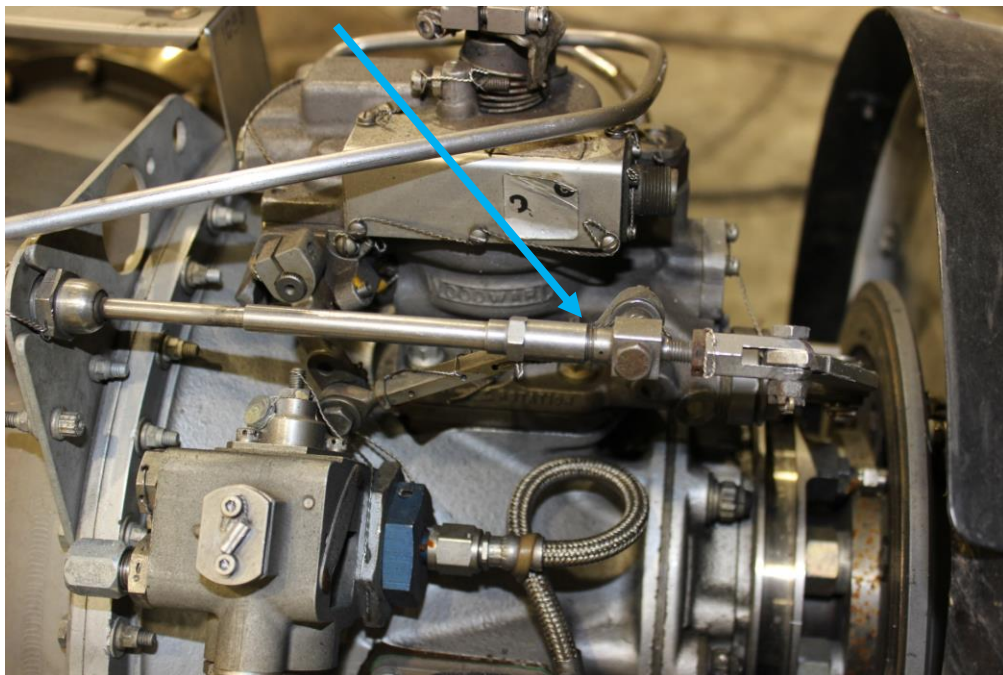
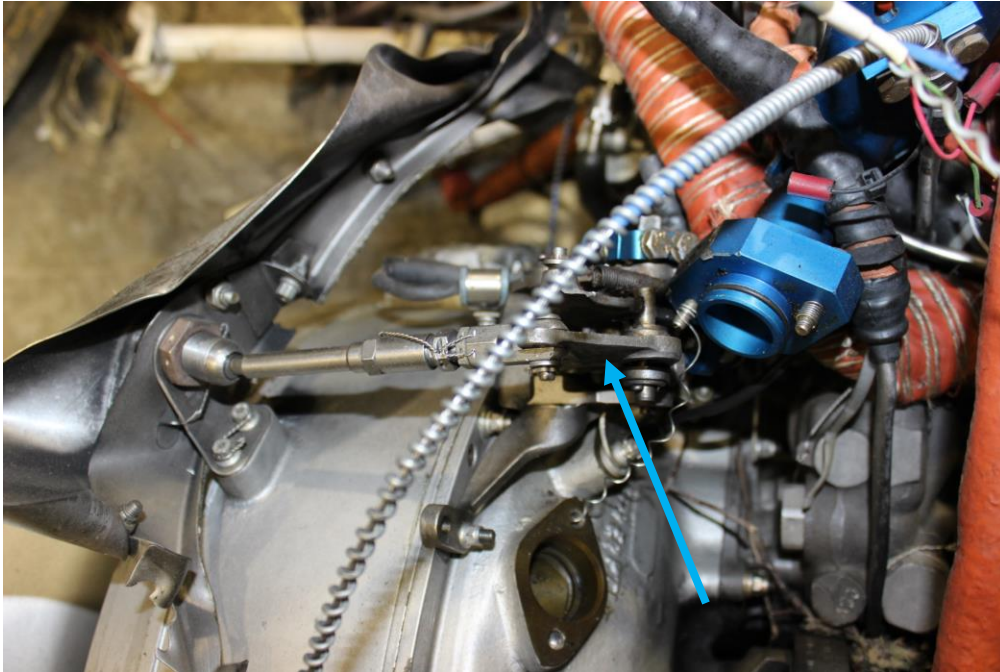
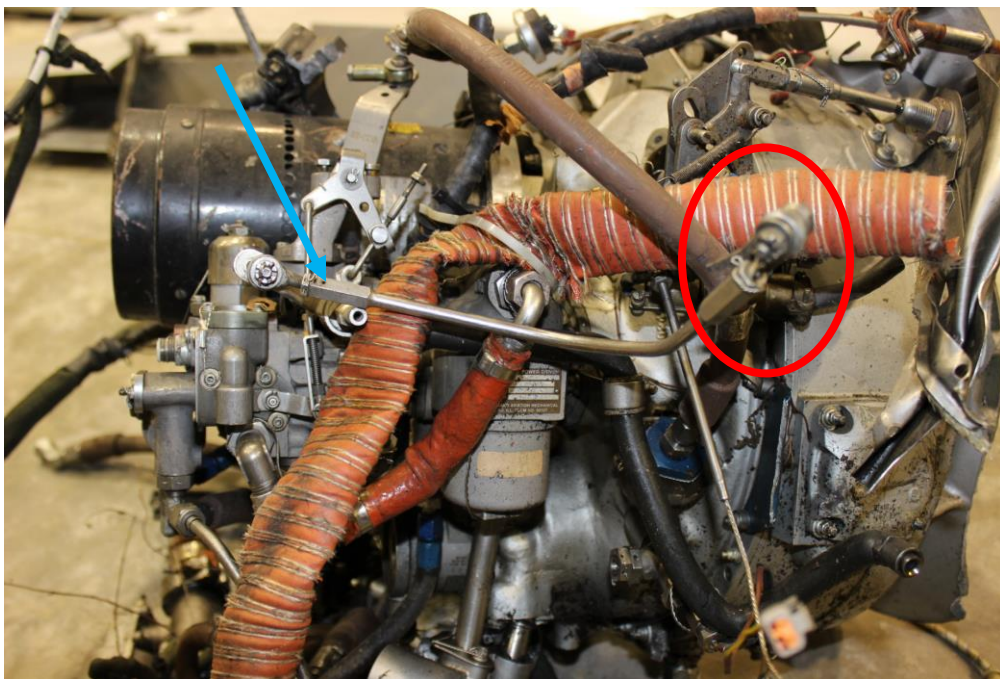
3.1.2 **Power Control and Reversing Linkage:** The front linkage was in place and secure (Ref. Photos No. 14 & 15, blue arrows). The wire rope and casing were fractured adjacent to the rear fire seal. The CAM box was in place but the actuating control lever was fractured at the fuel control unit rod connection (Ref. Photos No. 16, blue arrow & 17, red oval). The fuel control rod was bent (Ref. Photo No. 17, blue arrow).

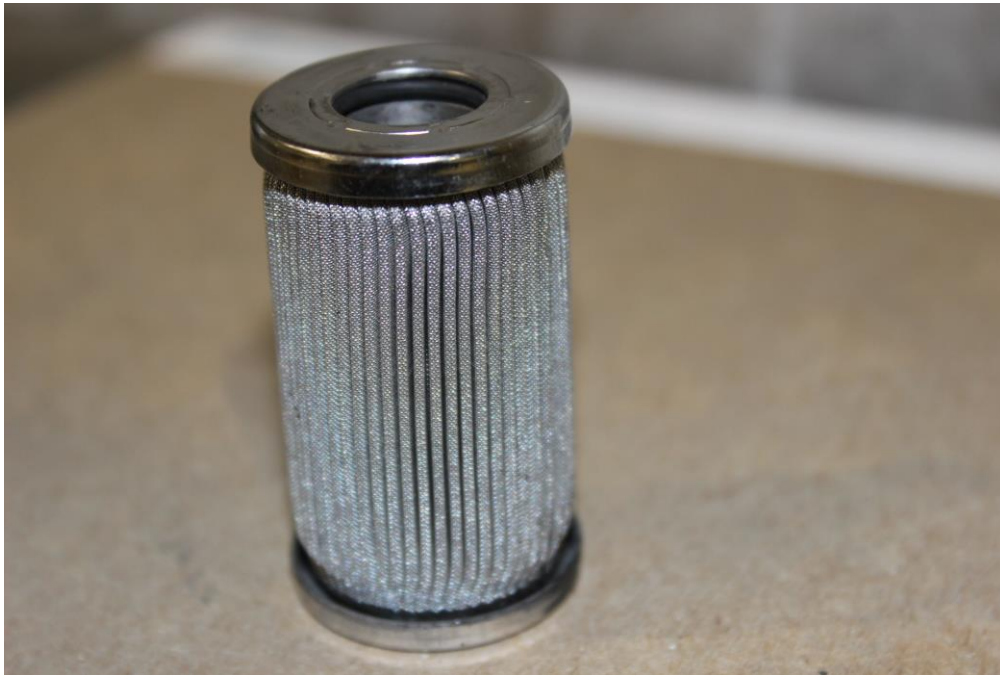
Photo No. 18

Compressor Discharge Air (P3): The tube was in place and secure except it was separated from the connection adjacent to the filter housing (Ref. Photo No. 20, green arrow). The filter was clean (Ref. Photo No. 18).

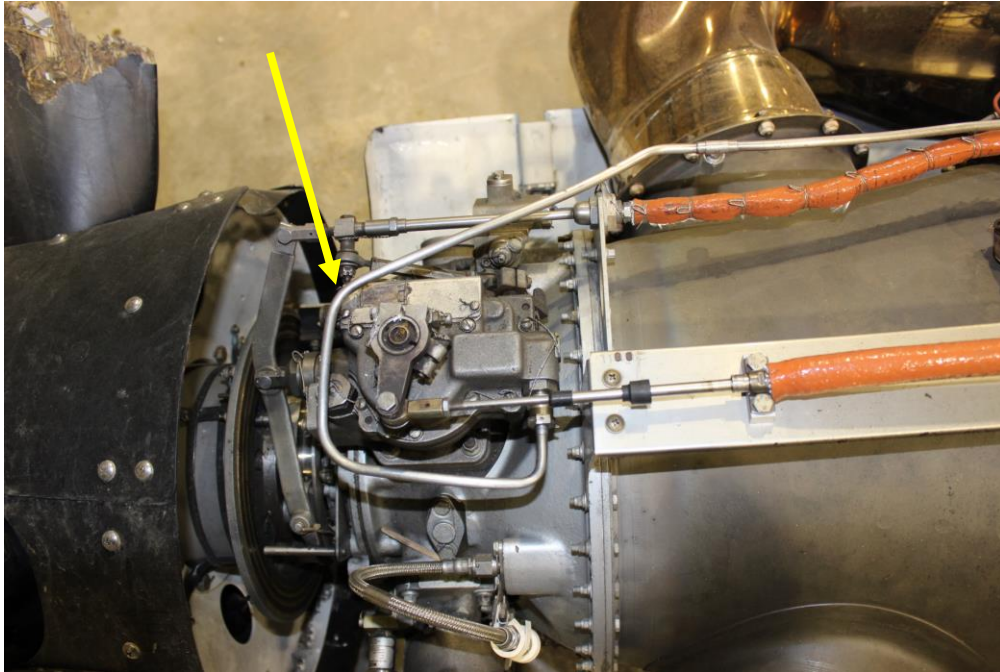
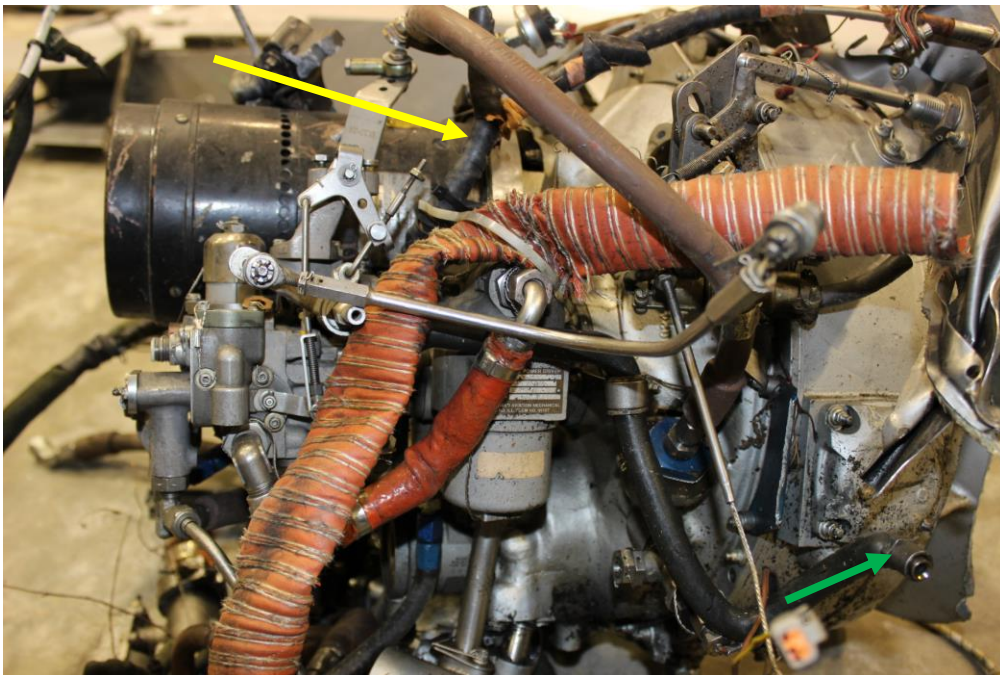
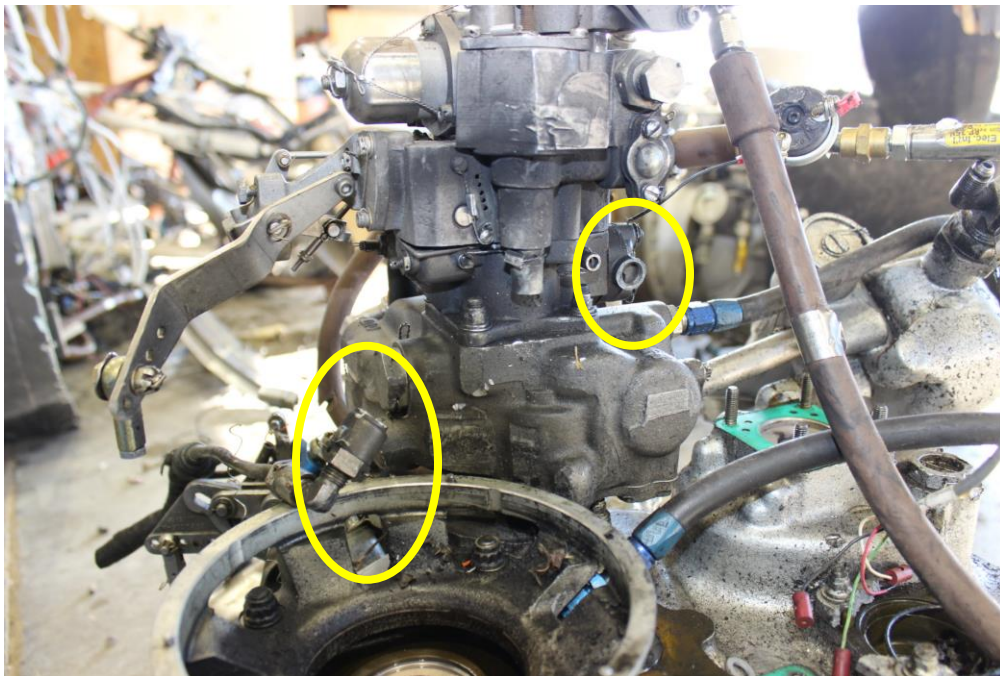
Power Turbine Control (Py): The front of the tube was in place and secured (Ref. Photo No. 19, yellow arrow). The tube was distorted from the centre fire seal to the fuel control and the fuel control boss for the tube was fractured (Ref. Photos No. 20 & 21, yellow ovals).

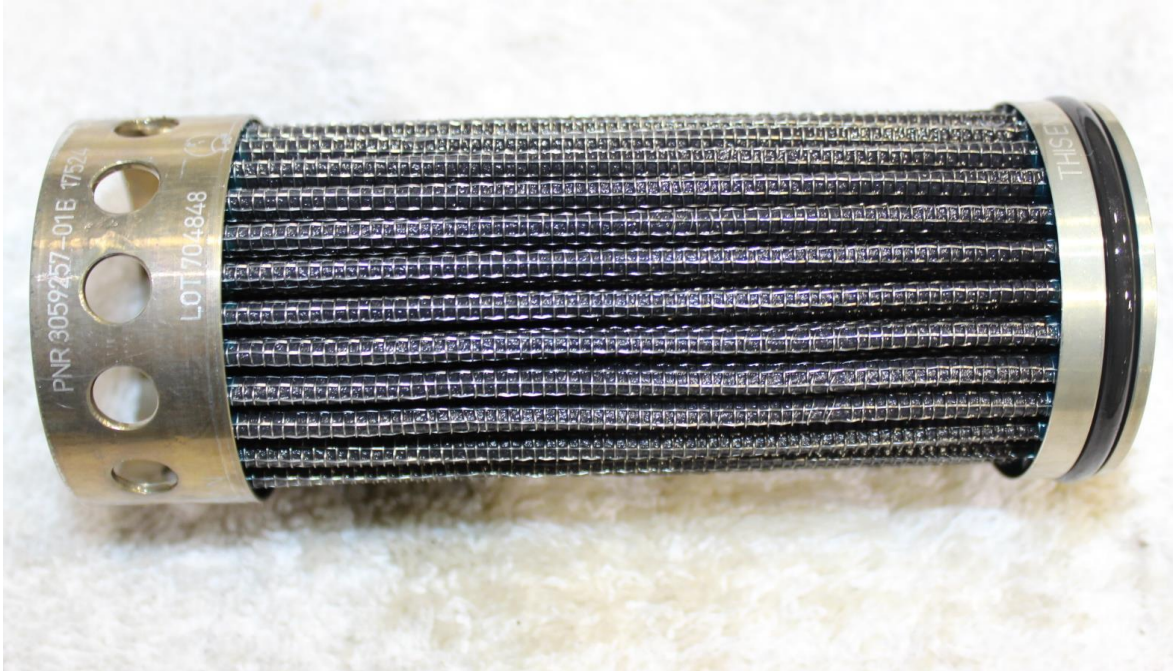
Photo No. 23

Oil Filter: No visible contamination was evident in the oil filter (Ref. Photo No. 23).

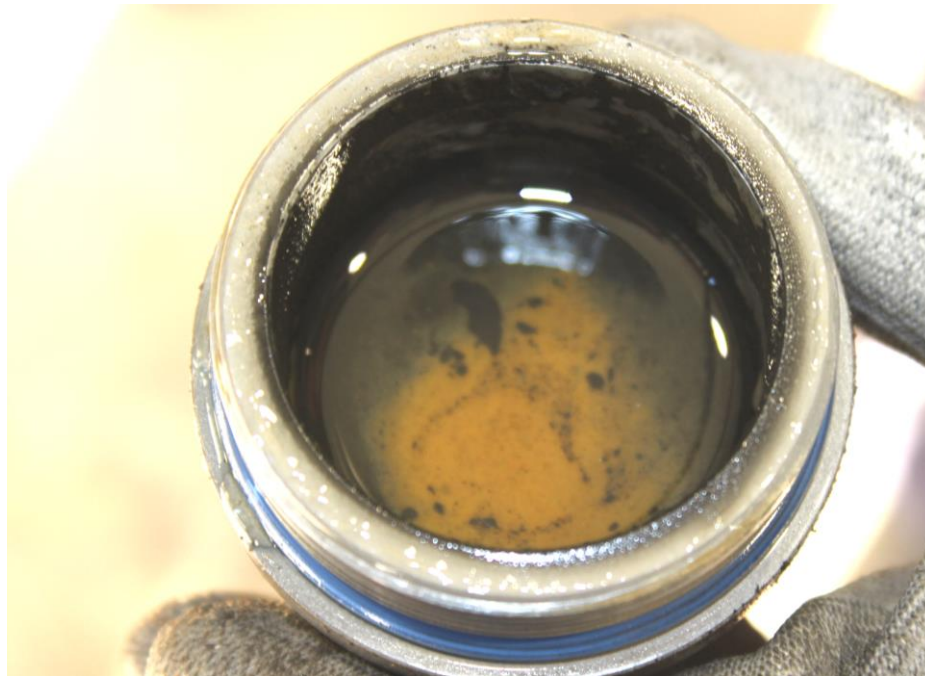
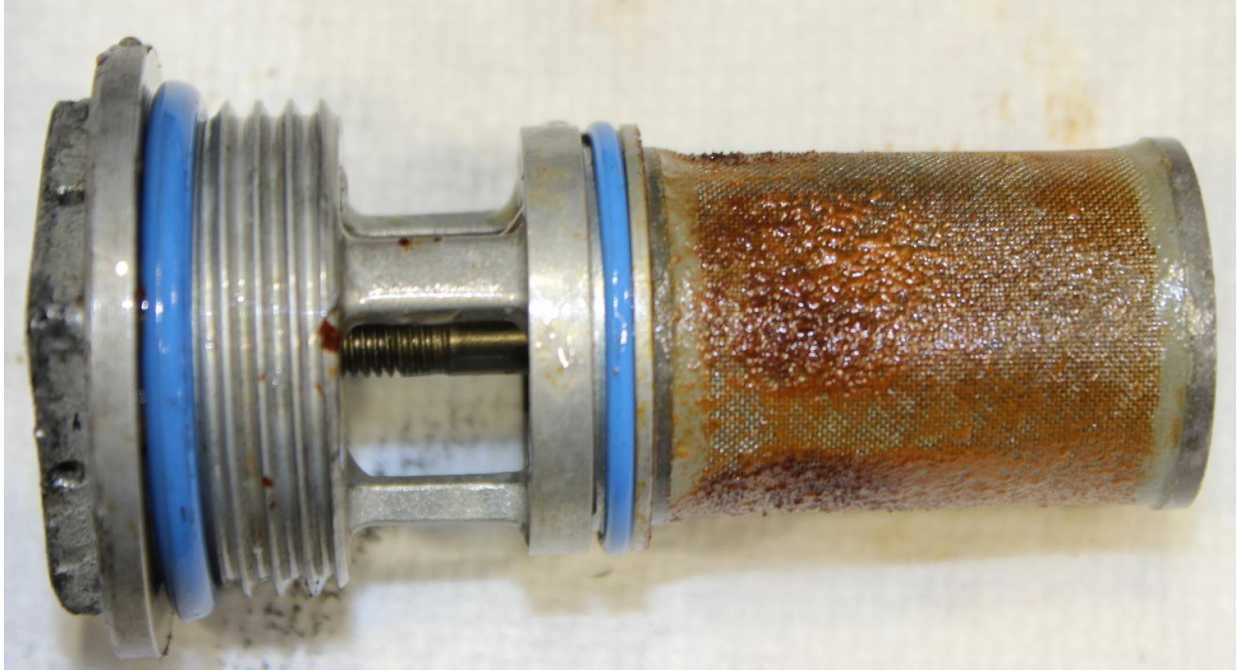
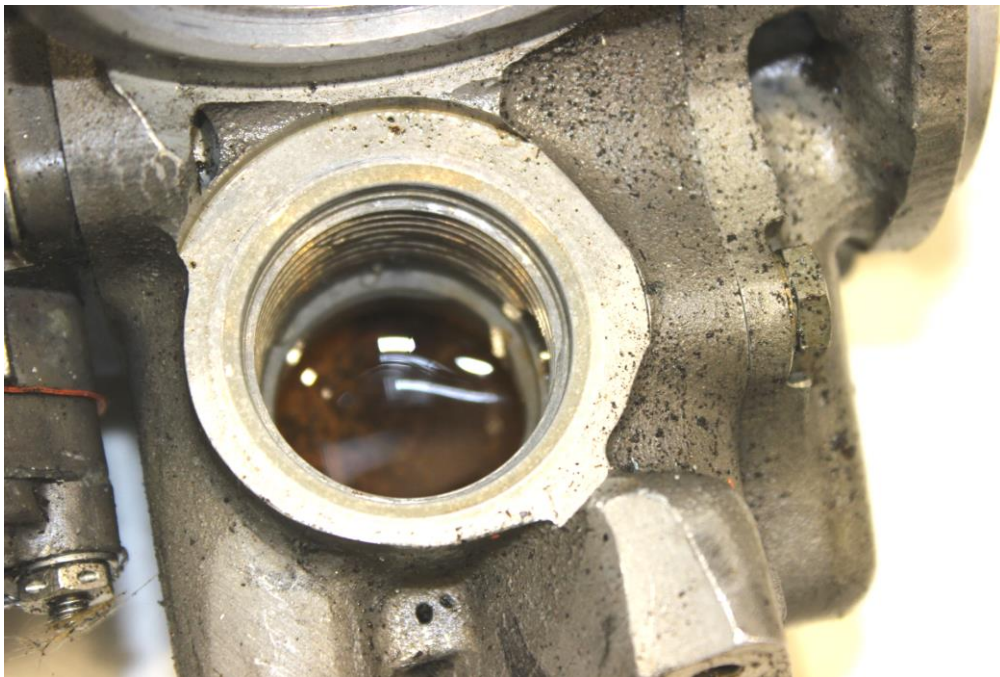
The analysis of the fluid recovered from the fuel pump showed water contamination and the discoloured/separation of fluids from all of the fuel wetted components indicates the fuel system was contaminated, most likely with water.

Fuel Filter: Outlet filter was discoloured and sediment was evident on the surface of the filter (Ref. Photo No. 24). The residual liquid in the outlet filter cover bowl was contaminated with sediment and there was a visible separation of the liquids, indicating it was most likely contaminated with water (Ref. Photo No. 25). The liquid was retained by the NTSB for analysis. The inlet filter exhibited a sediment build up on the surface (Ref. Photo No. 26). The residual liquid in the inlet filter cavity of the pump was contaminated with sediment and there was a visible separation of the liquids, indicating it was most likely contaminated with water (Ref. Photo No. 27). The liquid and filter were retained by the NTSB for analysis.

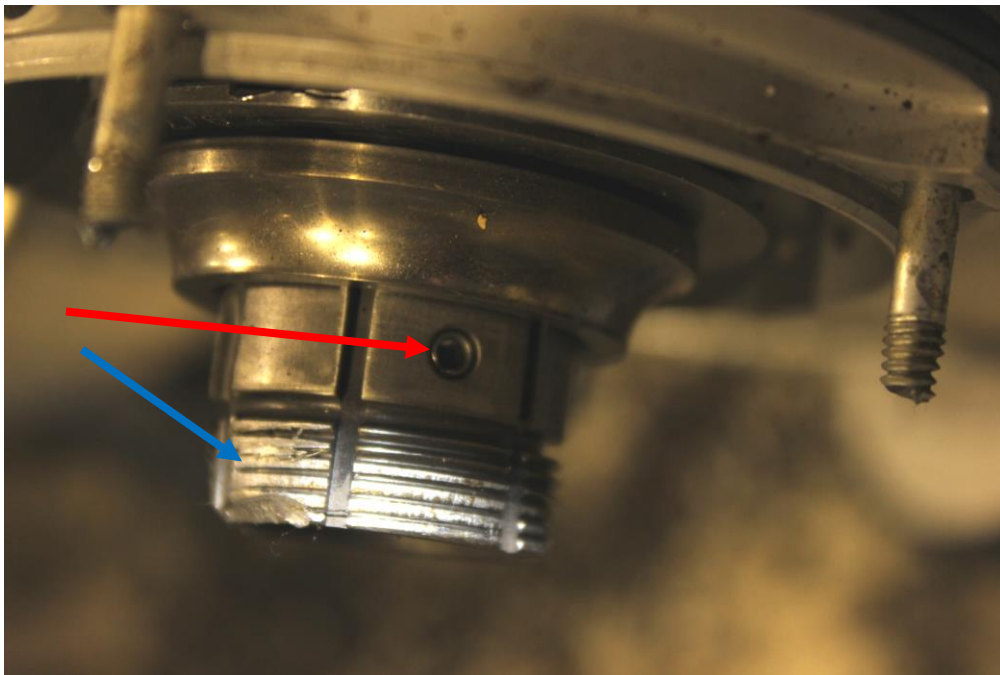
Photo No. 28

- 3.2.1 **Compressor Section:** The compressor rear hub coupling, No. 1 bearing grooved inner race, bearing cage, ball elements, and the No. 1 bearing retention nut were not recovered. Both ends of the spring pin that retains the compressor rear hub coupling into the 1st stage compressor rotor were in place (Ref. Photo No. 28, red arrow). The No. 1 bearing retention nut threads were damaged (Ref. Photo No. 28, blue arrow).

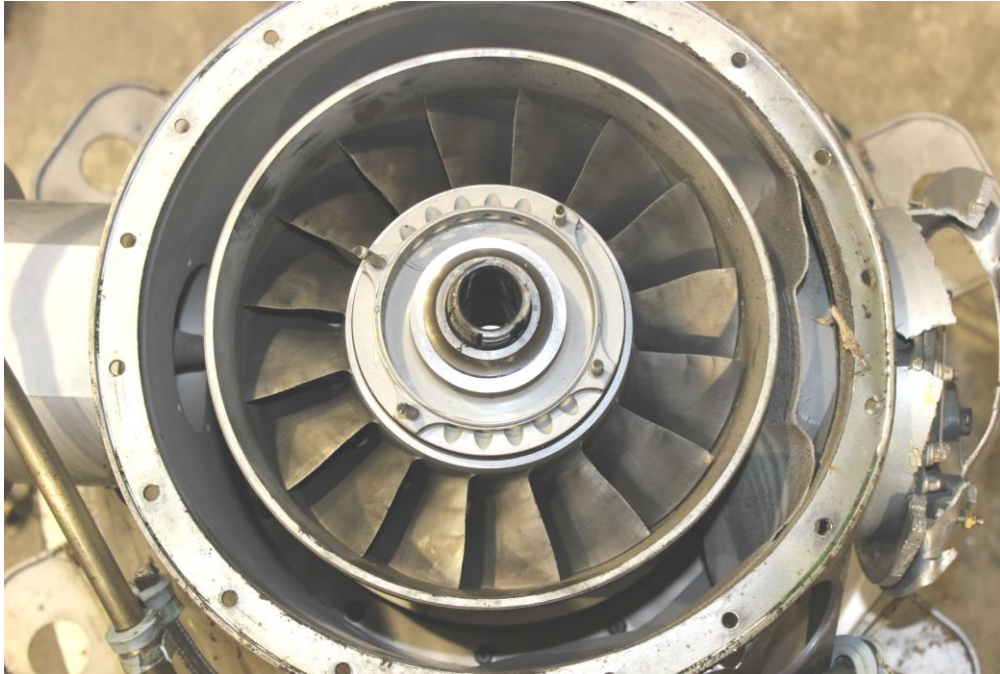
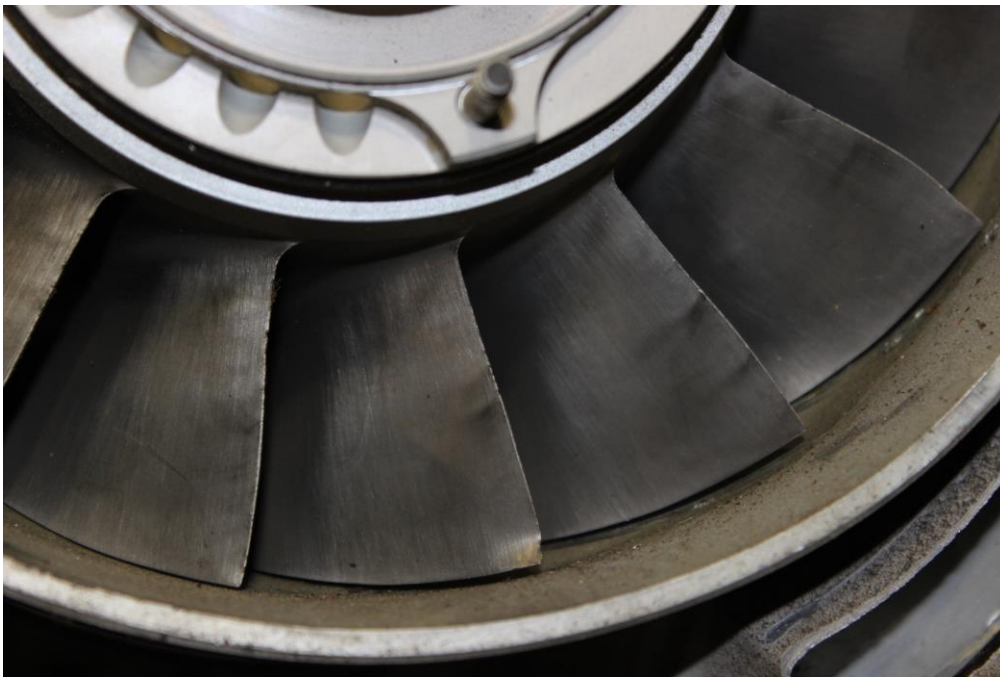
Compressor 1st, 2nd, and 3rd Stage Discs and Blades: One 1st stage blade exhibited a bent tip and one additional blade exhibited light impact damage (Ref. Photos No. 29 & 30). The compressor was not removed or disassembled to access the 2nd and 3rd stage blades for the purpose of this investigation.

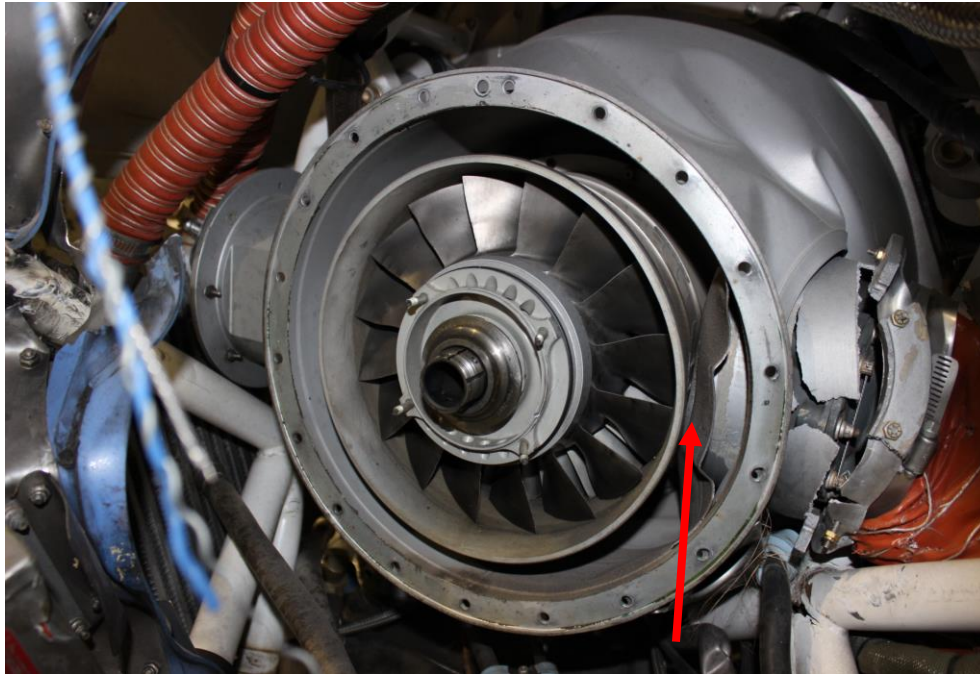
Photo No. 31

Compressor 1st, 2nd, and 3rd Stage Stators and Shrouds: The 1st stage shroud exhibited a light rub. The 1st stage stator exhibited a bent region where the right hand bleed valve and gas generator case were bent inward (Ref. Photo No. 31, red arrow). The 2nd and 3rd stage stators and shrouds were not accessed for the purpose of this investigation.

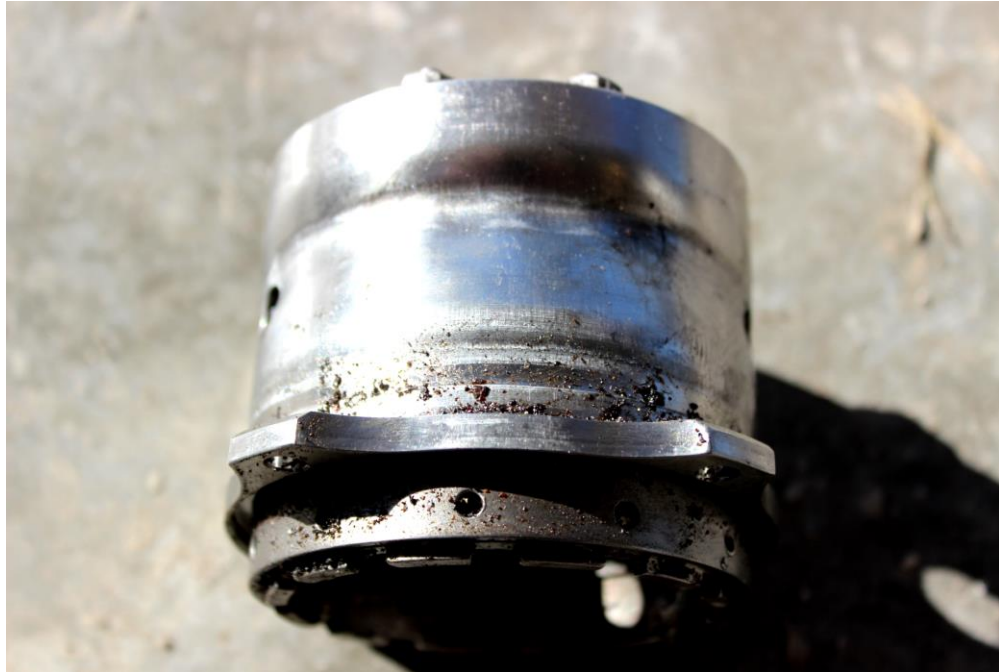
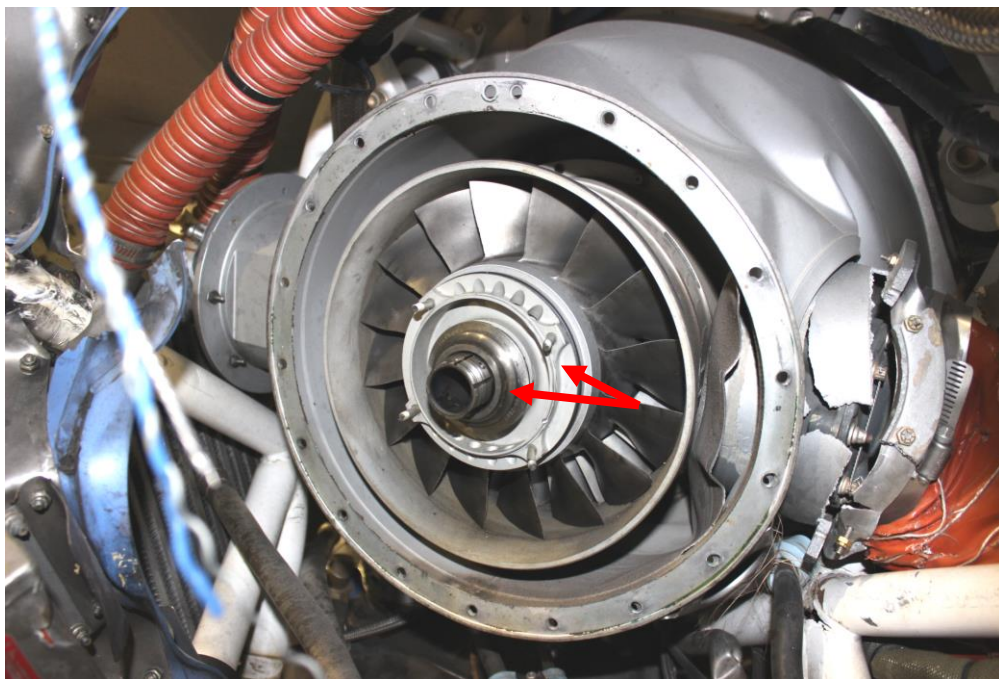
No. 1 Bearing and Airseals: The No. 1 bearing grooved inner race, cage and ball elements were not recovered. The No. 1 bearing housing was separated from the engine due to impact during the forced landing and it was distorted/bent (Ref. Photo No. 32). The outer race was in place in the bearing housing. The plain inner race and the air seals were in place but were not removed for the purpose of this investigation (Ref. Photo No. 33, red arrows).

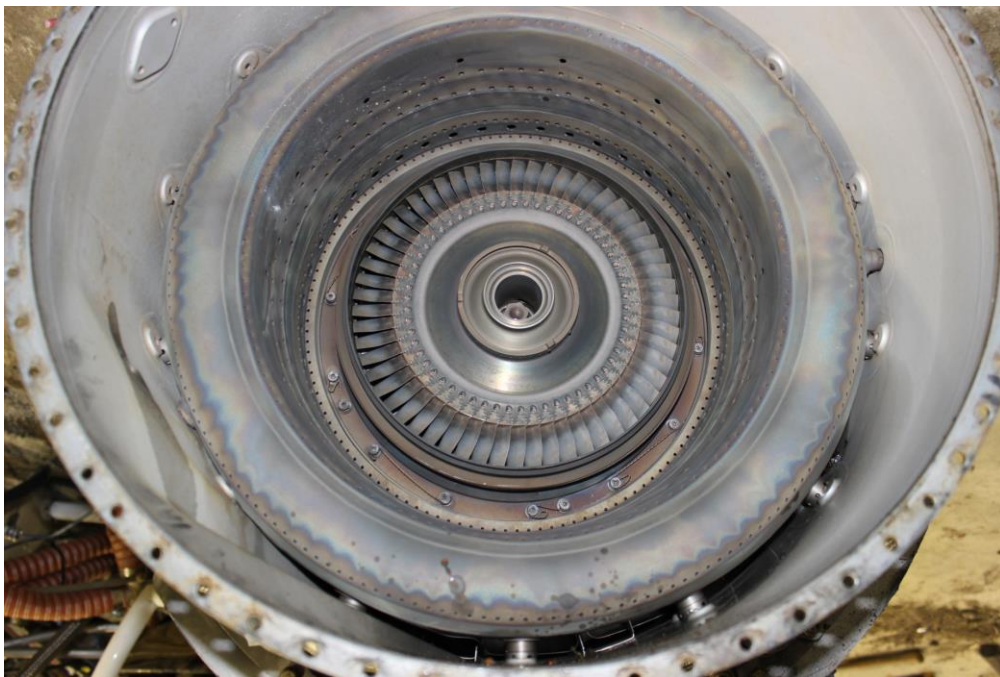
Photo No. 34

Combustion Chamber Liner: The visible portion of the liner exhibited operational discoloration (Ref. Photo No. 34). The liner was not removed for the purpose of this investigation.

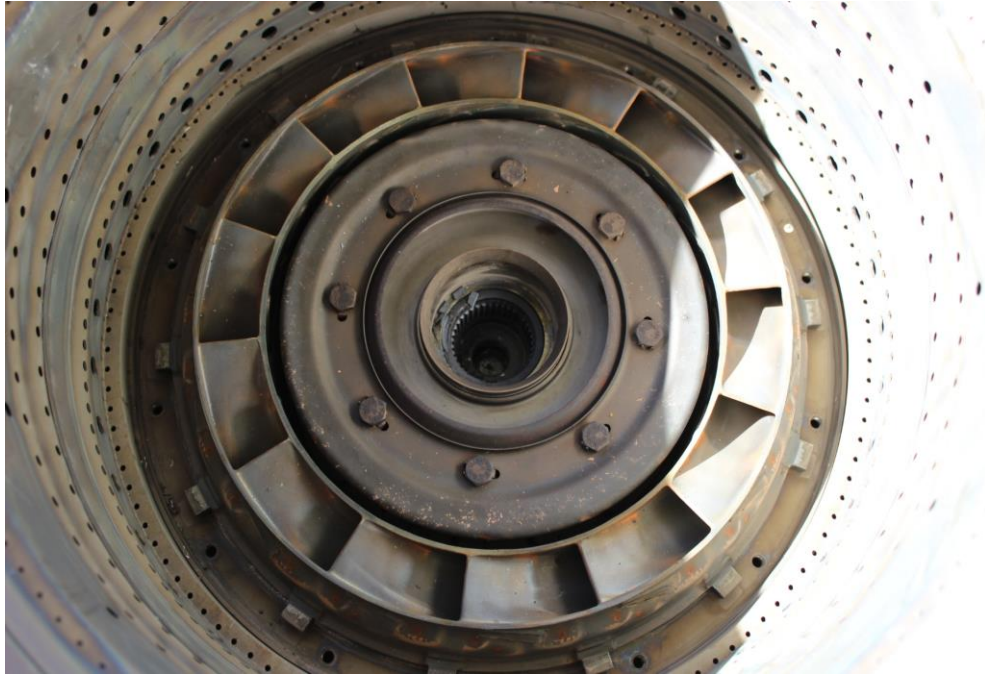
Photo No. 35

Compressor Turbine Guide Vane Ring: The visible section of the vane was unremarkable except for some operational stains (Ref. Photo No. 35). The vane was not removed.

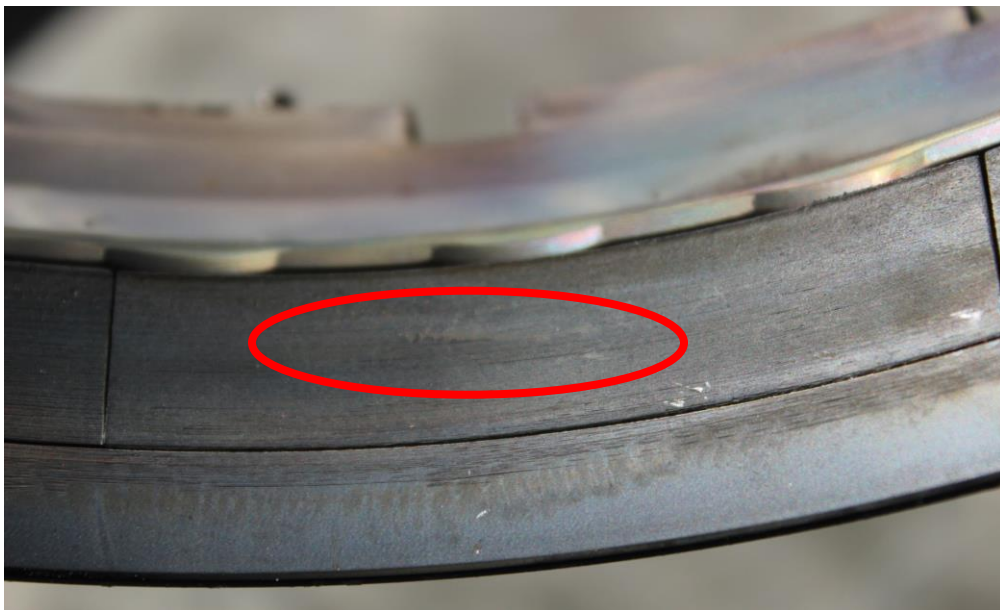
Photo No. 36

Light rotational scoring on the 1st stage compressor shroud and compressor turbine shroud indicates the compressor was rotating during the landing. The rotational scoring on the downstream side of the 1st stage power turbine baffle and vane, the 1st stage turbine shroud and the 2nd stage power turbine shroud indicates rotation during the landing/impact.

Compressor Turbine Shroud: The shroud exhibited some circumferential rubs from contact with the compressor turbine blades (Ref. Photo No. 36, red oval).

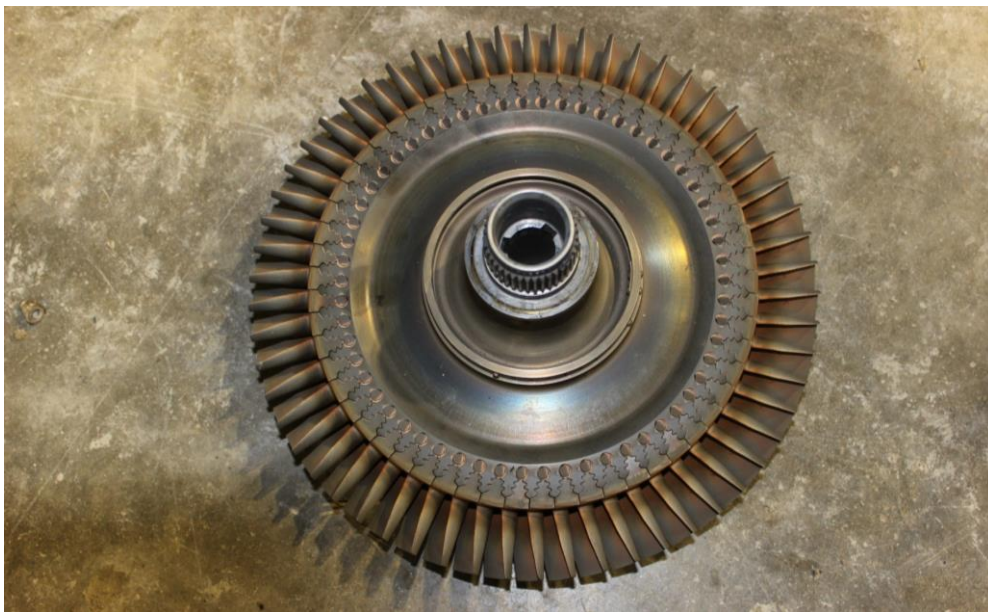
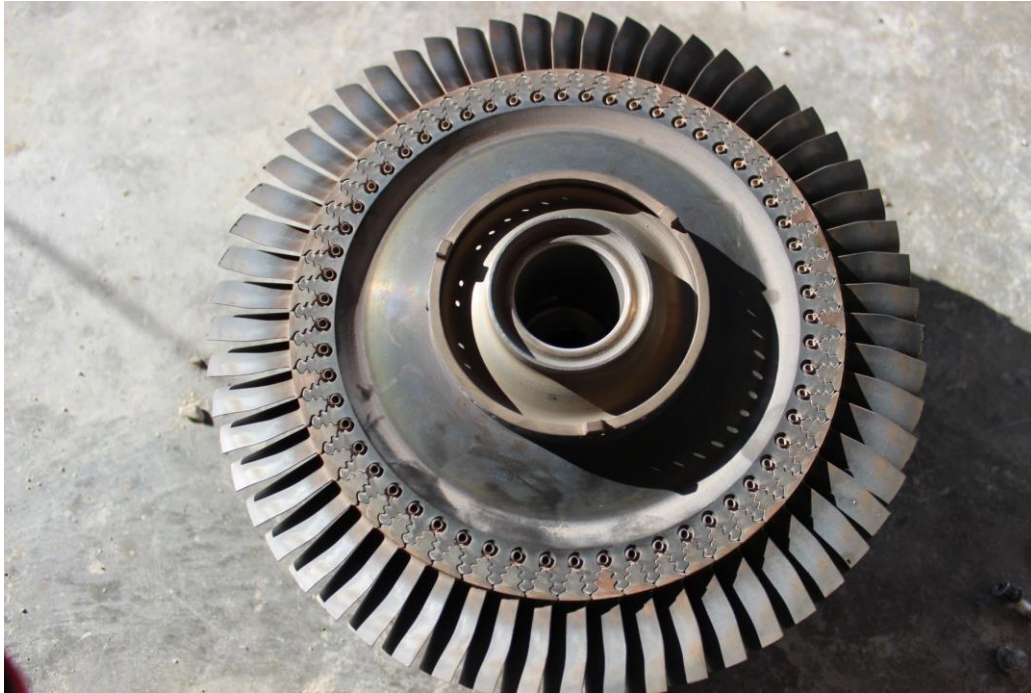
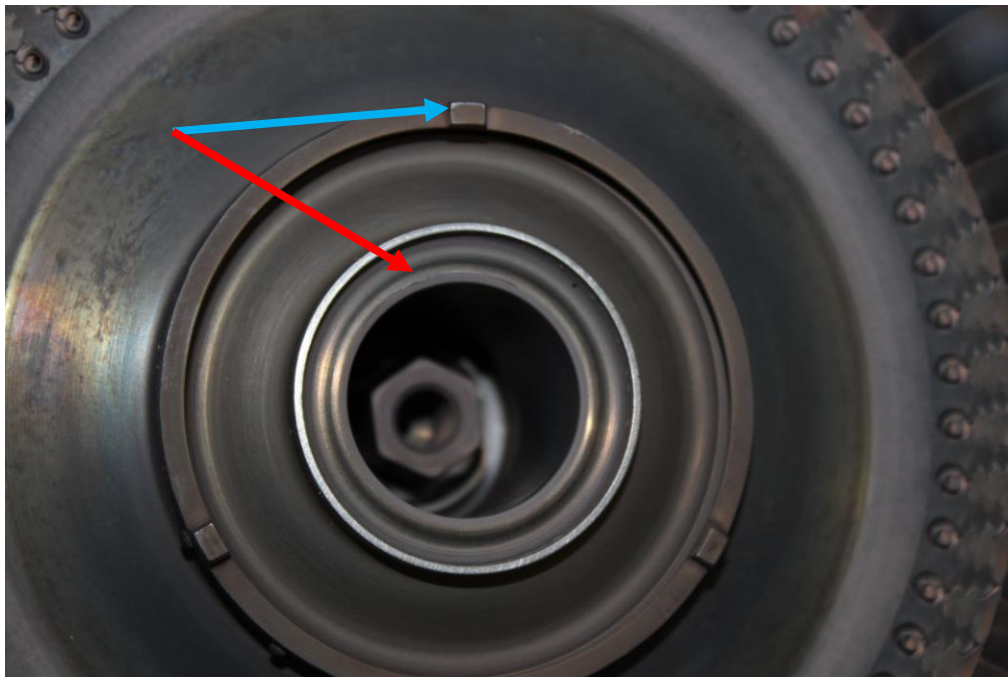
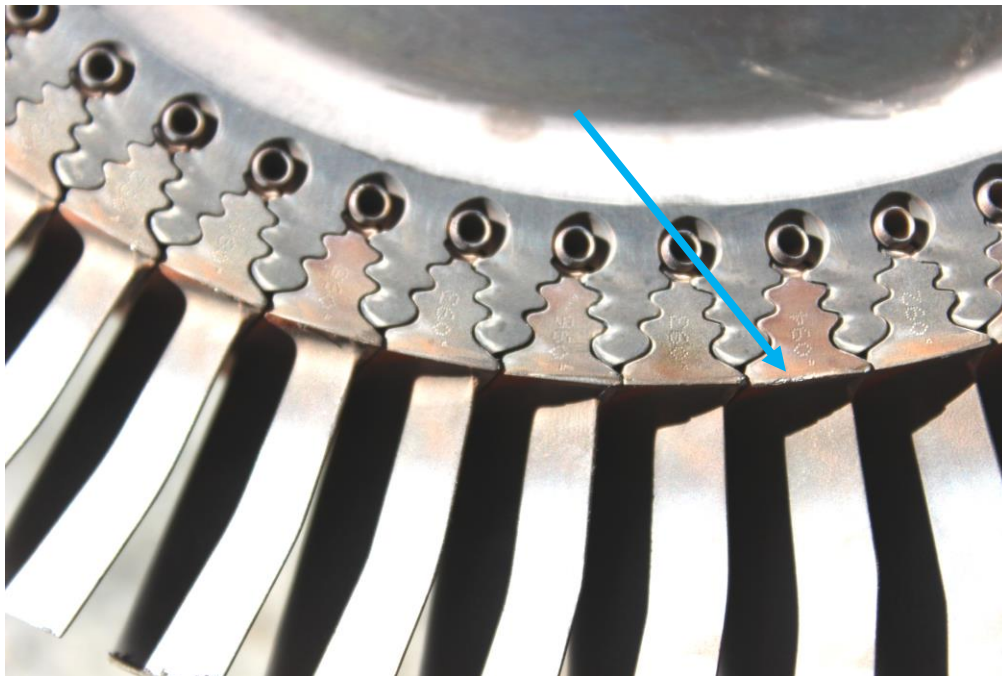
Compressor Turbine: The upstream side of the turbine and blades exhibited operational stains (Ref. Photos No. 37 & 38). The area adjacent to the retention bolt bore on the downstream side was polished from contact with the 1st stage power turbine baffle (Ref. Photos No. 39 & 40, red arrow). One of the tooling lugs was polished and several blade platforms exhibit mechanical damage (Ref. Photos No. 40, blue arrow & No. 41, blue arrow). The polished lip, polished lug and the blade platform damage were most likely from the compression of the gas generator case and rotor displacement from the loss of inlet case/No. 1 bearing support.
