Service Investigation
Accident / Incident Report

Report No.:16-157

**Aero Smart Solutions Inc.
Lancair Evolution & Registration No. N38DM
Allen County, Kansas
October 1st 2016
PT6A-42
S/N 93158**

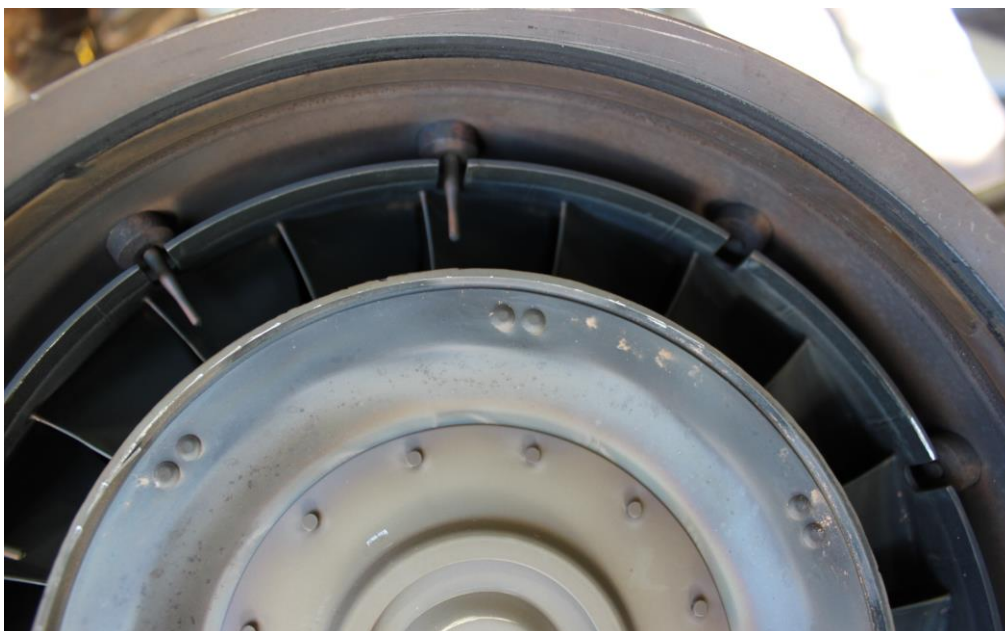
Photo No. 42

ITT Probes, Busbar, and Harness: The probes, busbar, and harness were visually unremarkable (Ref. Photo No. 42).

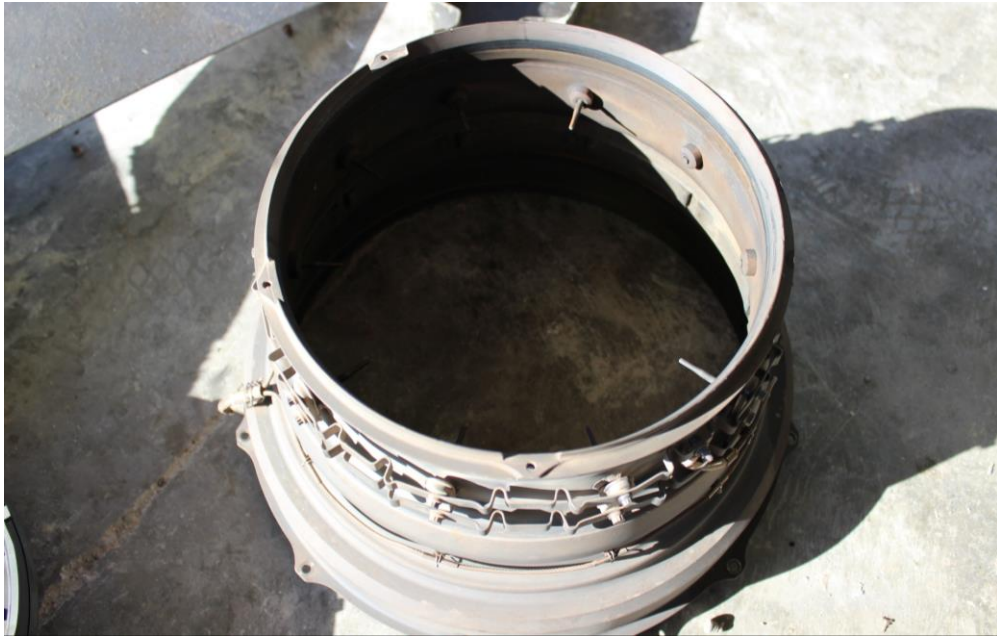
Photo No. 43

Power Turbine Housing: No visible distress was noted on the housing (Ref. Photo No. 43).

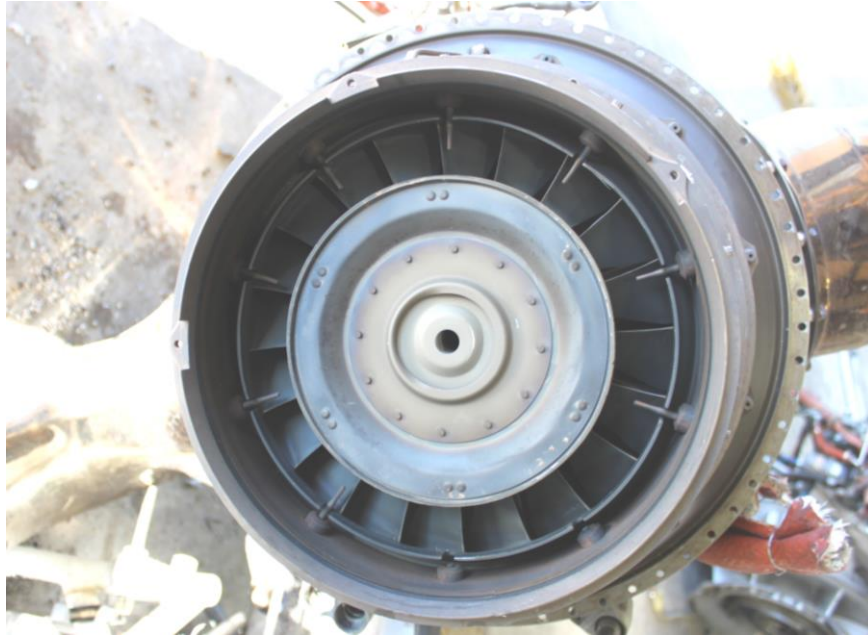
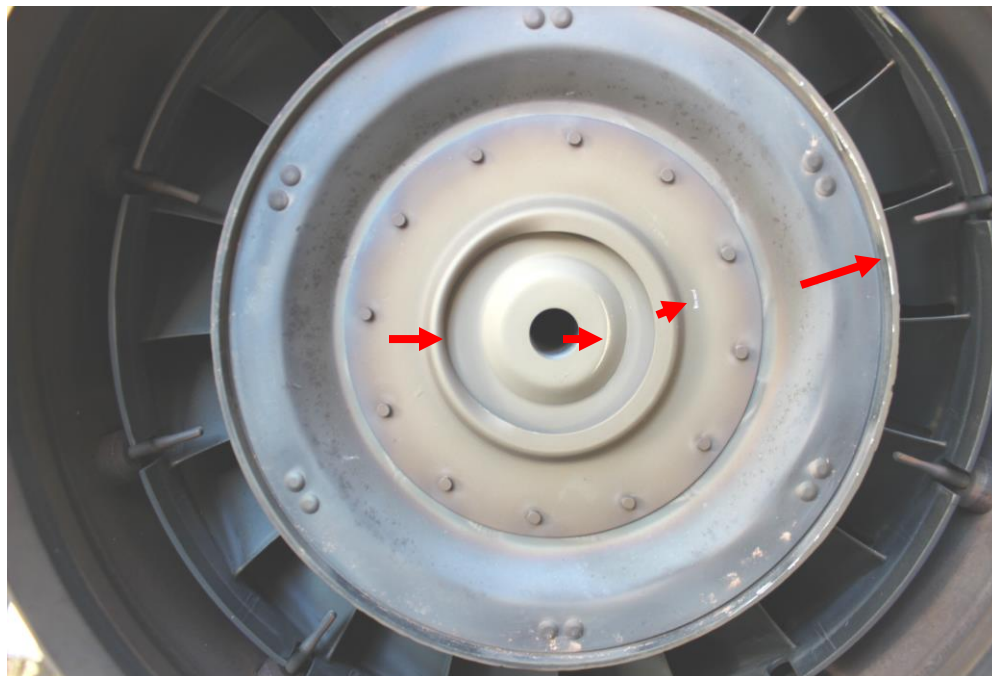
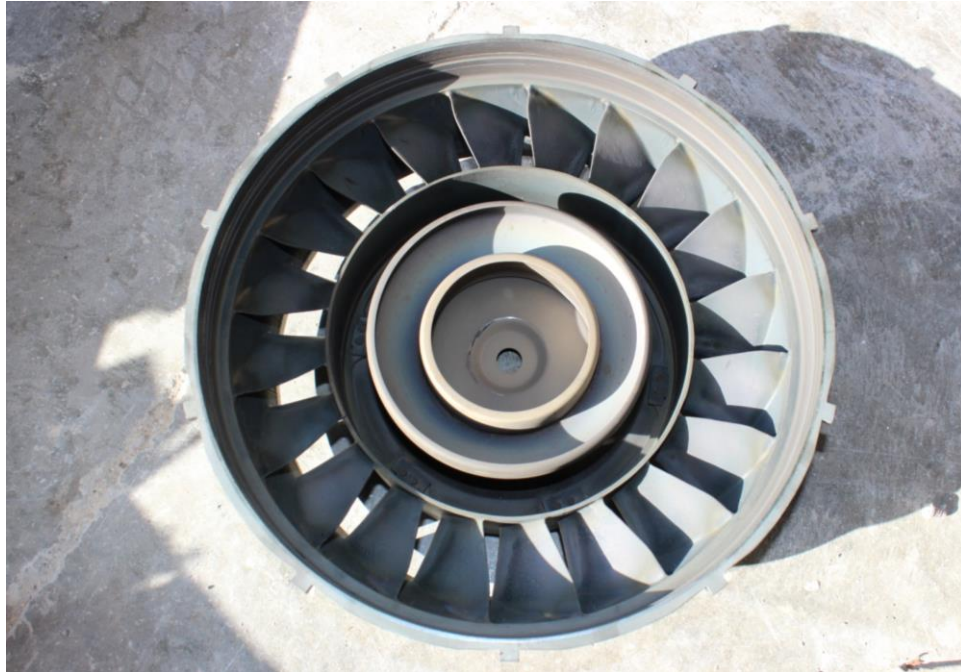
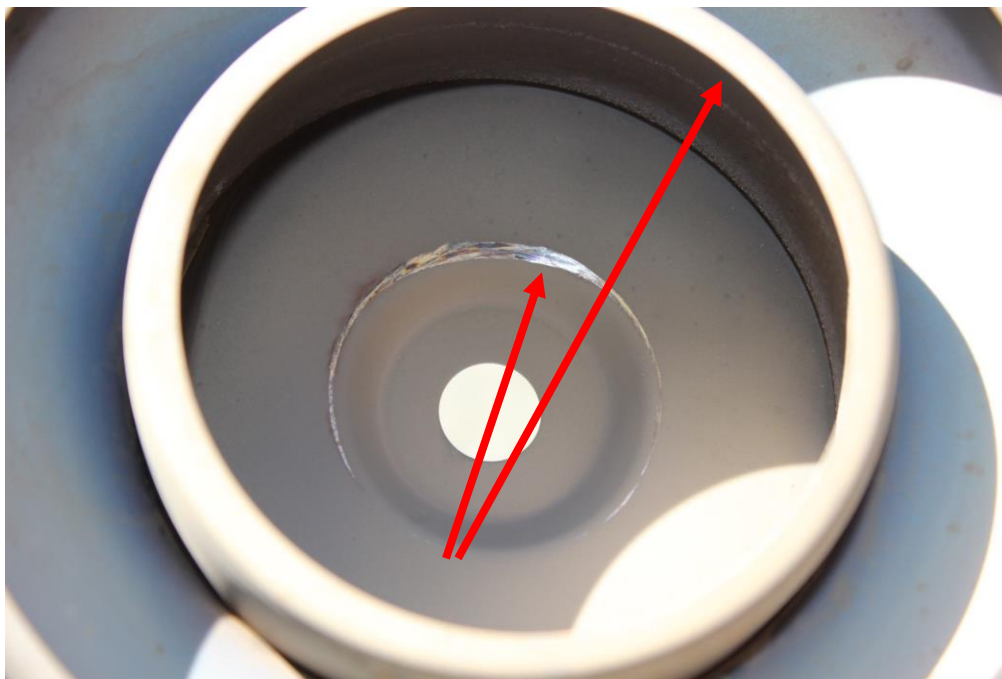
1st Stage Power Turbine Guide Vane Ring and Interstage Baffle: The compressor turbine had contacted the upstream side of the baffle, the centre area was polished, a section of the baffle lip was bent, an imprint from a tooling lug, and displaced material on the inner rim of the vane (Ref. Photo No. 44 & 45, red arrows). The downstream side exhibited circumferential rub on the centre from contact with the turbine retention nut and the lip of the baffle from contact with the 1st stage disc (Ref. Photos No. 46 & 47, red arrows). The inner rim of the vane exhibited an operational crack.

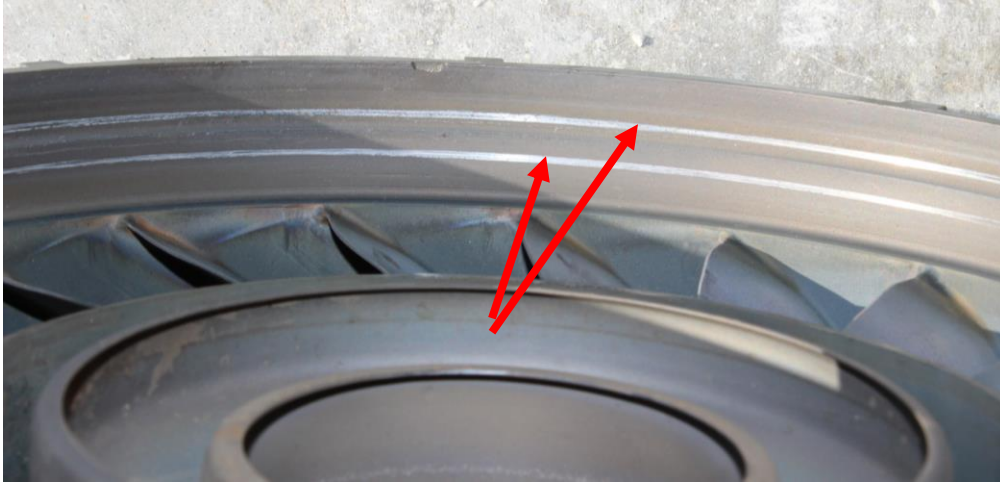
Photo No. 48

Light rotational scoring on the 1st stage compressor shroud and compressor turbine shroud indicates the compressor was rotating during the landing. The rotational scoring on the downstream side of the 1st stage power turbine baffle and vane, the 1st stage turbine shroud and the 2nd stage power turbine shroud indicates rotation during the landing/impact.

1st Stage Power Turbine Shroud: The shroud exhibited a rub from both knife edges of the 1st stage power turbine blade tips (Ref. Photo No. 48, red arrows). The surface of the shroud also exhibited some blisters and missing material on the shroud restoration coating that was applied during a previous shop visit (Ref. Photo No. 49).

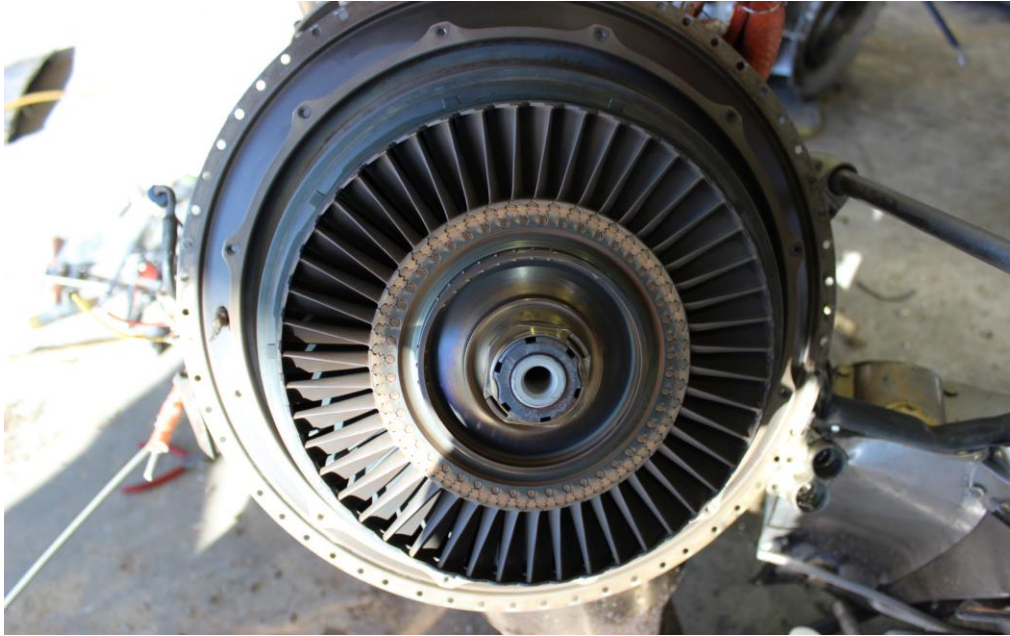
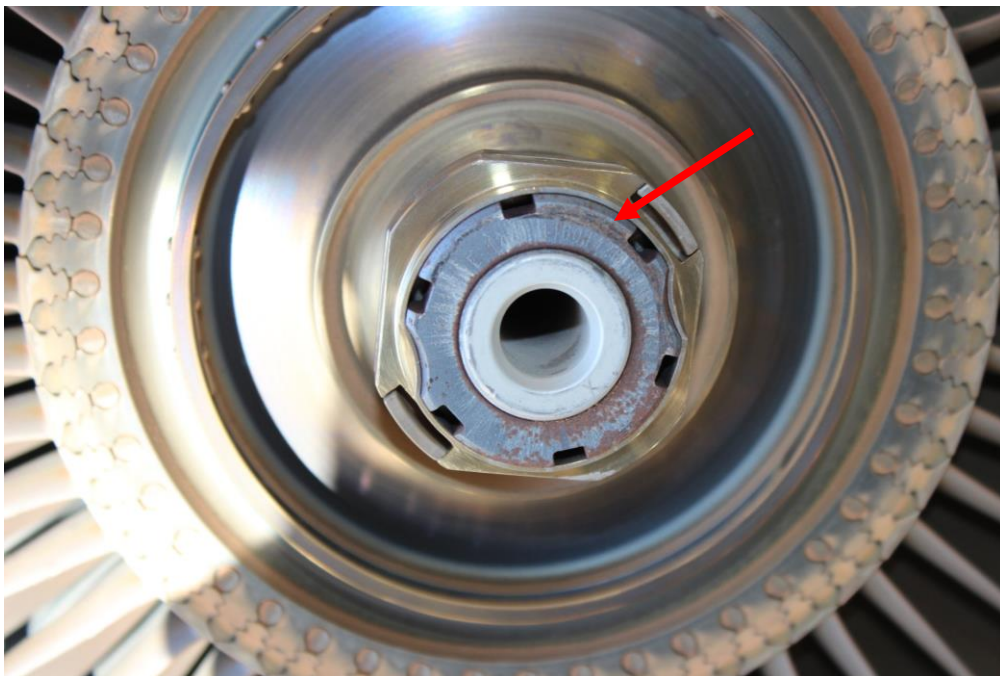
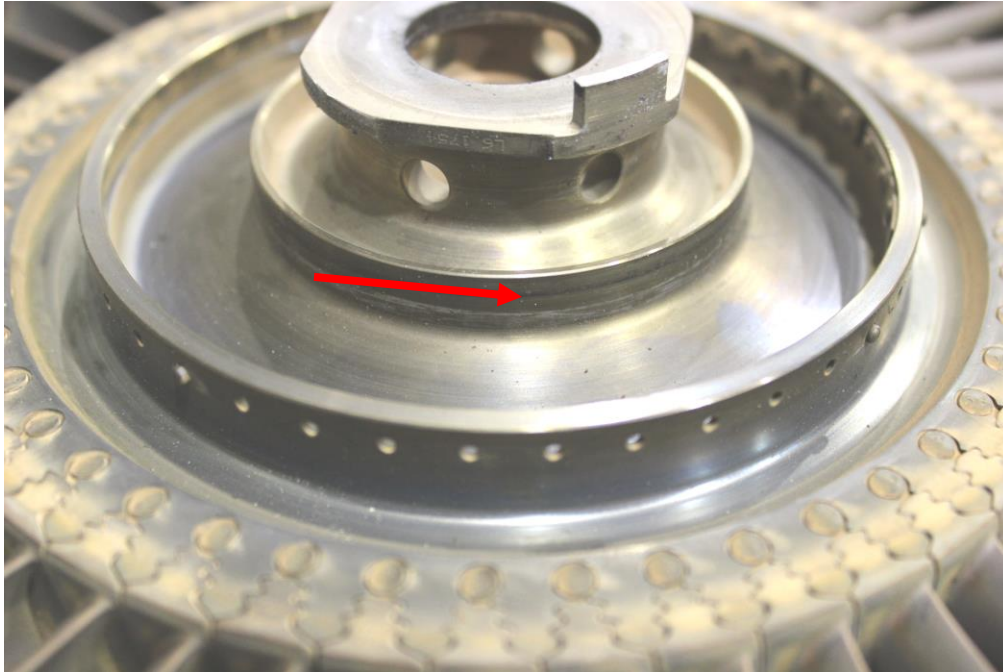
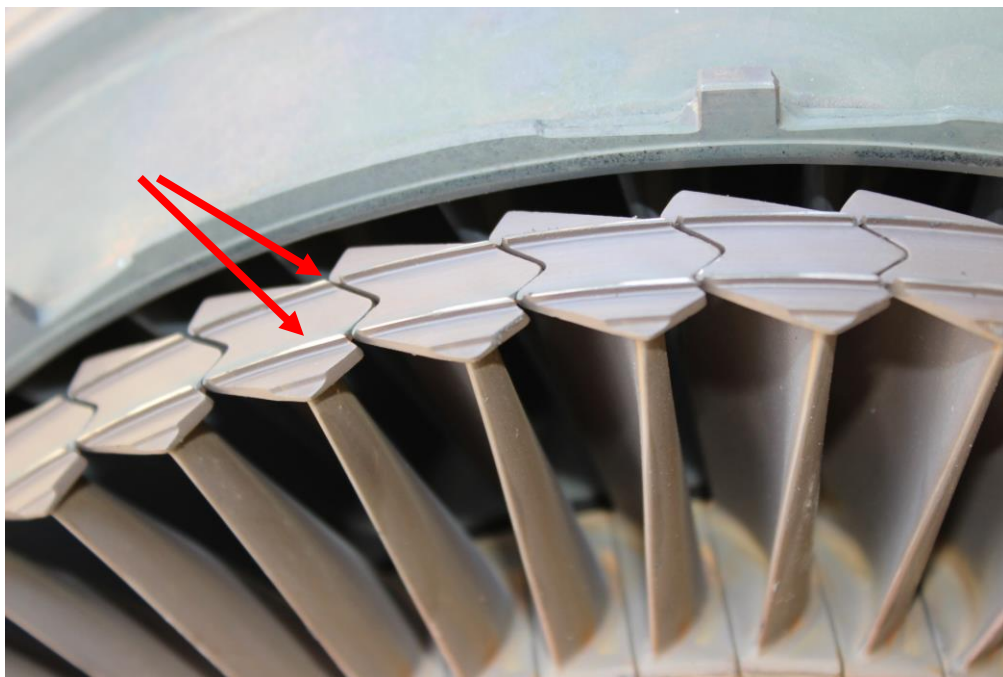
1st Stage Power Turbine: The turbine retention nut exhibited circumferential rubs from contact with the downstream side of the 1st stage baffle (Ref. Photos No. 50 & 51, red arrow). The disc exhibited a circumferential rub from contact with the lip of the baffle (Ref. Photo No. 52, red arrow). The tips of the blades had rubbed against their respective shroud (Ref. Photo No. 53, red arrows). The 1st & 2nd stage power turbines were not separated for the purpose of this investigation.

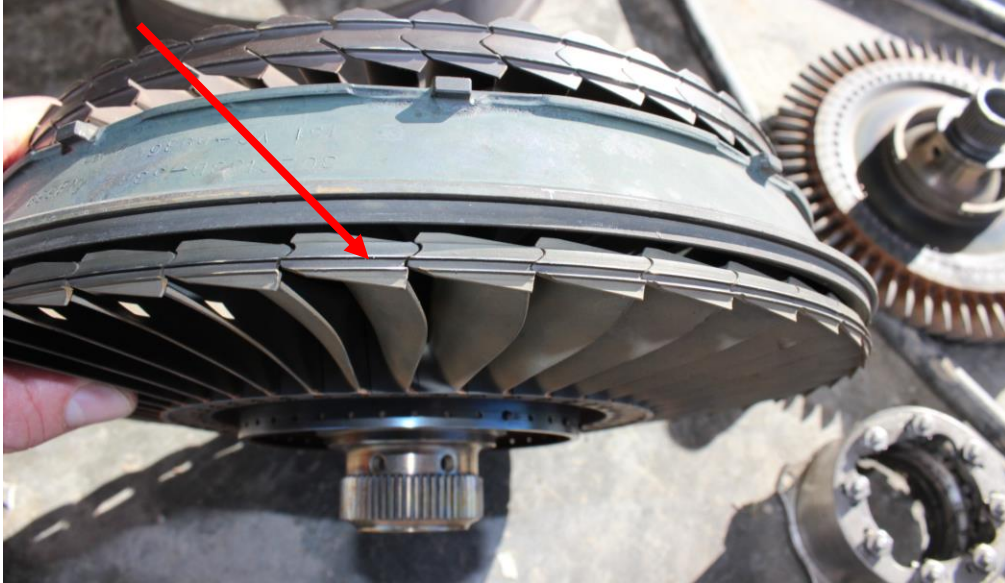
Photo No. 56

2nd Stage Power Turbine: The downstream side of the disc was unremarkable (Ref. Photo No. 55). The blade tips had rubbed with their respective shroud (Ref. Photo 56, red arrow).

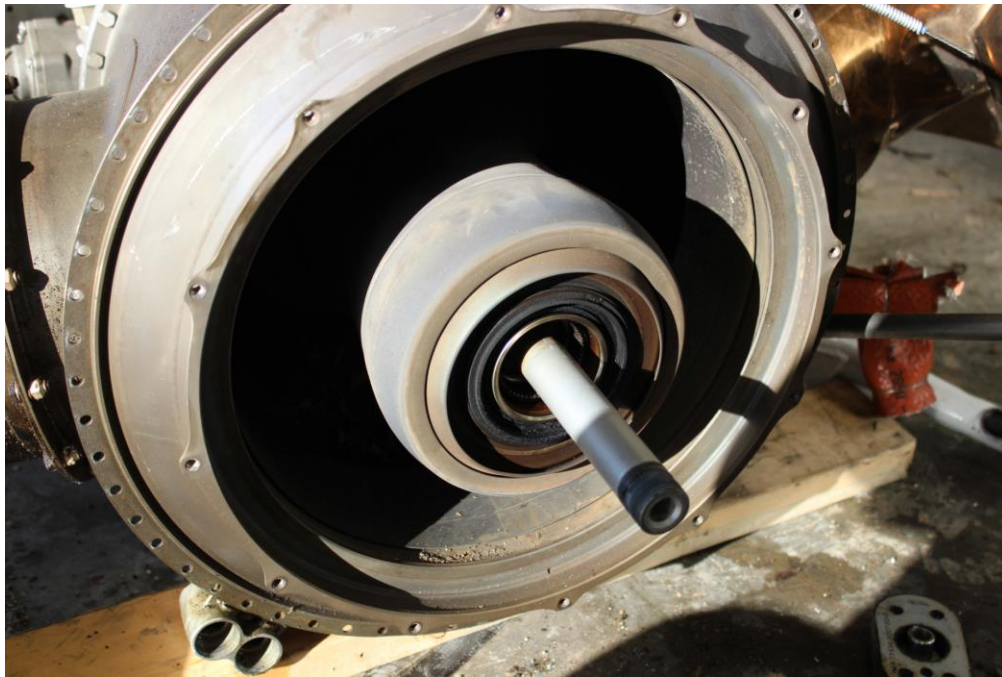
Photo No. 57

Power Turbine Shaft and Shaft Housing: A section of the shaft was visible after the power turbines were removed and was found unremarkable (Ref. Photo No. 57). The housing and the shaft were not accessed for the purpose of this investigation.

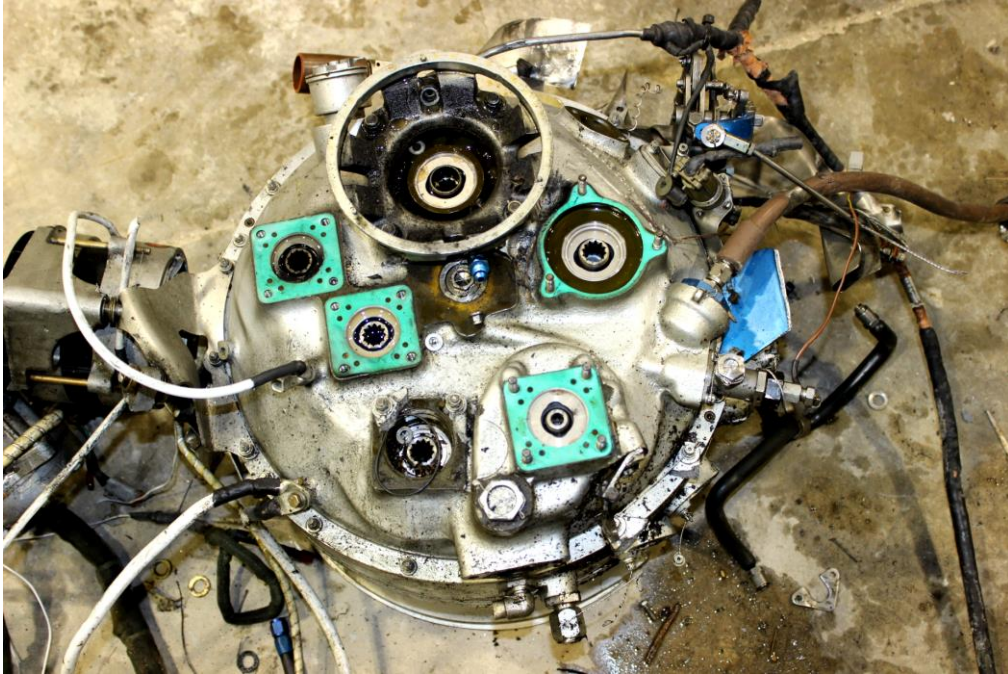
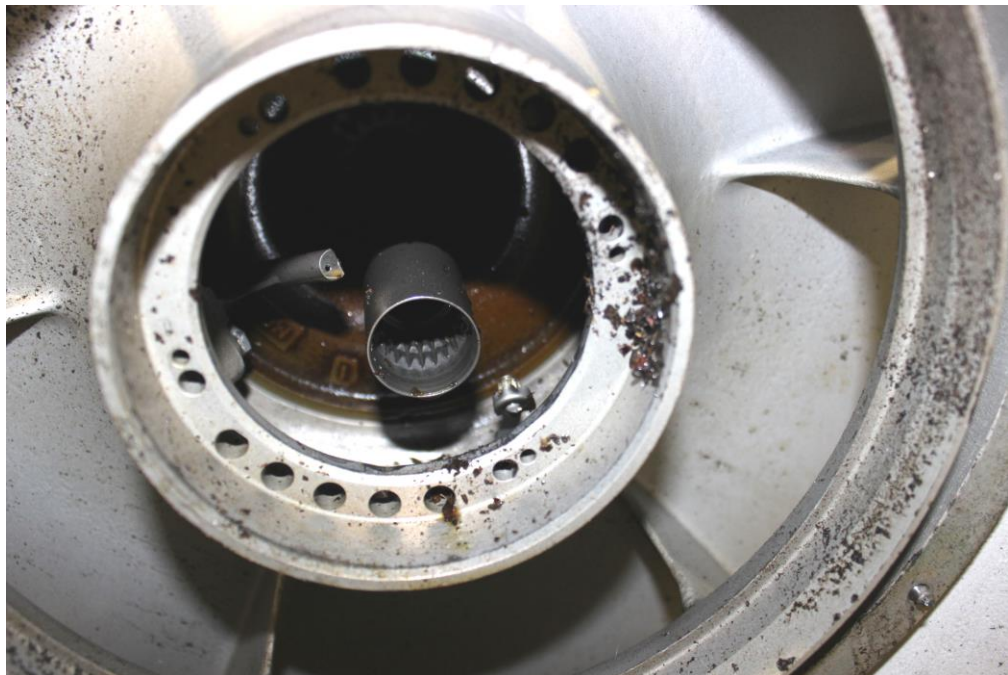
3.2.5 **Accessory Gearbox:** The external accessories were removed and the gearbox gear train was capable of rotation but an audible noise was evident (Ref. Photos No. 58 & 59).

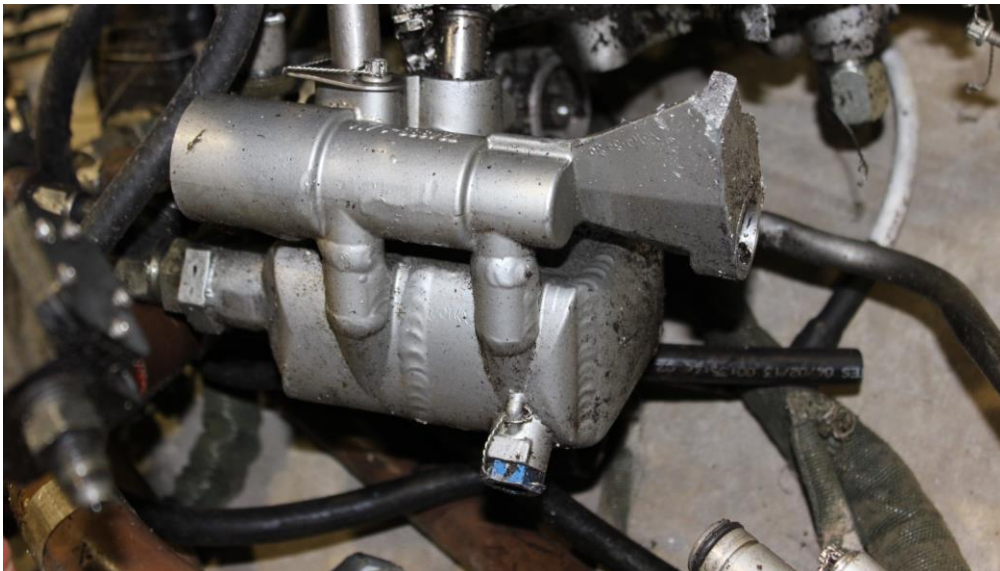
Photo No. 63

Fuel Heater: The heater mounting bracket was fractured (Ref. Photo No. 63).

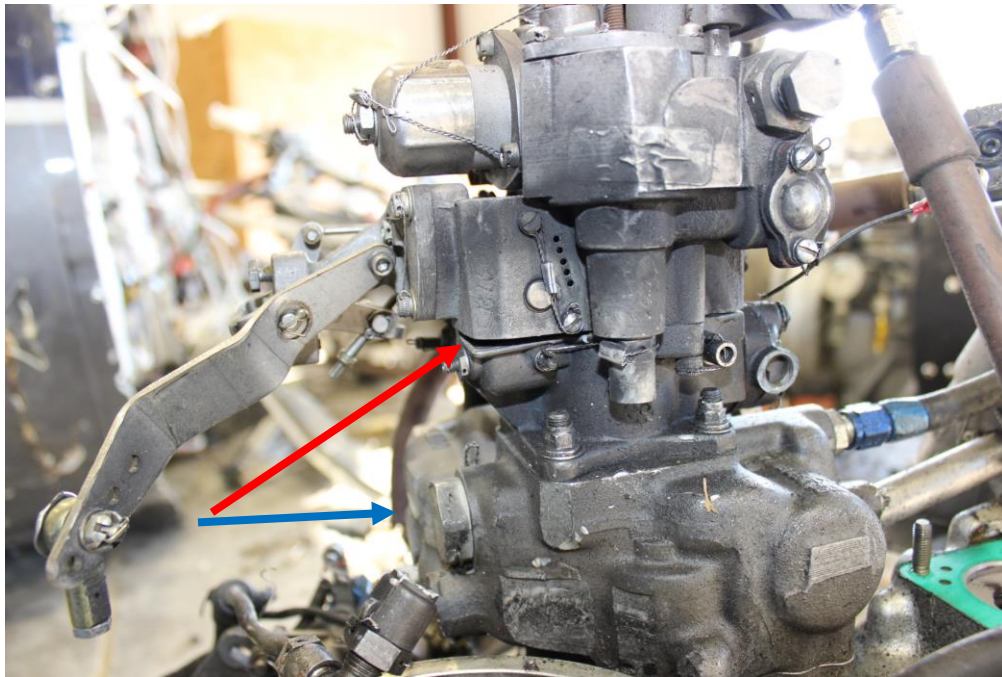
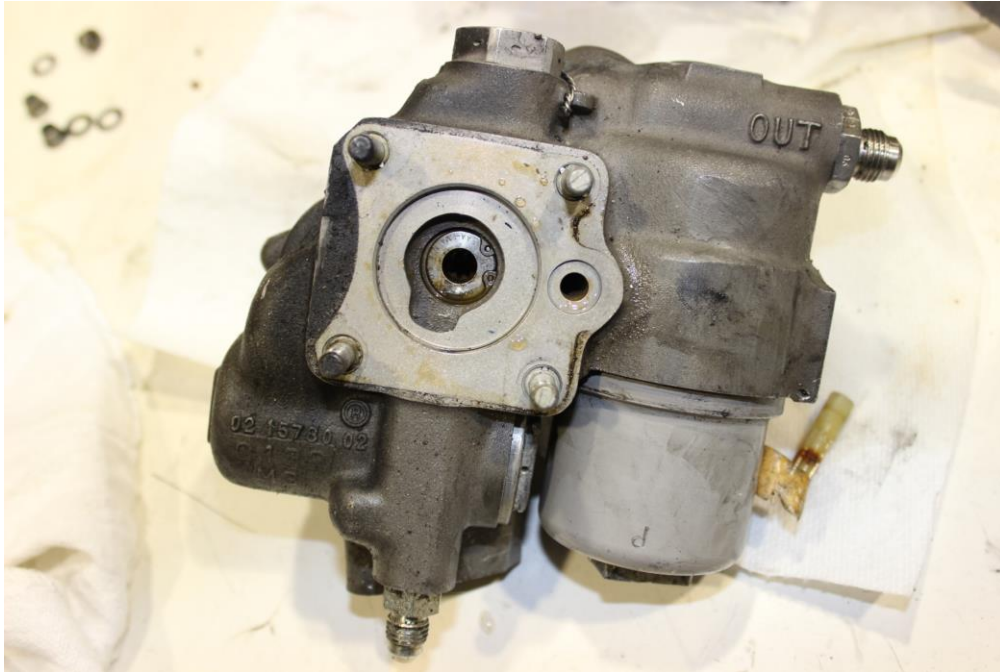
Fuel Pump: The pump was in place and secure (Ref. Photo No. 64, blue arrow). The inlet filter and the outlet filter bowl were reinstalled and the pump was forwarded to P&WC's Accessories Investigation for additional testing and analysis (Ref. Photo No. 65).

A visual examination found a dark residue was present in the outlet filter bowl and some residual brown liquid was still in the inlet filter cavity. The liquid was collected for testing. The Chemical analysis of the liquid recovered from the inlet filter cavity identified the presence of water with traces of sulphur, sodium, calcium, and potassium in the presence of oxygen and carbon. Iron oxide was also detected.

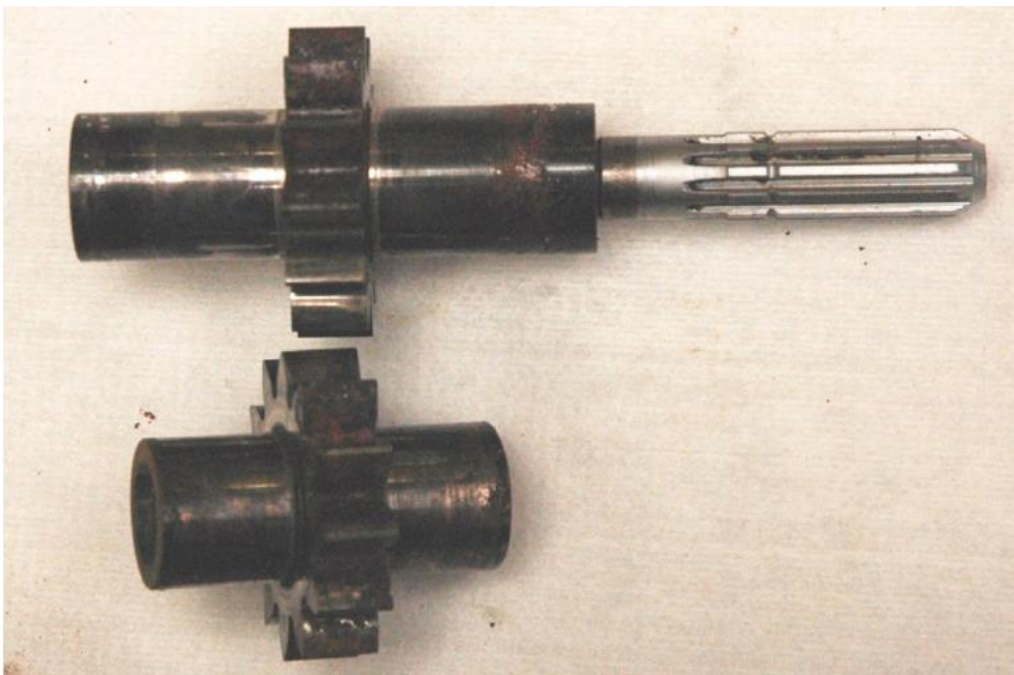
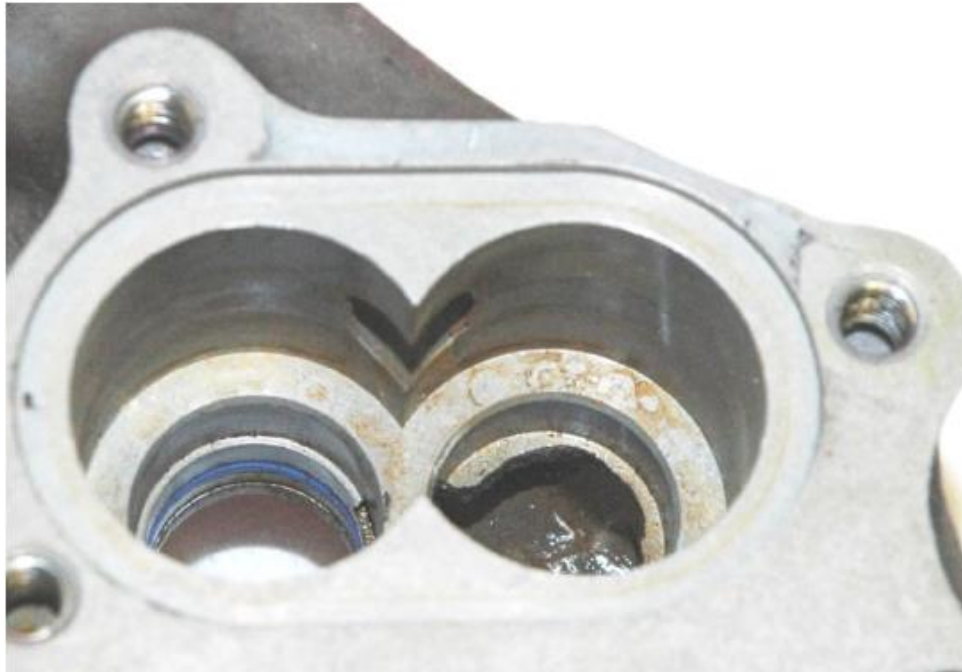
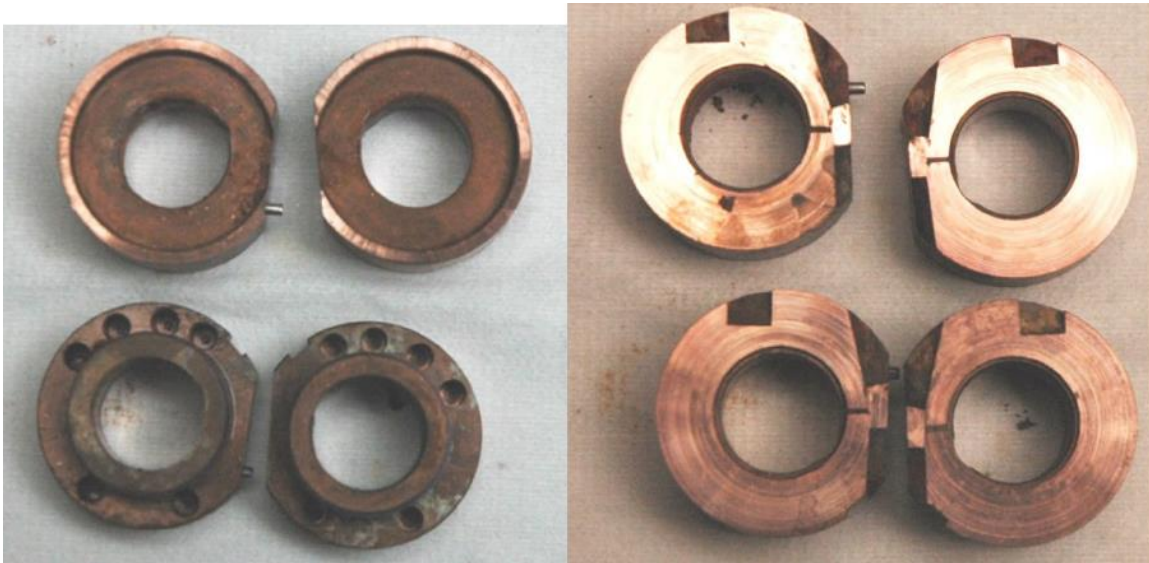
The pump was flushed, a clean inlet and outlet filter were installed. The pump was submitted for testing per the manufactures overhaul manual and the test was satisfactory. The pump was disassembled for examination. Corrosion was present on the steel components including the gears (Ref. Photo No. 66). Rust deposits were apparent on the bearings. There was no visible cavitation in the gear pockets, bearings or on the gear teeth (Ref. Photos No. 67 & 68). The corrosion deposit on the gears was not smeared, suggesting that it had formed while the pump was not turning.

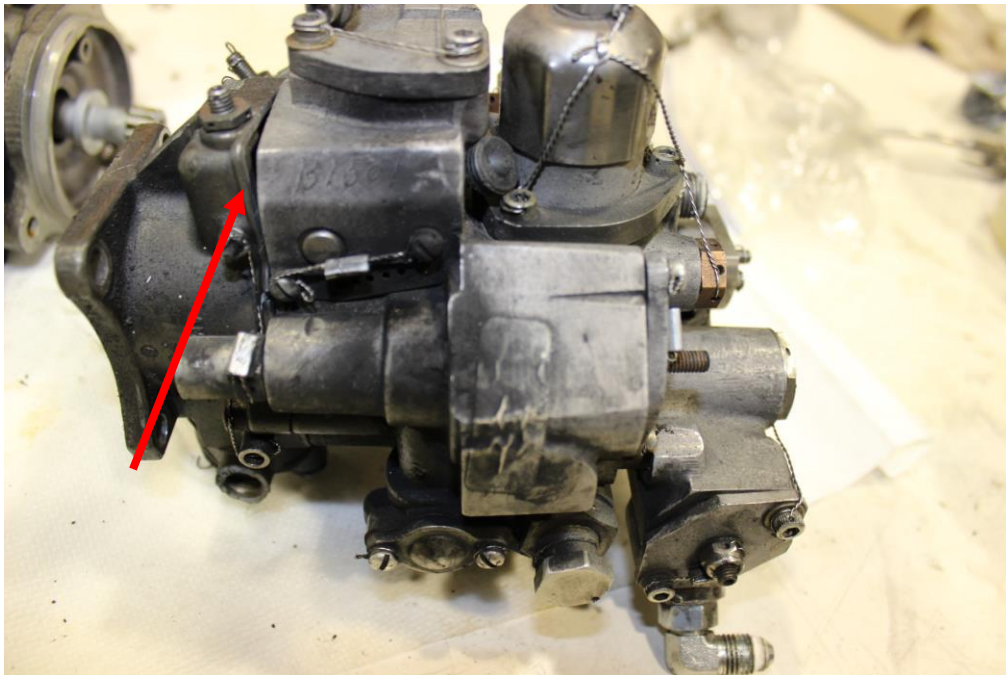
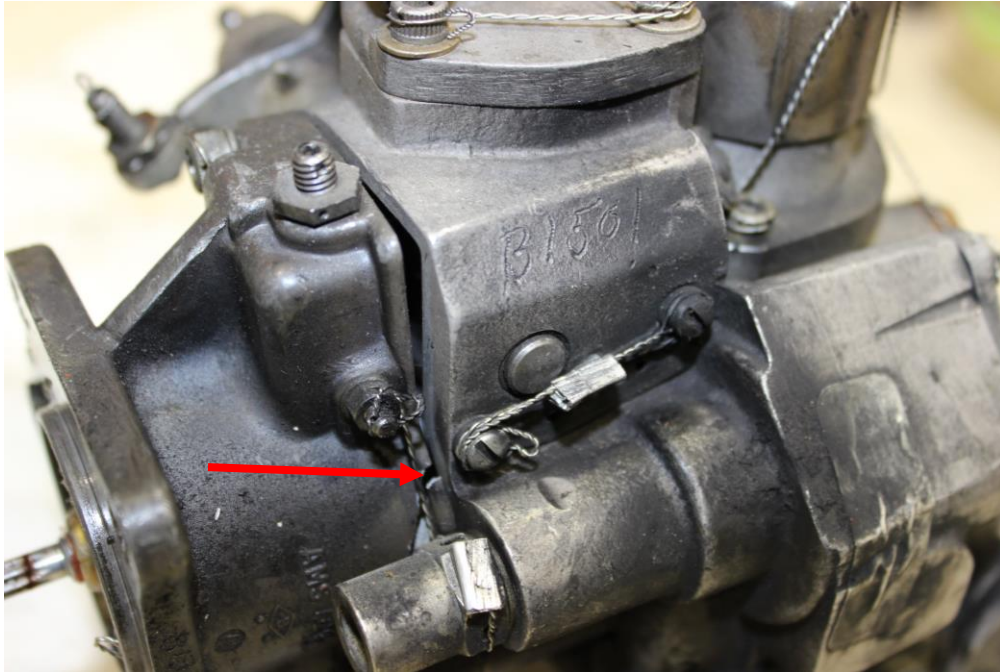
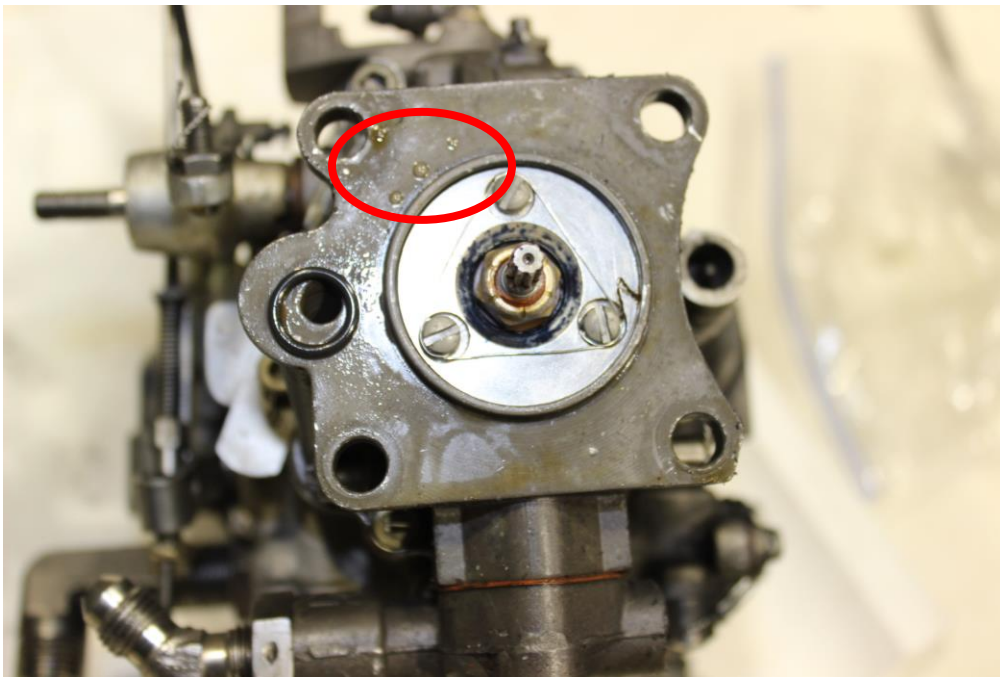
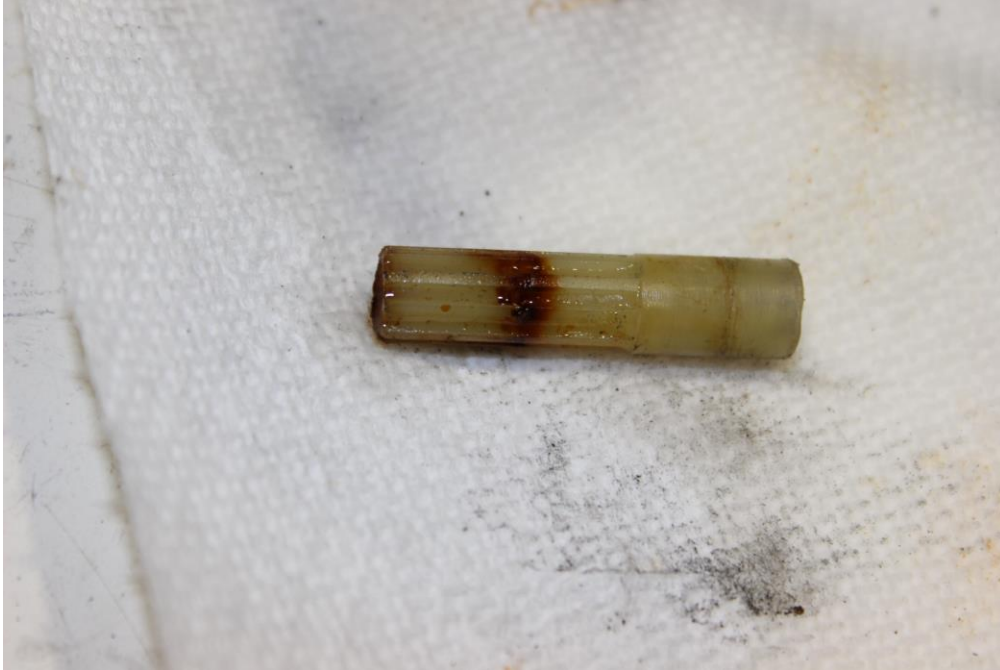
Fuel Control Unit: The fuel control unit (FCU) was in place and secure (Ref. Photo No. 64, red arrow). One of the FCU housings was fractured and partially separated from the adjacent housing (Ref. Photos No. 69 & 70, red arrows). Some of the residual fluid that remained on the FCU housing flange after it was separated from the fuel pump appeared to be water (Ref. Photo No. 71, red oval). The FCU was forwarded to P&WC's Accessories Investigation for additional testing and analysis. The fuel pump to FCU coupling surface exhibited a rust coloured stain (Ref. Photo No. 72).

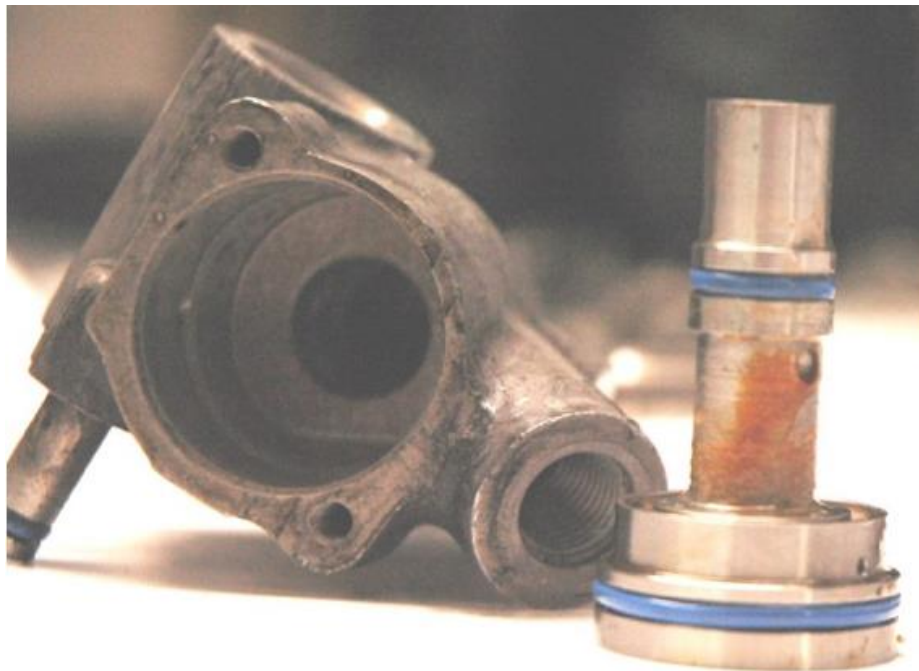
Photo No. 74

The FCU was disassembled. Contamination was present in the spill-valve sleeve and cavity (Ref. Photo No. 74).

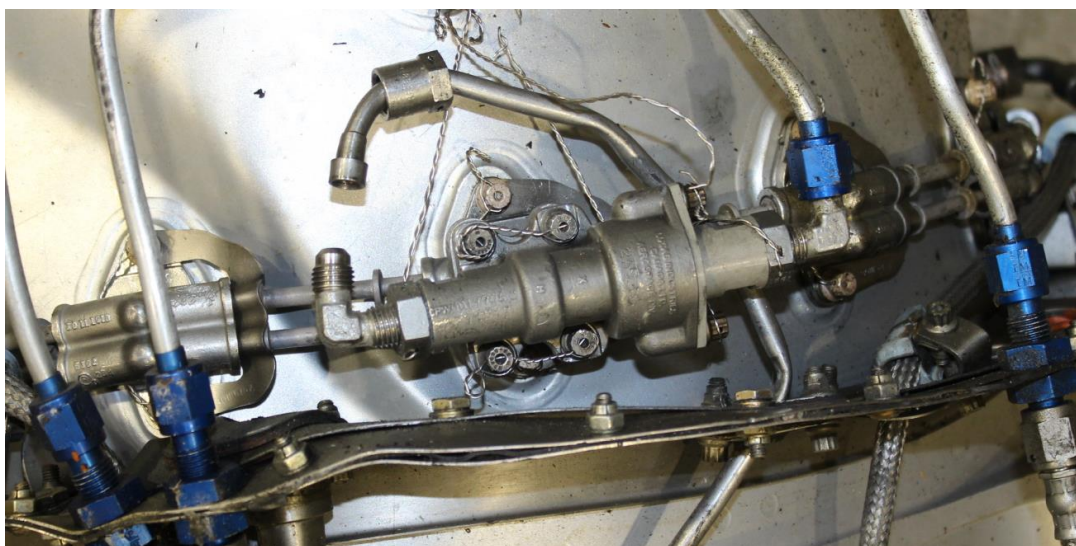
Photo No. 75

Flow Divider: The divider was in place and secure (Ref. Photo No. 75). The fuel supply tube from the FCU was removed and some fluid was captured. The fluid was retained by the NTSB for analysis.

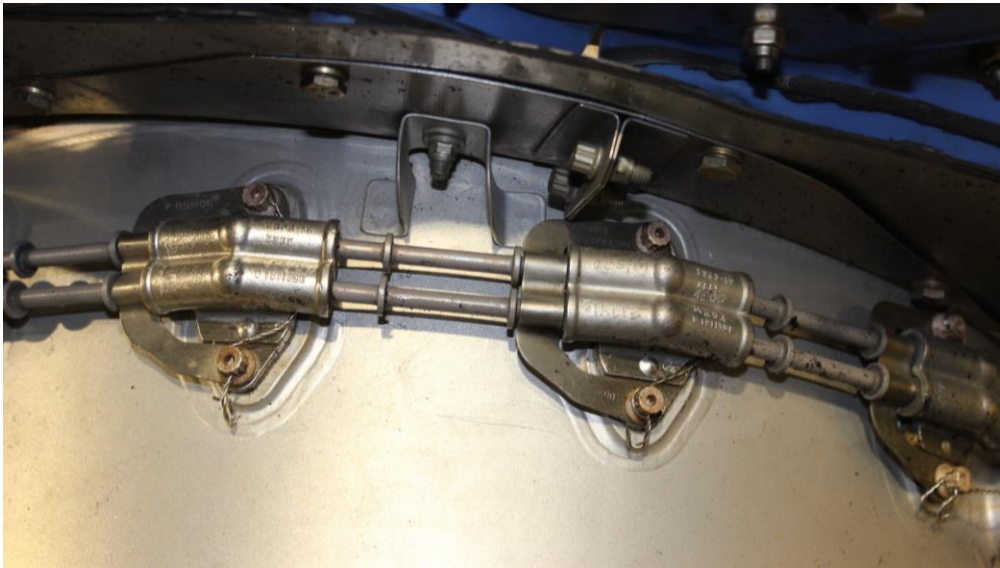
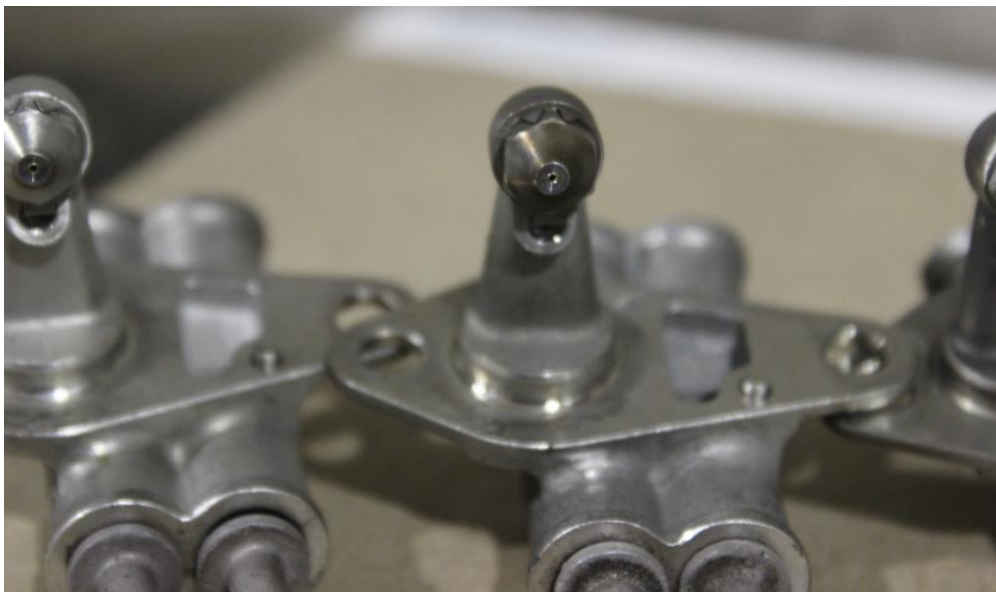
Fuel Nozzles: The nozzles were in place and secure (Ref. Photo No. 76). Three nozzles were removed. The nozzle tips were visually inspected and were found unremarkable except for some minor staining (Ref. Photo No. 77).

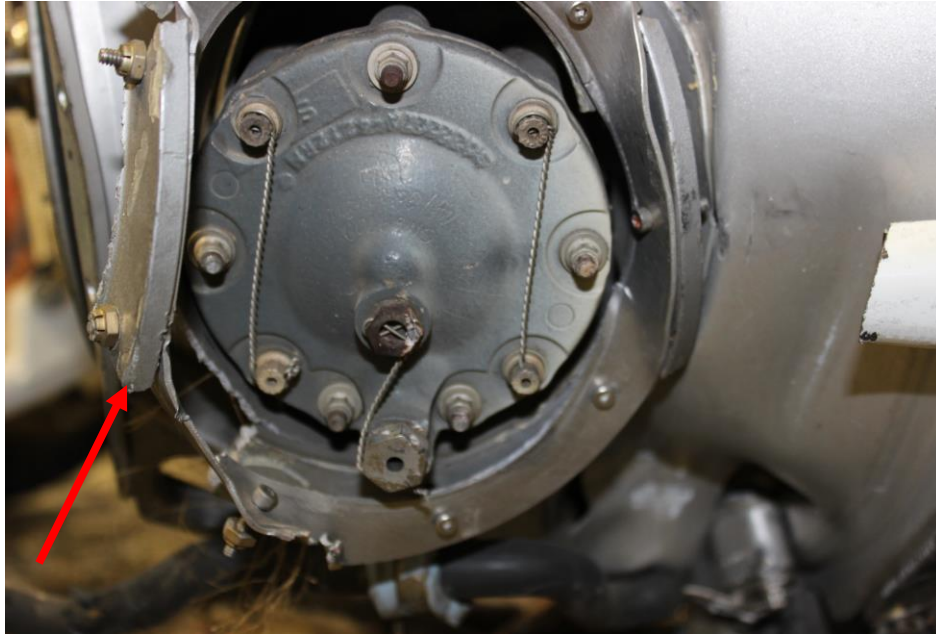
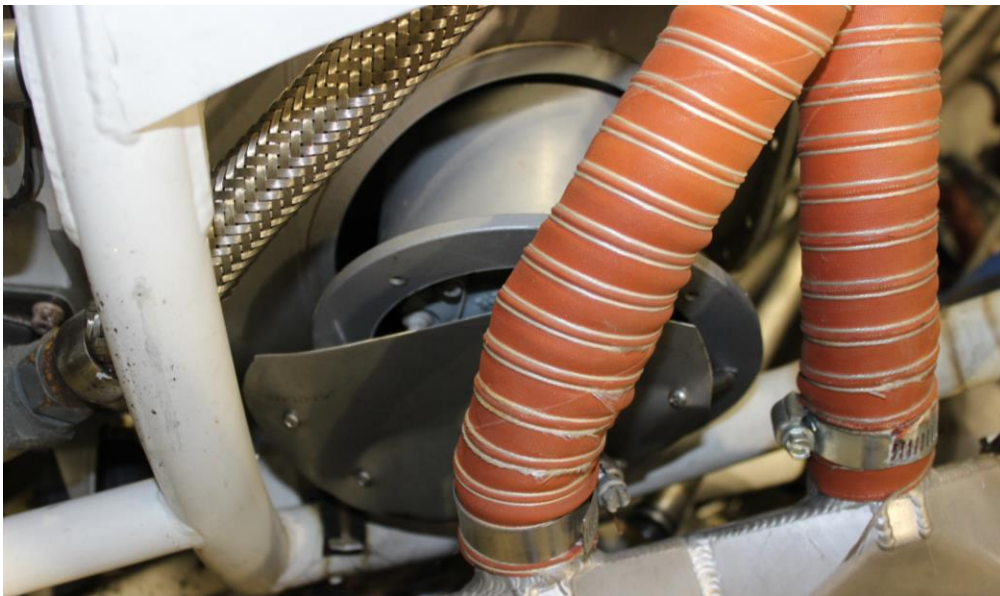
Compressor Bleed Valves: Both valves were in place and secure (Ref. Photos No. 78 & 79). The right hand valve housing was fractured at several locations (Ref. Photo No. 78, red arrow).

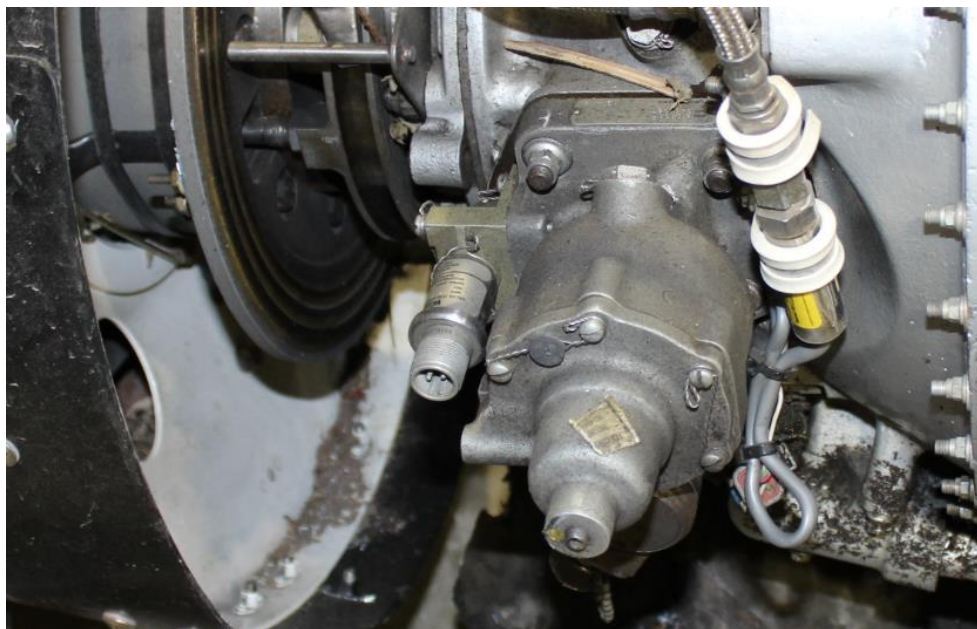
Photo No. 81

Overspeed Governor: The governor was in place and secure (Ref. Photo No. 81).
