Metallurgical Investigation Final Report

Subject: Metallurgical Investigation of Delta Air Lines PW2037 Engine No. 716595

Date: January 2nd, 2018

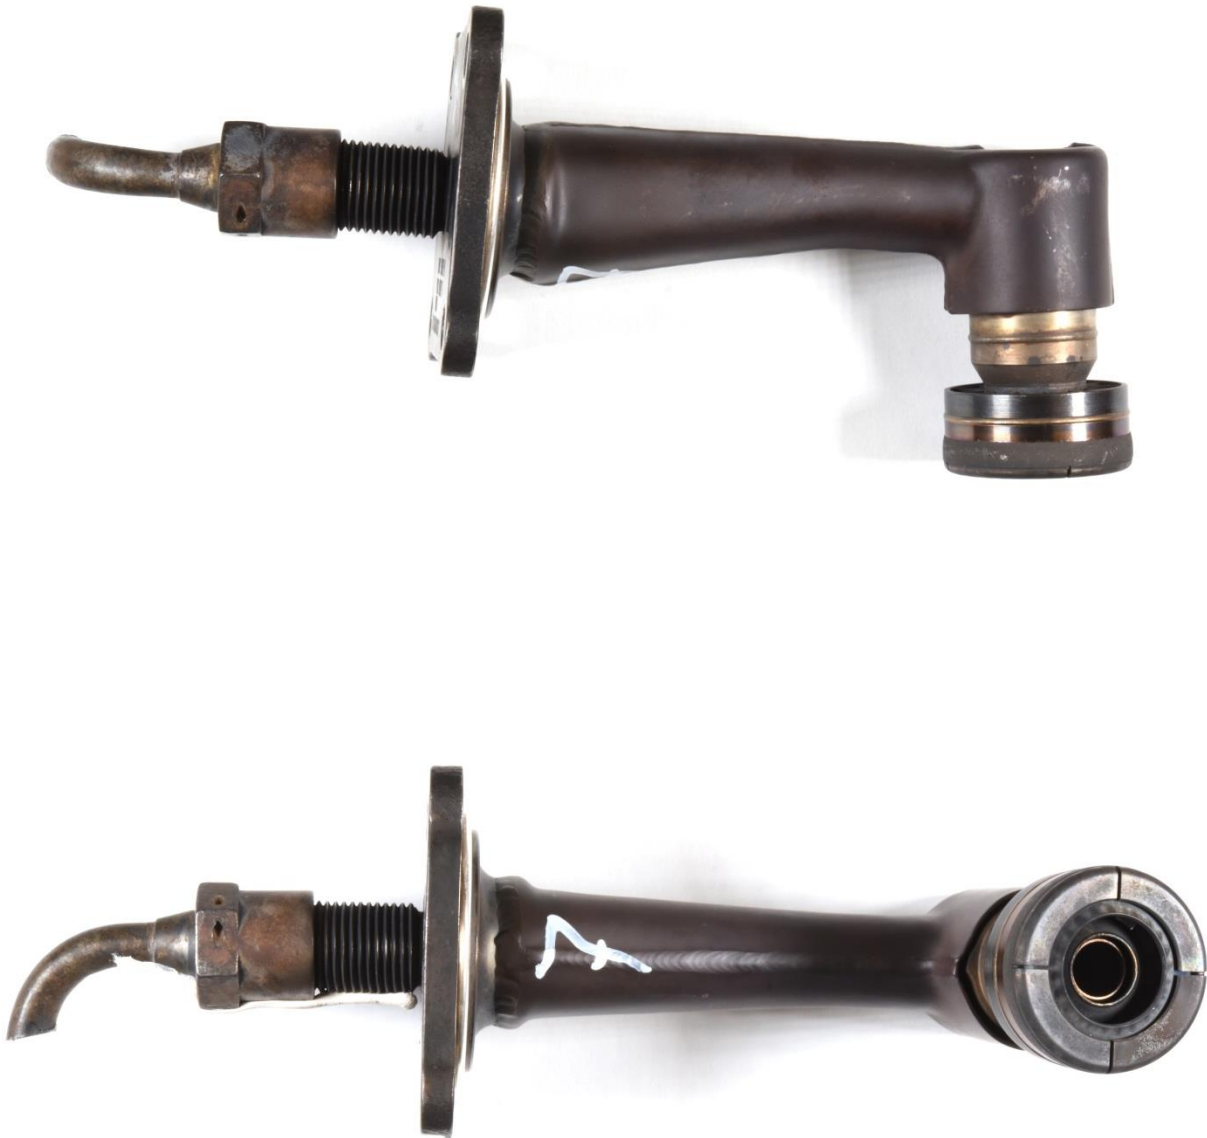
Visual examination of the fuel nozzle found that no significant distress was observed. The nozzle heat shield was intact and was dark brown in color. The B-nut was still in place; the attached tube had been sectioned in order to facilitate removal from the engine without moving the B-nut. The fuel nozzle was identified as being from position 7 (Figure 1).

Figure 1: Overall appearance of the fuel nozzle in the as-received condition.

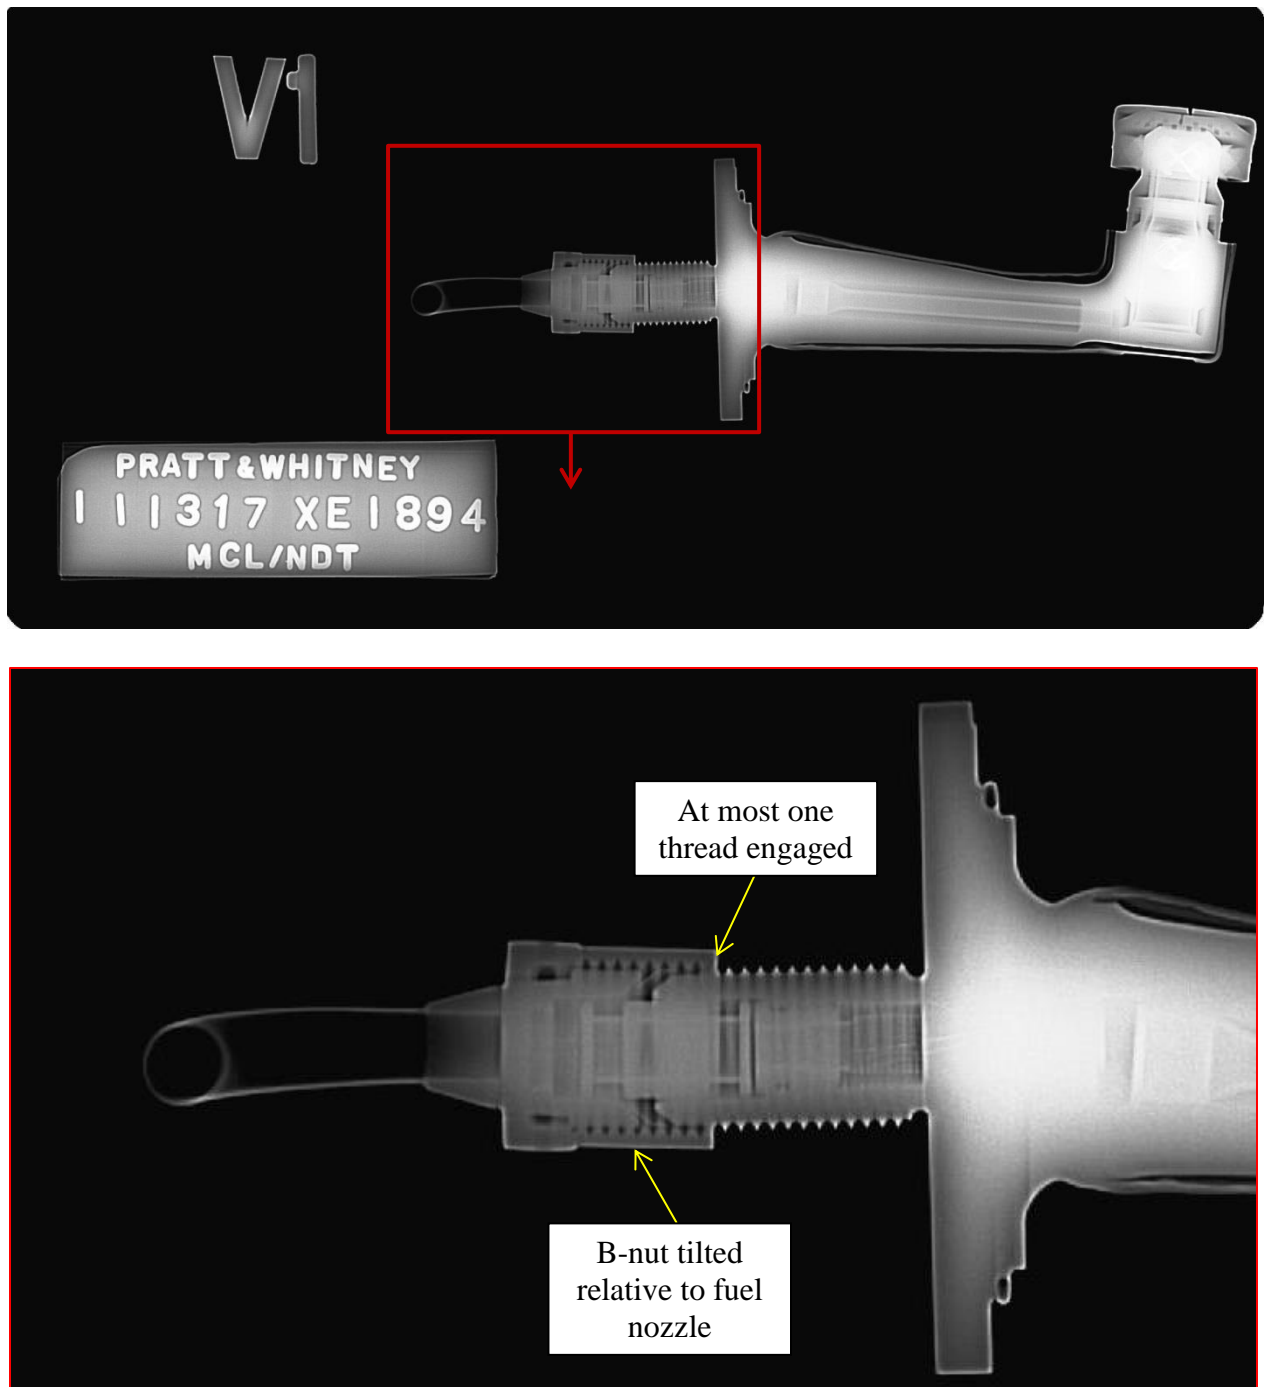
Prior to any further analysis, the fuel nozzle was submitted to the Pratt & Whitney Quality & Standards Laboratory for X-ray examination. X-ray found that the B-nut appeared cross threaded on the fuel nozzle with at most one thread engaged (Figure 2). The B-nut contains approximately 9-10 threads and the mating thread on the fuel nozzle has approximately 13 threads.

Figure 2: X-ray images showing apparent cross threading of the B-nut on the fuel nozzle and lack of full engagement.

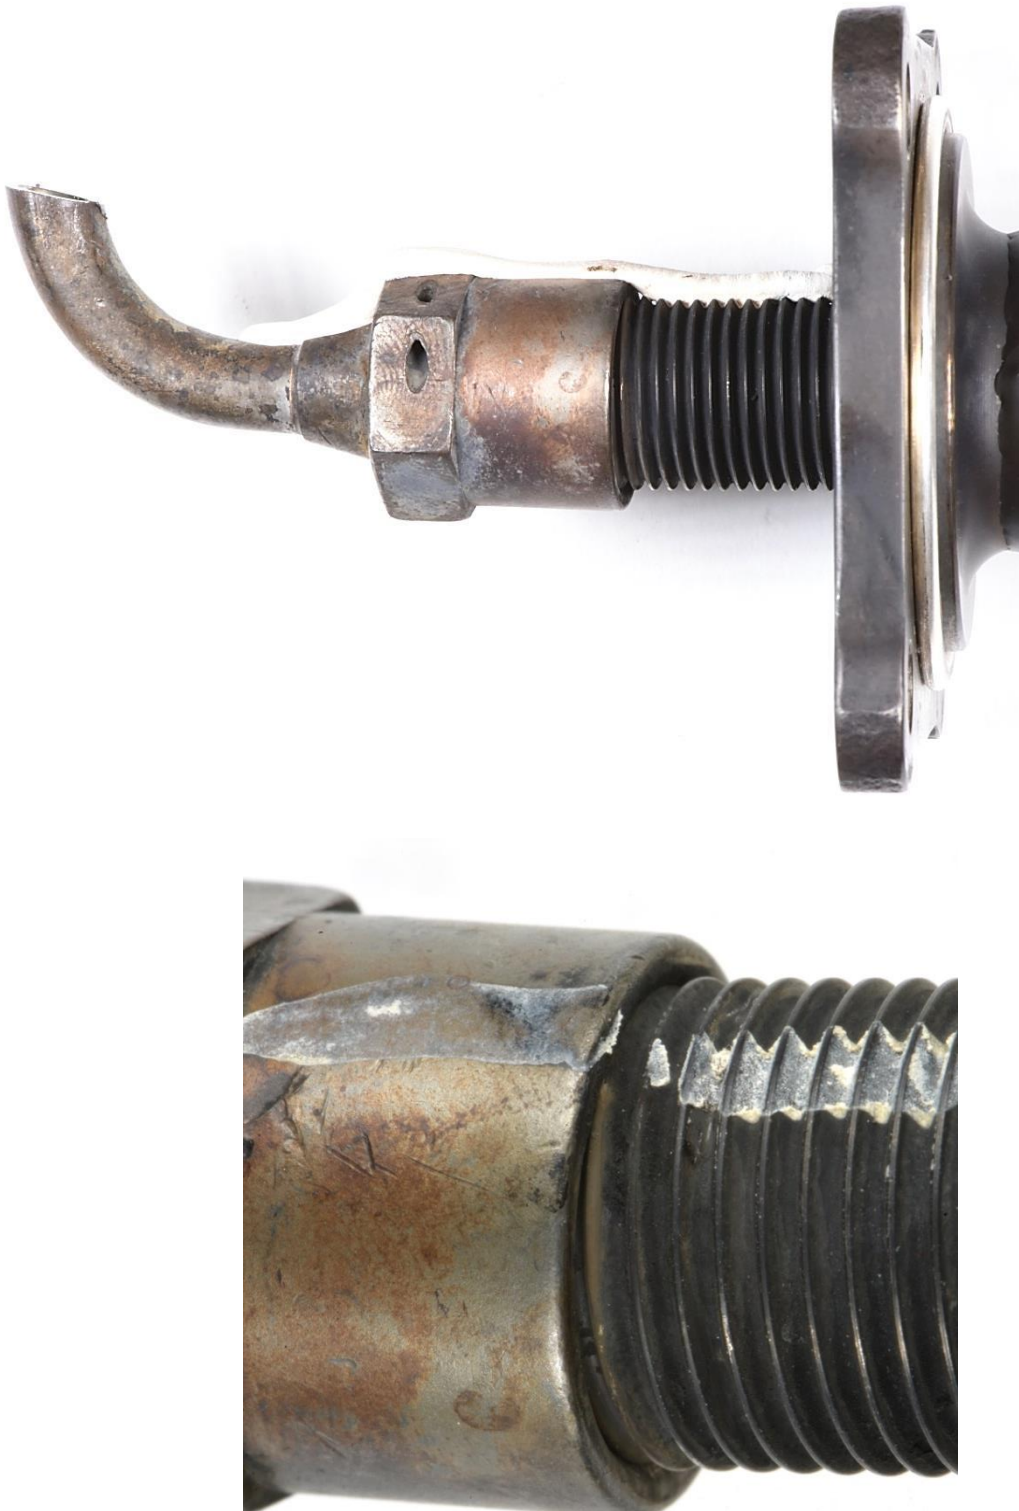
Continued visual examination of the fuel nozzle confirmed that the B-nut appeared to be tilted relative to the nozzle platform and threads. Review of the end of the B-nut found that the tube was not centered in the nut (Figures 3-4).

Figure 3: Views of the B-nut showing apparent cross threading observed.

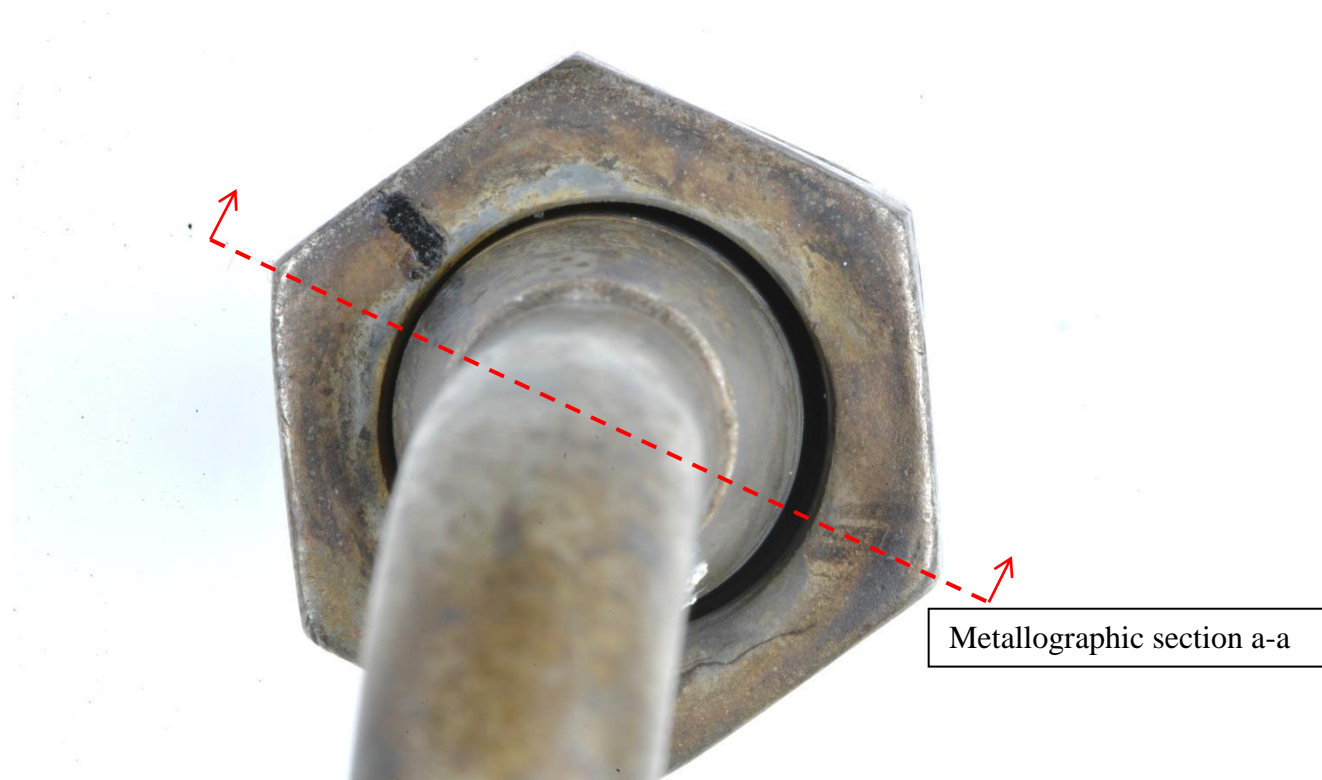
Figure 4: Image showing the off-center location of the tube in the B-nut. Dashed lines indicate the approximate location of metallographic section a-a.

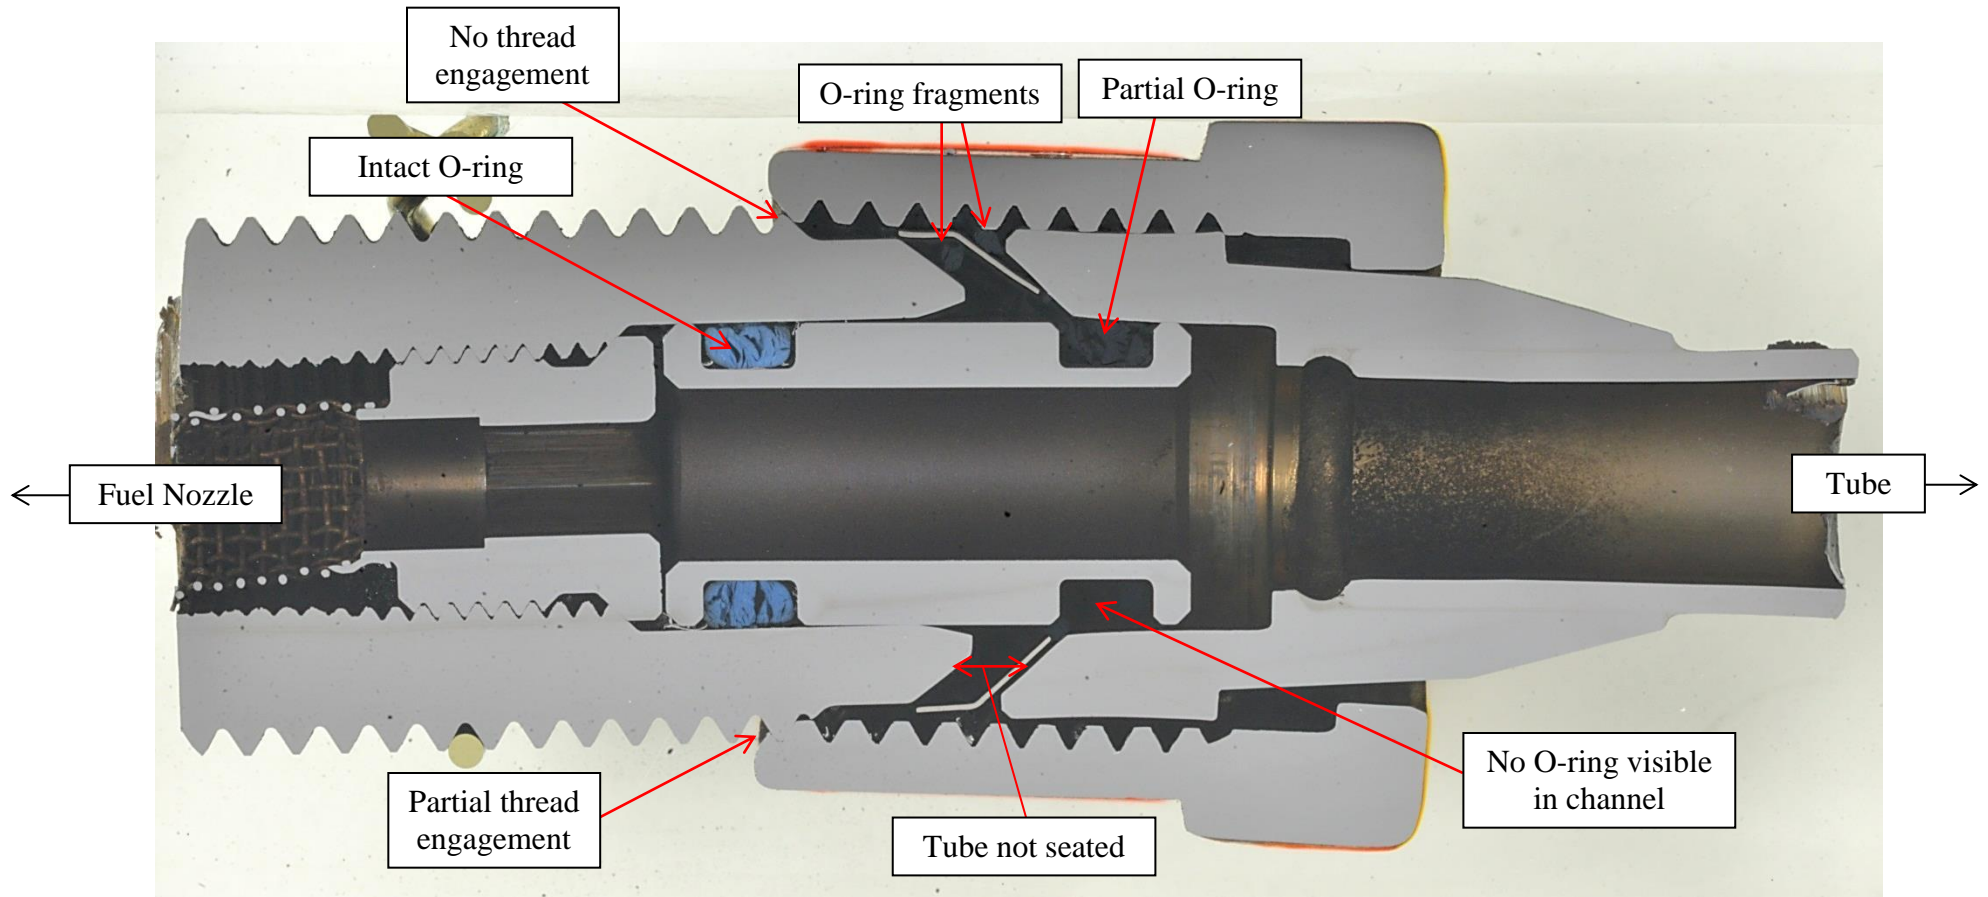
The lack of the tube side O-ring and lack of engagement by the B-nut cone seat likely allowed fuel leakage that led to the observed fire.

A metallographic section (section a-a) was prepared through the nozzle and tube assembly, as shown in Figure 4. Examination of the section confirmed that at most one thread was engaged. The tube and B-nut were not fully seated. The nozzle was tilted relative to the B-nut, indicating that it was cross threaded. The nozzle side O-ring appeared in place and intact in the groove. The tube side O-ring was only partially intact; some pieces of O-ring were noted in the area of the Voi-Shan (conical sheet metal) seal (Figure 5). The distressed/torn O-ring and angled/not fully engaged B-nut cone seat appeared to have provided a leakage path for fuel.

Figure 5: Image of metallographic section a-a showing internal condition of fuel nozzle.

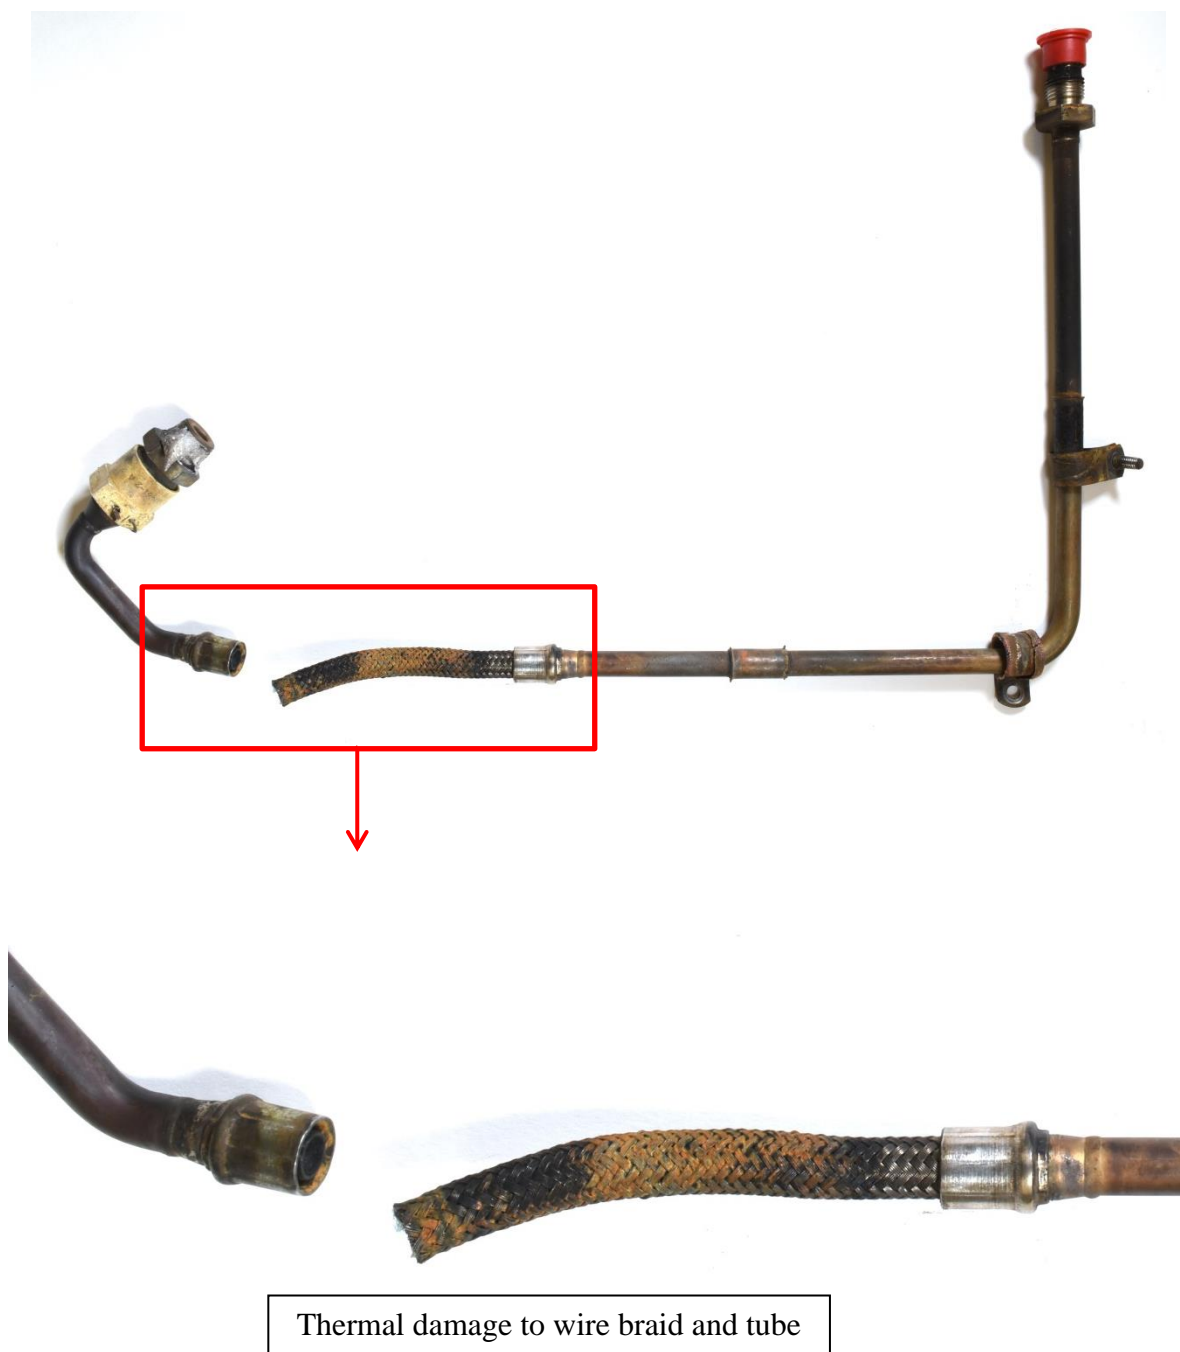
Visual review of the SVA hose and tube assembly as received found that the tube exhibited signs of thermal damage, including melted and re-solidified material on one B-nut and discoloration of the tube and wire braid. Additionally, the wire braid had separated from one end of the joint and there was no remaining evidence of the hose liner or fire sleeve present. Examination of the tube

Figure 6: Images of the SVA hose and tube assembly in the as-received condition.

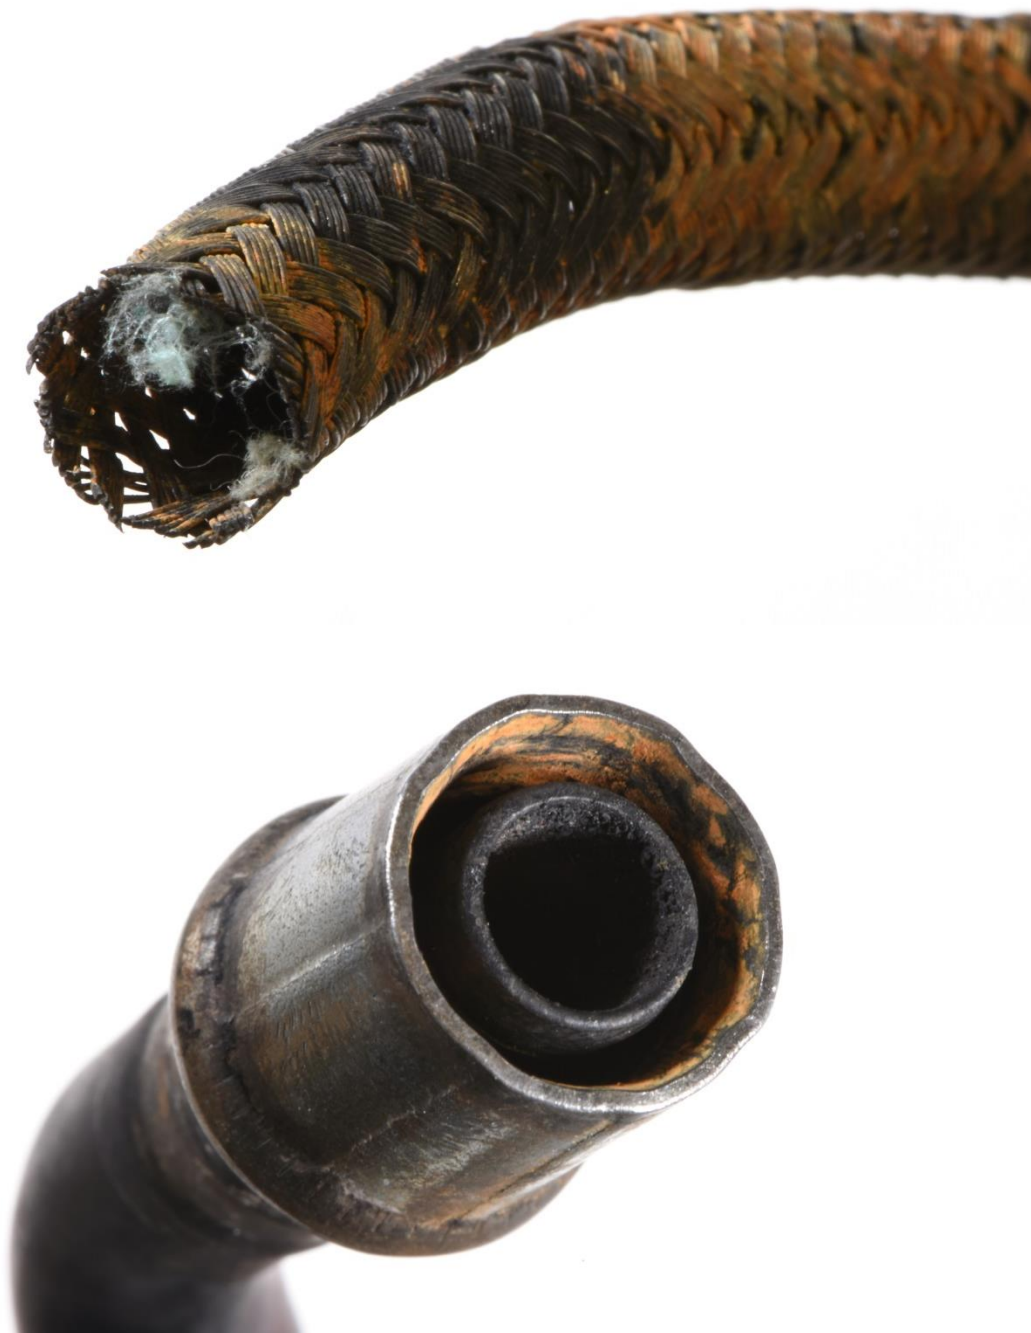
and wire braid at the separation found no evidence of fracture; the wire braid appeared to have pulled out from the joint (Figures 6-7).

Figure 7: Views of the end of the wire braid and the swage joint. The wire braid appeared to have pulled out from the joint and the inner liner was gone.

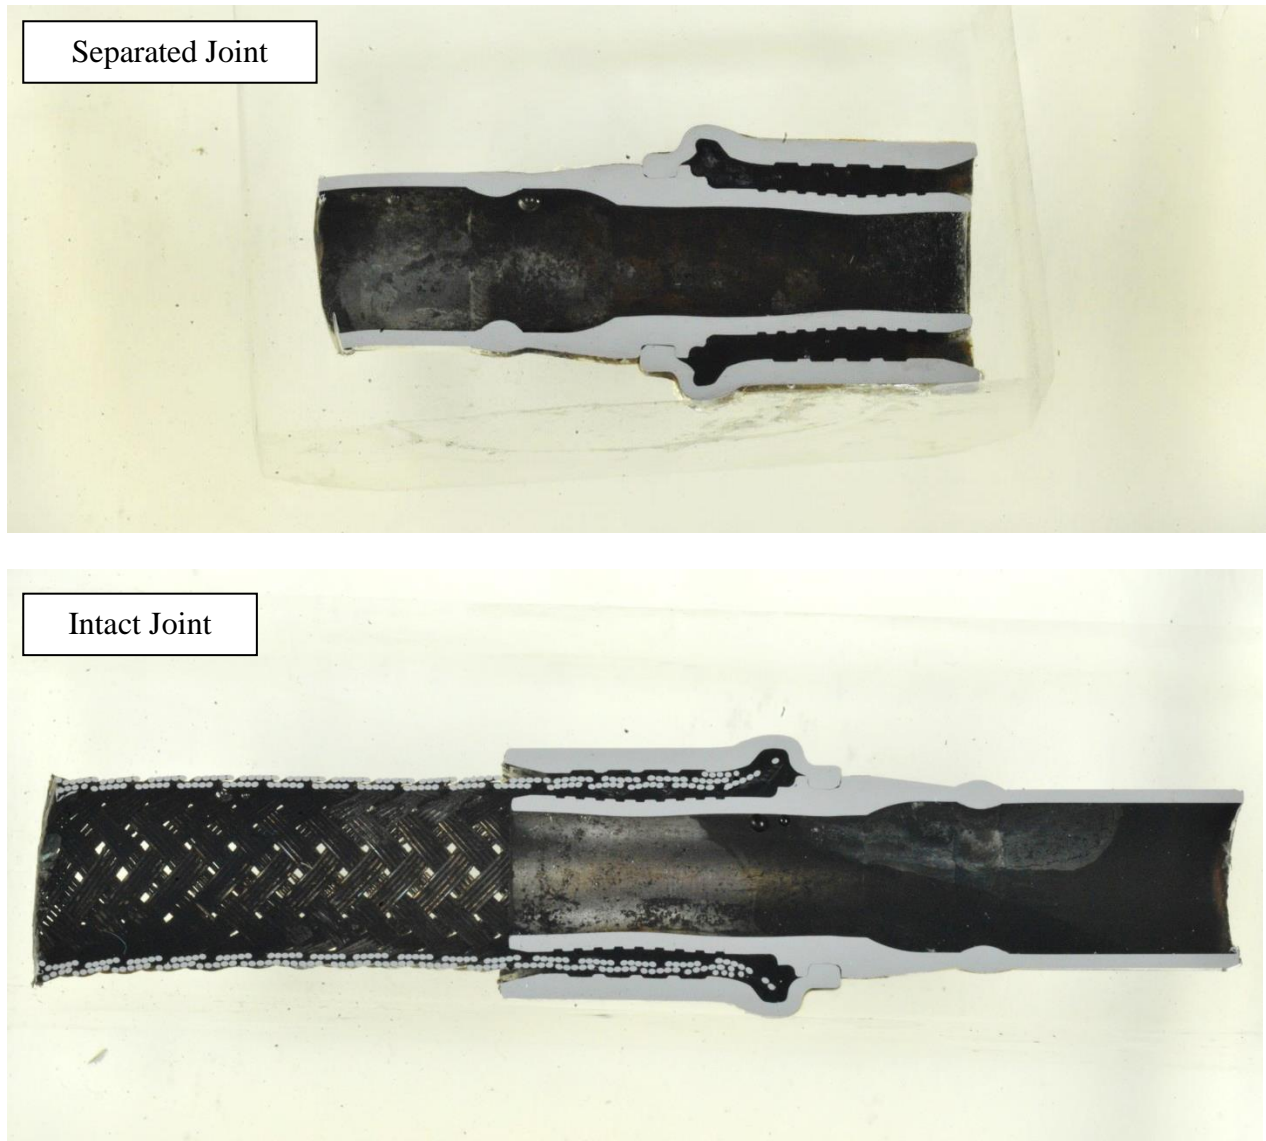
Metallographic sections were prepared through the approximate center of both the intact and separated joints. Review of the sections confirmed that the wire braid appeared to have pulled out on the separated side. No significant differences were observed between the two joints (Figure 8).

Figure 8: Views of metallographic sections through the approximate center of the intact and separated joints. No significant differences were observed. The entire inner liner was no longer present.
