PRATT & WHITNEY
SUBMISSION
AIRCRAFT ACCIDENT
DELTA AIR LINES, INC. FLIGHT 1288
MD-88, N927DA
PENSACOLA REGIONAL AIRPORT
PENSACOLA, FLORIDA
JULY 6, 1996

Pratt & Whitney (P&W) is a designated party to the National Transportation Safety Board (NTSB) investigation of the aircraft accident involving Delta Airlines Flight 1288 at Pensacola Regional Airport, Pensacola, Florida. Pursuant to 49 C.F.R. 831.14, P&W provides its submission to the NTSB.

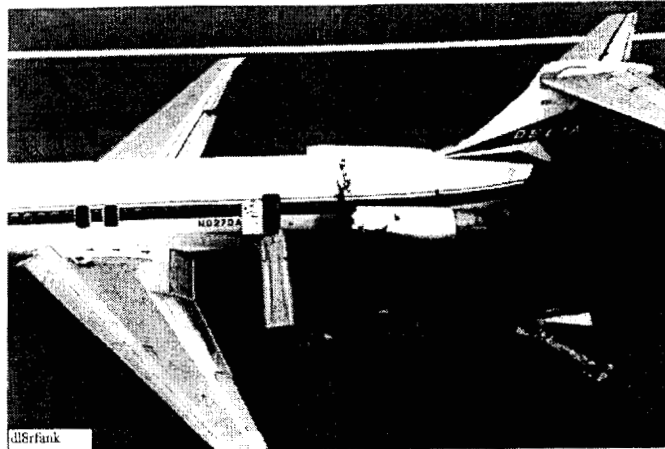
Aerial view showing damage to left fuselage and left engine.

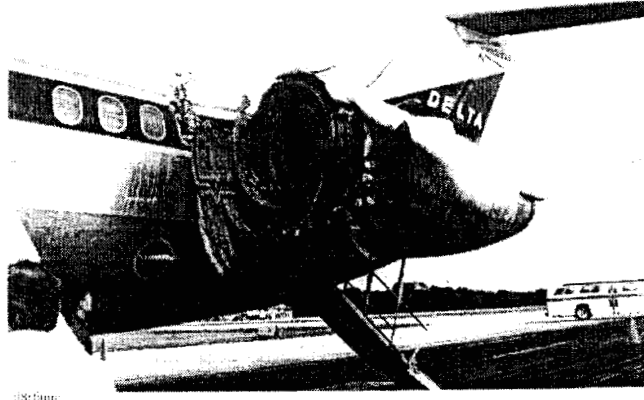
Left fuselage and engine damage, including fire damage to nacelle.

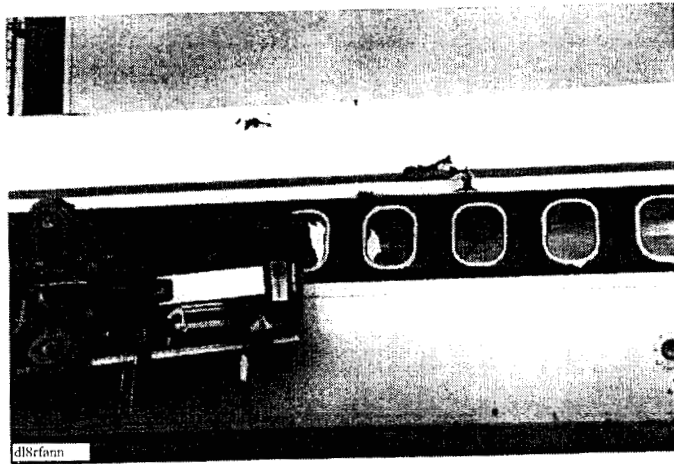
Right fuselage exit damage.

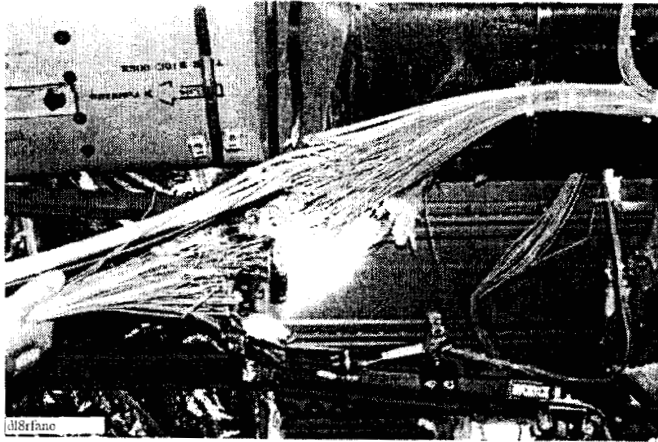
Wire bundle located along right longeron 4; 146 of the 154 wires in the wire bundle had been severed.

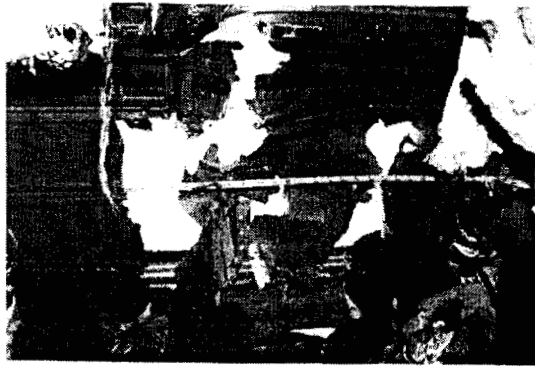
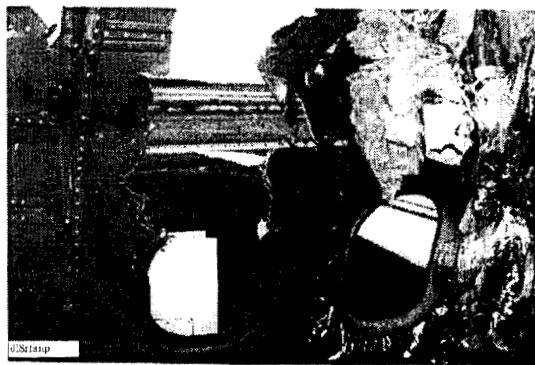
Interior view of left fuselage penetration damage adjacent to row 37
