National Transportation Safety Board

Tallahassee Runway 09 Precision Approach Path Indicator (PAPI)

FedEx Flight 1478, Boeing 727-232 (N497FE)

Investigation of Tallahassee Runway 09 PAPI

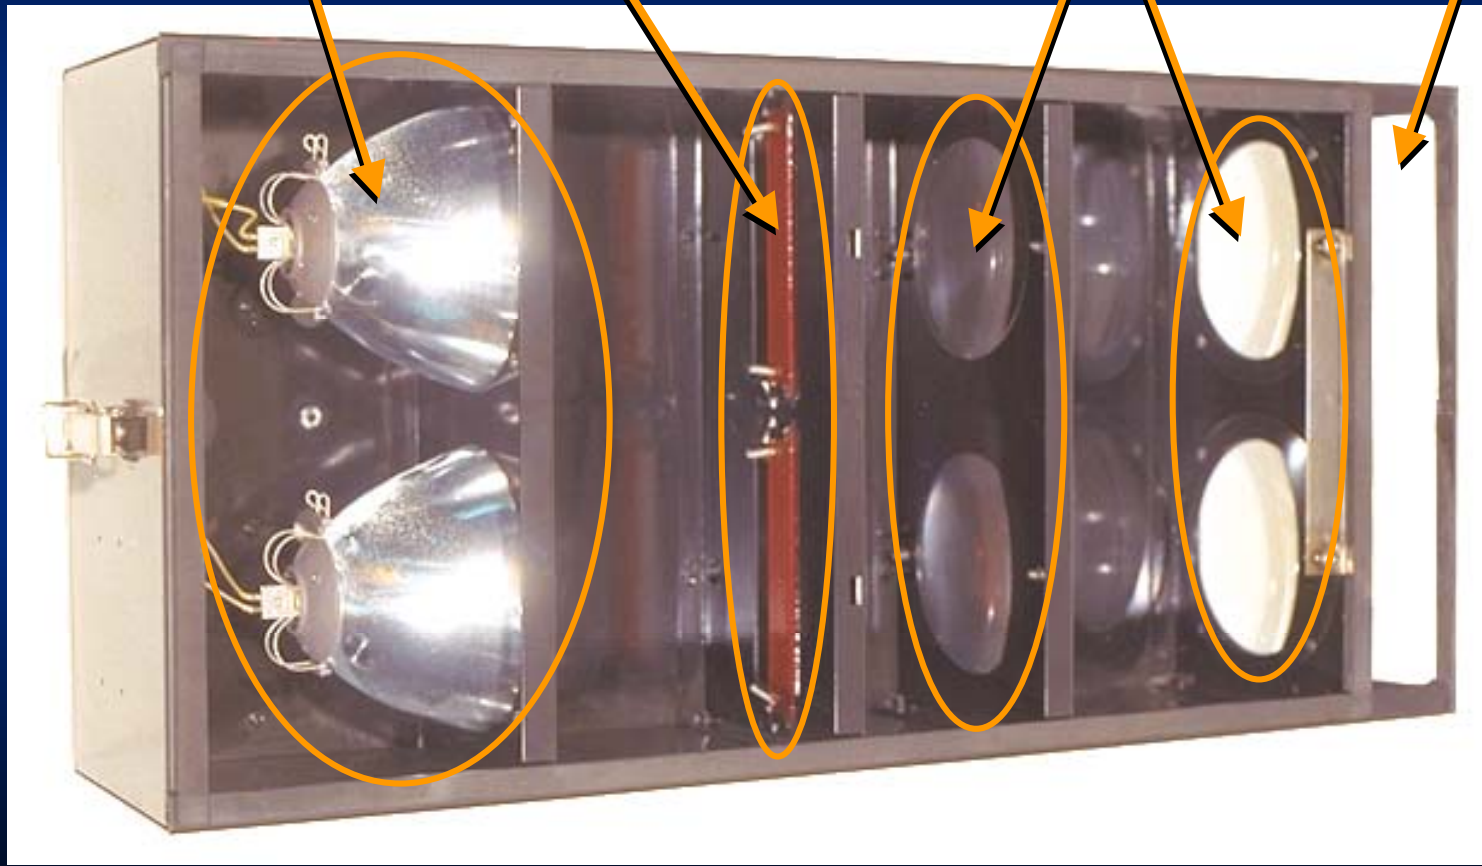
PAPI Components

Lamps

Red Filters

Lenses

Protective
Lens Shield
