PRELIMINARY REPORT

Over-pressure of a Columbia Gas of Massachusetts Low-pressure Natural Gas Distribution System

Merrimack Valley, Massachusetts

PLD18MR003

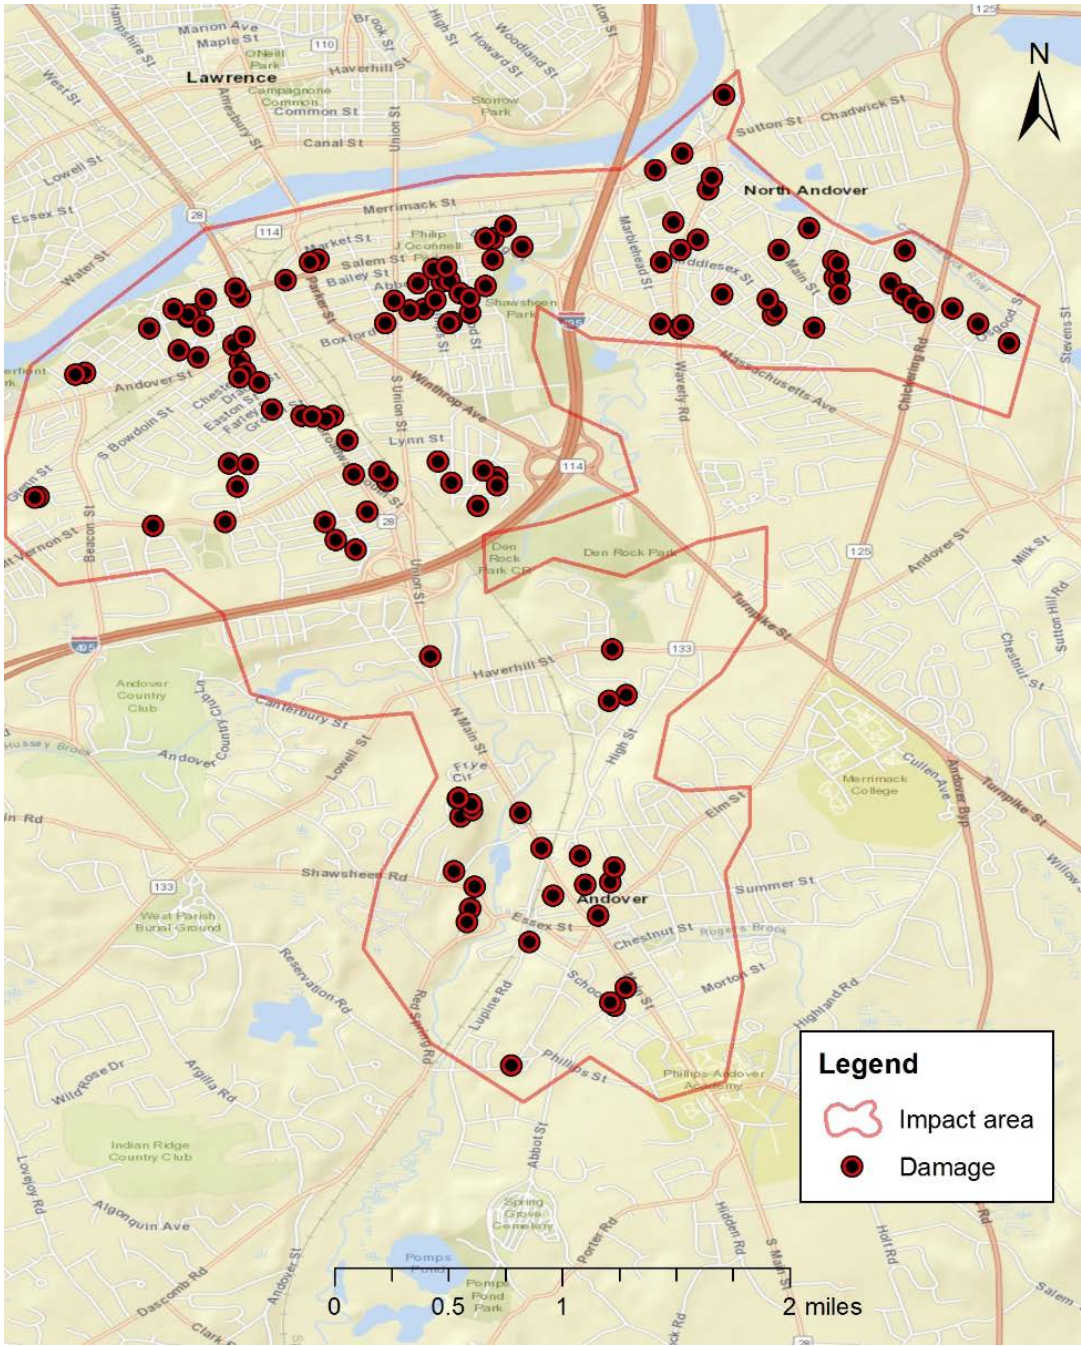
Figure 1. Area impacted by accident depicting structures that were damaged.
