PRELIMINARY REPORT

HIGHWAY

HWY17MH015

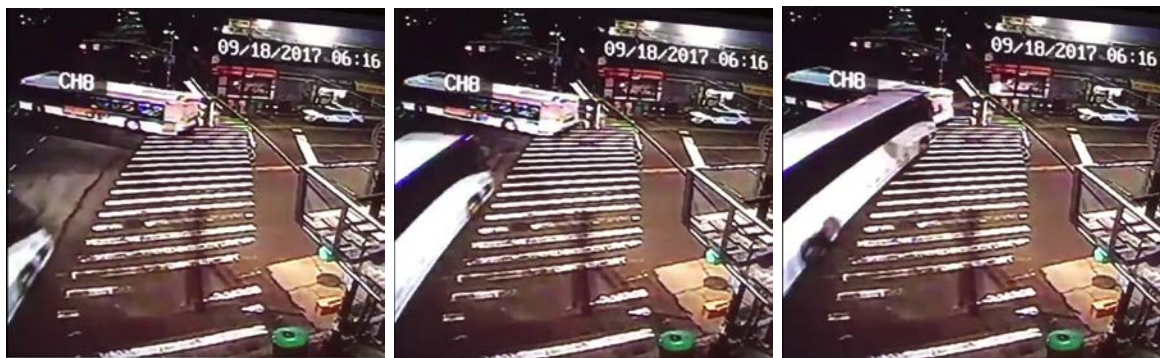
On Monday, September 18, 2017, about 6:16 a.m. eastern daylight time (EDT), a New York Metropolitan Transit Authority (MTA) 38-passenger transit bus was traveling northbound on Main Street approaching the intersection with Northern Boulevard in the Queens borough of New York City, New York. The intersection was controlled by a traffic signal, which was displaying a green right-turn arrow for northbound traffic on Main Street. At the same time, a 2015 MCI, 56-passenger motorcoach, operated by Dahlia Group Inc., was traveling eastbound on Northern Boulevard (see figure 1). As the transit bus began turning right onto Northern Boulevard, the motorcoach did not stop at the red traffic signal and it struck the transit bus at the left rear (see figure 2).

Figure 2. Still images from a surveillance camera mounted on the southwest corner of the intersection. (Source: Computer Street)

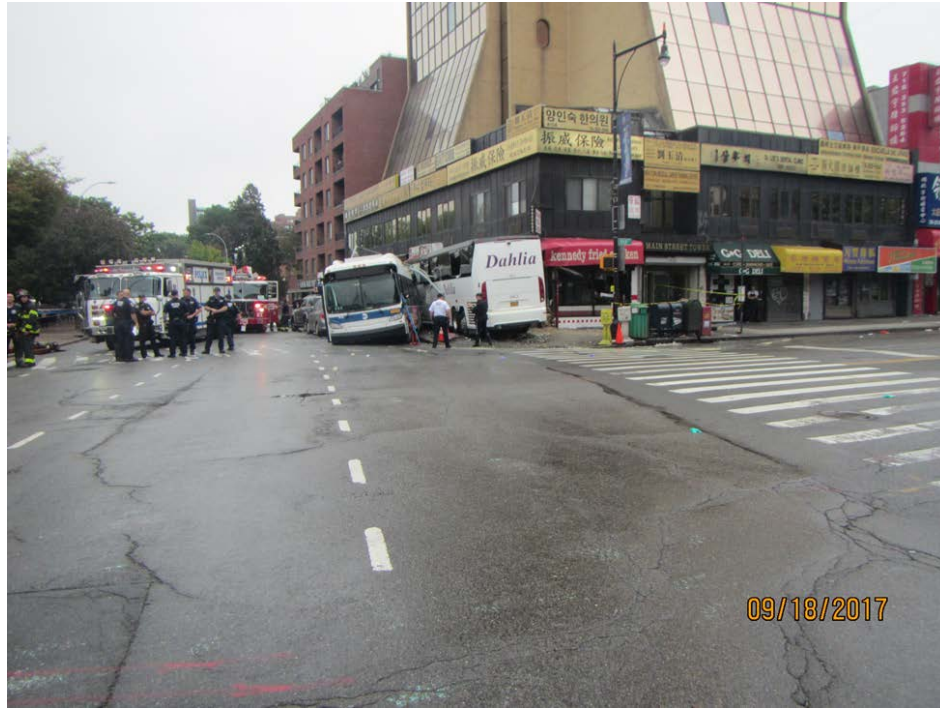
During the collision sequence, the transit bus rotated about 180 degrees counter-clockwise. It then struck and pushed an unoccupied parked passenger car into another parked passenger car, which was occupied by a driver and front-seat passenger, before coming to rest (see figure 3). The motorcoach departed the roadway, crossed over the sidewalk, and crashed into a building on the southeast corner of the intersection before coming to rest. Three pedestrians were struck during the collision sequence.

Figure 3. Eastbound view of the transit bus (on the left) and motorcoach (on the right) at final rest. (Source: MTA New York City Transit)
