PRELIMINARY REPORT

HIGHWAY

HWY18MH005

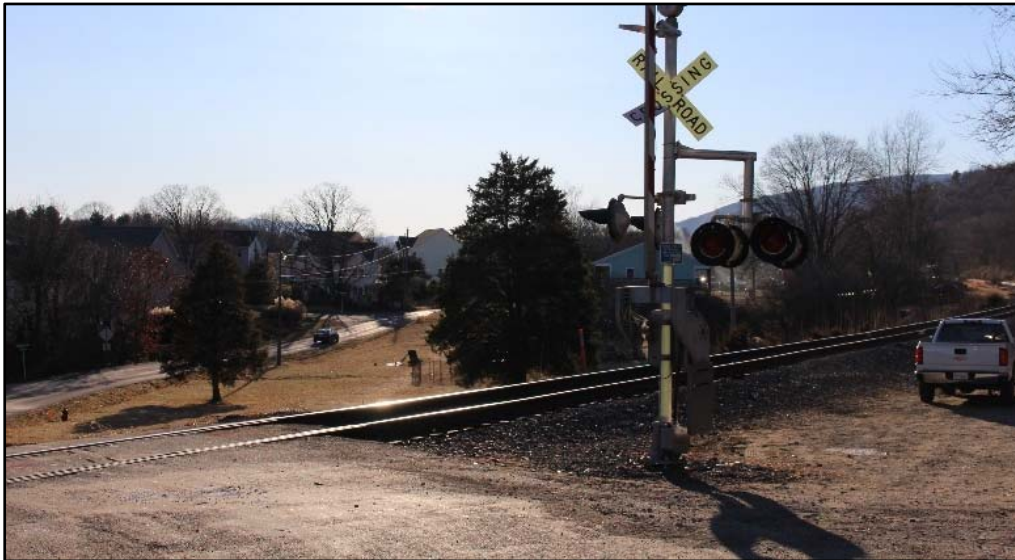
Figure 1. Southbound view of highway–rail grade crossing showing active warning devices.

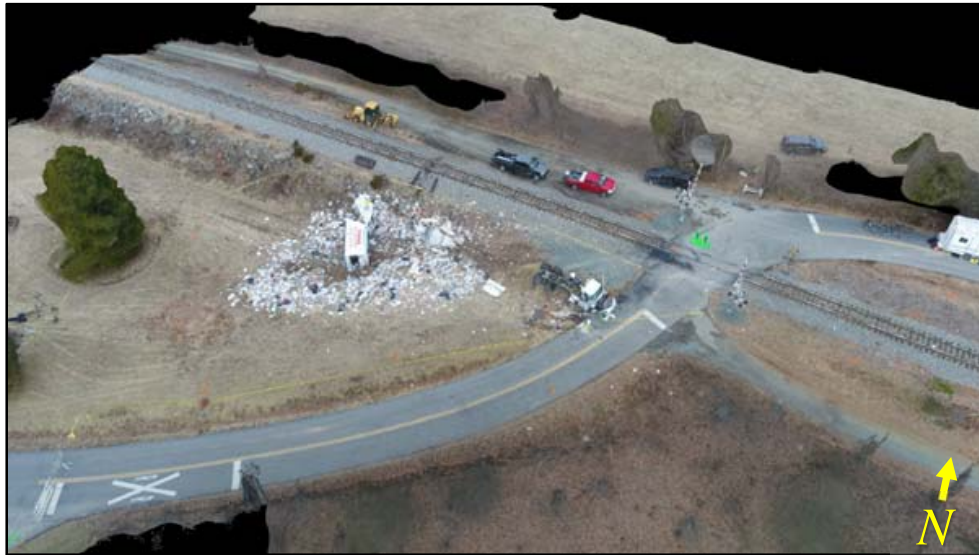
railroad signal bungalow next to the tracks on the southwest side of Lanetown Road (see figure 2). The refuse body separated from the truck, and the truck's two passengers were ejected. The truck came to rest off the southwest edge of Lanetown Road.

Figure 2. Aerial view of the highway-railroad grade crossing, truck chassis, body, and debris at final rest. (National Transportation Safety Board drone)

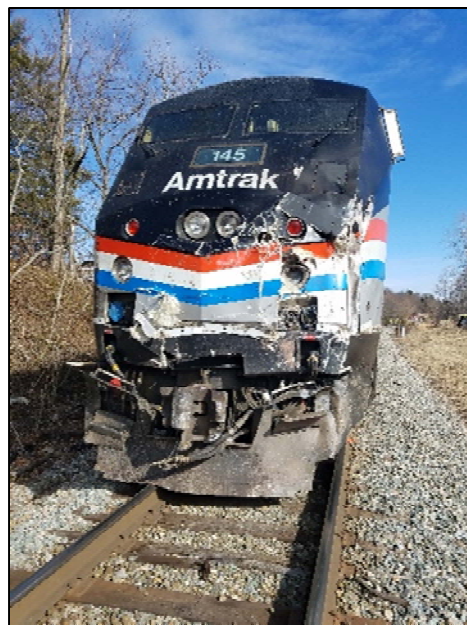
During the crash sequence, the front axle of the lead locomotive derailed as the train continued west; however, the locomotive remained upright (see figure 3).

Figure 3. Front of lead locomotive.
