PRELIMINARY REPORT

HIGHWAY

HWY18MH010

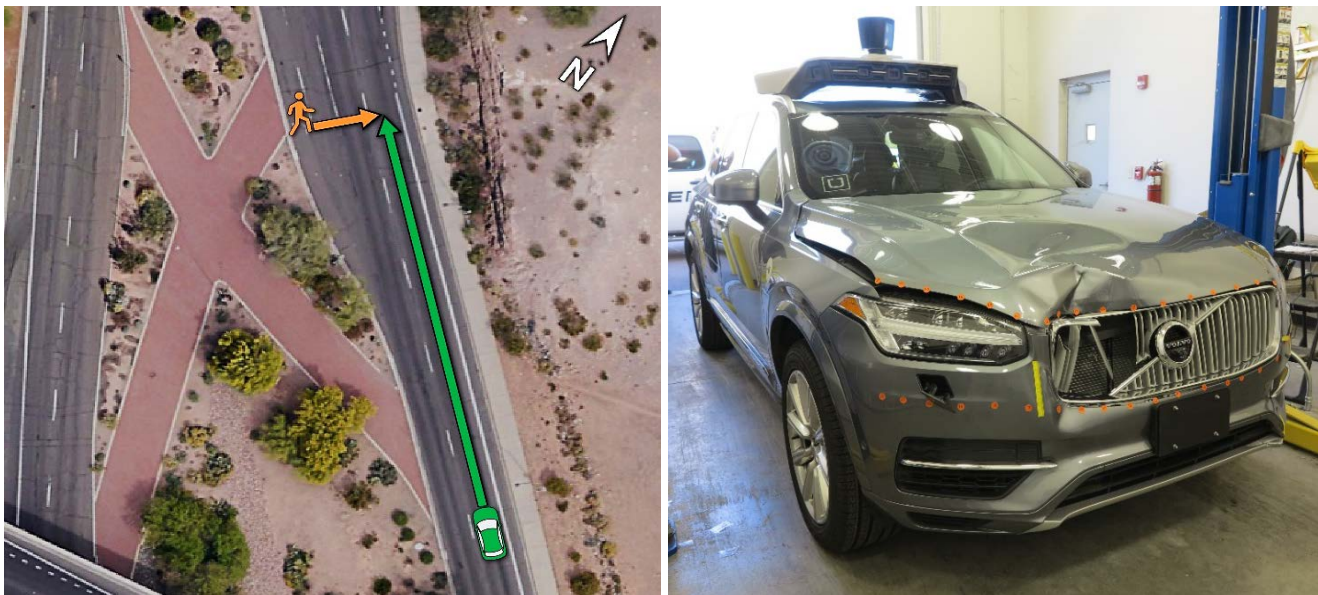
The crash occurred as the pedestrian, a 49-year-old female, walked a bicycle east across Mill Avenue. The Uber test vehicle was traveling in the right through lane when its right front side struck the pedestrian (see figure 1). As a result of the crash, the pedestrian died. The vehicle operator was not injured.

Figure 1. (Left) Location of the crash on northbound Mill Avenue, showing the paths of the pedestrian in orange and of the Uber test vehicle in green. (Right) Postcrash view of the Uber test vehicle, showing damage to the right front side.

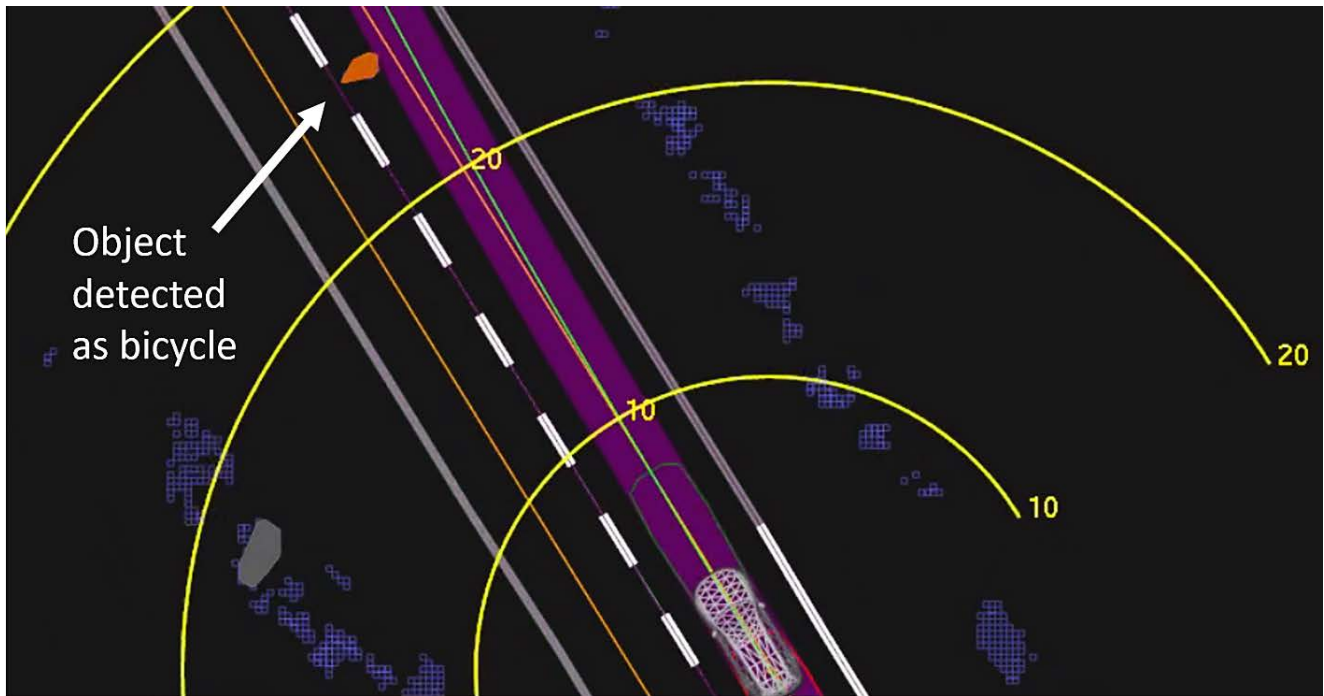
According to data obtained from the self-driving system, the system first registered radar and LIDAR observations of the pedestrian about 6 seconds before impact, when the vehicle was traveling at 43 mph. As the vehicle and pedestrian paths converged, the self-driving system software classified the pedestrian as an unknown object, as a vehicle, and then as a bicycle with varying expectations of future travel path. At 1.3 seconds before impact, the self-driving system determined that an emergency braking maneuver was needed to mitigate a collision (see figure 2).² According to Uber, emergency braking maneuvers are not enabled while the vehicle is under computer control, to reduce the potential for erratic vehicle behavior. The vehicle operator is relied on to intervene and take action. The system is not designed to alert the operator.

Figure 2. View of the self-driving system data playback at about 1.3 seconds before impact, when the system determined an emergency braking maneuver would be needed to mitigate a collision. Yellow bands are shown in meters ahead. Orange lines show the center of mapped travel lanes. The purple shaded area shows the path the vehicle traveled, with the green line showing the center of that path.
