PRELIMINARY REPORT

Ft. Lauderdale, Florida

HWY18FH013

PRELIMINARY REPORT HIGHWAY HWY18FH013

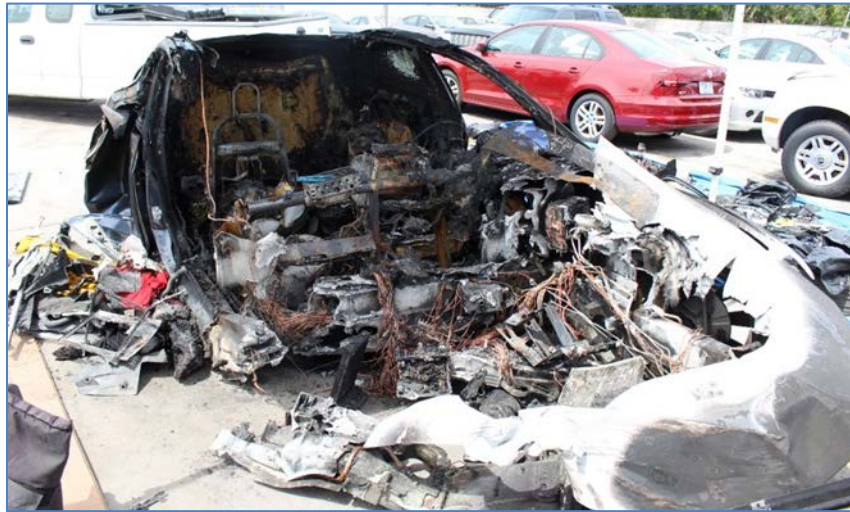
The Fort Lauderdale Fire and Rescue Department arrived at the crash scene and found the Tesla fully engulfed in flames. They extinguished the vehicle fire using 200–300 gallons of water and foam. Small portions of the lithium-ion high-voltage battery had separated from the vehicle, and—though there was no visible fire—they applied water and foam to the debris. During the loading of the car for removal from the scene, the battery reignited and was quickly extinguished. Upon arrival at the storage yard, the battery reignited again. A local fire department responded to the storage yard and extinguished the fire. Figure 2 shows the Tesla postcrash.

Figure 2. Remains of Tesla Model S at storage yard.
