## CEN18FA368

### Hartzell Propeller Air Safety Investigator Observations (based on photos provided by on-scene investigators)

Aircraft: Piper PA-32RT-300T

Registration: N500MJ

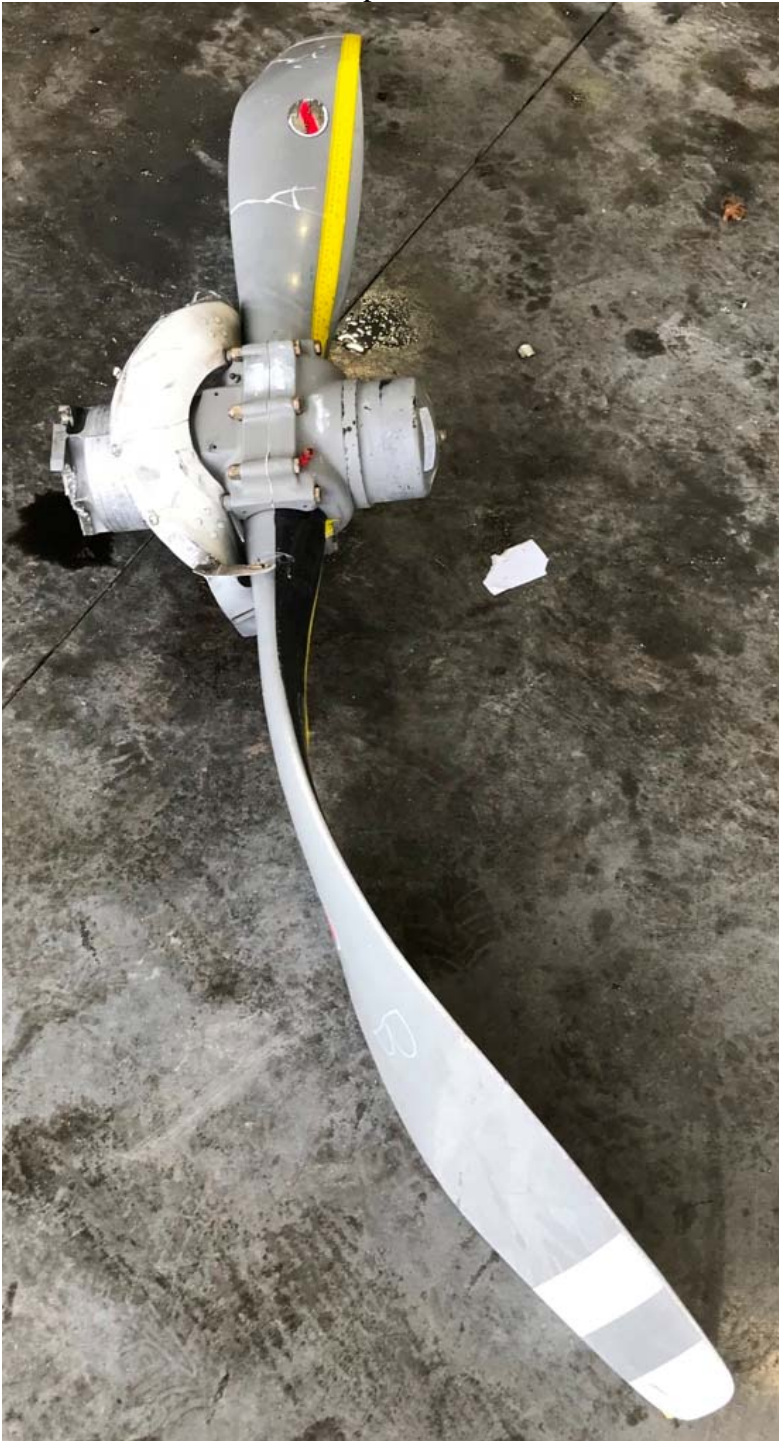
Photo #1 – Propeller As-Received

The propeller fractured from the engine during the impact sequence and was recovered from the water as-shown in Photo #1.

Both blades were bent aft and twisted leading edge down in varying degrees. Both blades appeared to be forcibly rotated in the assembly lower than the low pitch stop, indicating fractured pitch change knobs.

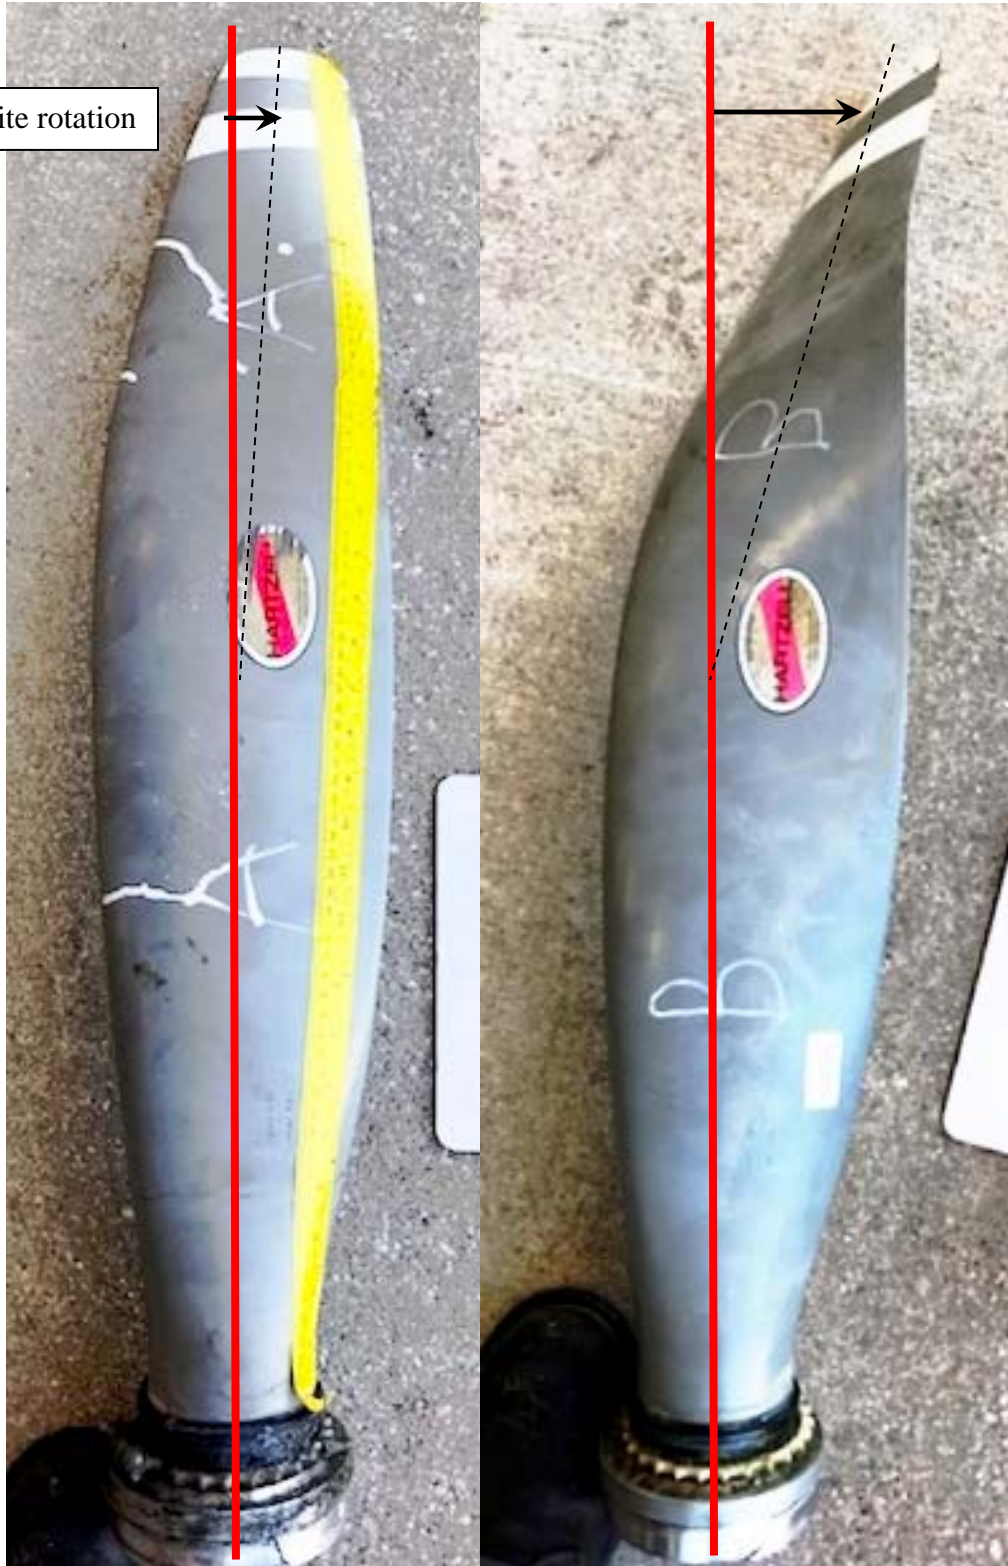
Photo #2 – Blade camber side view

Both blades exhibited bending opposite rotation as shown in Photo #2, Blade B being more prominent. Bending opposite rotation suggests power. Both blades had fractured pitch change knobs indicating forcible rotation while under power. There were no apparent chordwise/rotation scoring marks which is consistent with impact into water.

Bending opposite rotation

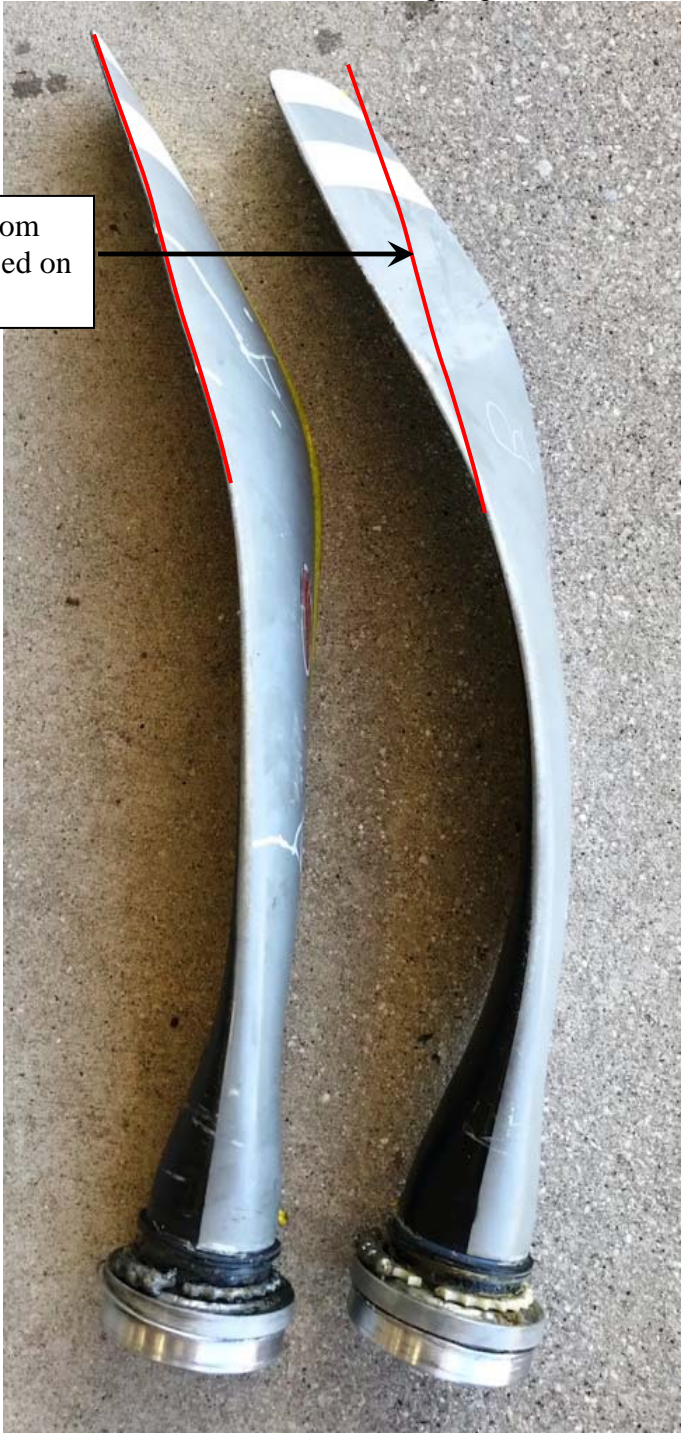
Photo #3 – Blades leading edge view

Blade A exhibited some “untwisting” (twist towards high pitch) near the tip of the blade as shown in Photos #3 and #4. Also Blade A exhibited a small amount of S-bending in the tip area. Both of these characteristics suggest impact with power ON.

Leading edge line from Blade A superimposed on Blade B

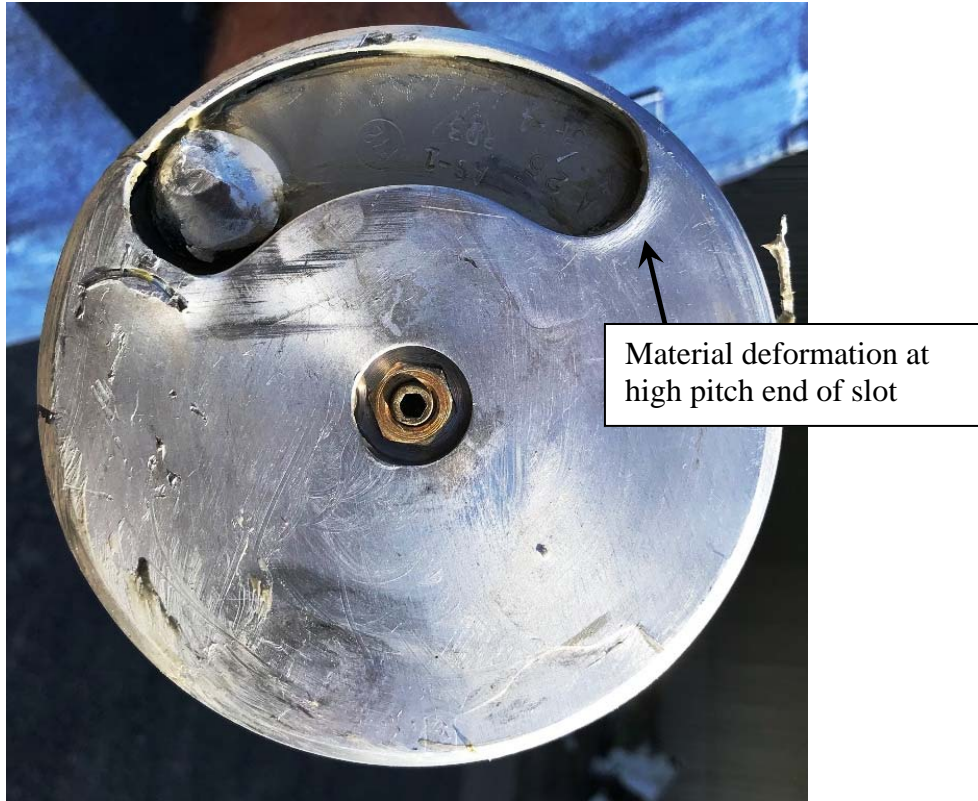
Photo #5 – Preload Plate A

The Blade A preload plate had material deformation at the high pitch end of travel slot (Photo #5. This suggests the blade was forcibly rotated towards high pitch at initial impact. This is consistent with the “untwisting” and S-bending seen in the tip area of Blade A.

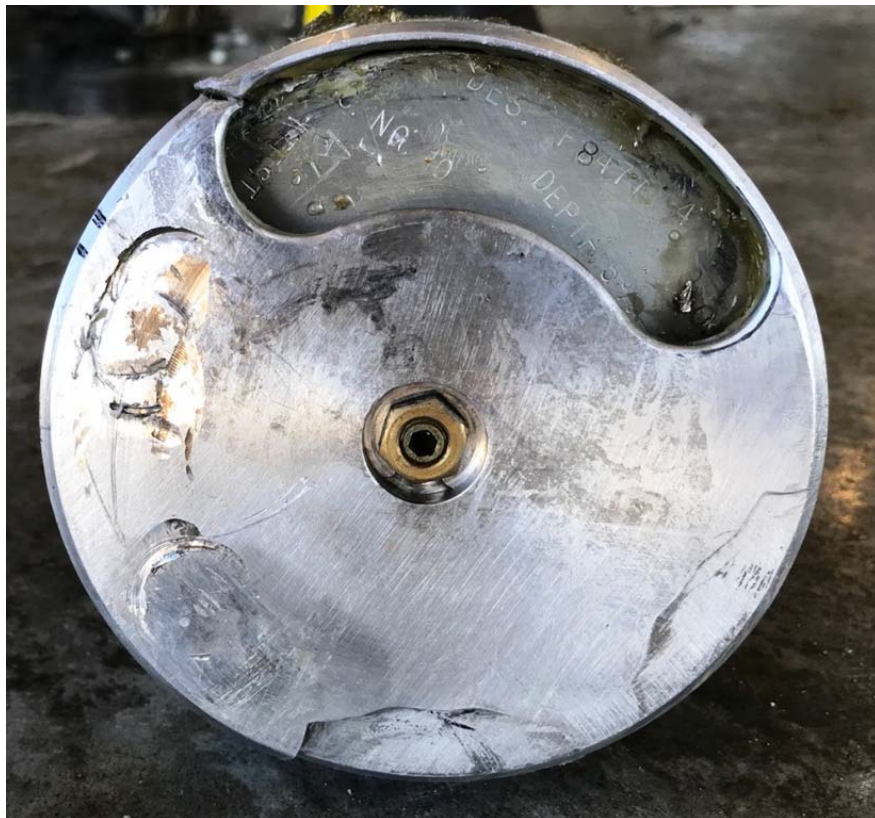
Photo #6 – Preload Plate B

Preload plate B had one credible pitch change knob block impact mark near the low pitch stop blade angle position. All other impact marks on the preload plates were post-initial impact.
