NATIONAL TRANSPORTATION SAFETY BOARD
Office of Aviation Safety
Washington, D.C. 20594

Computed Tomography Specialist's Factual Report

CEN-15-FA-048

Operator: Central Airlines, Inc., dba Central Air Southwest
Location: Chicago, IL
Date: November 18, 2014
Time: 0245 central standard time
Vehicle: Aero Commander model 500 B airplane, N30MB

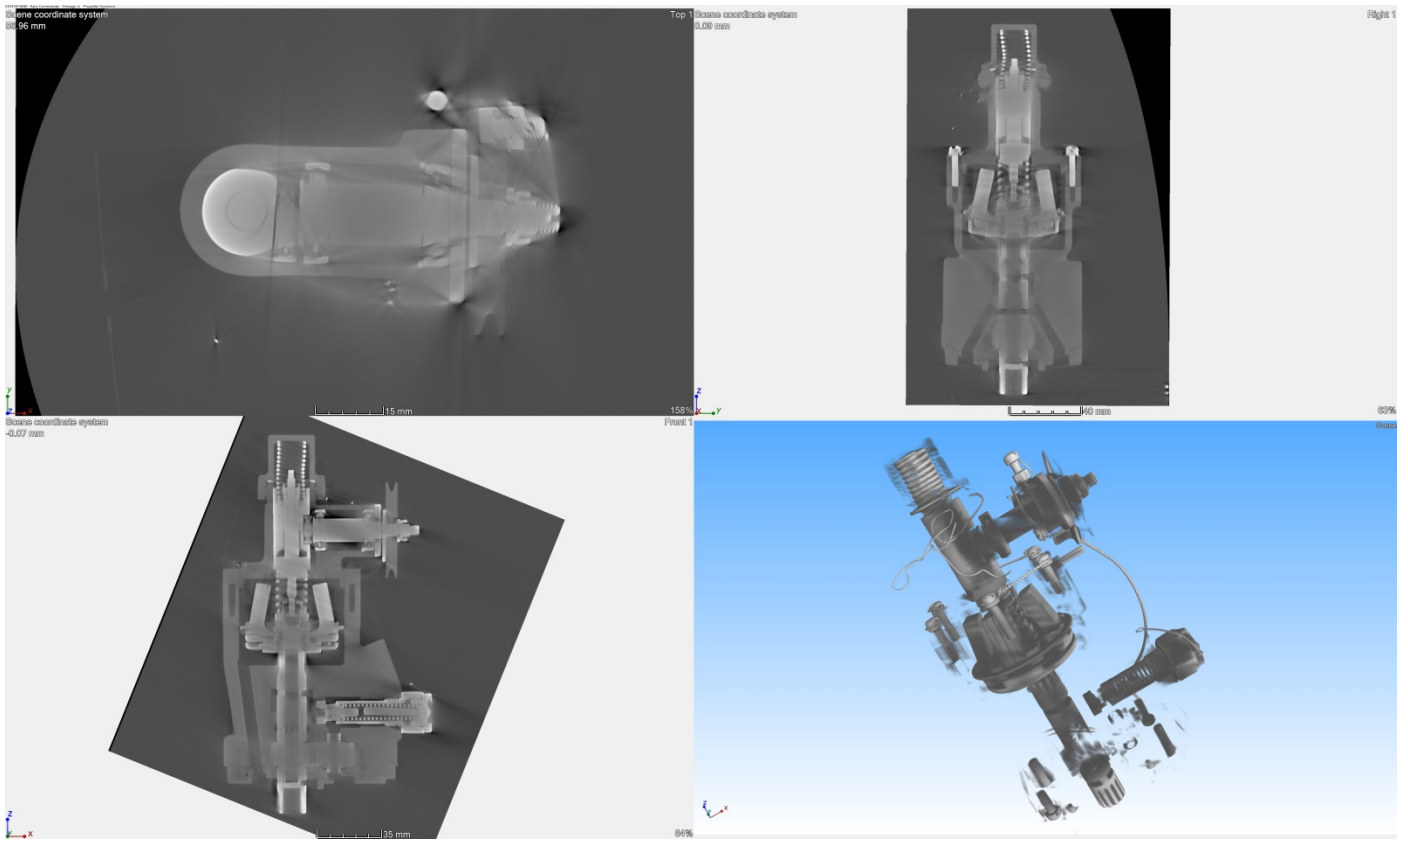
1. The flyweights were found to be in a position near the top of the flyweight cavity;
2. The driveshaft splines and the flyweight splines were aligned so that the driveshaft was not inserted into the flyweight mechanism;
3. All of the bearings within the governor appeared to be intact;
4. There was a high density material fragment noted within the flyweight cavity.

Figure 1
Left propeller governor – microfocus – Overall cross section

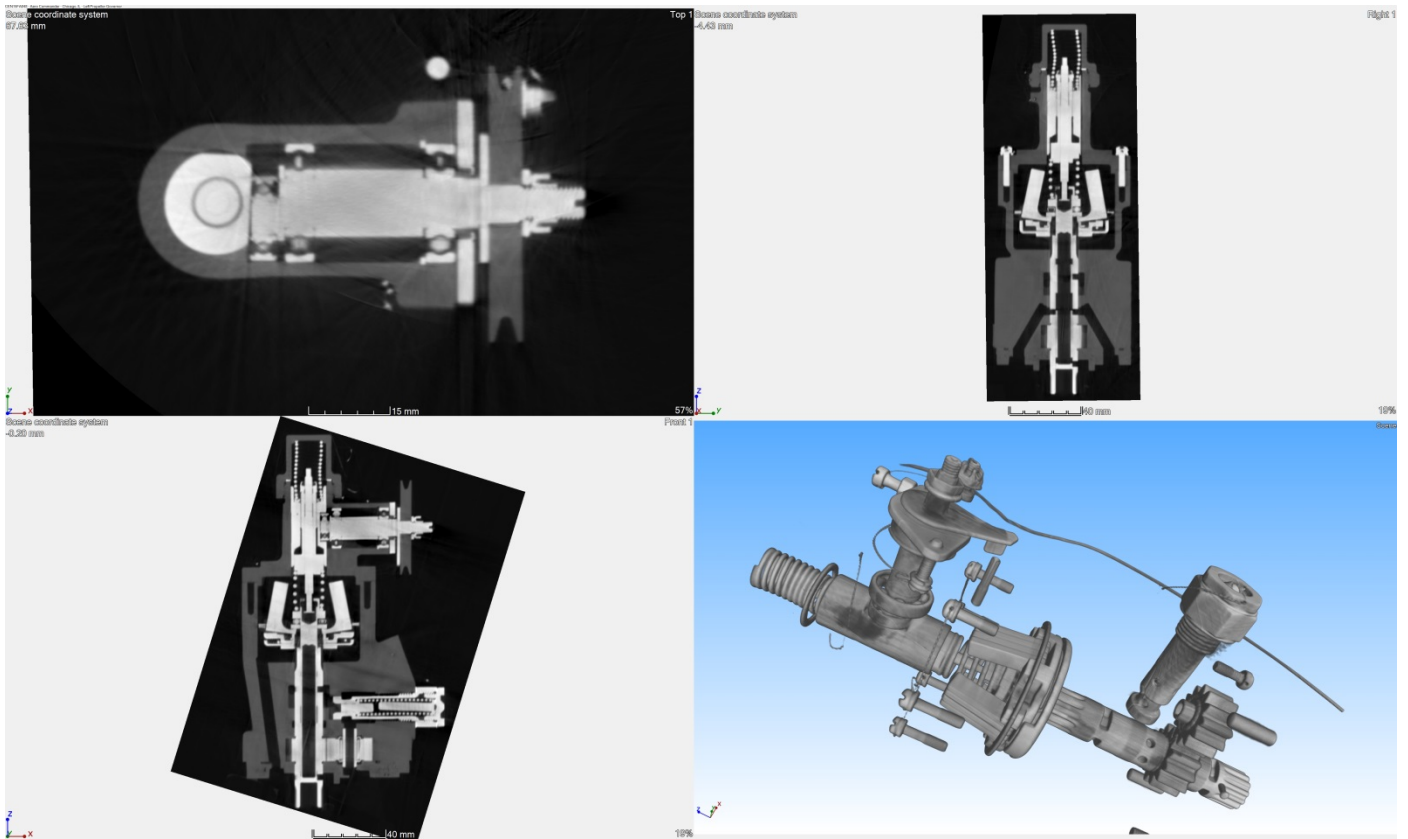
Figure 2
Left propeller governor – standard focus – Overall cross section

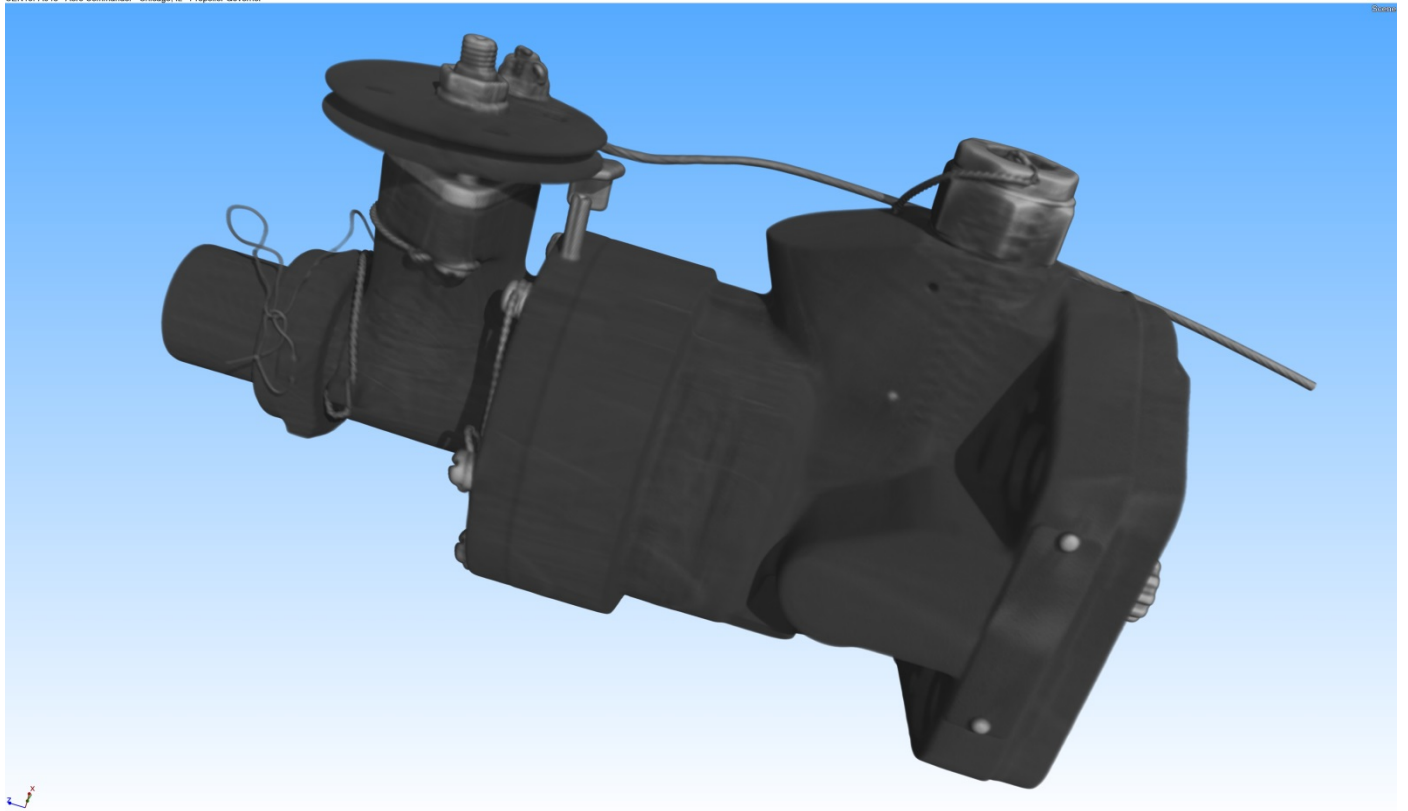
Figure 3
Left propeller governor – 3D view – Outer surface

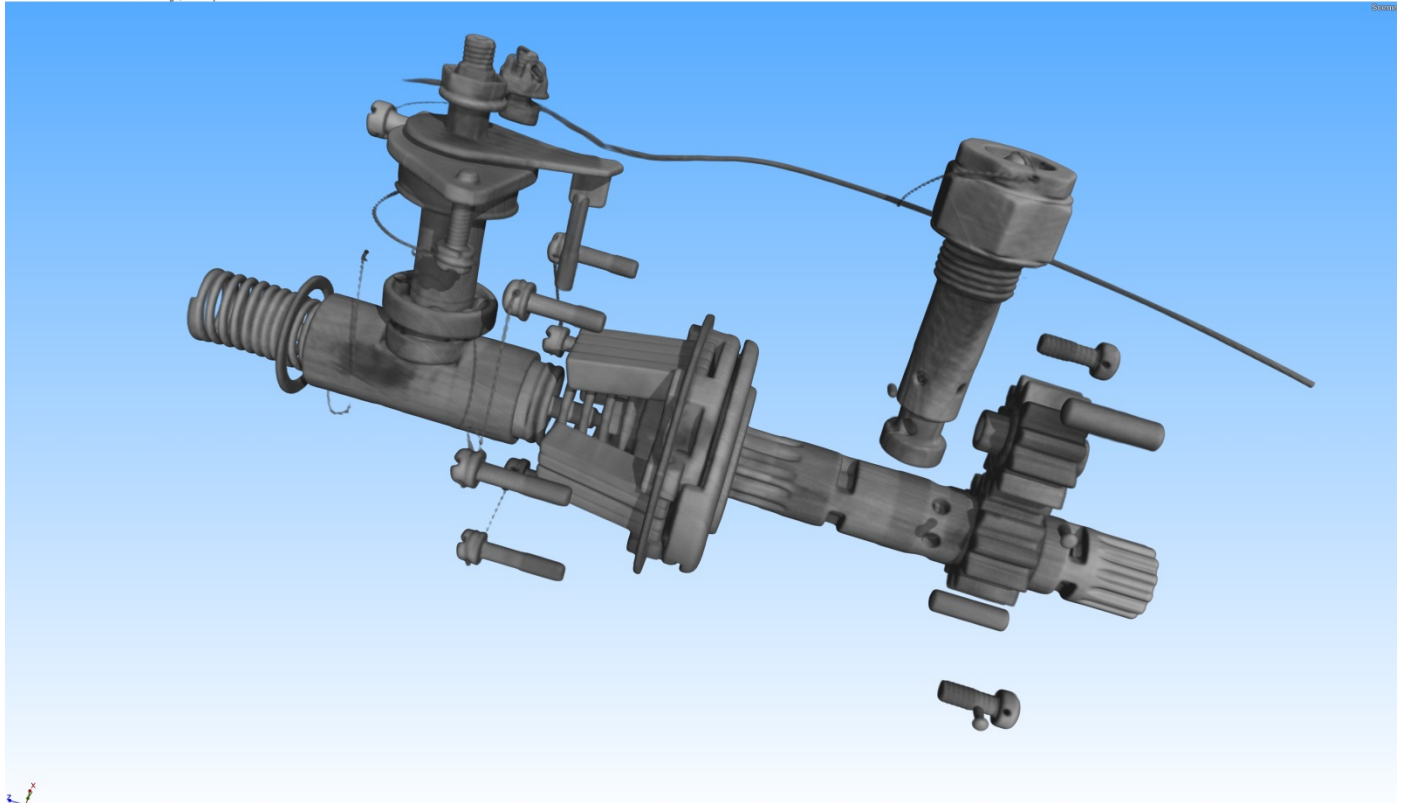
Figure 4
Left propeller governor – 3D view – high density components

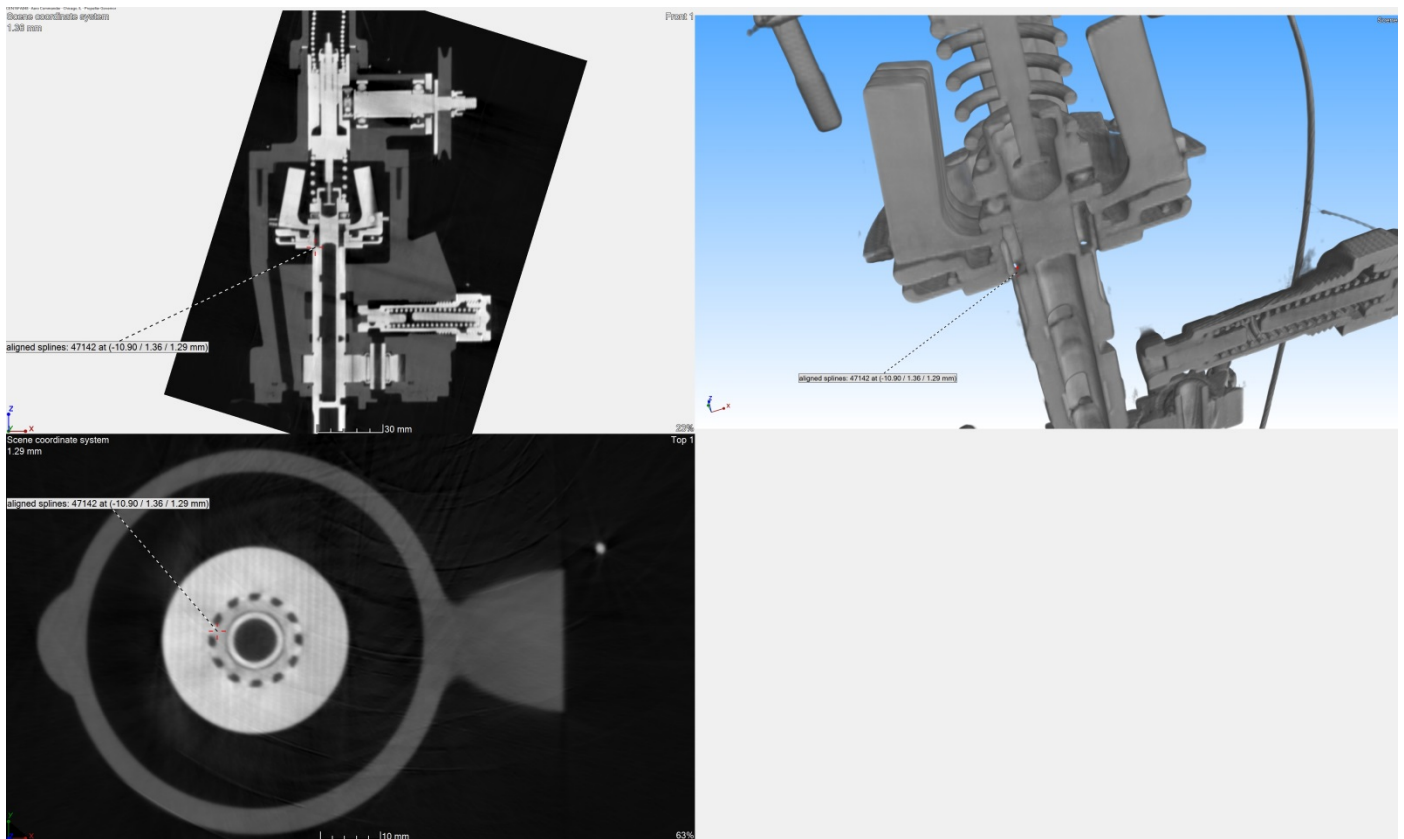
Review of the images determined that the left propeller governor flyweight mechanism was located at a position close to the upper wall of the flyweight mechanism cavity, and that the splines for the driveshaft and the flyweight mechanism were aligned so that the drive shaft was not inserted into the flyweight mechanism.

Figure 5
Left propeller governor – standard focus – aligned shaft and flyweight splines

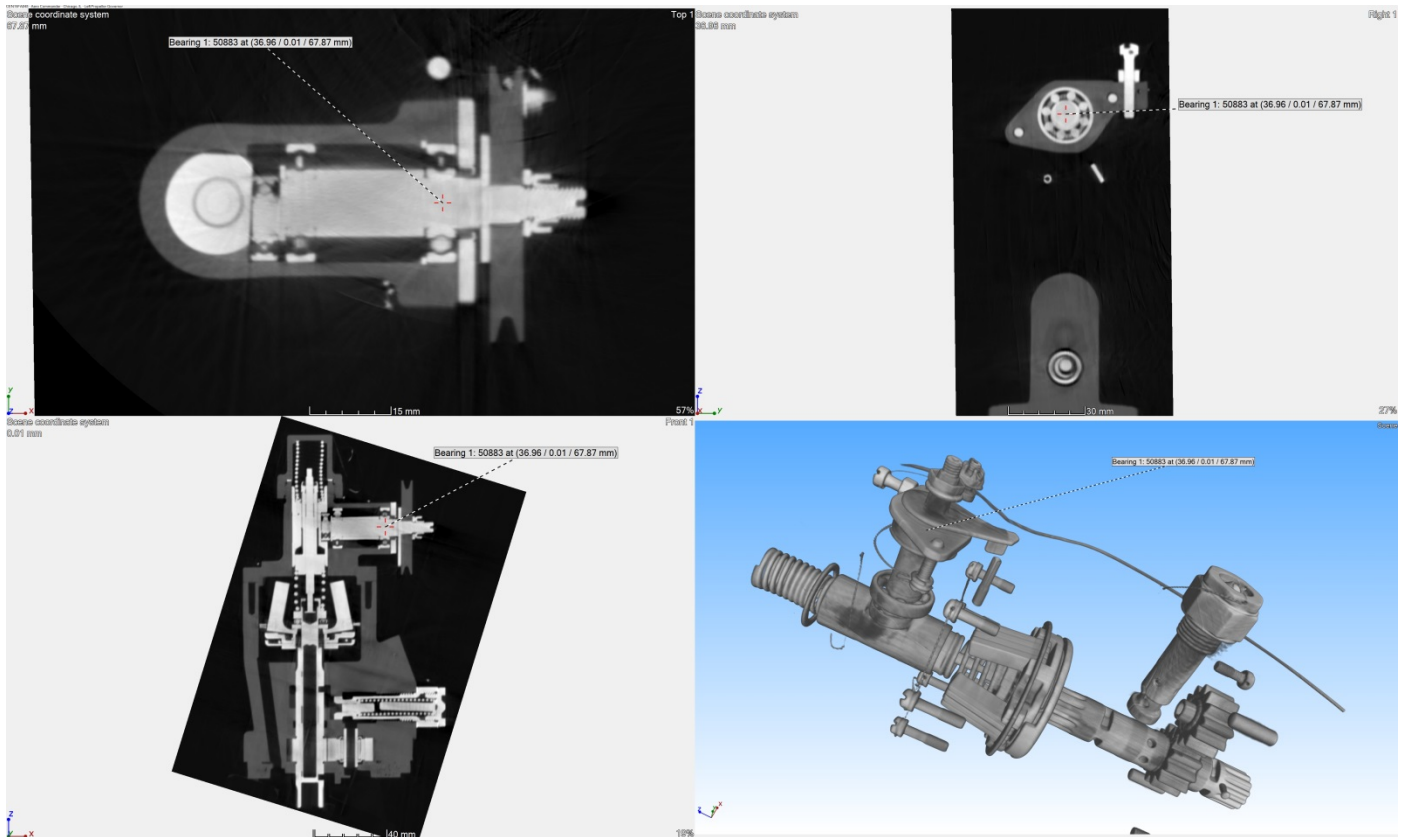
Figure 6
Left propeller governor – standard focus – bearing number 1

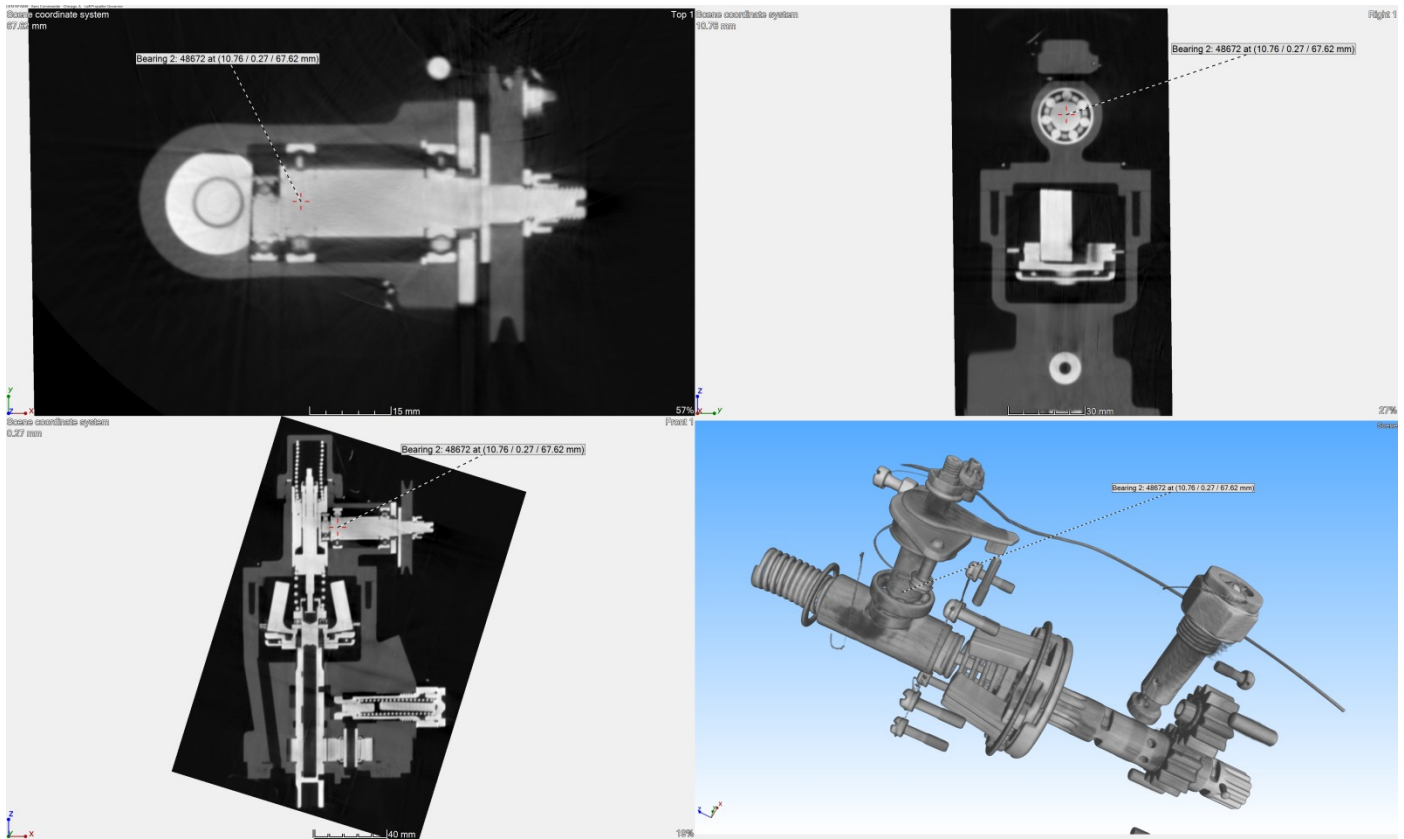
Figure 7
Left propeller governor – standard focus – bearing number 2

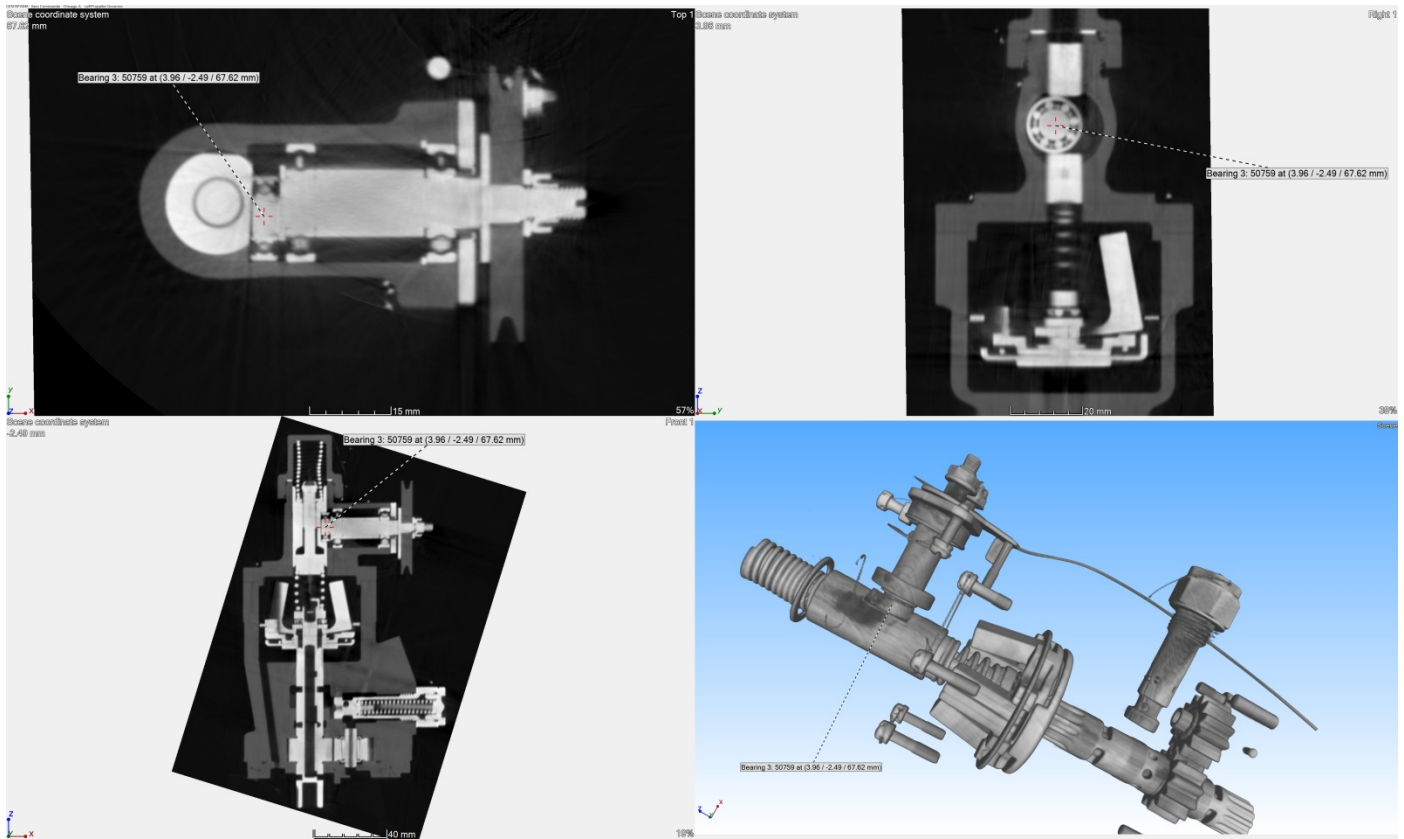
Figure 8
Left propeller governor – standard focus – bearing number 3

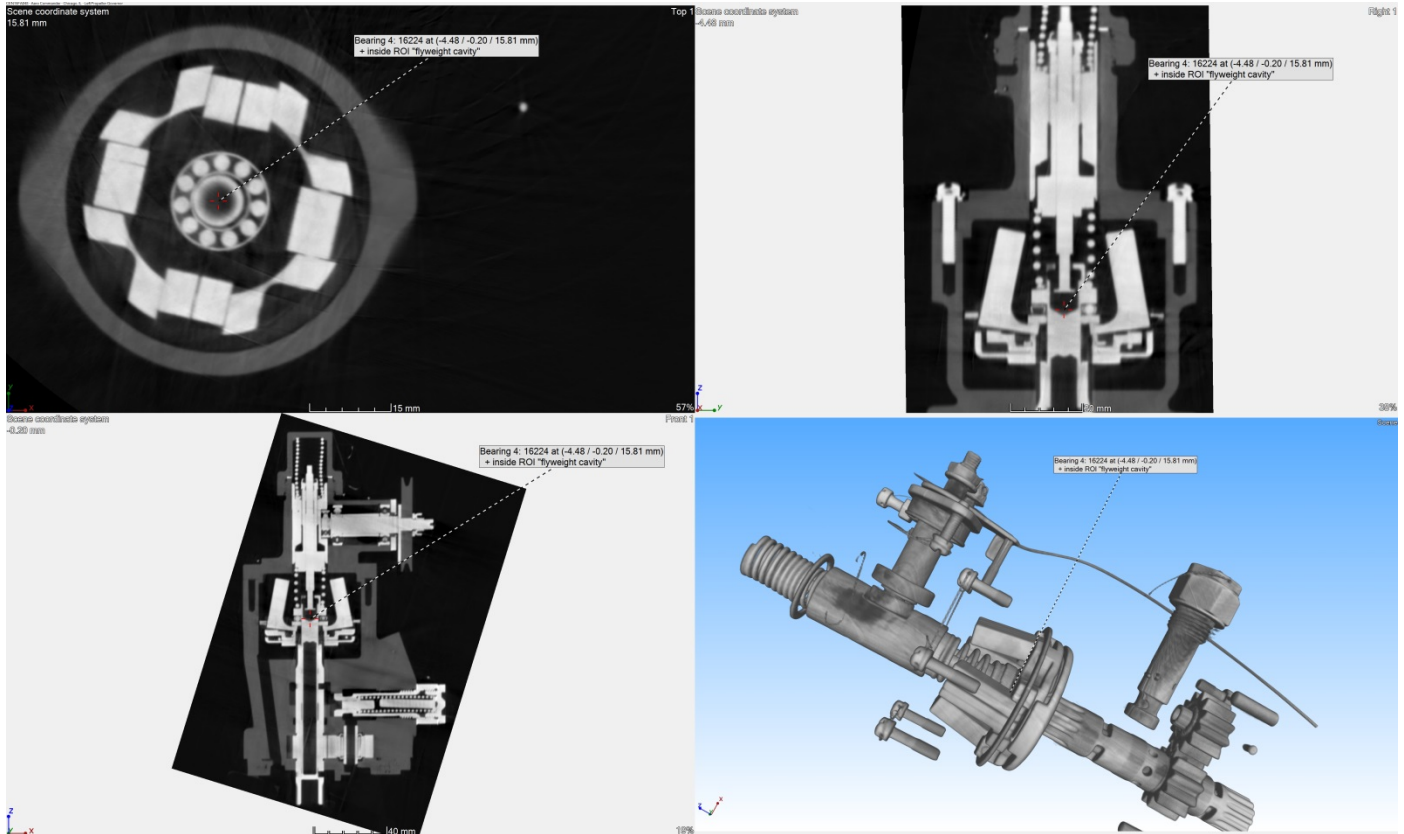
Figure 9
Left propeller governor – standard focus – bearing number 4

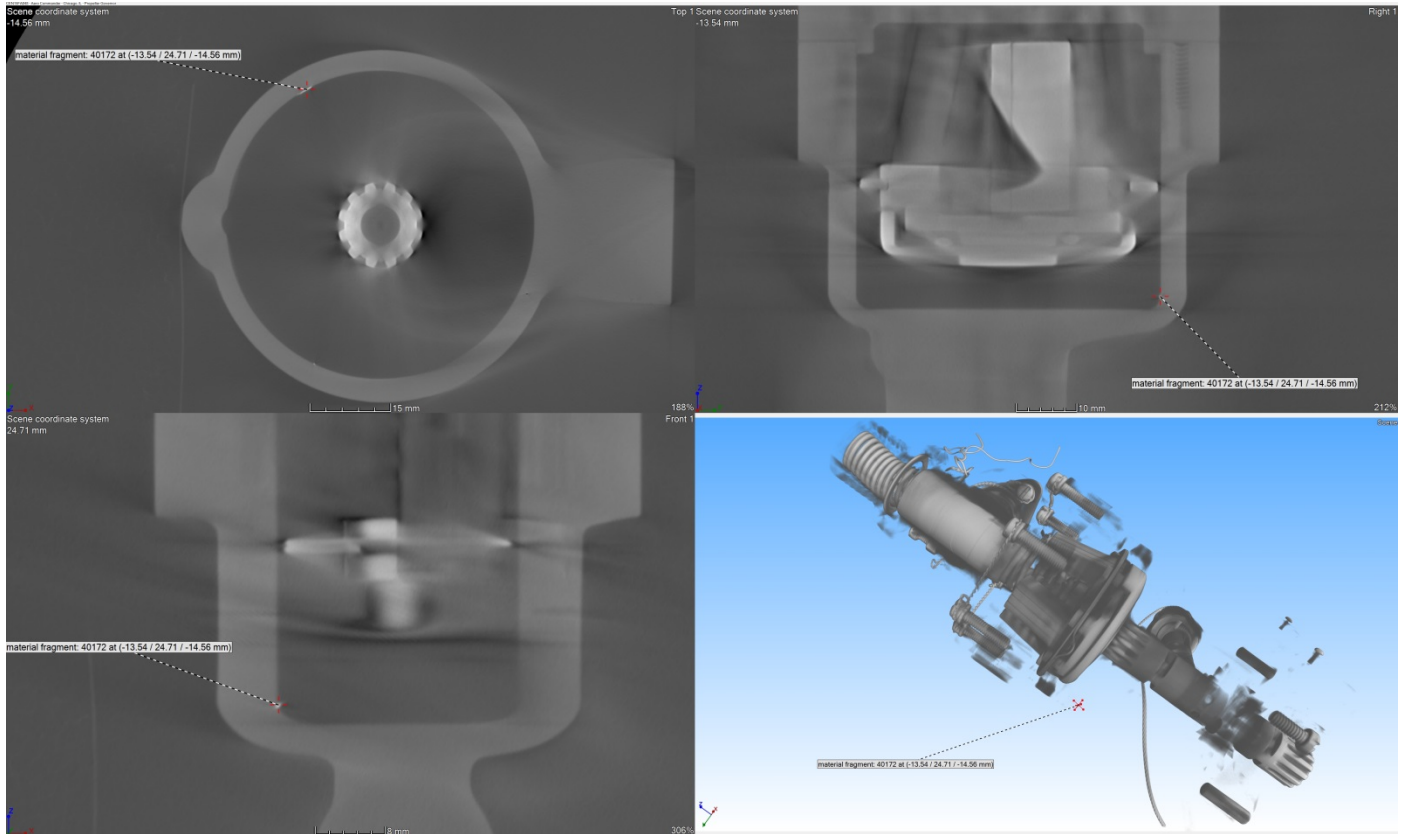
Figure 10
Left propeller governor – microfocus – material fragment within flyweight cavity

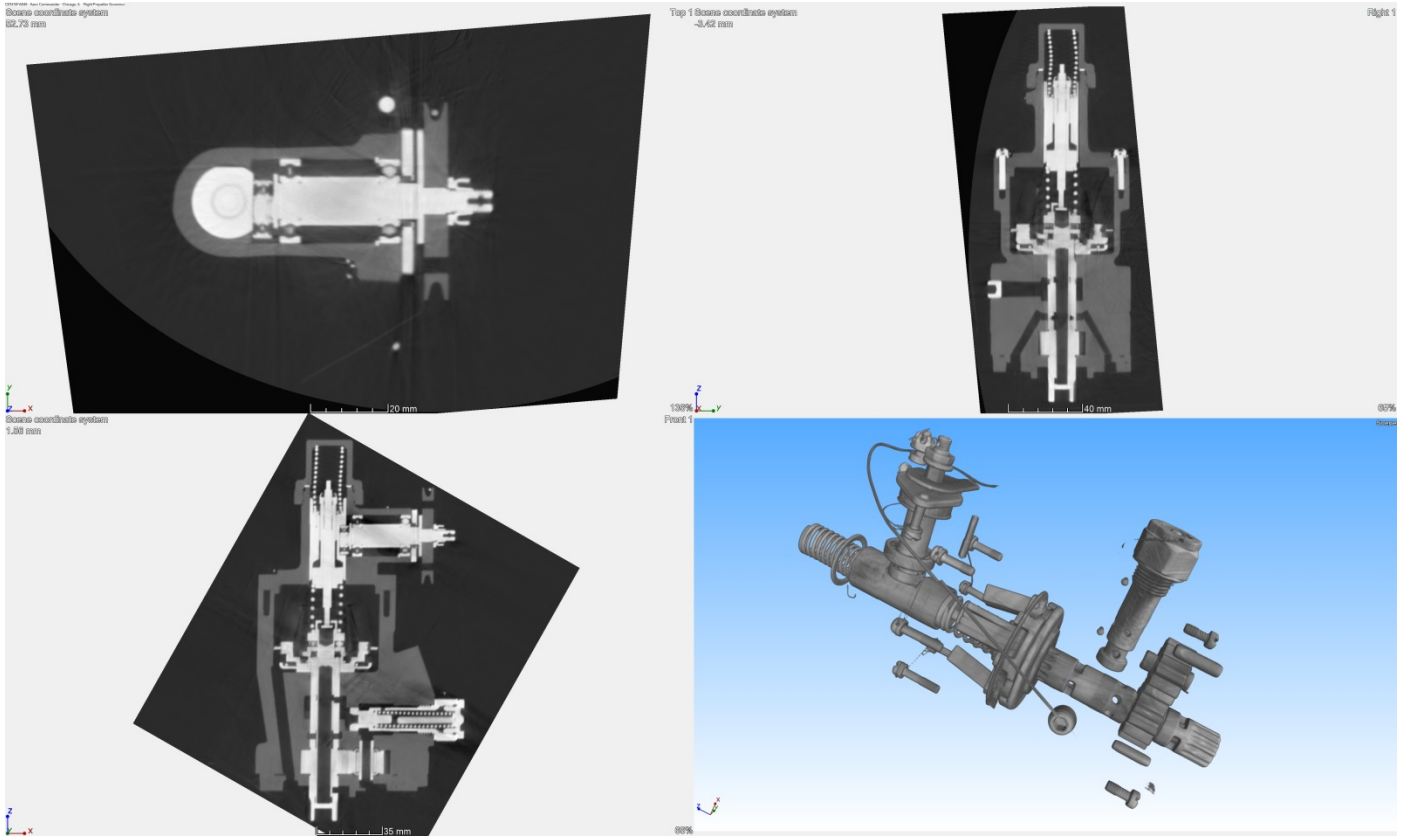
1. The bottom of the flyweight mechanism was located at the bottom of the flyweight cavity and the driveshaft appeared to be seated inside the flyweight mechanism;
2. All of the bearings within the governor appeared to be intact.

Figure 11
Right propeller governor – standard focus – Overall cross section

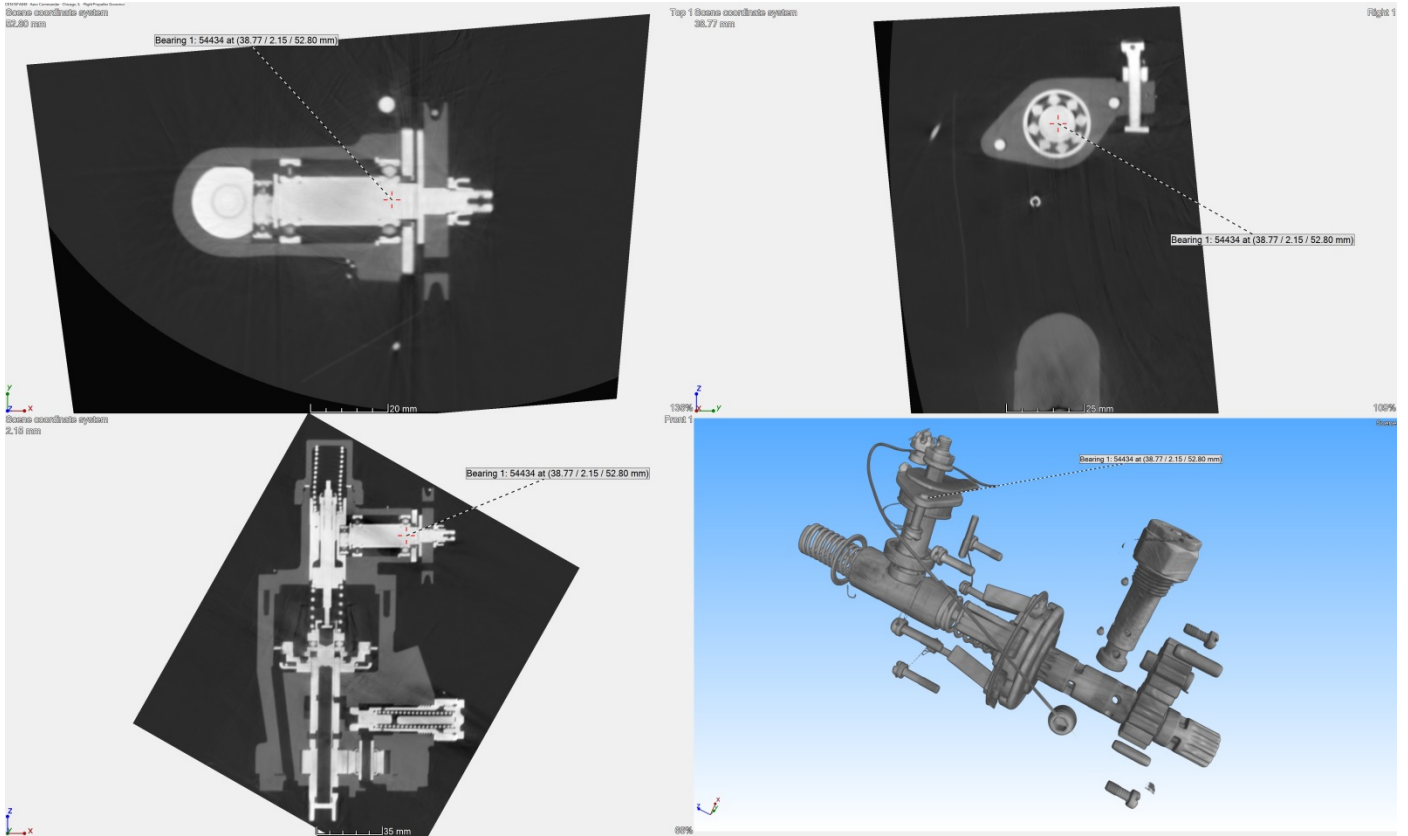
Figure 12
Right propeller governor – standard focus – bearing number 1

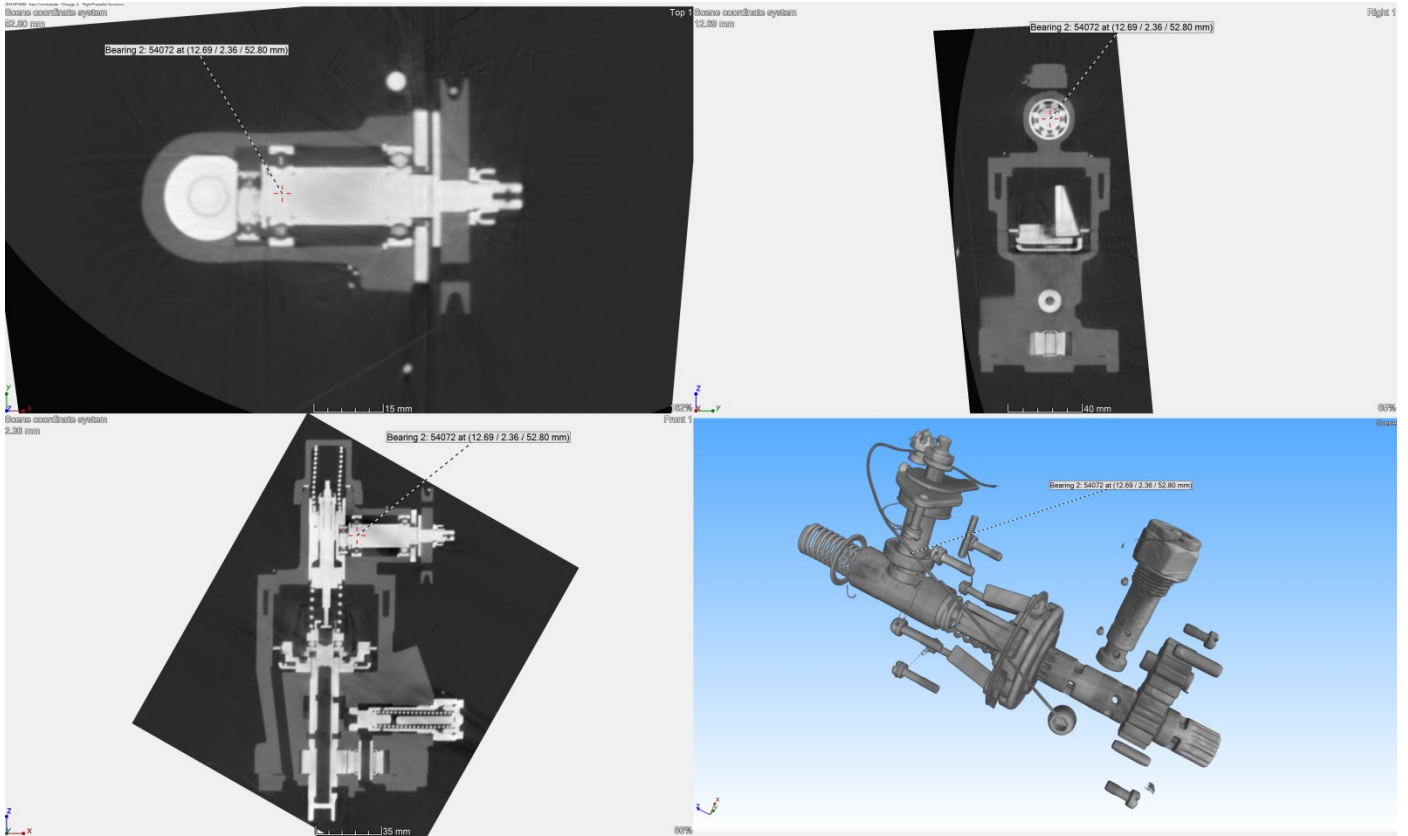
Figure 13
Right propeller governor – standard focus – bearing number 2

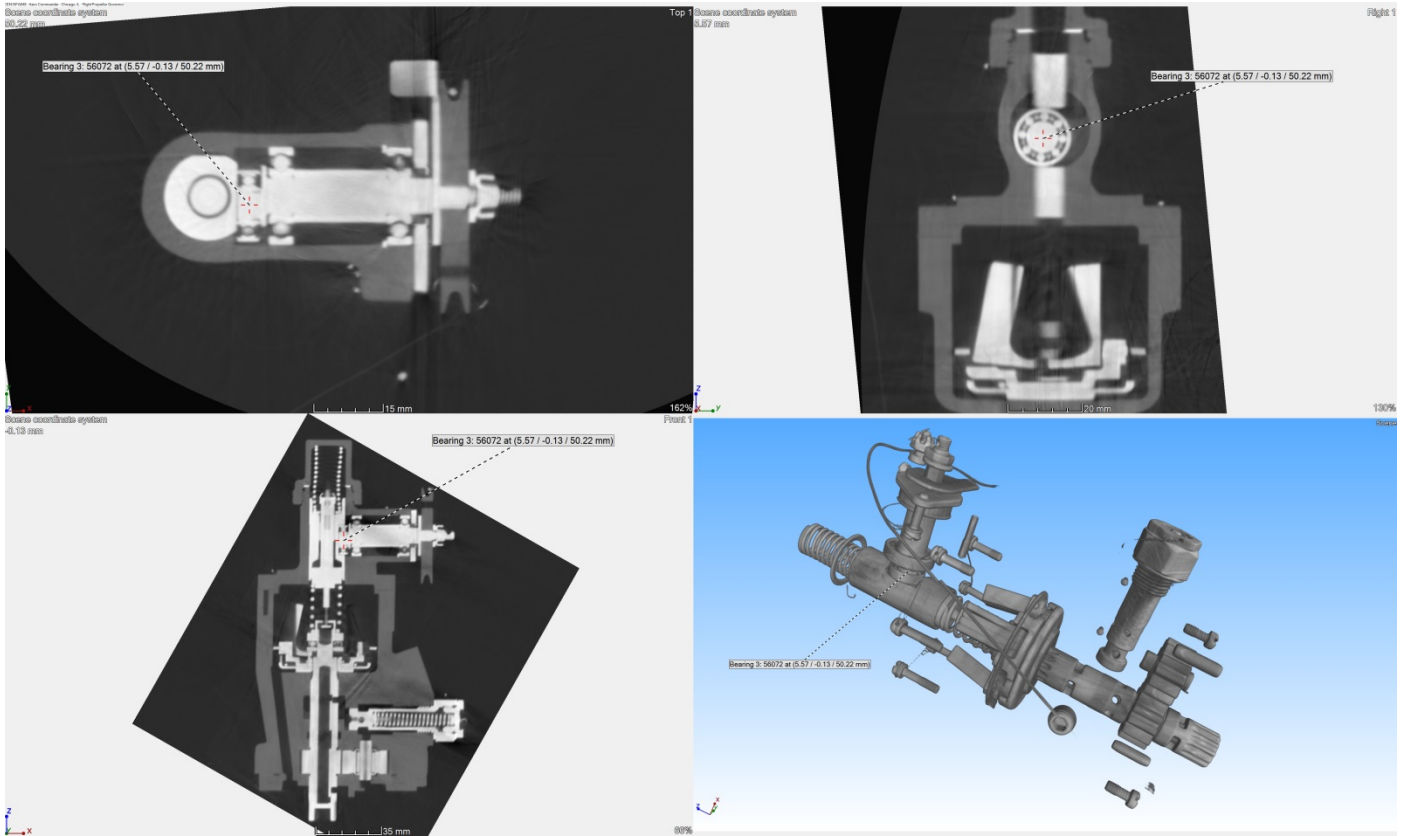
Figure 14
Right propeller governor – standard focus – bearing number 3

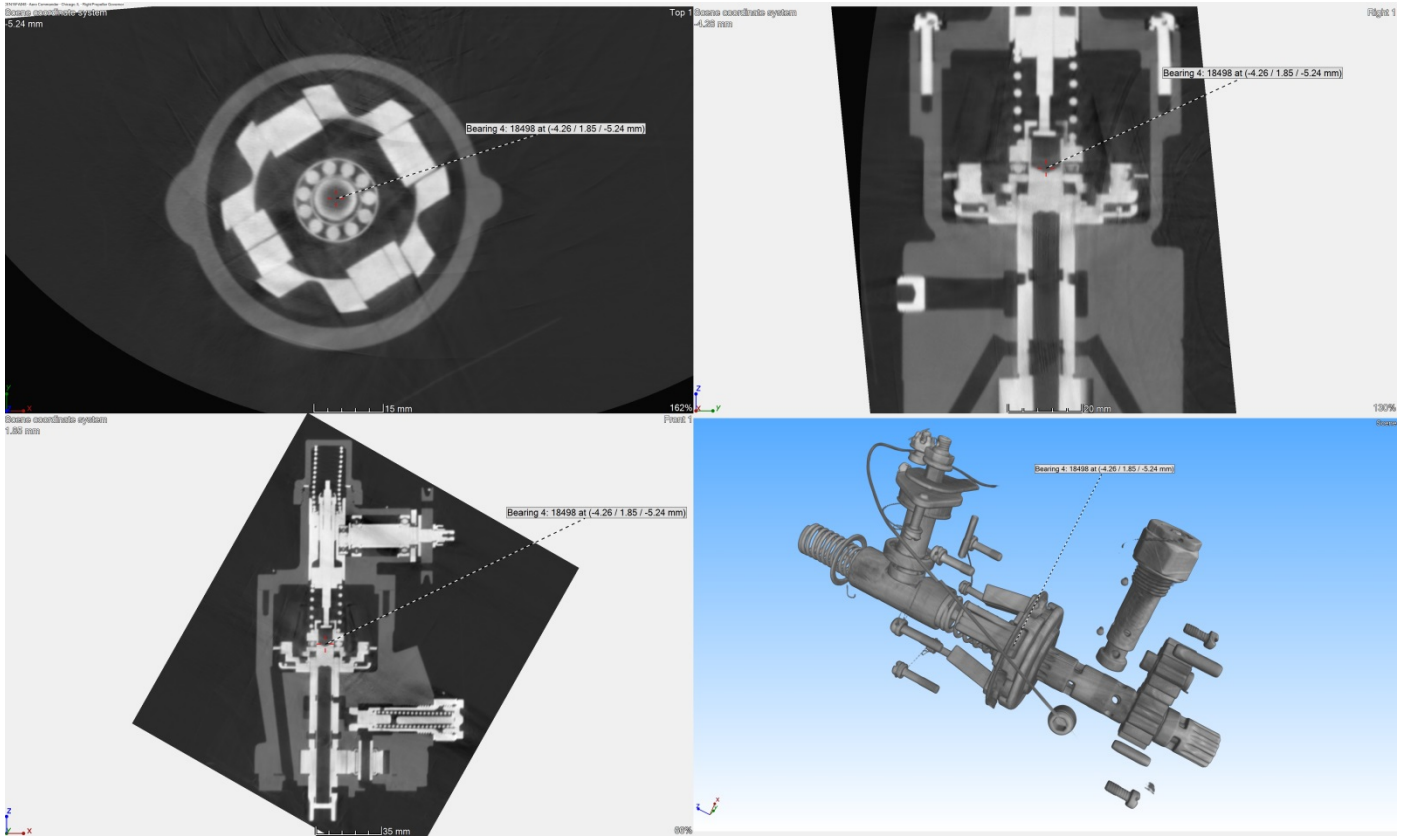
Figure 15
Right propeller governor – standard focus – bearing number 4
