PROPELLER GOVERNOR INSPECTION SUPPLEMENT

NTSB File No.: ERA15FA208

Aircraft: Piper PA-32R-300

Registration No.: N5802V

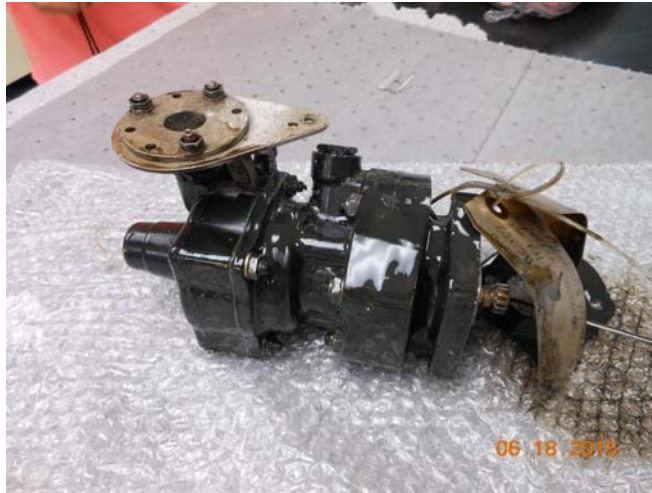
See Photos #1-3 for the as-received condition. The control arm and pump shaft moved freely by hand directly after removal from the shipping container.

Photo #1 – As-received

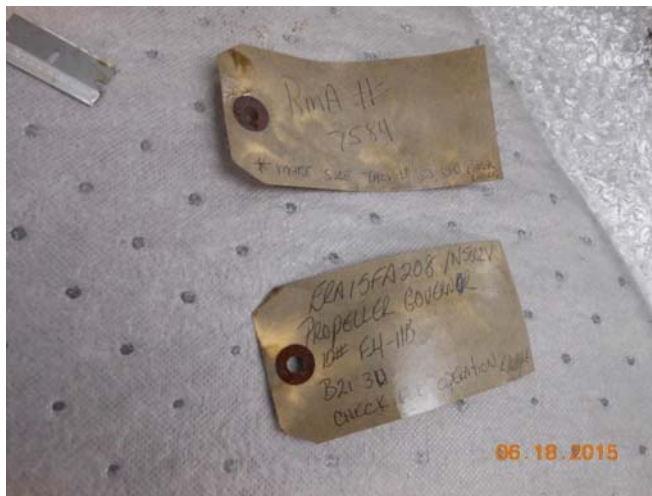
Photo #2 – Identifying tag signed by NTSB Investigator in Charge

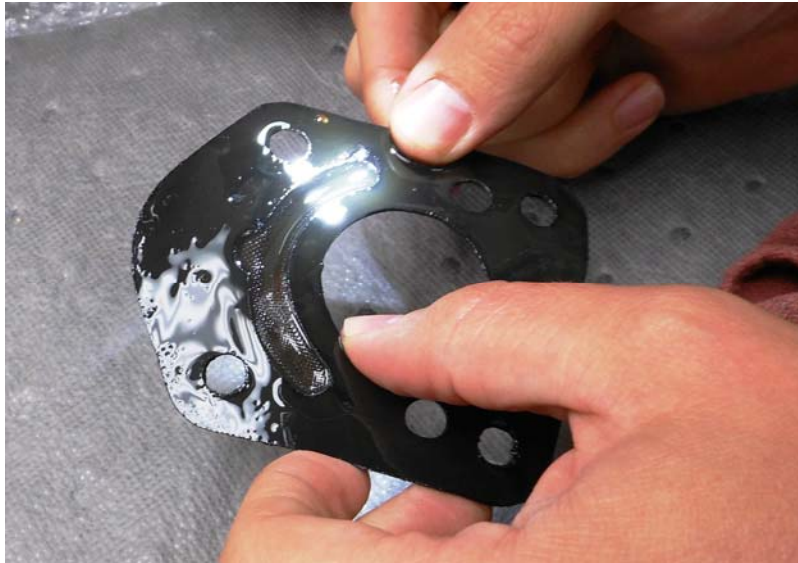
Photo #3 – Gasket/Screen as-received

The mounting pad was undamaged and the gasket/screen did not have any contamination or foreign debris (See Photo #3).

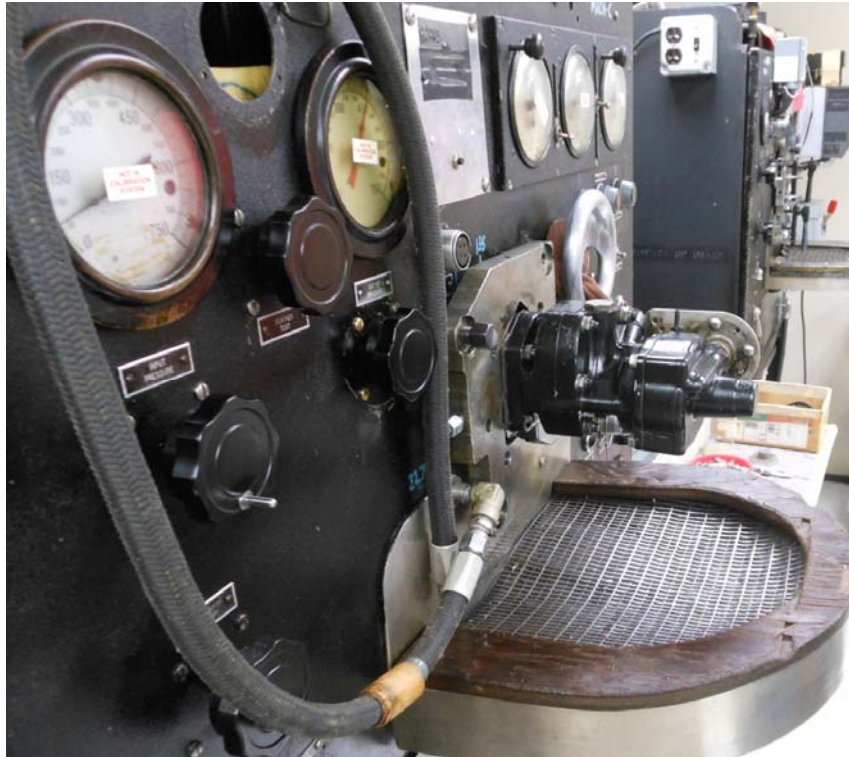
The governor was mounted on the Hartzell governor test stand for a functional test as specified in Hartzell Manual 130B (see Photo #4). The governor was not flushed out prior to this test. A particle screen was positioned to capture all oil drained from or pumped out of the governor during the test. There was no foreign debris detected in the screen following the test. The following tests were run with the noted performance:

1. Pressure relief setting was 295 psi vs. a requirement of 275-300 psi.
2. Pump capacity flow rate was 9.84 quarts/min at 1750 vs. a requirement of 8-12 quarts/min.
3. Leakage rate was 3.25 oz./min vs. a maximum limit of 8 oz./min.
4. High RPM setting was 2660 RPM at 118°F oil temperature vs. a requirement of 2555 +/-10 RPM.

Although the high RPM setting was higher than factory specifications, it does not affect the governor performance. A higher than specified RPM setting indicates an adjustment was made to the governor high RPM stop while installed on the aircraft. This adjustment is typically described in the aircraft maintenance manual should an aircraft installation require it to reach rated RPM inflight. A governor RPM setting of 2660 is equivalent to 2808 engine/propeller RPM on the IO-540-K() series engine.

Photo # 4 – Governor installed on Test Stand (fine screen not positioned yet)

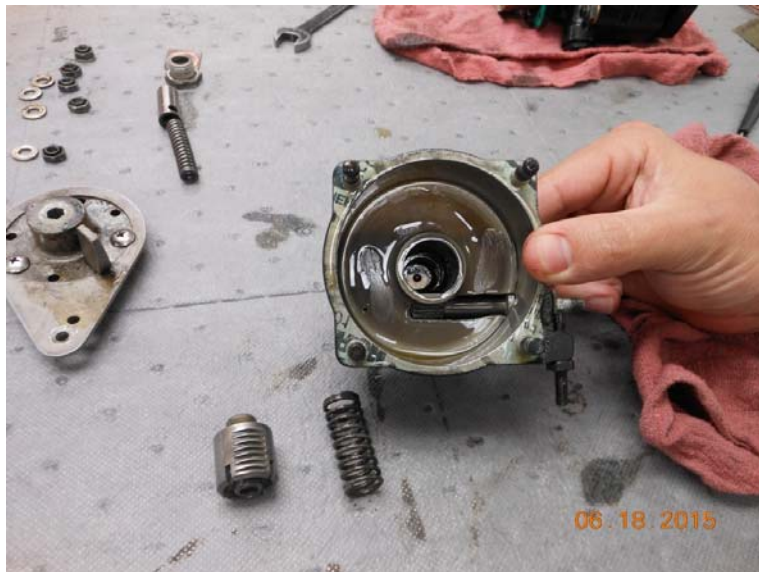
- Pressure Relief Valve –** Serviceable, no discrepancies noted.
- Control Arm/Head –** Serviceable, no discrepancies noted (see Photo #5).
- Oil Pump –** Serviceable, no discrepancies noted (see Photo #6-7).
- Spool –** Serviceable, no discrepancies noted (see Photo #8).
- Flyweight Assembly –** Serviceable, no discrepancies noted (see Photo #9).
- Drive Coupling –** Serviceable, wear on drive face showed some signs sudden stoppage (see Photo #10) consistent with propeller ground impact but does not affect functionality or performance.

Photo #5 – Control Arm and Head

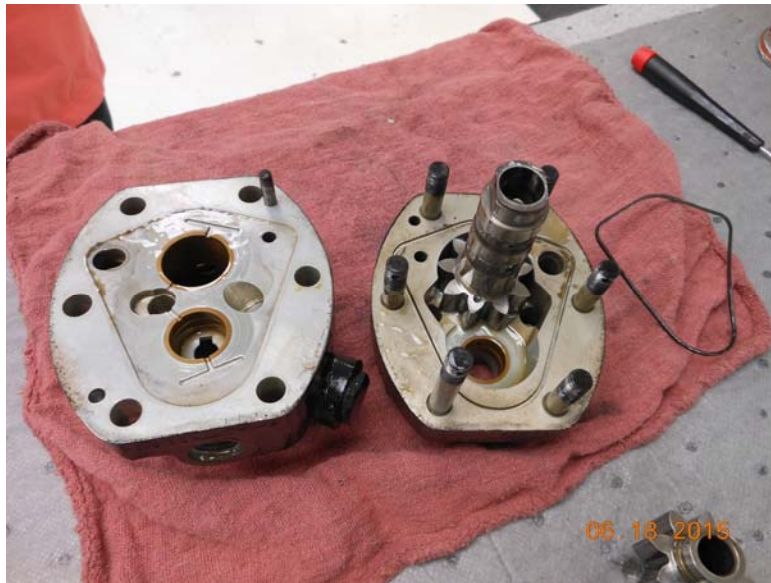
Photo #6 – Governor oil pump

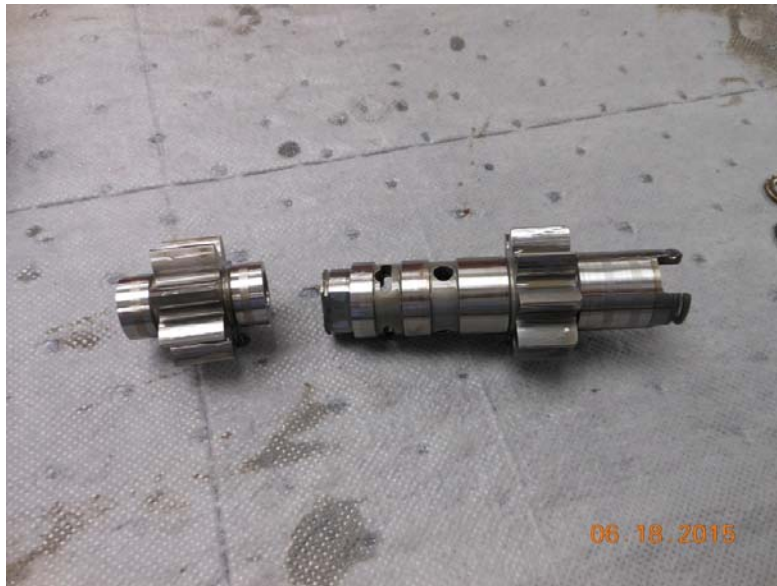
Photo #7 – Governor oil pump gears

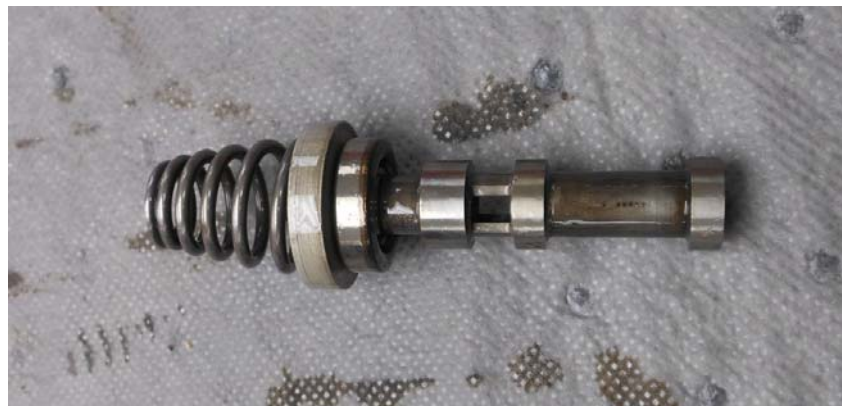
Photo #8 – Governor spool

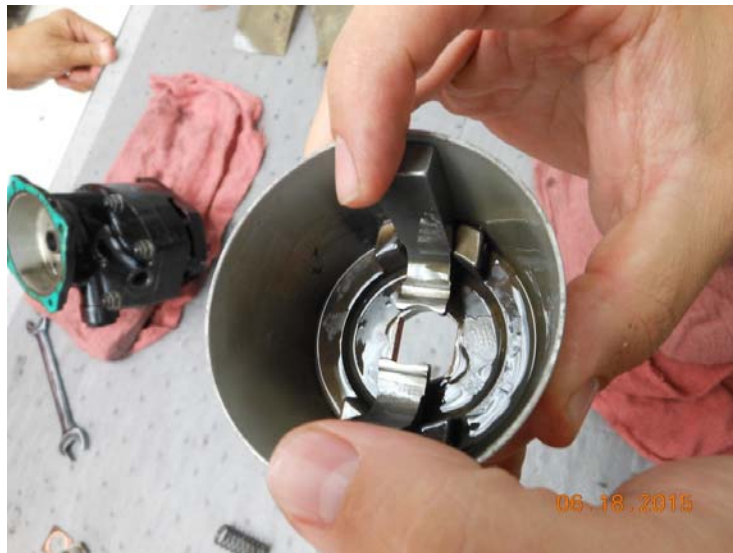
Photo #9 – Flyweight Assembly

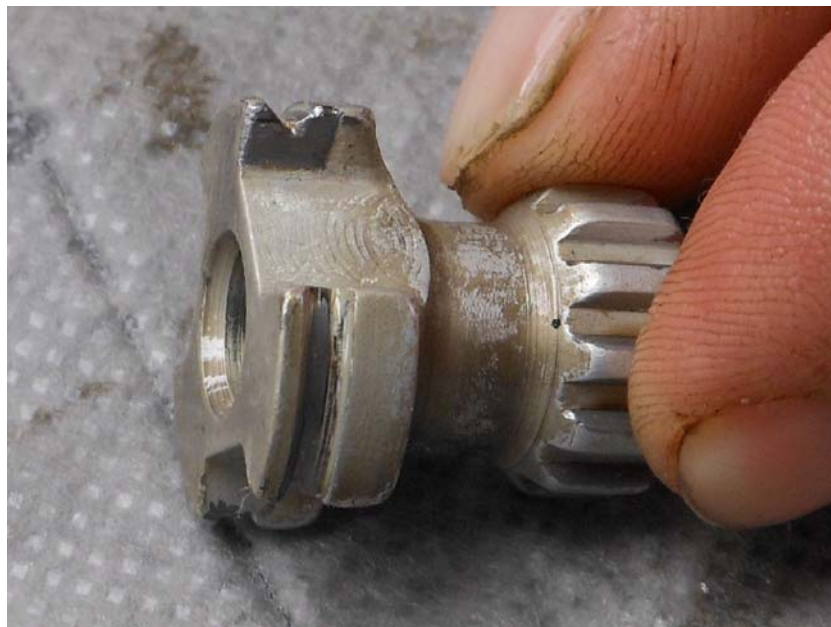
The as-received F-4-11B propeller governor functioned normally and met all factory specifications except for maximum RPM; the governor maximum RPM setting was 2660 RPM vs. a factory specification of 2555 +/- 10. The governor drive coupling showed some signs of sudden stoppage consistent with a propeller ground impact but it did not affect performance or functionality. There were no discrepancies noted that would prevent or degrade normal operation.

Photo #10 – Drive Coupling
