Aircraft Accident/Incident Report No.: 060729

Date of Accident: July 29, 2006
Location: Sullivan, MO

Aircraft: DeHavilland DHC-6-100 Twin Otter
Registration No.: N203E
Serial No.: 53

Written by: Tom McCreary
Air Safety Investigation Manager

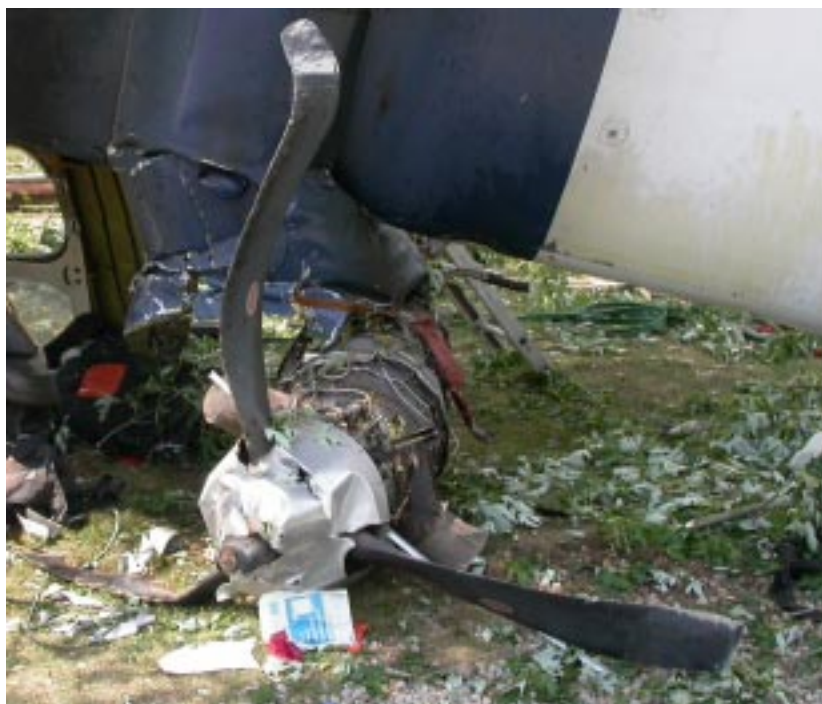
The blades of the left propeller had rotational scoring and leading edge damage. They had multiple bends, twisting, and tearing in the tip area of all three blades. The tip of one blade was torn off. This is characteristic of impact at high rotational energy, i.e. power ON.

On-scene photos show the left propeller with the spinner dome installed. One photo shows a severed blade tip. (The spinner dome and blade tip were not observed during the investigation in Montreal).

Left propeller at accident site

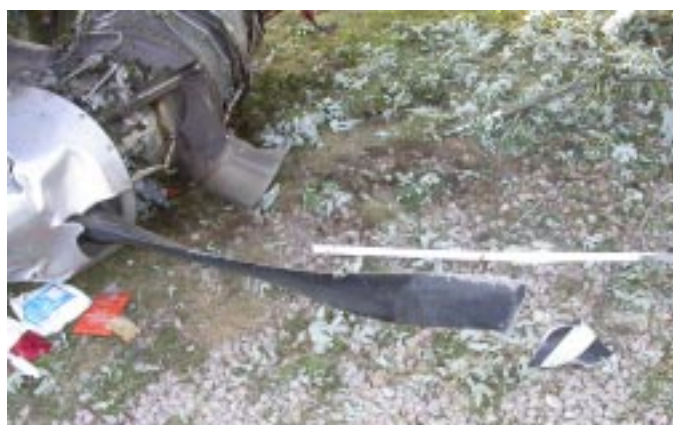
Left propeller blade tip

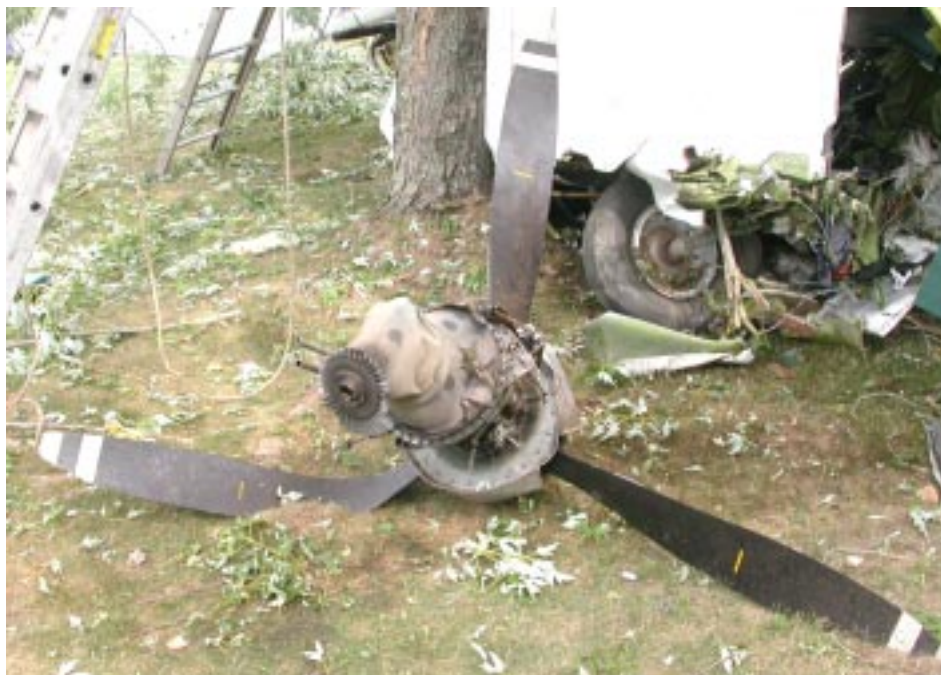
On-scene photos show the right propeller and portion of the engine located behind the right wing. In these photos the propeller is at a high blade angle, estimated to be 65° to 70°.

Right propeller at accident site (Sheriff's Dept. photo)

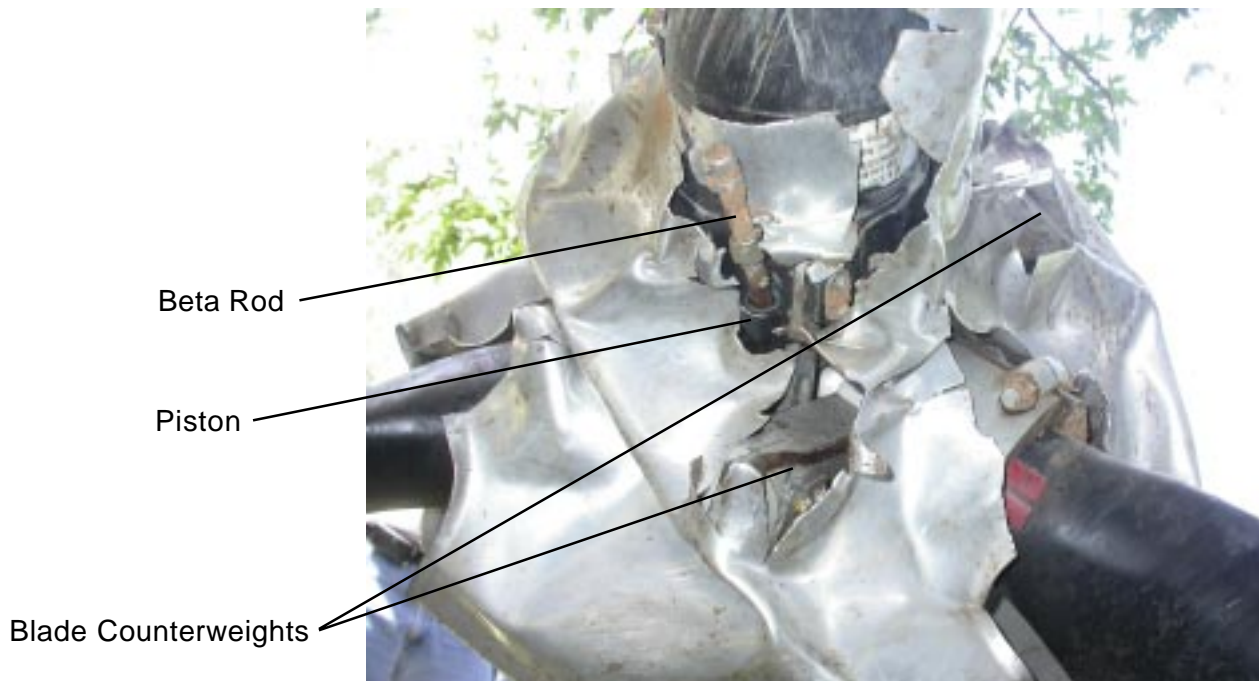
On-scene photos show a crushed spinner dome encompassing two blade counterweights protruding at a high blade angle position. The estimated blade angle in this photo (photo page 5) is approximately 65° to 70°.

Right propeller with spinner crushed over blade counterweights (NTSB photo)

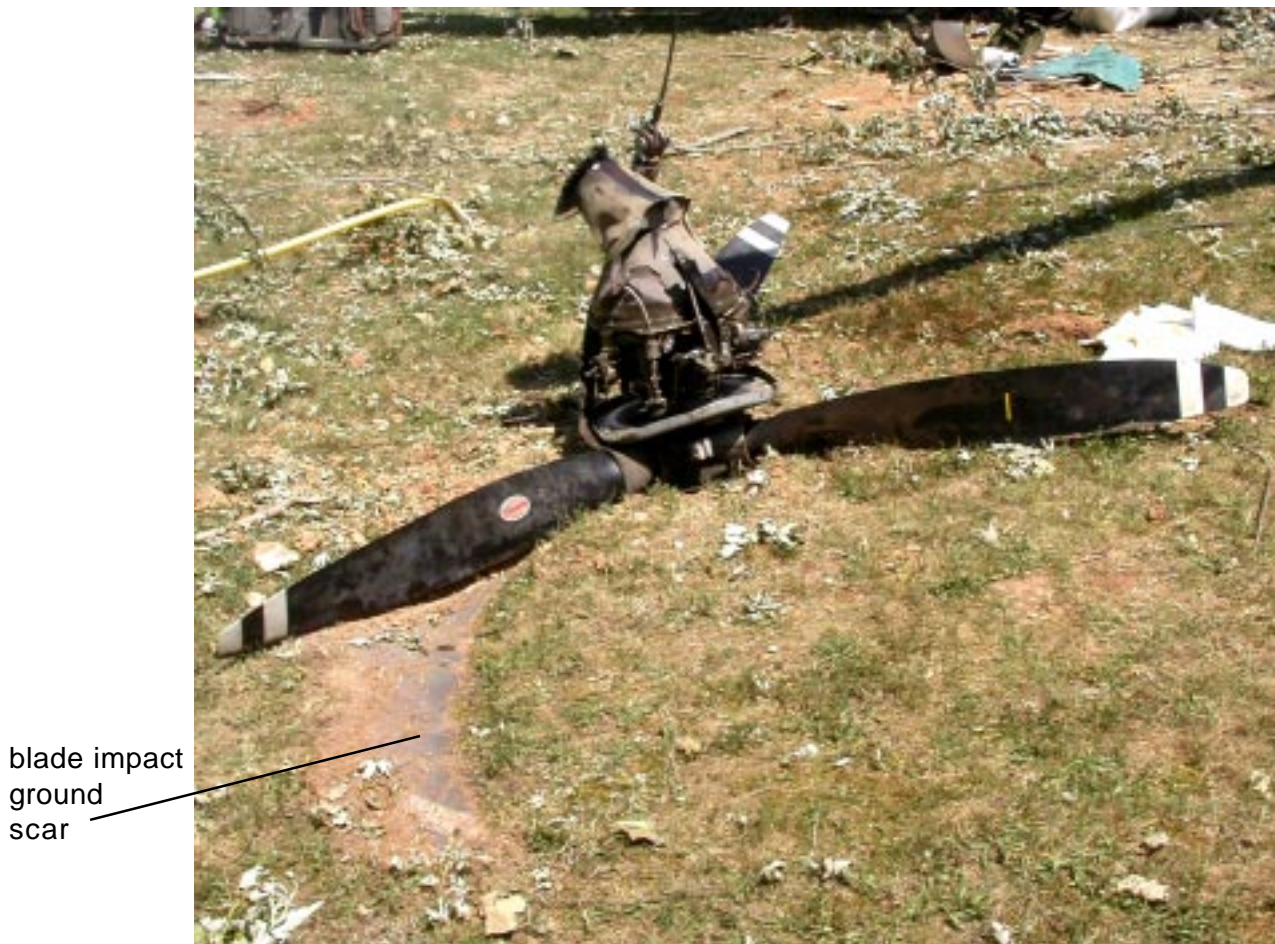
On-scene photos of the impact crater of the right propeller show a spiral motion of one blade, which possibly suggests some rotation at impact. (However, Pratt & Whitney reported that the power turbine had created static imprint marks.)

The NTSB reported that during the recovery operation the propeller was attached to a hoist and relocated to the crater formed by initial impact of the right propeller as shown below. The impact crater was located in front of the right wing. In these photos the propeller is partially imbedded in the ground and there is a cable (hoist) attached to the propeller. In the photo below, the right propeller is in the feather position and the spinner dome has been removed. (Evidently the blade angle changed from a high angle to feather after the spinner dome was removed.)

Right propeller repositioned in impact crater during NTSB investigation
(NTSB photo)

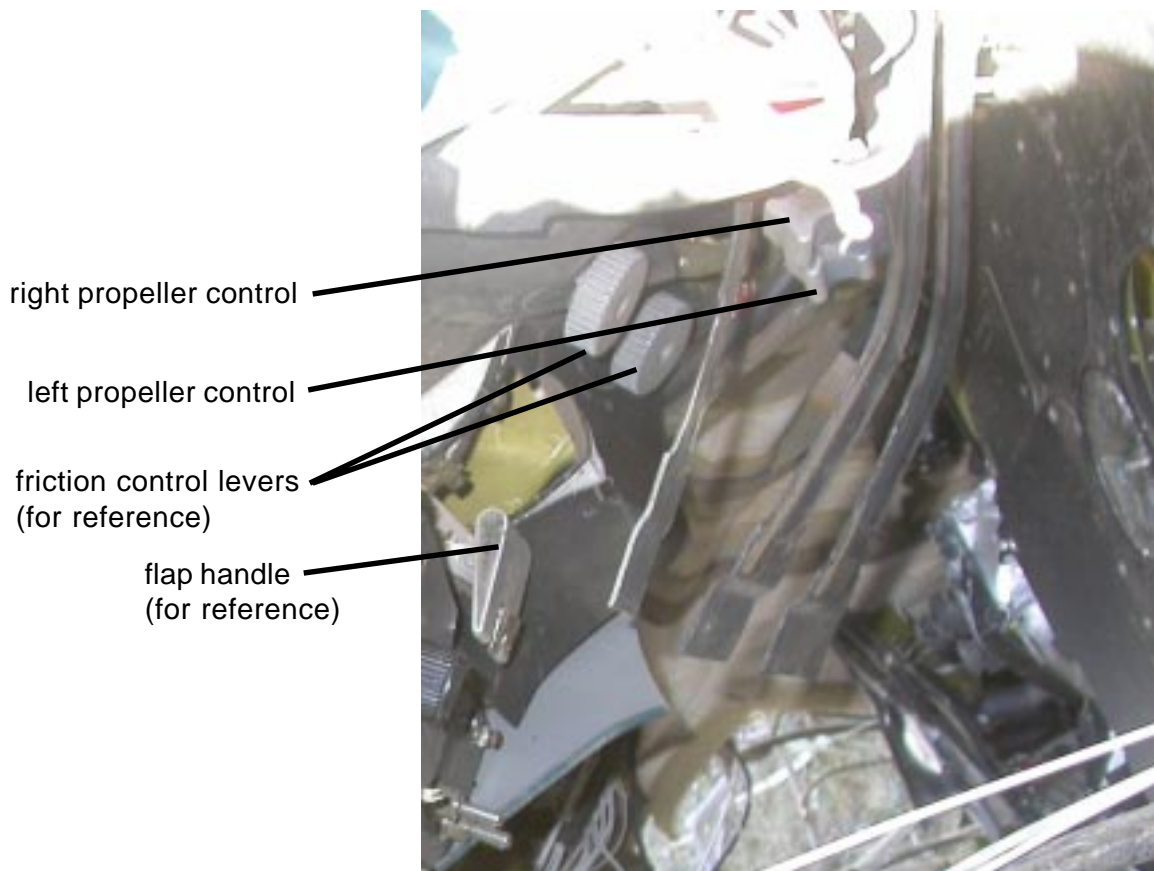
On-scene photos of the cockpit controls did not provide any evidence to indicate that the pilot had attempted to feather the right propeller (photo page 7).

On-scene photos show both of the propeller control levers in nearly the same position. Photos also show a placard indicating that the autofeather system was deactivated.

Overhead engine controls (NTSB photo)

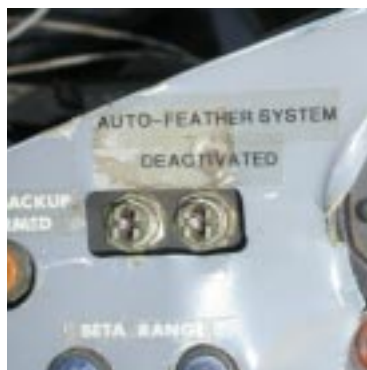
Autofeather placard (NTSB photo)

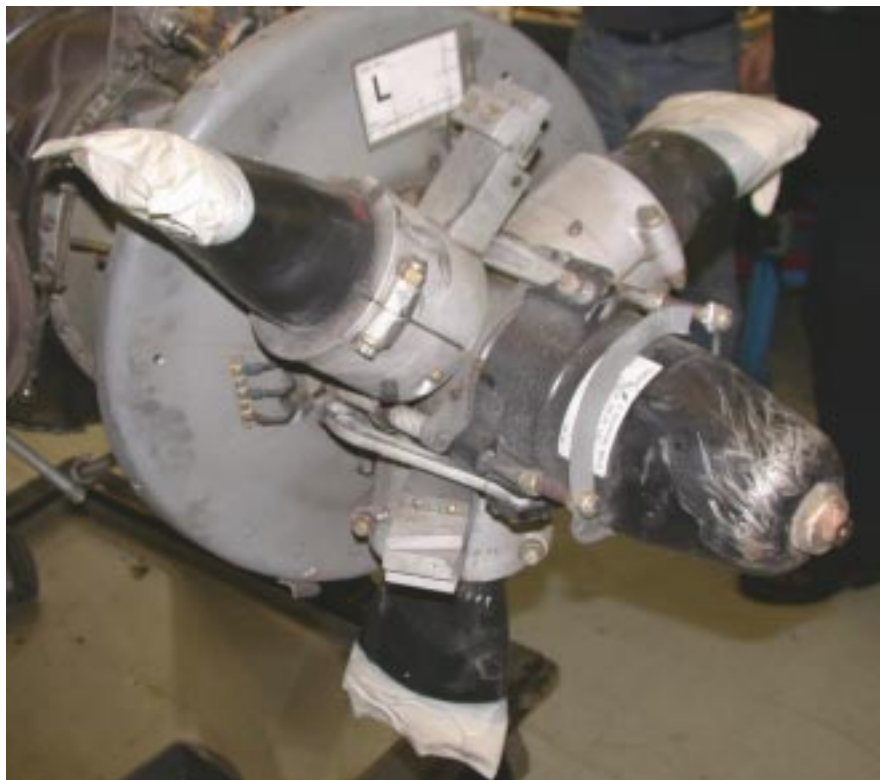
The blades had been cut off to facilitate shipment. The spinner dome was missing and the propeller remained attached to the engine. The beta rod end ring was fractured and bent aft. L1 link arm was connected. L2 and L3 link arms were disconnected. L2 linkscrew had separated from its clamp. The outer end of L3 link screw was broken off. L1 and L2 blade clamps/counterweights were at or near the feather position. L3 blade clamp/counterweight was at a low blade angle position. The aft end of the piston was measured to be 22/32 inch from the guide collar. This equates to approximately 68° blade angle.

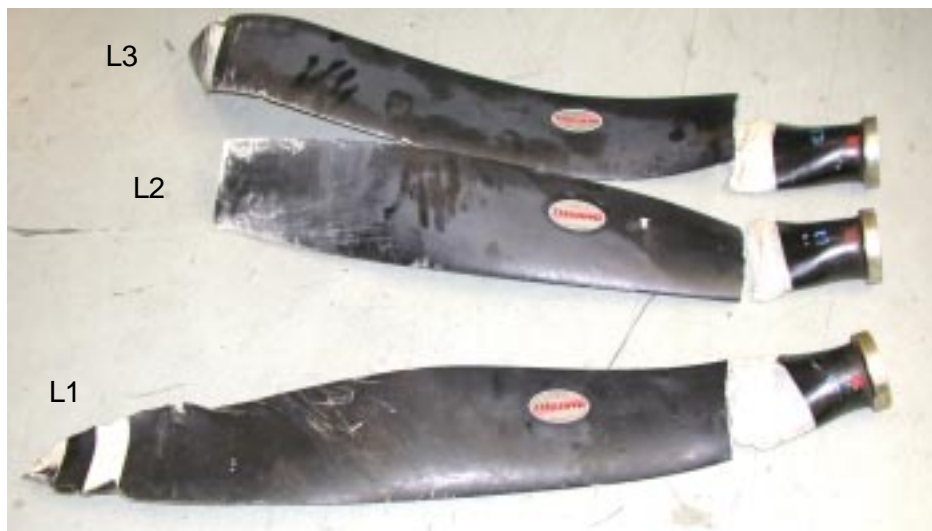
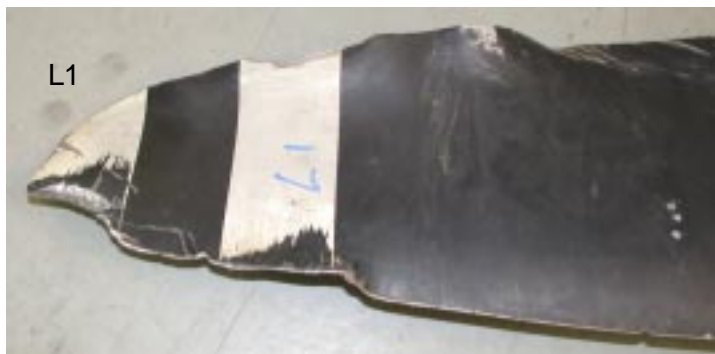
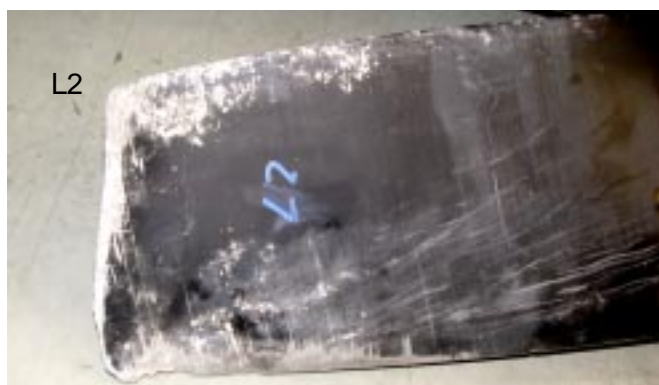
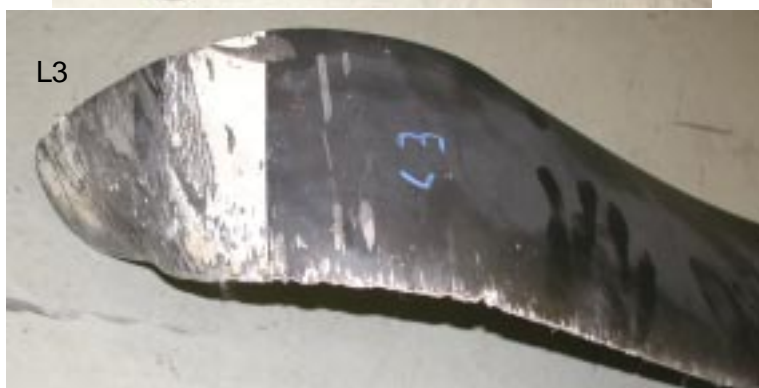
See blade photos on Page 12.

L1 blade had multiple fore and aft bends. It was bent forward at 1/3 radius and bent aft at 2/3 radius. It had wavy bends at the tip. The outer 10 inches of the blade had tears, bending and gouges in the leading and trailing edges.

L2 blade was bent aft at 2/3 radius and bent forward at the tip. The outer 6 inches of the tip was torn off and was missing. It had rotational scoring in the paint.

L3 blade had multiple fore and aft bends. It was bent forward at mid-blade. It was curled aft at the tip and twisted toward low pitch. There was rotational scoring on both the flat side and cambered side.

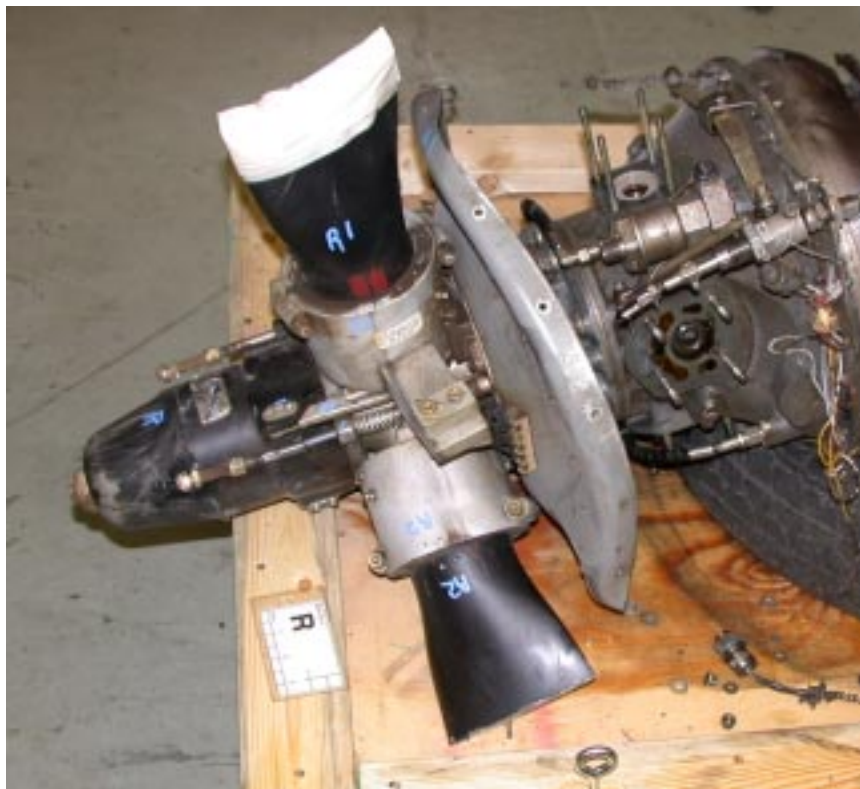
The spinner dome had been removed. The propeller remained attached to the engine. The blades had been cut off to facilitate shipment. All three beta rods were bent; the beta rod end ring was missing. The propeller was in the feather position; the piston and all three clamps/counterweights were in the feather position. All three start locks were intact. The piston, cylinder, and pitch change linkage was intact. The low pitch stop nuts were measured to be 2 to 2-3/32 inches from the piston with the piston in the feather position.

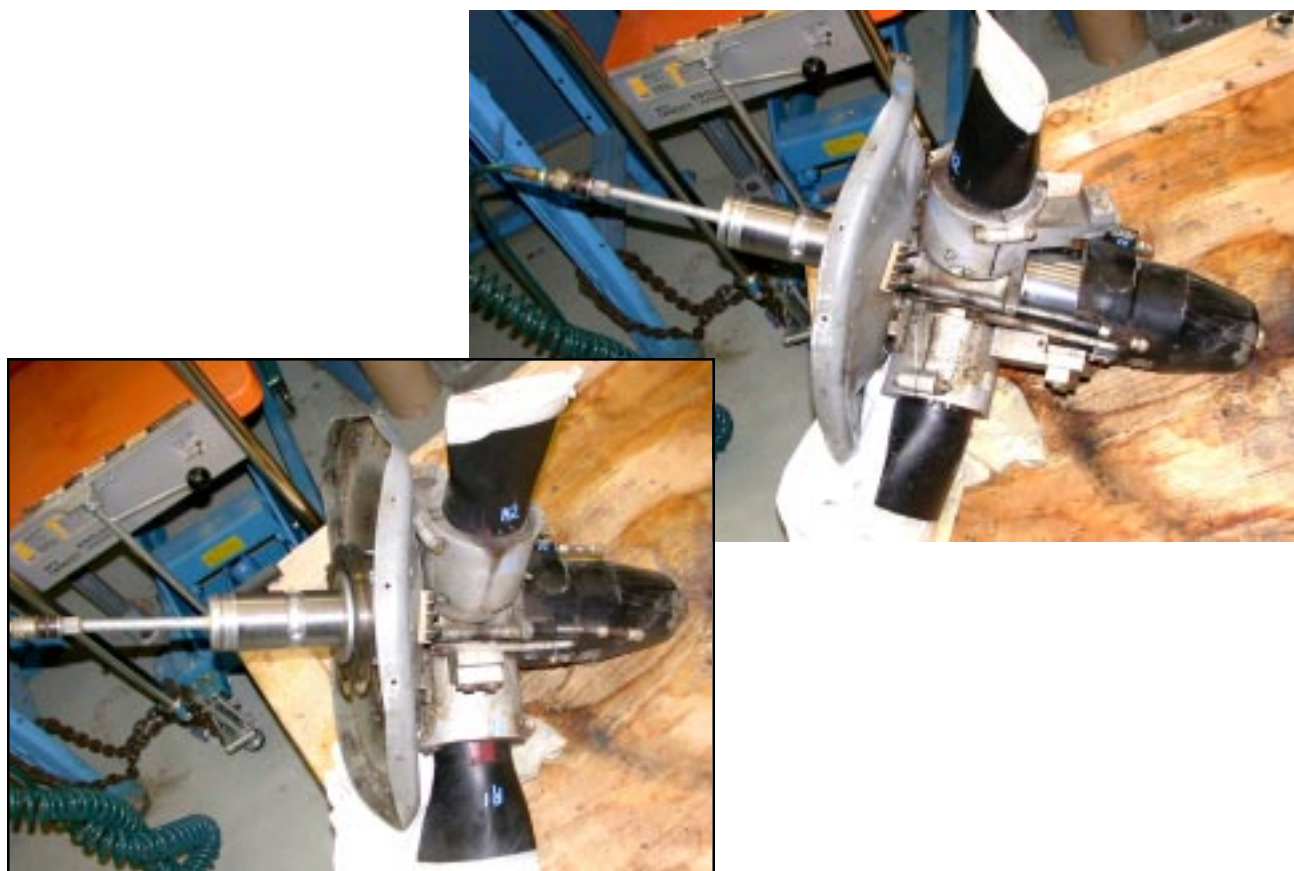
An air fixture was attached to the mounting flange and air pressure was applied. The propeller actuated from the feather position to a low blade angle position (flight idle or lower). The mechanism was cycled from feather to low pitch four times.

NOTE: The pitch change mechanism did not actuate completely to the maximum reverse position and the start locks did not engage. This is attributed to the line pressure being approximately 80 psi. Greater air pressure is required to fully actuate to a deep reverse position.

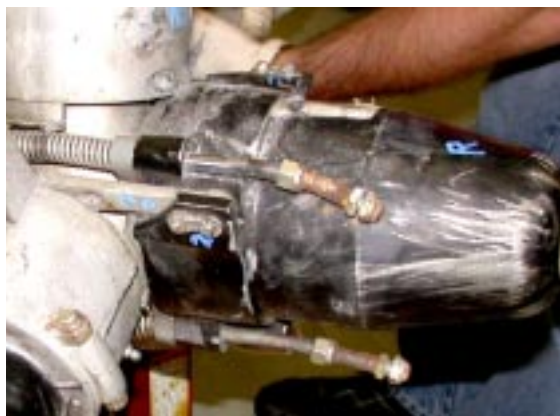
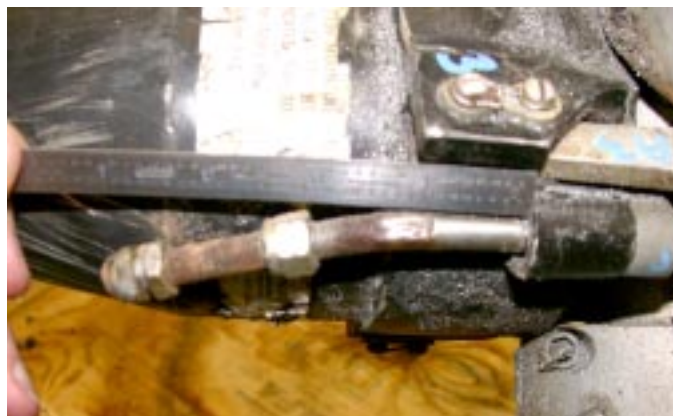
Beta rods: All three beta rods were bent about 30°. They had to be straightened in order to remove the piston. The guide collar had shifted (rotated) slightly out of position. The bending of the beta rods appeared to have occurred with the piston positioned roughly 1 to 1-1/4 inches from the feather position, which equates to blade angles in the range of approximately 47° to 55°. See photos below.

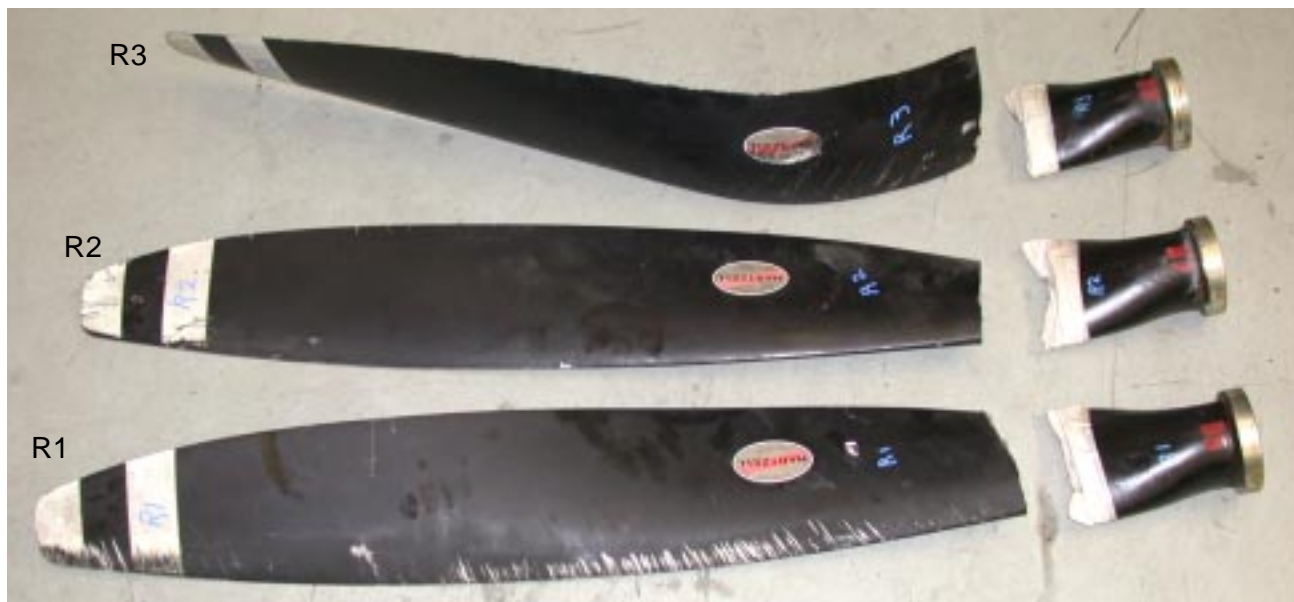
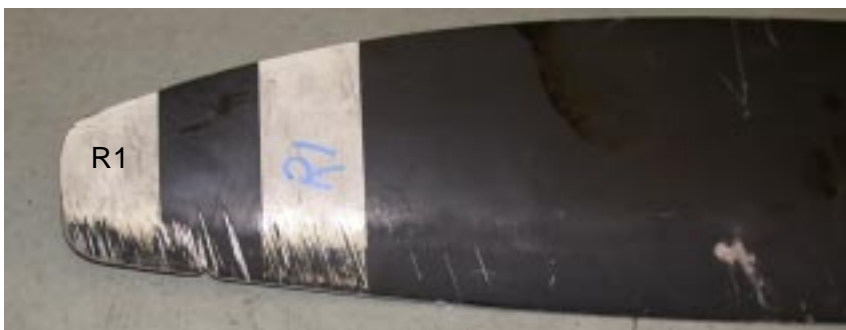
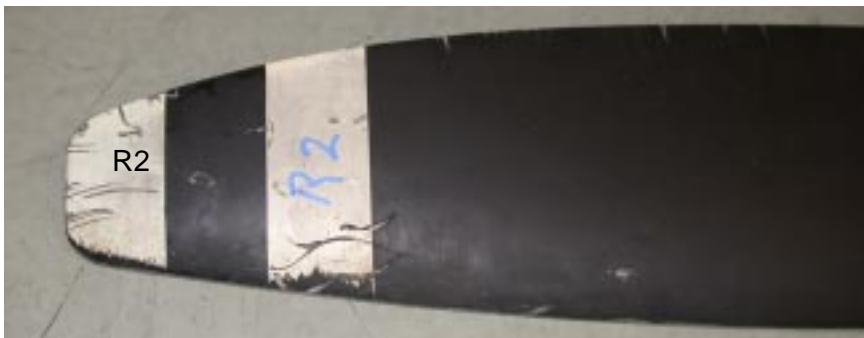
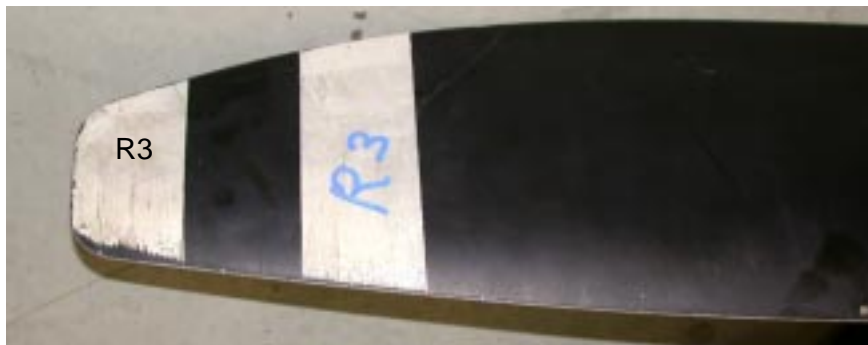
See photos on Page 17.

R1 blade had two small gouges in the leading edge approximately 3 inches from the tip. There was angular scoring in the paint on the camber side (non-rotational) near the leading edge along the full length of the blade. The blade was not bent or twisted.

R2 blade had no significant damage with no bending or twisting.

R3 blade was bent aft approximately 45° and was not twisted.
