**Date of Accident:** 8 May 2015

**NTSB File No.:** ERA15FA208

**Aircraft:** Piper PA-32-300

**Propeller Teardown Report****Date of Investigation:** 11 May, 2015**Location:** Griffin, GA Atlanta Air Salvage**Propeller Model:** HC-C3YR-1RF with F7663R blades

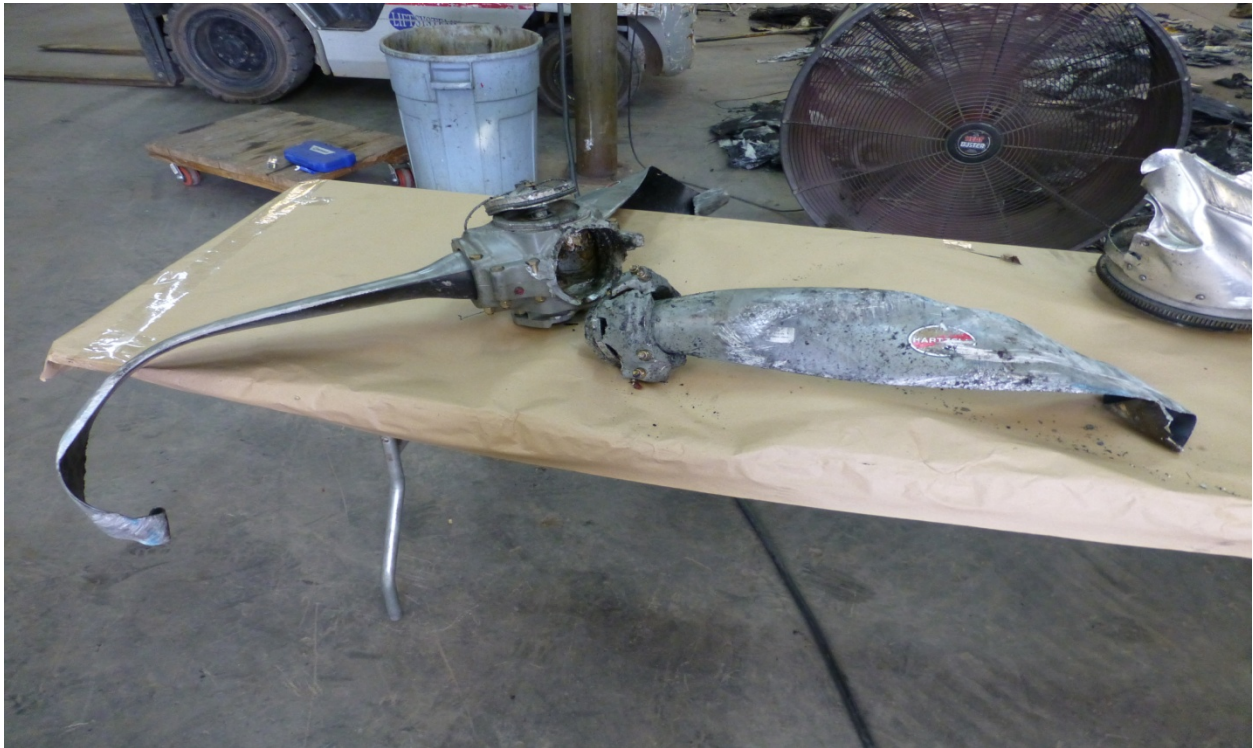
Photo #1, propeller as received.

The propeller was received with the propeller fractured off the engine, One blade was fractured off the hub. The spinner dome was torn off the spinner bulkhead. All three blades showed rotational scoring and curling of the blade tips. There were impression marks on the preload plates indicating that the propeller was in the low blade angle position prior to impact.

The cylinder was fractured off the hub. The piston was smashed against the hub and had to be cut off at the pitch change rod to facilitate splitting the hub unit.

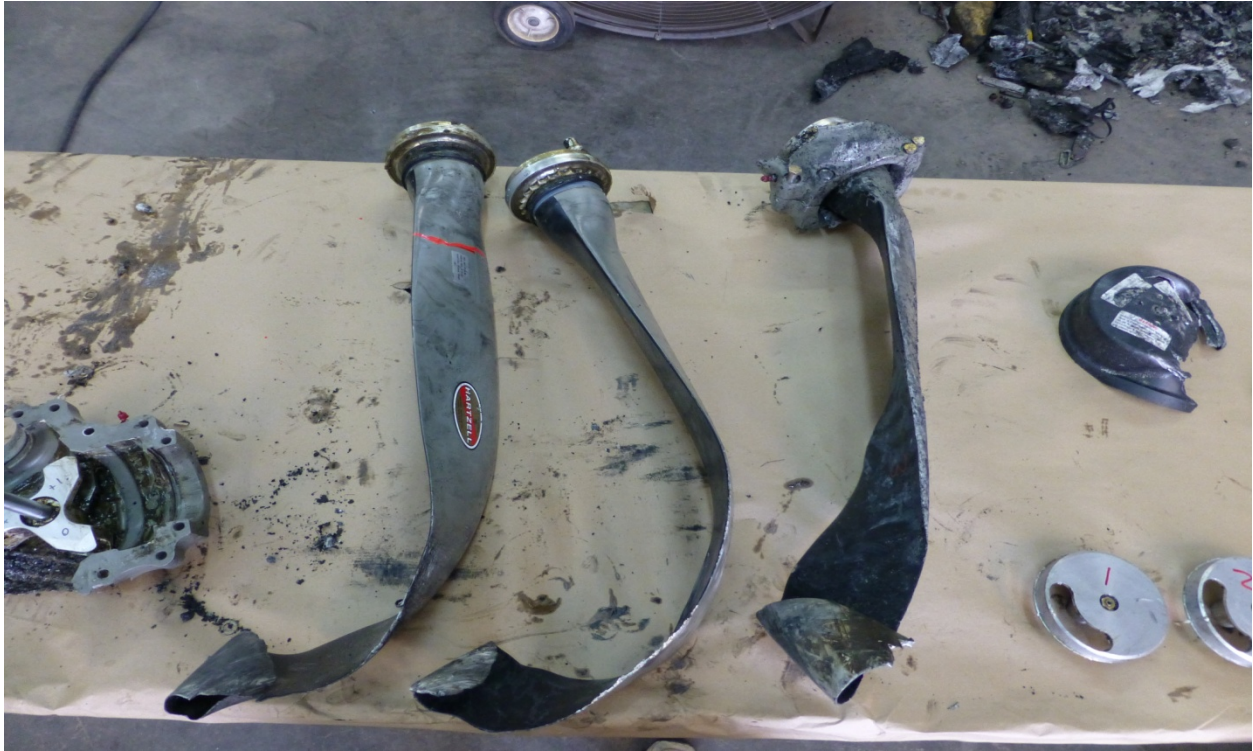
Photo #3, propeller blades.

paint, camber side - rotational scoring.  
paint, flat side - intact.  
bend - aft at tip.  
twist - tip curled under.  
lead edge damage - gouges, nicks, and dents.  
trail edge damage - gouges, nicks, and dents.  
knob condition - fractured off.

paint, camber side - rotational scoring.  
paint, flat side - intact.  
bend - aft at tip.  
twist - tip curled under.  
lead edge damage - gouges, nicks, and dents.  
trail edge damage - gouges, nicks, and dents.  
knob condition - intact.
