Date of Accident: April 7, 2015

NTSB File No.: CEN15FA190

Aircraft: Cessna 414A

Propeller Teardown Report

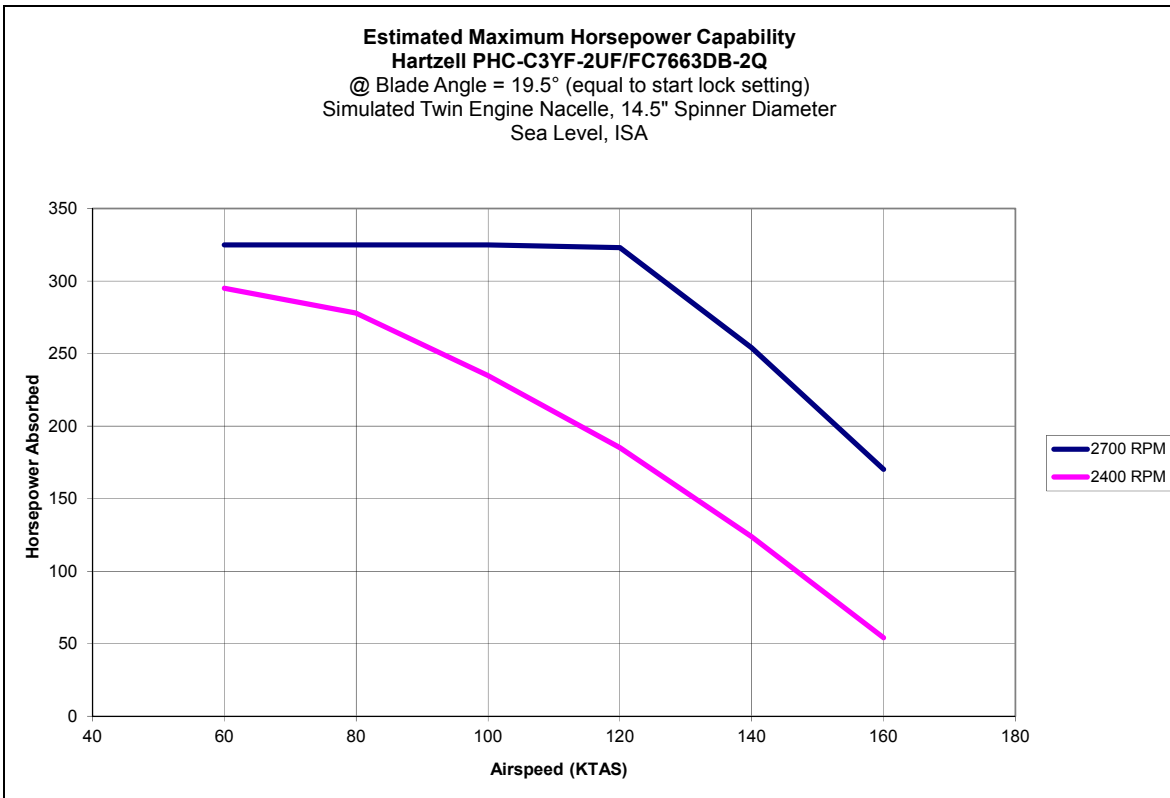
Figure 1

The propeller model on the accident aircraft has a start lock angle specification of $19.5^{\circ} \pm 1.5$. Estimated propeller performance with a blade angle setting of 19.5° is shown in Figure 1. This chart represents a maximum horsepower possible with the blade angle at 19.5° and RPM 2700 or 2400. Therefore power on the engines at time of impact could have been as high as maximum rated depending on aircraft speed and RPM.

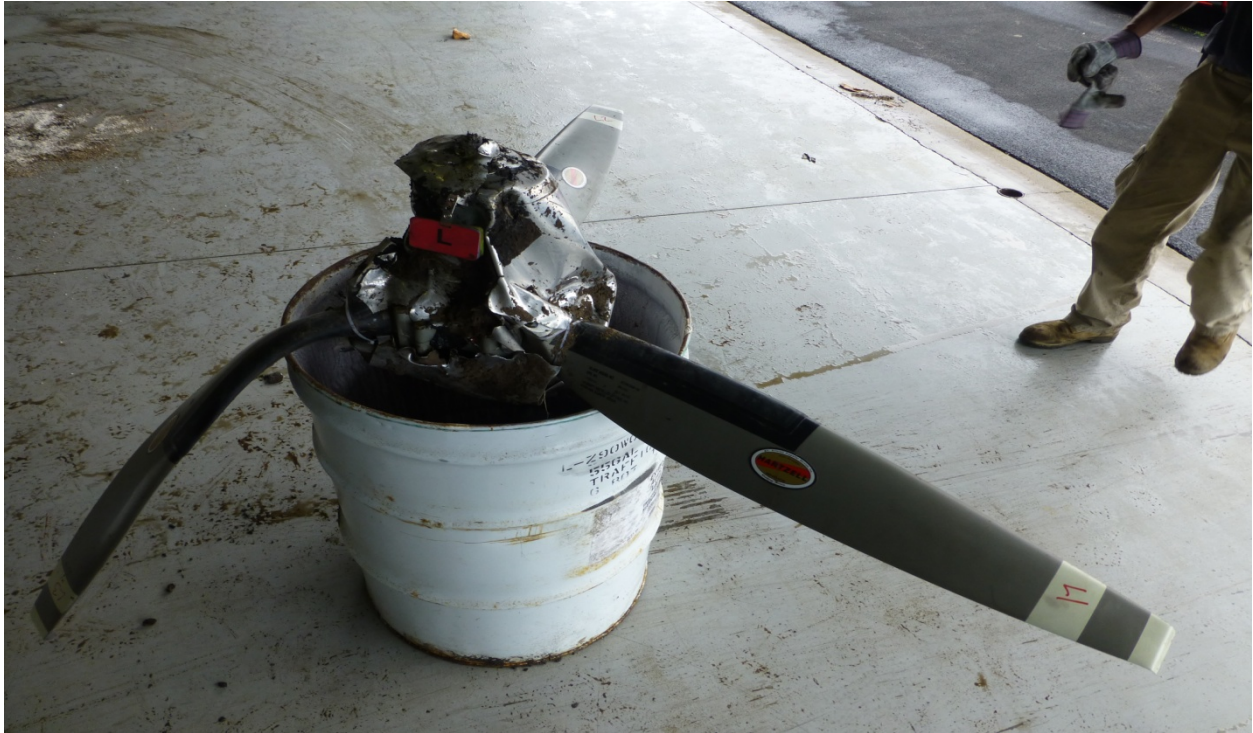
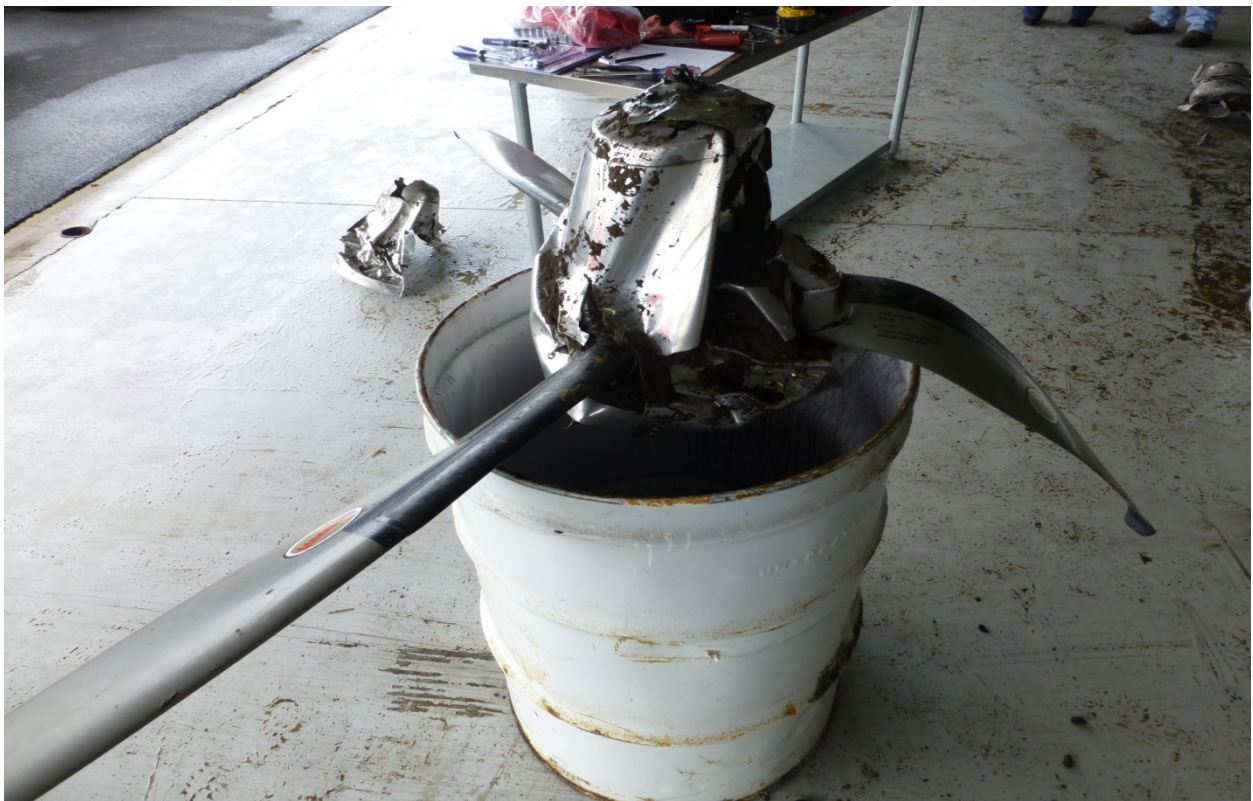
The propeller was fractured off the engine at the engine shaft. The NTSB stated it was approximately 2 feet down in the mud. The propeller was received on the start locks. One blade was bent aft, one blade appeared straight and one blade exhibited forward bending near the tip. The spinner dome was formed around the counterweights.

The spinner dome was crushed around all sides and formed around the counterweights. The spinner dome exhibited a spiral/twisting deformation pattern. The counterweights were in the start lock position.

Photo #1, left propeller as received.

Photo #2, left propeller as received.

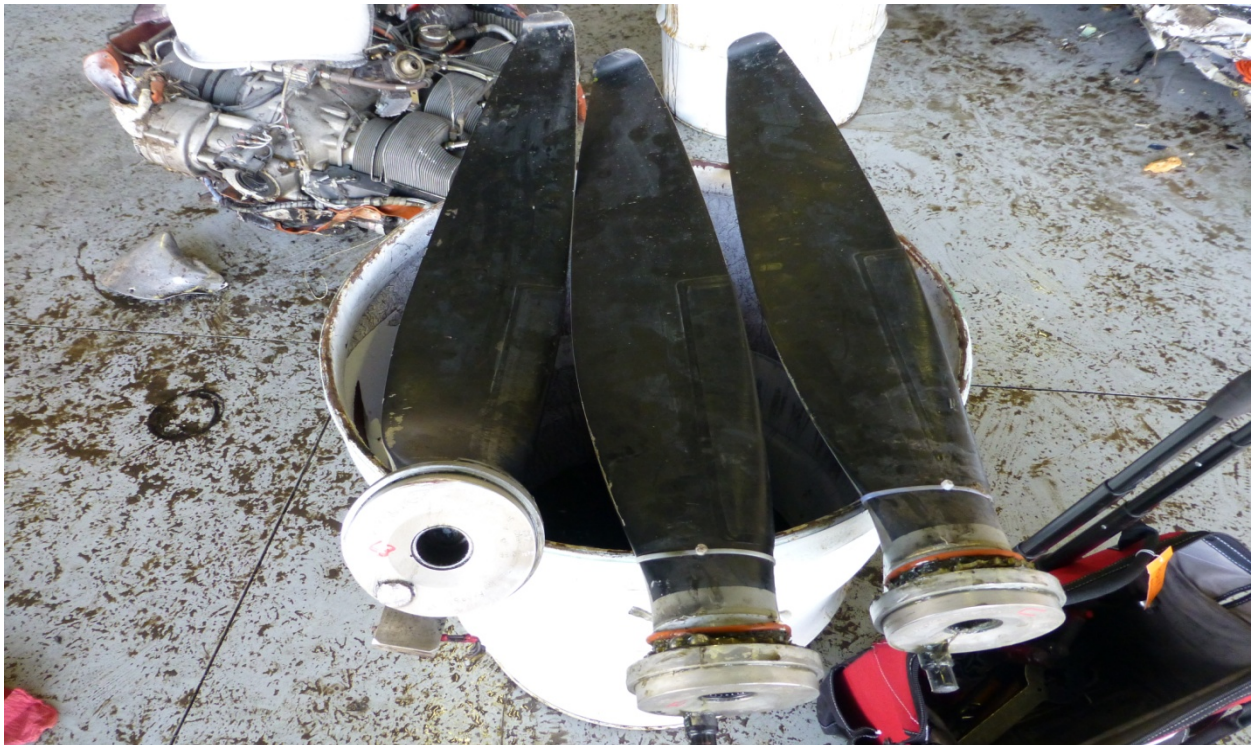
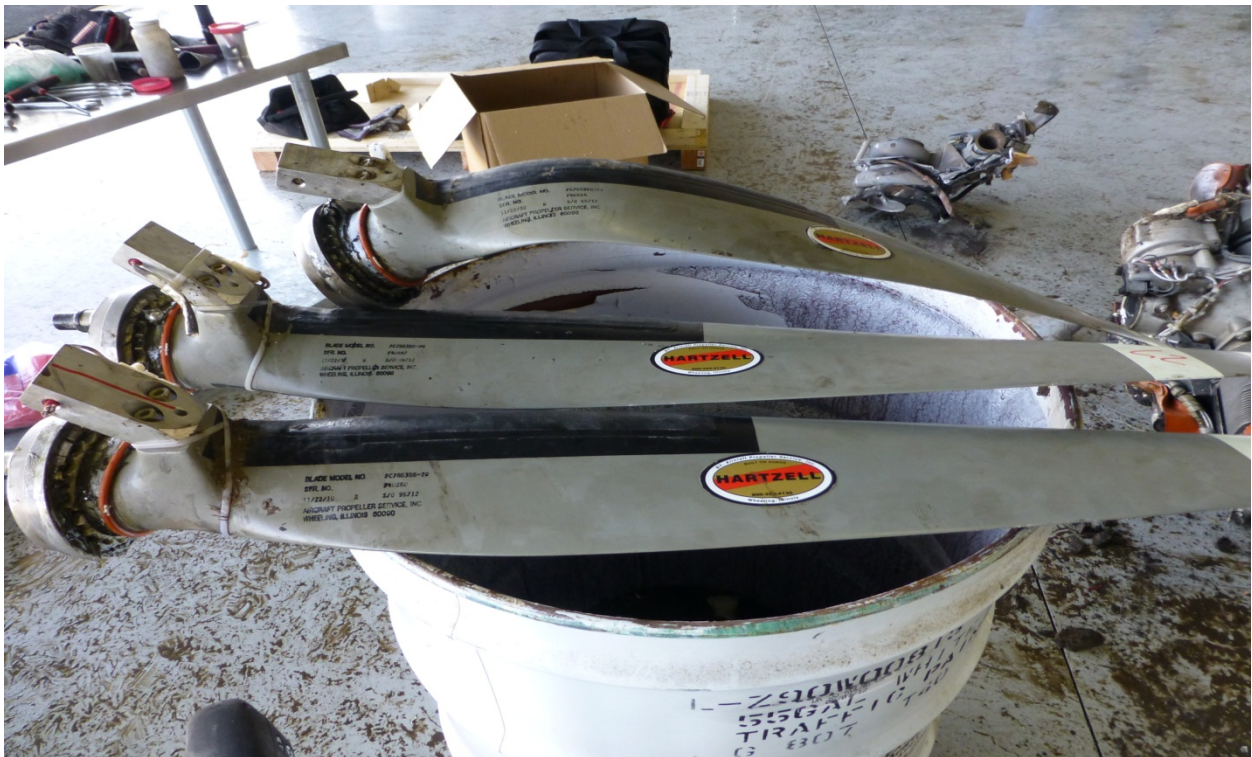
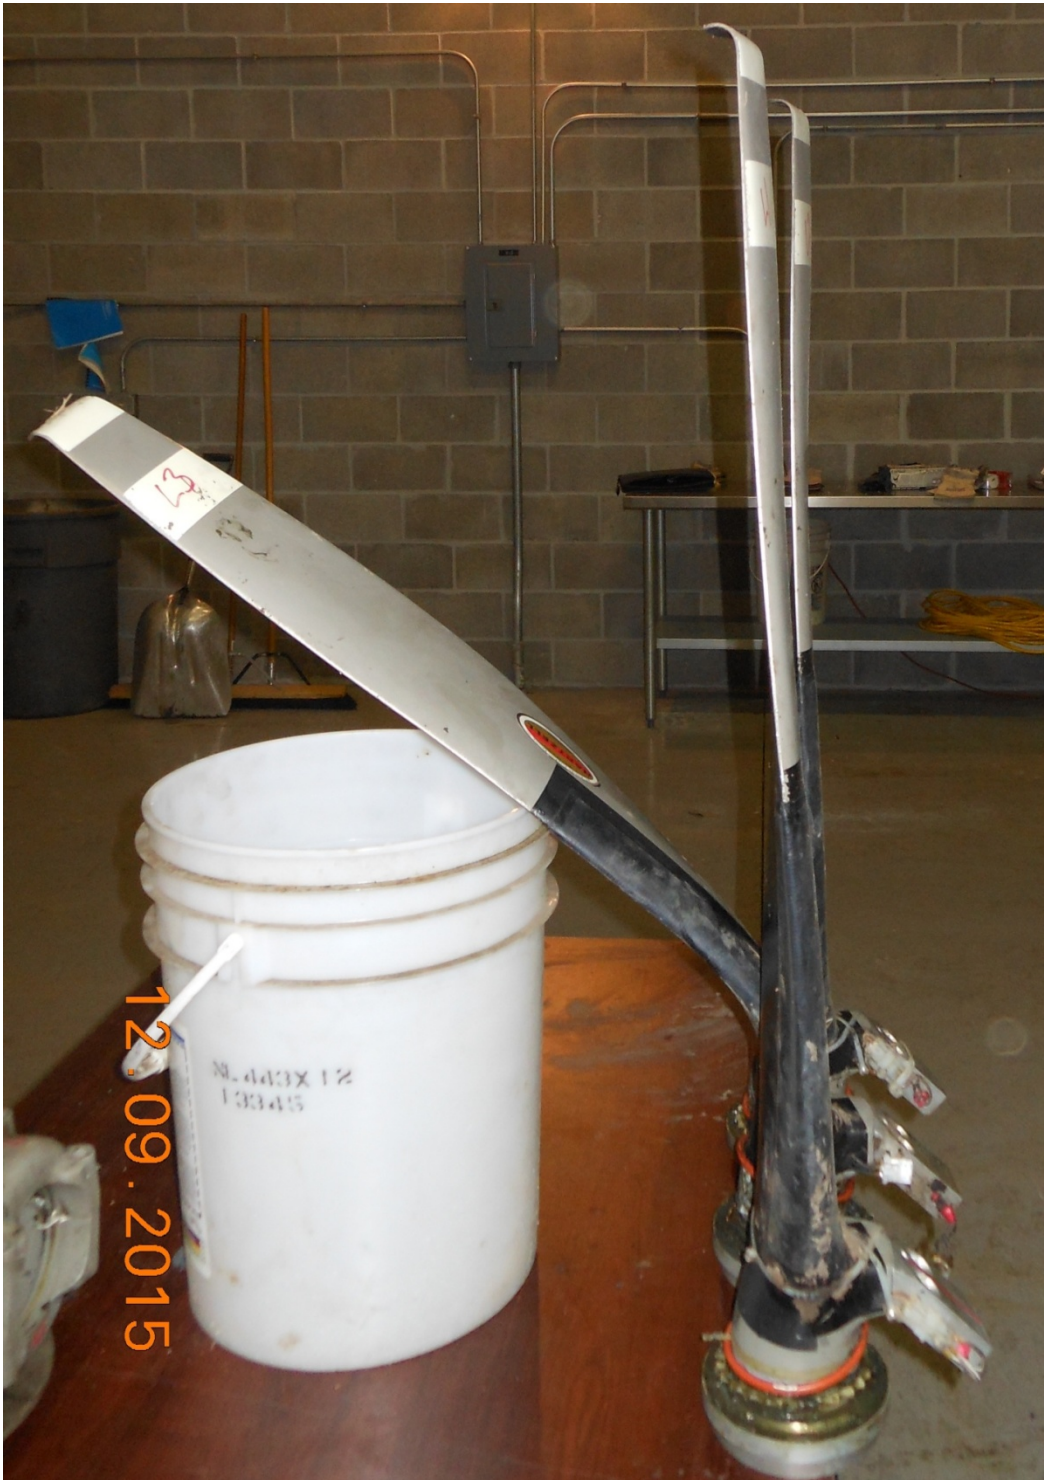
Blade L2 had distinct ball bearing impression marks on the face side bearing races consistent with a thrust force at impact. Blade L2 also exhibited forward bending near the tip consistent with force in thrust direction. The bearing and blade bending was similar to that on blade R2.

paint, camber side - intact.
 paint, flat side - intact.
 bend - aft.
 twist - leading edge down/lower pitch.
 lead edge damage - none.
 trail edge damage - none.
 knob condition - fractured off.
 counterweight - intact and unremarkable.

Photo #3, left propeller blades.

Photo #4, left propeller blades.

Photo #5, edge view of left propeller blades.

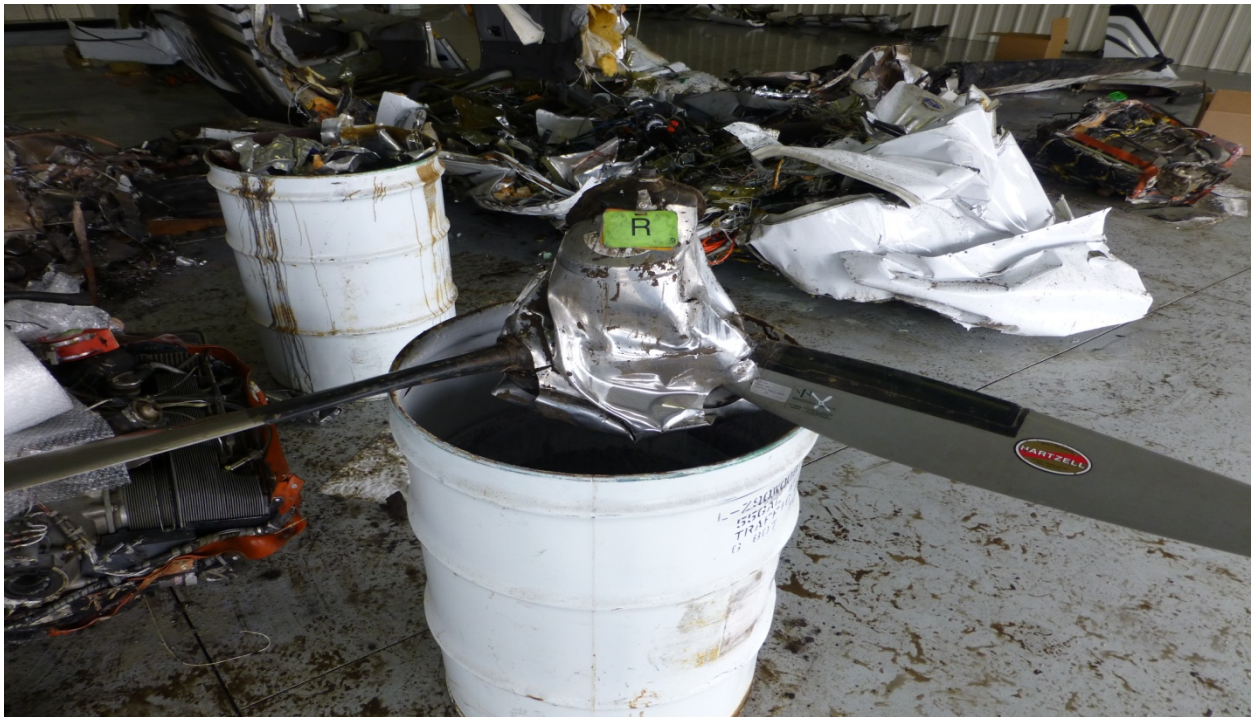
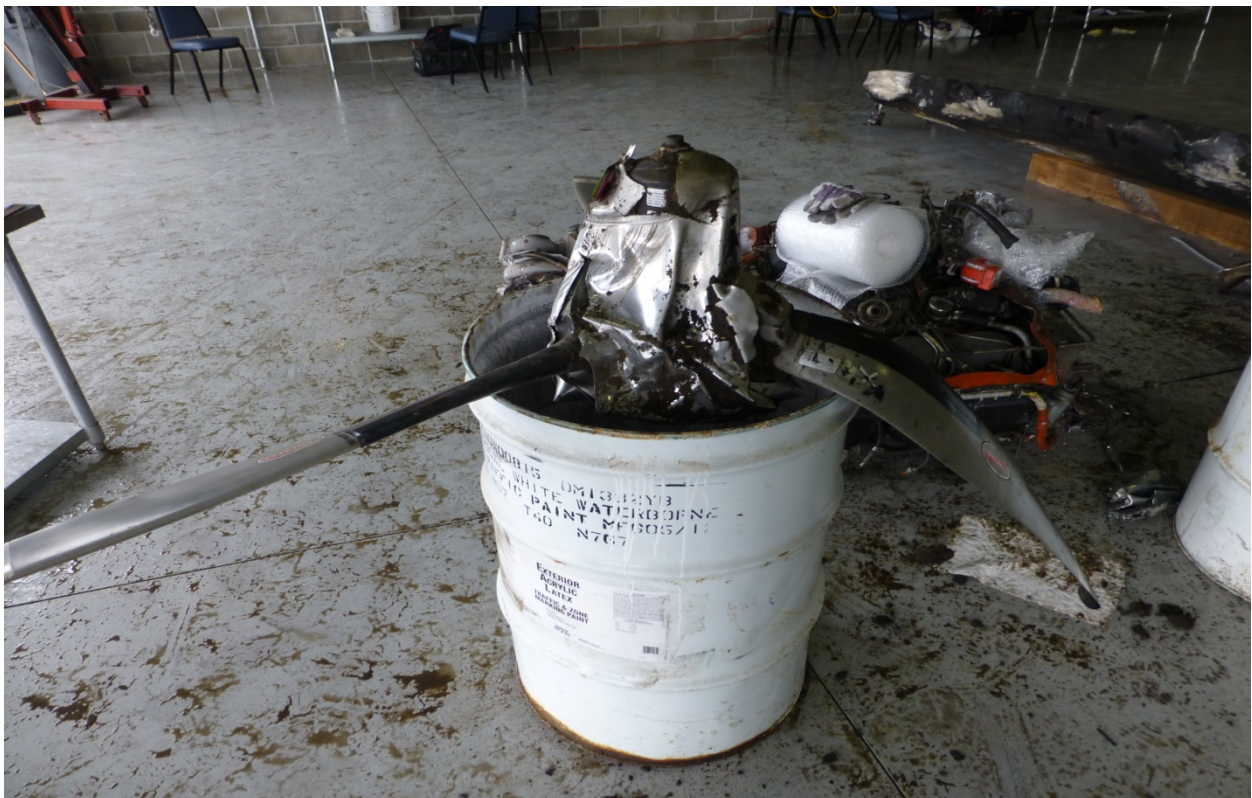
The propeller was fractured off the engine at the engine shaft. The NTSB stated it was approximately 2 feet down in the mud. The propeller was received on the start locks. One blade was bent aft, one blade appeared straight and one blade exhibited forward bending near the tip. The spinner dome was formed around the counterweights.

The spinner dome was crushed around all sides and formed around the counterweights. The spinner dome exhibited a spiral/twisting deformation pattern. The counterweights were in the start lock position.

Photo #6, right propeller as received.

Photo #7, right propeller as received.

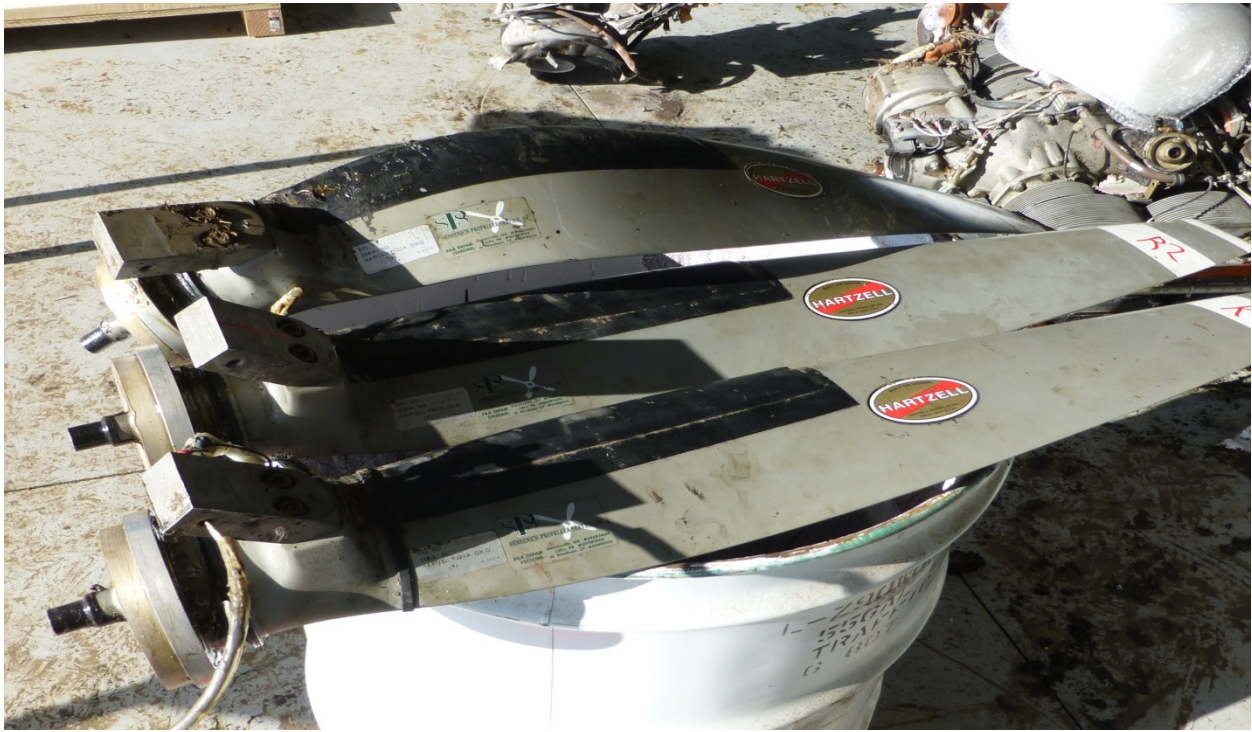
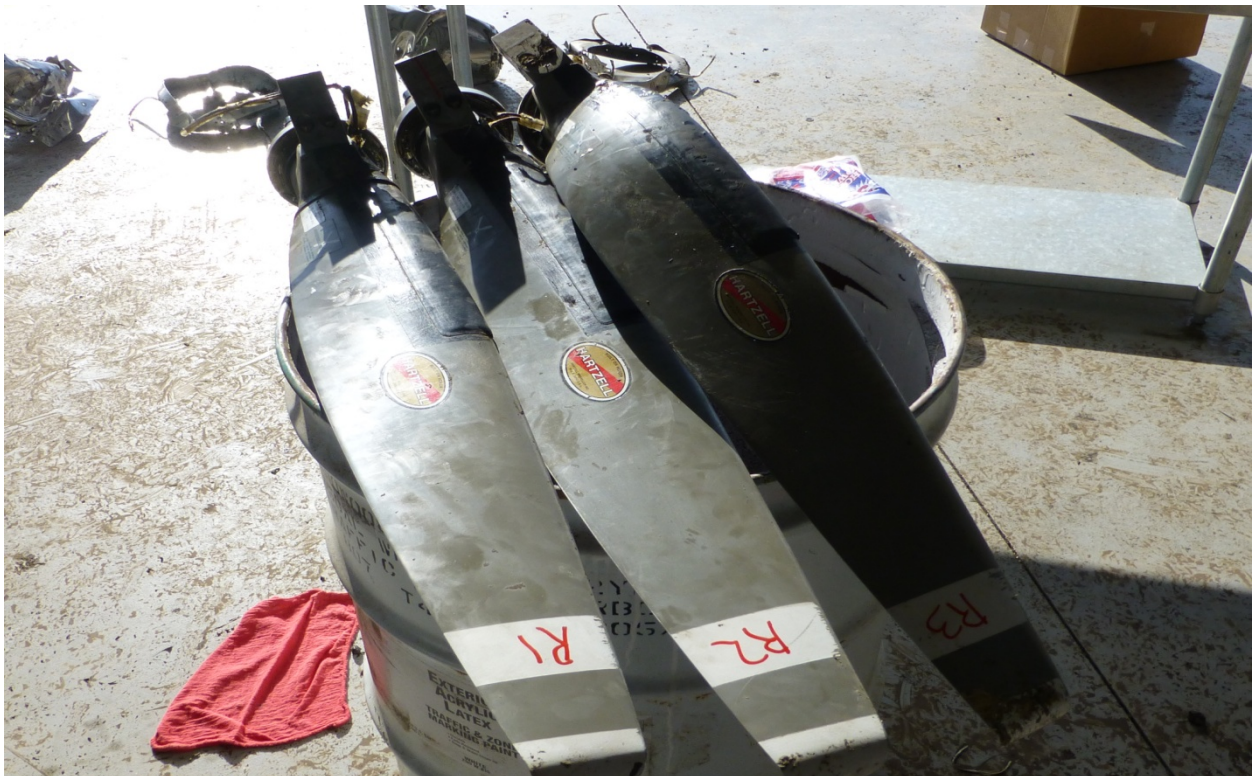
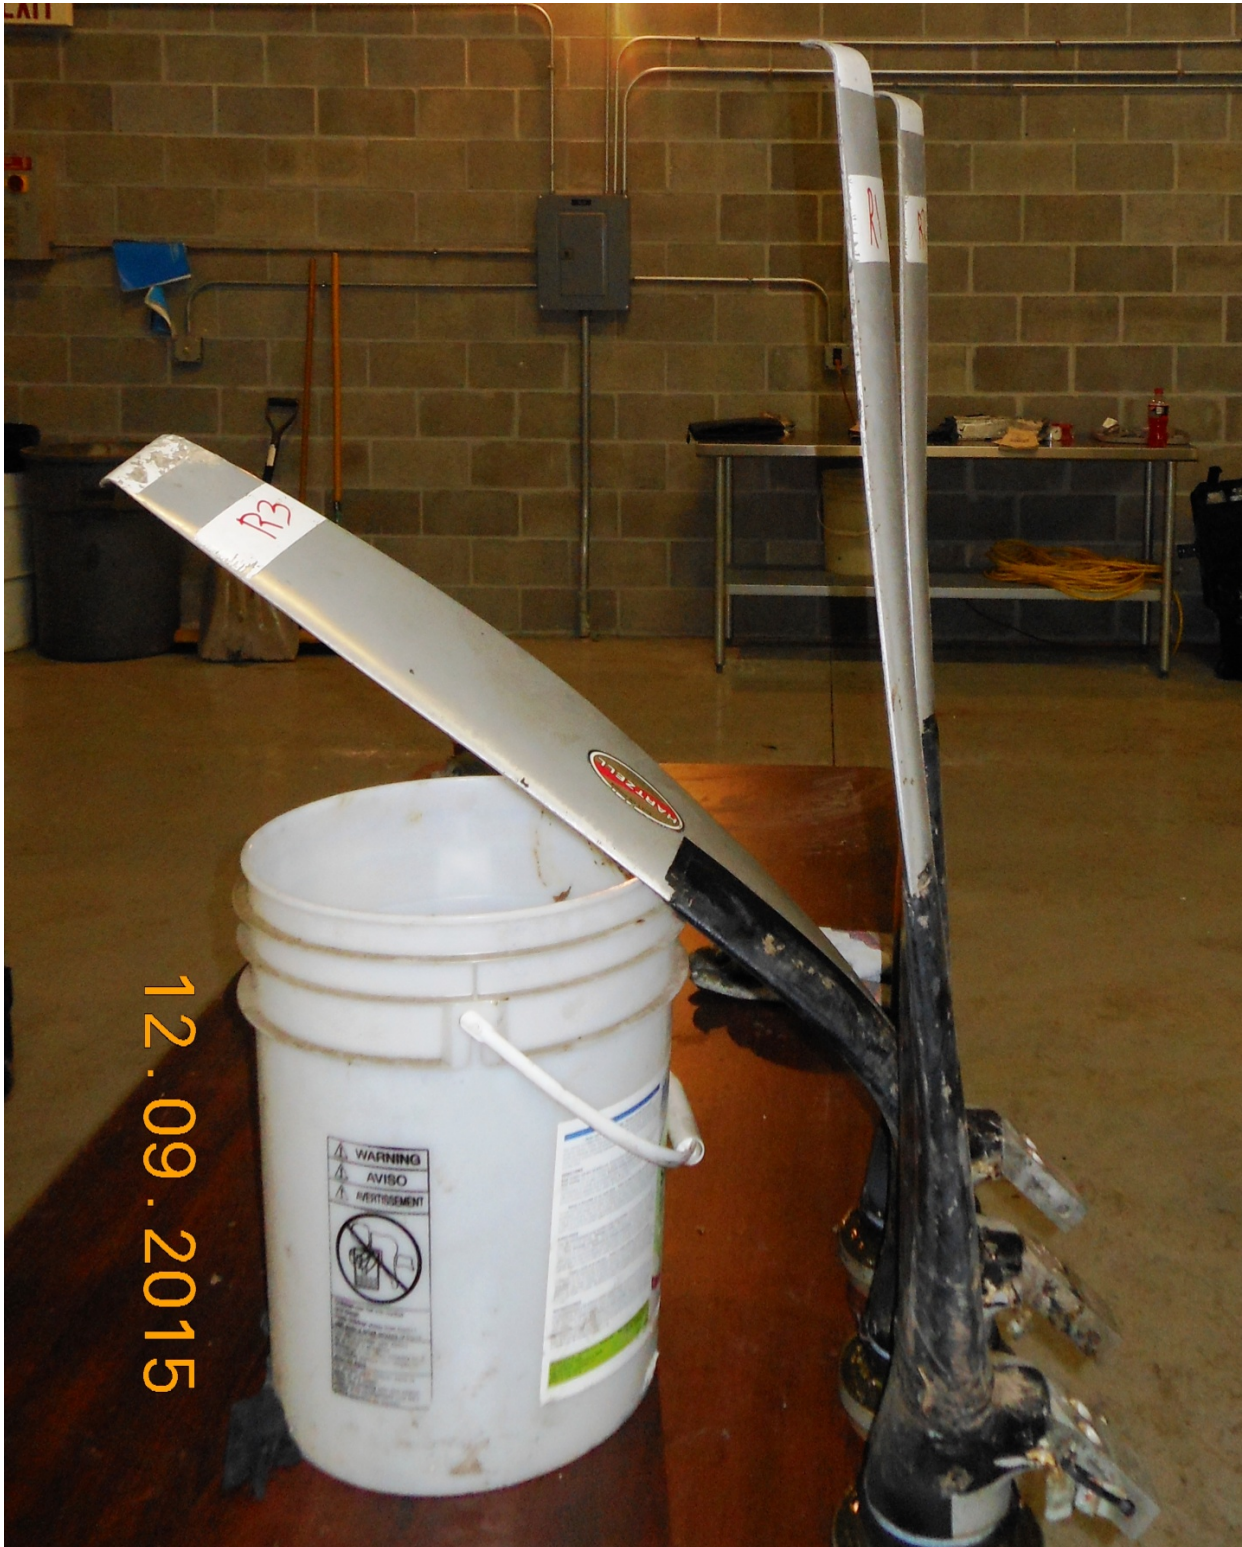
paint, camber side - intact.
paint, flat side - intact.
bend - aft.
twist - leading edge down/lower pitch.
lead edge damage - none.
trail edge damage - none.
knob condition - fractured off.
counterweight - intact and unremarkable.

Photo #8, right propeller blades.

Photo #9, right propeller blades.

Photo #10, edge view of right propeller blades.

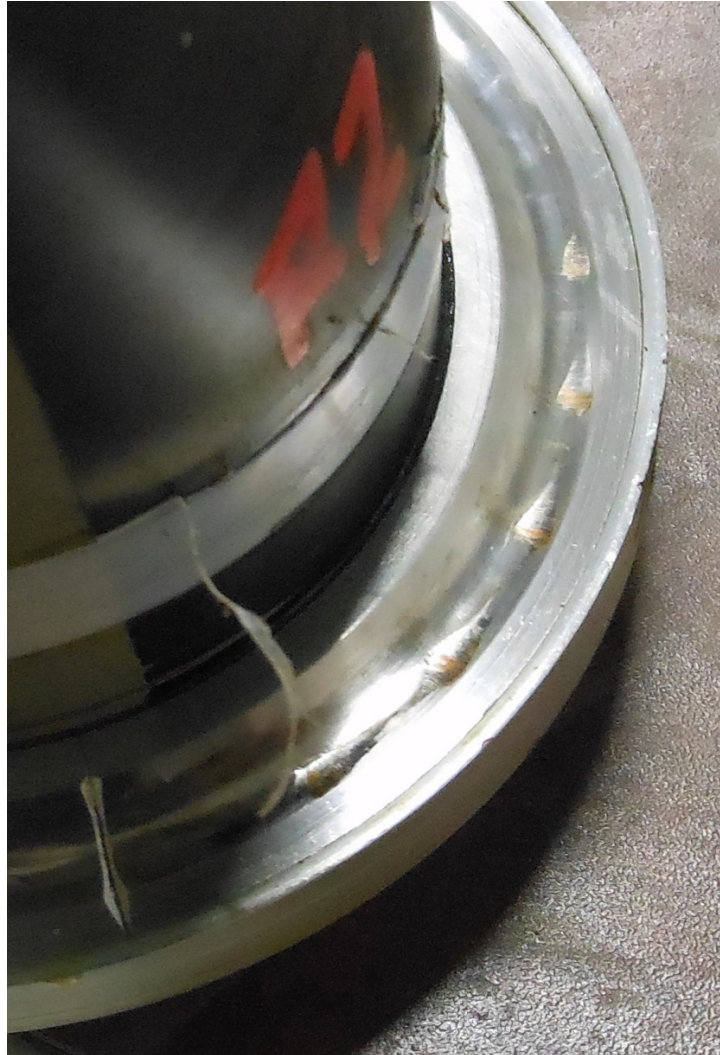
Blade R2 had distinct ball bearing impression marks on the face side bearing races consistent with a thrust force at impact while at RPM in the normal operating range (see Photo #11). Blade R2 also exhibited forward bending near the tip consistent with impact at a positive angle of attack. The bearing and blade bending was similar to that on blade L2.

Photo #11, blade R2 bearing race ball bearing impact marks.
