**NATIONAL TRANSPORTATION SAFETY BOARD**  
**Office of Aviation Safety**  
**Washington, D.C. 20594**

**PROPULSION GROUP CHAIRMAN'S FACTUAL REPORT**

**NTSB No: DCA15MA019**

Vehicle: Scaled Composites, LLC Model 339 SpaceShipTwo

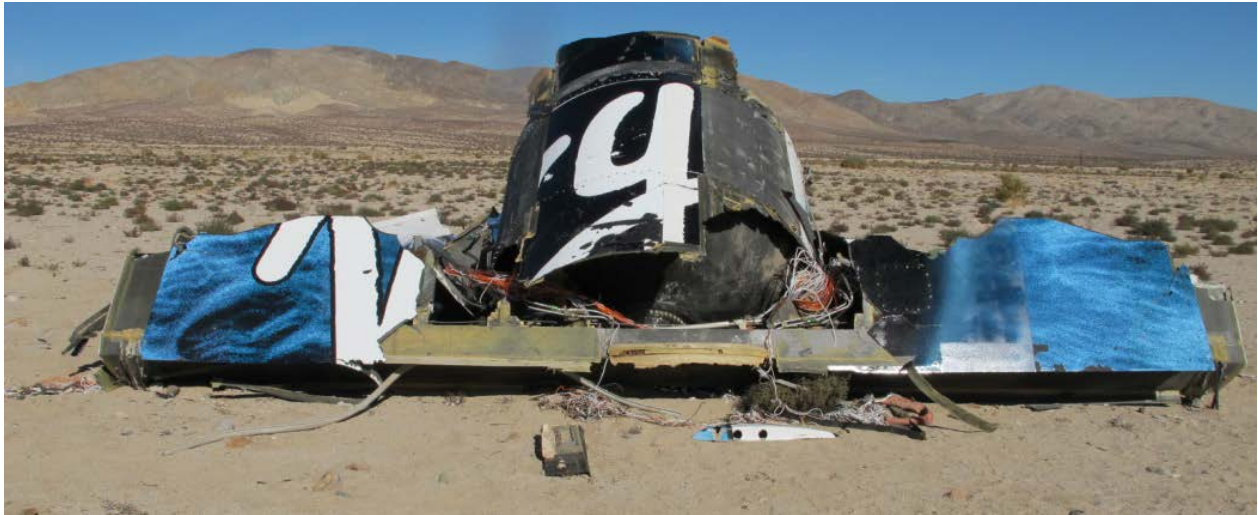
A section of the fuselage with the integral MOT was located at site 2 and impacted the ground in an inverted attitude (**Photo 2**). The forward end of the tank exhibited fractures and bulging along the lower half consistent with impact. The forward MOT bulkhead was intact but all external plumbing connections were severed. The internal plumbing within the MOT was deformed. Pressurization system plumbing and valves were sheared away from the MOT and exhibited bending and deformation consistent with impact. The MOT burst disk was recovered intact/unburst on the ground under the wreckage (**Photo 3**). The MOT burst disk thrust cancelling tee connection was found sheared off, laying on the ground.

**Photo 2- Fuselage Wreckage with Integral MOT, Inverted, Aft Side**

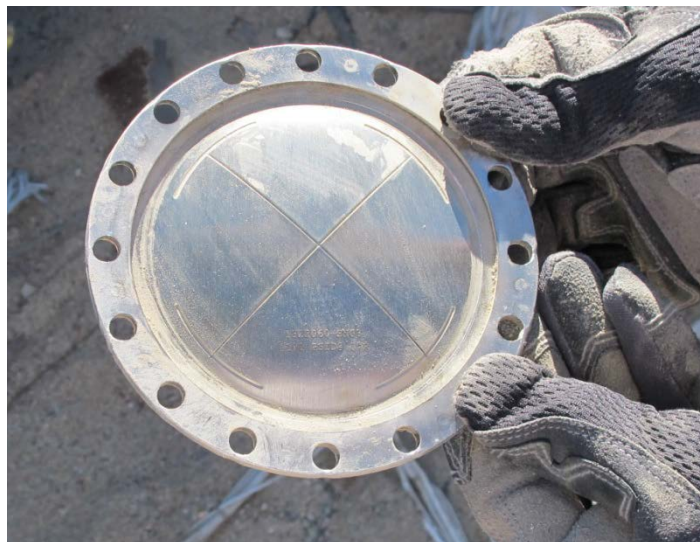
**Photo 3- MOT Burst Disk, Intact**

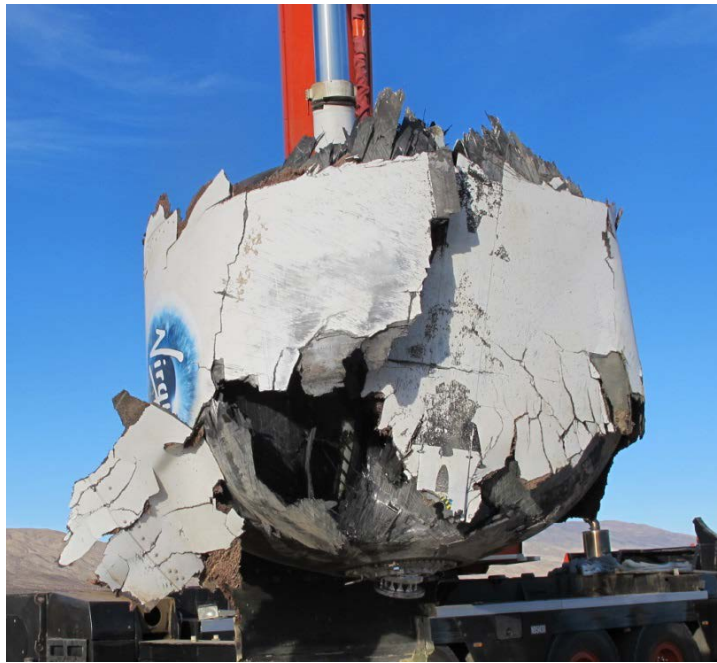
The MOT was lifted away from the wreckage with a crane. The 12 o'clock position of the tank was flat where it contacted the ground (**Photo 5**). A small amount of liquid ran from the tank when it was lifted.

**Photo 5- MOT, Lifted By Crane**

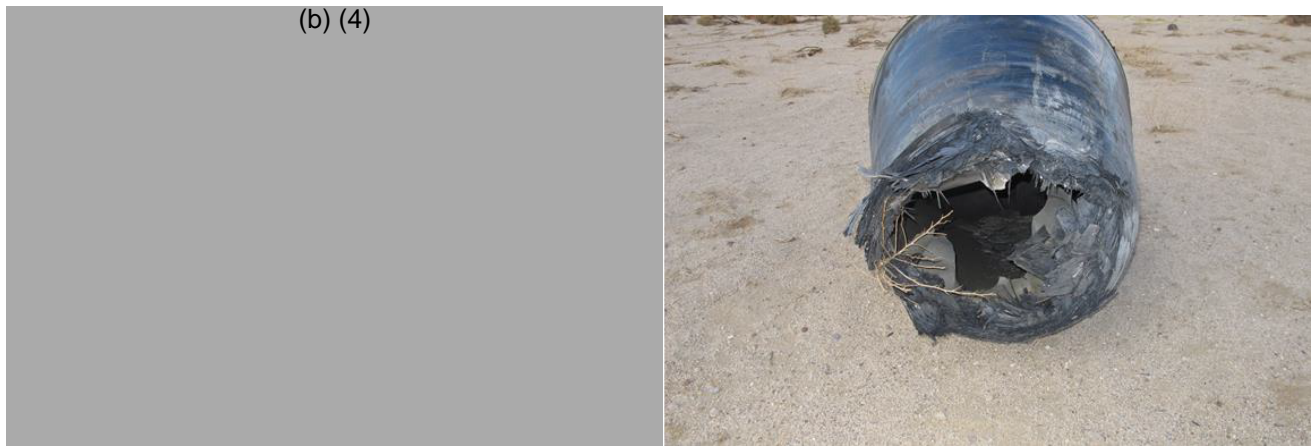
The FPT was recovered at site 4a, several hundred yards away from the impact crater where the cockpit wreckage was located (**Photo 7**). The main body of the FPT was lying on its side and the nose of the tank was separated. The carbon fiber around the fracture surface was frayed and the metal liner exhibited curling. The nose of the tank was recovered closer to the cockpit wreckage. The metal liner was curled, the carbon fiber was fractured, and the forward tank line ports were bent consistent with impact (**Photo 8**). Both FPT sections and associated debris were in a line with the cockpit impact location. Inconel fragments from the FPT were identified in the impact crater. The PSC was recovered from the scattered wreckage near the cockpit.

**Photo 7- (L) Left Side of FPT, (R) Forward Side of FPT**

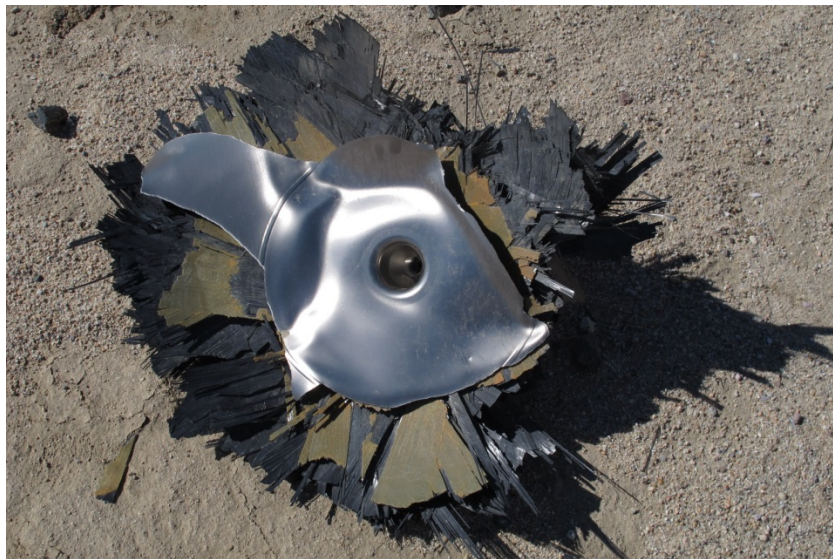
**Photo 8- FPT Nose**

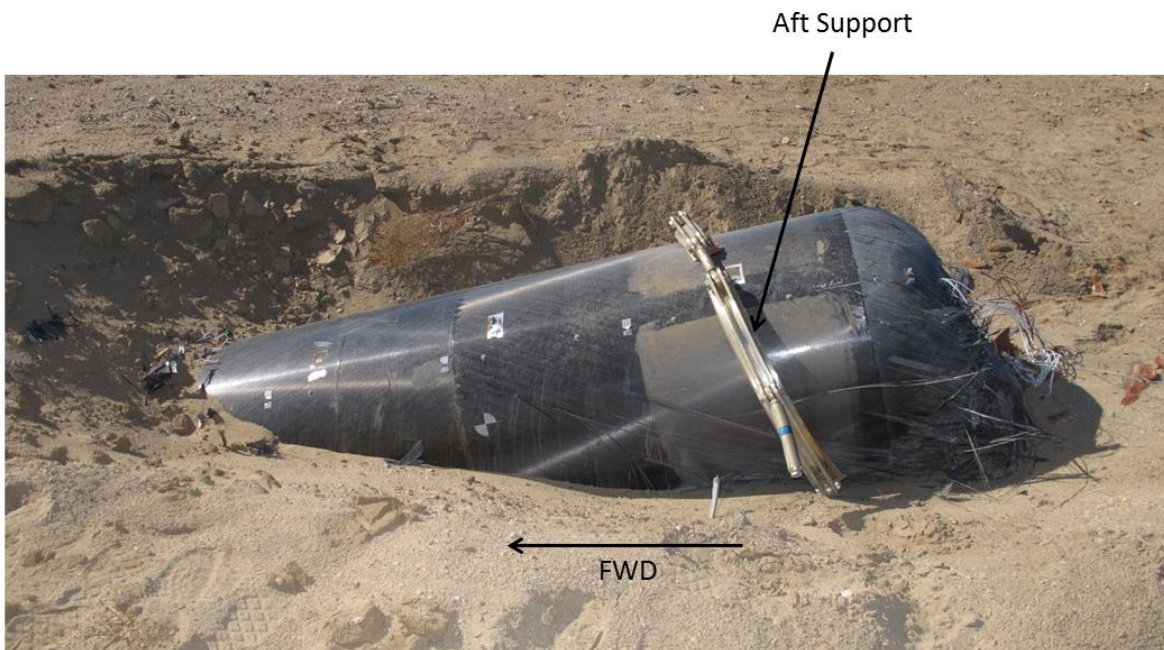
The CTN was found at site 5 in a 20 degree nose down attitude in a crater created by the impact. The forward most section of CTN was covered in dirt (**Photo 9**). The forward dome exhibited buckling and the carbon fiber was fractured between the 3 and 9 o'clock positions. The (b) (4) that connects the CTN to the MOT remained affixed, and showed some signs of metal fracture (**Photo 10**). The bottom most link of the aft support<sup>6</sup> was broken but the support was still resting on the case. The carbon on the aft dome was fractured and severed motor wiring harnesses were hanging from the aft end. The rocket nozzle was fragmented and pieces were scattered over about a 50 foot area behind the aft end of the rocket. The recovered nozzle fragments exhibited charring similar to what was seen after previous powered flights and rocket ground fire tests according to Scaled Composites engineers (**Photo 11**).

**Photo 9- Case/Throat/Nozzle Assembly**

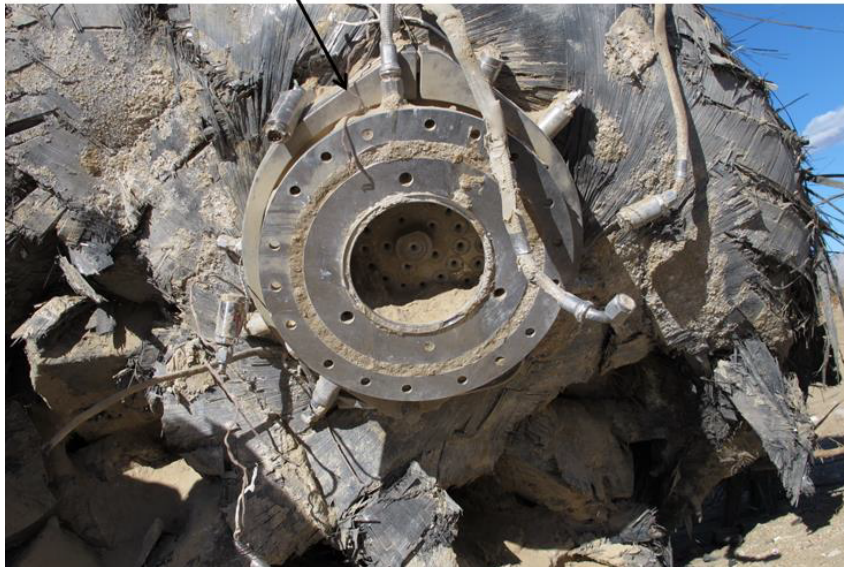
Photo 10- CTN Forward Dome (b) (4)

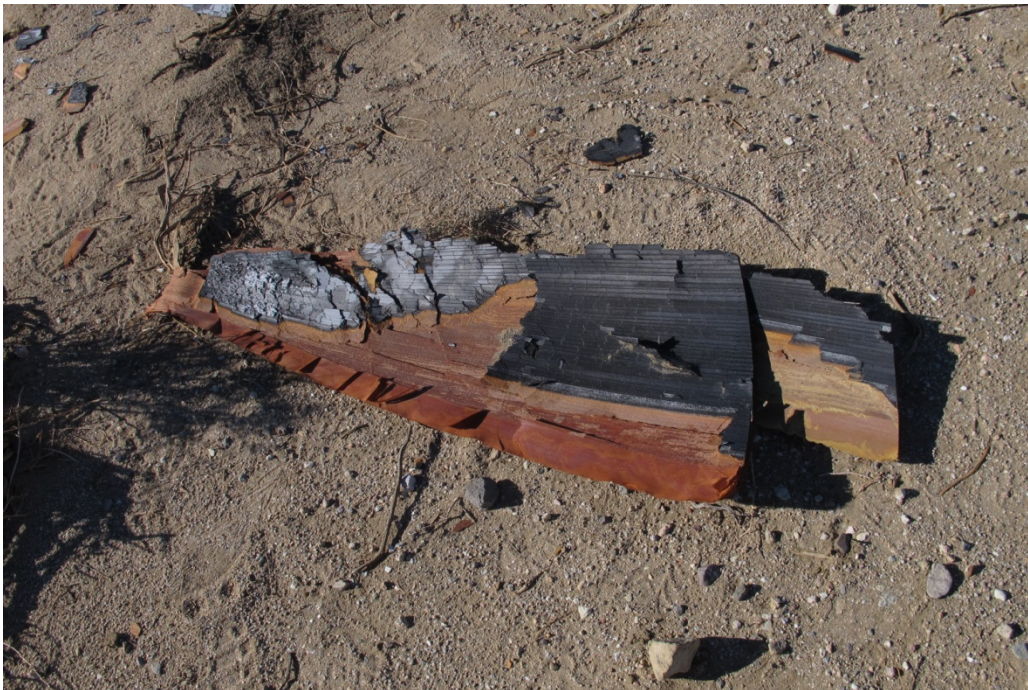
Photo 11- Rocket Nozzle Fragment Charring

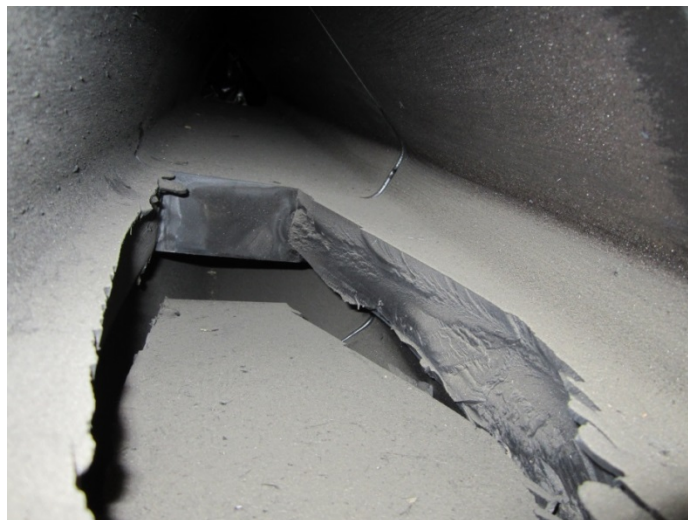
(b) (4) had fuel fracture near the forward end but the fracture surfaces did not exhibit thermal exposure indicating the fracture happened as a result of impact (**Photo 13**). The forward end of the case and fuel grain exhibited substantial impact damage concentrated between the 3 and 9 o'clock positions. (b) (4) from the forward dome was lodged into the (b) (4) and the (b) (4). Earthen debris was also found lodged along the lower half of the case.

**Photo 13- (b) (4) Fuel Grain Fracture**

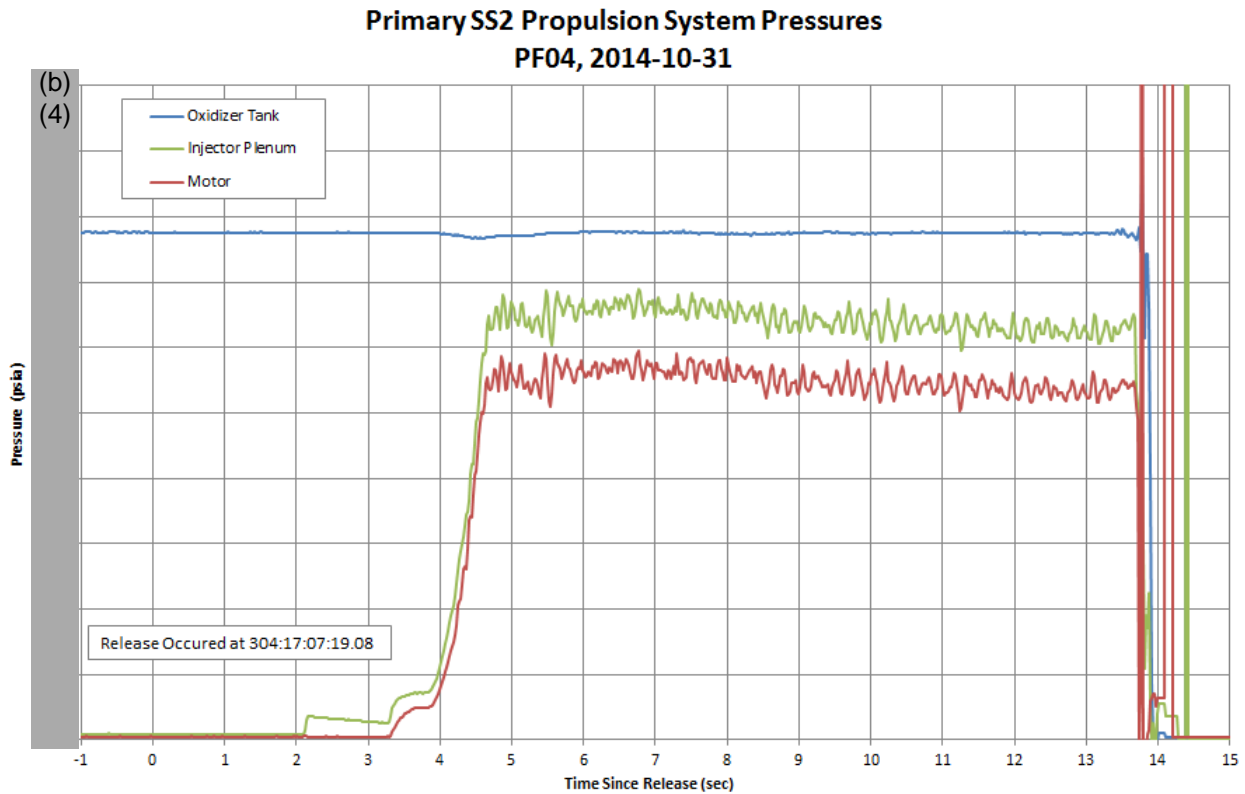
Select propulsion parameters were evaluated to determine if the rocket motor experienced any anomalies prior to or during operation. Pressure values in the oxidizer tank, the oxidizer injector plenum and the combustion chamber were plotted in **Figure (3)**. All pressures climbed normally after ignition and stabilized at expected values up to the point the data link was lost.

**Figure 3- Propulsion Telemetry Parameters**

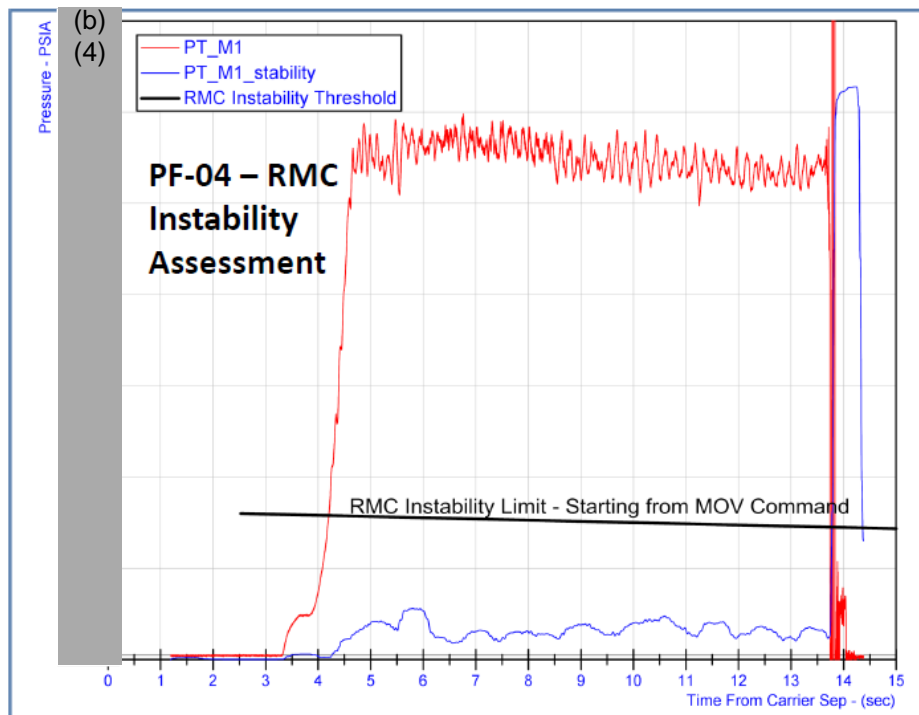
The instability threshold accounts for changes in g-loading as the vehicle weight decreases due to consumed propellant. During PF-04 the pressure fluctuations during the flight remained below the shutdown threshold limit (**Figure 4**). The black line "RMC Instability Threshold" indicates the value that "rocket motor chamber pressure (PT\_M1) stability" must exceed for the RMC to command abort. The blue line indicates the RMC's computation of peak-to-peak chamber pressure oscillation which is derived from the red line, PT-M1.

Figure 4- RMC Instability Plot
