Component Examination

Re: C018-2 Clutch Assembly
C166-4 Shaft S/N 4066
C188-3 Sprag S/N 4936 Rev G

At the request of the NTSB, a visual examination was performed on the C018-2 clutch assembly, previously removed from R44 N484AB SN11390.

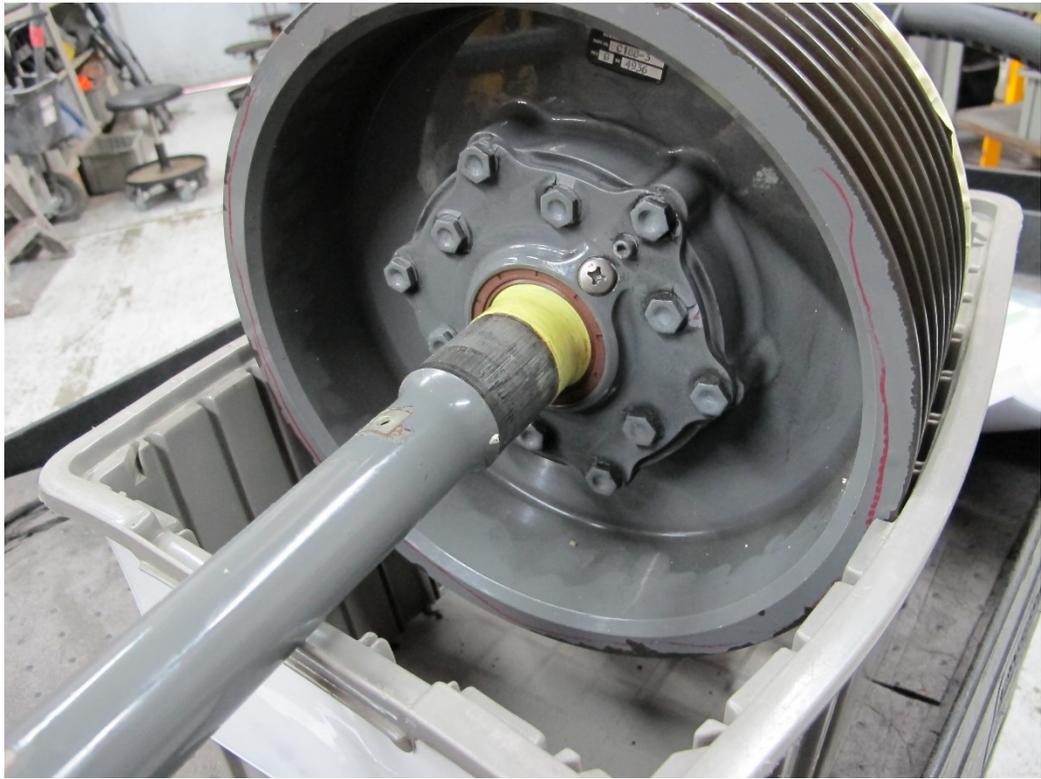
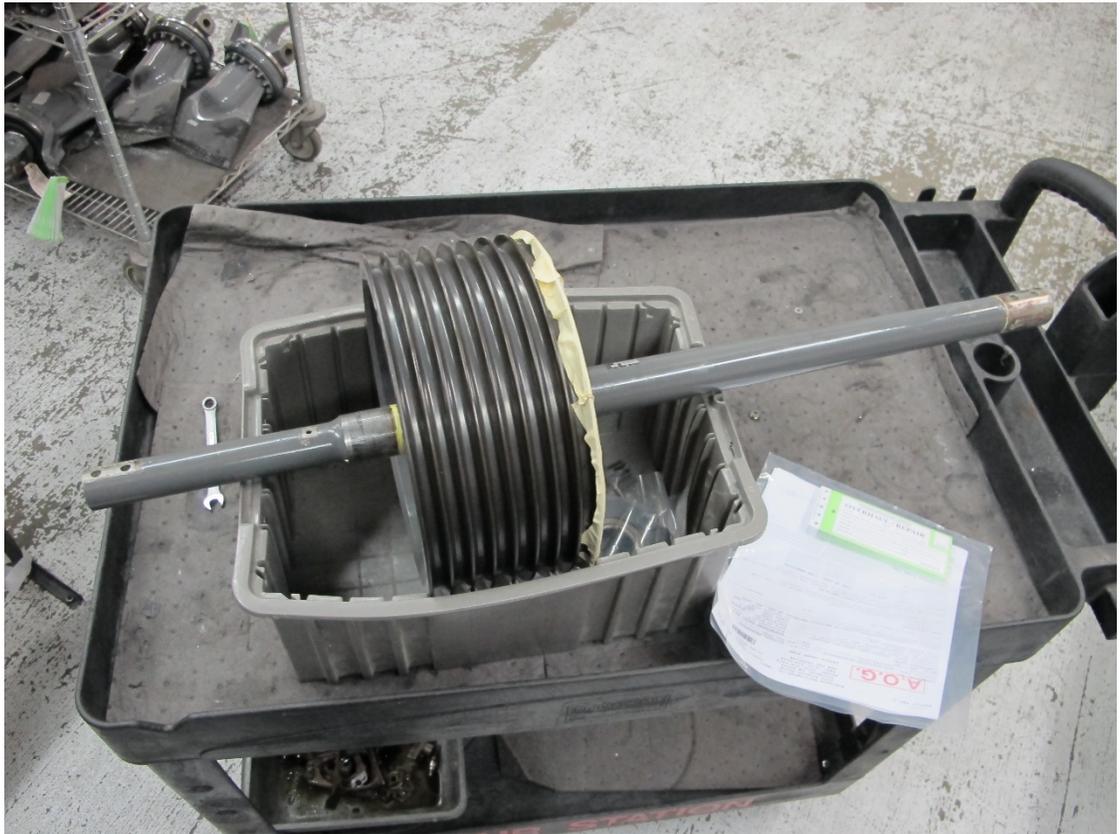
Above and below: Clutch assembly after actuator support bearing removed.

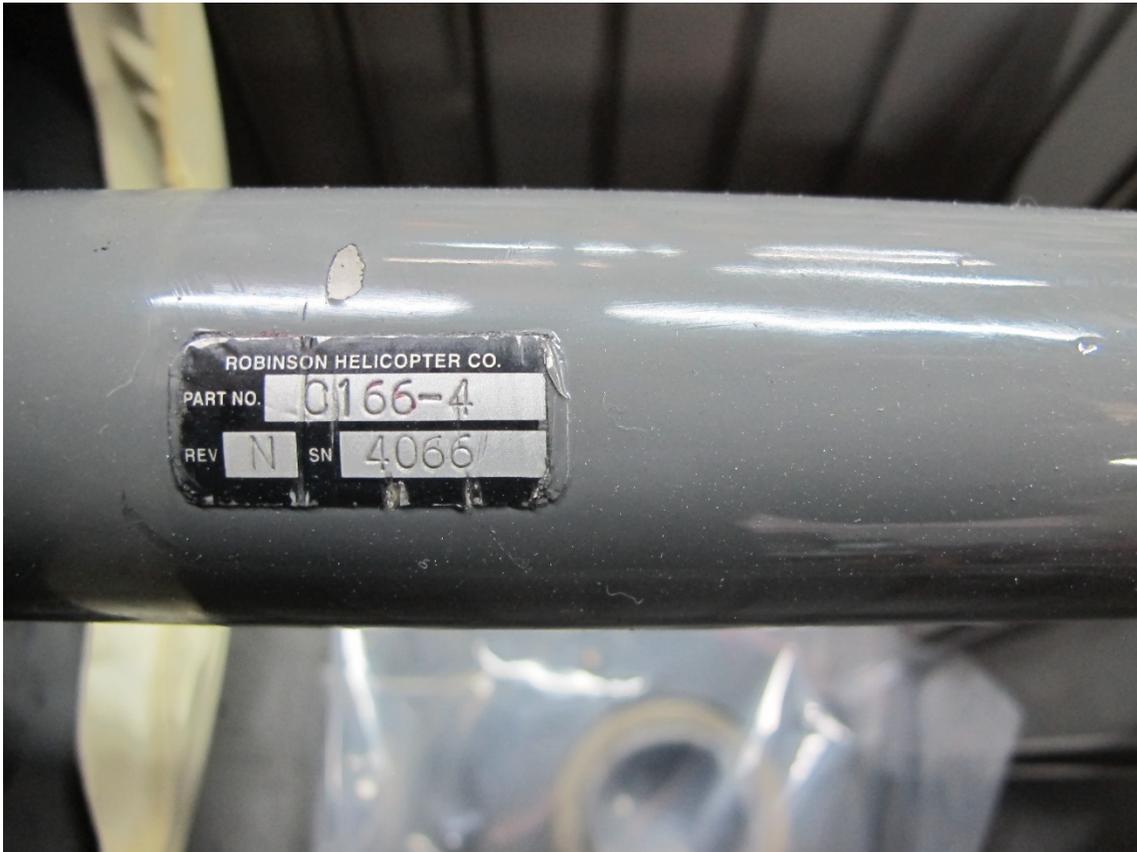
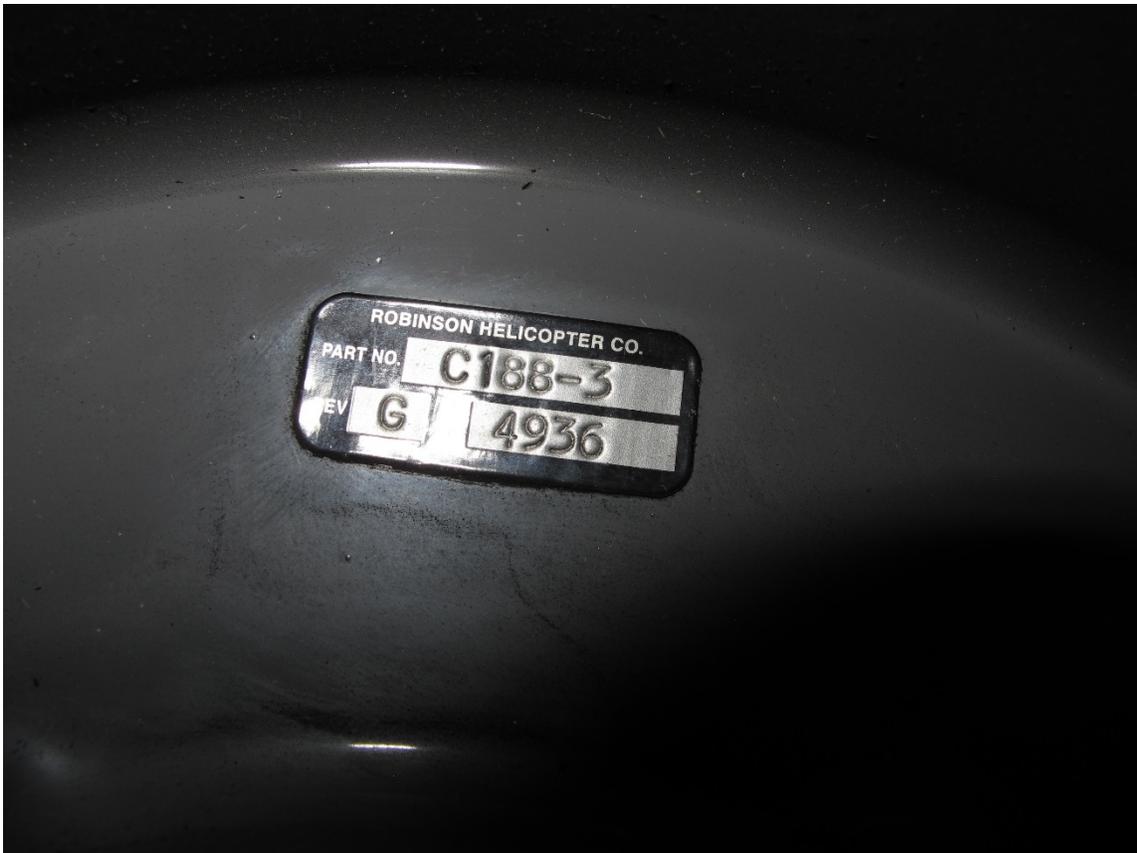
Component data plates.

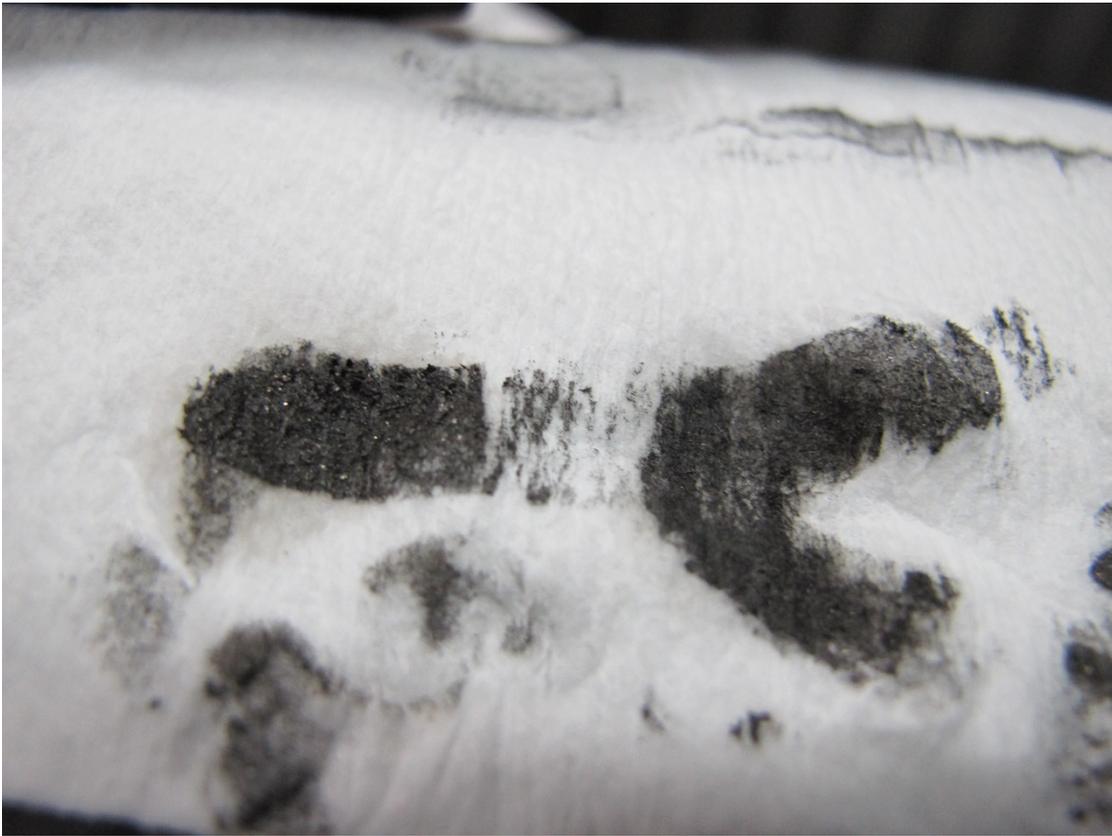
Mechanic reported very small metallic debris in the clutch oil.

Dirty oil with very fine metallic flakes (wiped on a paper towel).

R44 Maintenance Manual requires clutch assemblies to be inspected for metallic flakes every 500 hours.

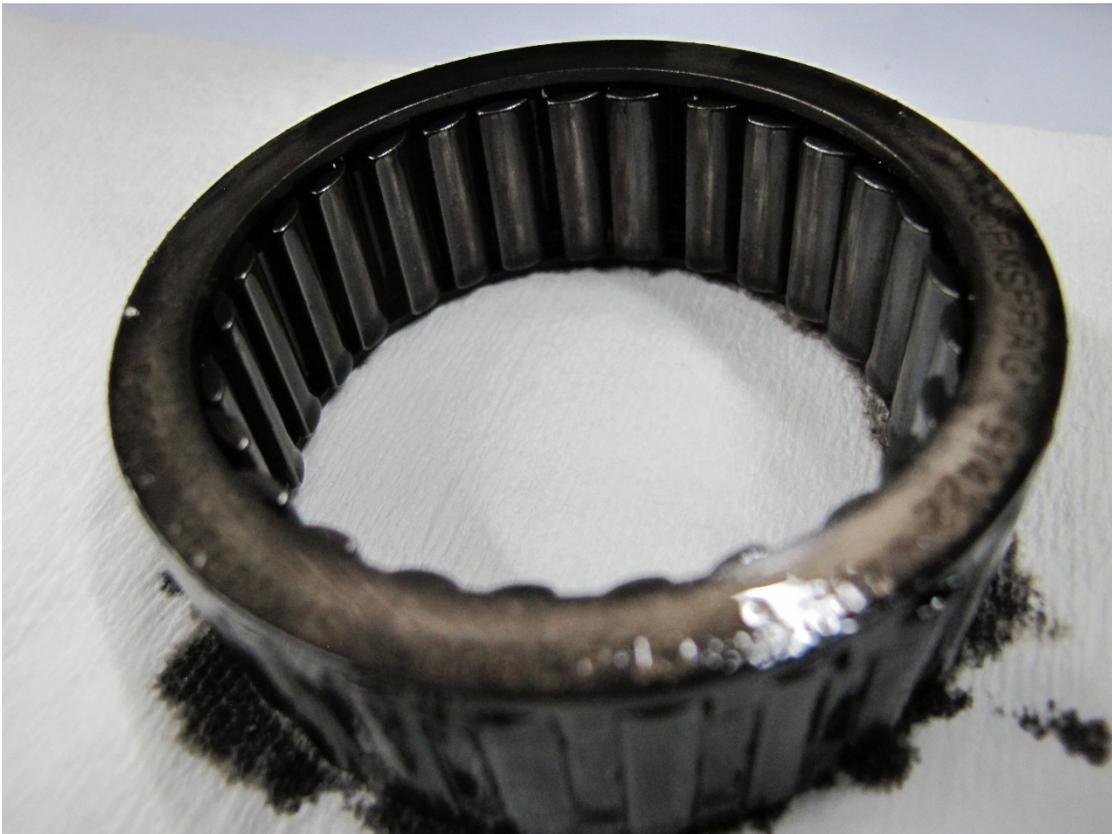
Sprag bearing as removed.

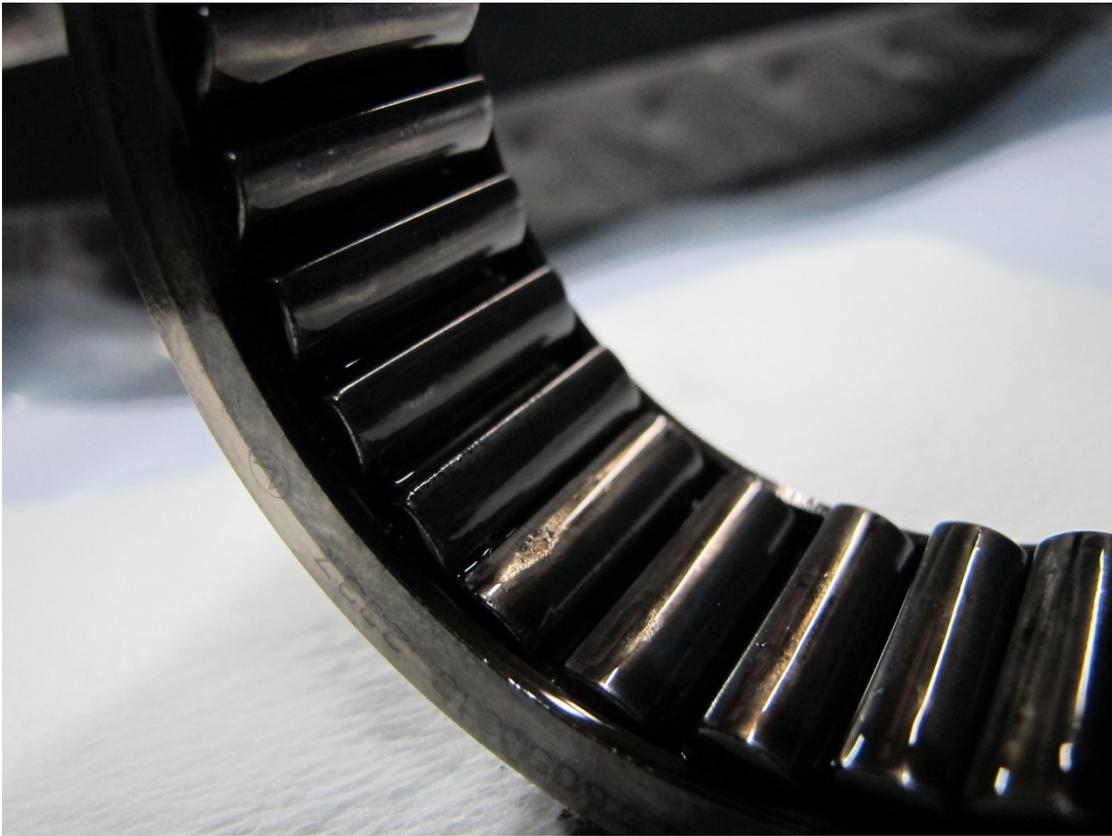
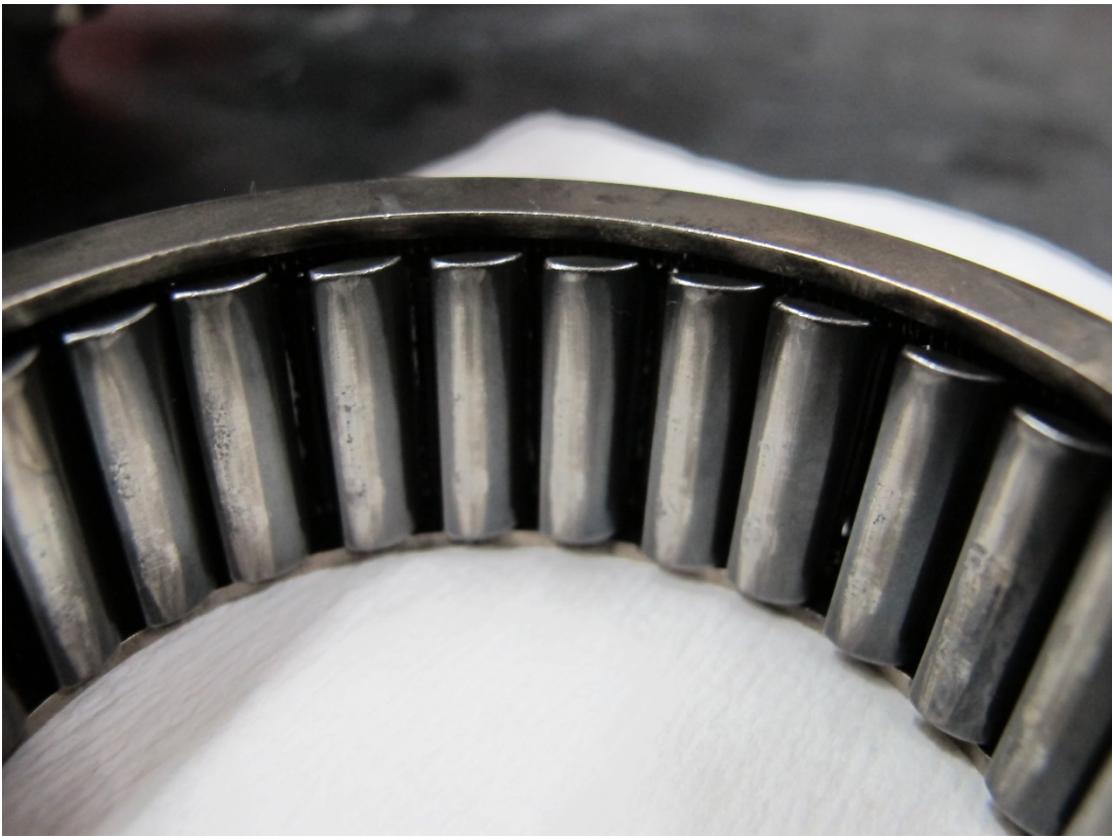
Visual examination after disassembly revealed galling between the sprags and the sprag contact surfaces on the shaft and the hub. See attached photos.

Above and below: Galling on internal contact surface of sprags.

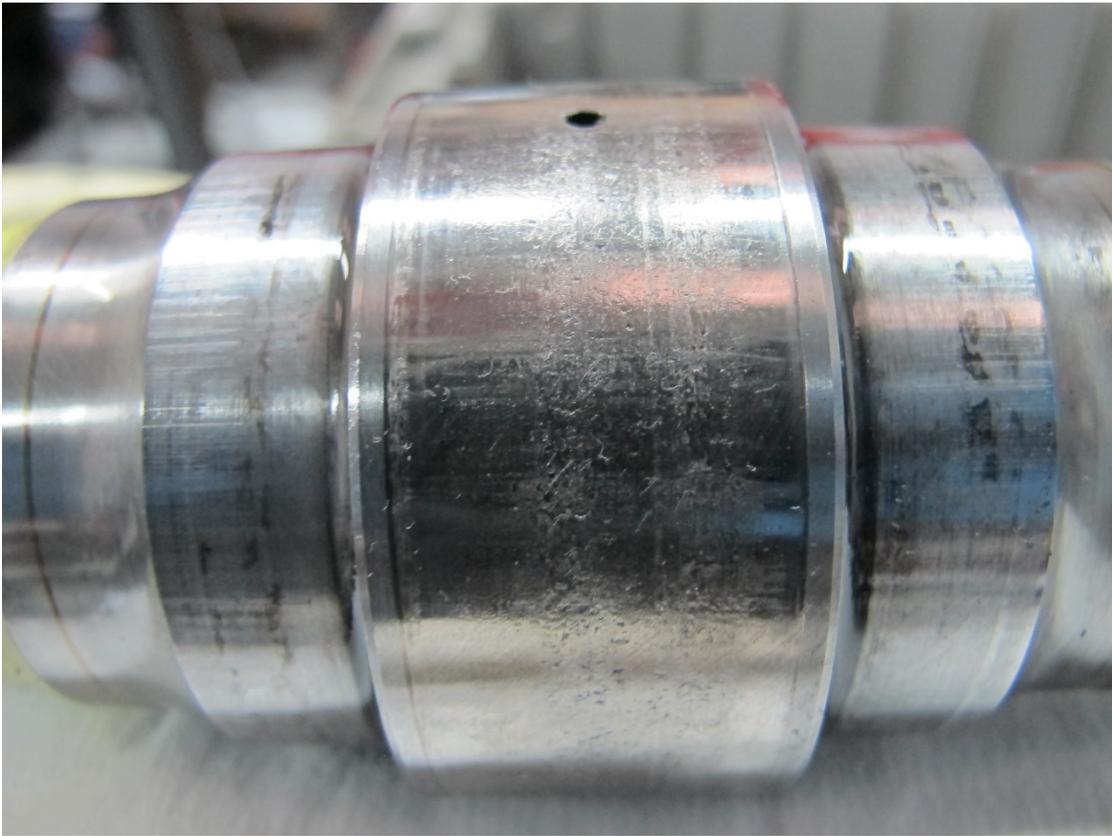
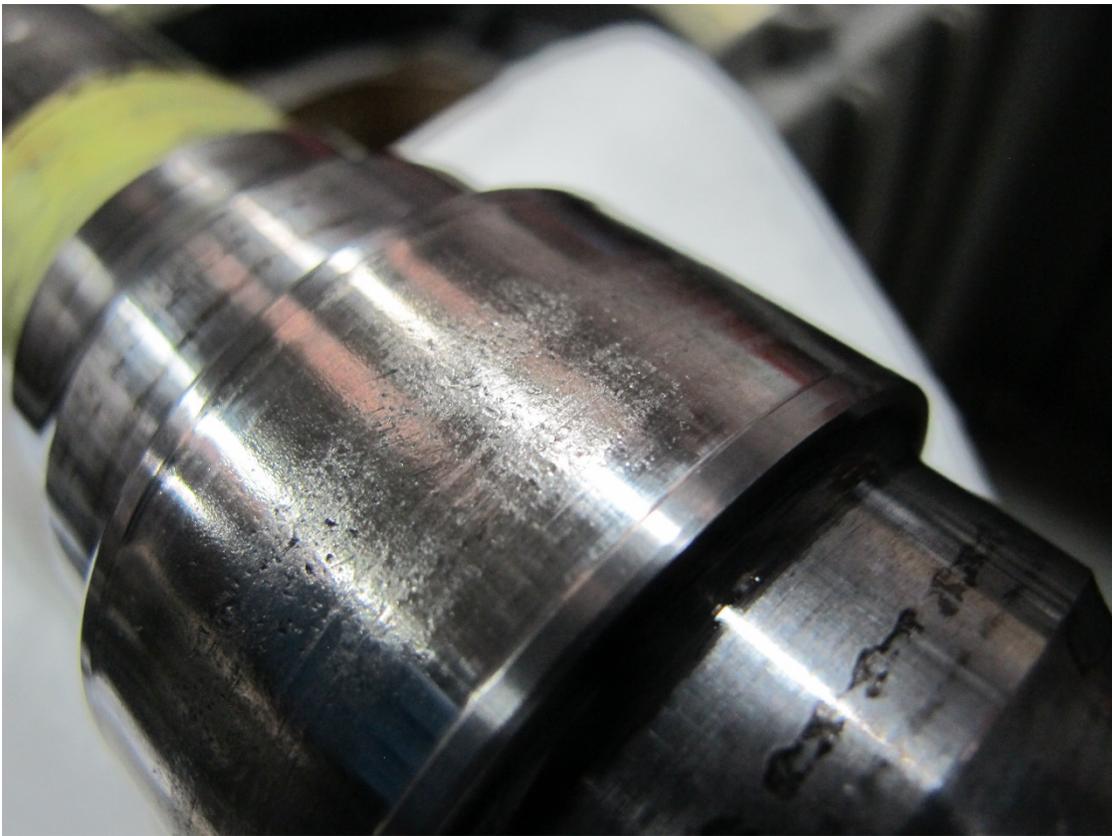
Above and below: Galling on sprag surface of clutch shaft.

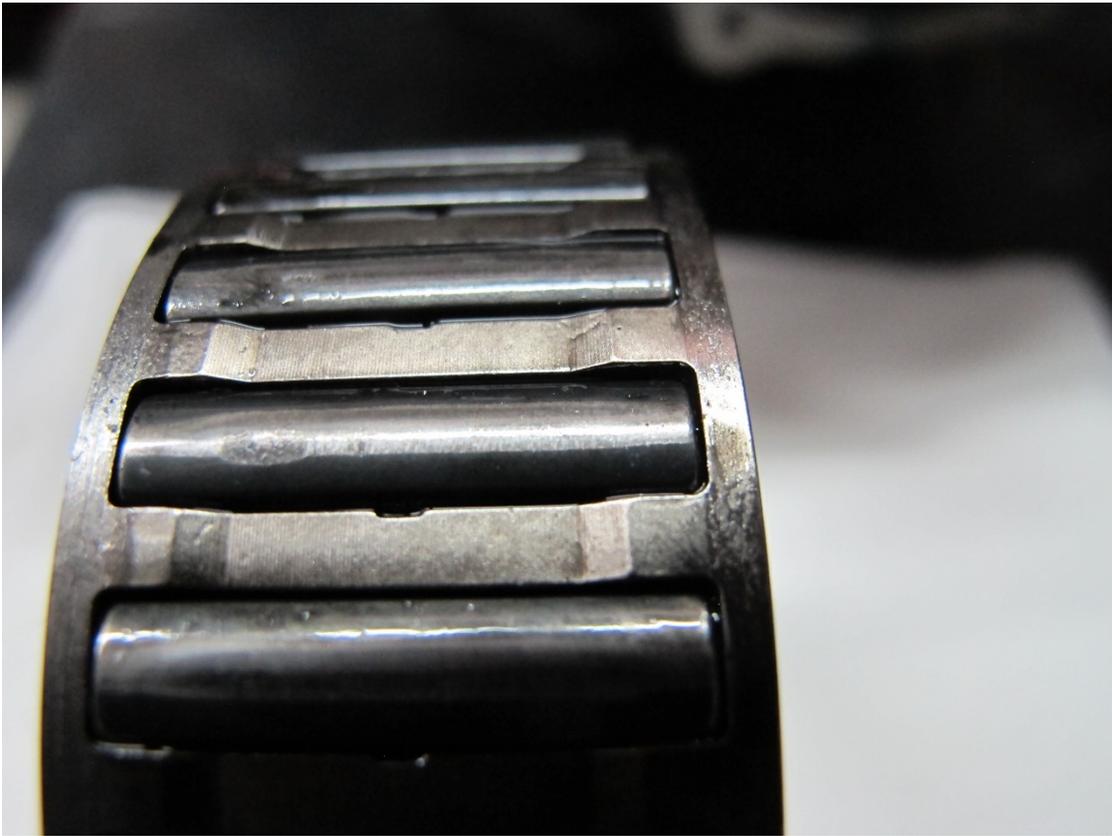
Galling on external contact surface of sprags.

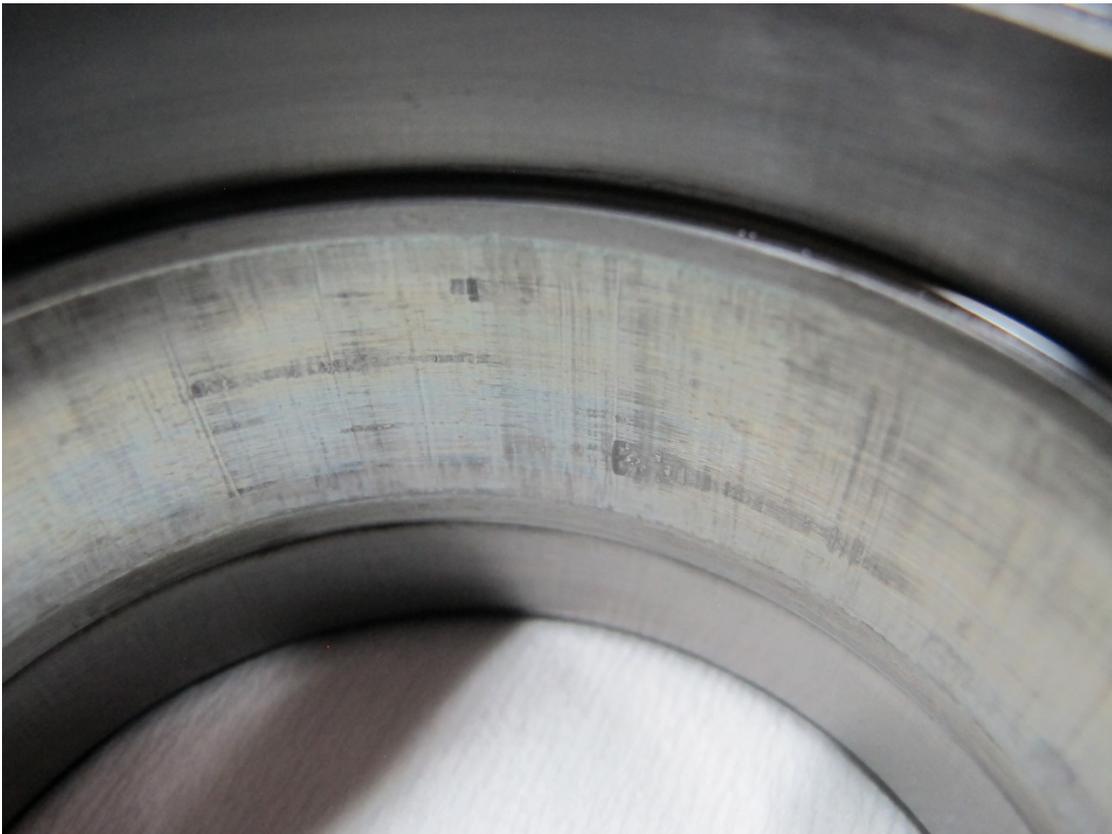
Galling on sprag contact surface of hub.
