## Radar Performance Study Addendum 1

**Location:** Teterboro, New Jersey  
**Date:** May 15, 2017  
**Time:** 1930 GMT ( 1530 EDT)  
**Airplane:** Learjet LJ35, N452DA  
**NTSB Number:** CEN17MA183

### **CEN17MA183, N452DA, Learjet LJ35A, 5/15/2017**

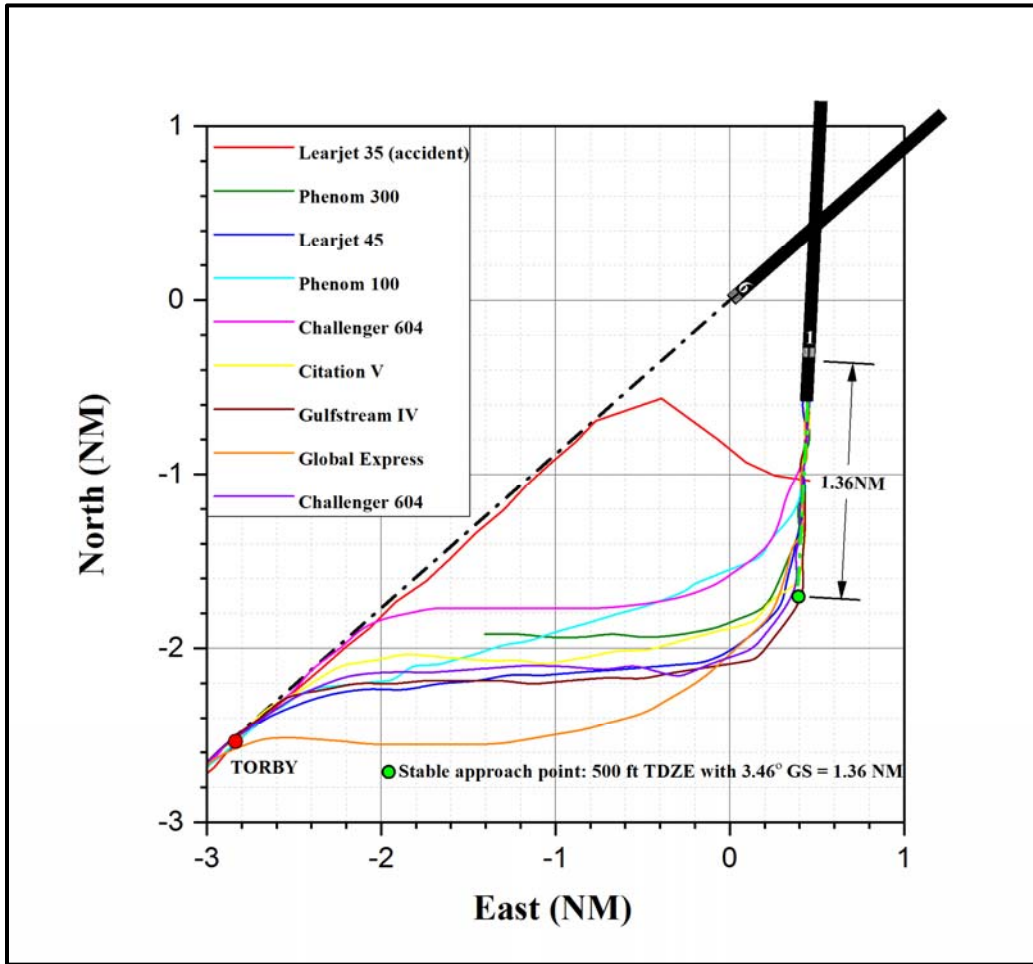
**Figure 1: Previous Flights from Day of the Accident**

Radar data for the approaches to runway 1 at TEB for the accident airplane and eight previous flights<sup>2</sup> on the day of the accident were compared to the FAA stabilized approach criteria listed above. Visual meteorological conditions prevailed, so the comparison is made at 500 ft above TDZE (vs. 1,000 ft for instrument meteorological conditions); “normal bracketing” bank angles as defined by the FAA are between  $\pm 5$  degrees. The parameters evaluated are shown in Figures 1 and 2. These evaluations indicate that:

- Six of the eight previous flights, in addition to the accident flight, were above the glideslope at 500 ft above TDZE (by between about 100 and 250 ft).
- Seven of the eight previous flights, in addition to the accident flight, were banking between 10-30 degrees between the 500 ft above TDZE point and the runway.

The radar data therefore show that most of the previous flights examined were unstable based on the above-cited FAA stable approach criteria, despite radar ground tracks that showed all but one<sup>3</sup> turned at or slightly beyond TORBY<sup>4</sup>, as the accident flight was instructed to do.
