**National Transportation Safety Board**  
Office of Research and Engineering  
Washington, D.C. 20594

**Radar Performance Study**

**Location:** Charleston, West Virginia  
**Date:** May 5, 2017  
**Time:** 1051 GMT (6:51 am EDT)  
**Airplane:** Shorts SD3-30, N334AC  
**NTSB Number:** DCA17FA109

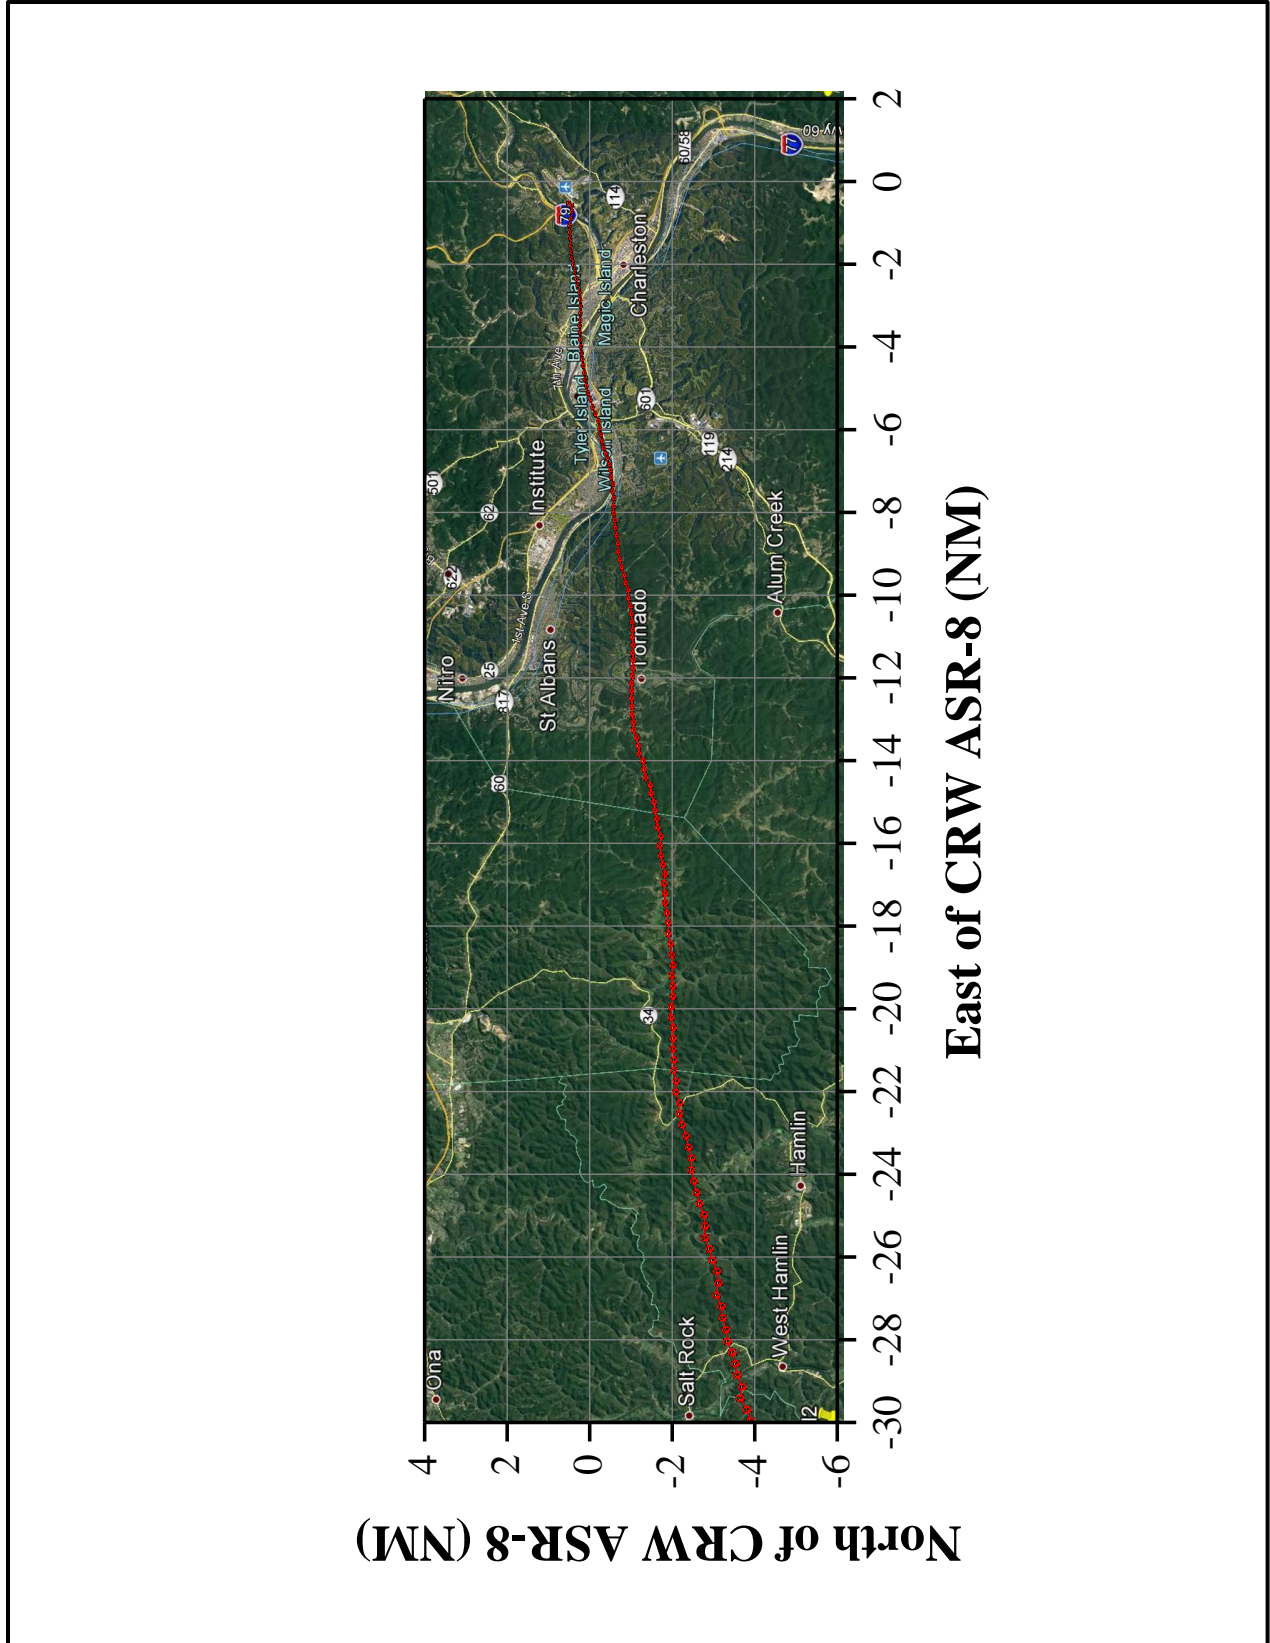
Figure 2: Radar Ground Track

Figures 2 and 3 highlight the radar ground track for the accident flight. The 230 NM planned flight took off from Louisville at about 5:40 am and was scheduled to take just over an hour. Note that the radar points in the figures are actually (red) boxes because of the uncertainty associated with radar.

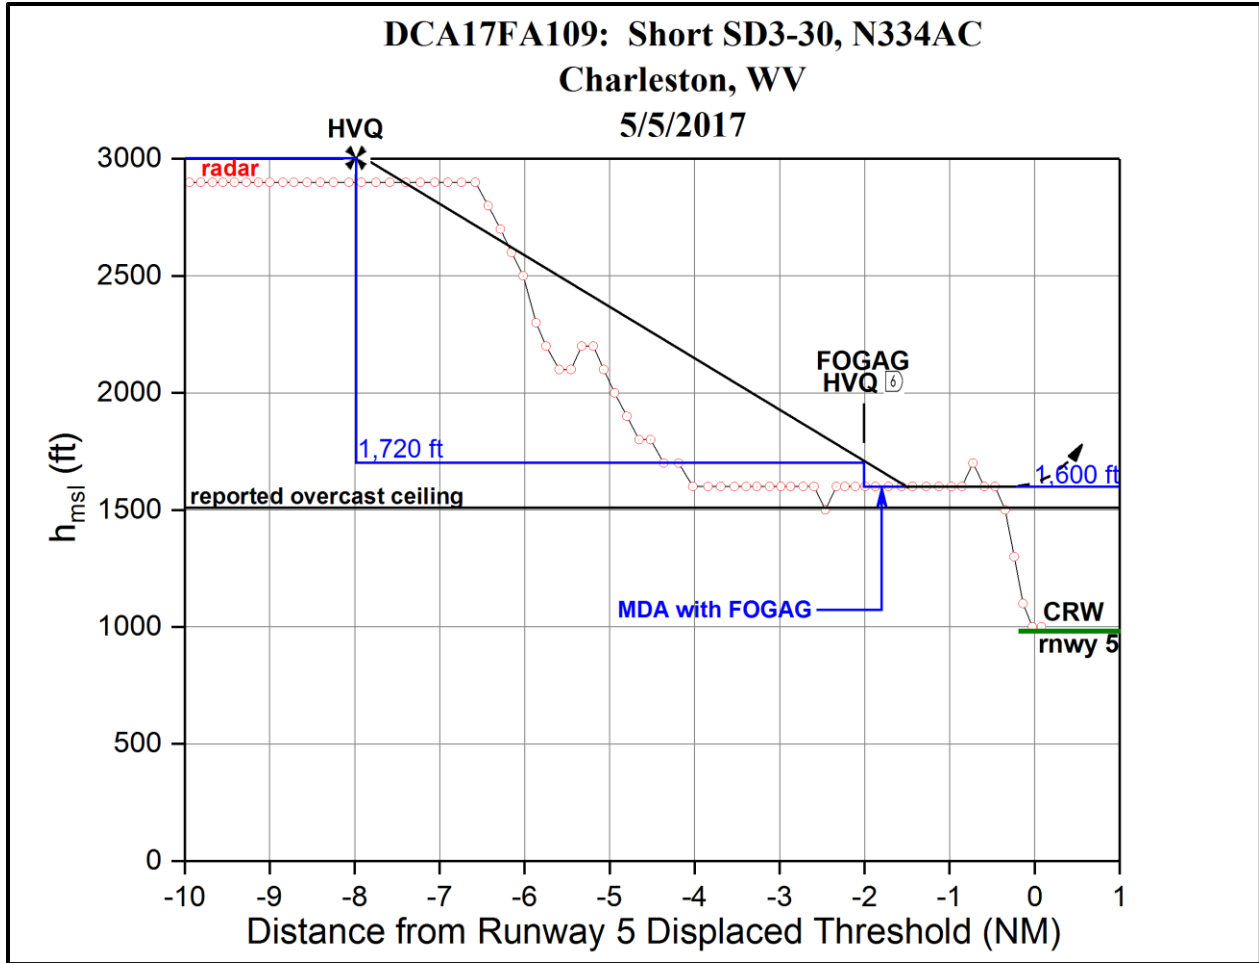
Figure 5: Profile View with Features of the VOR-A Approach

A profile view of the accident approach along with features from the approach plate are shown in Figure 5. As the figure shows, the accident airplane prematurely descended below the 1,720 ft minimum altitude limit to the Minimum Descent Altitude (MDA) of 1,600 ft approximately 2 NM prior to the fix FOGAG<sup>2</sup>.

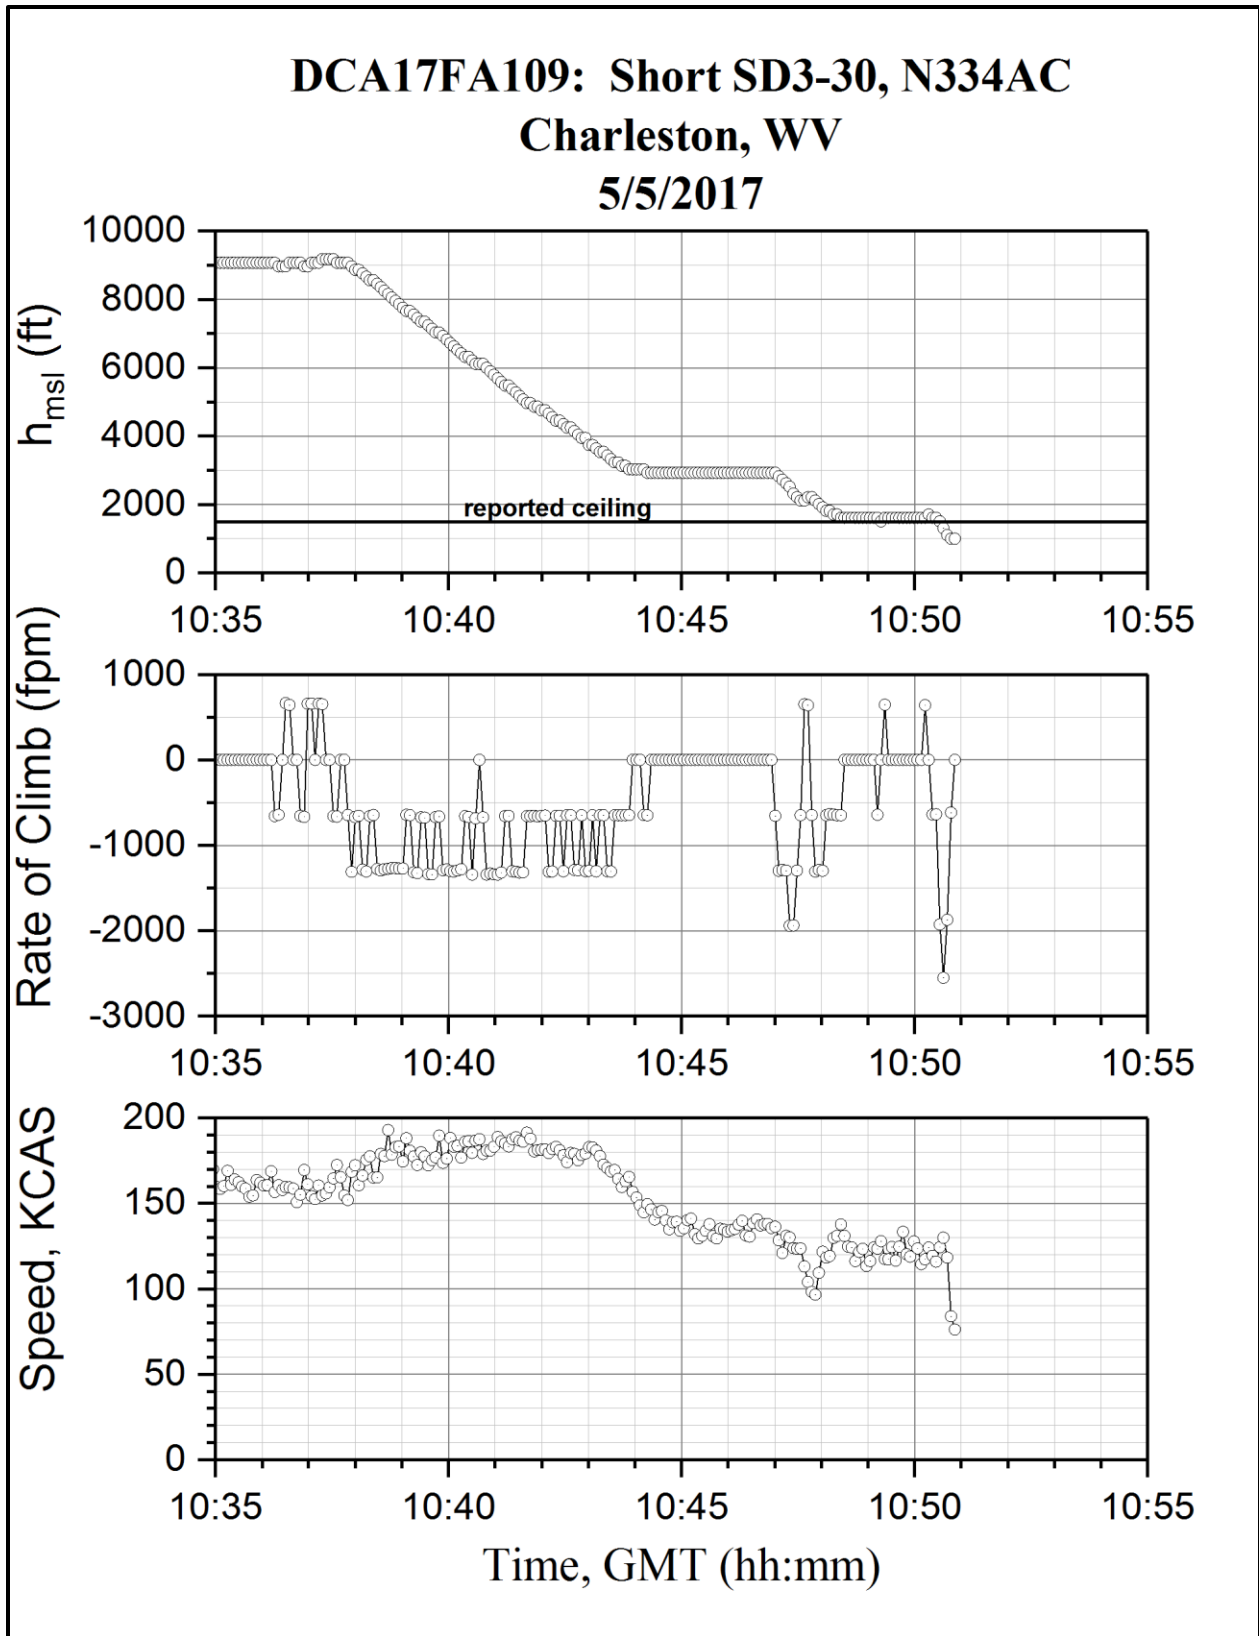
Figure 6: Altitude and Speed Based on Radar

Figures 6 thru 8 show airplane performance parameters that were derived from radar. The data indicate that the airplane approached the airport at an altitude around 1,600 ft which is both the top of the VOR-A approach and also close to the reported 500 ft agl ceiling. At about

6:50:18, the pilot initiated a 2,500 fpm descent<sup>3</sup> to the runway beginning at a calibrated airspeed of 124 kt. The descent rate and airspeed were reduced to about 600 fpm and 84 kt, respectively, just before impact at 6:50:47. The airplane was in approximately a 22° left bank and pitch was increasing from a 5° nose down attitude just before impact.
