**National Transportation Safety Board**  
Office of Research and Engineering  
Washington, D.C. 20594

**Radar Performance Study**

**Specialist Report**  
**Timothy Burtch**

**Location:** Teterboro, NJ  
**Date:** May 15, 2017  
**Time:** 1930 GMT (3:30 pm EDT)  
**Airplane:** Learjet LJ35, N452DA  
**NTSB Number:** CEN17MA183

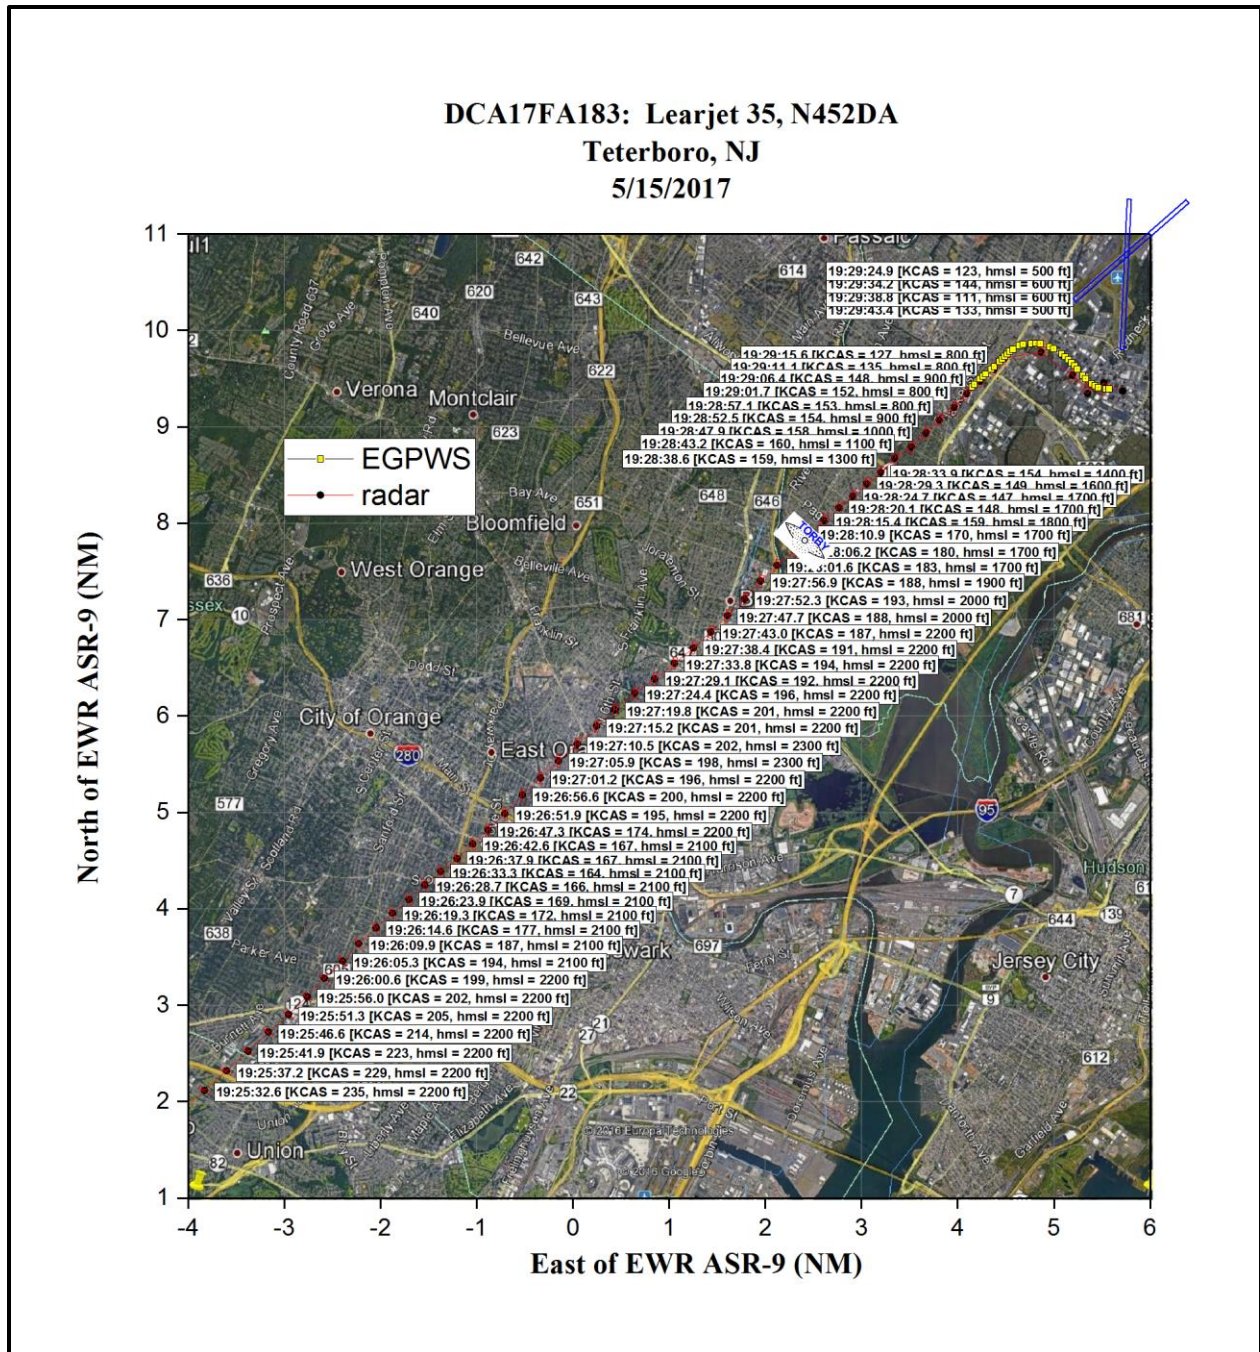
Figures 2 and 3 highlight N452DA’s ground track (with the radar uncertainty highlighted in red) during the approach. Altitude and estimated airspeed for N452DA are also included.

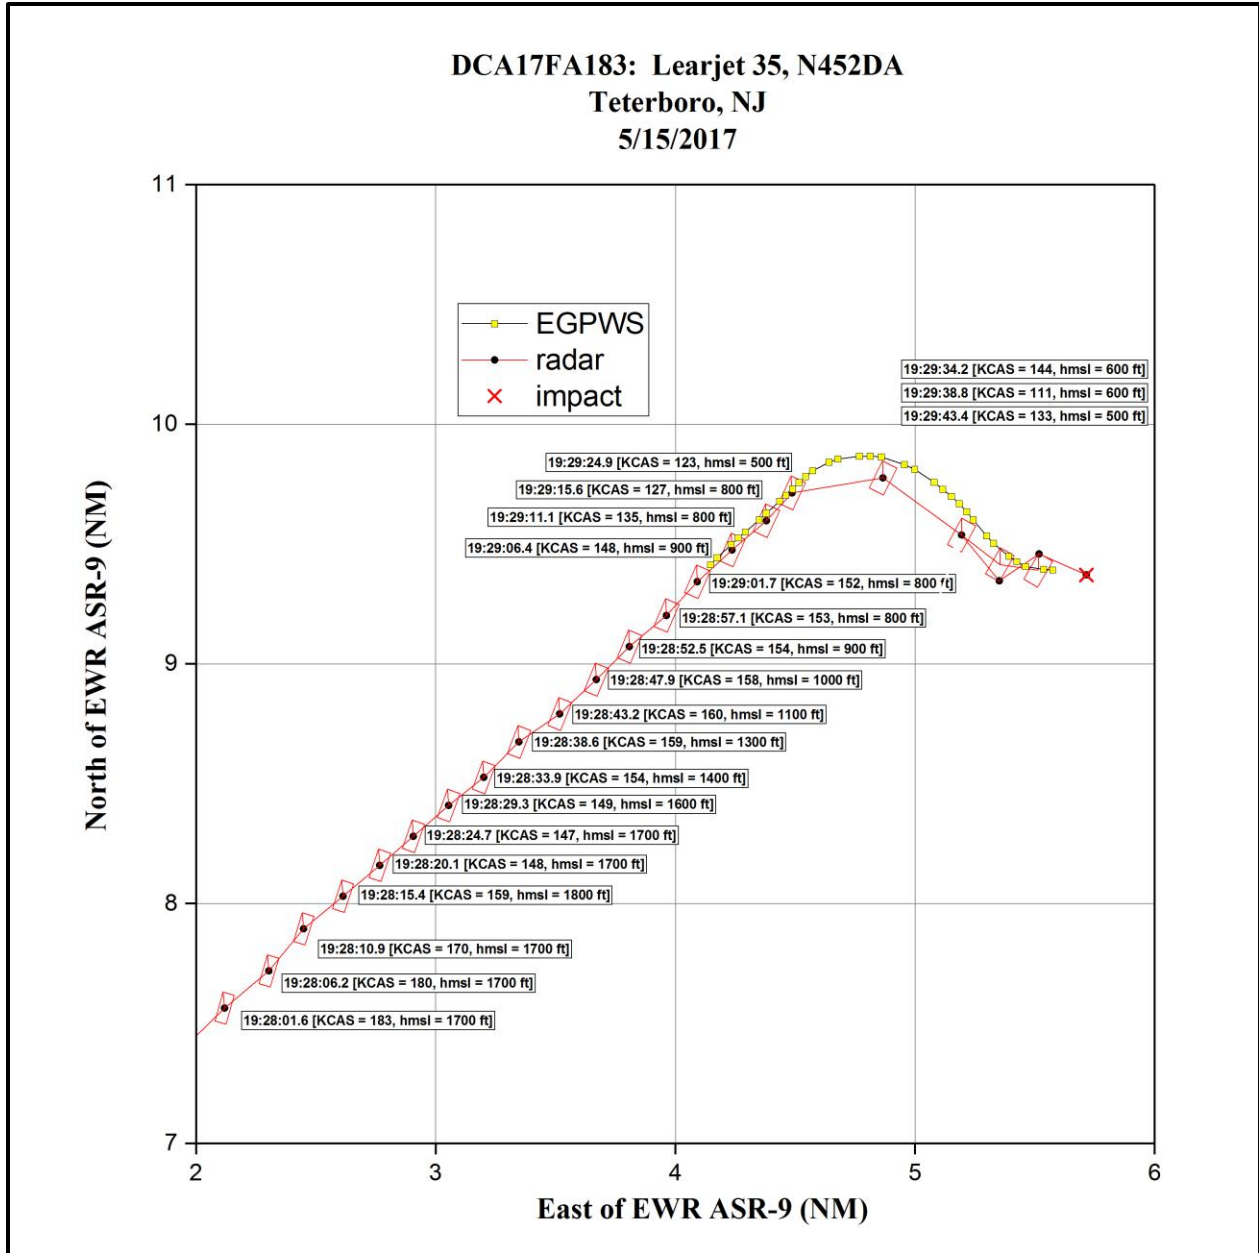
**Figure 4: Ground Track During Landing Attempt**

Figure 4 shows the ground track recorded by radar and the EGPWS data without the map overlay. Note that the radar and the EGPWS tracks are similar.

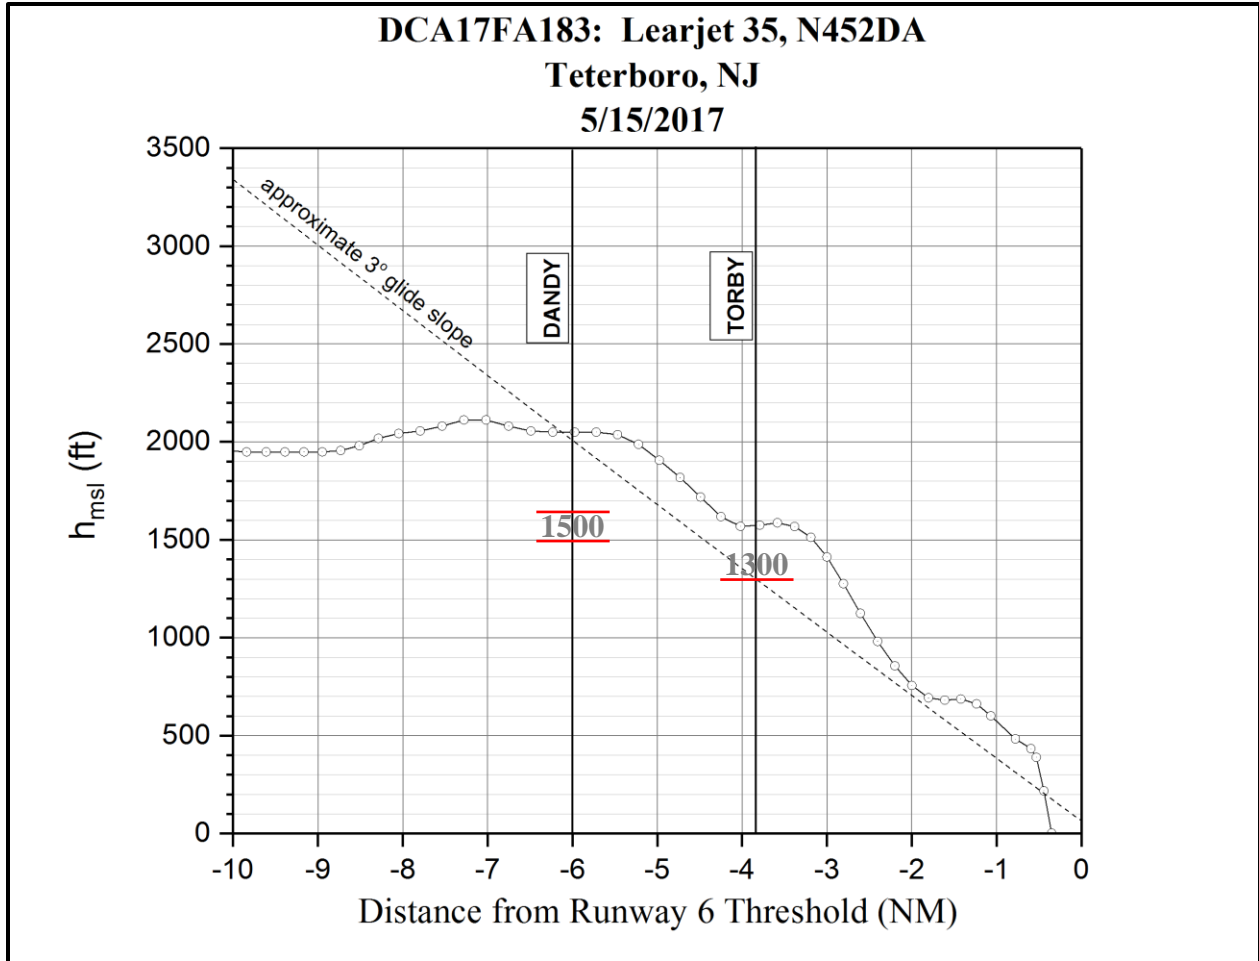
**Figure 5: Vertical Profile Relative to the ILS 6 Glide Slope**

Figure 5 captures N452DA’s vertical flight profile relative to the ILS 6 glide slope. The flight flew through the 3° glide slope just prior to the fix DANDY and never actually captured it.

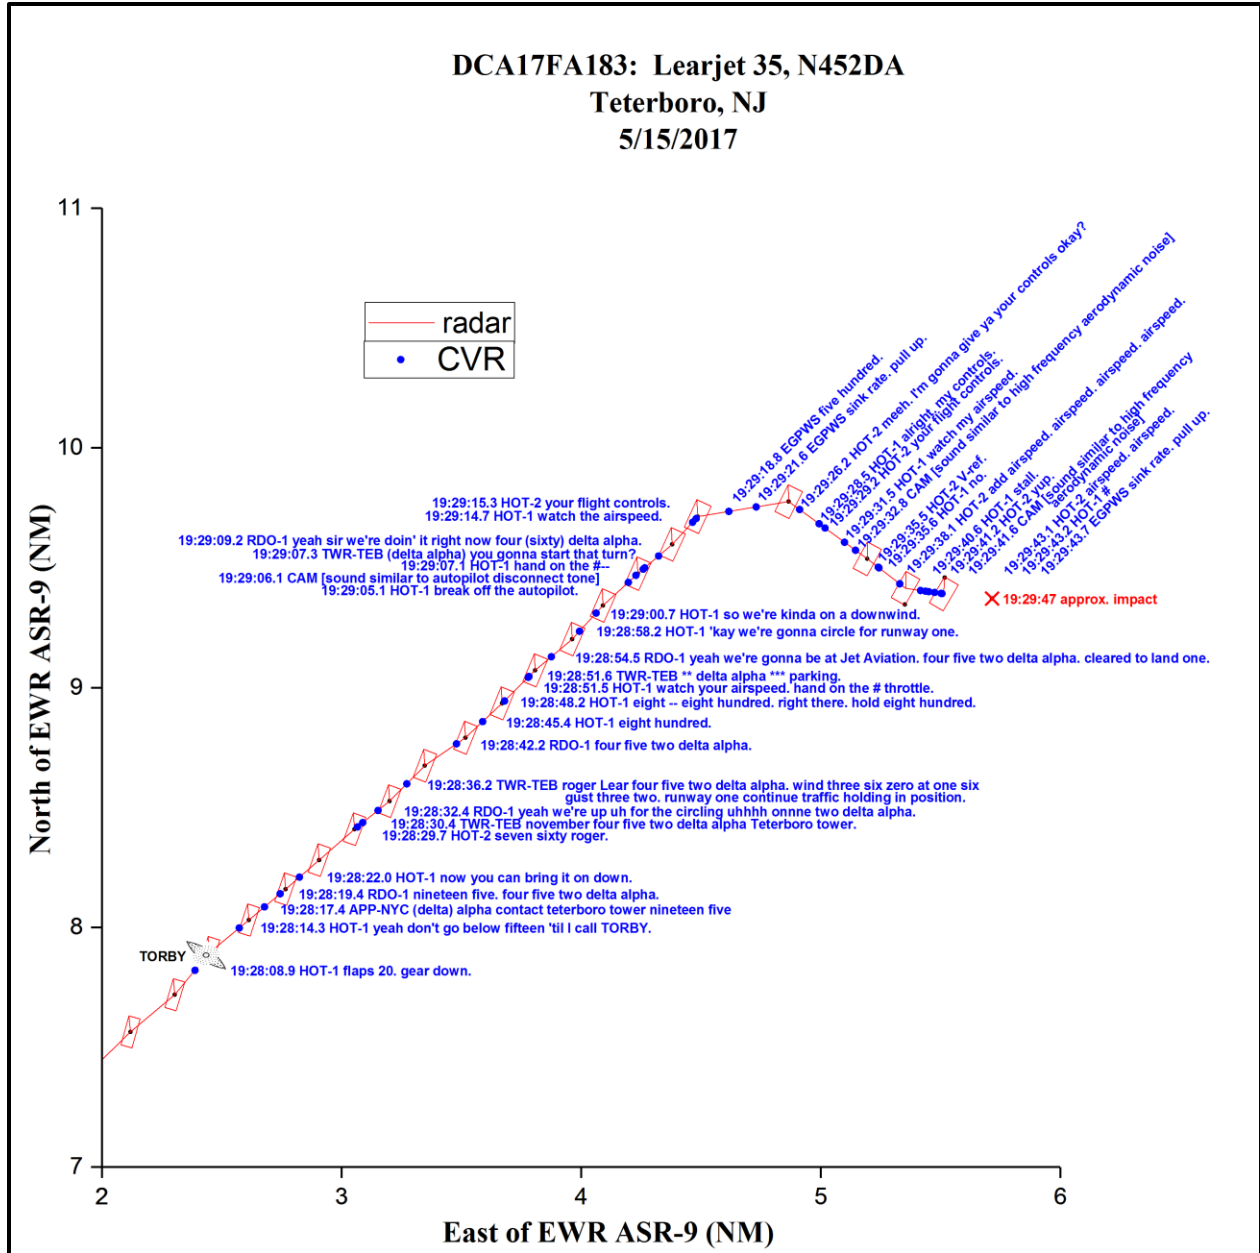
**Figure 6: Radar Ground Track with CVR Comments (time in GMT)**

Figure 6 highlights the CVR comments in the context of N452DA’s radar position.

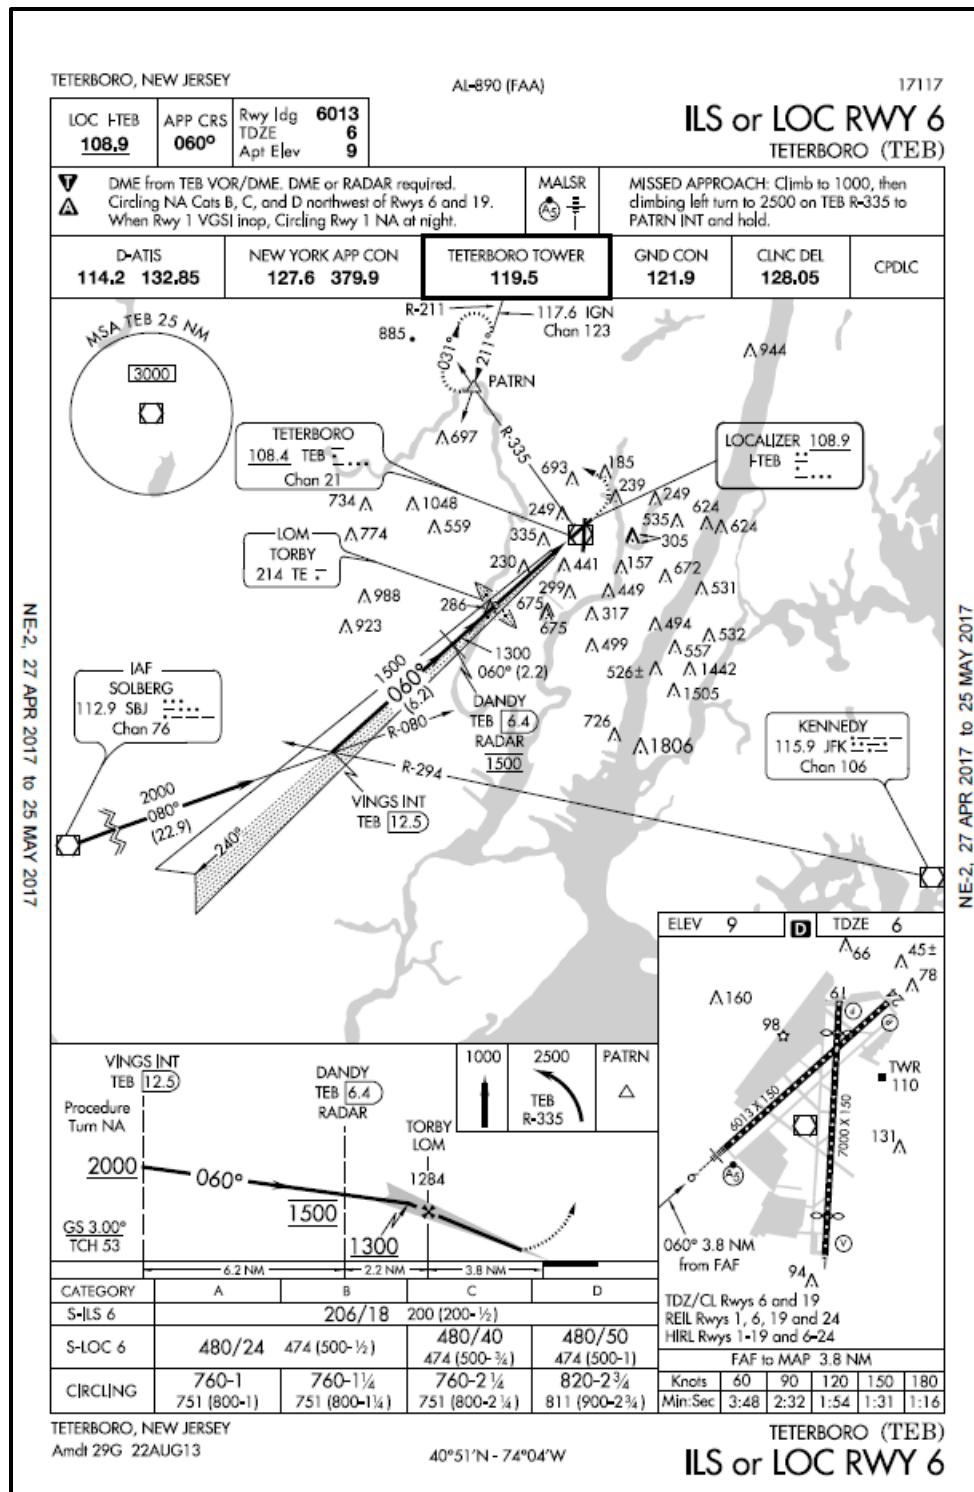
Figure 7: N452DA Cleared for the ILS 6, Circle to Land Runway 1

Approaching flights were instructed by air traffic control to fly the ILS to runway 6 and then to break off at the outer marker TORBY for a visual approach to runway 1. As shown on the approach plate for Teterboro’s ILS 6 in Figure 7, TORBY is 3.8 NM from runway 6. N452DA did not initiate the turn to align with runway 1 until about 1 NM from runway 6 or 2.8 NM beyond TORBY.

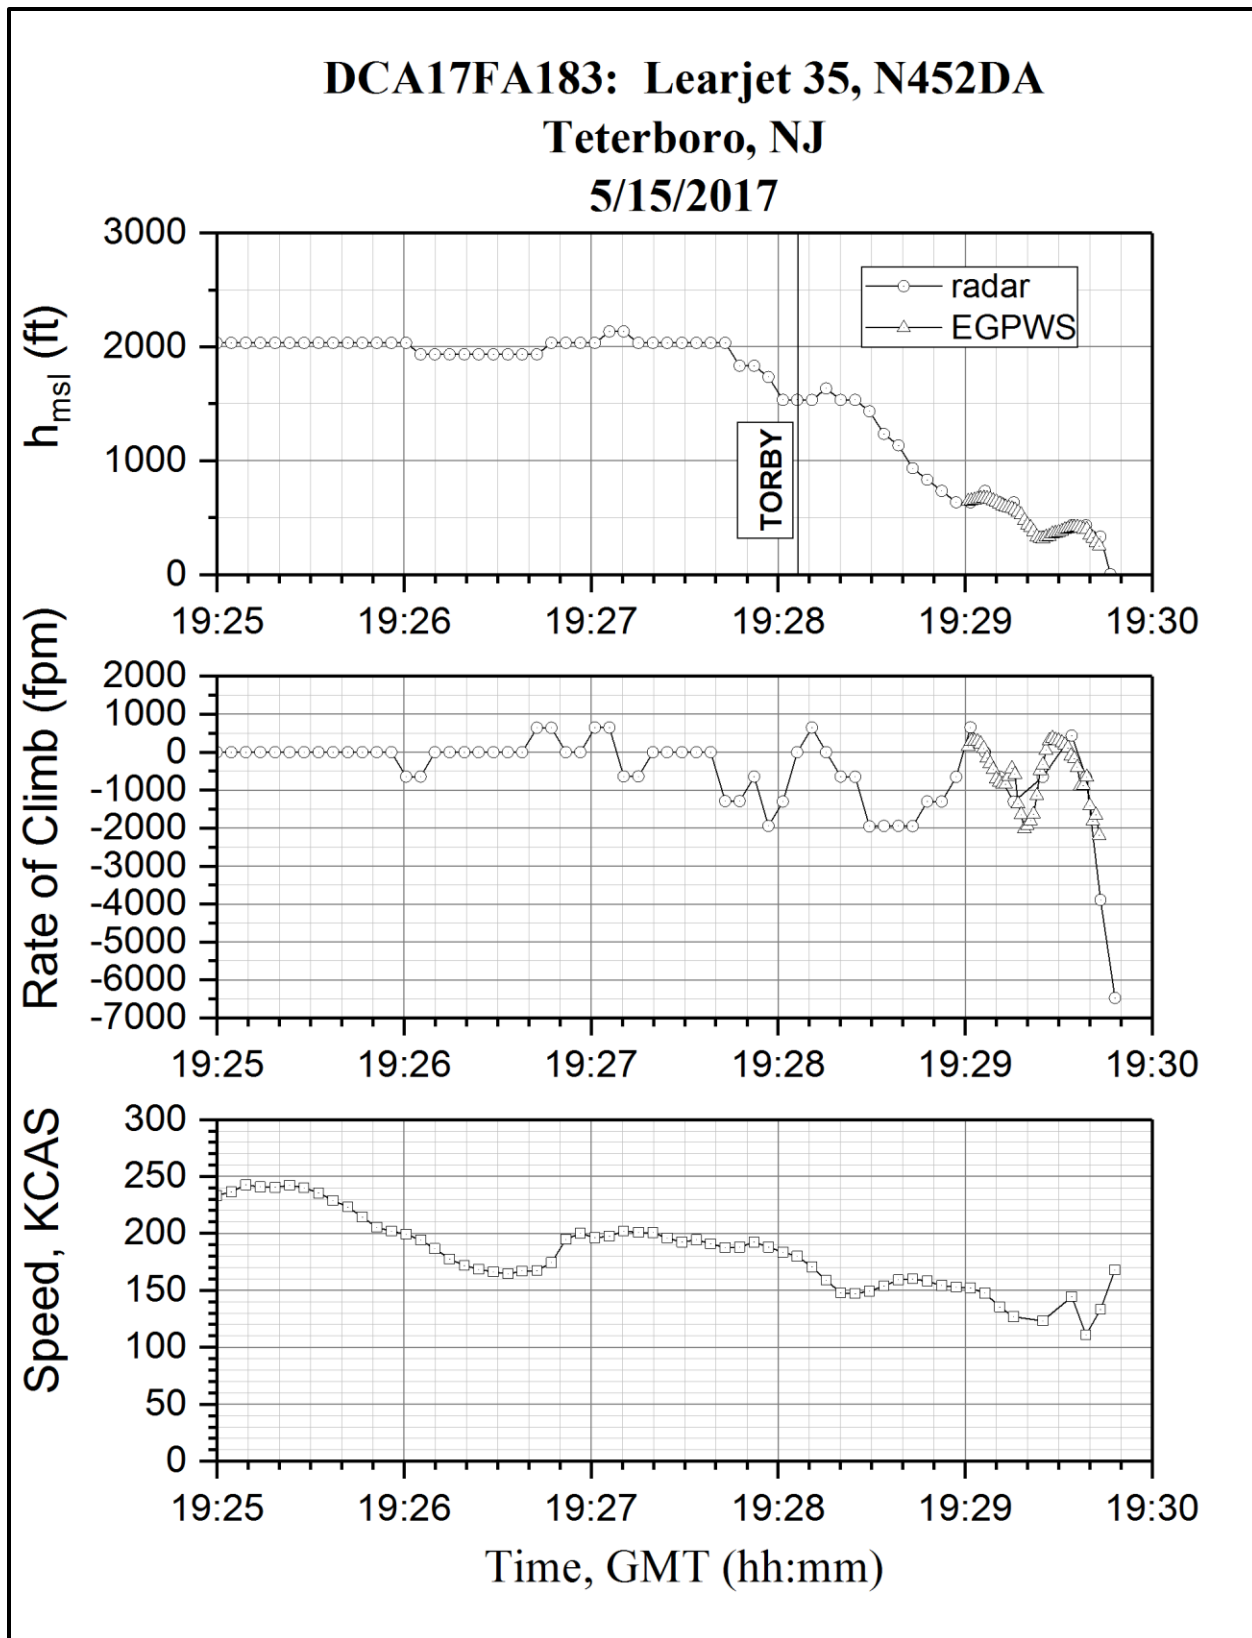
Figure 8: Altitude and Airspeed

Figures 8 thru 12 show airplane performance parameters derived from radar as well as EGPWS data where available. Airspeeds in Figure 8 were estimated from radar using winds from a sounding over TEB released from EWR at 1530. (From the estimated airspeed time history, it appears that N452DA exceeded the 250 kt airspeed limit that exists below 10,000 ft msl<sup>2</sup>.)

The crew of N452DA had filed for a cruising altitude of 27,000 ft; however, the accident flight never climbed above about 4,000 ft msl during the half hour flight from Philadelphia to Teterboro. The crew exceeded the Federal Aviation Administration's (FAA) 250 kt speed limit for flights below 10,000 ft msl.

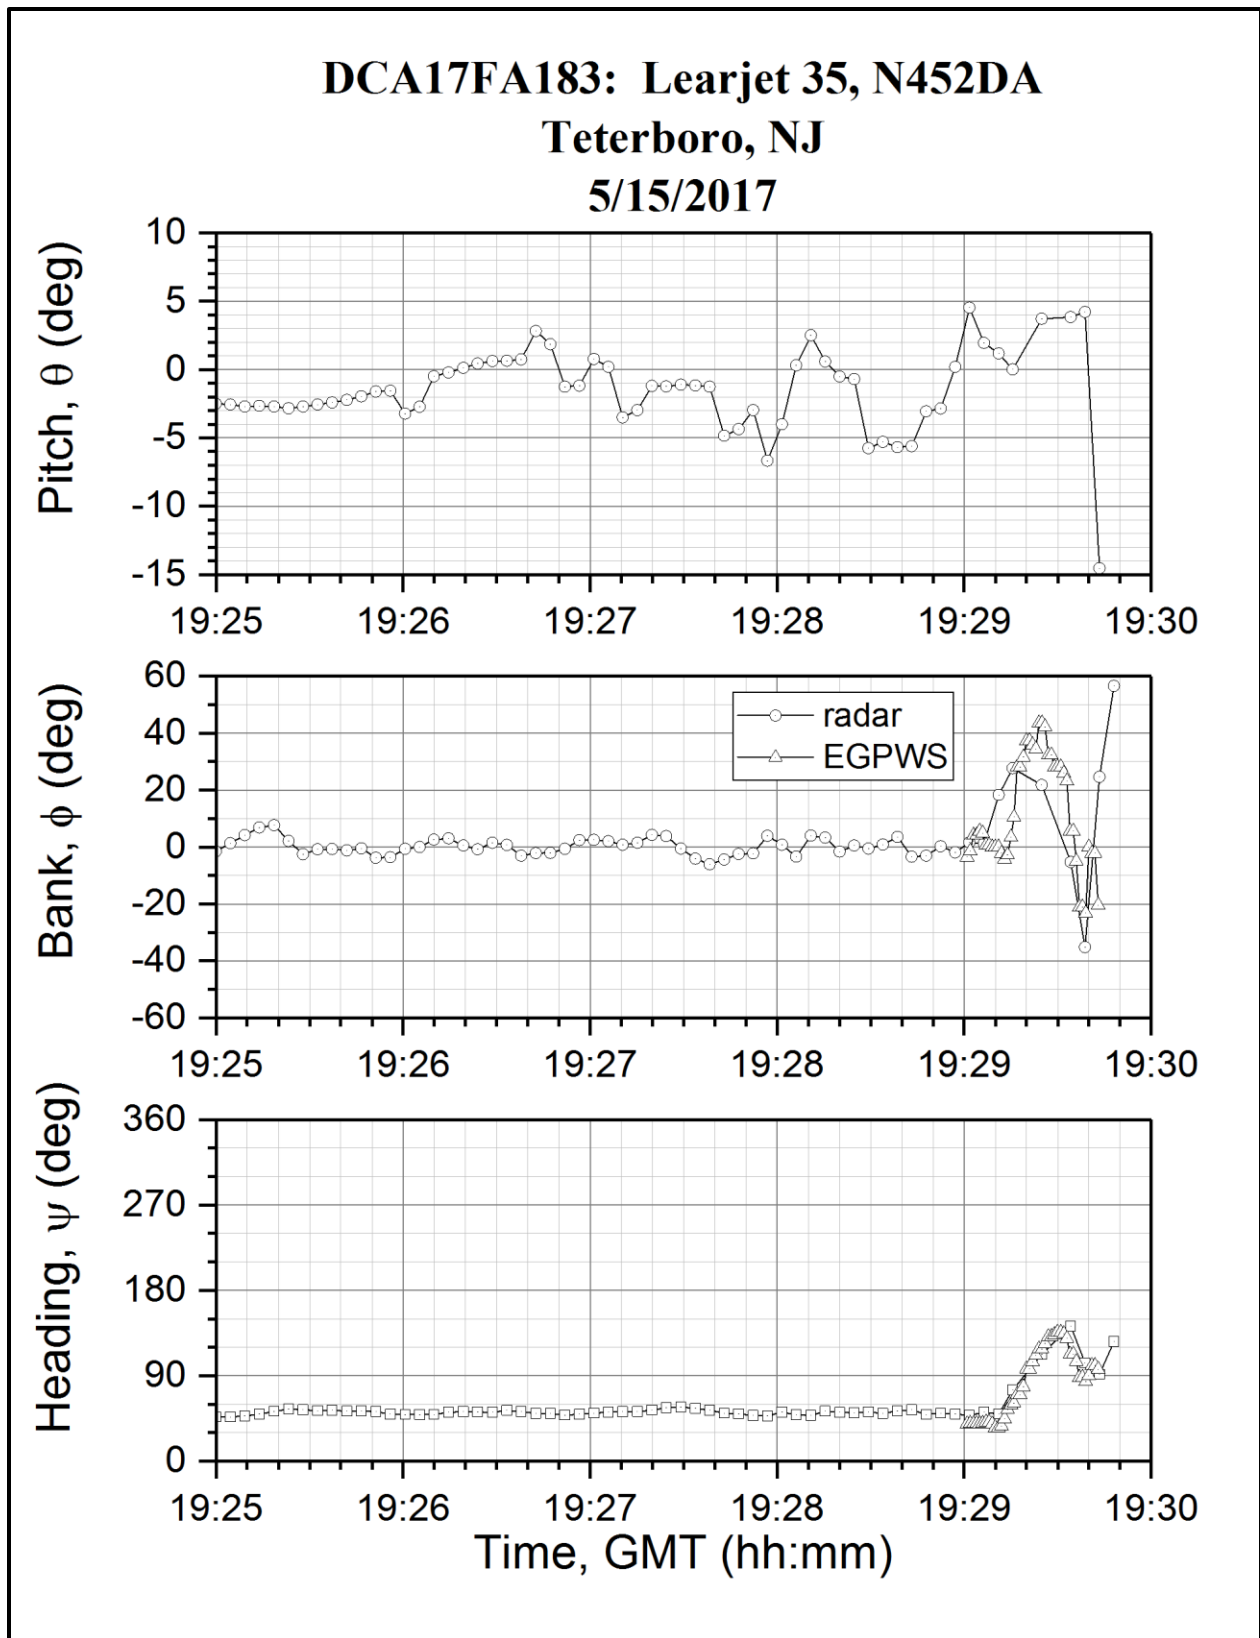
Figure 9: Pitch, Bank, and Heading

The airplane attitude time histories shown in Figure 9 are also based on the EWR short-range radar. Because ASR-9 radar returns are only recorded every four to five seconds, the attitude estimates are less accurate during dynamic flight (high-rate turns, stalls, etc.). This could explain the discrepancy between video footage that shows an impact bank angle in excess of 90° and the final radar-based bank angle estimate of 57°.

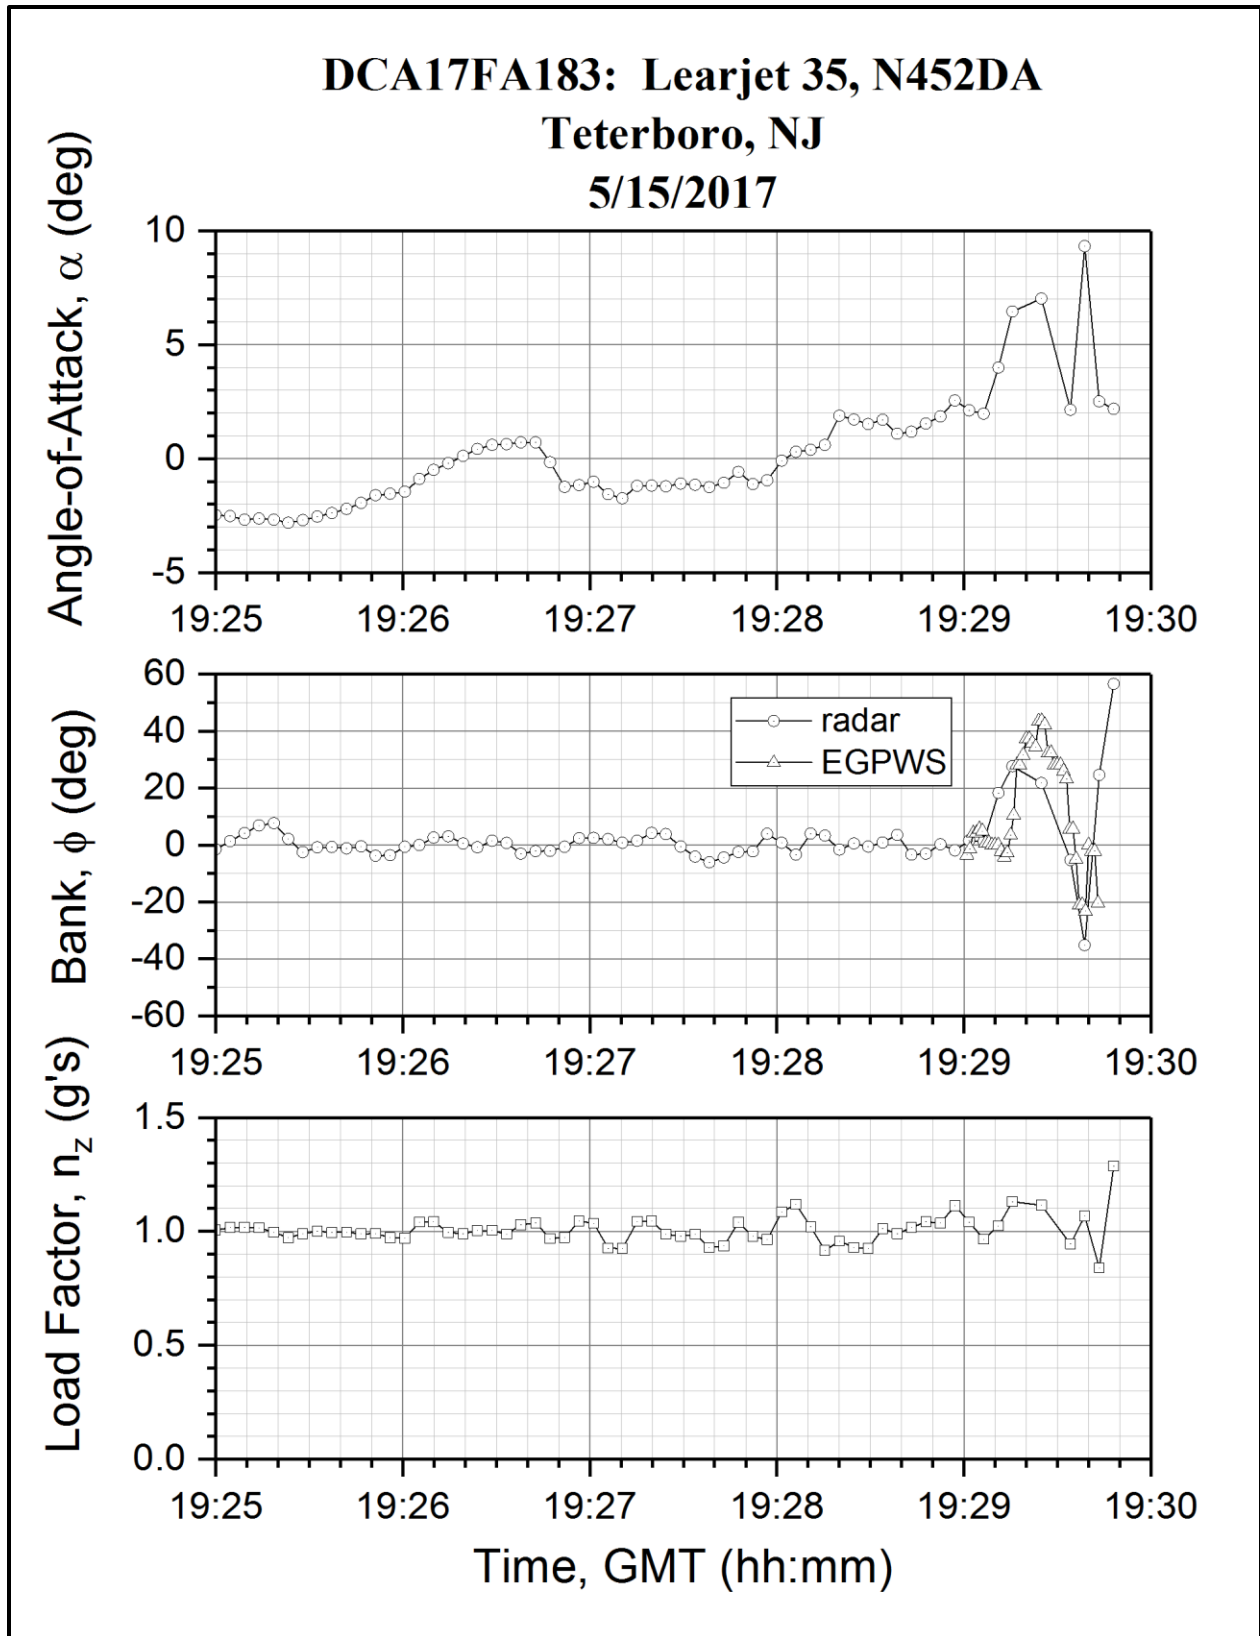
Figure 10: Estimated Angle-of-Attack and Load Factor

Figures 10 and 11 suggest that the airplane never reached stall speed. However, accelerated flight, uncoordinated flight, flight control inputs, and/or a momentary wind gust<sup>3</sup> could have negated the small stall speed margins highlighted in Figure 11. For example, the wings-level stall speeds for flaps 20° and flaps 40° are 97 kt and 92 kt, respectively<sup>4</sup>. The wings-level stall speed of 92 kt at flaps 40° increases to 102 kt in a 35° level turn, and the other conditions listed above would further increase the stall speed. The higher stall speed is within knots of the estimated airspeed just before the airplane abruptly banked right (away from the runway) and impacted terrain.

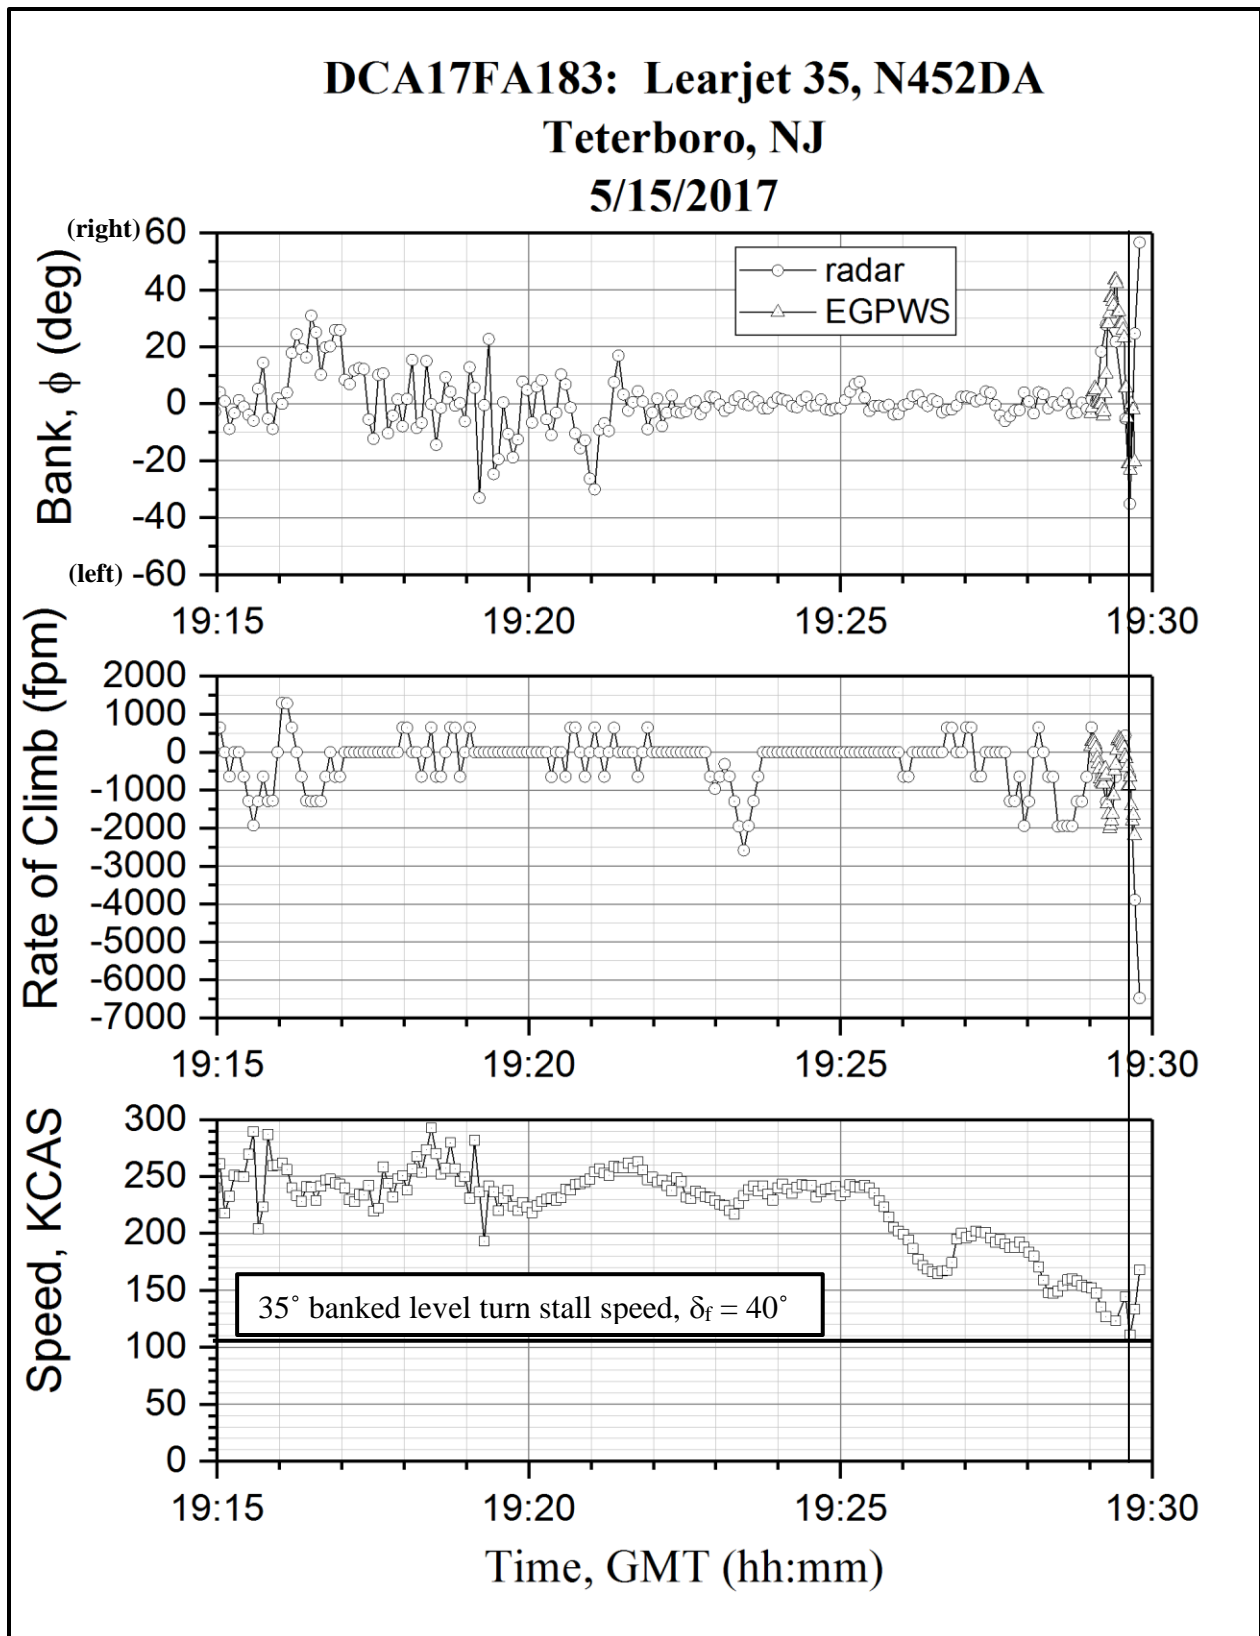
Figure 11: Bank, Rate of Climb, and Airspeed

The radar data indicate that the airplane slowed to within 9 kt of the 102 kt stall speed published in the FAA Approved Flight Manual for the Gates Learjet 35A in a level and coordinated 35° banked turn. However, the 9 kt margin does not account for wind gusts or flight control inputs which could quickly eliminate the stall margin<sup>6</sup>.

<sup>6</sup> At 19:29:39, the airplane was in a 35° left turn and at its slowest airspeed. The left-wing-down aileron that would be required to make the turn to final and to counter the strong left crosswind would increase the angle-of-attack on the right wing and potentially lead to stall on that wing first. N452DA's final turn before impacting a building was to the right, away from the runway.

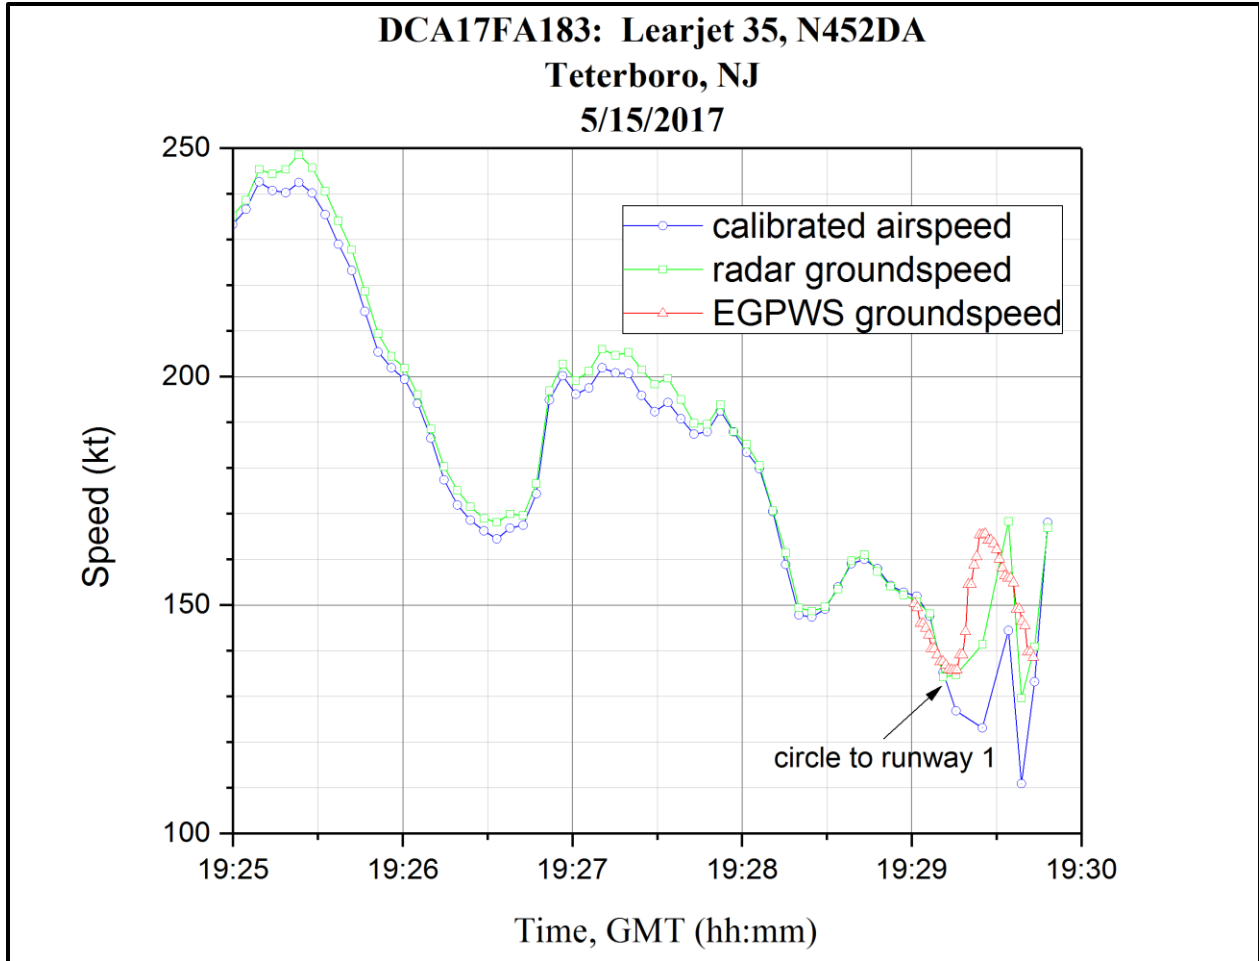
**Figure 12: 20 kt Tailwind during the Circle to Land Runway 1**

Figure 12 is a comparison between estimated airspeed<sup>5</sup> and groundspeed. The difference between the two speeds is due to the wind. The figure highlights the large crosswind from the northwest that resulted in approximately a 20 kt tailwind when N452DA made the late circling turn to runway 1. However, because the speeds were calculated from airplane position and reported steady wind velocities (not from varying wind velocity measurements at the time of the event), Figure 12 does not capture momentary gusts that could have affected the airspeed and possible stall.
